NONDESTRUCTIVE INSPECTION OF GENERAL
PURPOSE HEAT SOURCE (GPHS) GIRTH WELDS

INSTITUTE FOR SPACE AND NUCLEAR POWER
STUDIES
SPACE TECHNOLOGY & APPLICATIONS
INTERNATIONAL FORUM (STAIF-98)
JANUARY 25-29, 1998
ALBUQUERQUE, NM

NONDESTRUCTIVE INSPECTION OF GENERAL PURPOSE HEAT SOURCE (GPHS) GIRTH WELDS

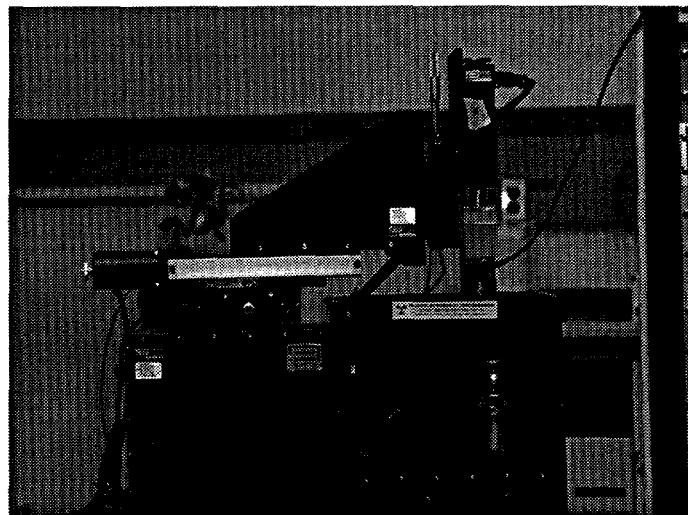
The "top scan" methodology used (Figure 3) offered time-of-flight enhancements that were used to indicate the location of the UT reflector relative to the weld centerline. The data generated was entirely digital and was consequently easily stored, retrieved, and more precise than the analog data obtained with the Galileo/Ulysses-era equipment. The scans were controlled and collected by a computer; this minimizes the amount of time the operator spends handling the GPHSs. Figure 4 shows the immersion tank with a GPHS mounted in the fixture and the transducer in measurement position.

Figure 4. UT Immersion Tank

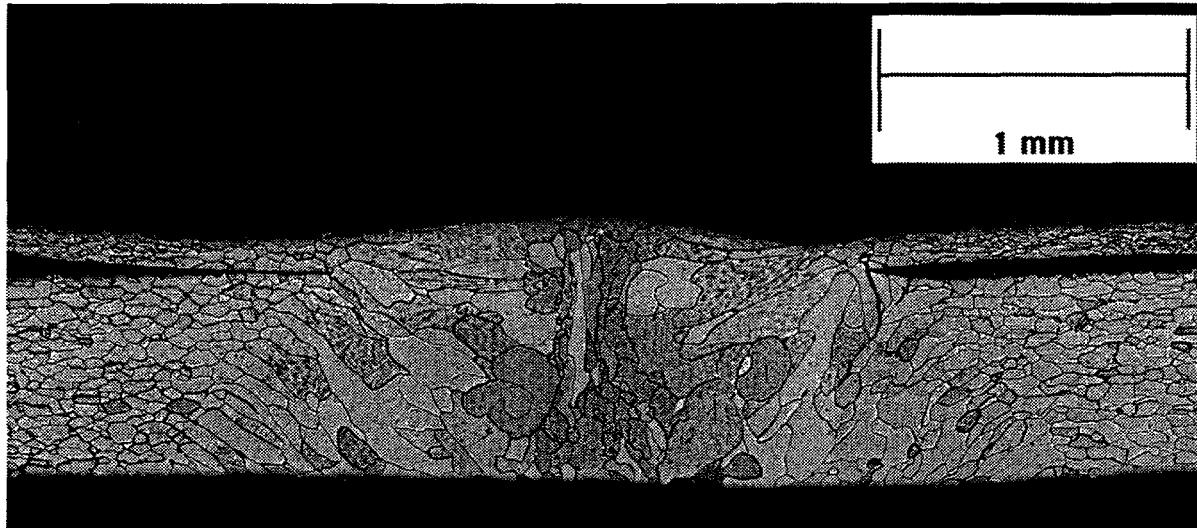
Several of the radiographic examination results were confirmed with metallographic examination. Figure 5 is a micrograph showing weld shield fusion, confirming the radiographic examination results of the 160 degree area of FC0149. Figure 6 is a micrograph of the weld area located 44 degree from the weld start of GPHS FC0234. The weld porosity shown in this figure confirms the results of the radiographic examination.

Figure 5. Weld Shield Fused to Weld Area (FC0149)
