ASSESSMENT OF STRENGTH LIMITING FLAWS IN CERAMIC HEAT EXCHANGER COMPONENTS

Final Report for the Period September 28, 1984—June 30, 1986

October 1986

By
Babcock & Wilcox Company
Lynchburg, Virginia

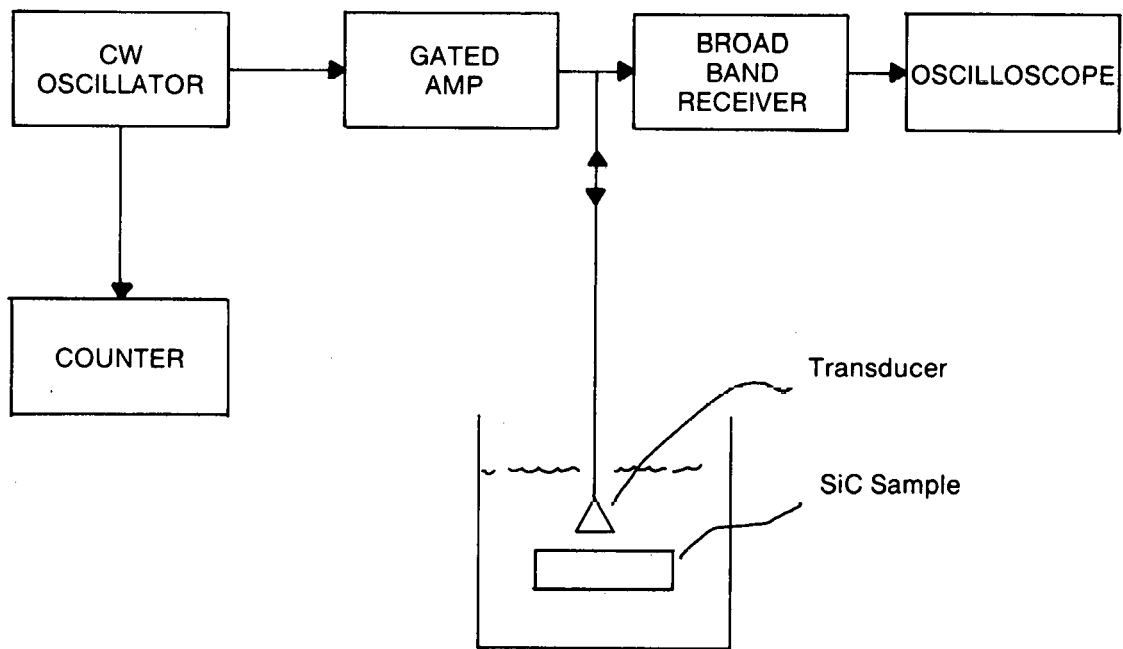
Figure 2-7. Resonance Thickness Measurement System

At the start of each pulse, the reflection coefficient at the front of the sample is dependent only upon the characteristic impedances of water and silicon carbide. When a standing wave has developed, the reflection coefficient is based on the characteristic impedance of water, and the input impedance of silicon carbide which can range from the characteristic impedance of water to well above the impedance of silicon carbide, depending upon the sample thickness in wavelengths.

By slowly tuning the oscillator through a range of frequencies, a number of resonant frequencies, at which the thickness is a multiple of a half wavelength, can be selected using the minimum amplitude in the center of the pulse as an indicator.

The method of thickness measurement developed for this project employs long pulses at a relatively low frequency. The pulses are sufficiently long that a standing wave is established in the sample. The standing wave causes the reflection coefficient at the surface of the immersed sample to vary, depending upon the thickness to wavelength ratio. The pulses are generated by using a continuous oscillator and a gated amplifier. Changing the oscillator frequency changes the reflection coefficient at the sample surface, and the amplitude of the reflected pulses will cycle through maxima and minima. By measuring a number of the frequencies at which either maxima or minima occur, the fundamental thickness frequency can be obtained. The period corresponding to the fundamental frequency and the known sound velocity can then be used to obtain thickness.

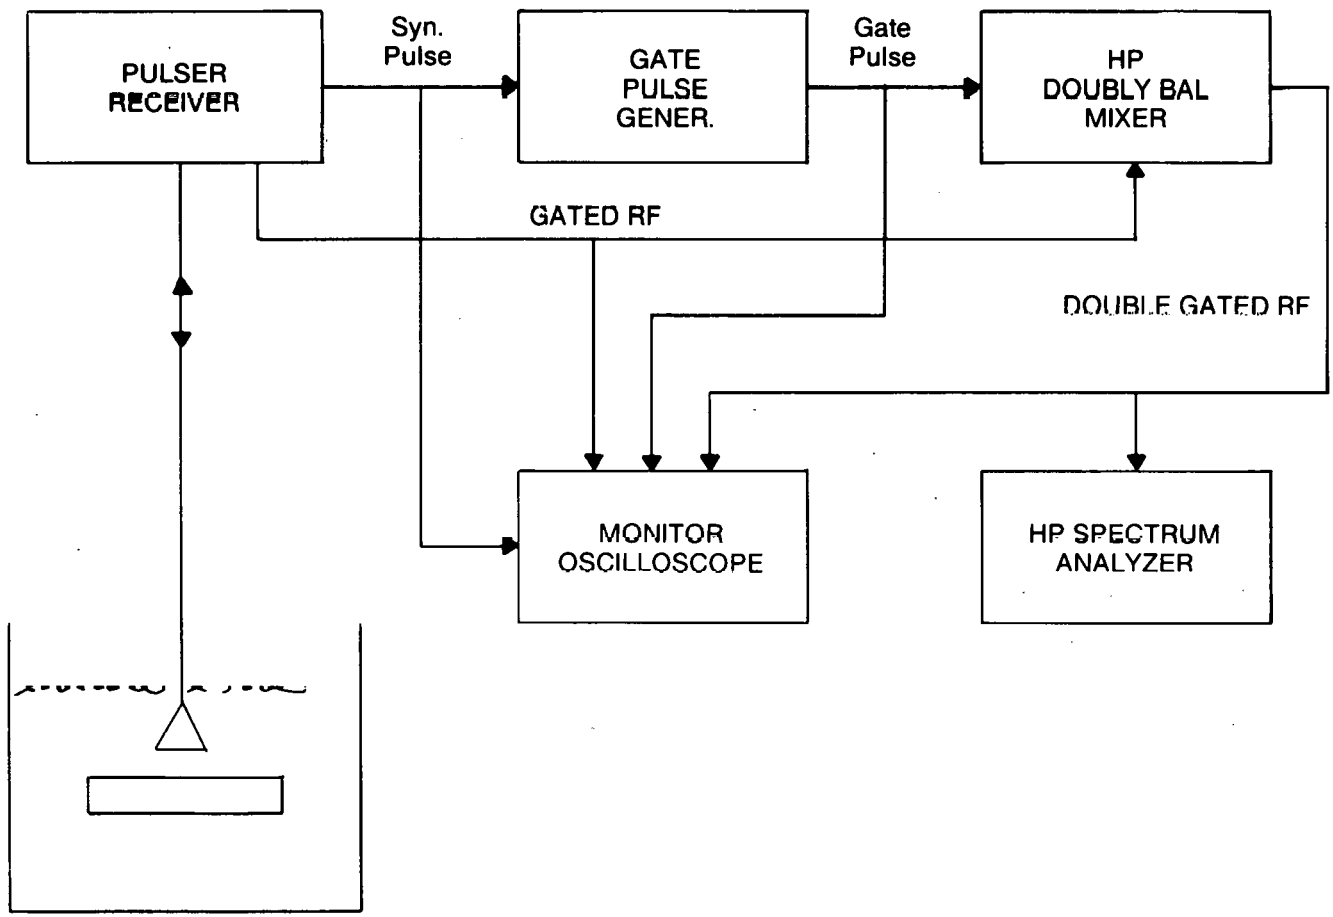
Figure 2-8. Spectral Analysis Thickness Measurement System

The transducer used was 10 MHz, 3/8 inch diameter, 1.625 inch focal length. The spectrum analyzer used was an HP3585A, which stores data digitally and allows moving a cursor for digital readout of frequencies. Minima were clearly readable beyond 30 MHz.

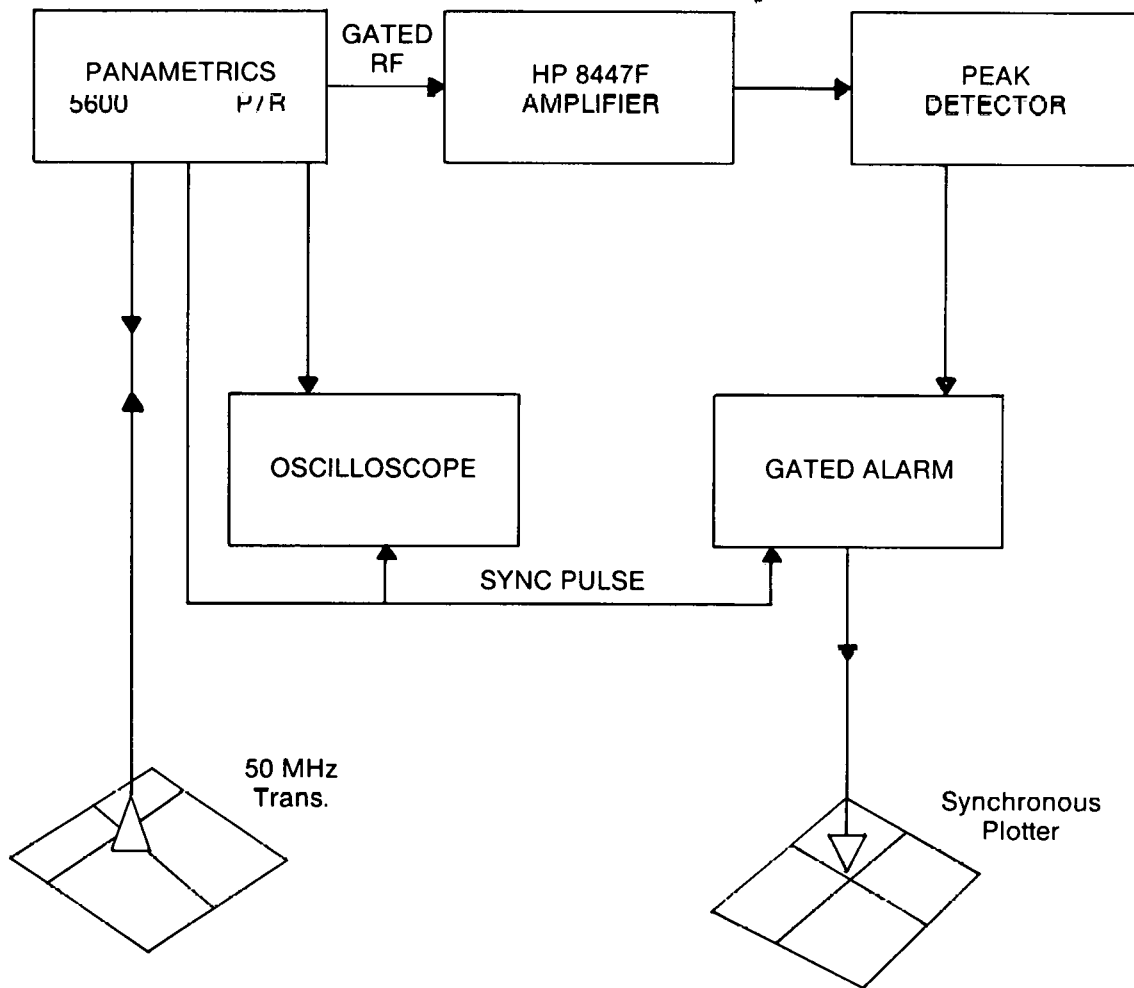
Figure 2-9. Ultrasonic C-Scan System

C-scan images are produced by scanning the transducer over the surface of the sample and recording the round trip transit time (time-of-flight) of the reflected acoustic wave. During scanning, the arrival times of the acoustic waves are compared to a simple set of conditions derived from a defect

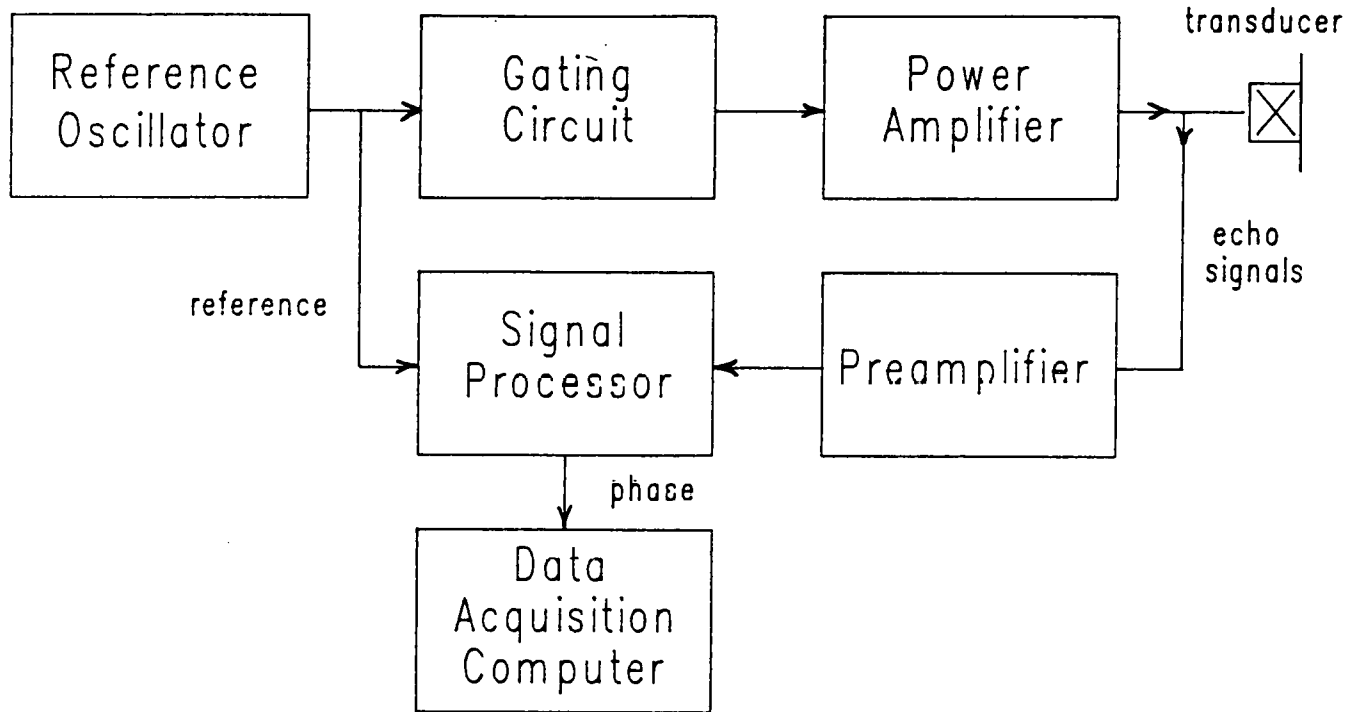
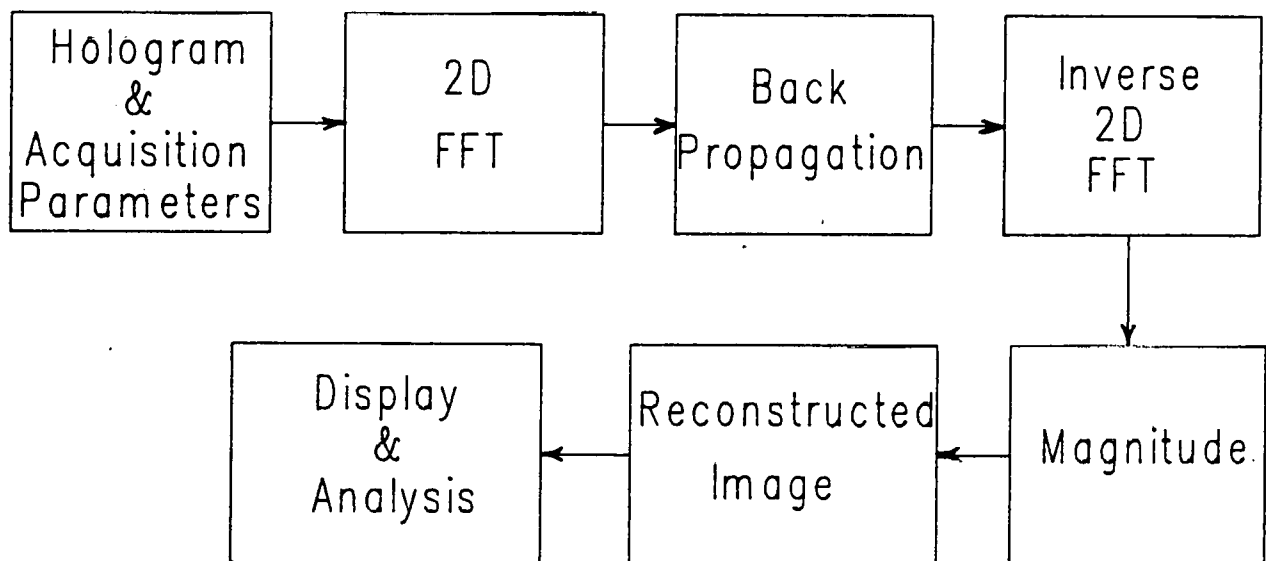
Figure 2-13. Block Diagram of Acoustic Holography System

DATA ACQUISITION

IMAGE RECONSTRUCTION

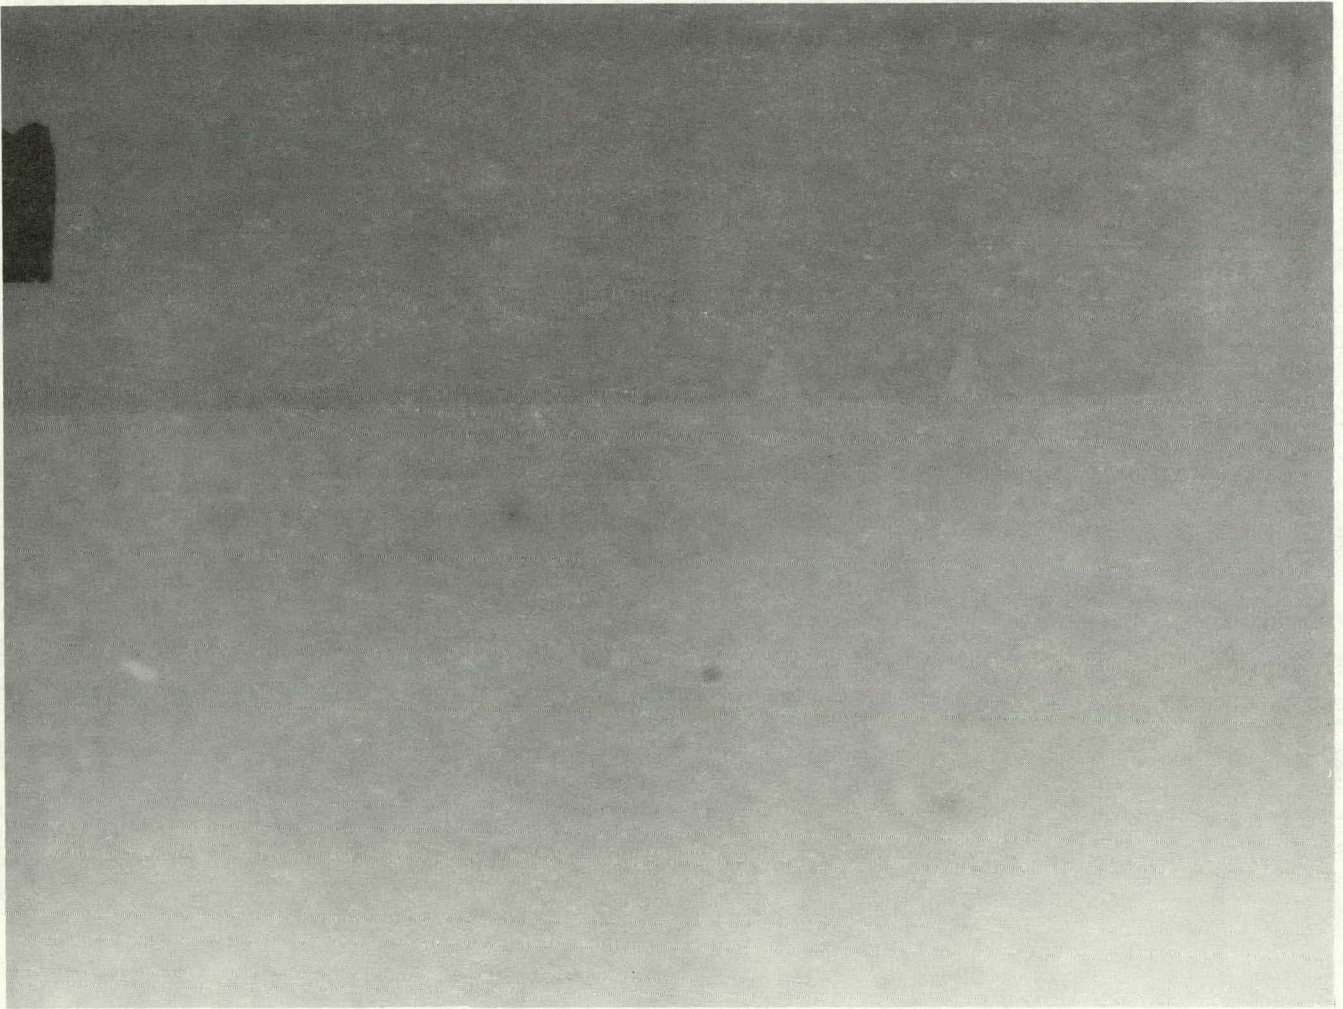
Figure 3-12. Microfocus Image of High Density Inclusions

Shown in Figure 3-12 is an example of high density inclusions. These inclusions were suspected to be a contamination of small iron particles. At a magnification factor of 5x, the high density inclusions are seen as small circular dark spots on the photographic reproduction of the radiographic film. The high density inclusions were in a silicon carbide plate (6.7 cm x 6.7 cm x 0.75 cm), both surfaces of which were very rough.

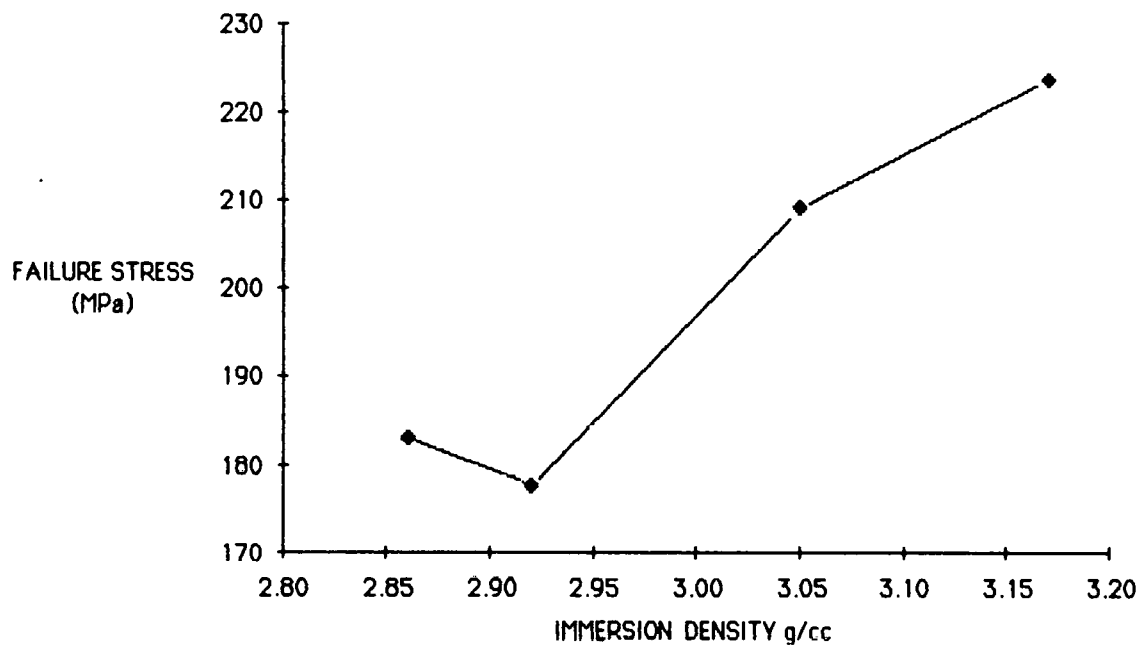
Figure 4-1. Failure Stress vs. Immersion Density

AVERAGE STRESS VS. IMMERSION DENSITY

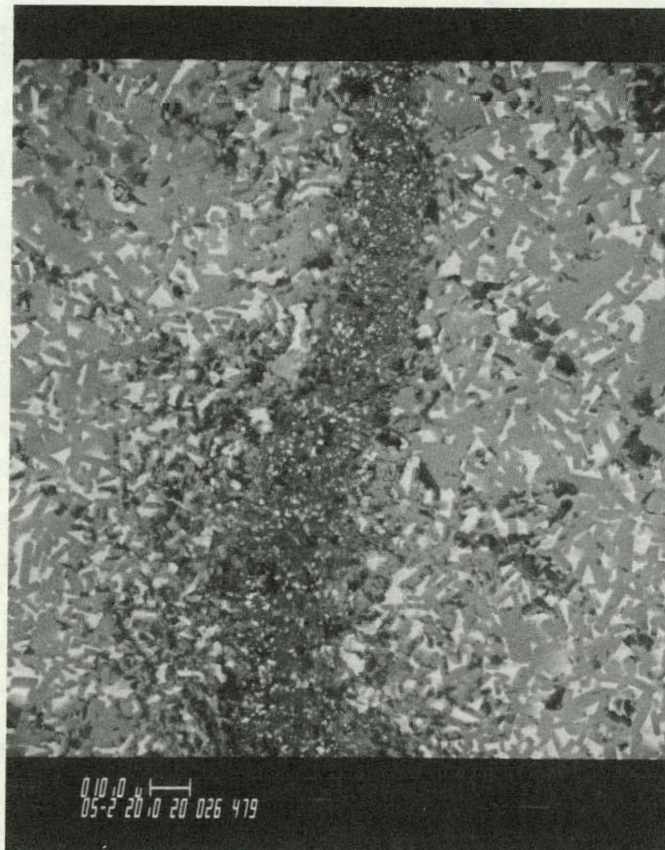
Figure 4-5. SEM Photomicrograph (500X) Showing
Fragmentation of Platinum Seeded Defect

pressure/temperature of the hot pressing cycle and has been spread through a much larger volume than the original sphere occupied.

processing information, it was determined that the wire in Figure 4-5 was the 0.5 mm wire and the wire in Figure 4-7 was the 0.3 mm wire. Because of the fragmentation of the platinum during the hot pressing cycle, it is difficult to differentiate the two from SEM photomicrographs.

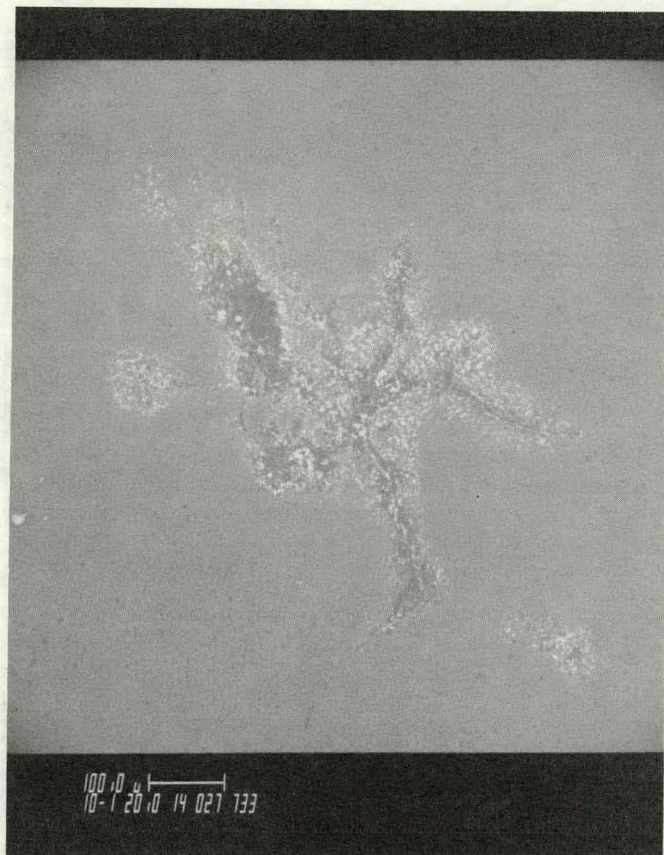
Figures 4-6 and 4-7 are SEM photomicrographs (100X) of the cross-sections (x-z plane of the billet) of the platinum wires. Figure 4-6 shows the first platinum wire, measured to be 2.0 cm from a reference edge of the billet to the center of the defect. The major dimensions were measured to be about 0.75 mm along the x-axis and about 0.65 mm along the z-axis. Figure 4-7 shows the second platinum wire, measured to be 3.5 cm from the reference billet edge. The major dimensions were measured to be about 0.5 mm along the x-axis and about 0.8 mm along the z-axis. Referring to

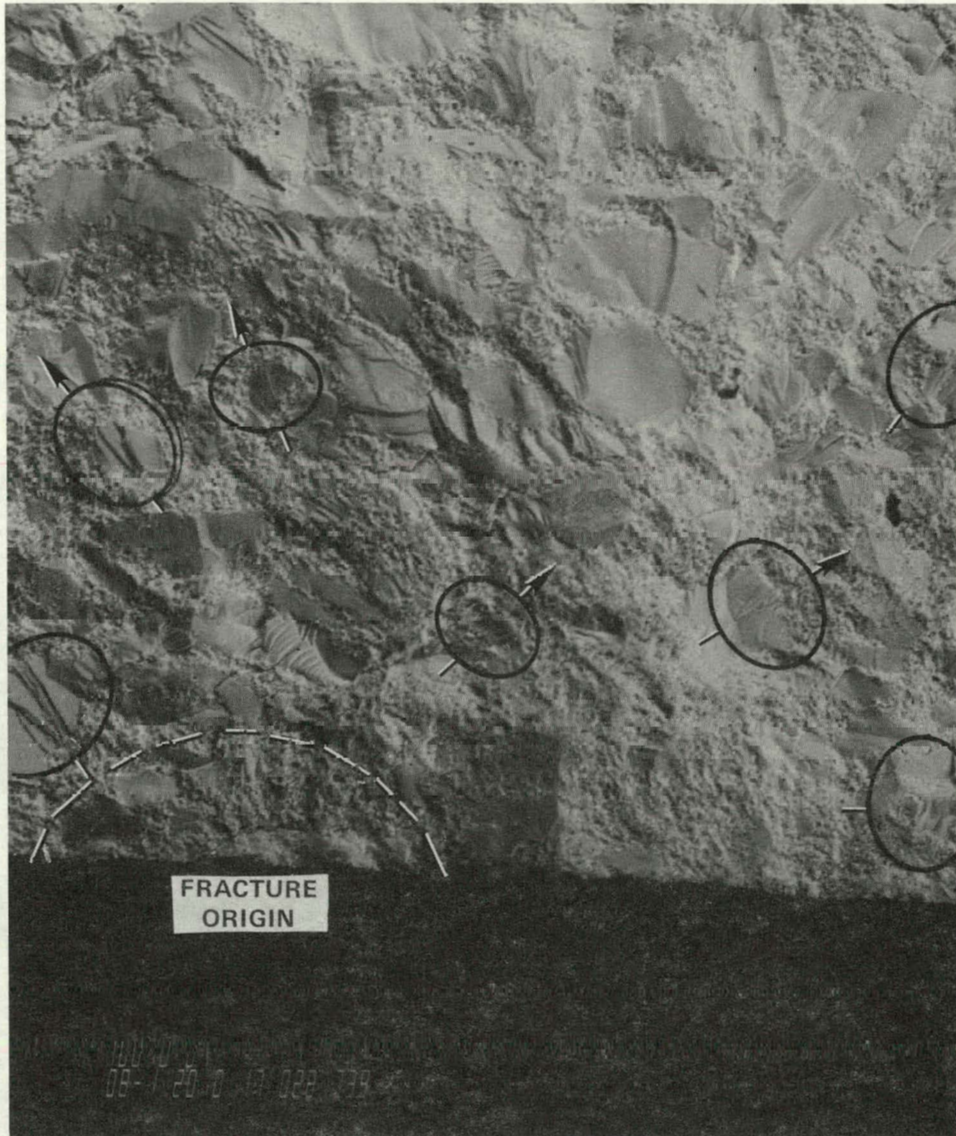
Figure 4-18. Fracture Origin

Figure 4-17 shows an overall view of the area containing the fracture origin. Present on this surface are a number of coarse hackle lines. The area at the hub of the hackle lines contains the fracture origin. Figure 4-18 shows a closer view of the fracture origin. Figures 4-19 and 4-20 compare the microstructure in and near the fracture origin and the microstructure in an area outside the fracture origin. The overall texture appears to be different. It also appears that there is a fine grained matrix on the fractured surface of the silicon carbide grain. It is believed that a crack in the silicon carbide grain had to exist before the firing operation in manufacturing to produce this feature.

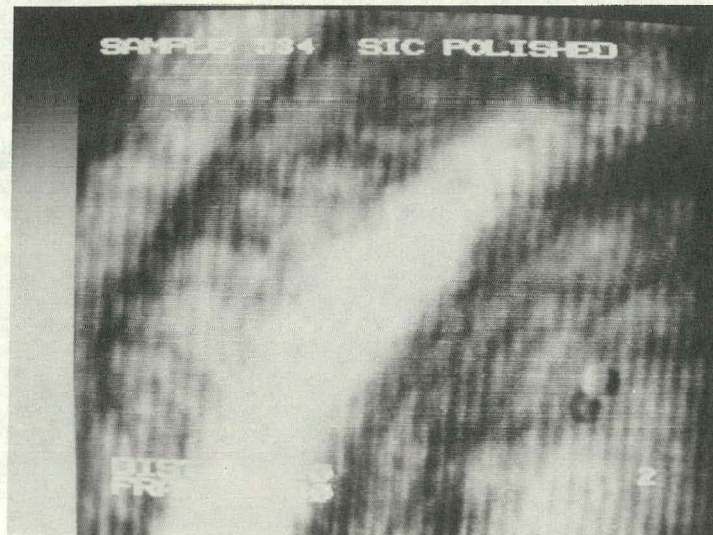
Figure 5-5. SLAM Image, Sample 534

Figure 5-5 is a SLAM view of a corner of the plate, showing the same circular pattern of density variations. It is interesting to note that X-Ray showed the density variation but no point like defects, while the ultrasonic tests showed many small and some large defects. The porosity pattern resulted from deliberate low densification, a method involving compression to a predetermined volume. None of the thinner samples showed this pattern.

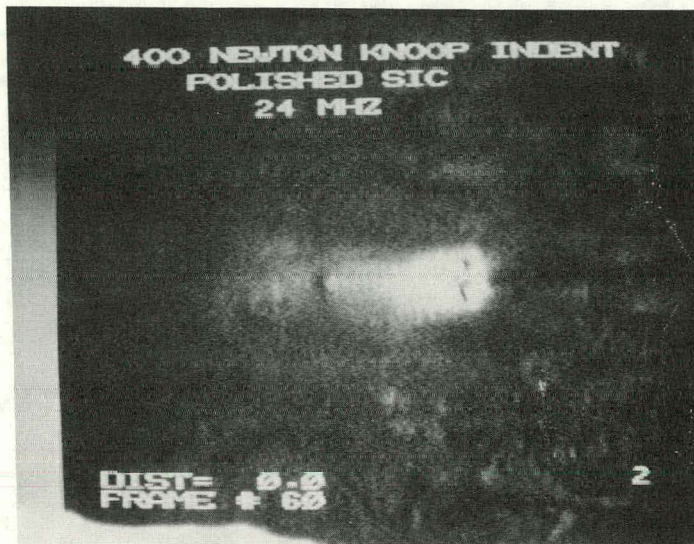
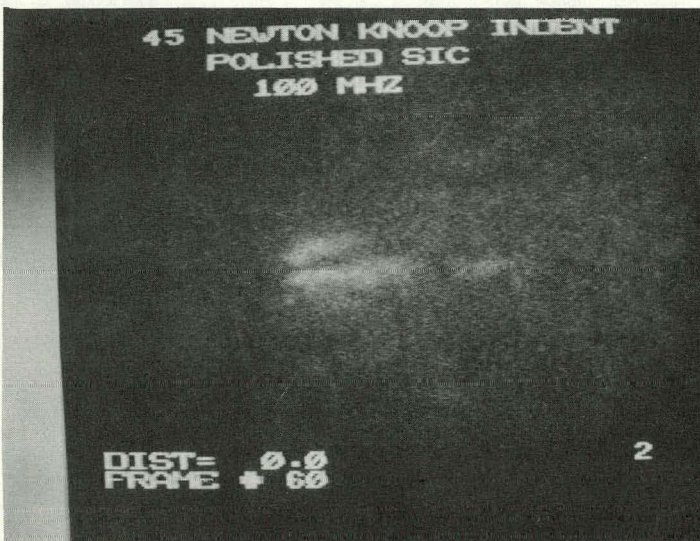
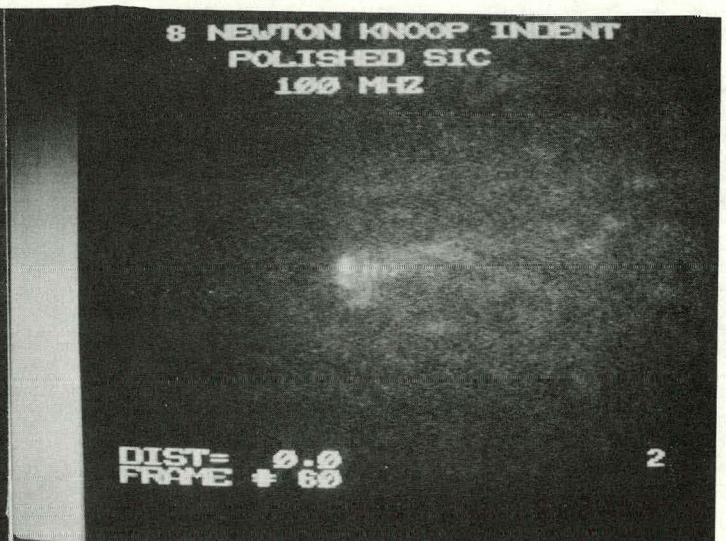
Figure 5-6. SLAM Images of Knoop Indents

The sample was later cut in half and used for Knoop indent tests. The surfaces were ground and some were polished before indenting. The indents ranged from 8 to 400 newtons in load. The SLAM detected all indents; conventional ultrasonics detected the largest one; and microfocus X-Ray found none. Figure 5-6 shows SLAM images of several indents.
