Characterization and Failure Analysis of Ceramic Filters Utilized for Emission Control During Coal Gasification

Topical Report
October 1, 1995 - September 30, 1996

Work Performed Under Contract No.: DE-FG21-94MC31203

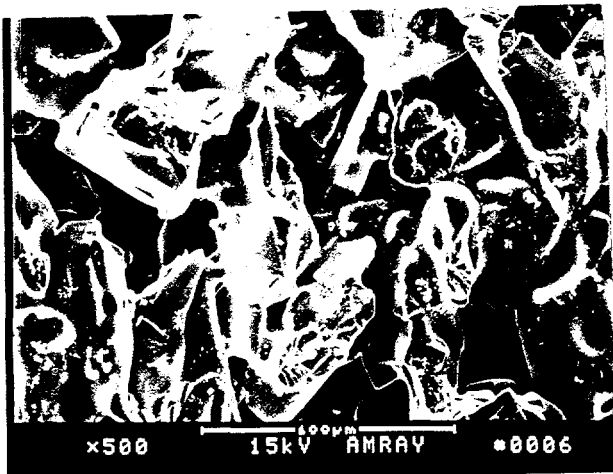
Figure 18 SEM micrographs of (a) outer and (b) inner layers of the unused ceramic filters showing microstructural features: particle's and pore's shape and size.

Figures 14, 15 and Table 1 summarize the XRD test and analysis results of the unused and used ceramic filters. They showed that after usage the crystal structures of the main composition, SiC, in both layers of the ceramic filter have been changed. The crystal constants of the SiC in the outer layer were increased. For the inner layer, not only have the crystal constants of the SiC been increased, the grain orientation has also been changed. The preferred orientation along (1 0 34) of SiC in the inner layer of the used ceramic filter can be seen clearly in Figure 15. The results indicate that recrystallization or phase transformation process of the SiC occurred during usage of the ceramic filter in the elevated temperature environment. The expansion of volume caused by growing and change in microstructure of the grain may result in great stress inside the filter, which may further promote the nucleation and propagation of the microcracks at the positions where inclusion and defects exist, and lead to the final fatigue fracture failure of the ceramic filters. It is shown in Figure 17. Particularly, the inconsistency in change of crystal constants and structure between inner and outer layers would cause delamination of the ceramic filter, which can be seen in Figure 16. The unused filter has a good combination between inner and outer layers, while the used filter show that some particles have dropped off the combination part. Meanwhile, the grain growing and volume expansion may lead to the reduce of the volume ratio of the pores, and as a result, decrease the permeability of the ceramic filters, see comparing of the microstructures of the used and unused ceramic filters shown in Figures 18 and 19.

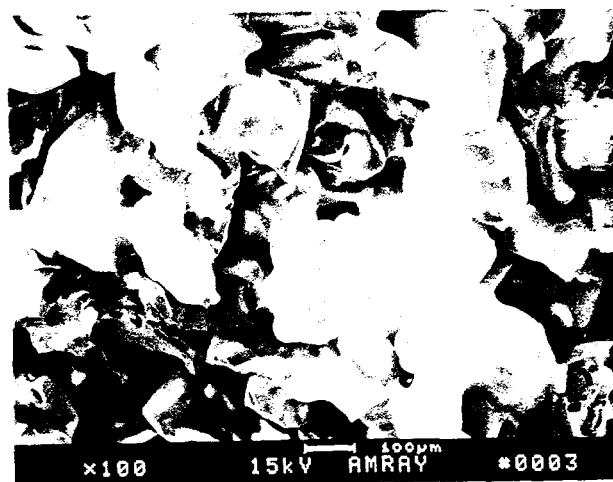
Observation of the post-run filters gave out that there are many cracks on the surface of the failed ceramic filter. Some of them caused fracture failure of the ceramic filter, they developed along longitude first and then deflected in 45 degree; the others had not propagated too much and met together. The morphological features of the fractured surface of the ceramic filter was illustrated in Figure 20. The broken surface of the filter candle indicates fatigue fracture process occurred, which resulted in the final failure of the ceramic filter. The structural stress discussed above and thermal stress caused by back-pulse cleaning may be responsible for the initiation and propagation of the microcracks. The more detailed experimental studies and theoretical analysis related to crack initiation and fracture process will be performed in the near future.

Figure 20 SEM micrographs of the failed ceramic filter showing morphological characteristics of the fractured surface.
