CORRELATION OF WATERSIDE CORROSION AND CLADDING
MICROSTRUCTURE IN HIGH-BURNUP FUEL AND GADOLINIA RODS*

H. M. Chung

Materials and Components Technology Division

INVITED PAPER for presentation at the International Atomic Energy Agency Technical Committee Meeting on "Fundamental Aspects of Corrosion of Zirconium-Base Alloys in Water Reactor Environments," Sept. 11-15, 1989, Portland, OR.

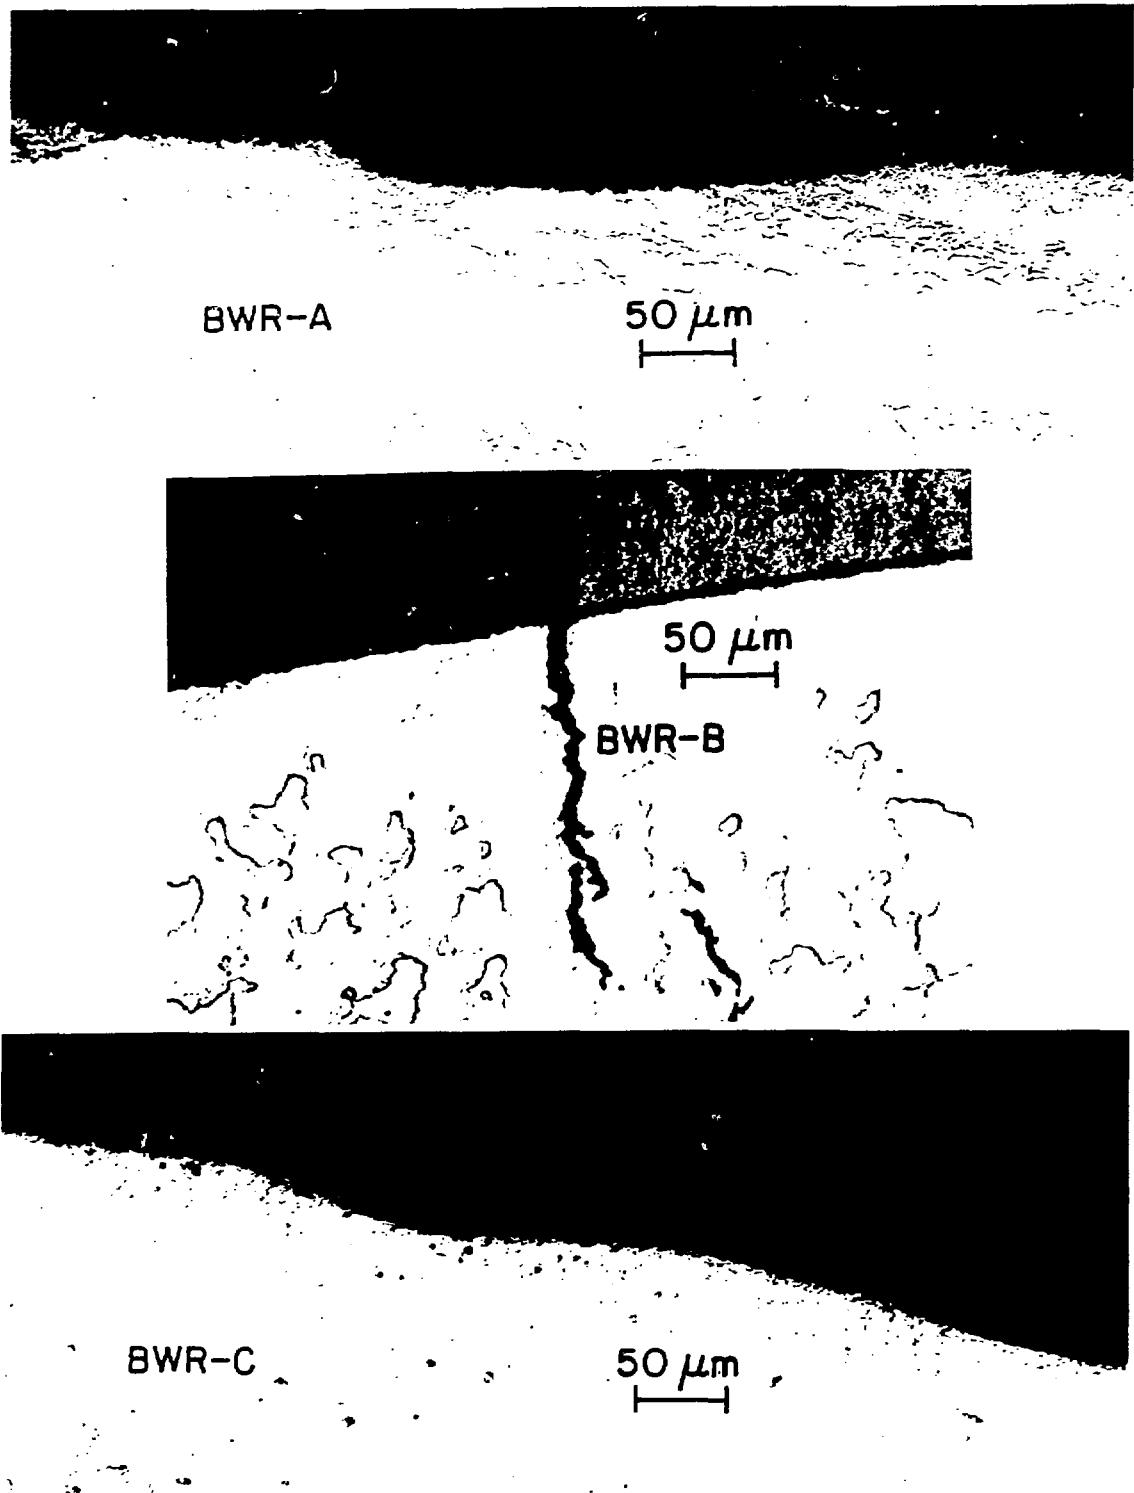
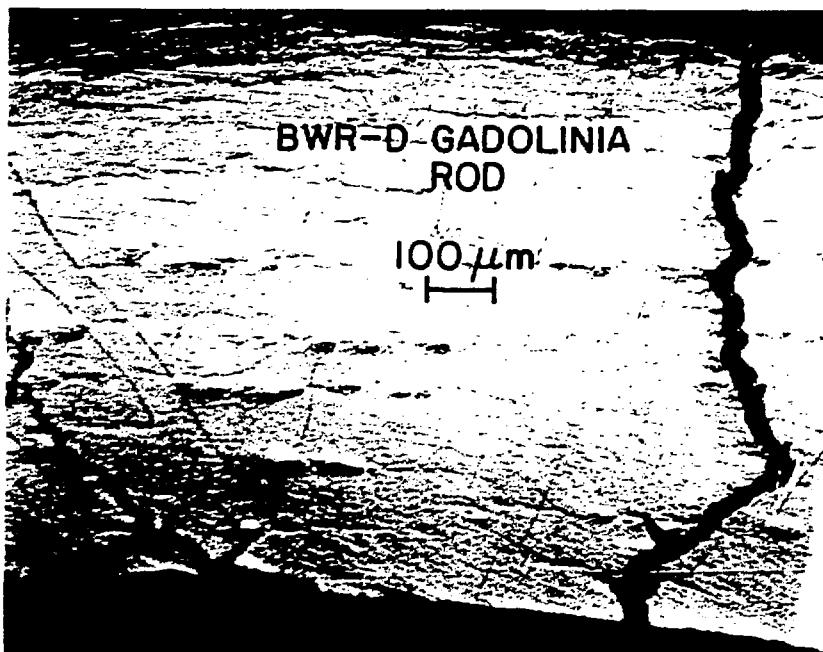
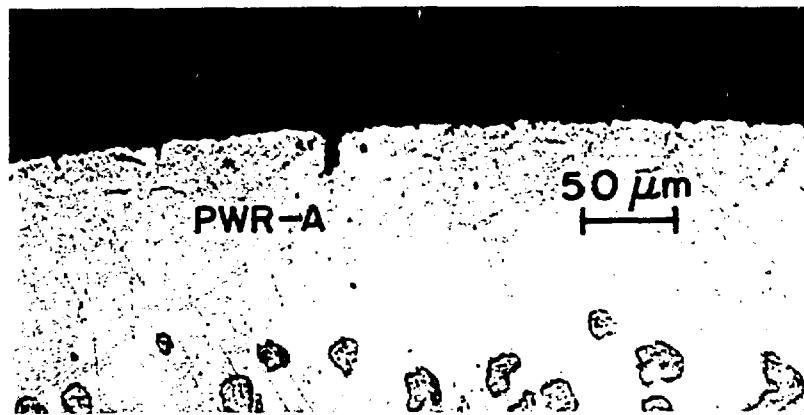
Fig. 1. Morphology and Thickness of Waterside Corrosion Layers of Fuel and Absorber Rods of BWR and PWR after Burnup of 11–30 MWd/kgU.

Oxide morphology and thicknesses of the fuel and absorber rods from the five reactors are shown in Fig. 1 and summarized in Table 1, respectively. Fuel rods from the BWR-A and -C showed nodular oxides with maximum local thickness up to \sim 45 μ m after burnup of \sim 14 MWd/kgU. Other fuel and the absorber rods showed uniform waterside corrosion layers. The uniform oxide layer of BWR-B was relatively thicker, i.e., 50–70 μ m after burnup of \sim 30 MWd/kgU. Compared to the normal operating temperature of 288°C of the other BWRs, BWR-B was operated at a higher temperature of 307°C. The higher temperature is believed to be a significant factor of the higher oxidation. The waterside oxidation of the gadolinia rods of BWR-D was minimal (oxide layer 5–9 μ m thick after 24 MWd/kgU), reflecting relatively lower operating temperature of \sim 240°C. However, corrosion layer thickness on the inner surface of the gadolinia rod cladding was significantly larger than the UO₂ rods.

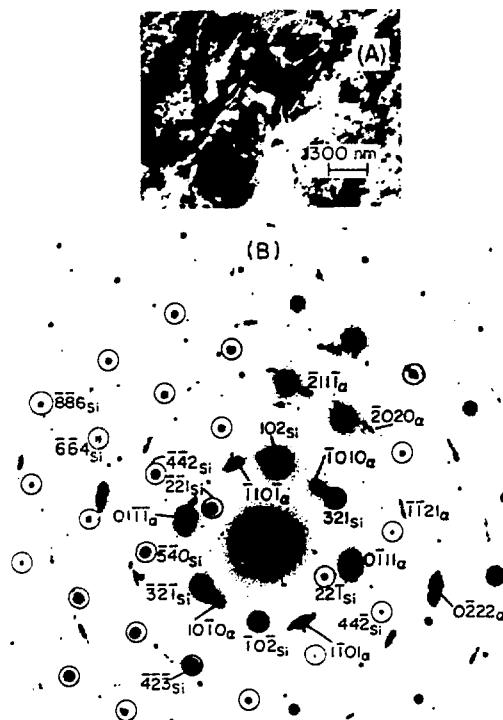
Fig. 6. Bright-Field Image (A) and SAD Pattern (B) of a Zr_3Si Precipitate Observed in Zircaloy-4 of PWR-A.

Zirconium silicides were present in minor amounts in the PWR spent-fuel cladding. An example of the silicides is shown in Fig. 6. SAD patterns of several different zones of the precipitate were obtained through a tilting experiment. The analysis of the SAD patterns showed the precipitate to be the tetragonal ($a = 1.101$ nm, $c = 0.545$ nm) Zr_3Si phase.

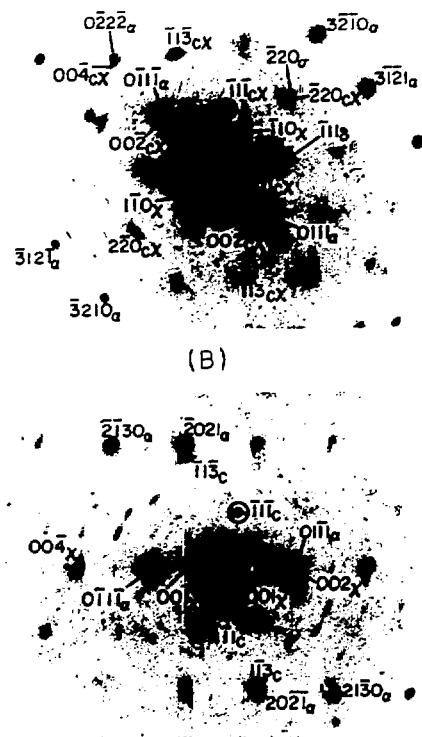
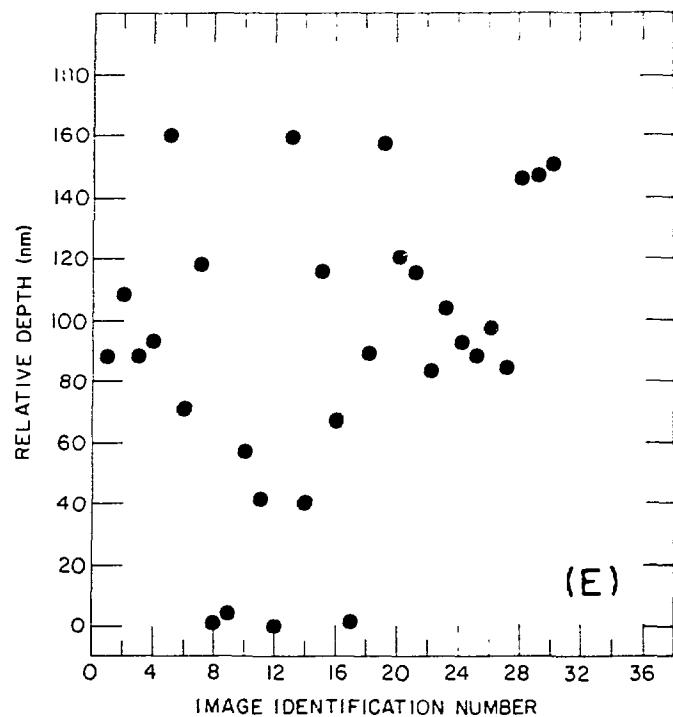
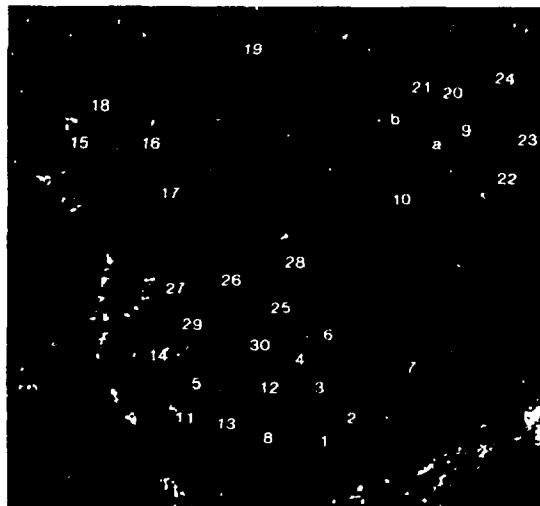
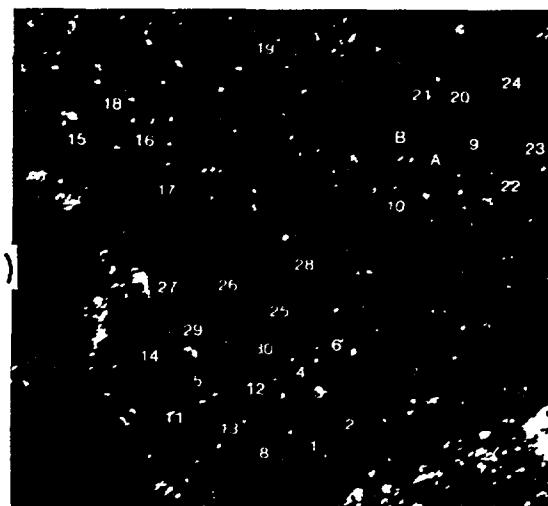
Fig. 7. Stereomicroscopy Analysis of Precipitates Observed in BWR-D Gadolinia Rod Zircaloy-2 Cladding. (A) Bright-field stereopair obtained by 10° tilting; (B) SAD patterns before and after the 10° tilt, showing reflections from α -Zr, cubic- ZrO_2 , δ -hydride, and surface artifact hydride, each denoted by letter α , c , δ , and χ ; (C) 75 images selected for determination of the relative depth distribution (images near the top, middle, and bottom part of the thin film are denoted by triangles, circles, and squares, respectively); (D) 30 stereopair dark-field images, produced from the $(\bar{1}\bar{1}\bar{1})$ reflections of cubic- ZrO_2 in (B), selected for measurement of relative depth distribution of the precipitates; (E) relative depth distribution of the 30 selected cubic- ZrO_2 precipitates of (D), showing a more or less random bulk distribution.

TEM specimens, sectioned from regions adjacent to the metallographic mount shown in Fig. 1 for the BWR gadolinia rod, exhibited distinctively complex microstructural characteristics. Typical examples of bright-field images of the region are shown in Fig. 7A. In the figure, a pair of stereomicrographs, obtained by $\sim 10^\circ$ tilting of the gadolinia-rod specimen, are shown. Corresponding SAD patterns are shown in Fig. 7B. Analysis of the SAD patterns showed reflections from δ hydrides and cubic- ZrO_2 phases in addition to those from surface artifact hydrides denoted by “ χ ” letters in the SAD patterns. The δ hydrides are shown in Fig. 7A by nearly spherical or elliptical dark lumps 30–100 nm in size. Also

The hydrides shown in Figs. 7A and 7B are not the same as the long δ -hydride stringers (~50 nm wide and ~1000 nm long) that can be readily resolved metallographically in most of the irradiated or hydrided Zr alloys. To resolve the nature of the smaller δ hydrides of Fig. 7A (i.e., bulk or surface nature), a stereoview examination of the bright-field image has been conducted. In Fig. 7C, 75 images of the dark hydrides and light-contrasted regions (either cavities or secondary phase rich in alloying elements) were selected and examined with a Cartographic Engineering Ltd. mirror stereoscope. Thirty images on or near the top surface, 27 images in the middle of the specimen, and 18 on or near the bottom surface have been identified and marked in Fig. 7C with black triangles, circles, and squares, respectively. For instance, Images B, D, and E are located near the top surface. Images C, F, A, and G are located approximately 56, 65, 122, and 141 nm below Images B, D, and E. Relative depth of the images was determined from the equation

The result of Fig. 7C shows that the dark hydride and the white dots and lumps are distributed in the bulk of the film that is ~140 to 145 nm in thickness. A careful examination of the bright-field images at higher magnifications shows a large number of void-like "white dots" ~3 nm in size distributed in most regions of Fig. 7A. Also visible in the bright-field images are "black-dot" defects ~3 nm in size. When the small "white-dots" contrast are superposed on the dark hydride images, characteristic "strawberry-like" morphologies are visible, for example, Images 2 and 5.

Evidence for the bulk nature of the cubic-ZrO₂ particles cannot be obtained from the bright-field stereopairs since the fine cubic-ZrO₂ particles were usually invisible in the bright-field. therefore, extensive tilt experiments were conducted to obtain dark-field stereopairs of good quality. Tilt angles of 5 to 12° for image magnifications of 30 to 50 thousand times were tried. The dark-field stereopair of Fig. 7D was obtained from the (111) reflections from the cubic-ZrO₂ phase, which is shown in the SAD patterns of Fig. 7B. Detailed examination of the dark-field stereopair clearly showed bulk nature of the cubic-ZrO₂ particles, which are distributed more or less uniformly through the specimen thickness. To show the bulk distribution to a reader in a more direct manner, 30 particles were selected in Fig. 7D from a stereoview of the dark-field pair. In identifying the matching particles in the stereopair, great care should be exercised since all the particles are not visible in both micrographs. The diffraction conditions are not identical in both micrographs of Fig. 7D. Relative depth of the particles selected in Fig. 7D was determined from parallax measurement and plotted in Fig. 7E. The result shows a more or less random distribution of the cubic-ZrO₂ particles through the thin-film specimen ~160 nm in thickness. The film thickness measured in Figs. 7B and 7E (i.e., 141 versus 160 nm) is in good agreement.

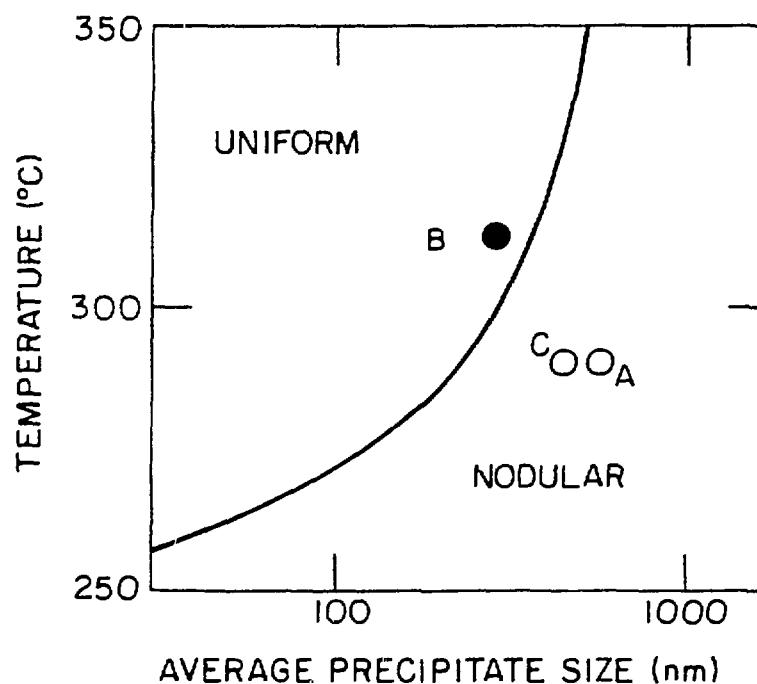
Fig. 9. Schematic Illustration of Expected Occurrence of Uniform and Nodular Oxidation in BWR as a Function of Clad Temperature and Average Size of Intermetallic Precipitates.

In the case of the BWR-B, thick (50–70 μm) uniform oxide layer instead of nodular oxide was formed despite the large size of intermetallic precipitates. This is attributed to a higher cladding service temperature that is associated with the higher coolant outlet temperature (i.e., 307 vs 288°C). That is, for the BWR environment, nodular oxide formation appears strongly dependent not only on the intermetallic precipitate size, but also on the fuel operating temperature. This is shown schematically in Fig. 9. In the figure, expected regions for uniform and nodular oxide formation are illustrated schematically as a function of cladding operating temperature and average precipitate size.
