## DEVELOPMENT OF AN ACOUSTIC SENSOR FOR A GEOTHERMAL BOREHOLE TELEVIEWER

By  
J. W. Wonn

March 1979

Westinghouse Electric Corporation  
Research and Development Laboratories  
Pittsburgh, Pennsylvania

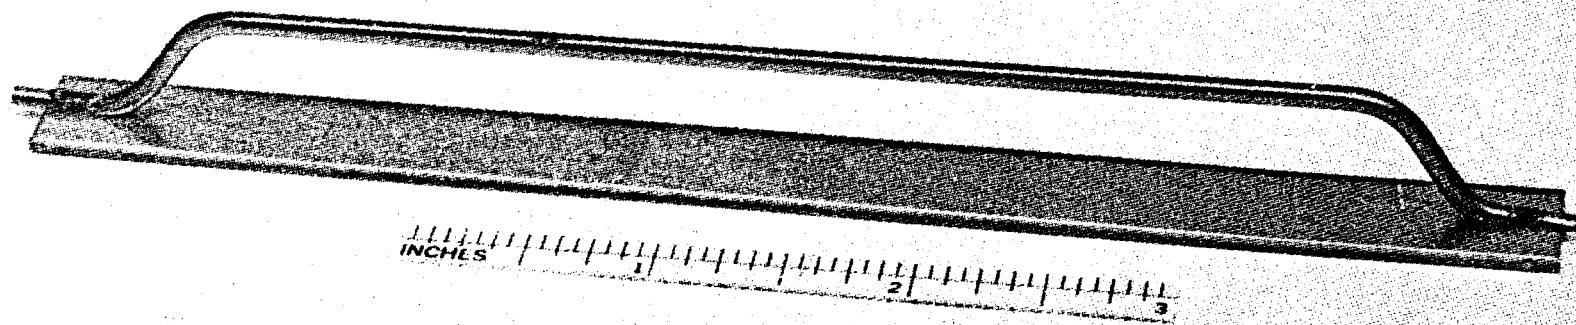
Figure 10.2. Typical acoustic target assembly designed for autoclave sensor evaluation testing. The stainless steel rod (target) is spot-welded to a stainless steel plate to provide for attachment to autoclave internals.

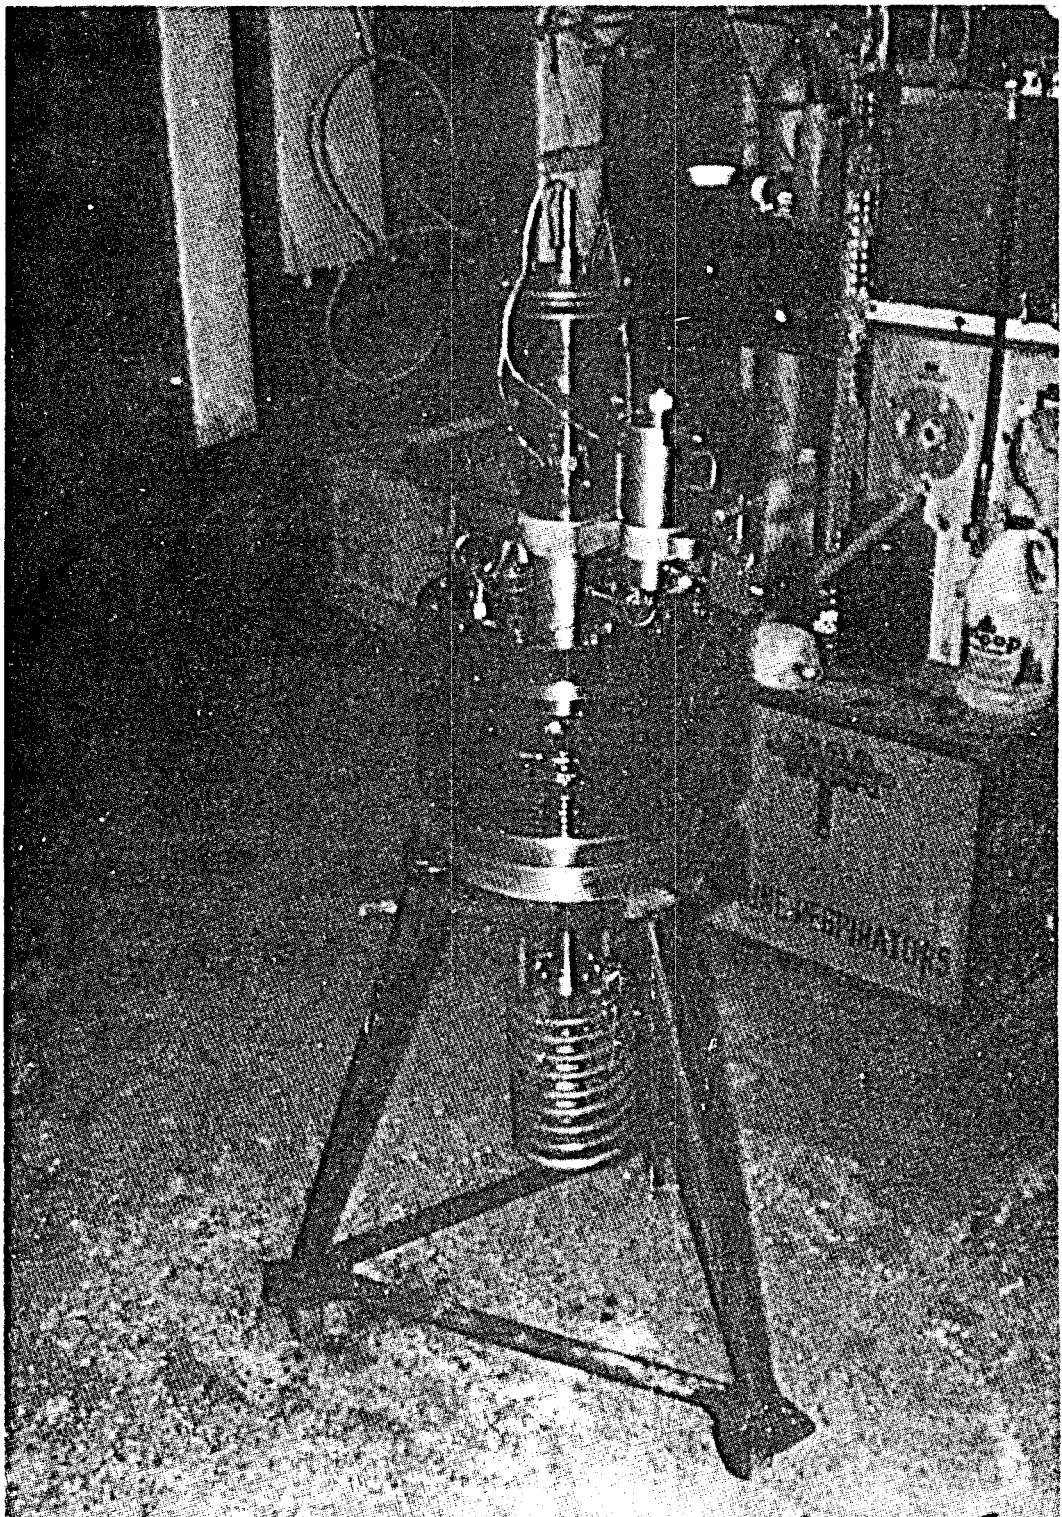
Figure 10.3 shows the test sensor installed in the autclave head just prior to installing the head on the autoclave vessel. The electrical leads can be seen coming out of the top of the hollow support shaft. The acoustic targets are wired in place on the inside of the spiral cooling coil.

Figure 10.3. Experimental sensor and three targets shown installed (inside cooling coil) in the autoclave head assembly prior to testing. Electrical leads can be seen coming out of the top of the hollow support shaft.
