Solid Rocket Motor Acoustic Testing

Jonathan D. Rogers

Sandia National Laboratories

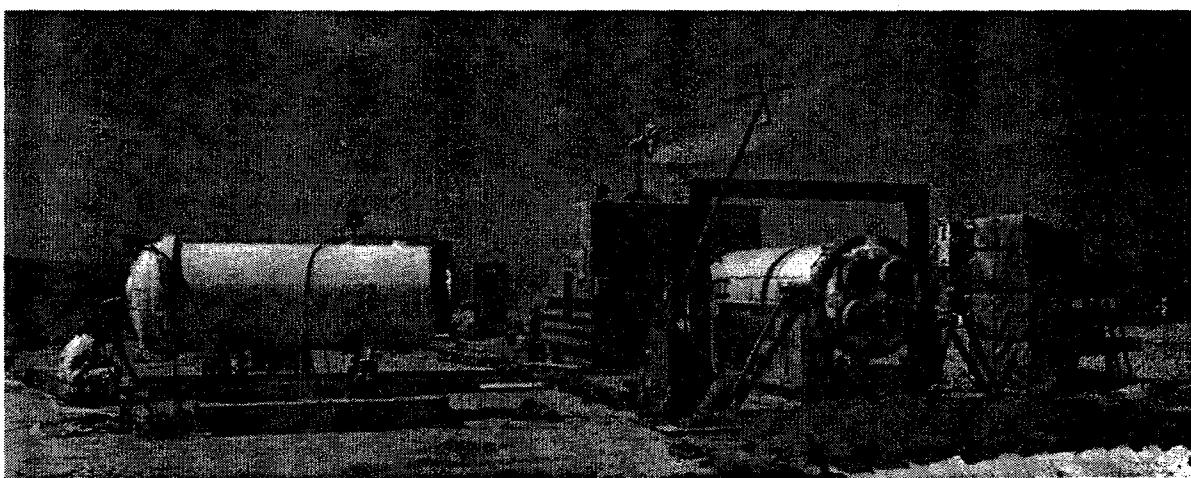
Figure 3. Overall view of Static Firing 2

An overall view of test 2 is shown in Figure 3. The nozzles of the rocket motor are facing the photographer. The large cylinder on the left is an X-ray source for radiographic imaging. Figure 4 shows the instrumentation set-up for the microphone and adjacent accelerometer. The microphone is covered

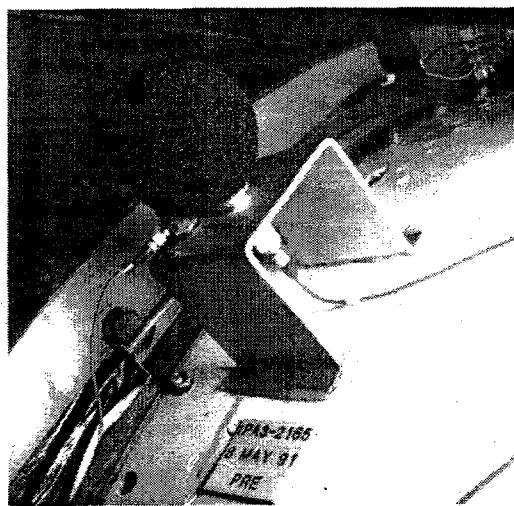
Figure 4. Instrumentation on Static Firing 2

by a foam windscreens to reduce the noise signal from wind. For each test, all microphones were covered with a windscreens and mounted in a similar manner.

There was concern that the vibration of the motor case could lead to erroneous SPL measurements. An accelerometer, shown in Figure 4, was mounted beside one microphone to measure the vibration environment in the direction of the sensitive axis of the microphone. The microphone manufacturer listed the acceleration sensitivity of the microphone as 0.0015 psi/g (114 dB / g). With expected SPLs on the order of 140 dB a large acceleration could contribute to the SPL measurements. The accelerometer was present only for test 2.
