SAND98-0319 • UC-906
Unlimited Release
Printed February 1998

Nondestructive Inspection Assessment of Eddy Current and Electrochemical Analysis to Separate Inconel and Stainless Steel Alloys

David G. Moore, N. Rob Sorensen

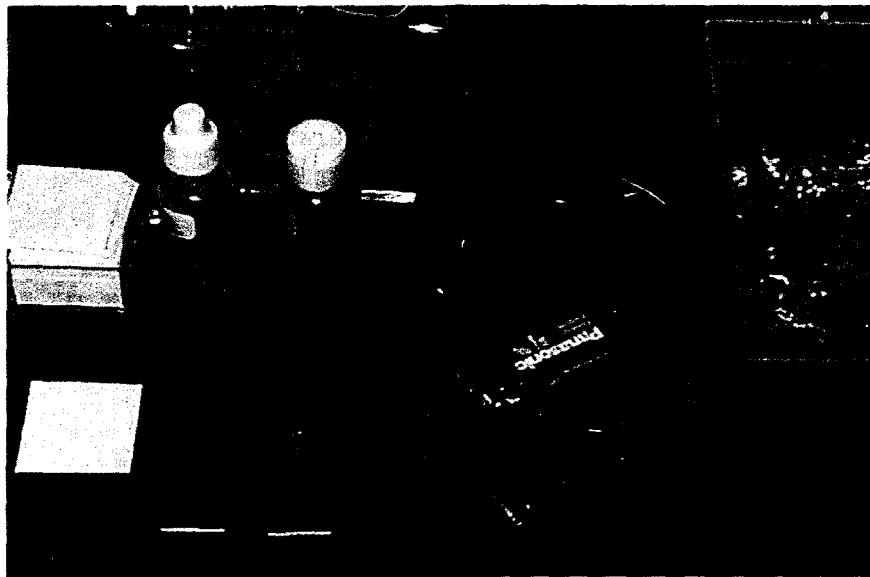
Figure 7. Electrochemical spot test kit from Systems Scientific Laboratories, Inc.
