NONDESTRUCTIVE EVALUATION TECHNIQUES FOR SILICON CARBIDE HEAT-EXCHANGER TUBES

Second Annual Report
October 1978—September 1979

ARGONNE NATIONAL LABORATORY, ARGONNE, ILLINOIS

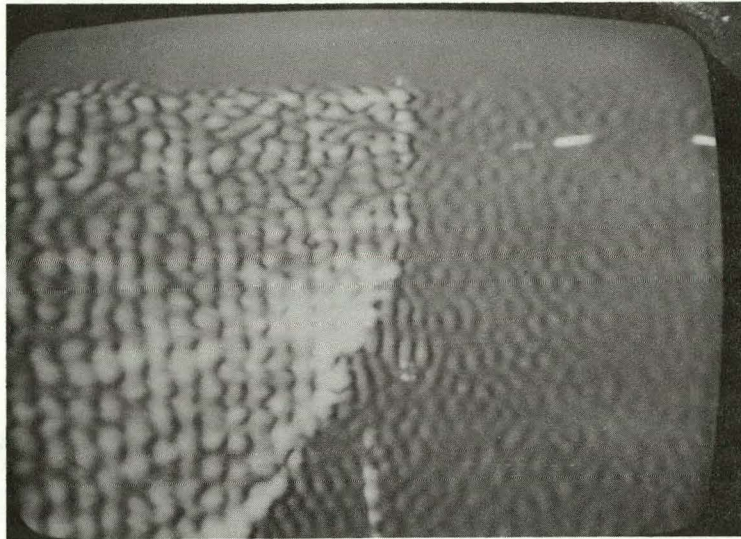
Fig. 8. Acoustic Micrographs (2 x 3 area) of Bar A2 Showing a Surface-breaking Crack. (a) Interferogram; (b) Amplitude Micrograph.

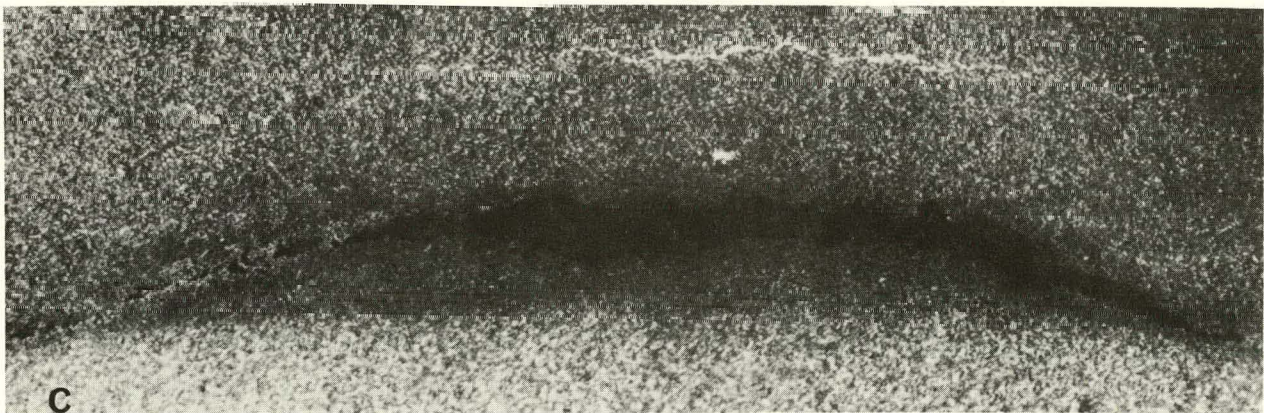
Fig. 11. (a) Acoustic Micrograph of Siliconized SiC (Carborundum SKT) Tubing Showing Defect (Circled); (b) X-ray of Tubing Showing Delamination in Axial View; (c) Optical Micrograph Showing Delamination in Circumferential View.

and then ground and polished for optical microscopy. Figure 11b shows a radiograph of the flaw (axial view), and Fig. 11c is an optical micrograph (circumferential view). The size of the flaw, as predicted acoustically, is 1.5 x 1.0 mm.

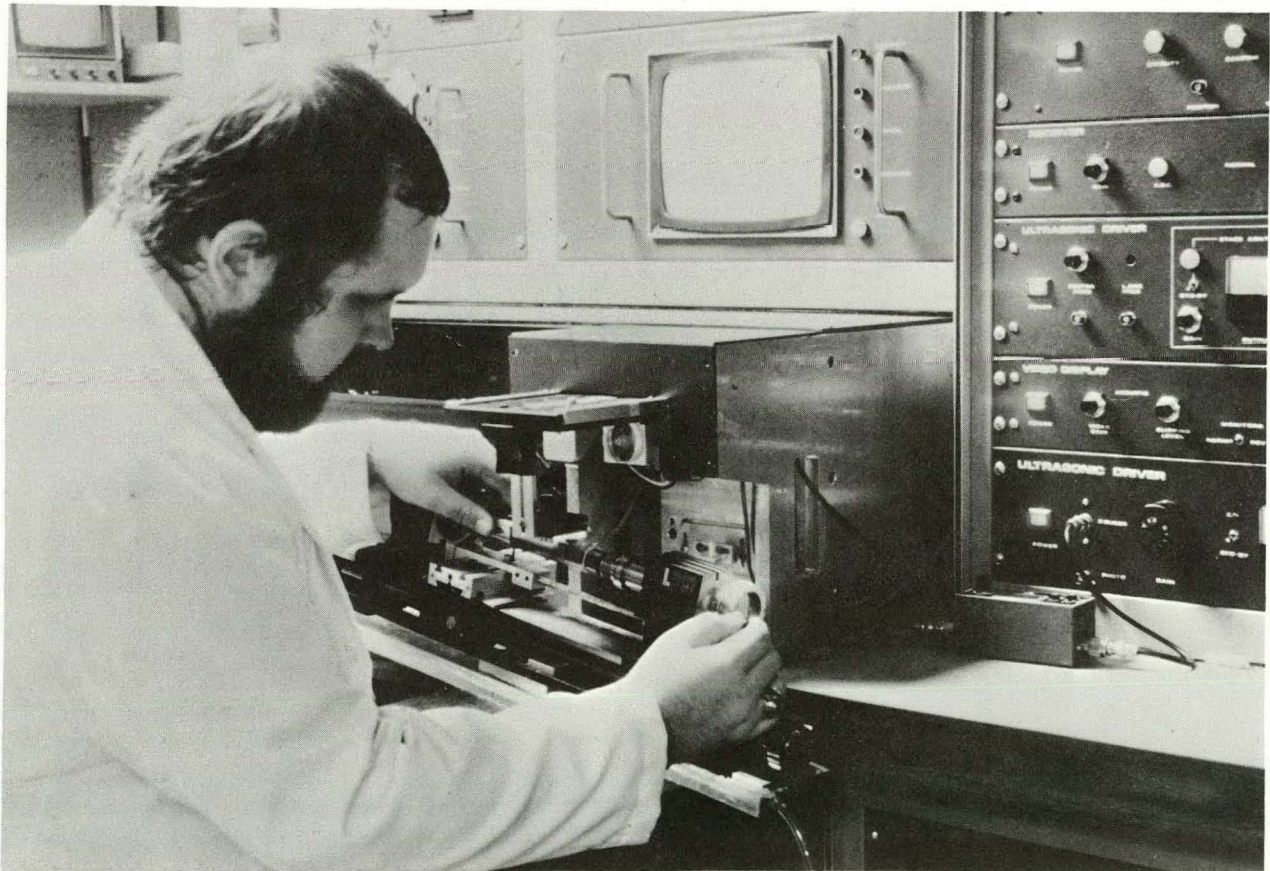
Fig. 14. Photograph of Acoustic Microscope and Stage for Examination of SiC Heat-exchanger Tube Sections.

As a result of the success experienced with acoustic-microscopy techniques for flaw detection in ceramic components, a stage was developed and is being evaluated to demonstrate that SiC heat-exchanger tubing can be helically scanned by means of acoustic microscopy. The stage is attached to the Sonoscan acoustic-microscope table. Figure 14 shows the stage with a tube in place; Fig. 15 shows the arrangement for carrying out the helical scan. A lathe bed is used which allows the tube to be manually rotated and/or translated axially under a coverslip and scanning laser beam. The transducer (100 MHz) remains stationary as the tube is moved around and over it. Motion of the tube is about as fast as it would be during examination with an optical microscope. The tube is virtually sealed at both ends and filled with water through a small tube. Water is also continuously fed to the coverslip as required. This arrangement assures good acoustic coupling between transducer, tube wall and coverslip. As the tube is scanned, a real-time acoustic image is displayed on the CRT screen. Each acoustic micrograph will cover an $\sim 2 \times 3$ -mm area.

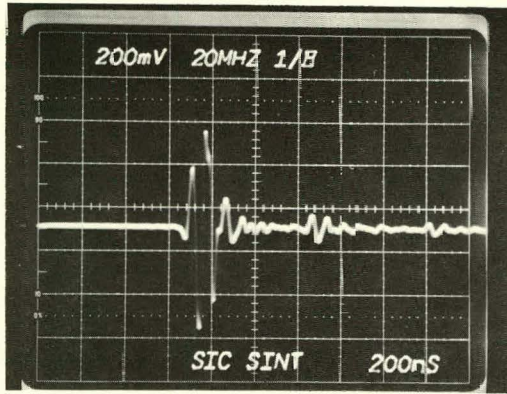
Fig. 25. Radio-frequency Inner-wall Reflector and Back-wall Echo Obtained from the Tube Bore Side with 20 MHz, 1/8-in.-dia Probe Employing (a) Impulse and (b) Tuned Initial Pulses.

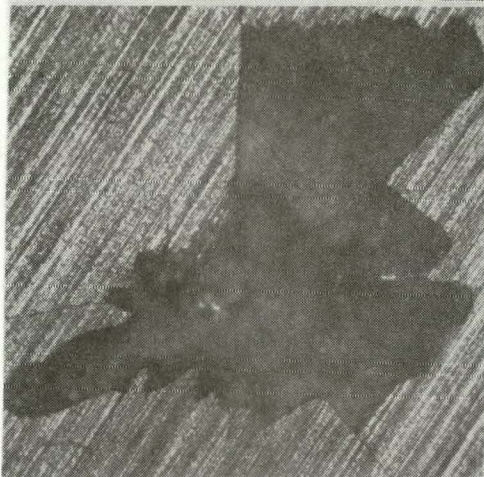
Fig. 28. Hot-pressed Si_3N_4 Bar B2 and 100X Photographs of Three Surface Dents Made with a Knoop Indenter.
