ENERGY RESEARCH CENTER

**Cermet Composite Thermal Spray Coatings for
Erosion and Corrosion Protection in Combustion
Environments of Advanced Coal-Fired Boilers**

Semiannual Technical Report Prepared for
U.S. Department of Energy

Project Period: 1/14/97-8/14/97

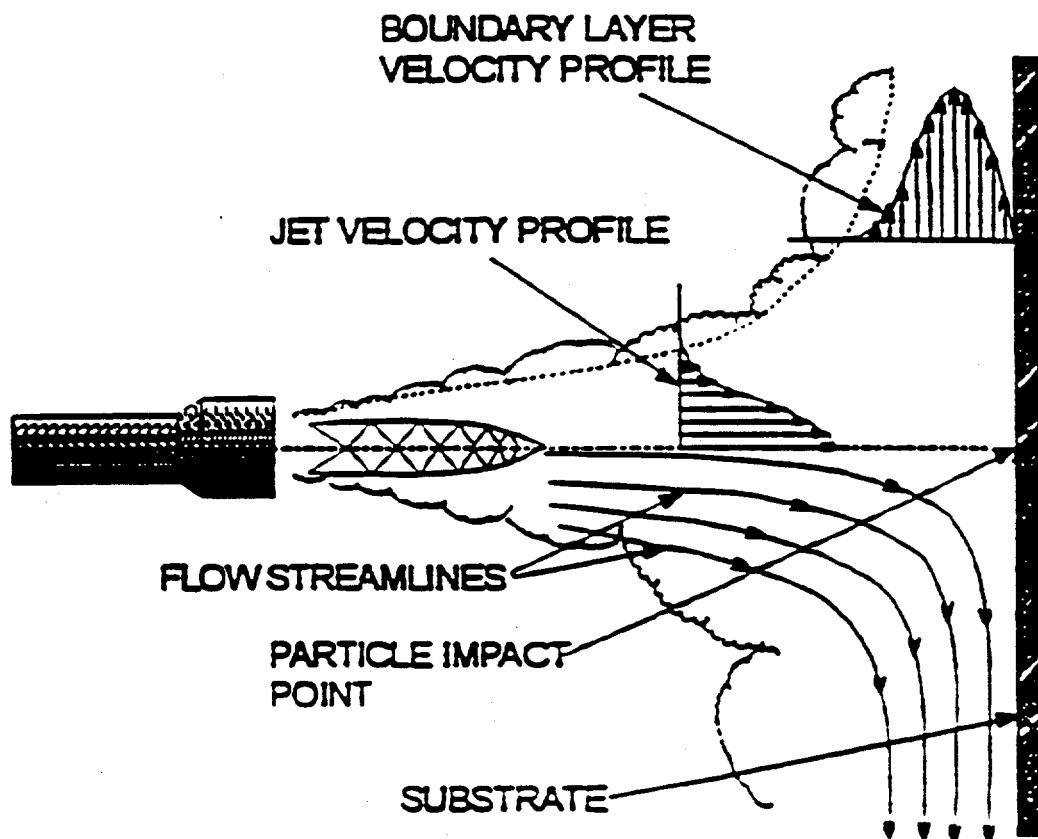
Figure II.6- HVOF jet impingement and boundary layer formation, causing oxygen to be trapped near the surface of the coating enhancing oxidation (15).

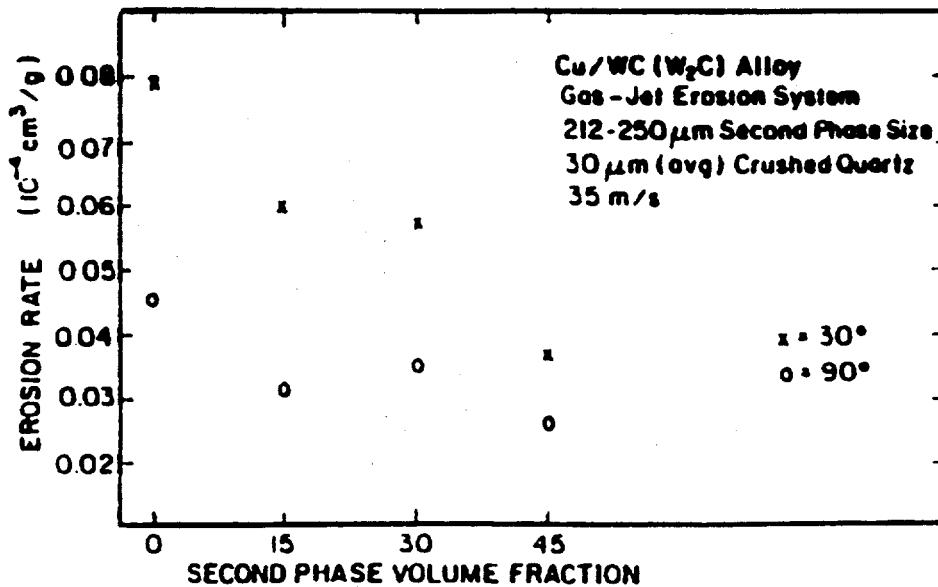
Figure II.13- Mild erosion condition results for Cu-Cr₃C₂ cermets at 90° (5): 30 μm crushed quartz particles and 35m/s (28).

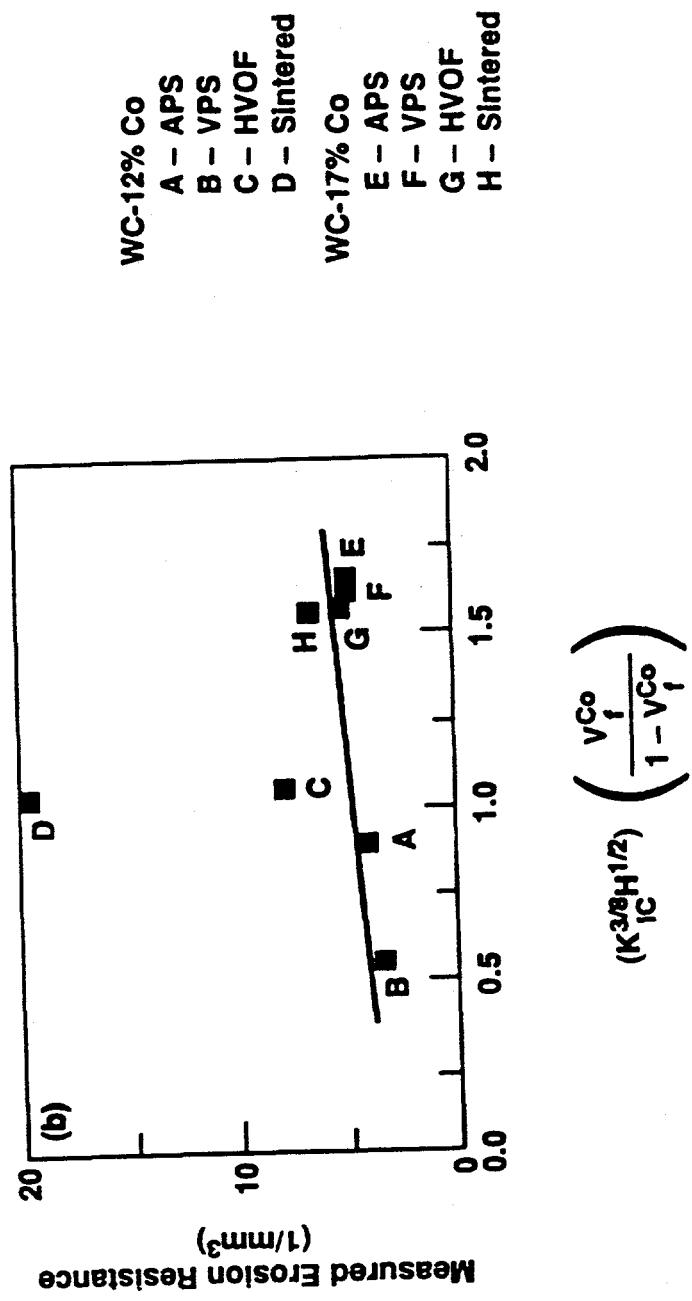
Figure II.17- Erosion data versus proposed microstructure/mechanical property parameter (12).

where V_f^{Co} is the volume fraction of cobalt. When they plotted the erosion resistance versus the above equation they found a fairly good correlation as shown in figure II.17, although the sintered 12% Co cermet could not be explained. Wayne and Sampath

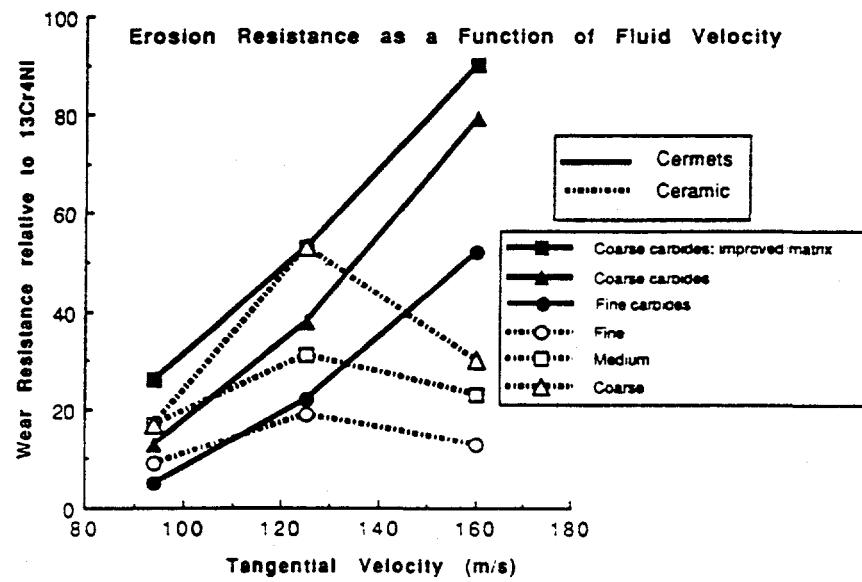
Figure II.18- Erosion rate versus particle velocity for various carbide reinforcement sizes (31).

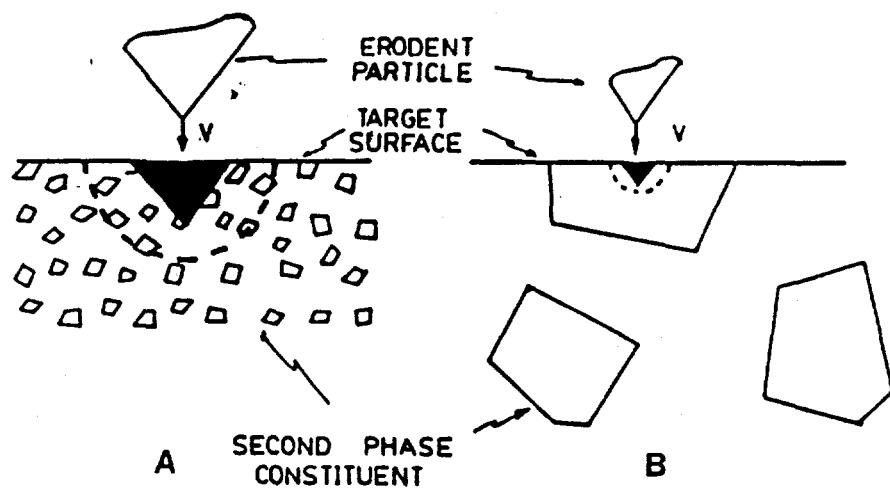
Figure II.19- Erodent size - hard phase (E/HP) ratio schematic: a. Large E/HP leading to matrix toughening and ductile failure --> lower erosion rates & b. Small E/HP leading to hard phase fracture and brittle failure --> higher erosion rates (32).

Anand and Conrad (32) defined both a brittle and ductile regime, depending on the the erodent particle-hard phase grain ratio (E/HP), shown schematically in figure II.19. When this ratio is large ductile failure was said to dominate and impact was absorbed by many particles. Anand and Conrad surmised that smaller reinforcement particles would resist cracking, resulting in a dominant erosion mechanism of plastic deformation of the ductile matrix with erosion rates that were roughly proportional to the square root of the

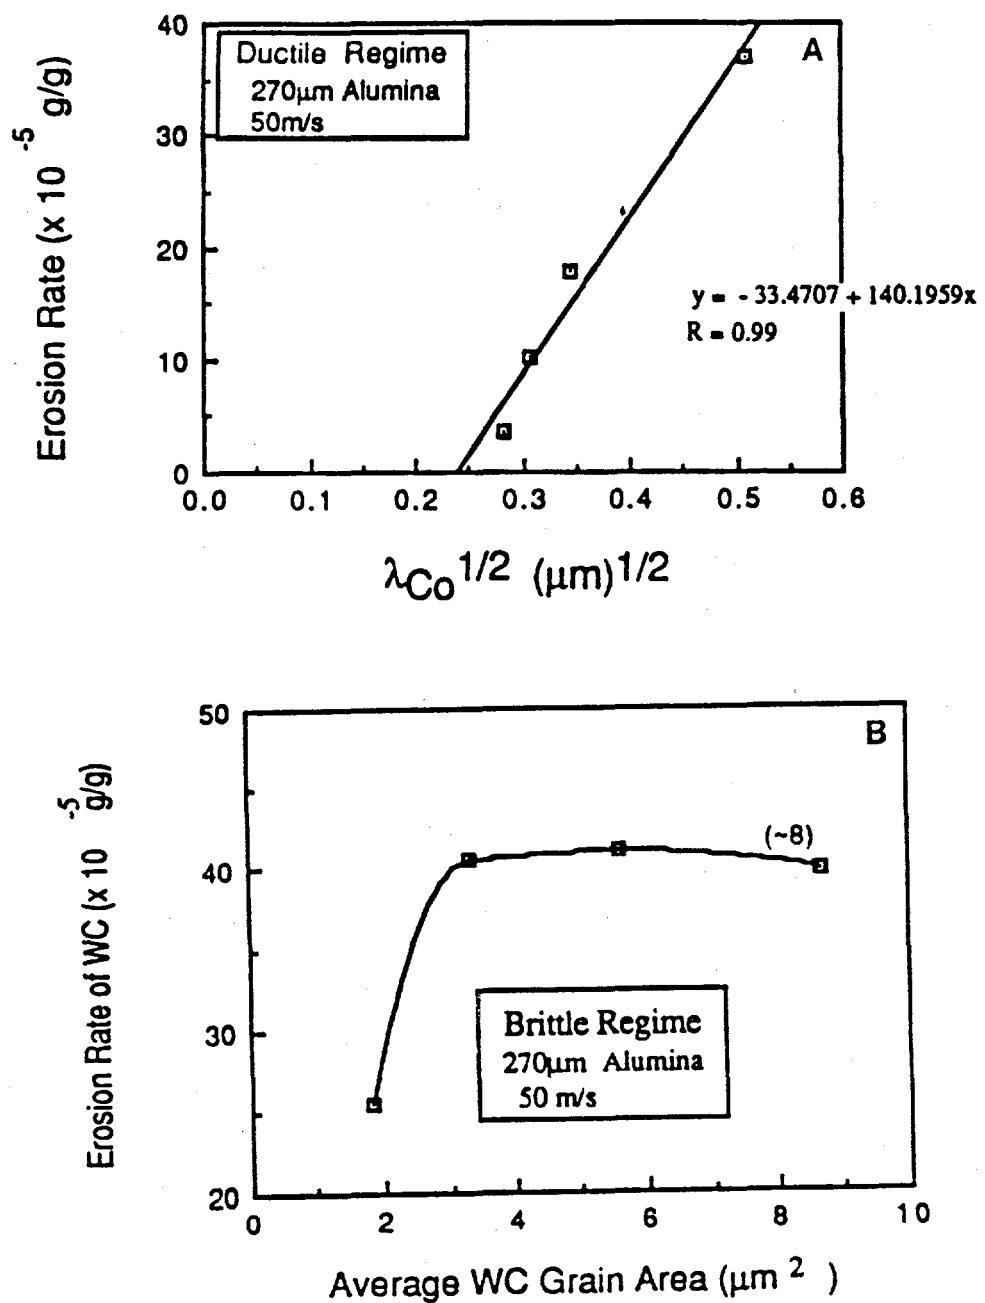
Figure II.20- Erosion rate versus various microstructural features for a.Ductile regime and b. Brittle regime (32).

binder mean free path (figure II.20a). It was thought that the small particles tend to reduce the overall plastic deformation of the matrix by toughening the material. Conversely when the particle/hard phase ratio is small brittle failure (chipping and cracking) was observed. The larger reinforcement particles absorb all of the impact (figure II.8.5), and usually respond by chipping and cracking due to their brittle nature. In this regime the erosion rate was found to increase as the size of the hard phase was increased up to a point, after which damage leveled off (figure II.20b). A more recent study of spheroidized carbon steels conducted by Lindsley (26) also found erosion to be controlled directly by the MFP. Lindsley found that as the microstructural spacing (MS), the distance between carbides and or grain boundaries, was reduced so was the erosion rate of the tested material. In addition, a linear relationship between the erosion rate and $1/(MS)^{-1/2}$ was also found to persist as shown in figure II.21, again suggesting precipitation toughening. To lend credence to the smaller reinforcement particles toughening the overall structure, Liu et. al. (33) related the size of the second phase to the toughness values of WC-Co cermet materials, figure II.22. Liu concluded that by reducing the size of the WC particles the reinforcements could begin to impede dislocation motion, which lead to higher toughness values. Additional (22,34) studies also mention the size of the reinforcement as important for erosion control, where smaller more evenly distributed reinforcements enhance erosion resistance, though none of them extensively studied the effect and provide little data to back up their claims.

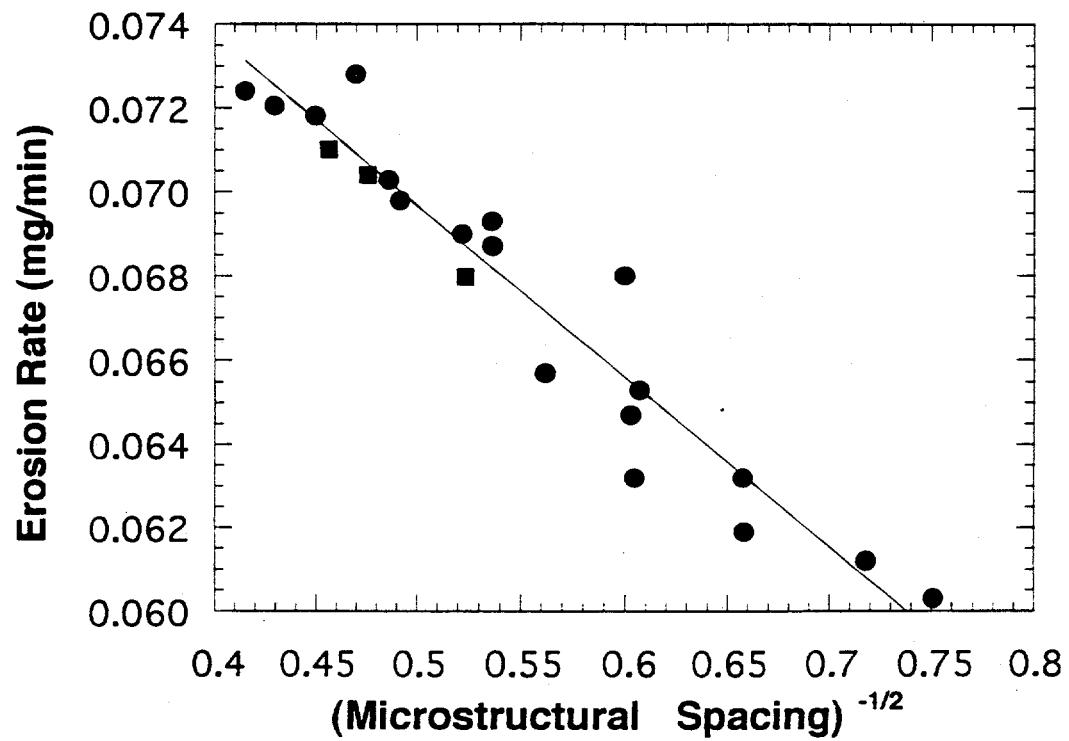
Figure II.21- Erosion rate versus $1/(\text{microstructural spacing})^{-1/2}$ for spherodized plain carbon steels (26).

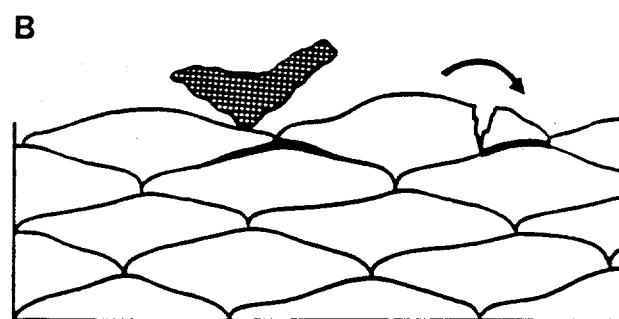
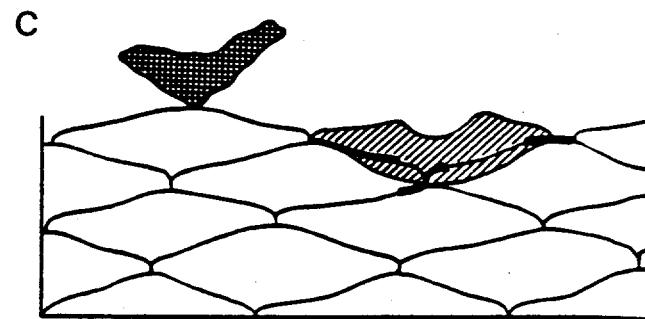
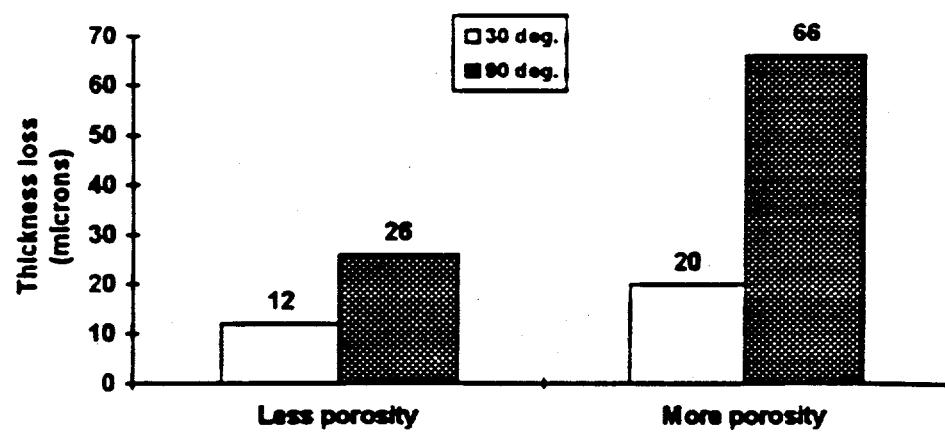
Figure II.25- Erosion failure mechanisms for thermal spray coatings: a) Splat debonding, b) Splat fracture associated with porosity , and c) Splat deformation (21).

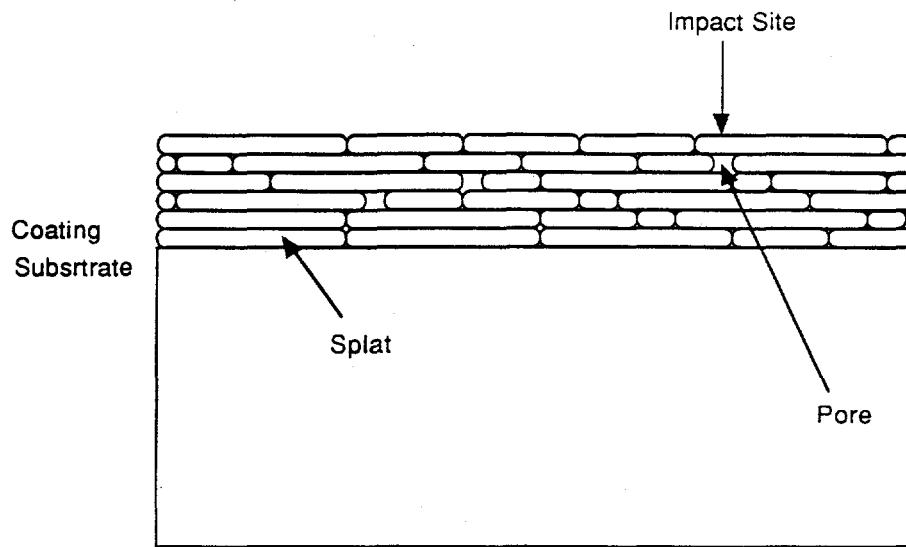
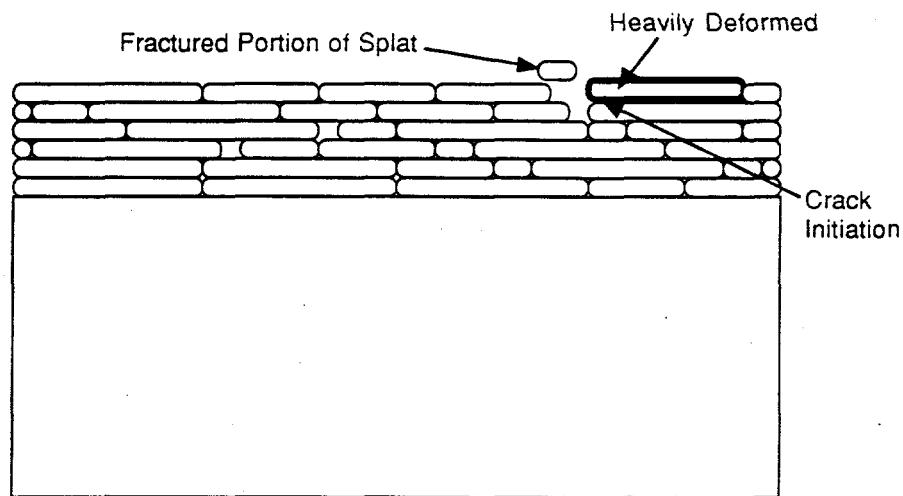
Figure II.27- Splat fracture and delamination associated with porosity of an impacting particle striking a splat directly above a pore. Due to the lack of support for the splat, excessive deformation and eventual splat fracture may occur or impact may be absorbed by the relatively weak splat to splat bonds failing resulting in delamination.

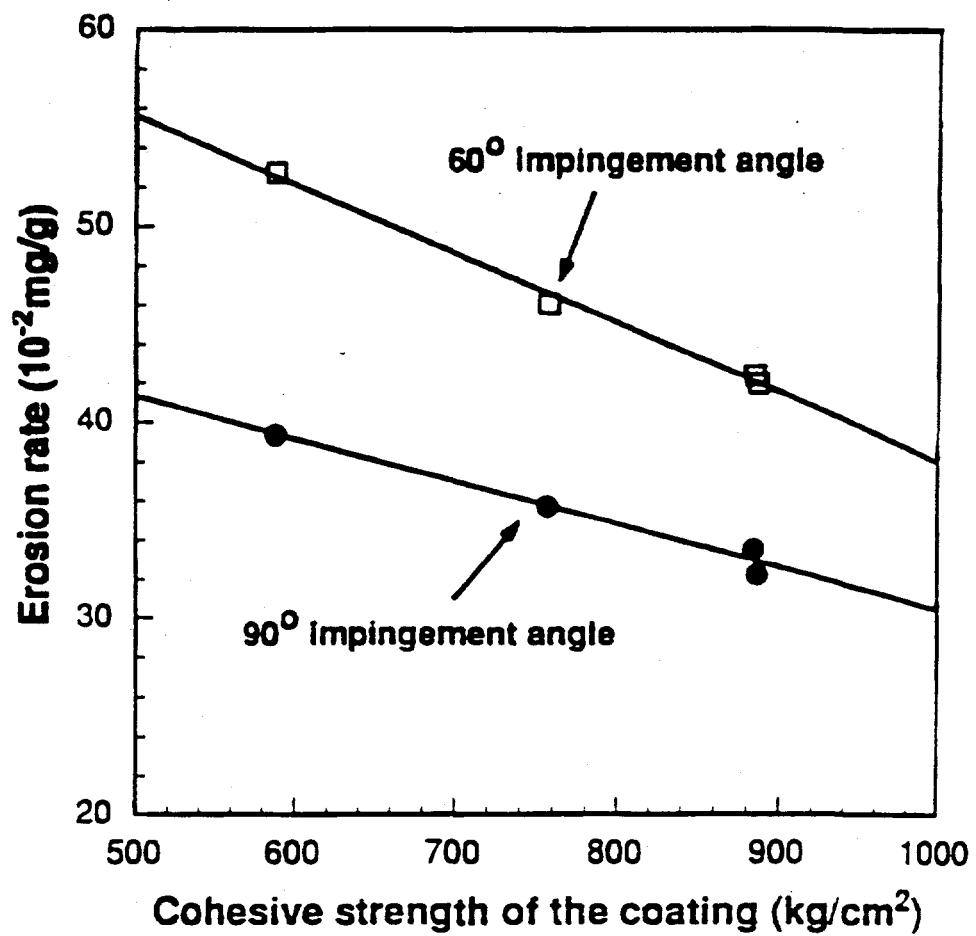
Figure II.29- Erosion rate versus cohesive strength for HVOF coatings (6).

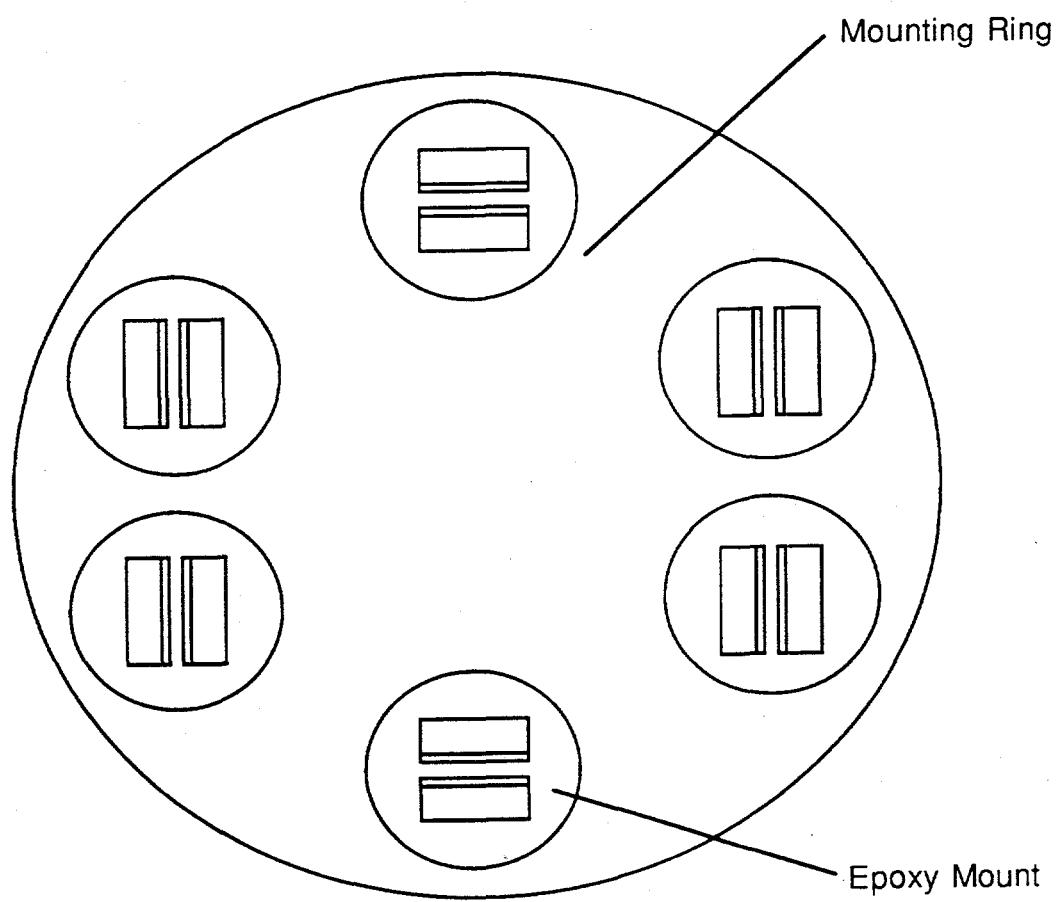
Figure III.2- Specimen orientation in Abrapol ring holder.

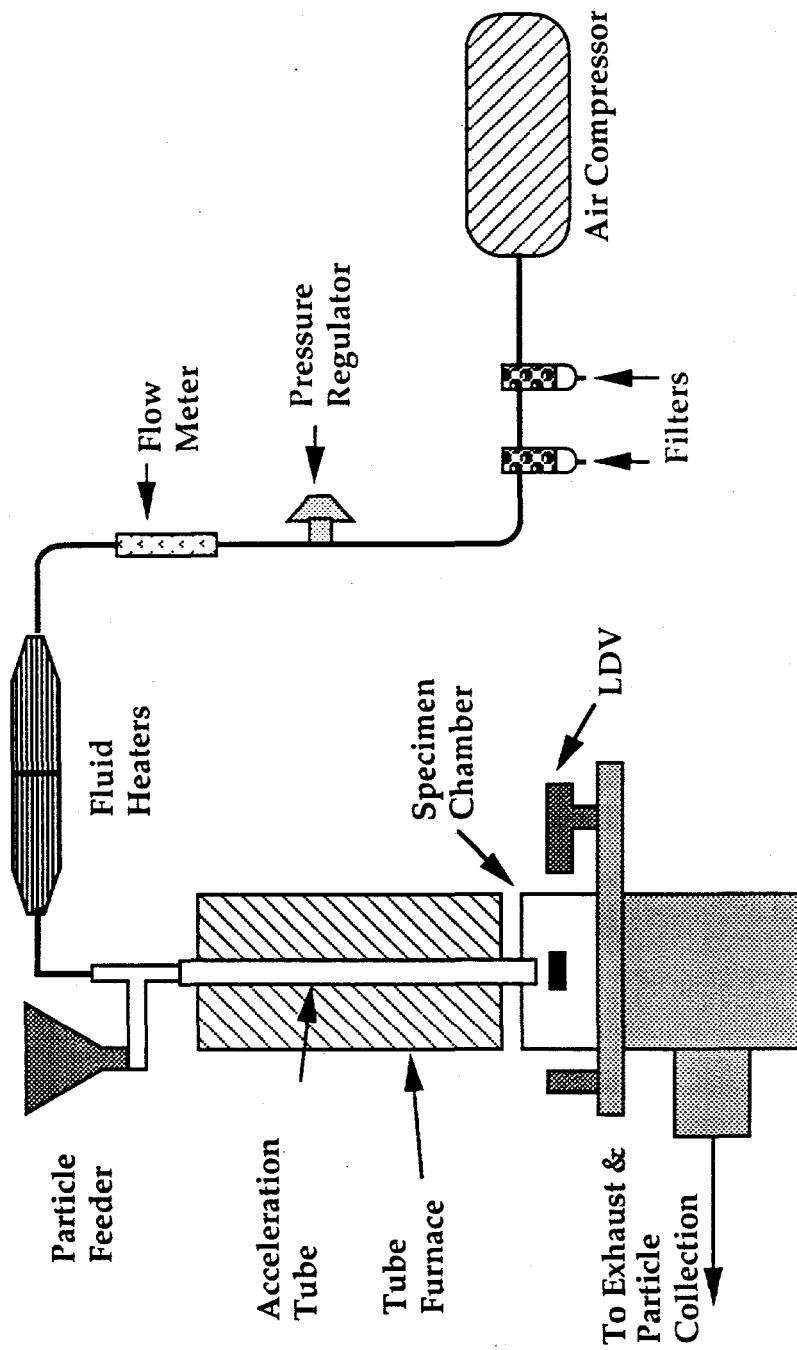
Figure III.5- Erosion tester schematic.

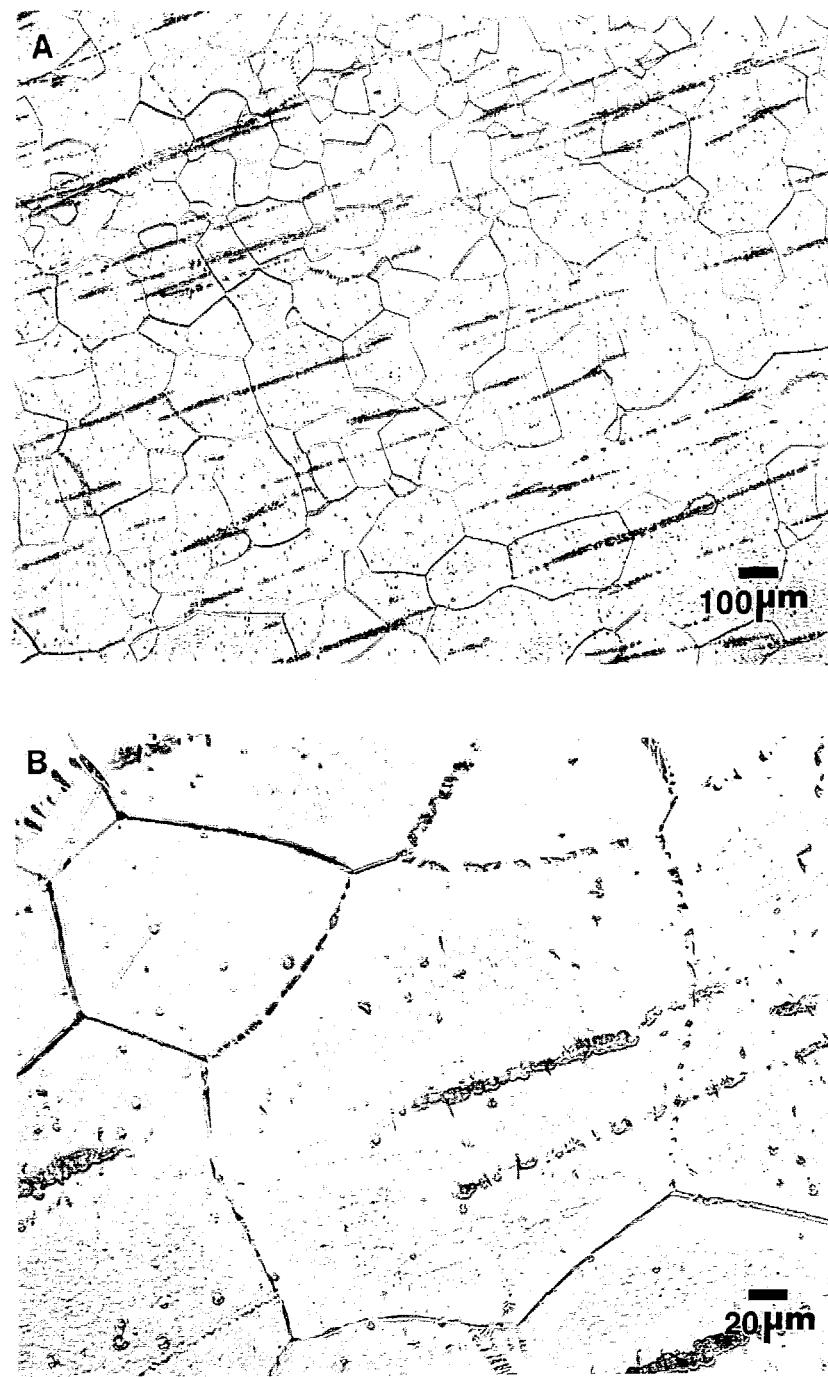
Figure IV.1- Wrought FeAl microstructures: a. 50x, b.250x.

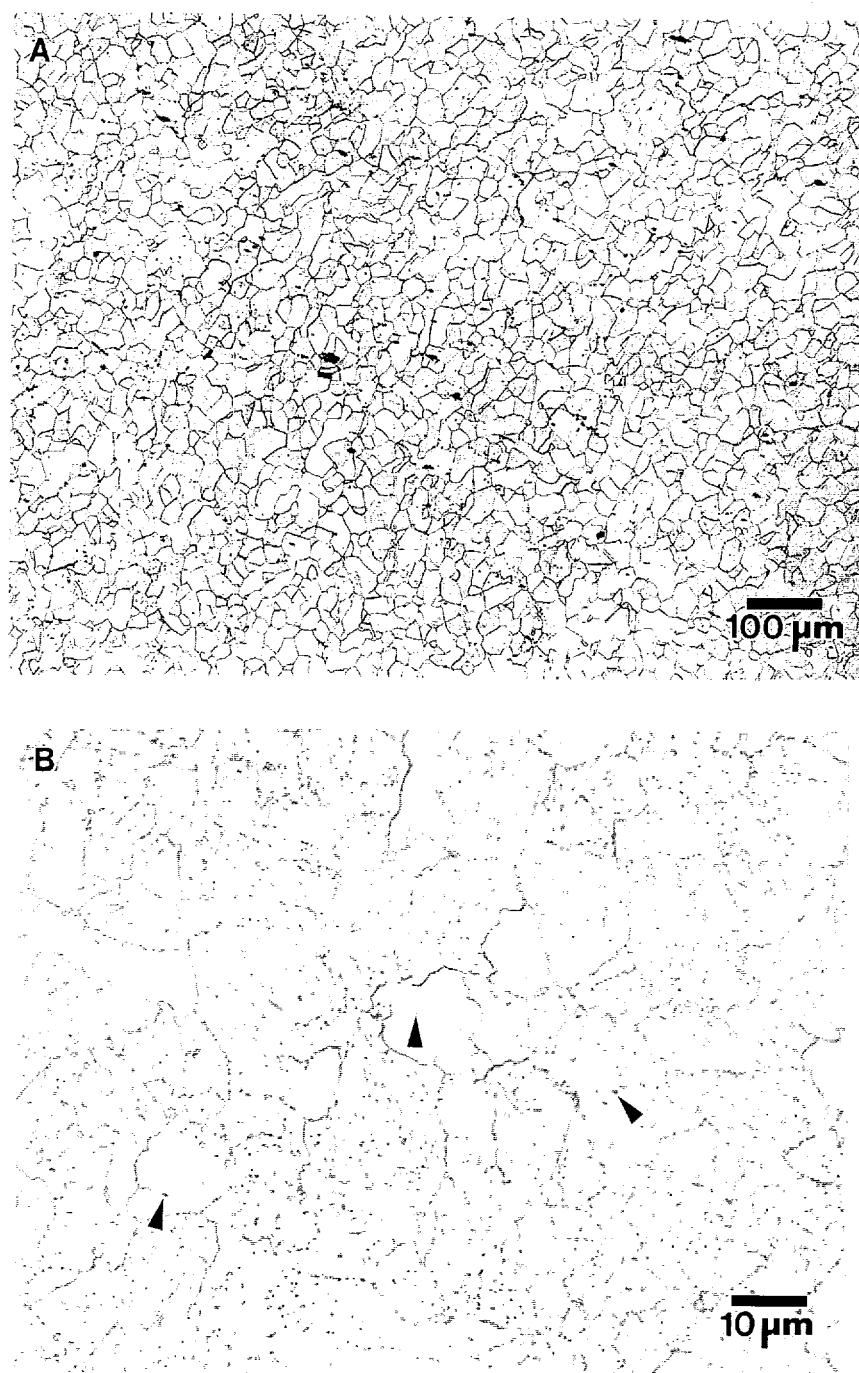
Figure IV.2- CrMo steel microstructures (T-11): a.100x, b.1000x.

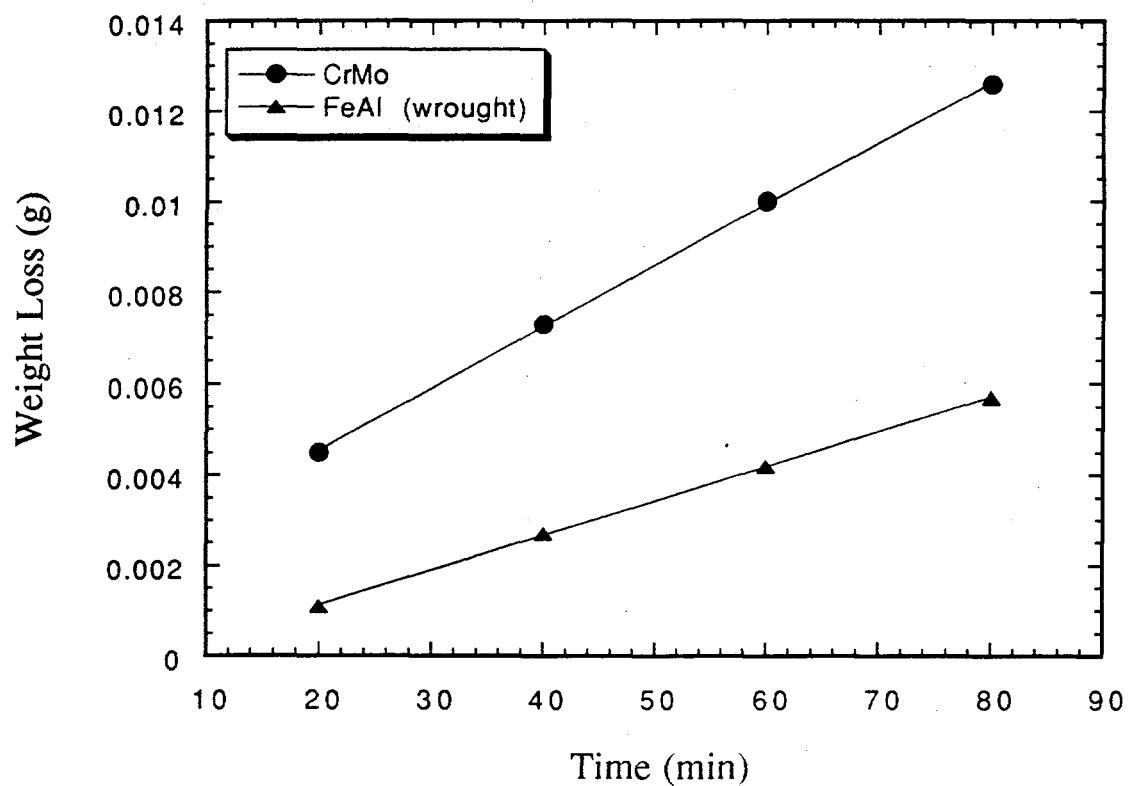
Figure IV.3 Weight loss versus time curves for CrMo steel and wrought FeAl, beginning time data was omitted to ensure accurate steady state erosion calculation.

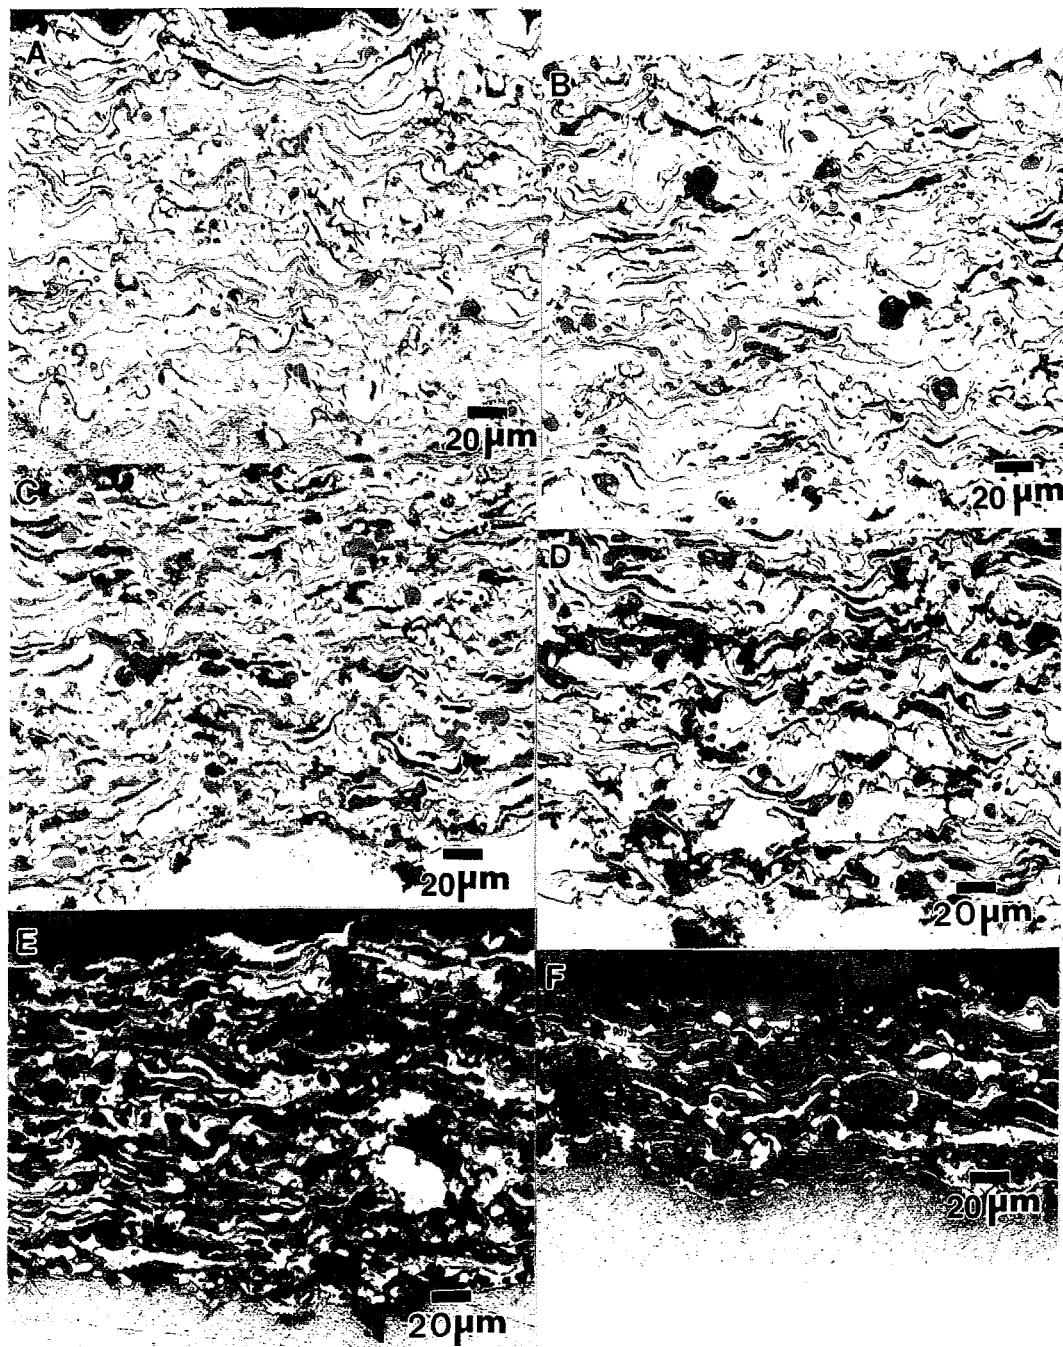
Figure IV.7-APS FeAl coating microstructures: a.0% Al_2O_3 , b.10% Al_2O_3 , c.20% Al_2O_3 , d.40% Al_2O_3 , e.60% Al_2O_3 , and f.80% Al_2O_3 (250x).

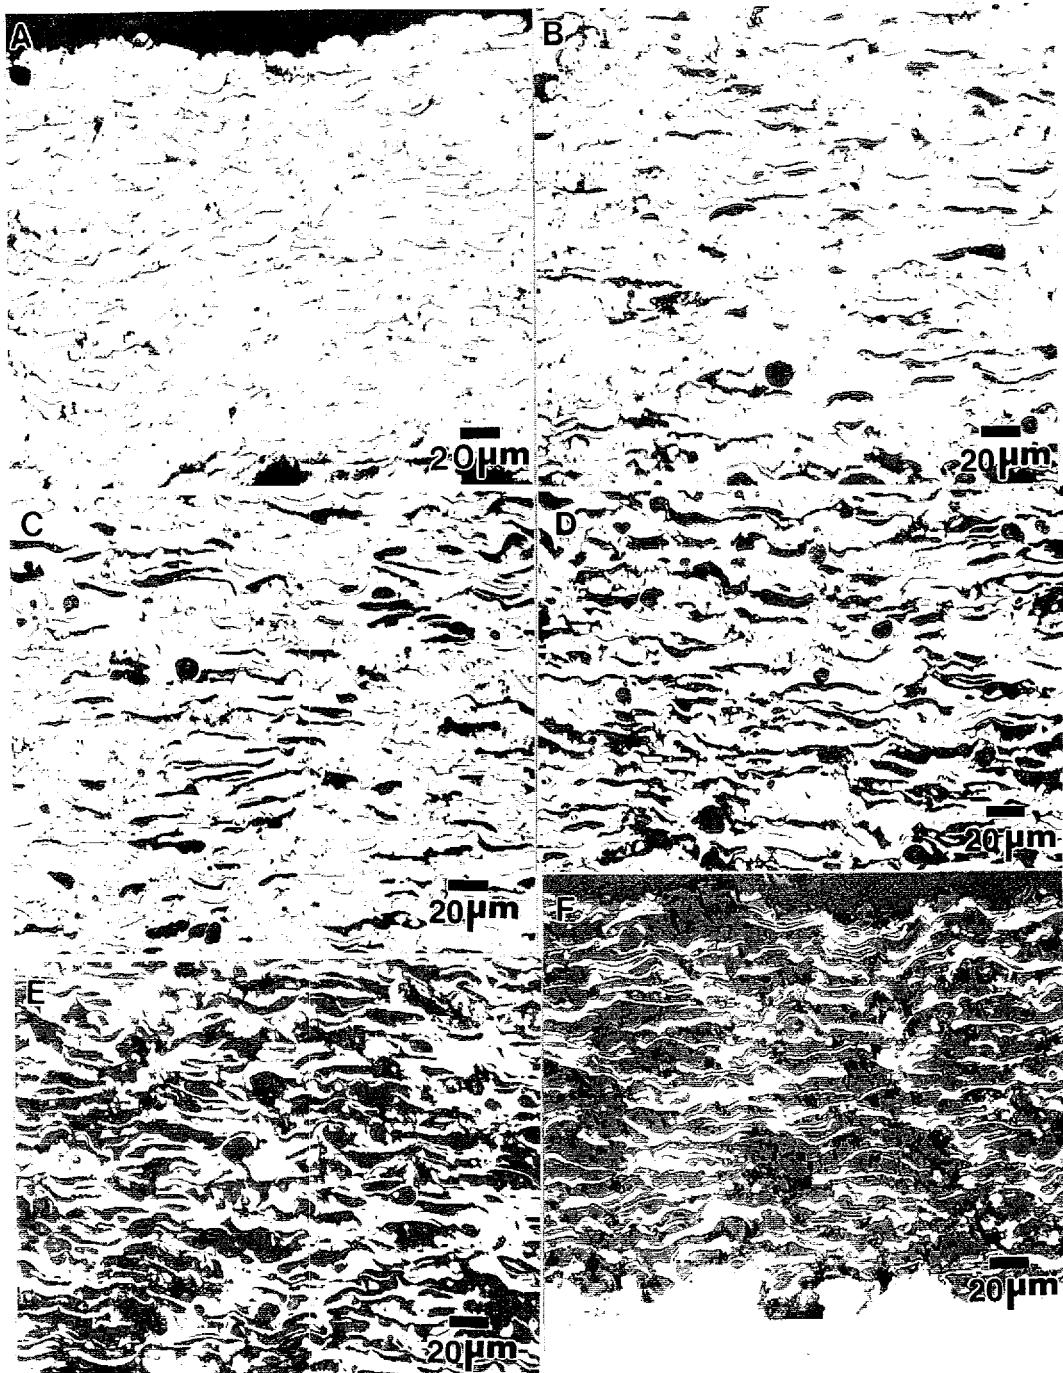
Figure IV.8 VPS FeAl (-25 μm) coating microstructures: a.0% Al_2O_3 , b.10% Al_2O_3 ,
c.20% Al_2O_3 , d.40% Al_2O_3 , e.60% Al_2O_3 , and f.80% Al_2O_3 (250x).

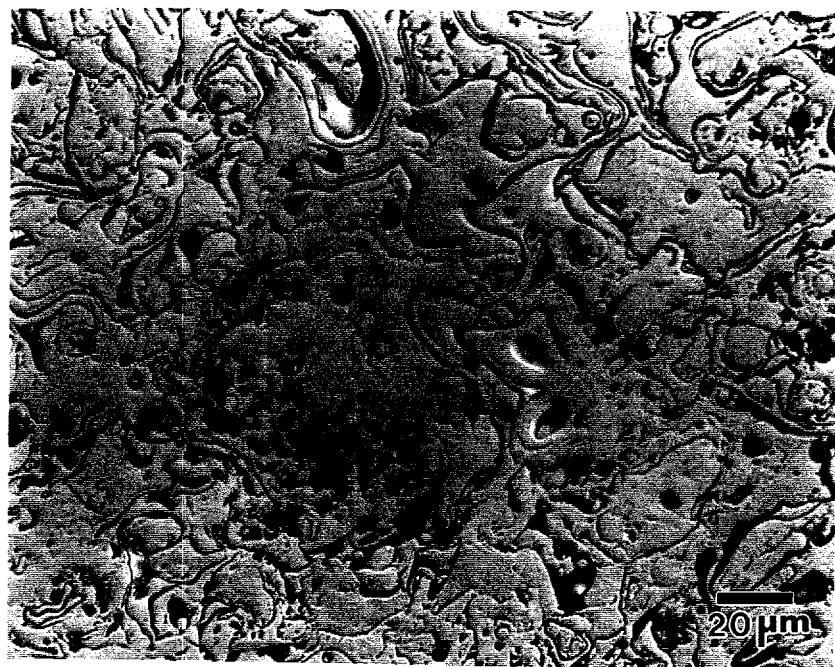
Figure IV.9 APS FeAl planar section (500x).

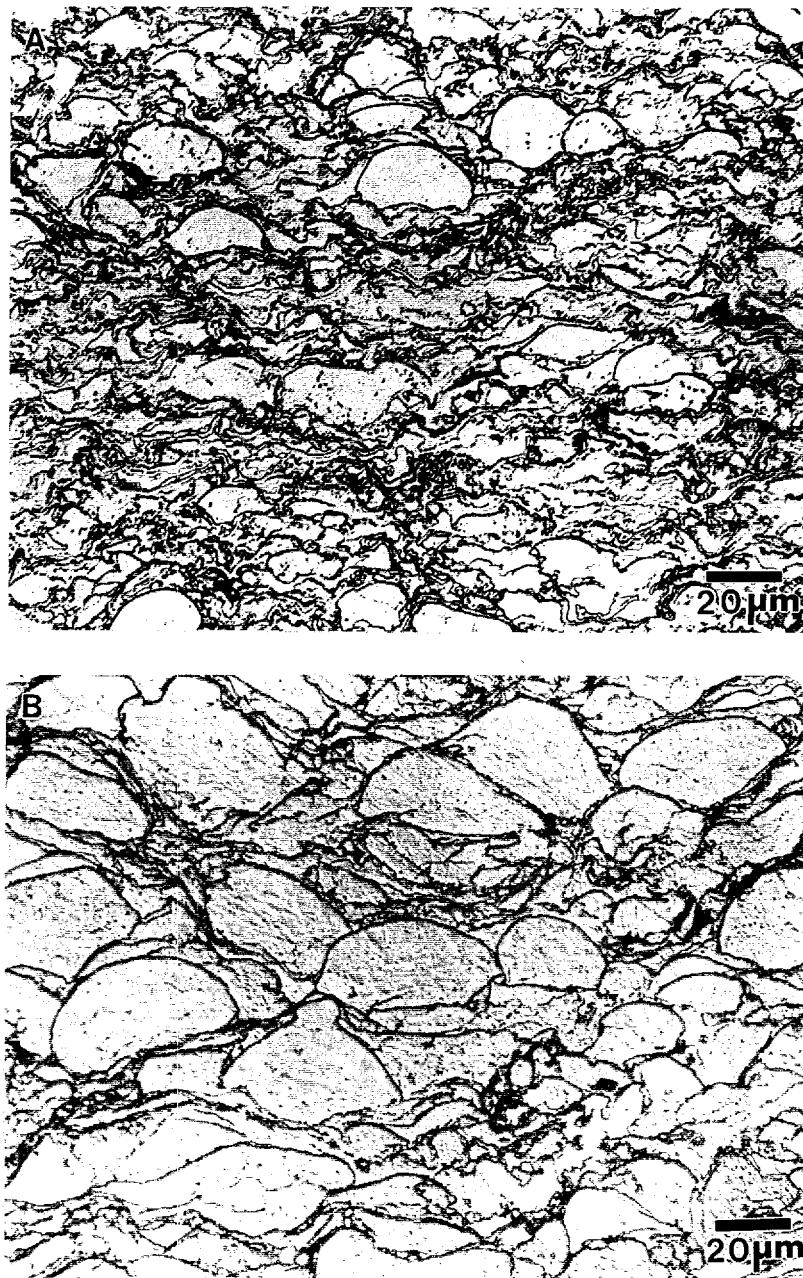
Figure IV.15 FeAl HVOF coating, etched: a.-25 μm , b.+25 μm (500x).

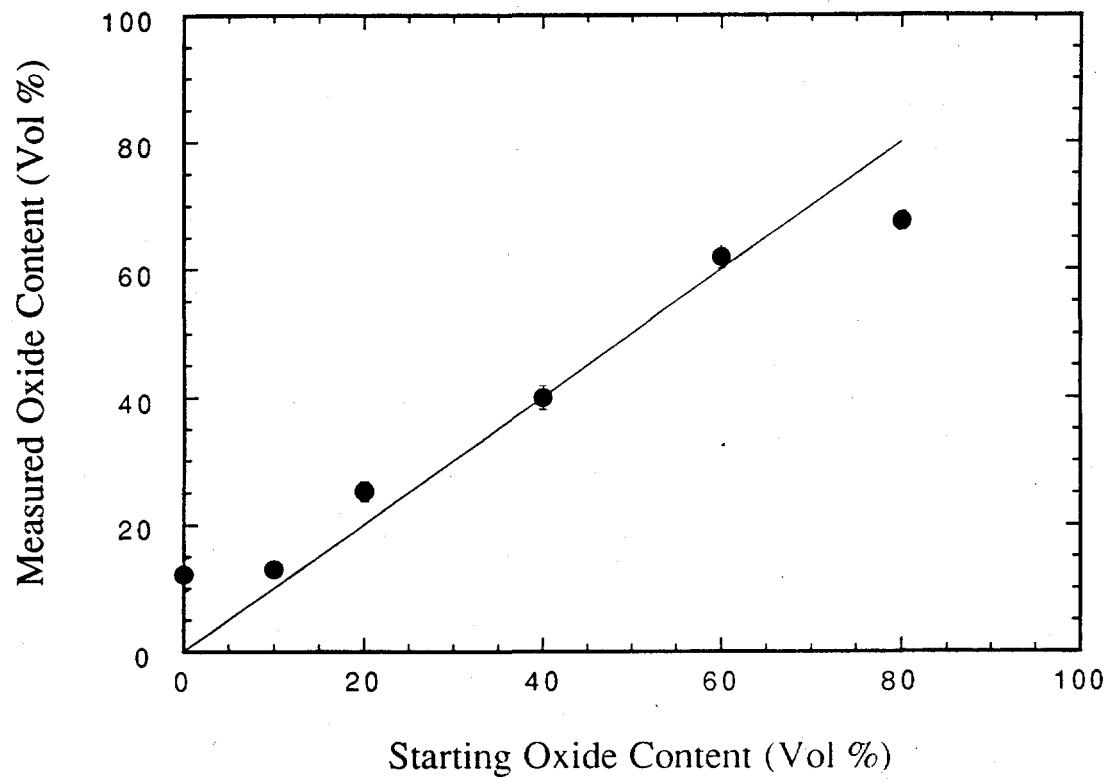
Figure IV.17- Measured oxide content versus the starting Al_2O_3 content in the VPS,+25 μm Fe/Al alloy coatings.

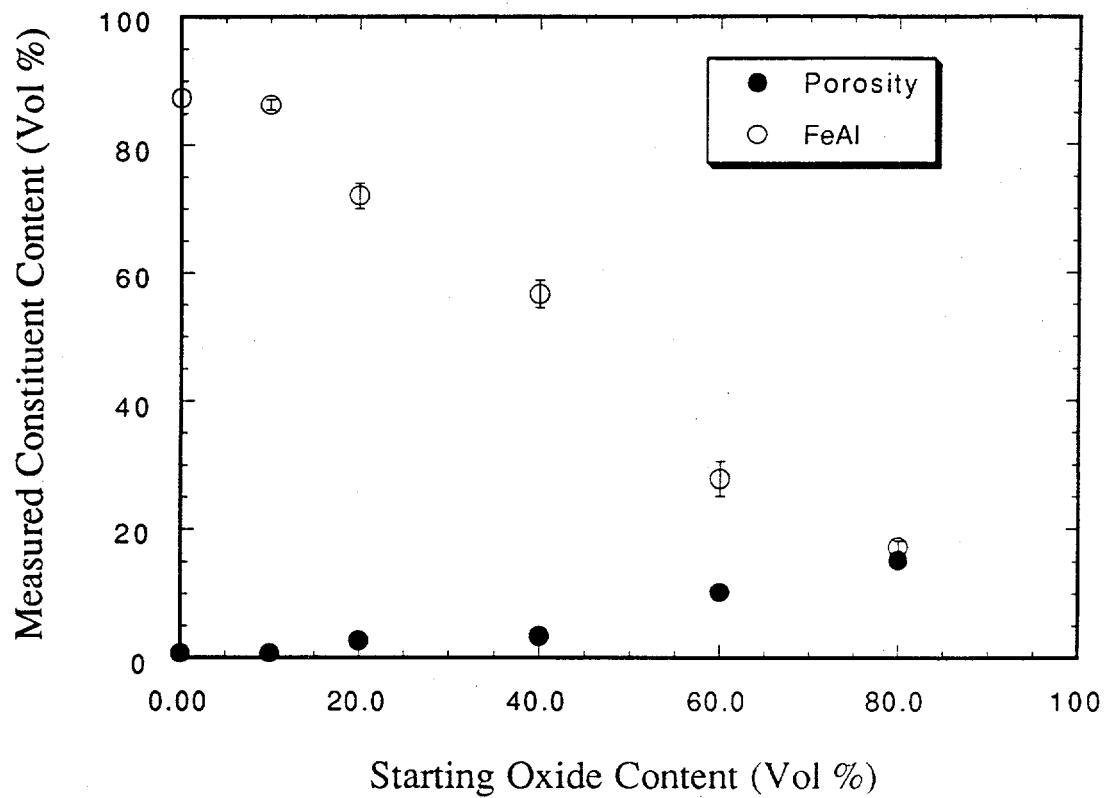
Figure IV.18- Measured porosity and FeAl content versus the starting Al_2O_3 content in the VPS, +25 μm Fe/Al alloy coatings.

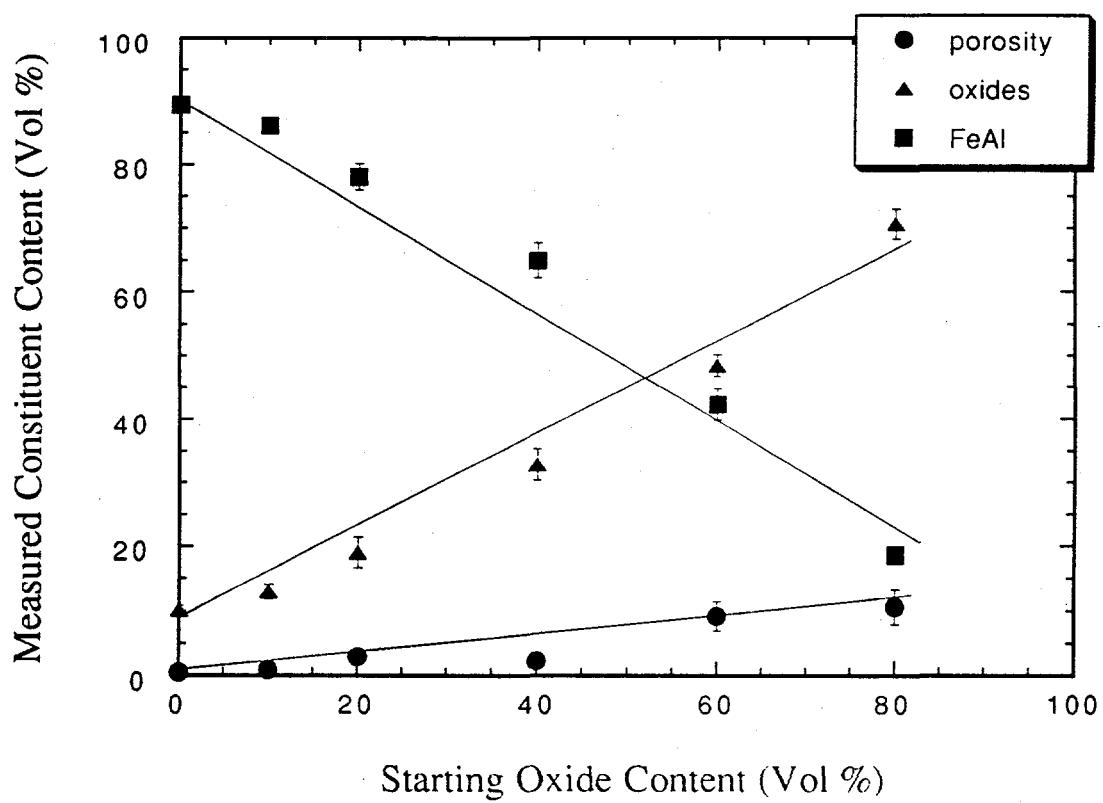
Figure IV.19 Measured constituent content versus the starting Al_2O_3 content in the VPS, - 25 μm Fe/Al alloy coatings.

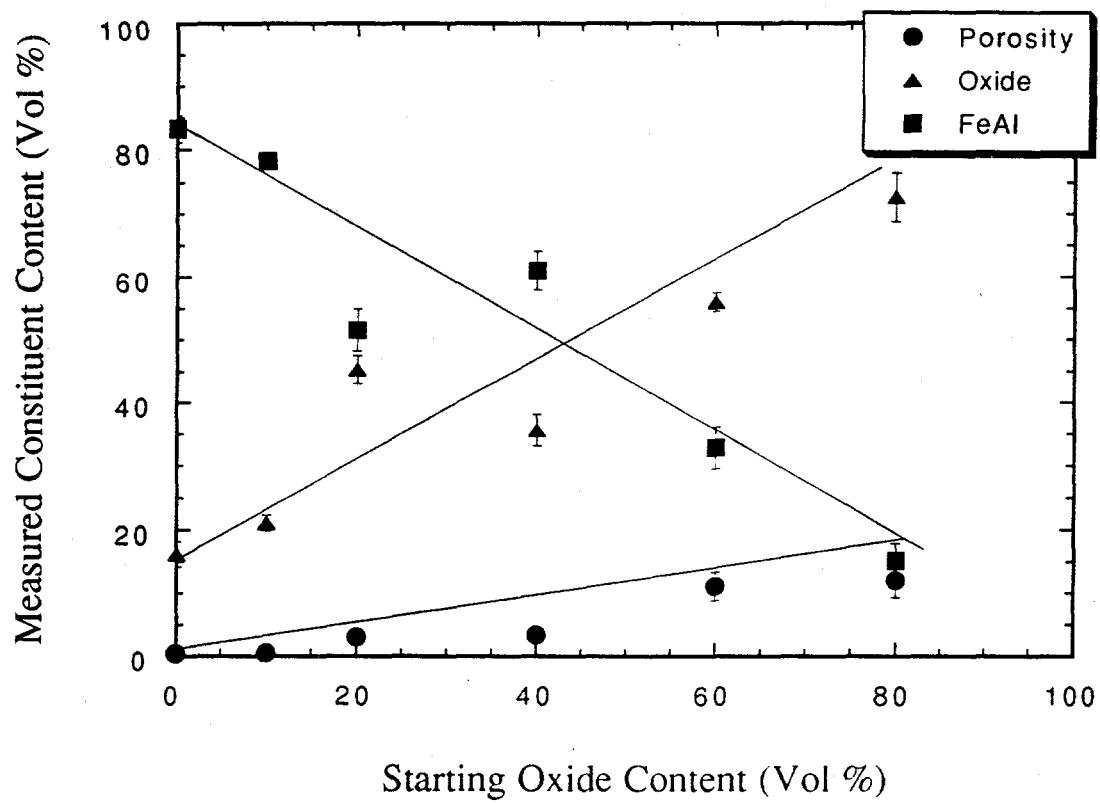
Figure IV.20- Measured constituent content versus the starting Al_2O_3 content in the APS Fe/Al alloy coatings.
