ENERGY RESEARCH CENTER

**Cermet Composite Thermal Spray Coatings for
Erosion and Corrosion Protection in Combustion
Environments of Advanced Coal-Fired Boilers**

Semiannual Technical Report Prepared for
U.S. Department of Energy

Project Period: 1/14/97-8/14/97

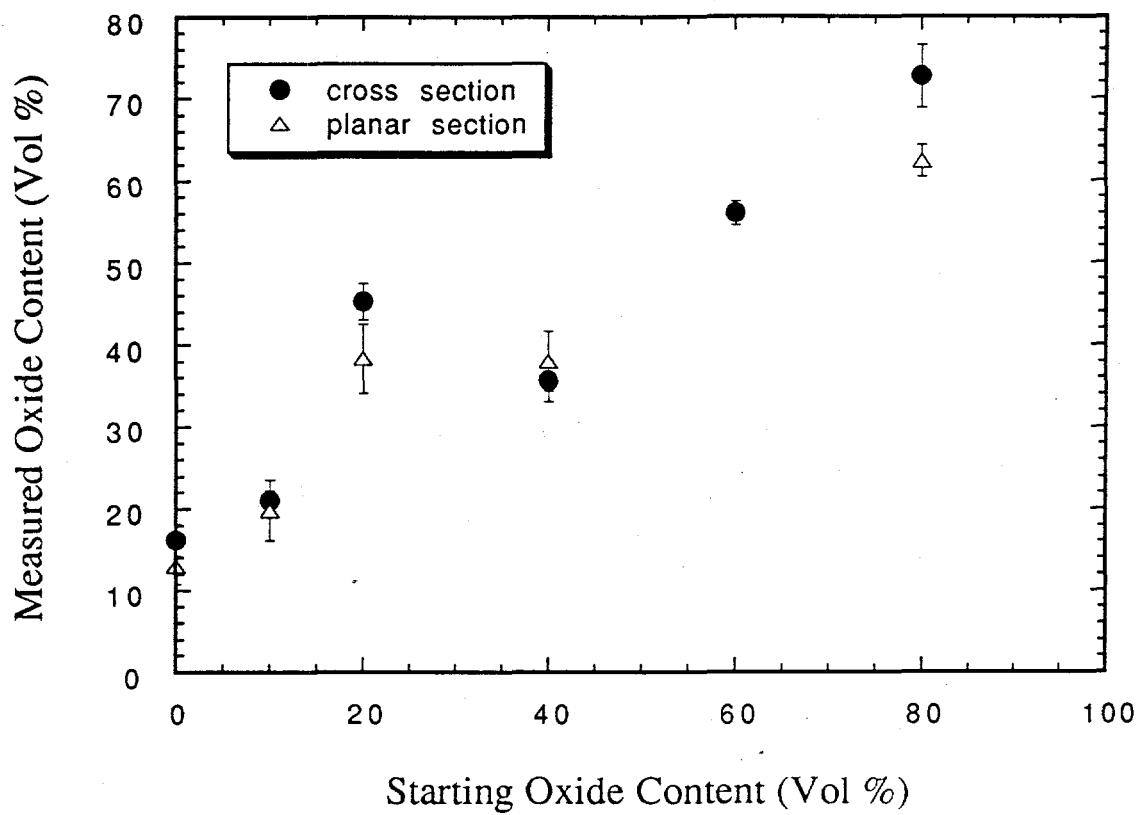
Figure IV.21- Measured oxide content versus starting Al_2O_3 content for both planar and cross sections in the APS Fe/Al alloy coatings.

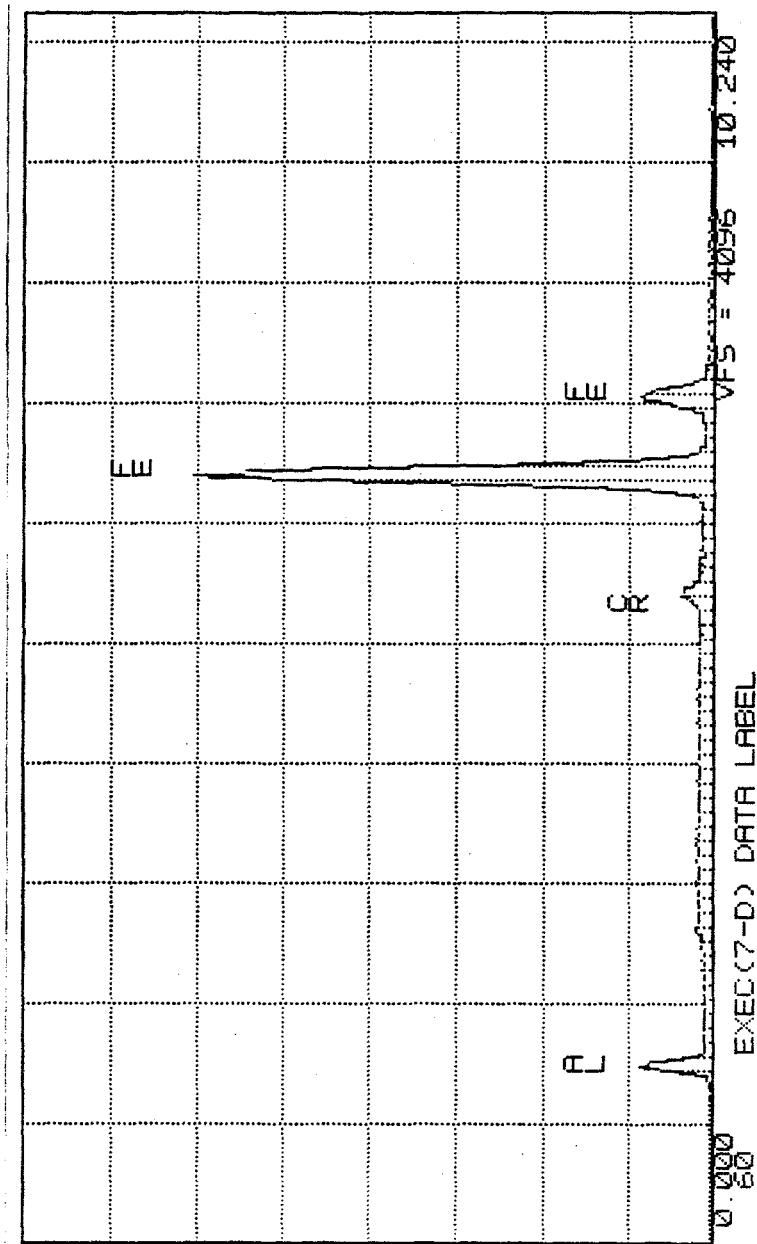
Figure IV.24 EDS spectra for phase 1 (white) in figure IV.23.

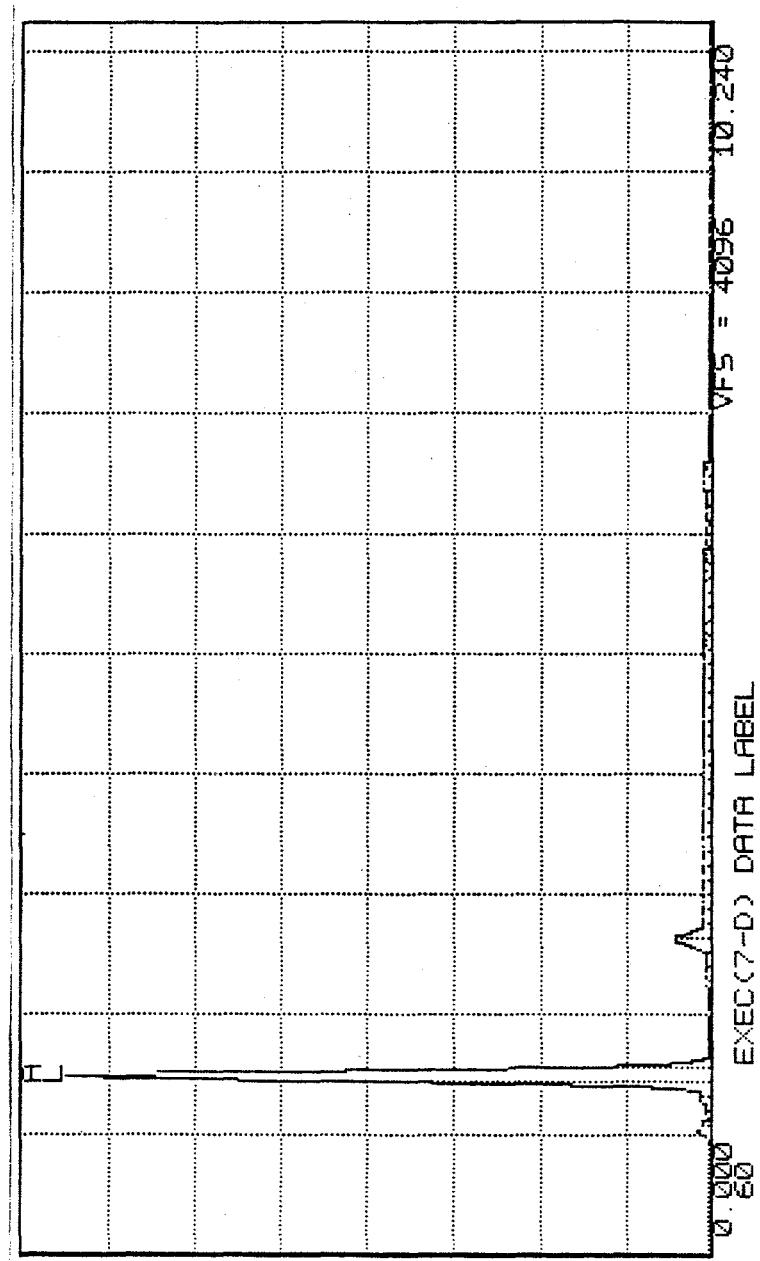
Figure IV.25 EDS spectra for phase 2 (dark gray) in figure IV.23.

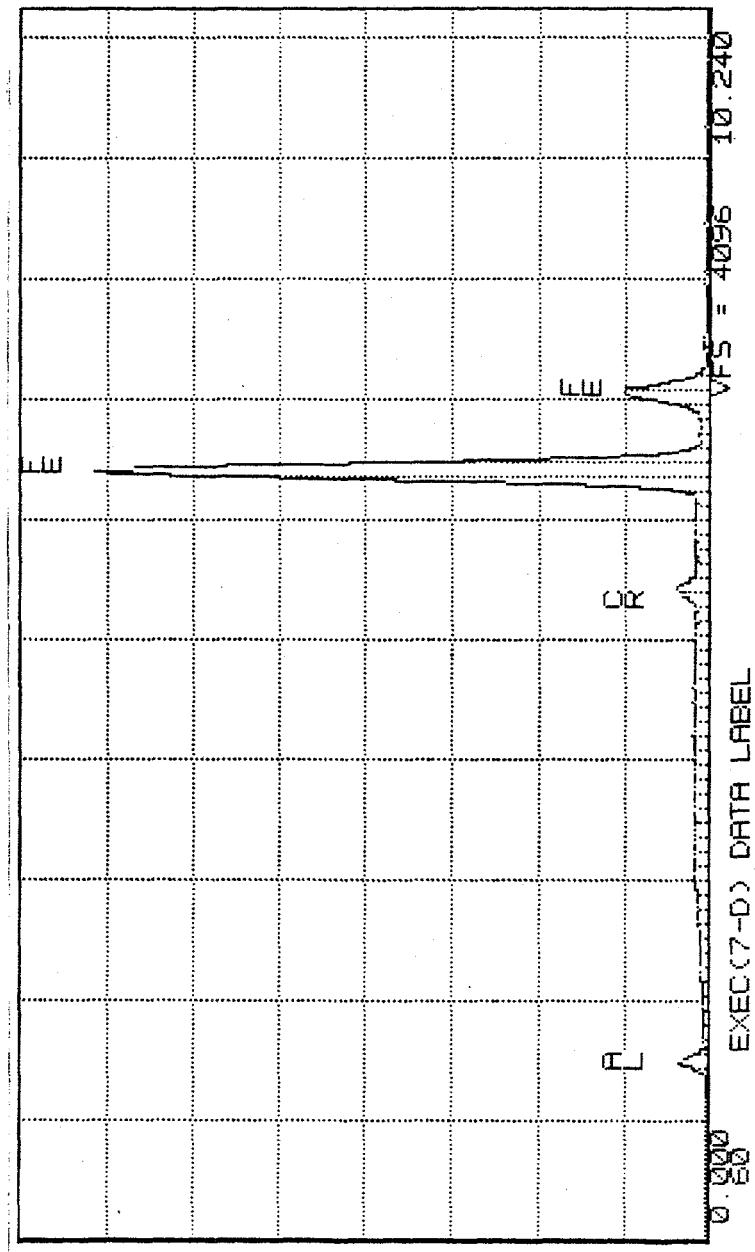
Figure IV.26 EDS spectra for phase 3 (light gray) in figure IV.23.

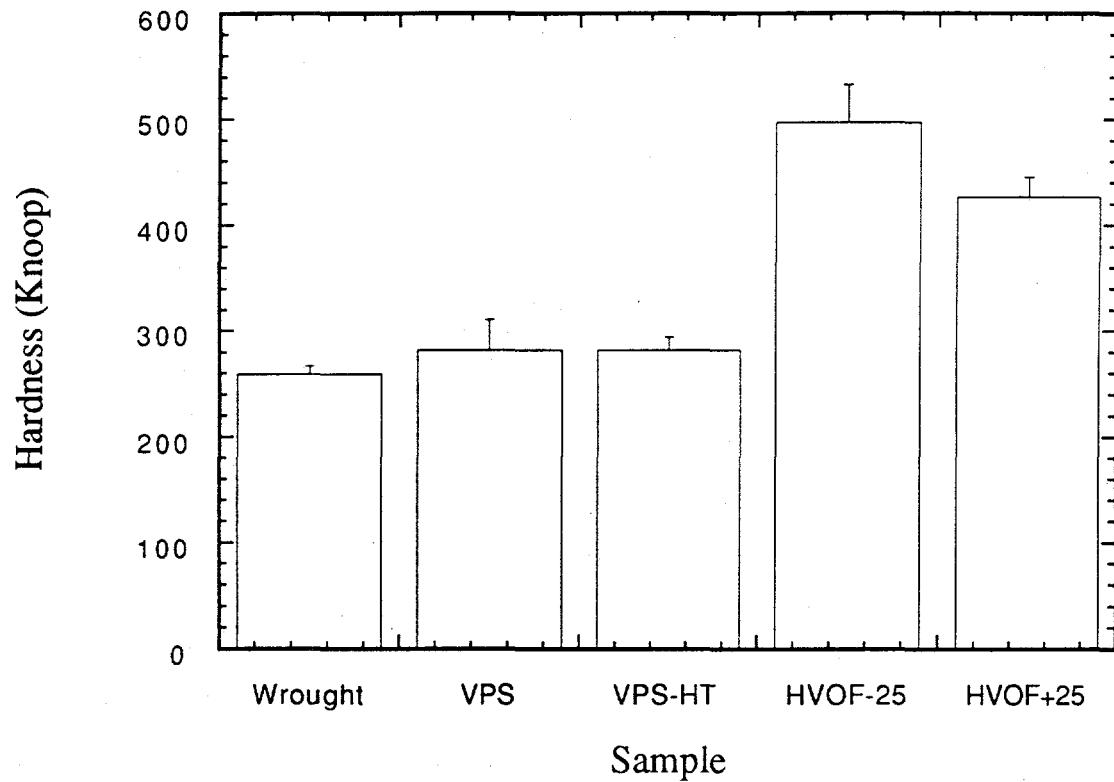
Figure IV.28- Knoop Hardness values for various FeAl materials (the lines at the top of each bar represent the standard deviation of each value).

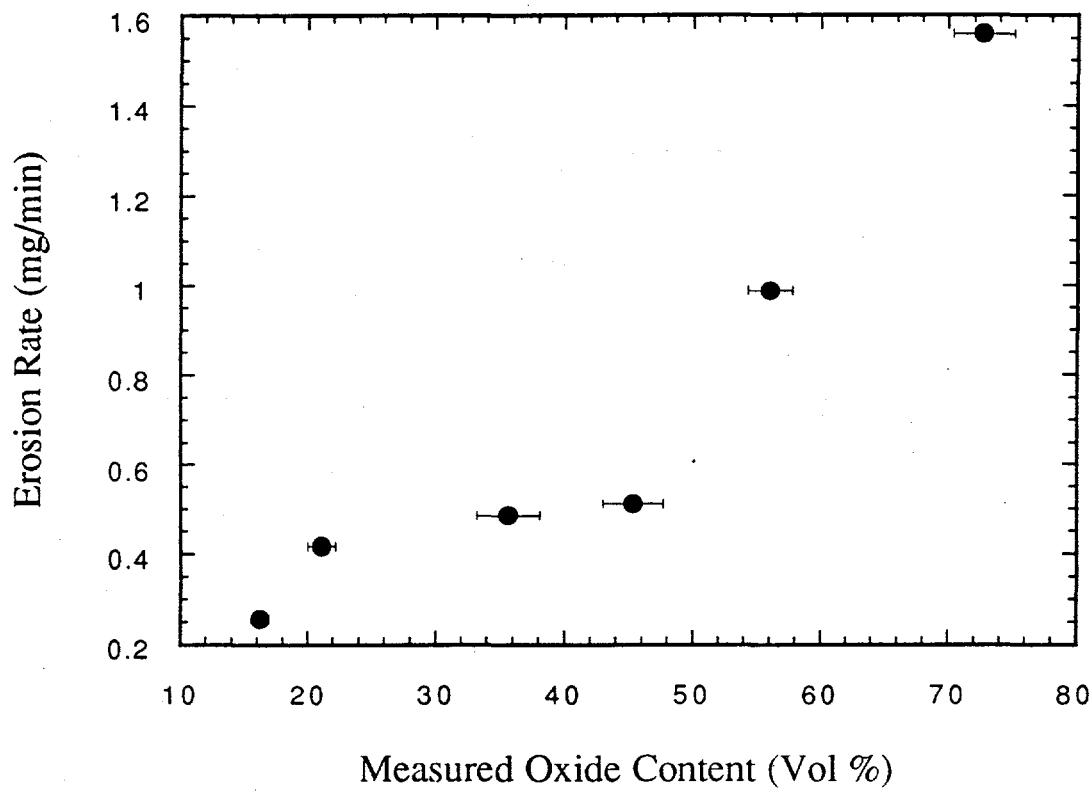
Figure IV.29 Erosion rate versus measured oxide content for the APS FeAl alloy coatings (90°).

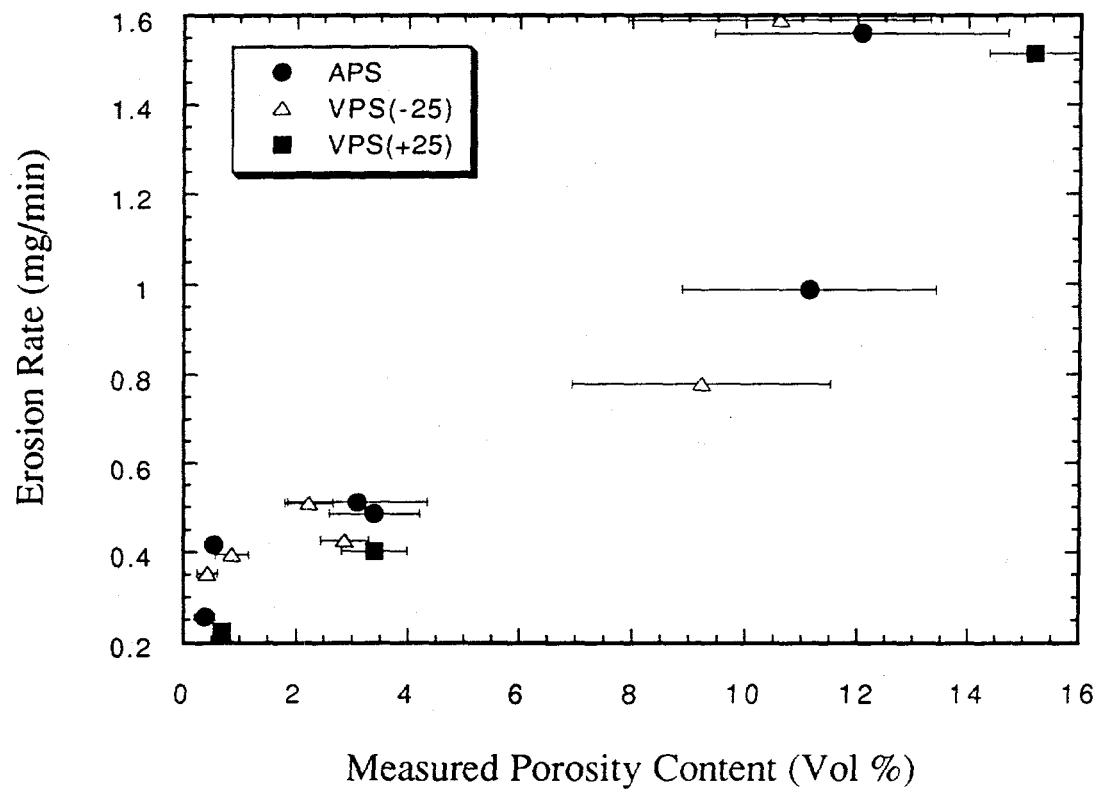
Figure IV.33 Erosion rate versus measured porosity content for all of the plasma FeAl alloy coatings (90°).

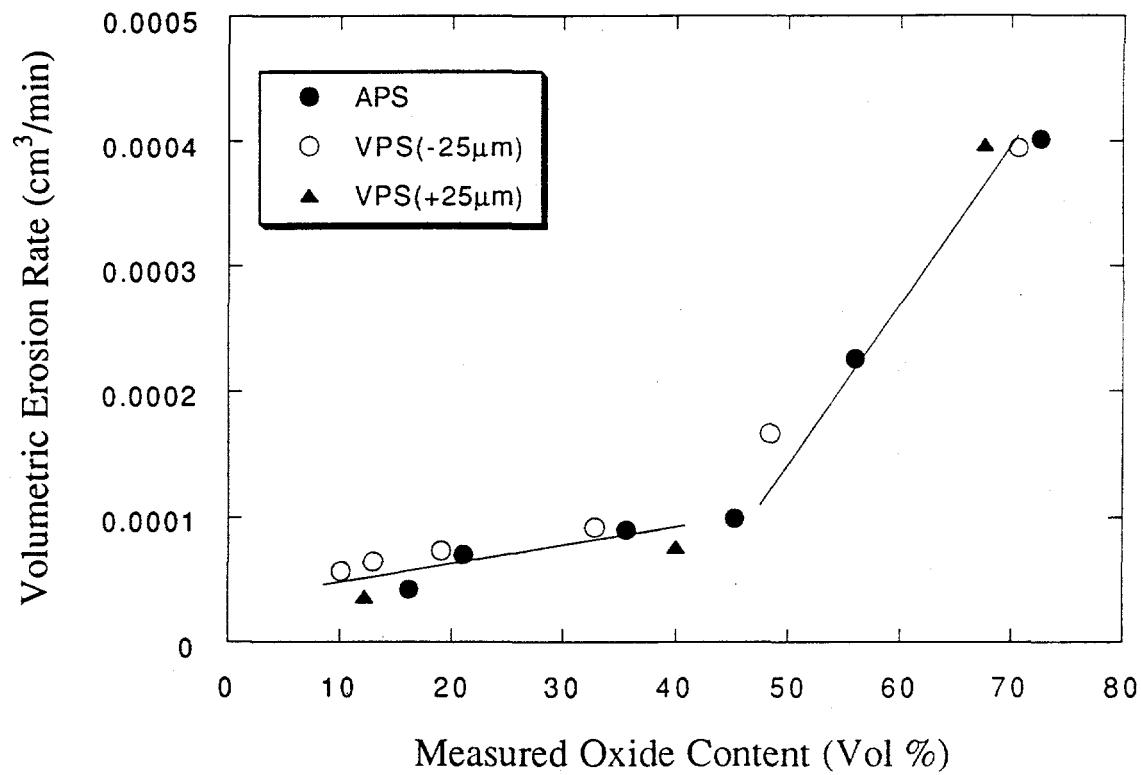
Figure IV.34 Volumetric erosion rate versus measured oxide content for all of the plasma Fe/Al alloy coatings (90°).

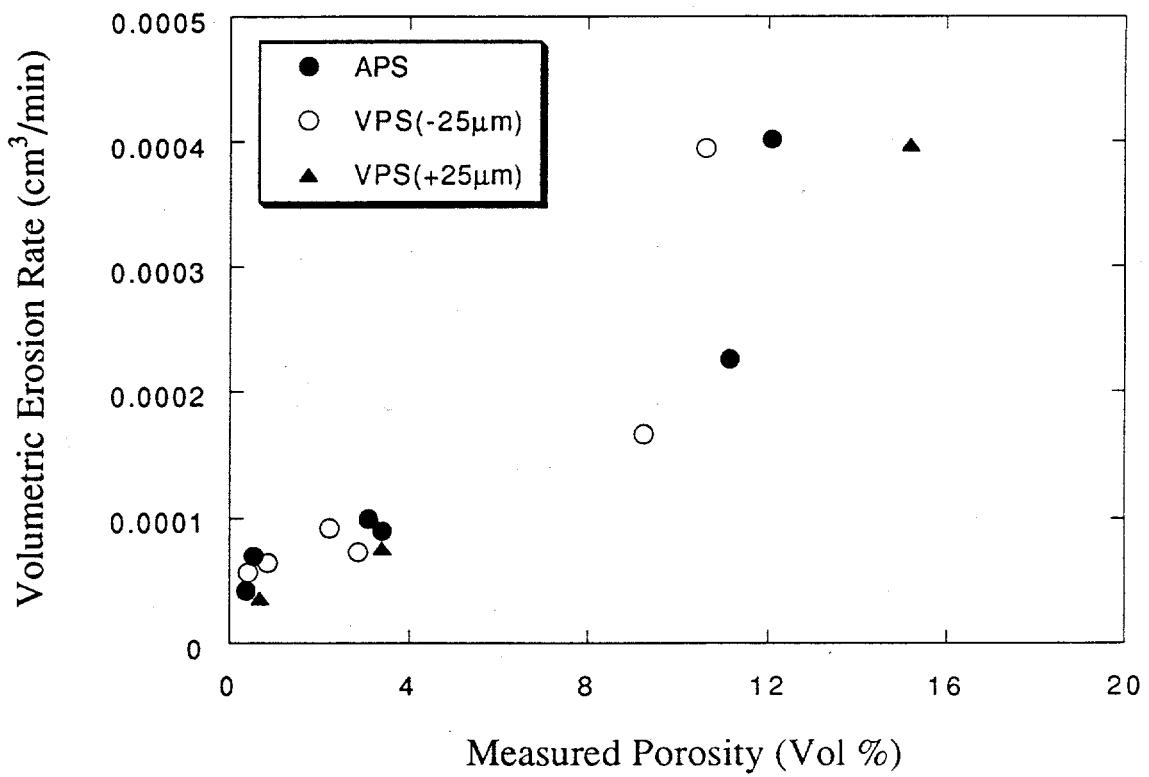
Figure IV.35 Volumetric erosion rate versus measured porosity for all of the plasma Fe/Al alloy coatings (90°).

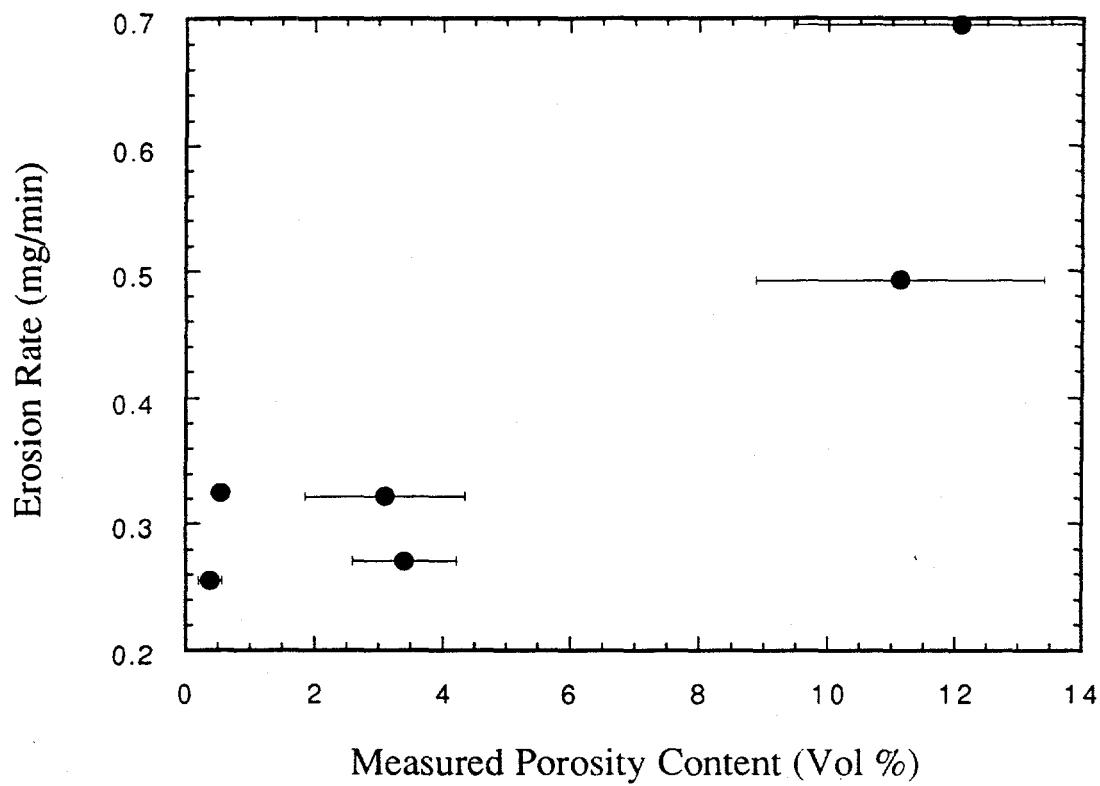
Figure IV.37- Erosion rate versus measured porosity for APS FeAl alloy coatings (30°).

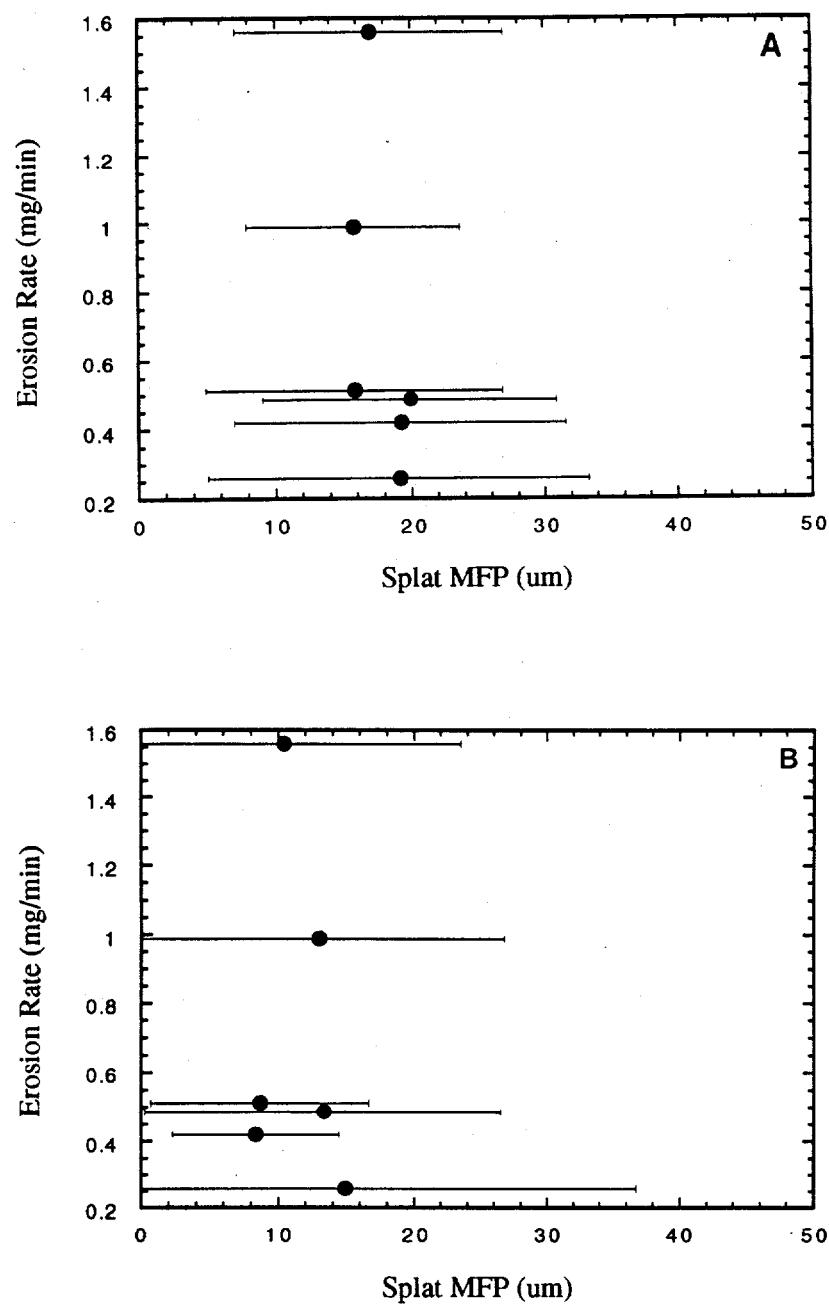
Figure IV.41- Erosion rate versus splat MFP for APS Fe/Al alloy coatings: a.planar, b.cross section (90°).

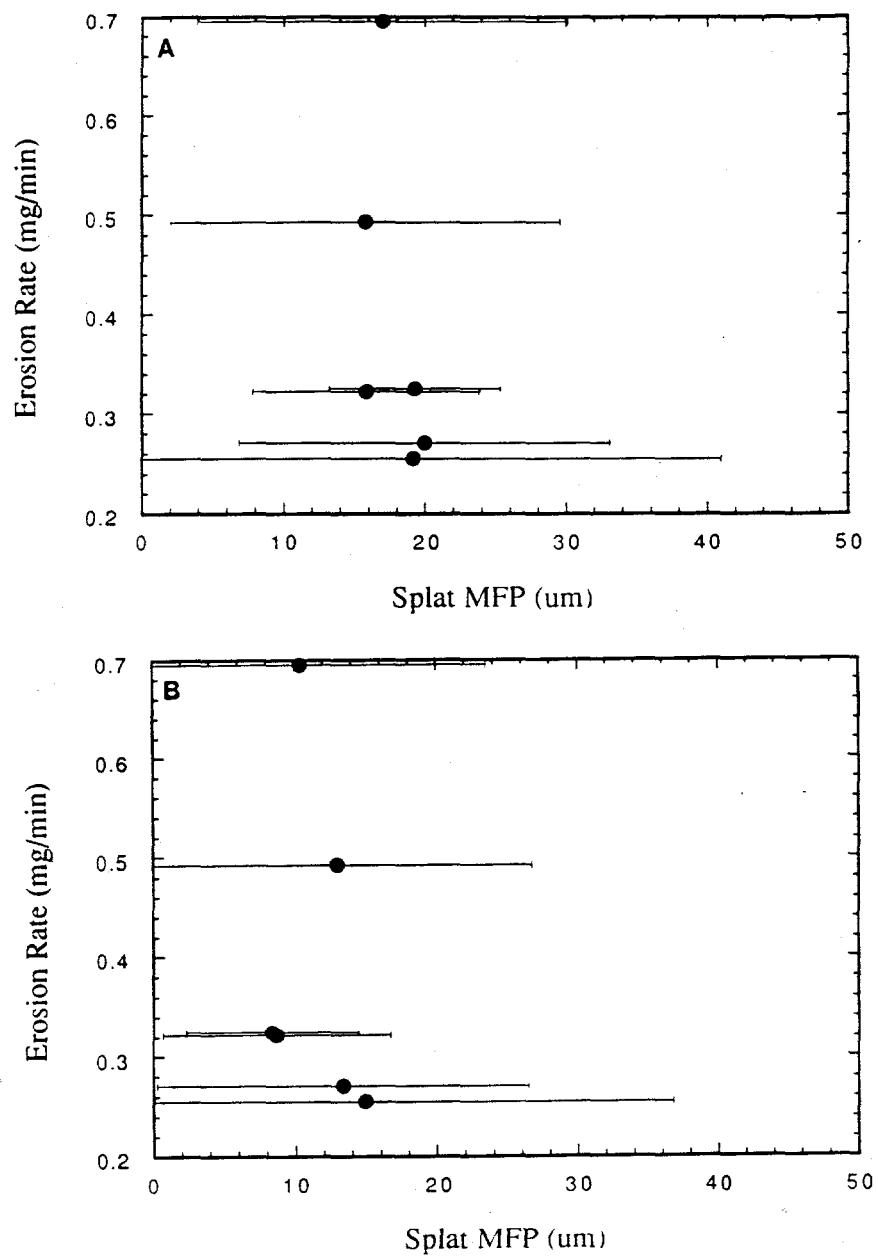
Figure IV.42 Erosion rate versus splat MFP for APS Fe/Al coatings: a.planar, b.cross section (30°).

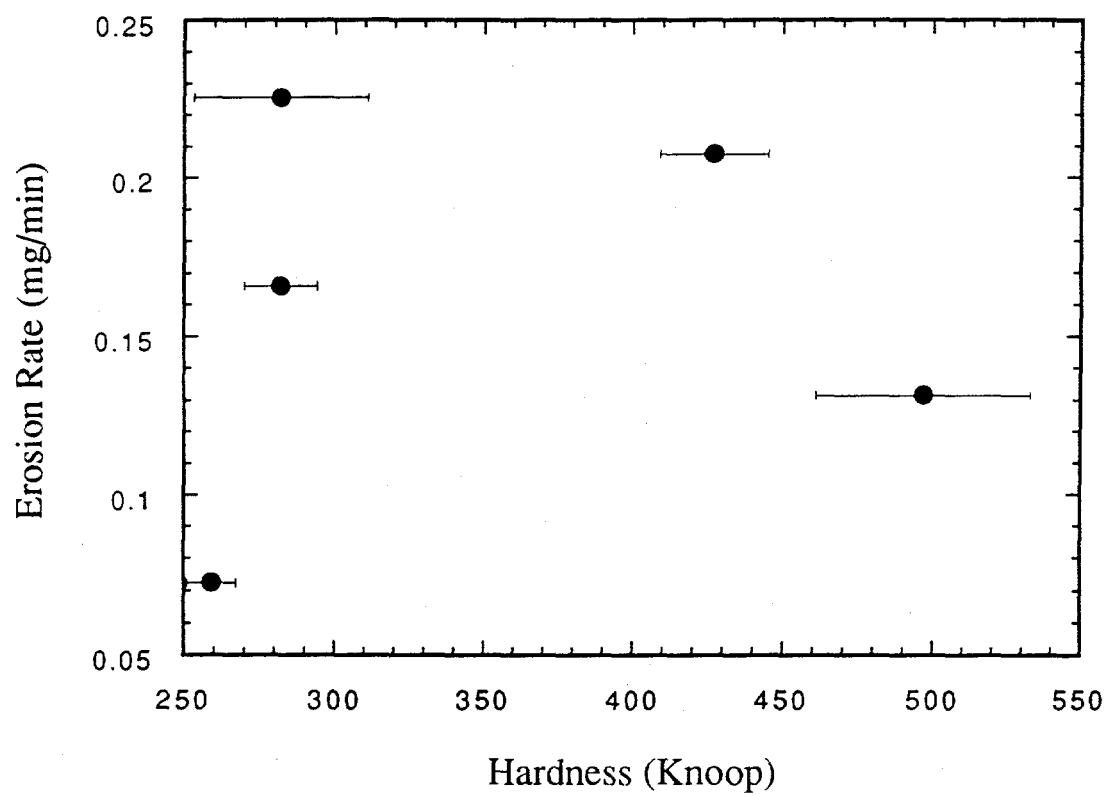
Figure IV.44 Erosion rate versus measured knoop hardness values for VPS, HVOF, VPS-HT, and wrought Fe/Al alloy materials (90°).

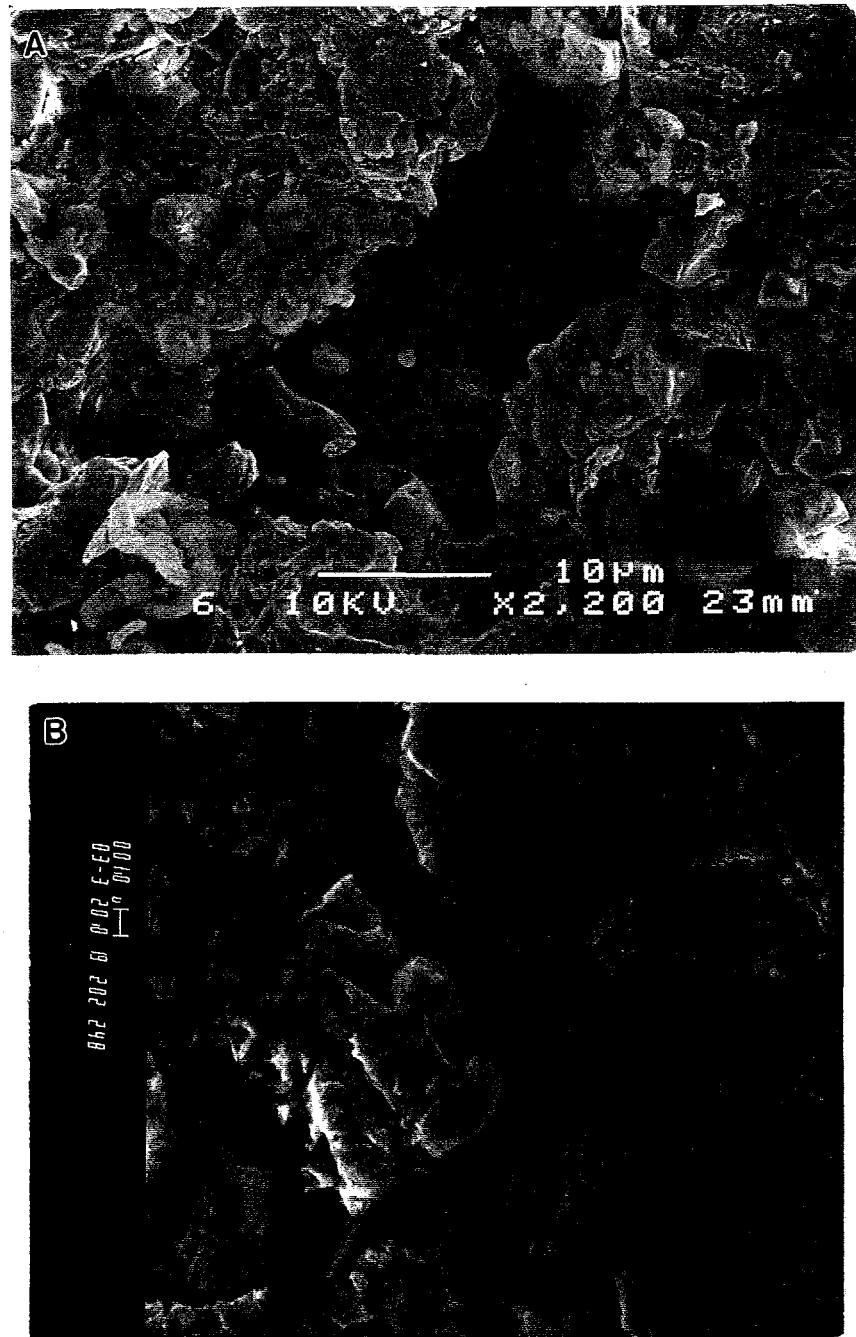
Figure IV.45 Missing splats in APS Fe/Al alloy coatings: 60% Al_2O_3 (30°), B. 60% Al_2O_3 (90°).

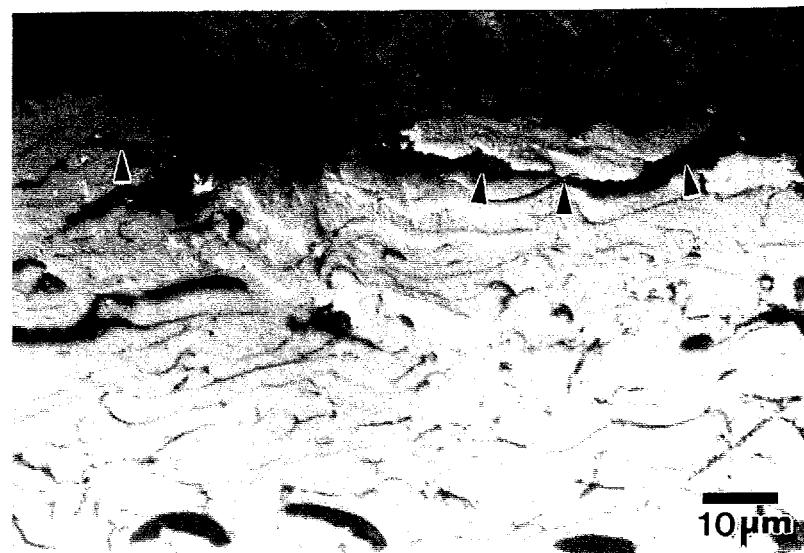
Figure IV.46- Splat debonding in a 10% Al_2O_3 -90% FeAl VPS +25 μm coating (90°), arrows indicate splat delamination sites.

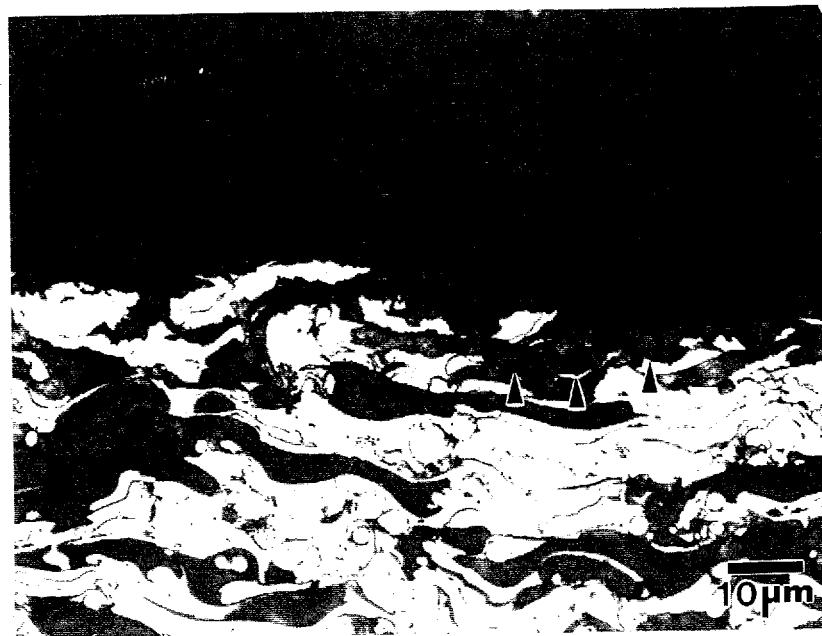
Figure IV.47- Surface cracking of alumina in a 40% Al_2O_3 - 60% FeAl VPS +25 μm coating (90°), arrows indicate cracked alumina.

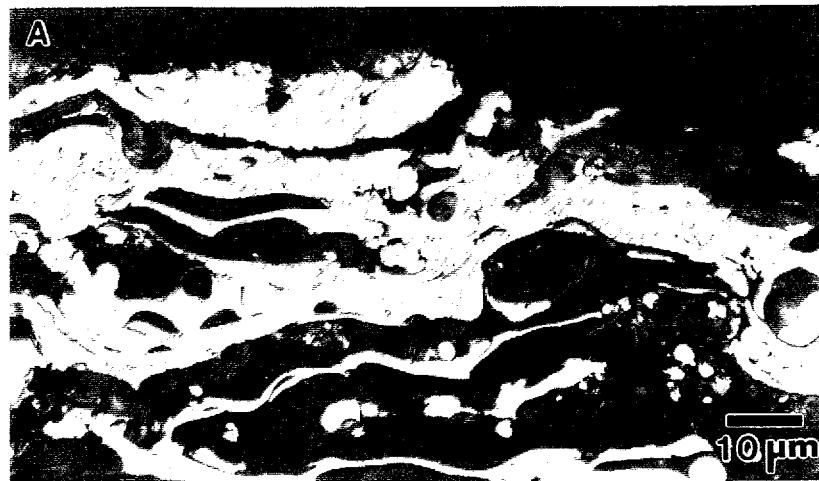
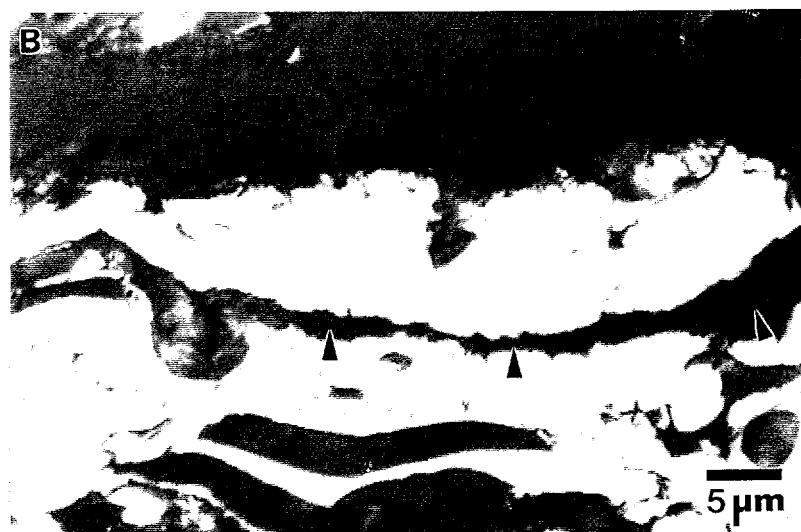
Figure IV.48- Undercutting of FeAl matrix via alumina cracking in a 60% Al_2O_3 -40% FeAl VPS +25 μm coating (90°): a. coating, b. individual partially delaminated splat, arrows indicate missing oxide which has lead to splat delamination.

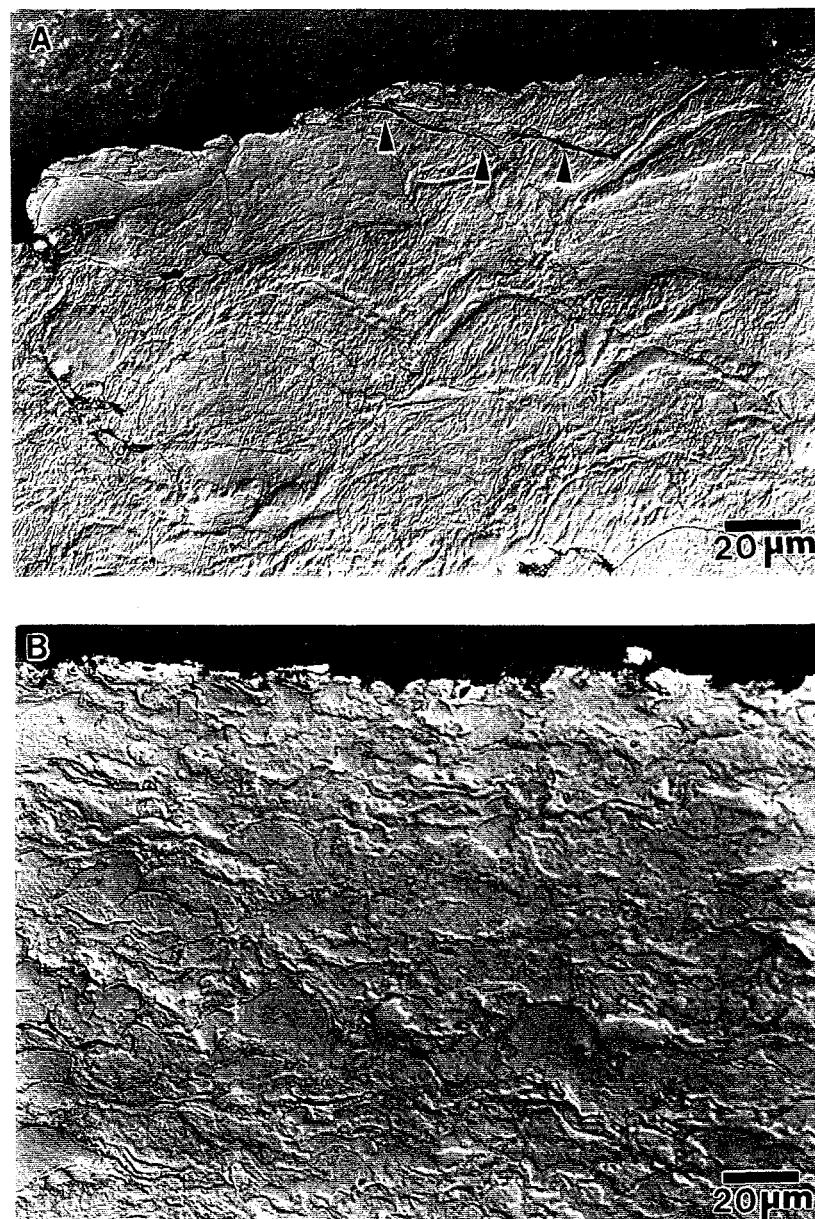
Figure IV.49- a. Cracking along splat boundaries in a 100% HVOF FeAl +25 μ m coating (90°), arrows indicate splat interface cracks, b. Lack of cracking along splat boundaries in a 100% HVOF FeAl -25 μ m coating (90°).

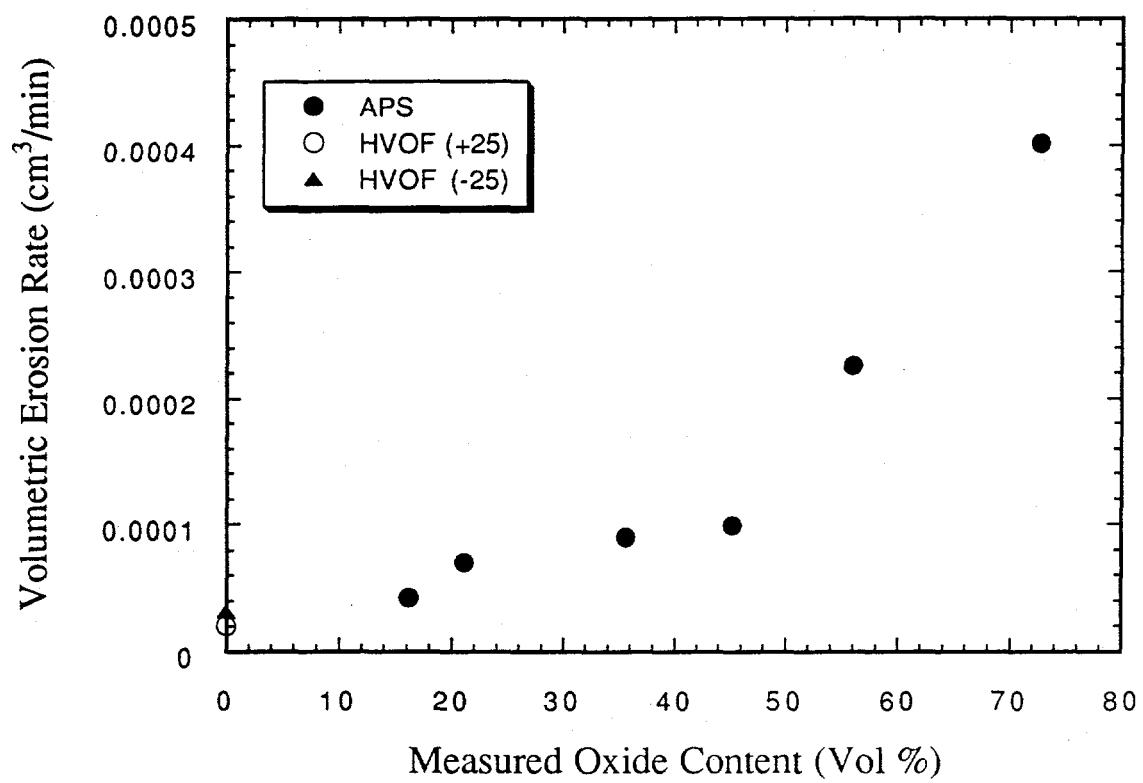
Figure IV.50- Comparison of FeAl alloy HVOF and FeAl alloy plasma coatings (90° erosion data).

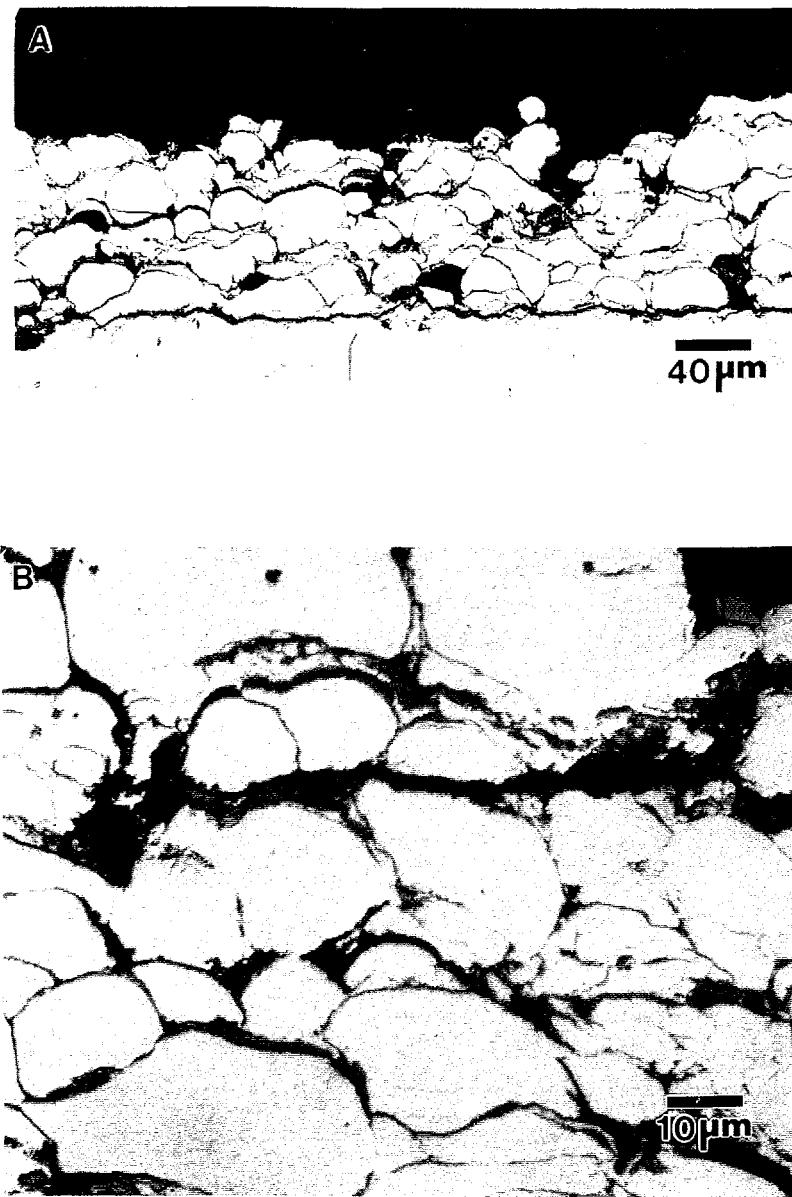
Figure IV.52- FeCrAlY HVOF coating with 99psi gun chamber pressure: a.250x, b.1000x(Nomarski).

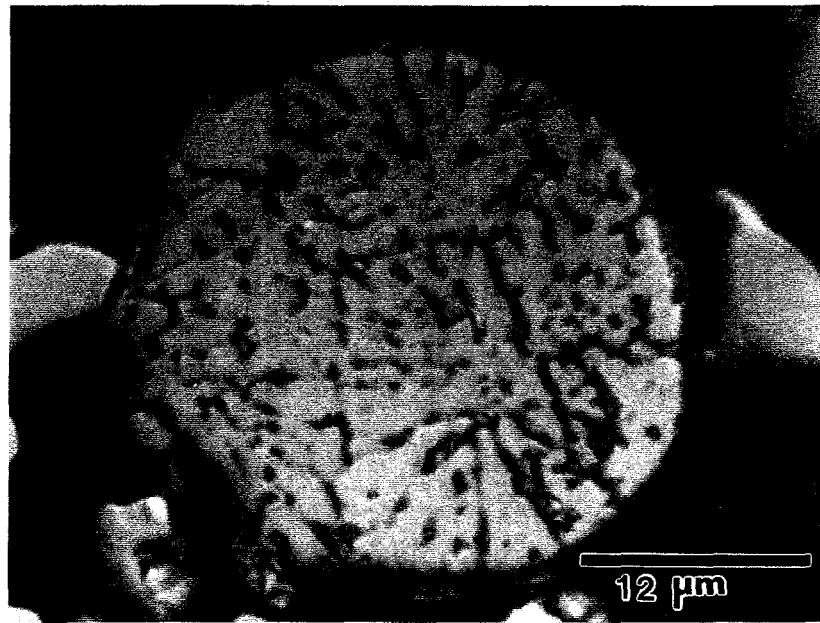
Figure IV.56- Starting FeCrAlY powder microstructure.

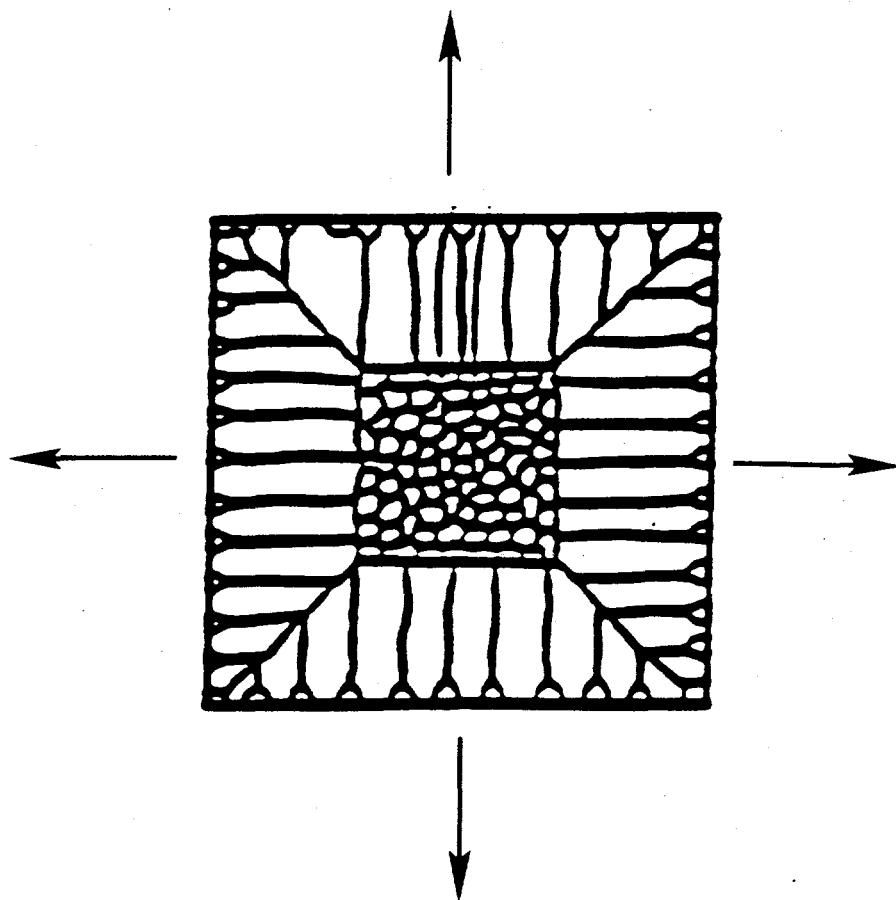
Figure IV.57- Casting schematic showing the columnar grain formation parallel to the heat flow, arrows indicate heat flow.

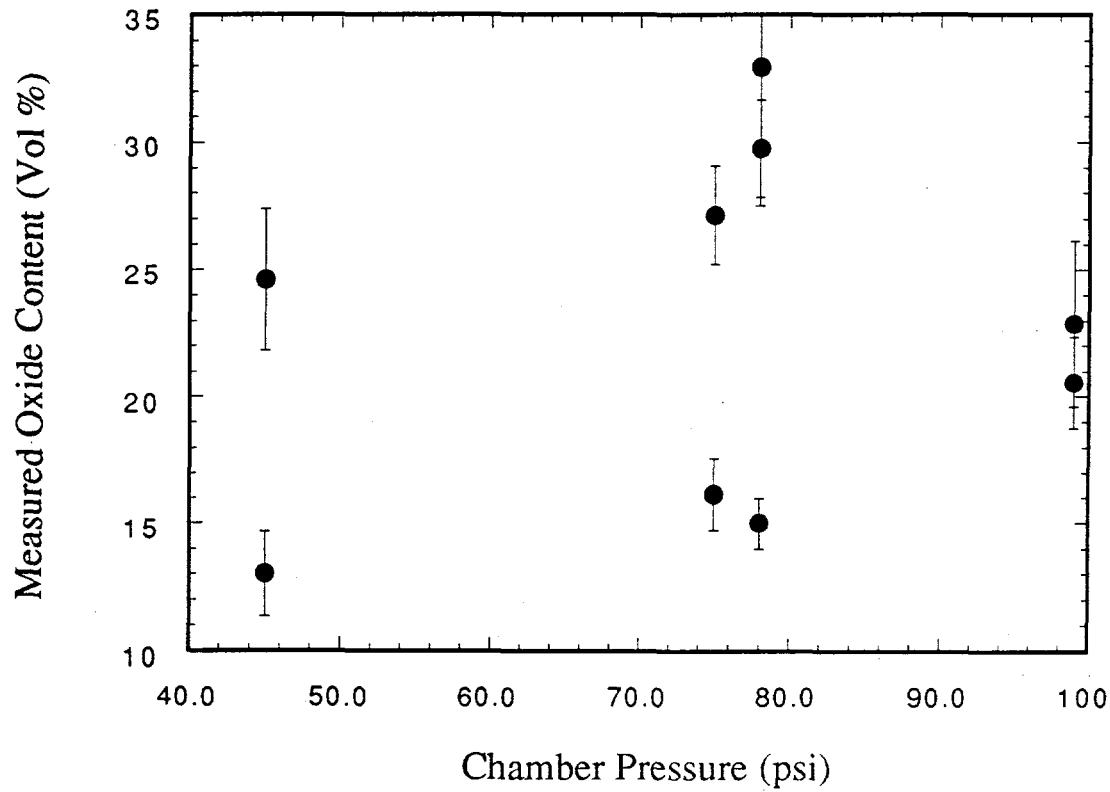
Figure IV.58- HVOF chamber pressure versus the measured oxide content in the FeCrAlY HVOF coatings.

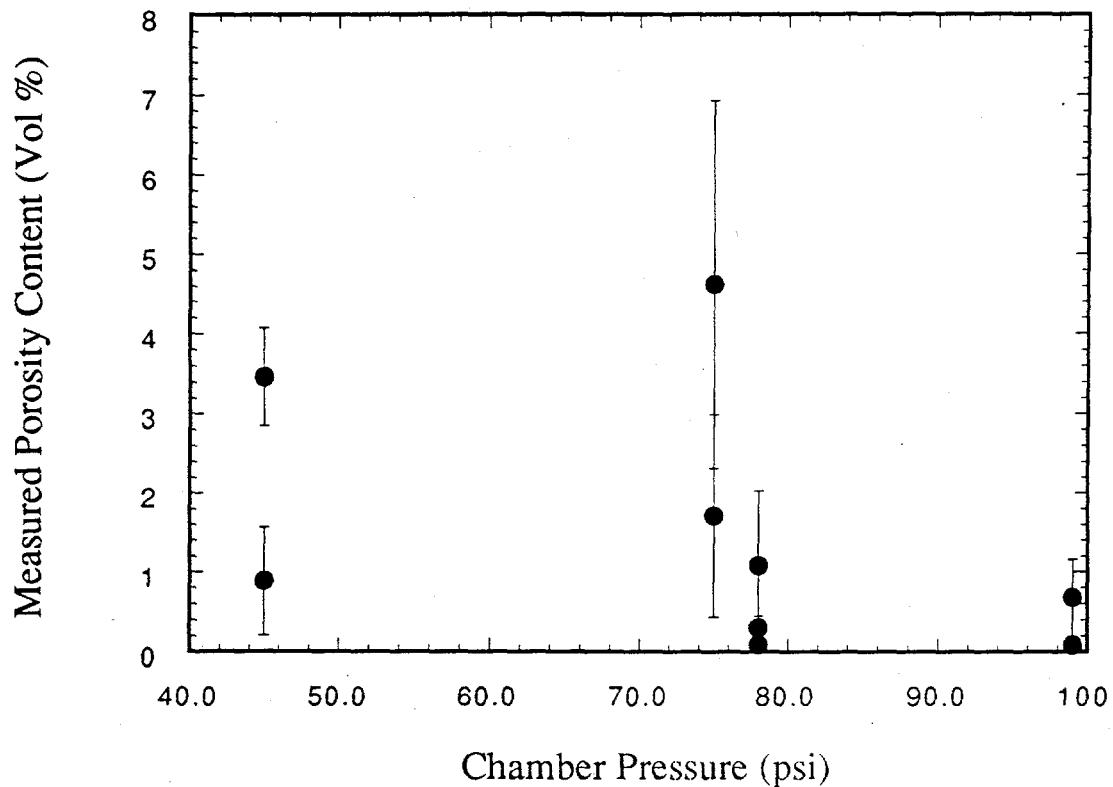
Figure IV.59 HVOF chamber pressure versus the measured porosity in the FeCrAlY HVOF coatings.

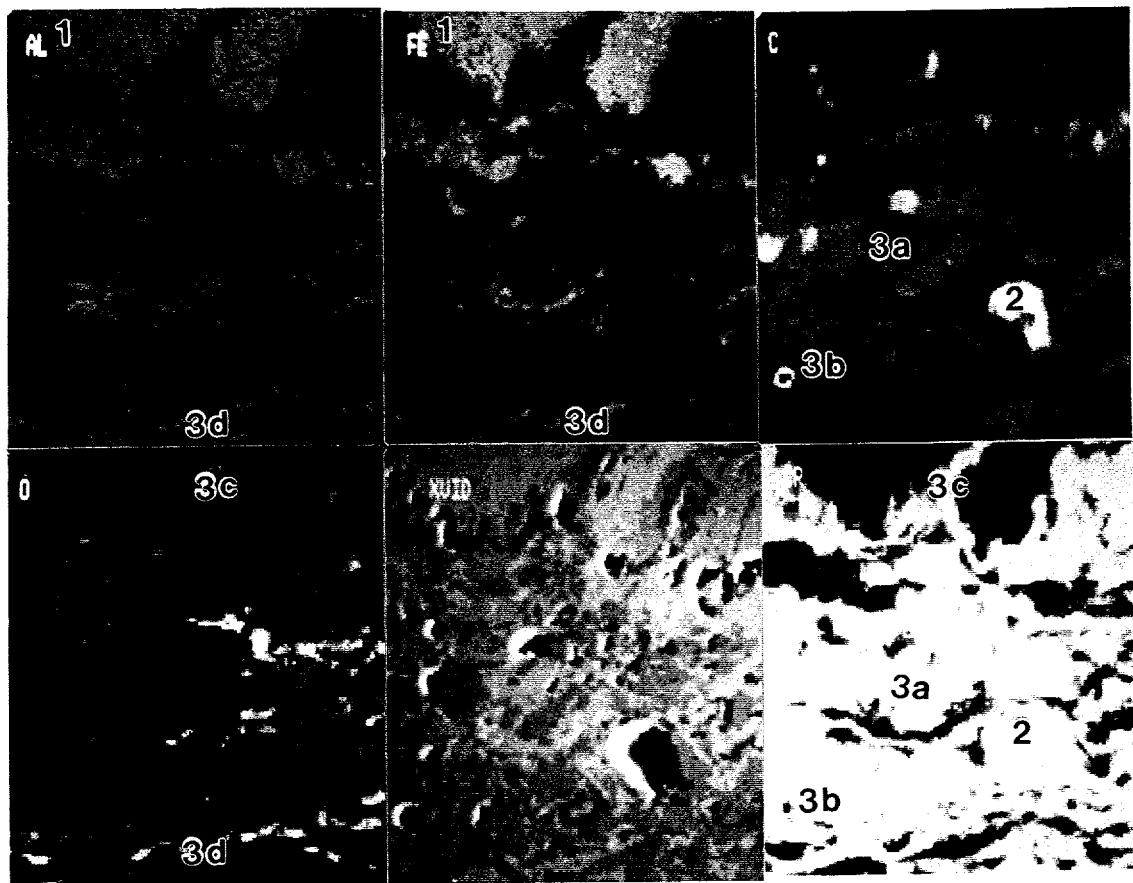
Figure IV.63 EDS/WDS dot map for 80% Cr_3C_2 -20% FeCrAlY coating (1500x): 1. matrix, 2. Cr_3C_2 , 3a. Cr_7C_3 , 3b. Cr_{23}C_6 , 3c. CrO , 3d. various Fe and possible Al oxides.
