ENERGY RESEARCH CENTER

**Cermet Composite Thermal Spray Coatings for
Erosion and Corrosion Protection in Combustion
Environments of Advanced Coal-Fired Boilers**

Semiannual Technical Report Prepared for
U.S. Department of Energy

Project Period: 1/14/97-8/14/97

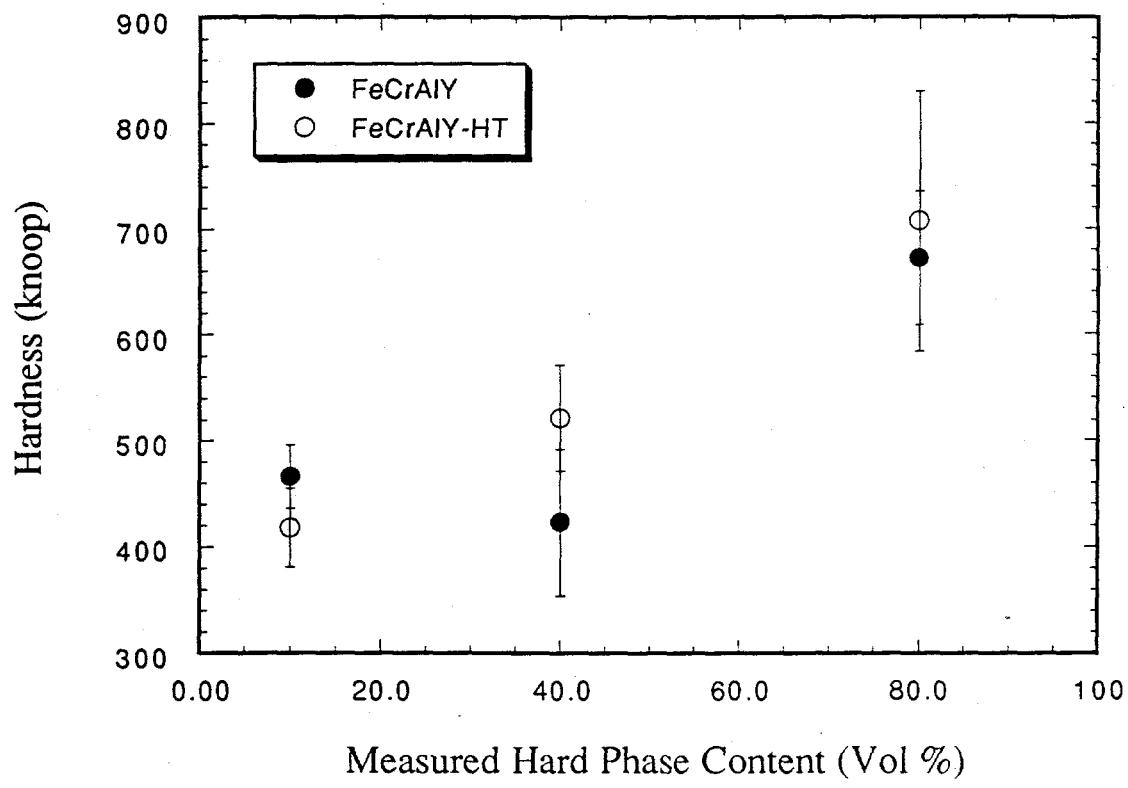
Figure IV.64 Knoop hardness data versus the measured hard phase content for the FeCrAlY- Cr_3C_2 HVOF coatings prior to and after heat treatment @ 600°C for 96 hours.

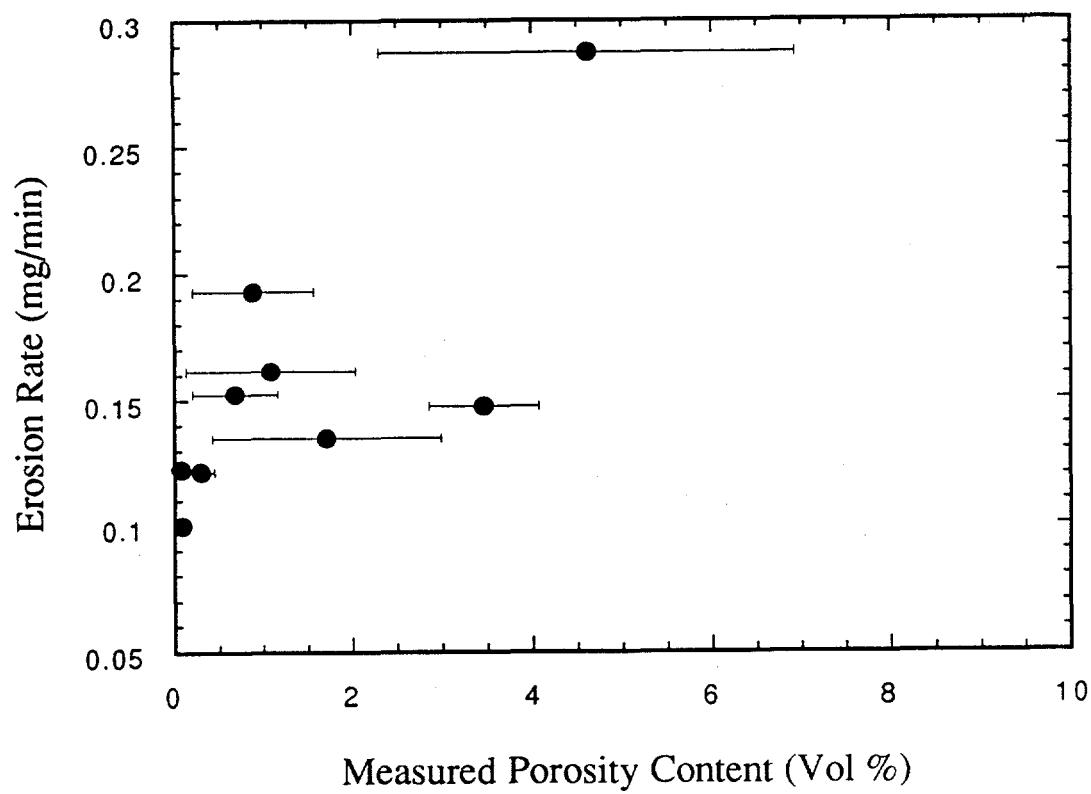
Figure IV.66 Erosion rate versus measured porosity for the 100% FeCrAlY HVOF coatings (90°).

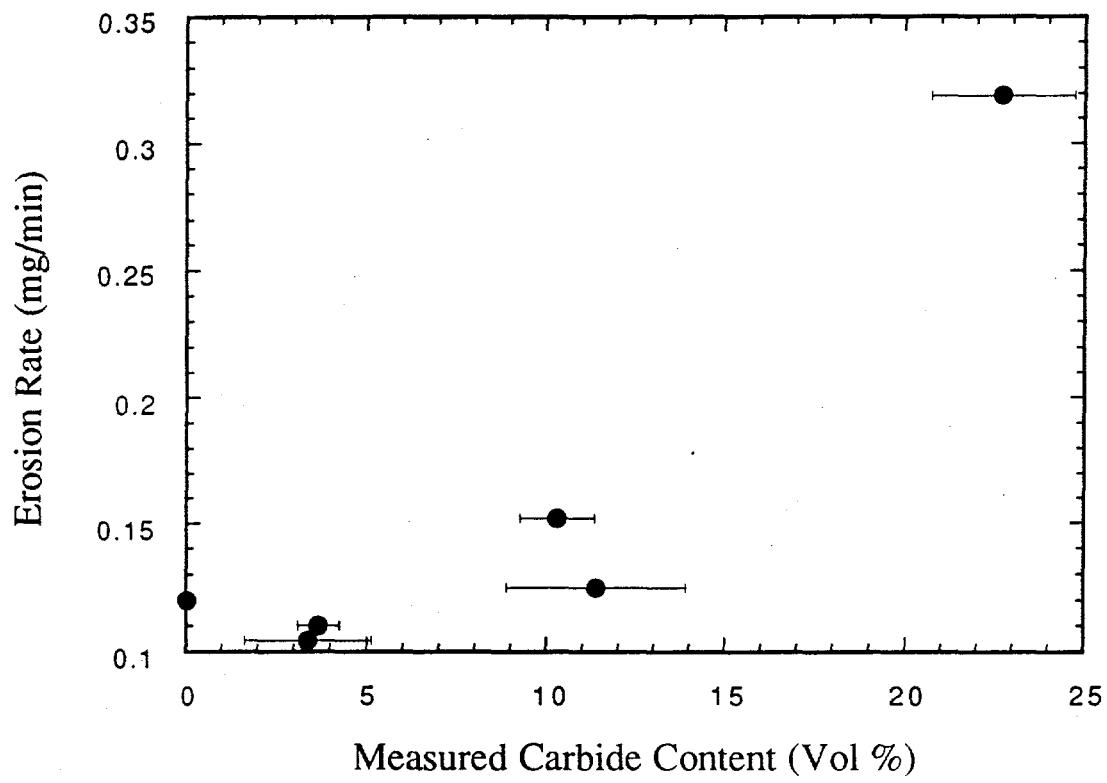
Figure IV.69 Erosion rate versus measured carbide content for the FeCrAlY- Cr_3C_2 HVOF coatings (90°).

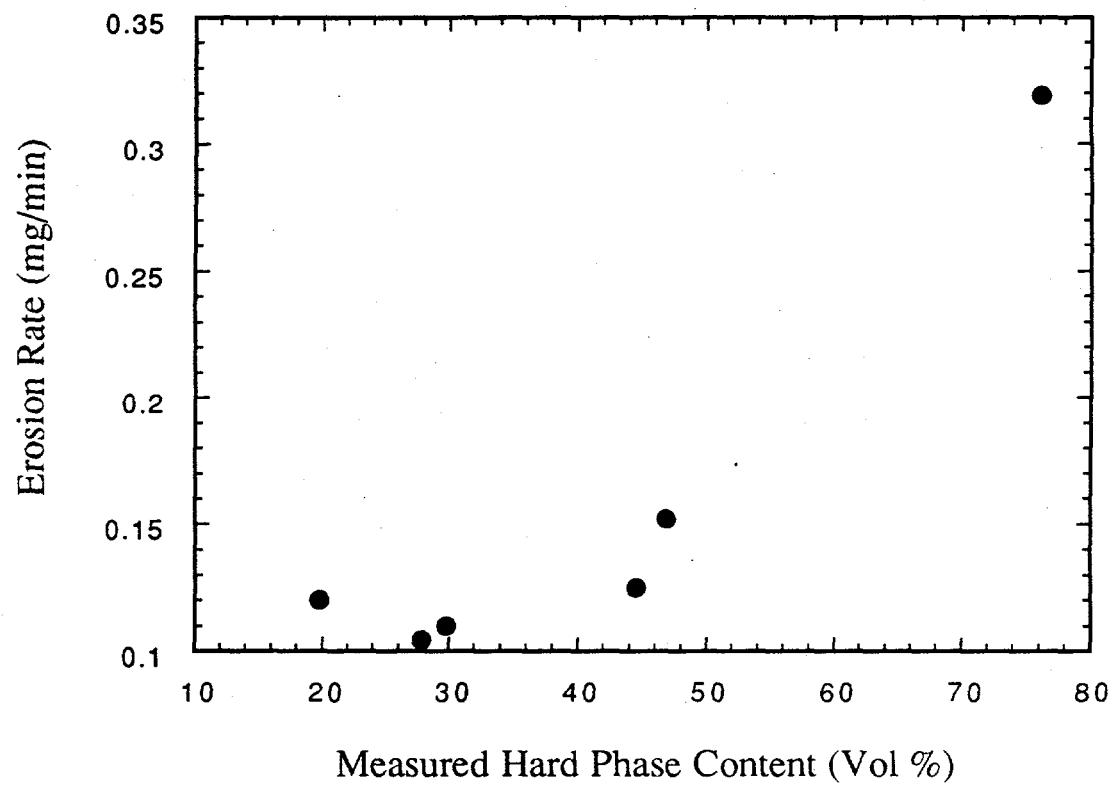
Figure IV.72- Erosion rate versus measured hard phase content (oxides and carbides) for the FeCrAlY-Cr₃C₂ HVOF coatings (90°).

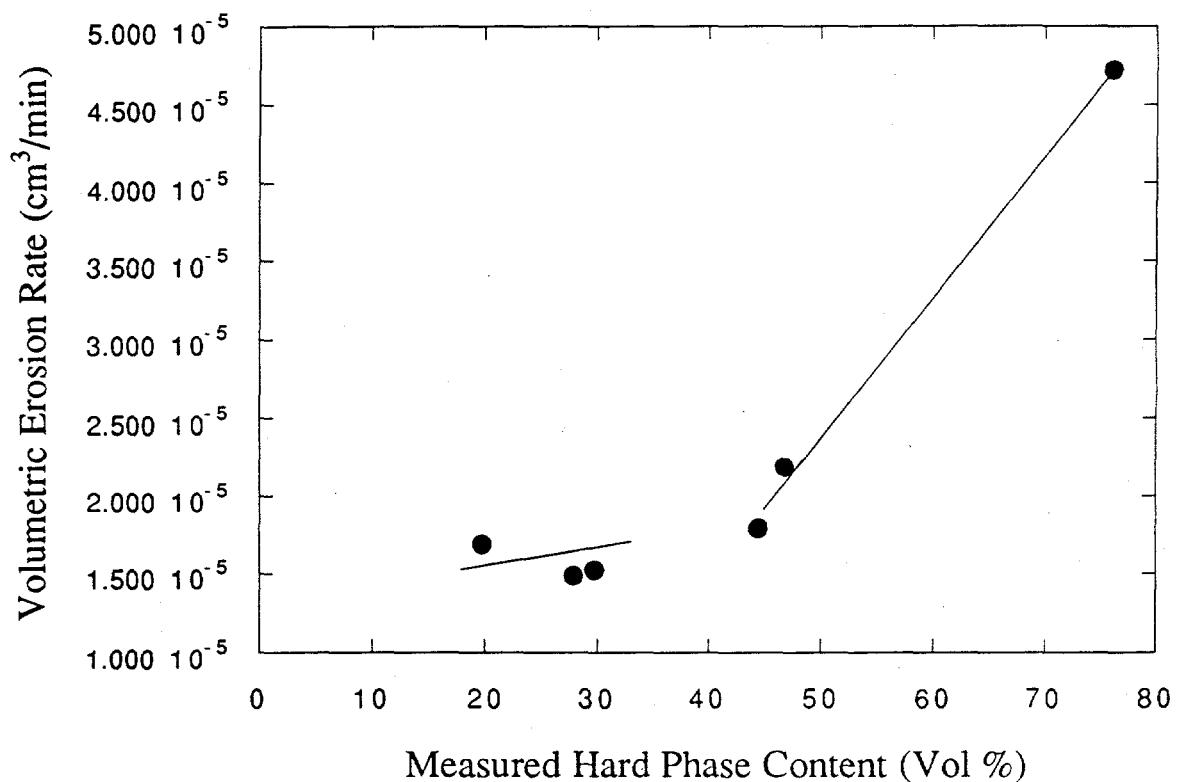
Figure IV.73 Volumetric erosion rate versus measured hard phase (oxides and carbides) content for the FeCrAlY-Cr₃C₂ HVOF coatings (90°).

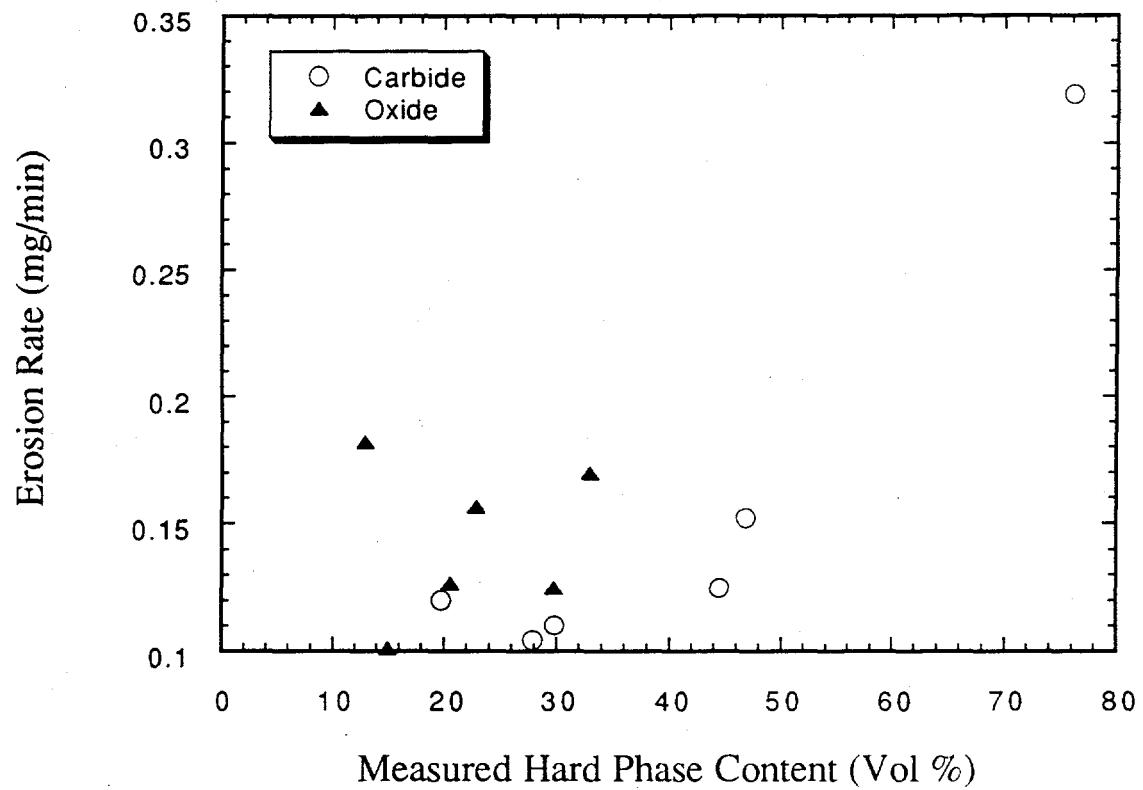
Figure IV.74 Erosion rate versus measured hard phase content (oxides and carbides) for the FeCrAlY-Cr₃C₂ and 100% FeCrAlY HVOF coatings (90°).

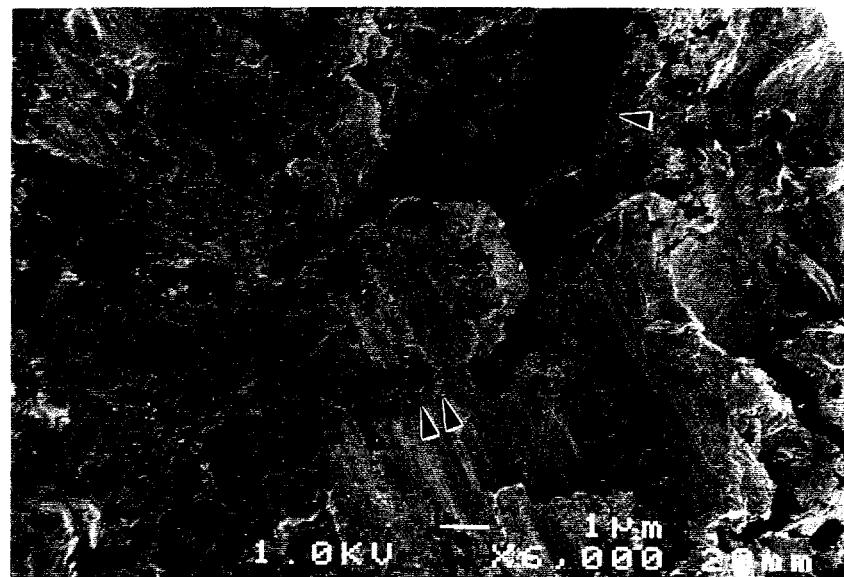
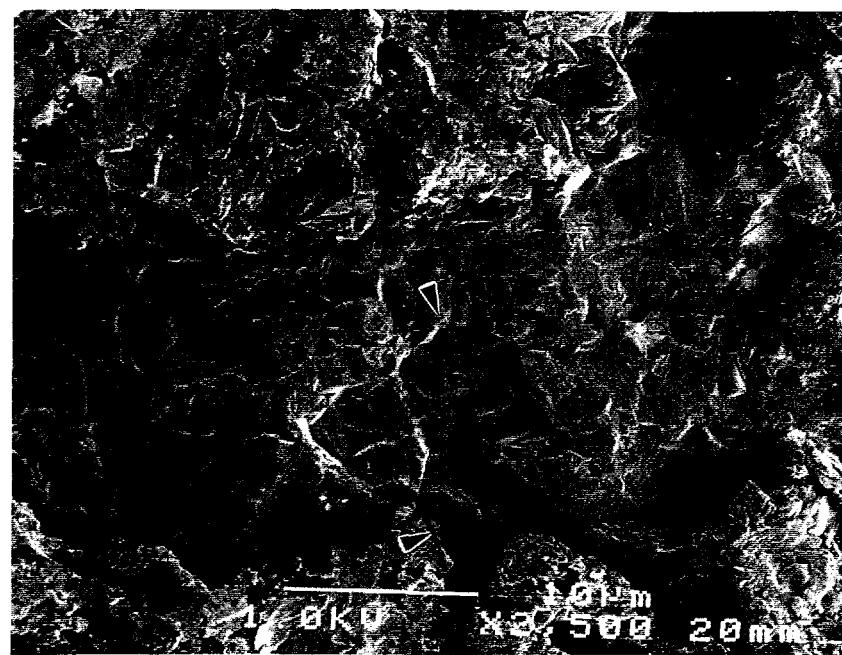
Figure IV.77- Possible carbide pullout (see arrows) in an 60% Cr_3C_2 -40% FeCrAlY HVOF coatings (90°), note the crack in the top picture (indicated by the double arrow) may represent a carbide in the early stages of pullout.

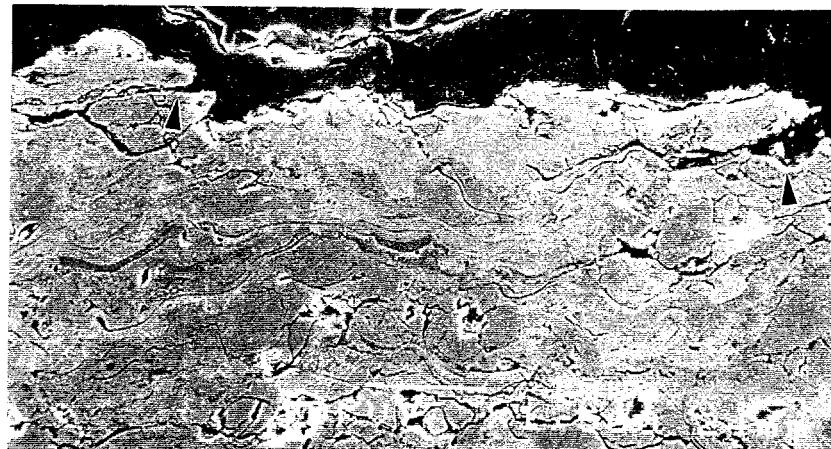
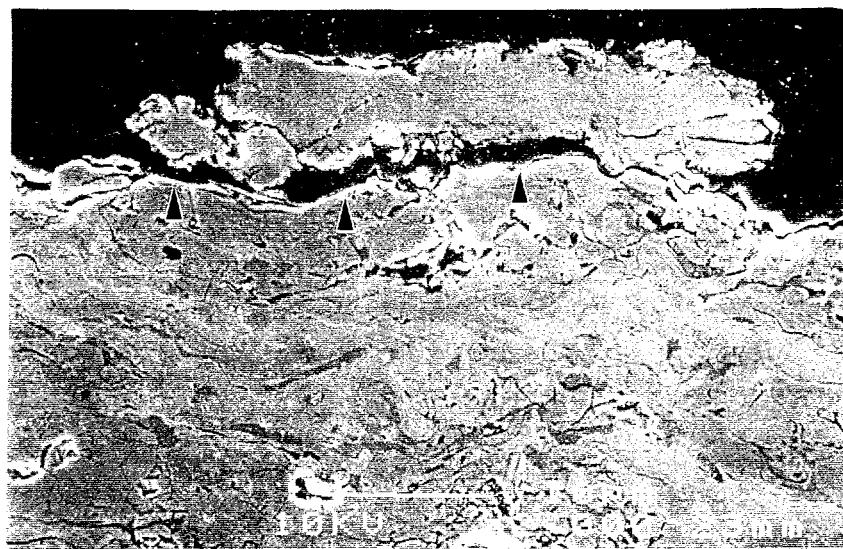
Figure IV.78- Debonding (indicated by arrows) in an 80% Cr_3C_2 -20% FeCrAlY HVOF coatings (90°).

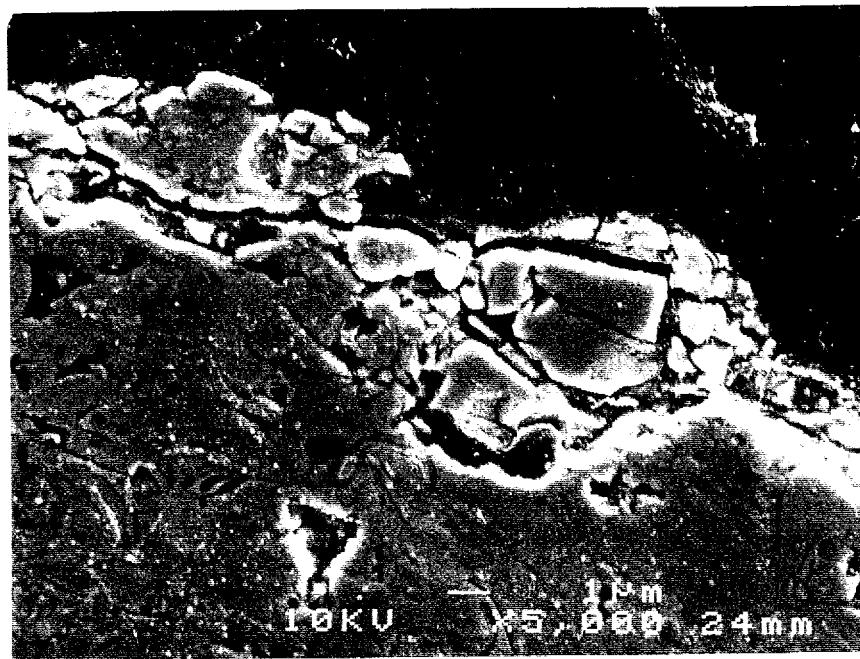
Figure IV.79 Surface cracking in an 80% Cr_3C_2 -20% FeCrAlY HVOF coating (90°).

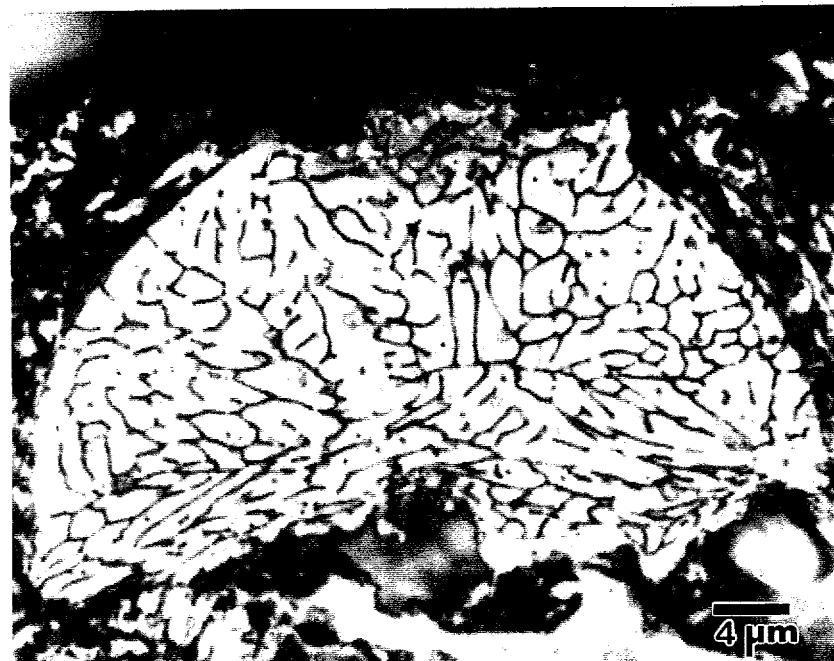
Figure IV.80- Potential dendrite spallation in a 40% Cr_3C_2 -60% FeCrAlY HVOF coating (90°).

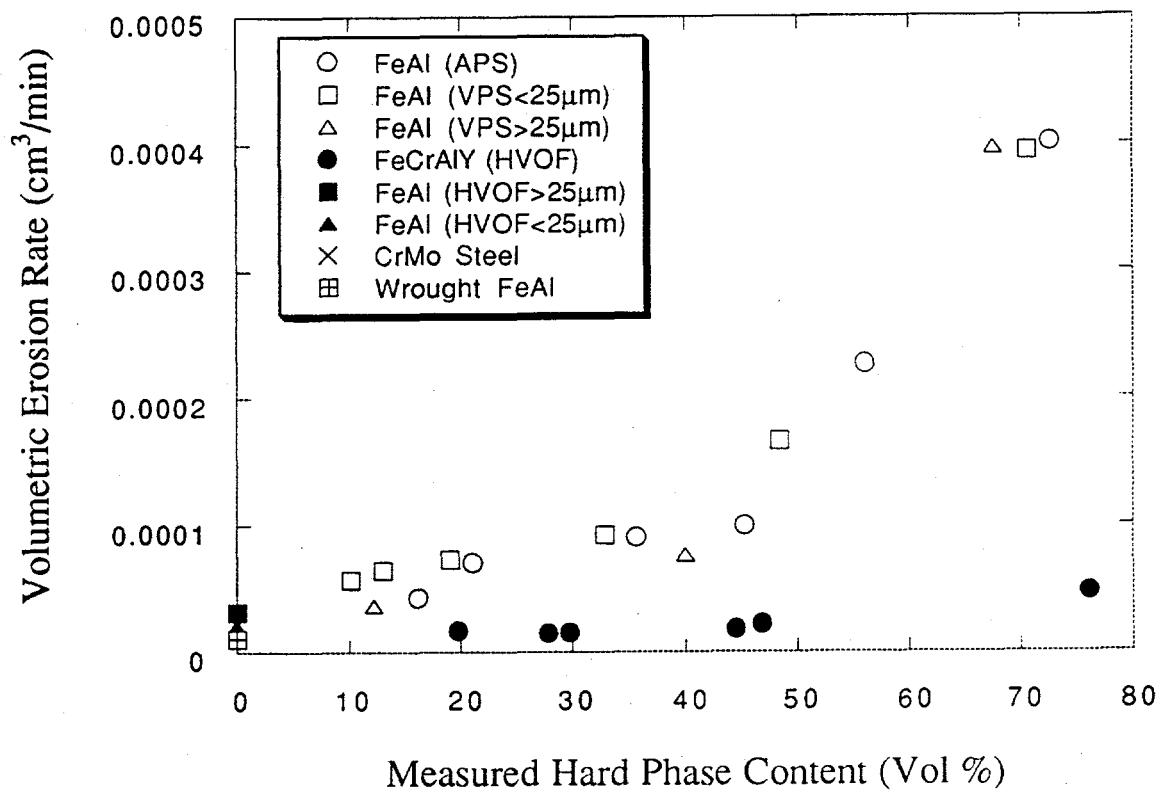
Figure IV.81- Volumetric erosion rate versus measured hard phase content (oxides and carbides) for all of the tested materials (90°).

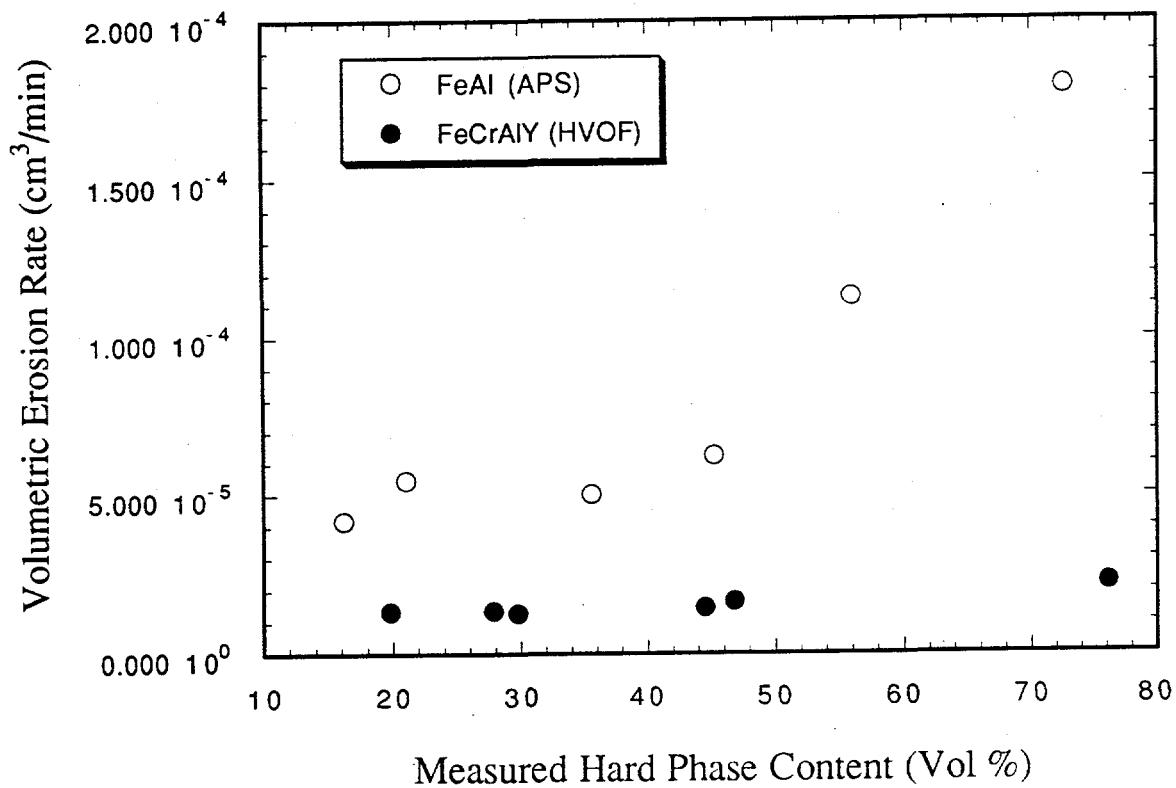
Figure IV.82- Volumetric erosion rate versus measured hard phase content (oxides and carbides) for all of the tested materials (30°).
