November 4, 1981
Proposal: 12:0341
Grant No: DE-FG4480R4 10104

FINAL REPORT

FREEZE-PROTECTION LOOP FOR DIRECT SOLAR-WATER-HEATING SYSTEMS

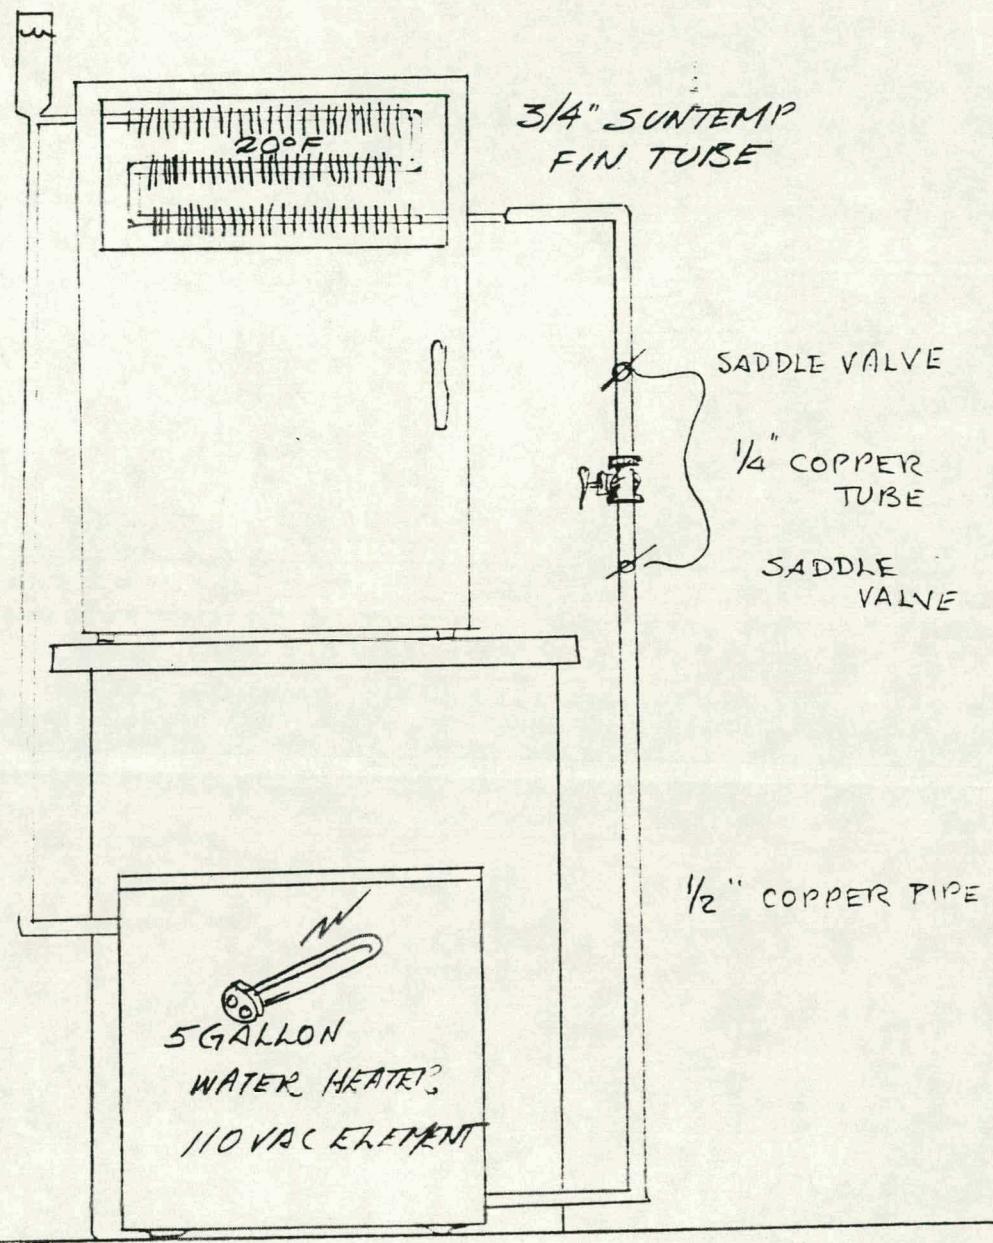
FREEZE PROTECTION BYPASS-

STANDPIPE

84"

A method of regulating the flow produced by the pump in a solar system has been to install a bypass around the pump. If the bypass loop also bypasses the check valve, purportedly this technique can be used to prevent freezing.

Before the winter of 1980-81 grantee obtained permission from several owners, usually those who had experienced freeze damage to collectors, to install the Freeze Protection Bypass Loop (FPBL) at no expense to them. Any repairs necessitated by freeze damage likewise would be made by us and charged to the grant. Owners who agreed to participate were instructed in the theory of the FPBL and seemed to understand the application. Drawings of each installation were likewise provided. The owners were also instructed in how to manually drain down their systems.

In order to have more control over the experiment we employed a refrigerator (used) to obtain below-freezing temperatures. A five gallon electric water heater was configured with tees to simulate a solar storage tank. This was placed at floor level. Ambient temperatures were indoors 68-70°F. Temperatures in the freezing compartment were 20-25°F. The refrigerator was elevated, freezing compartment was about 84" above floor level. Holes were drilled in the freezing compartment and about four feet of 3/4" fin tube (base board heating elements) were run back and forth, graded up. Outside the freezing compartment a standpipe arrangement ensured that the loop was filled with water at all times. A gate valve in the return line simulated a check valve or meterized valve. An FPBL was installed to bypass this valve. Tubing was half inch and the bypass loop was quarter inch. Water in the tank was not heated initially.
