TOPICAL REPORT
Project No.: 9-61-5329

**TITLE: FIRESIDE CORROSION TESTING OF
CANDIDATE SUPERHEATER TUBE ALLOYS,
COATINGS, AND CLADDINGS**

Final Report, August 1991

FOSTER WHEELER DEVELOPMENT CORPORATION
12 Peach Tree Hill Road
Livingston, New Jersey 07039

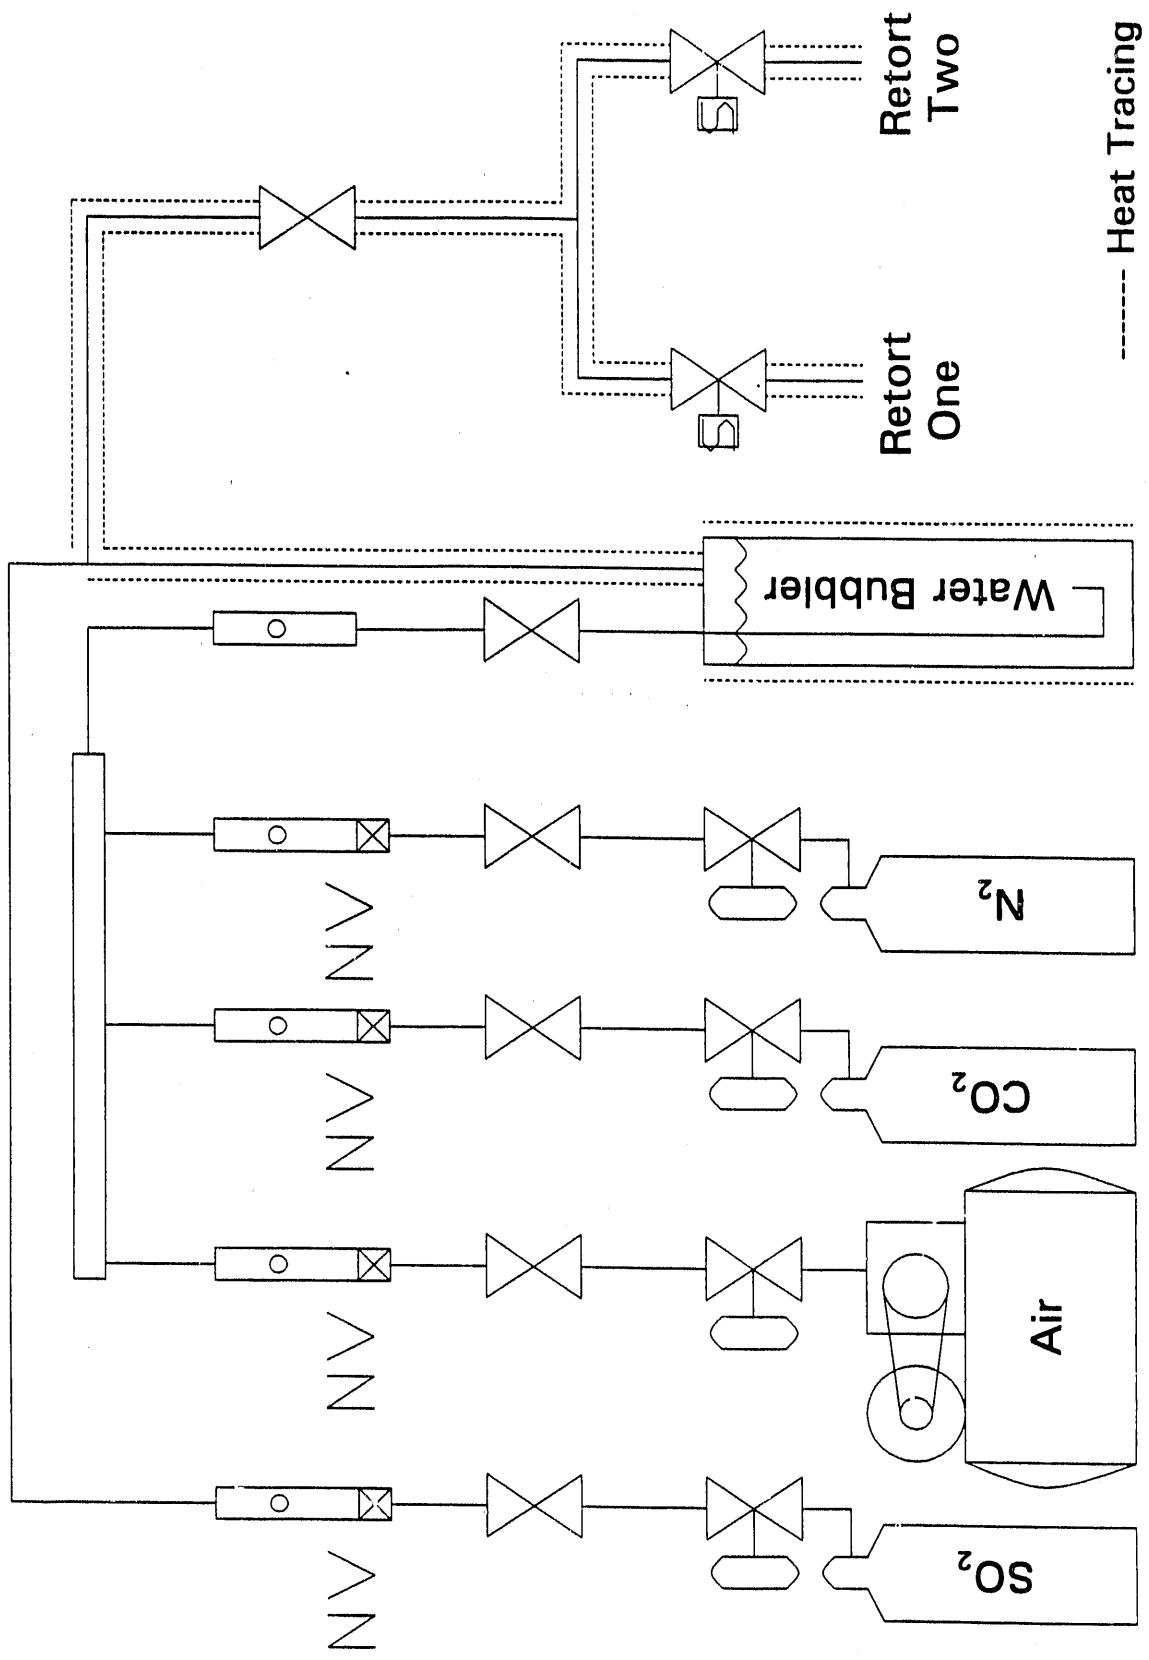
Figure 2.1 Gas Train Schematic

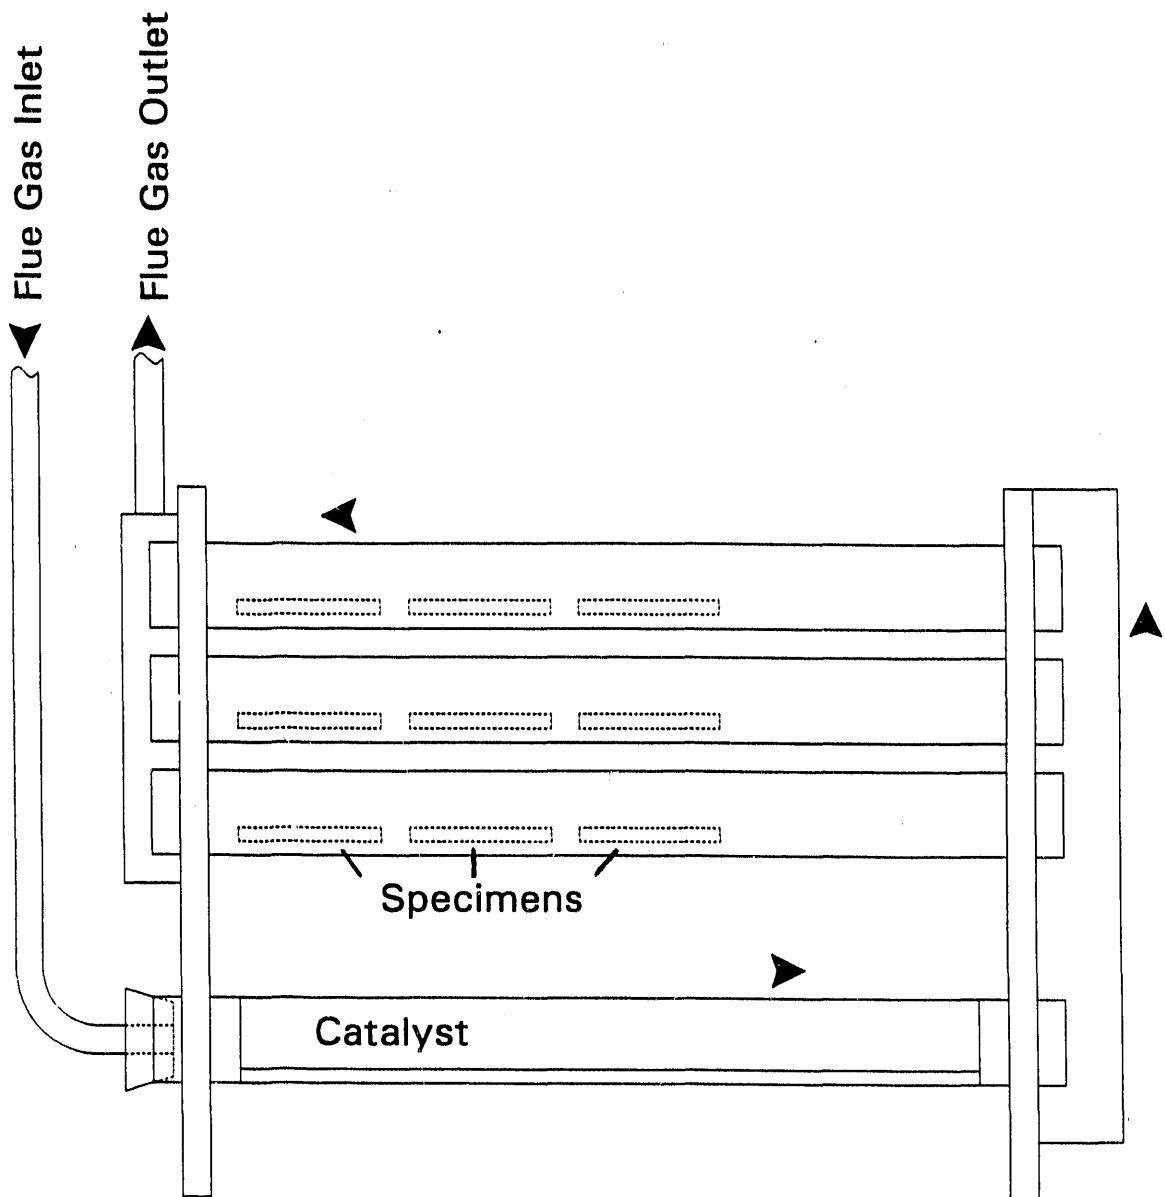
Figure 2.2 Furnace Experimental Retort

The retorts for this project were similar to the retorts used in earlier fireside corrosion studies by Rehn [1]. Figure 2.2 illustrates a side view of a retort. Simulated flue gas was passed from the inlet, through iron turnings placed to catalyze SO_2 to SO_3 , over the specimens, and out the exhaust tubes. Thermowells in the retorts monitored interior temperatures during the experiments.

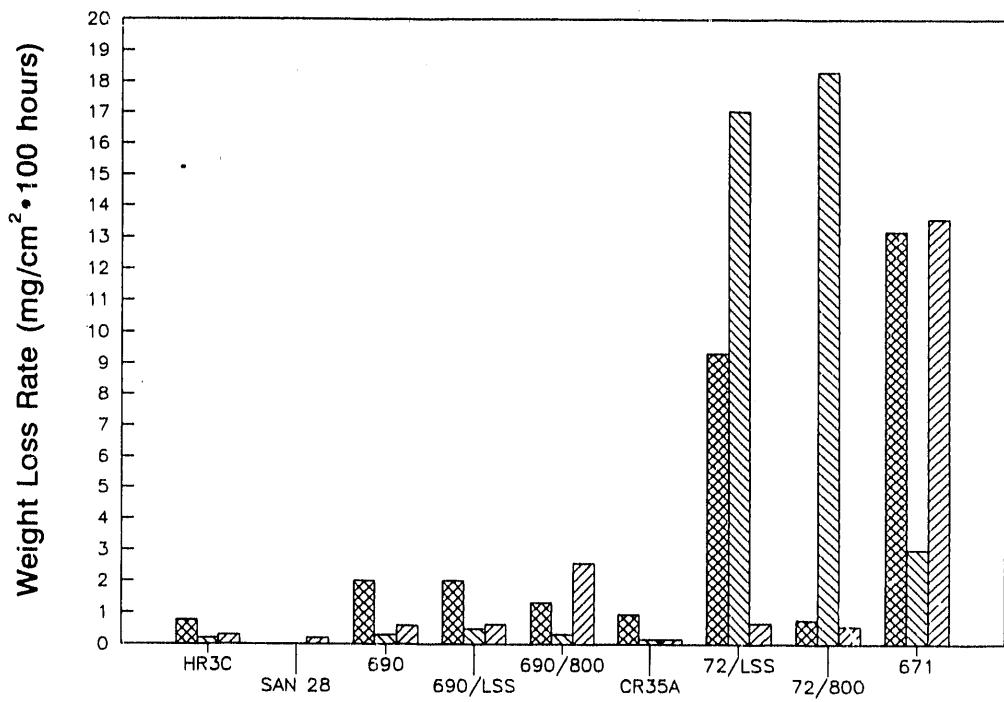
Figure 3.7 Normalized Weight Loss Rates for Alloys Coated With a 10 wt% Alkali Sulfate Ash and Exposed at 650°C to a 0.25 vol% SO₂ Flue Gas

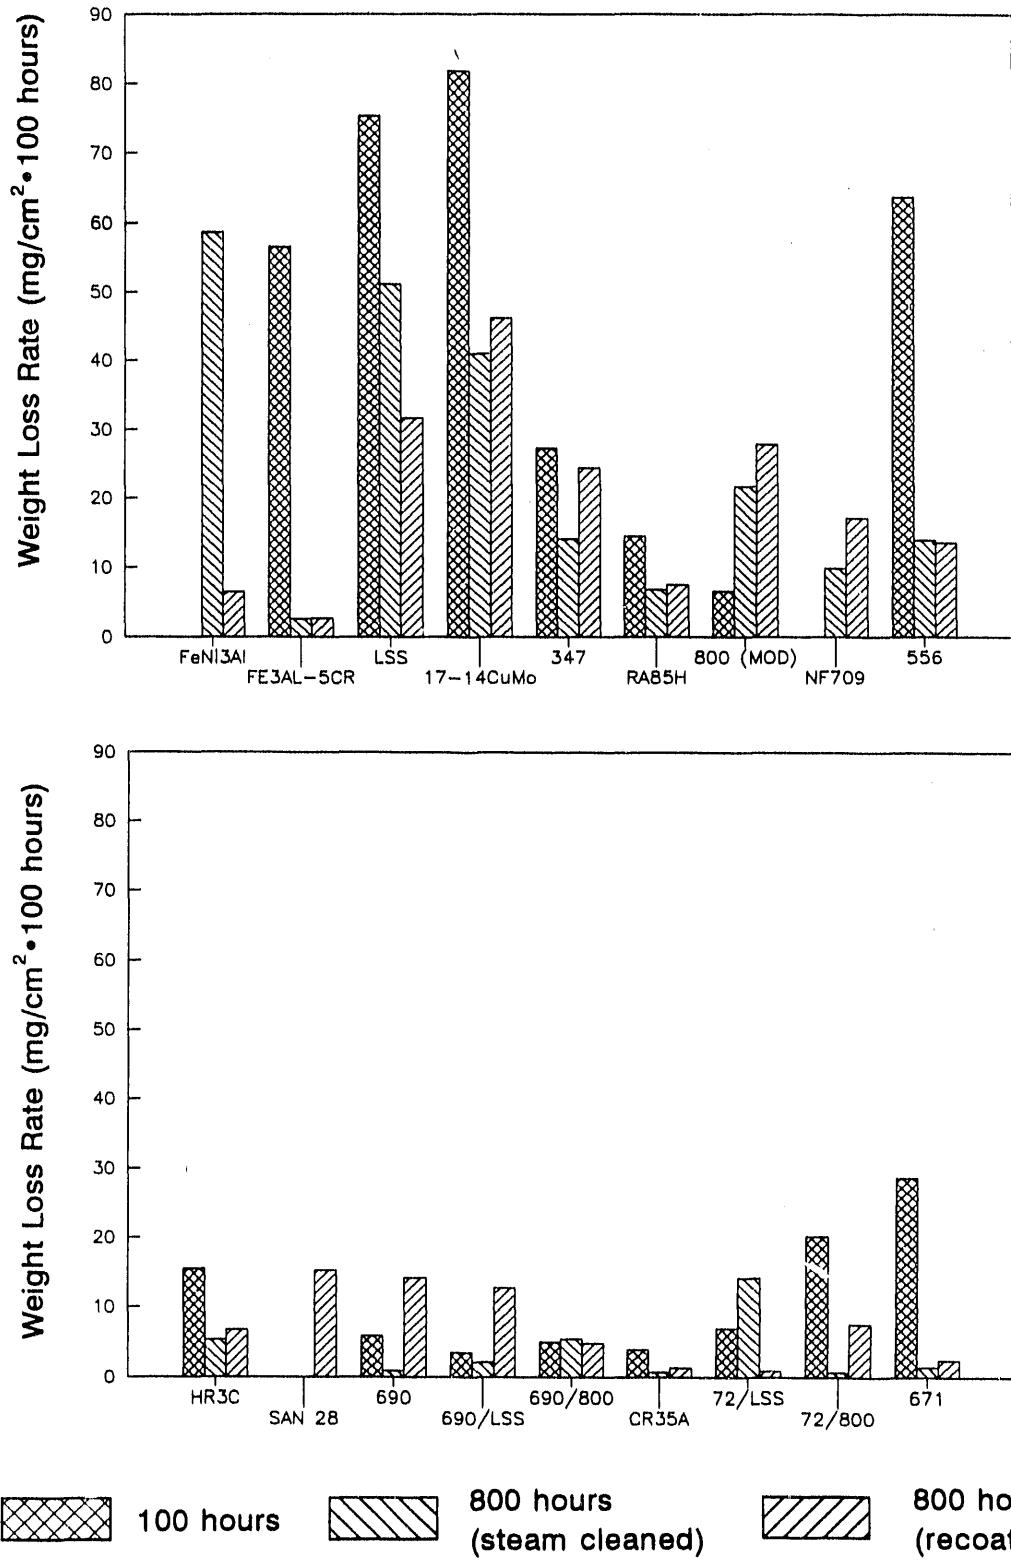
Figure 3.8 Normalized Weight Loss Rates for Alloys Coated With a 10 wt% Alkali Sulfate Ash and Exposed at 700°C to a 0.25 vol% SO₂ Flue Gas

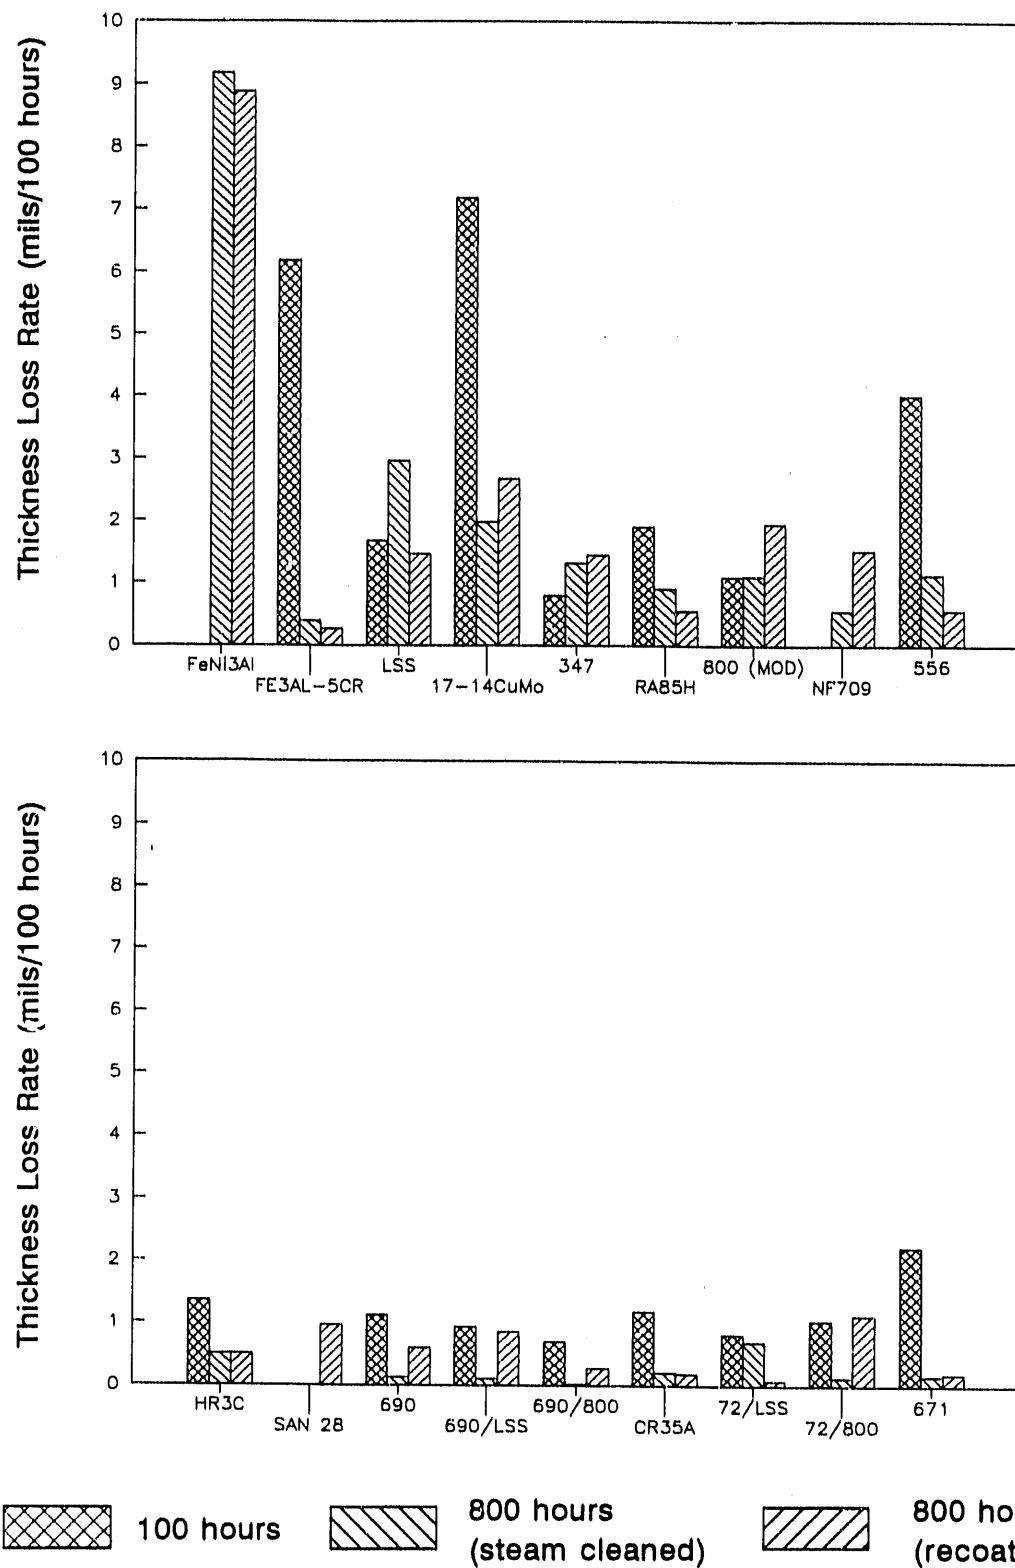
Figure 3.10 Normalized Thickness Loss Rates for Alloys Coated With a 10 wt% Alkali Sulfate Ash and Exposed at 700°C to a 0.25 vol% SO₂ Flue Gas

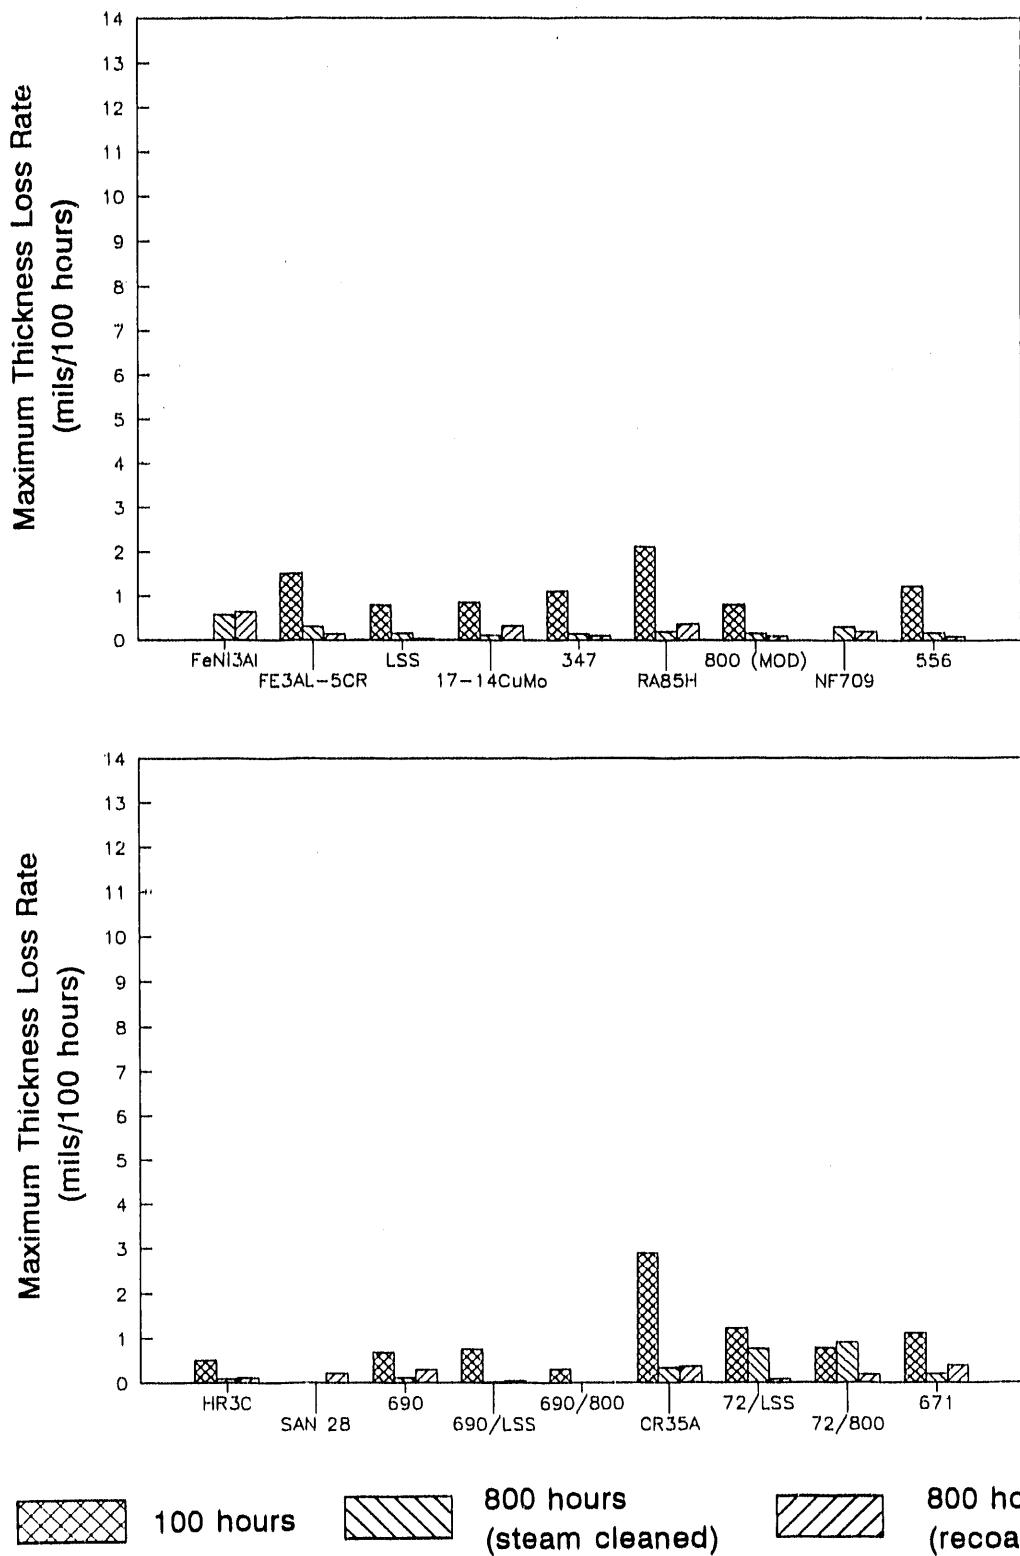
Figure 3.11 Normalized Maximum Thickness Loss Rates for Alloys Coated With a 10 wt% Alkali Sulfate Ash and Exposed at 650°C to a 0.25 vol% SO₂ Flue Gas

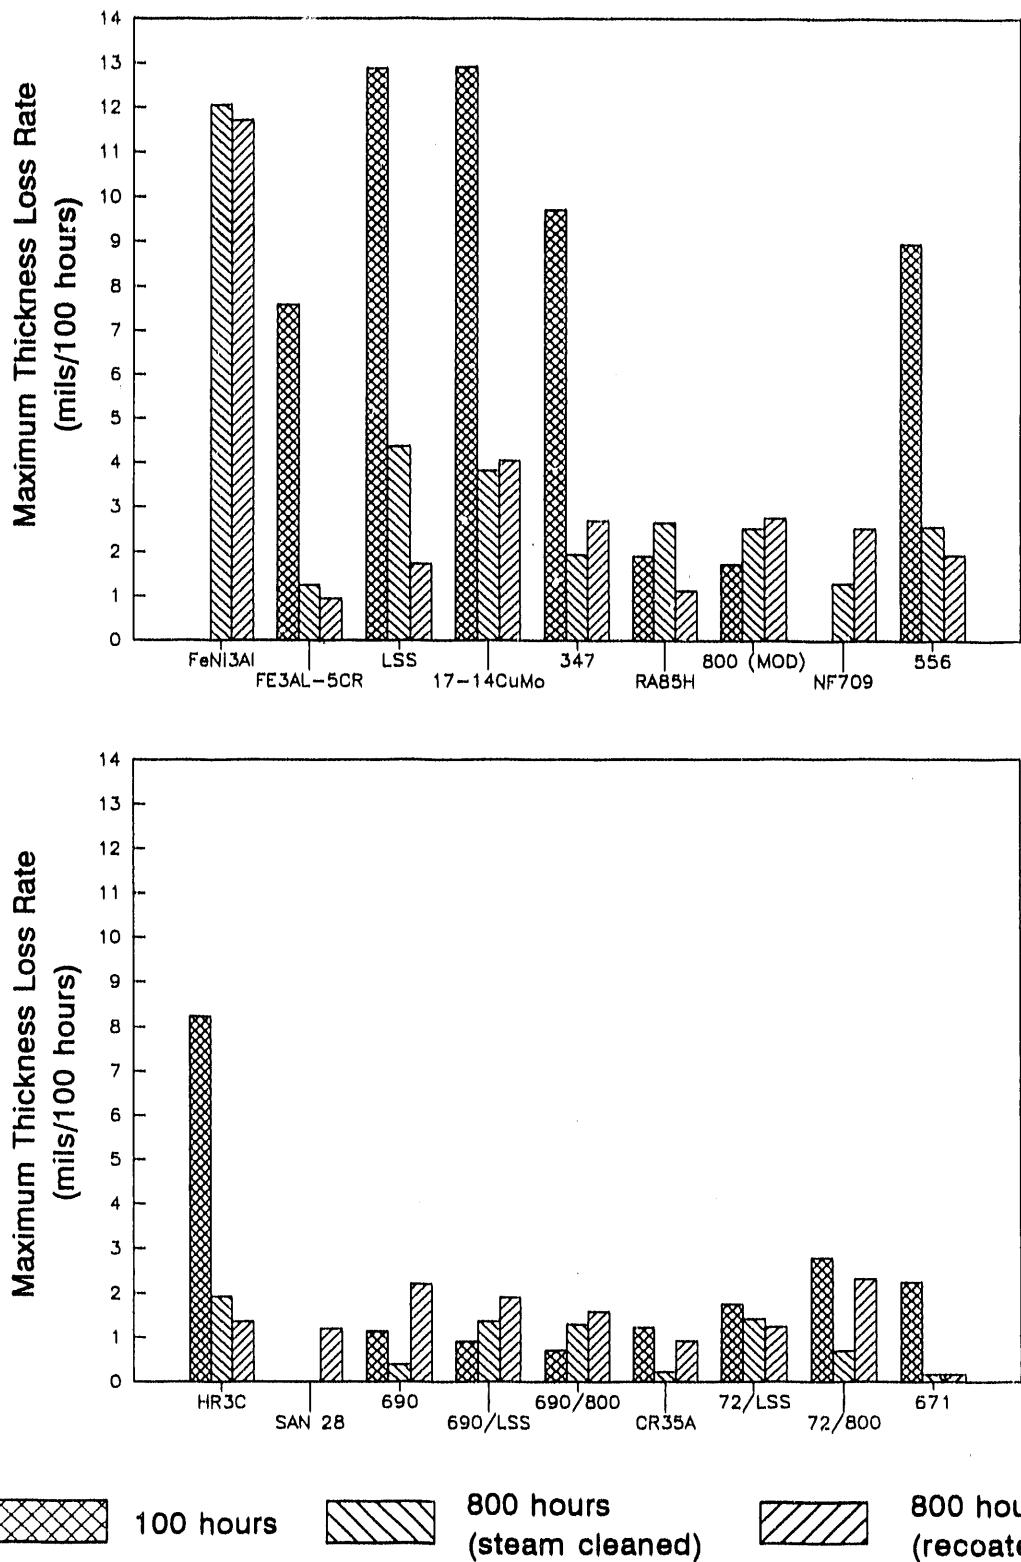
Figure 3.12 Normalized Maximum Thickness Loss Rates for Alloys Coated With a 10 wt% Alkali Sulfate Ash and Exposed at 700°C to a 0.25 vol% SO₂ Flue Gas

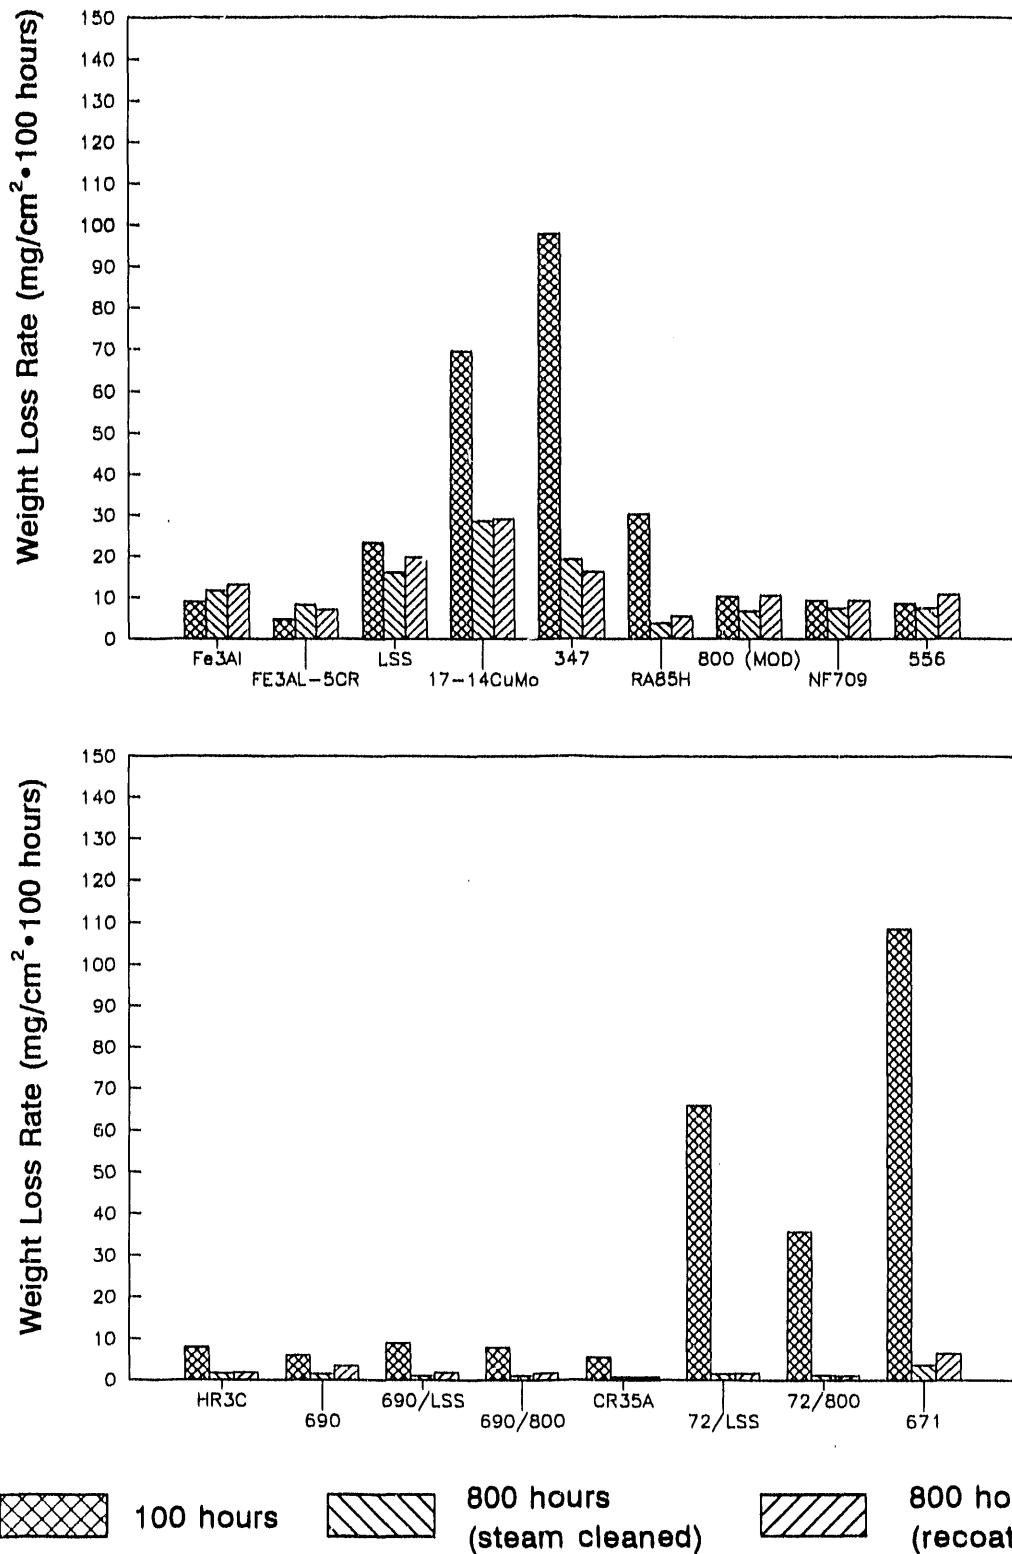
Figure 3.13 Normalized Weight Loss Rates for Alloys Coated With an Ash Containing 10 wt% Alkali Sulfates and Exposed at 650°C to a Flue Gas Containing 1.0 vol% SO₂

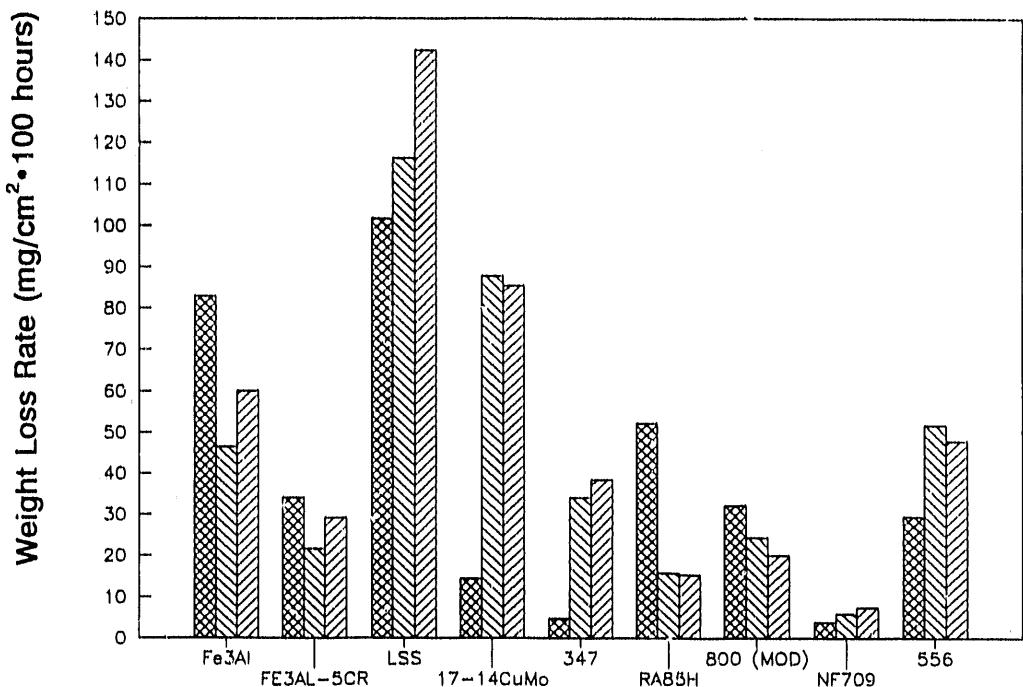
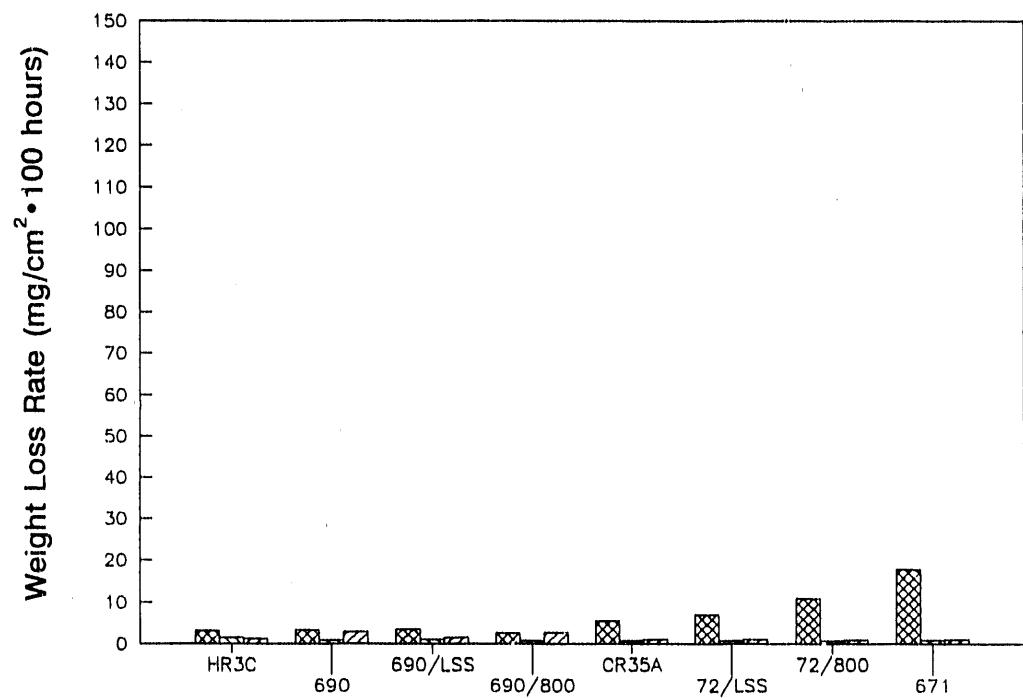
Figure 3.14 Normalized Weight Loss Rates for Alloys Coated With an Ash Containing 10 wt% Alkali Sulfates and Exposed at 700°C to a Flue Gas Containing 1.0 vol% SO₂

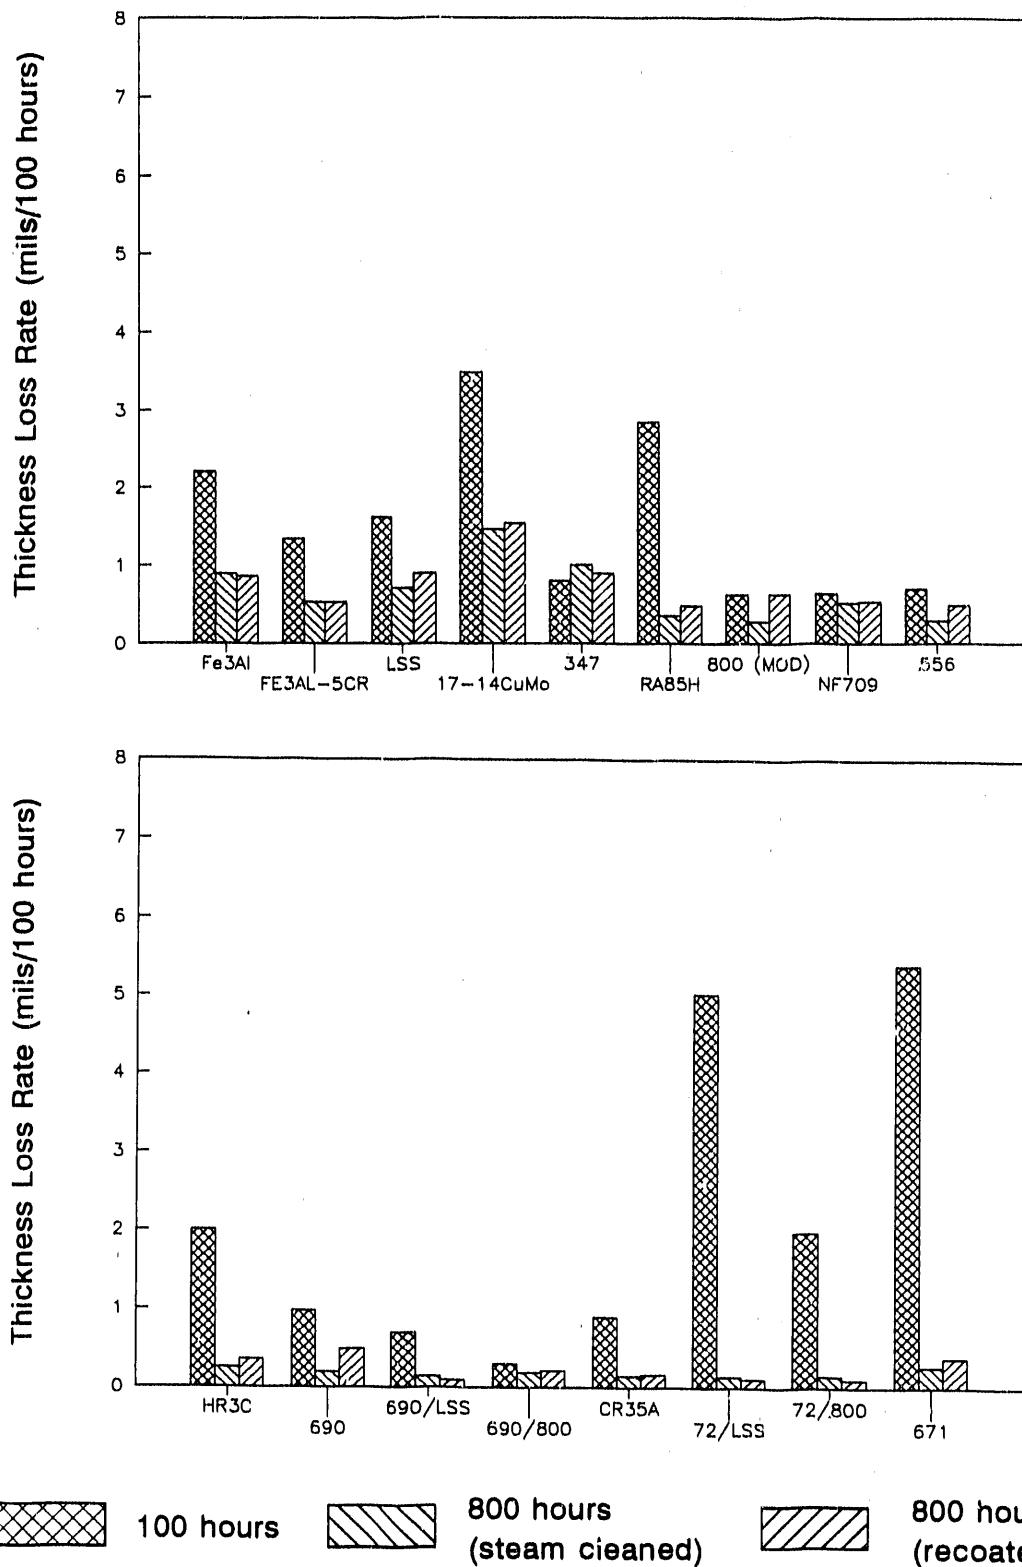
Figure 3.15 Normalized Thickness Loss Rates for Alloys Coated With an Ash Containing 10 wt% Alkali Sulfates and Exposed at 650°C to a Flue Gas Containing 1.0 vol% SO₂

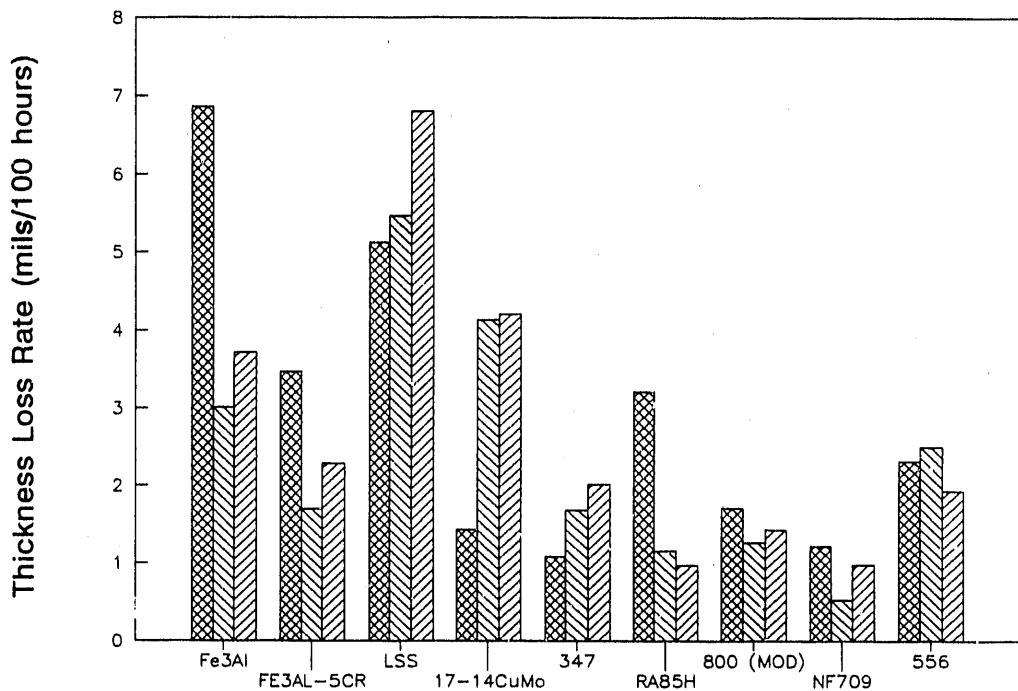
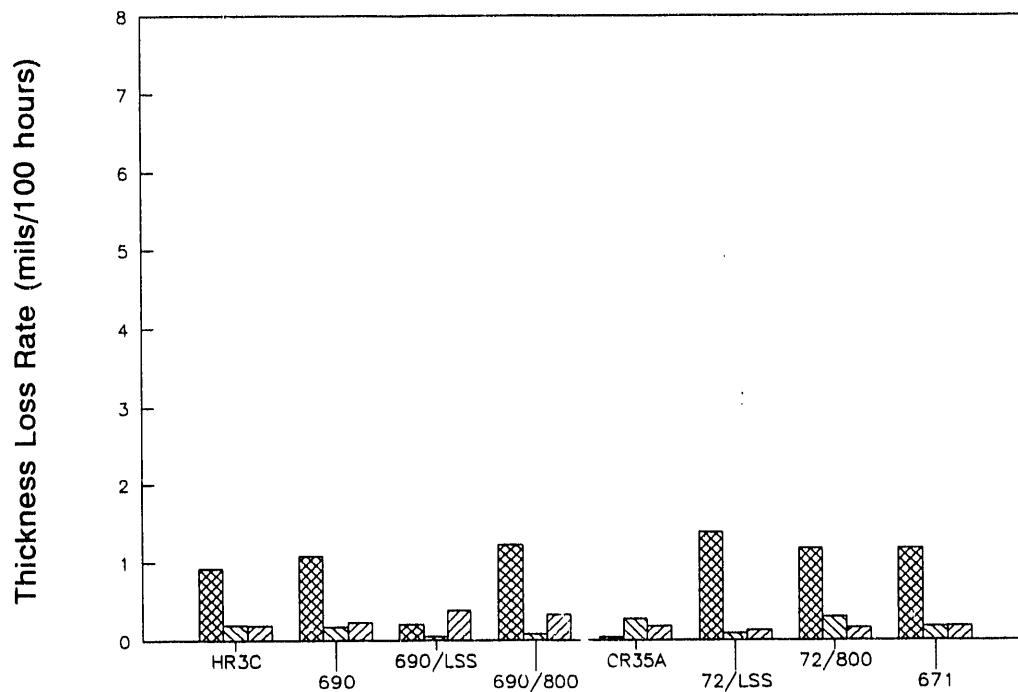
Figure 3.16 Normalized Thickness Loss Rates for Alloys Coated With an Ash Containing 10 wt% Alkali Sulfates and Exposed at 700°C to a Flue Gas Containing 1.0 vol% SO_2

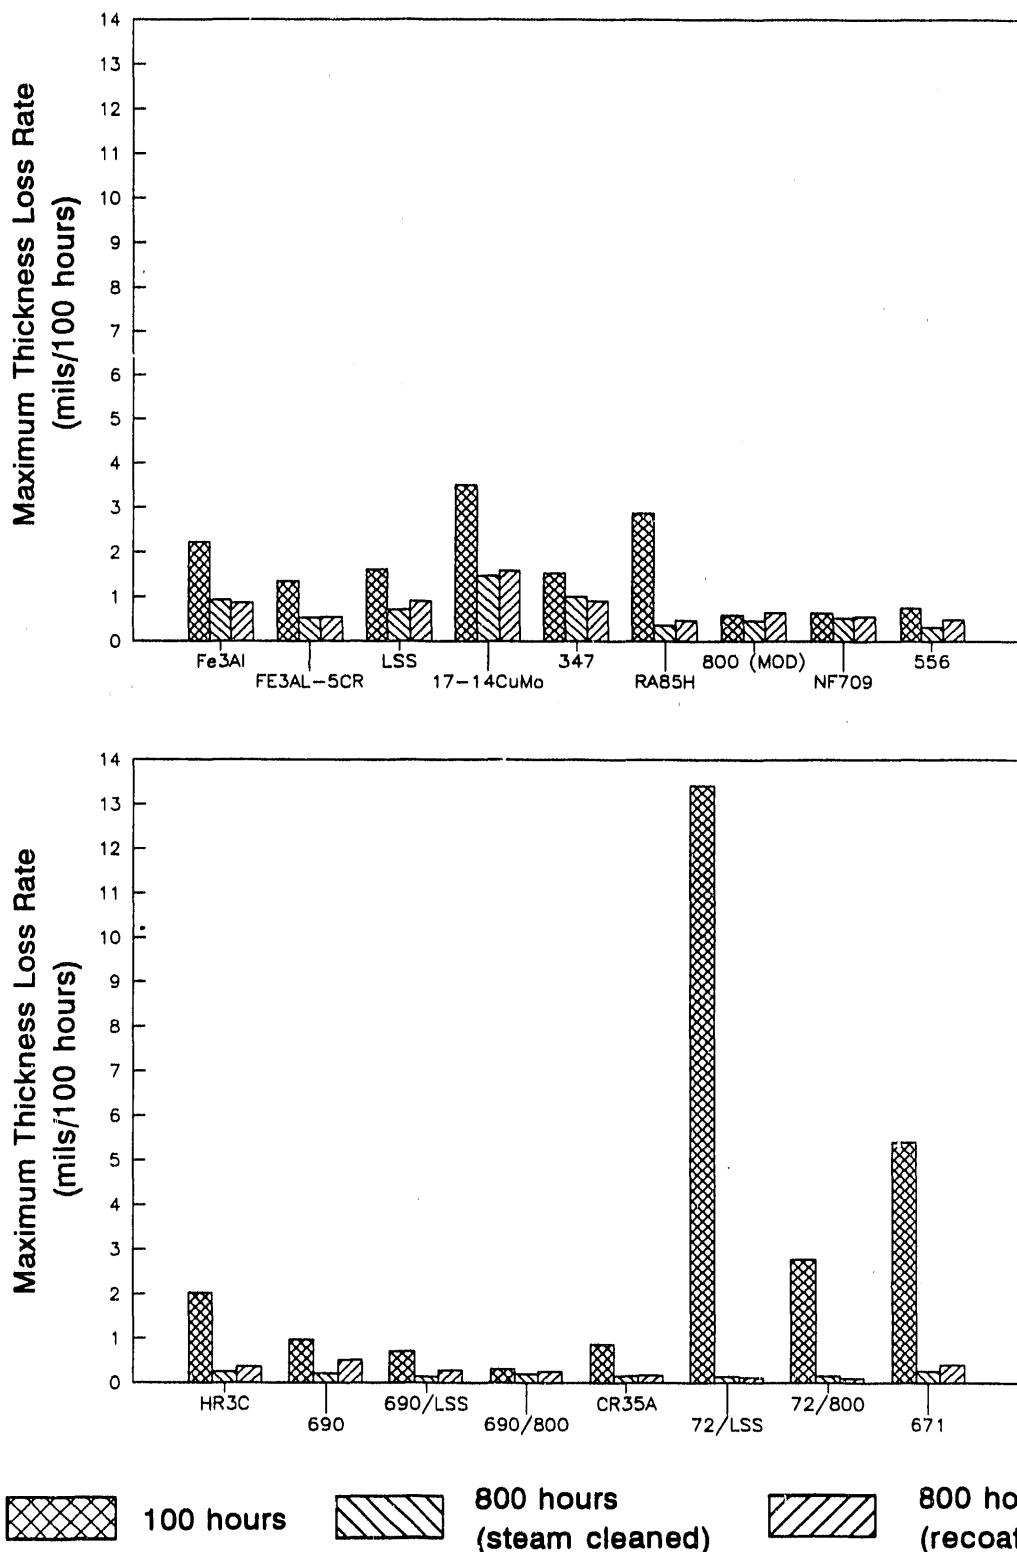
Figure 3.17 Normalized Maximum Thickness Loss Rates for Alloys Coated With an Ash Containing 10 wt% Alkali Sulfates and Exposed at 650°C to a Flue Gas Containing 1.0 vol% SO₂

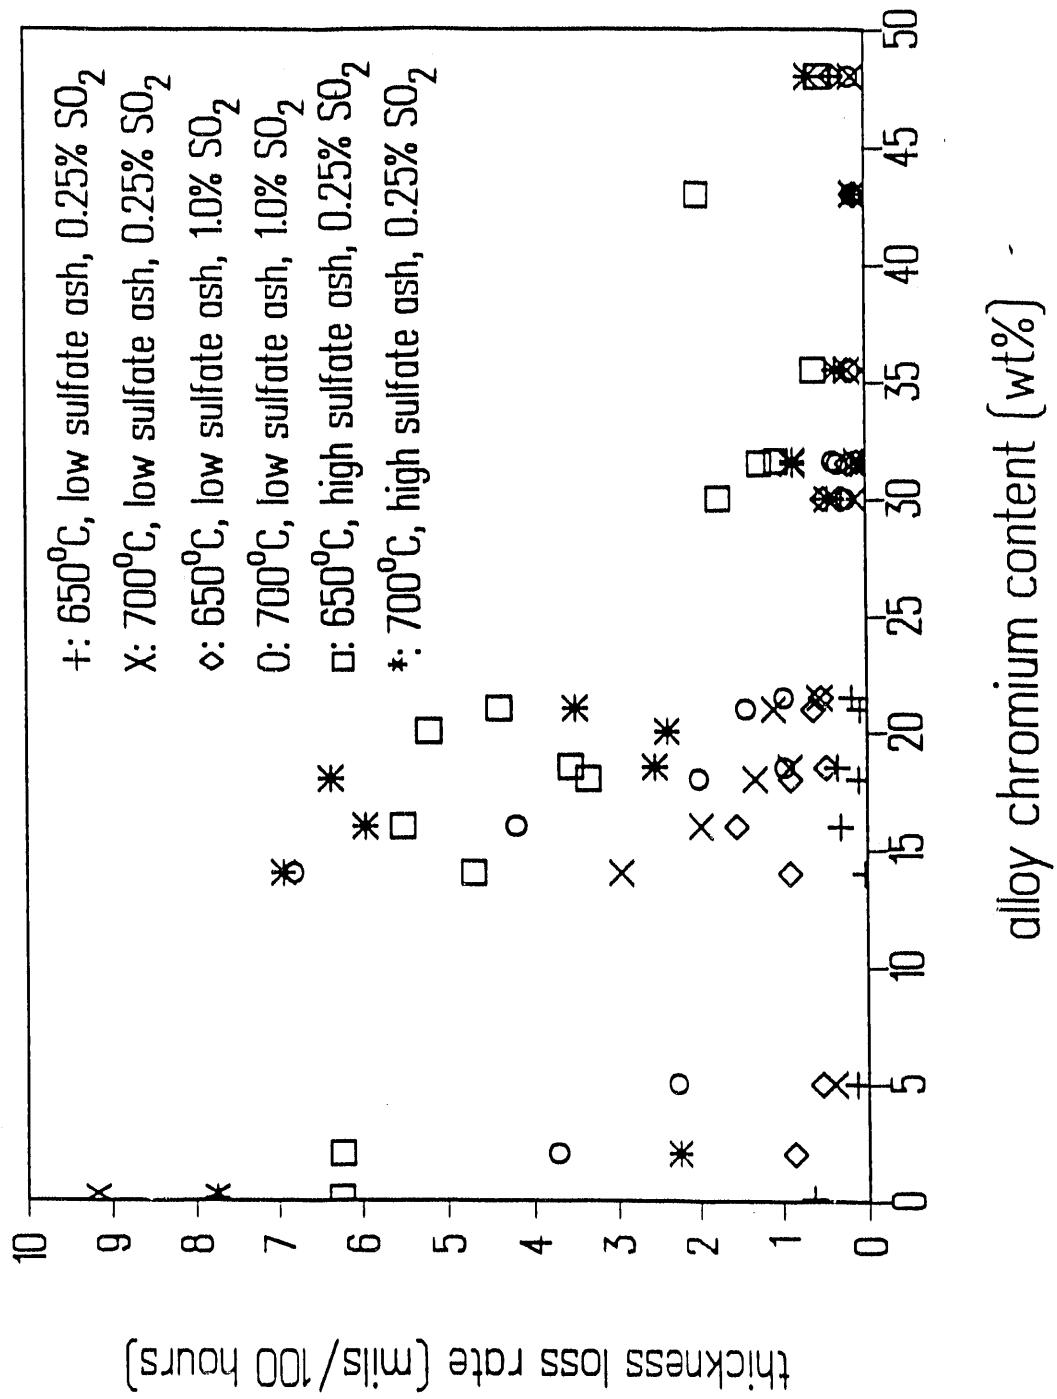
Figure 4.1 Average Thickness Loss Rate of Alloy Compared With Chromium Content of Alloy (Plot contains data for all alloys exposed under every environment tested in program.)

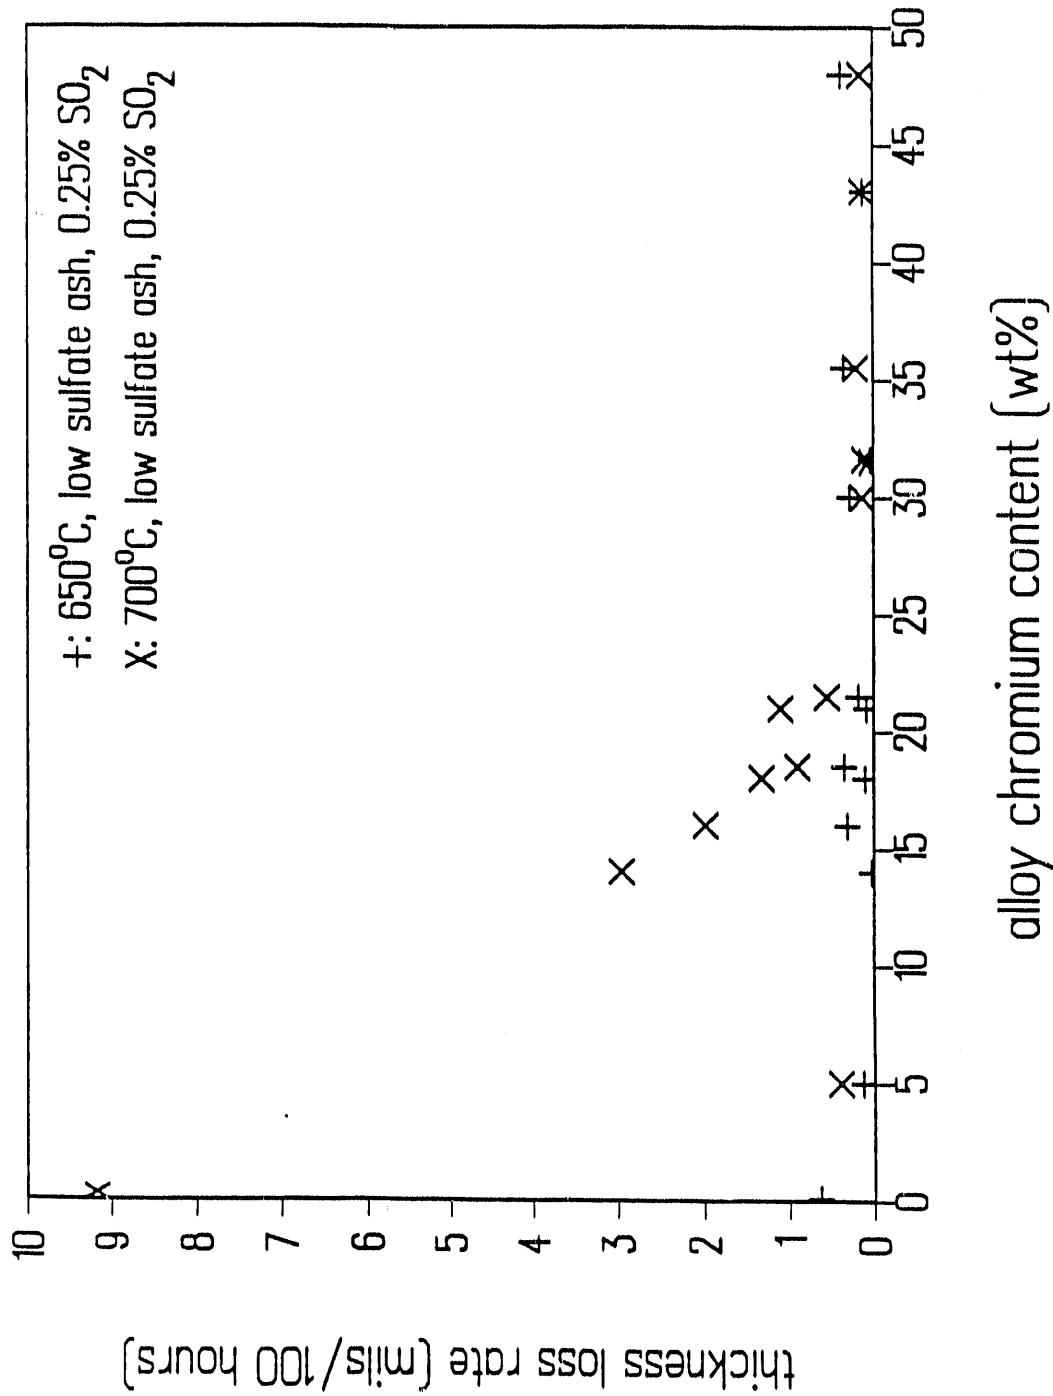
Figure 4.2 Average Thickness Loss Rate of Alloy Compared With Chromium Content of Alloy (Plot contains data for alloys exposed to flue gas containing 0.25 vol% SO₂ and coated with ash containing 10 wt% alkali sulfates.)

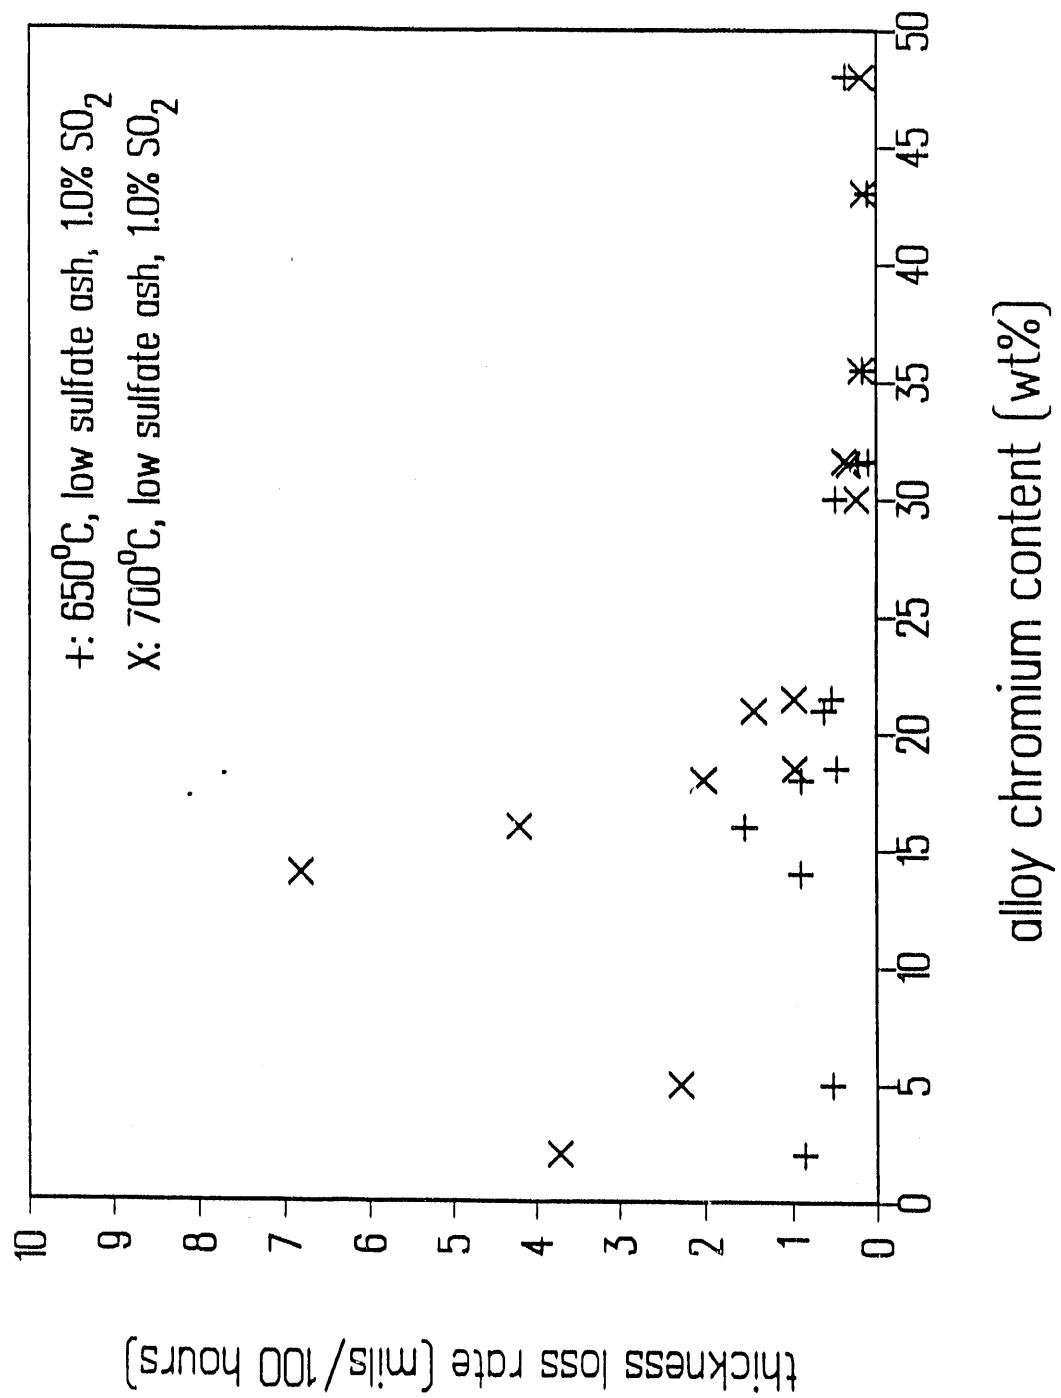
Figure 4.3 Average Thickness Loss Rate of Alloy Compared With Chromium Content of Alloy (Plot contains data for alloys exposed to flue gas containing 1.0 vol% SO₂ and coated with ash containing 10 wt% alkali sulfates.)
