TOPICAL REPORT
Project No.: 9-61-5329

**TITLE: FIRESIDE CORROSION TESTING OF
CANDIDATE SUPERHEATER TUBE ALLOYS,
COATINGS, AND CLADDINGS**

Final Report, August 1991

FOSTER WHEELER DEVELOPMENT CORPORATION
12 Peach Tree Hill Road
Livingston, New Jersey 07039

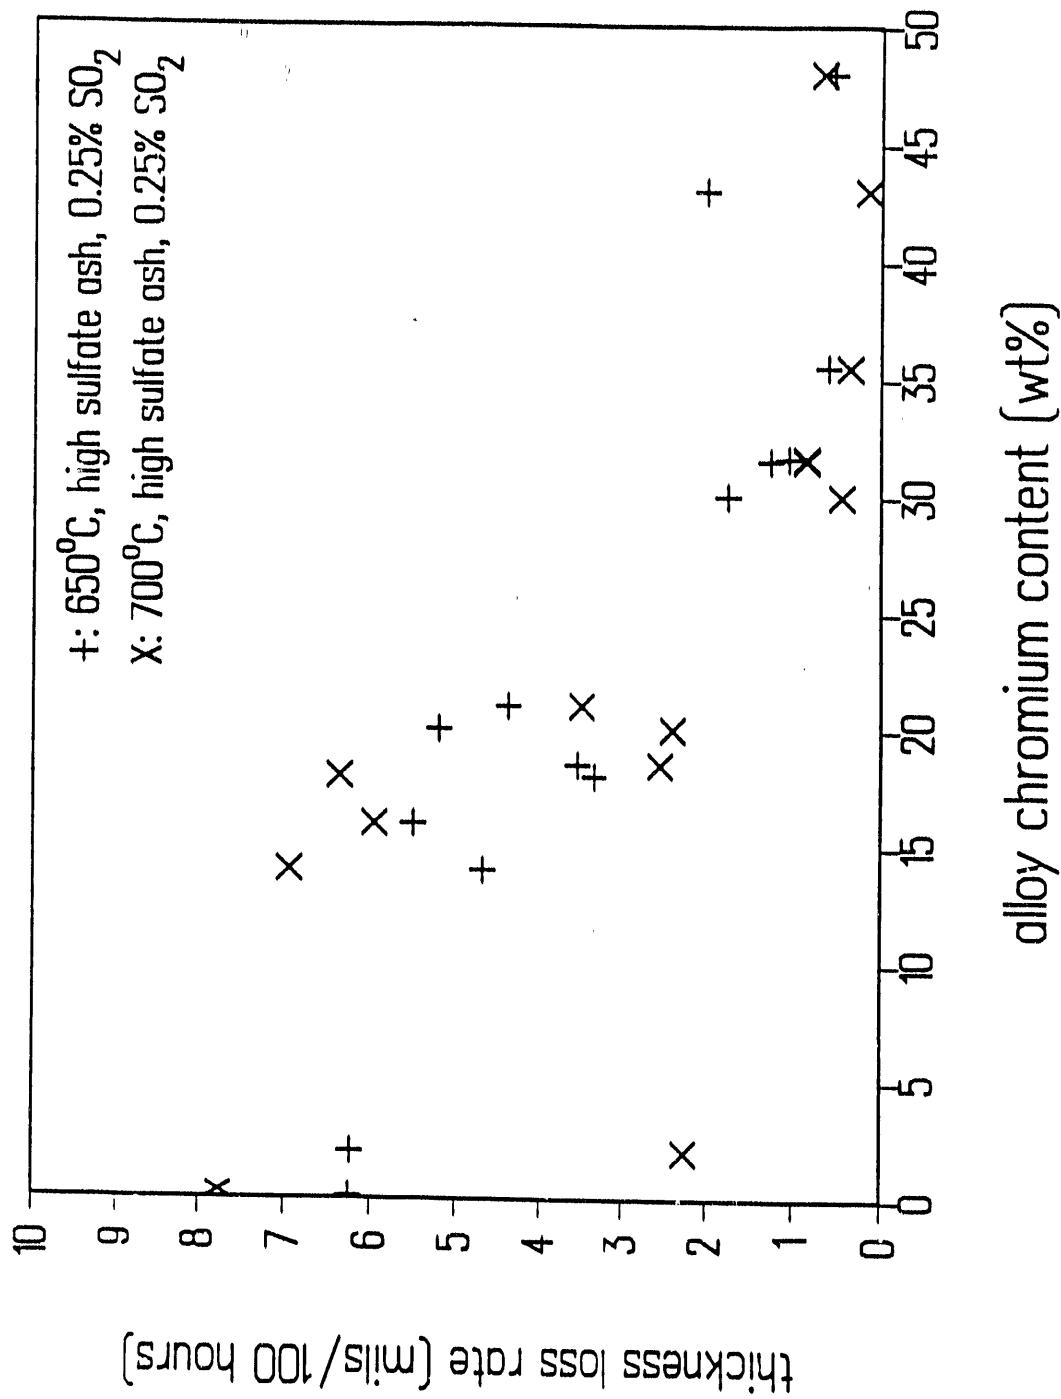
Figure 4.4 Average Thickness Loss Rate of Alloy Compared With Chromium Content of Alloy (Plot contains data for alloys exposed to flue gas containing 0.25 vol% SO₂ and coated with ash containing 75 wt% alkali sulfates.)

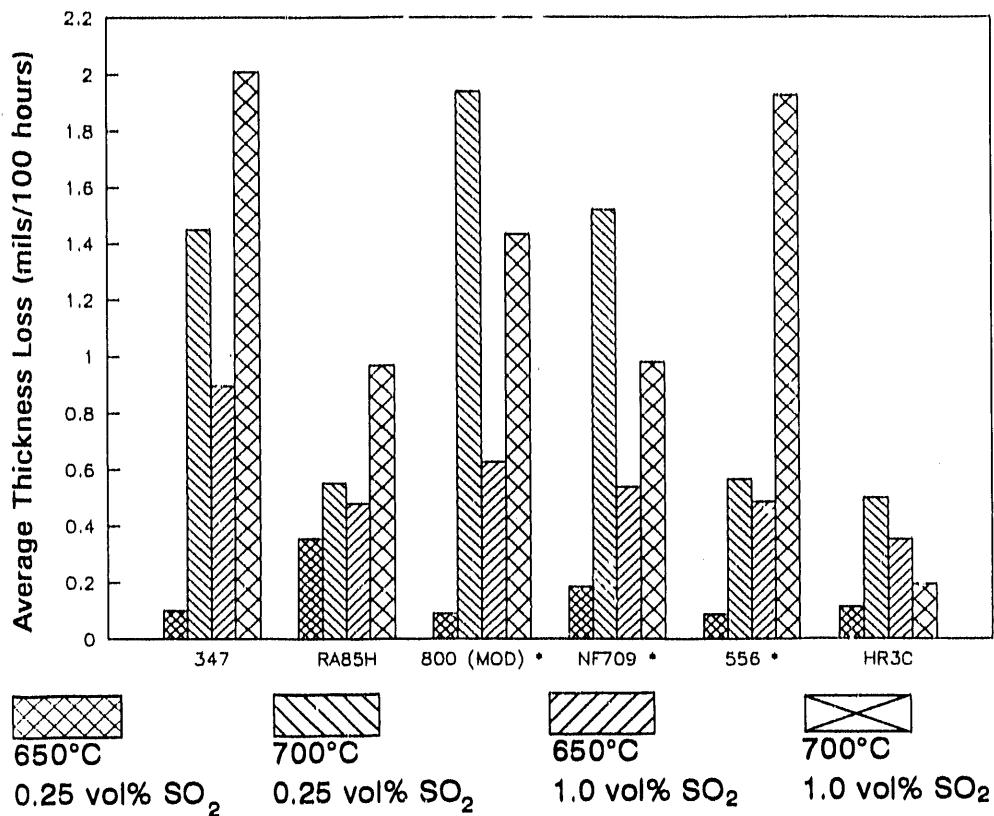
Figure 4.5 Average Thickness Loss Rate of Alloys Containing 14- to 30-Percent Chromium (Alloys marked with an asterisk contain between 1 and 4 percent molybdenum.)

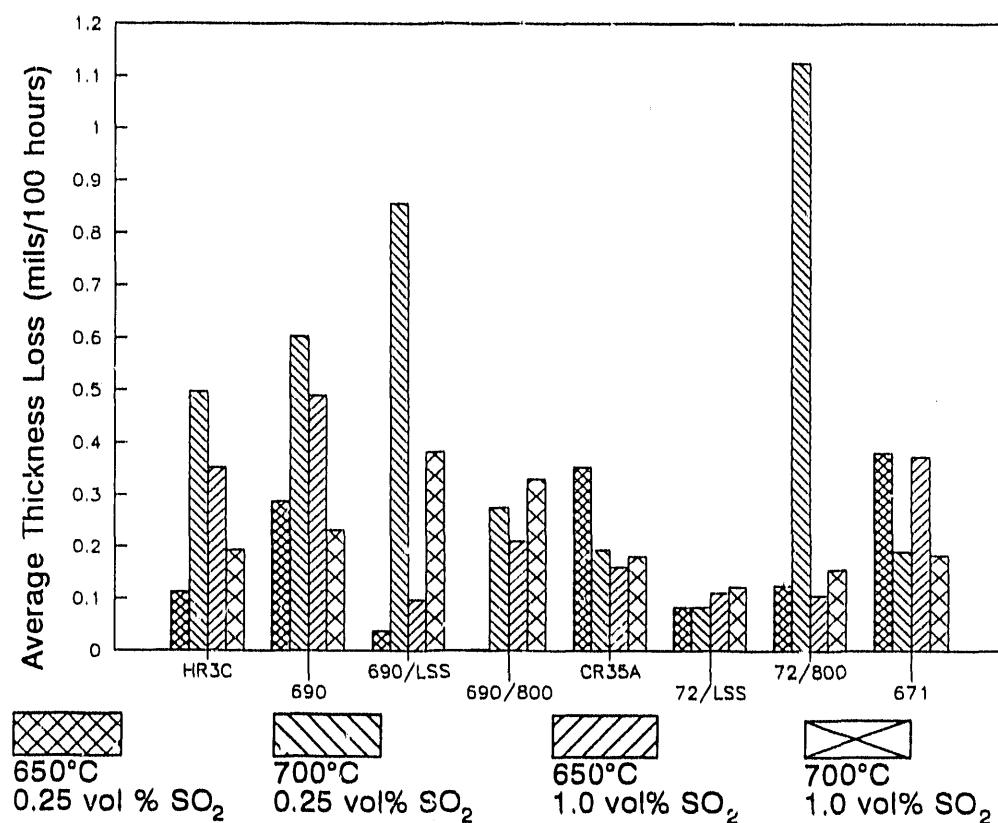
Figure 4.6 Average Thickness Loss Rates of Various Monolithic Alloys and Claddings Coated With Ash Containing 10 wt% Alkali Sulfates and Exposed for 800 Hours

Figure 4.6 illustrates the comparative corrosion resistance of base metals and cladding of the same nominal composition. The cladding performed as well as the base metals within the range of scatter for these tests. Two exceptions are the 690 clad Type 316 exposed to 0.25 vol% SO₂ at 700°C and the 72-clad 800 exposed to 0.25 vol% SO₂ at 700°C. The reasons for the lowered corrosion resistance of these specimens are discussed in Section 4.8.

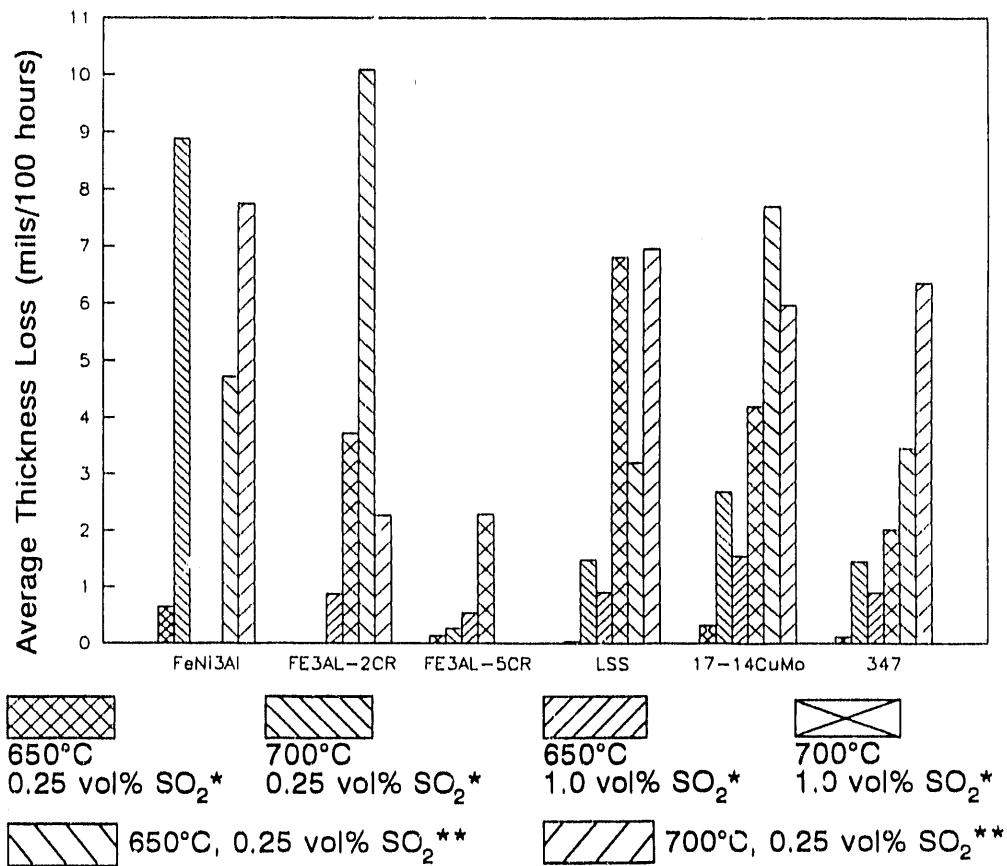
Figure 4.7 Average Thickness Loss Rates of Three Intermetallic Aluminides and Two Stainless Steels Exposed to a Variety of Environments (* = Low Sulfate Ash, ** = High Sulfate Ash)

Iron nickel aluminide specimens performed poorly in all environments. At 700°C, when exposed to a flue gas containing 1.0 vol% SO₂, the iron-nickel aluminide suffered catastrophic wastage. Most of the specimen was completely converted to scale. The morphology of attack on the iron-nickel aluminides appears to be primarily oxidation and sulfidation rather than liquid salt attack. In contrast to the iron-nickel aluminide, the iron aluminides did not suffer catastrophic wastage. Both aluminides were subjected to approximately the same degree of attack as the low-chromium stainless steels, with the iron aluminide containing 5 wt% chromium generally suffering less wastage than the iron aluminide containing 2 wt% chromium.

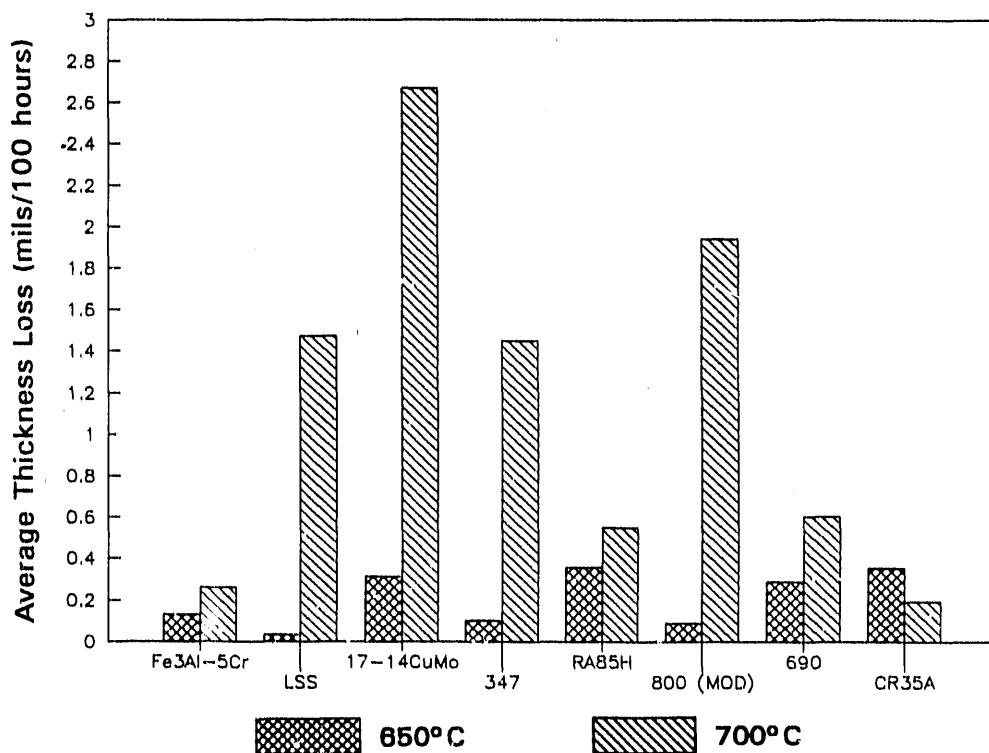
Figure 4.8 Average Thickness Loss Rates of Representative Alloys Coated With Ash Containing 10 wt% Alkali Sulfates and Exposed at 650 and 700°C for 800 Hours to Flue Gas Containing 0.25 vol% SO_2

The alloys coated with the low-sulfate ash and exposed to 0.25 vol% SO_2 (Figure 4.8) show minimal wastage at 650°C, indicating that liquid AITs may have had difficulty forming because of the lower SO_2 level. Specimens exposed at 700°C can be divided into two groups--alloys exhibiting wastage rates similar to those exposed at 650°C and alloys suffering much greater wastage at 700°C than at 650°C. A possible explanation for this behavior is that the alloys with high wastage rates promote the formation of a liquid phase. Several of the alloys exhibiting high wastage rates contained a

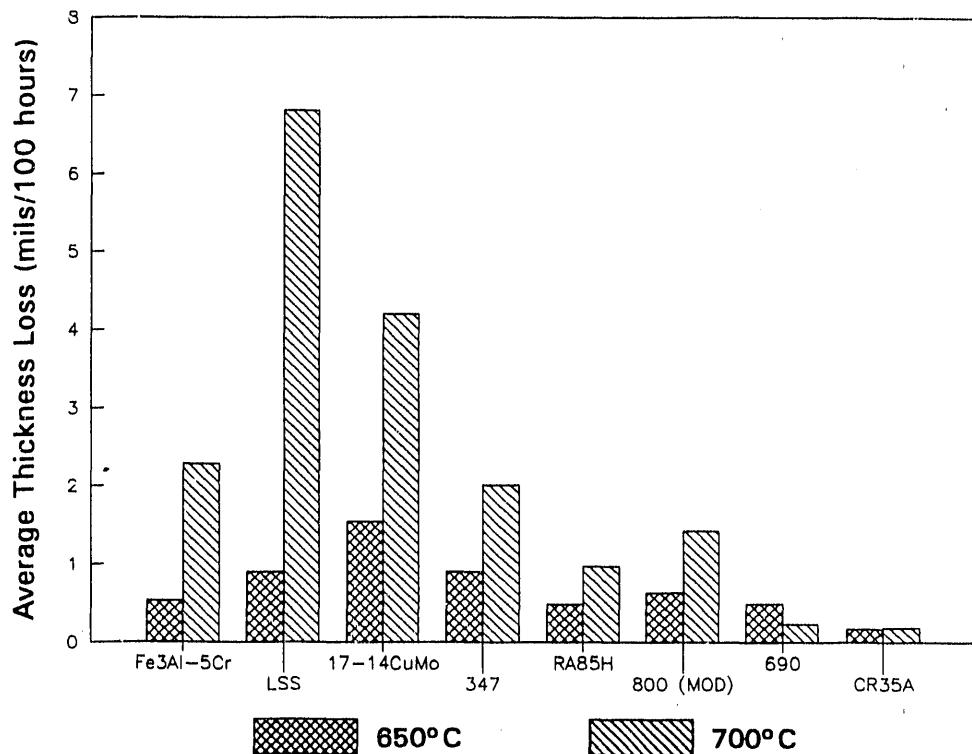
Figure 4.9 Average Thickness Loss Rates of Representative Alloys Coated With Ash Containing 10 wt% Alkali Sulfates and Exposed at 650 and 700°C for 800 Hours to Flue Gas Containing 1.0 vol% SO_2

Lower-chromium alloys exposed to a flue gas containing 1.0 vol% SO_2 while coated with the lower-sulfate coal ash (Figure 4.9) suffered greater wastage rates at 700°C than at 650°C, while the higher-chromium alloys (690 and CR35A) exhibited approximately the same corrosion rates at 650°C as at 700°C. Note also that the corrosion rates of the alloys drop as the chromium content of the alloy increases, illustrating the beneficial effect of chromium.

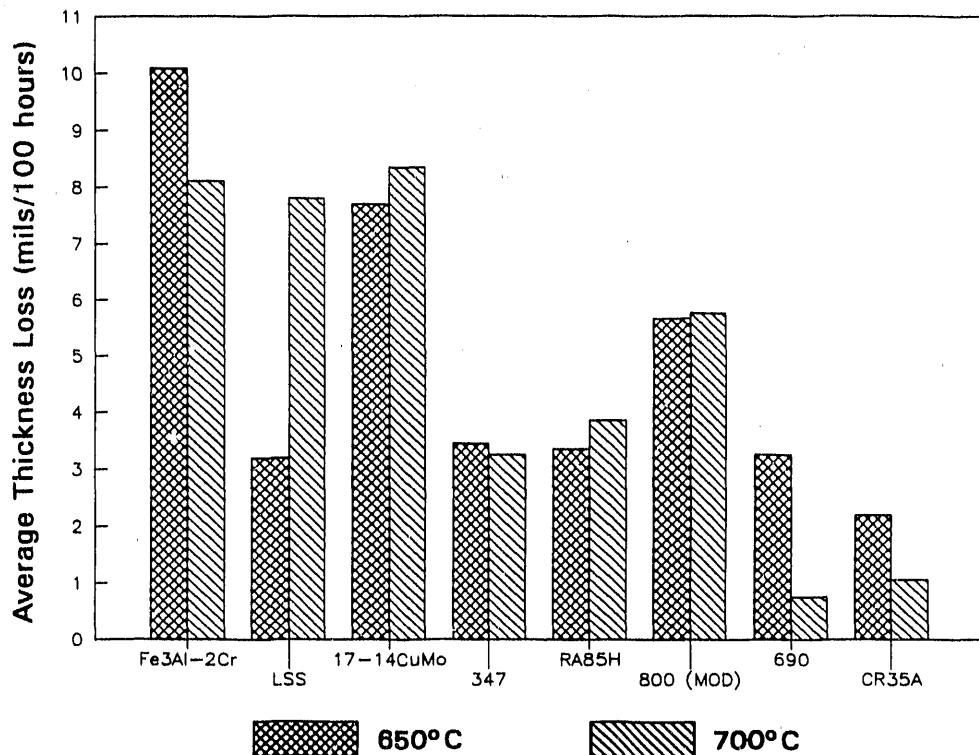
Figure 4.10 Average Thickness Loss Rates of Representative Alloys Coated With Ash Containing 75 wt% Alkali Sulfates and Exposed at 650 and 700°C for 200 Hours to Flue Gas Containing 0.25 vol% SO₂

The alloys coated with a 75 wt% alkali sulfate coal ash while exposed to 0.25 vol% SO_2 flue gas (Figure 4.10) did not display a consistent temperature dependence. The two higher-chromium alloys (690 and CR35A) suffered greater corrosion losses at 650°C than at 700°C, a dependence found in previous studies by Kihara [4] and Rehn [1].

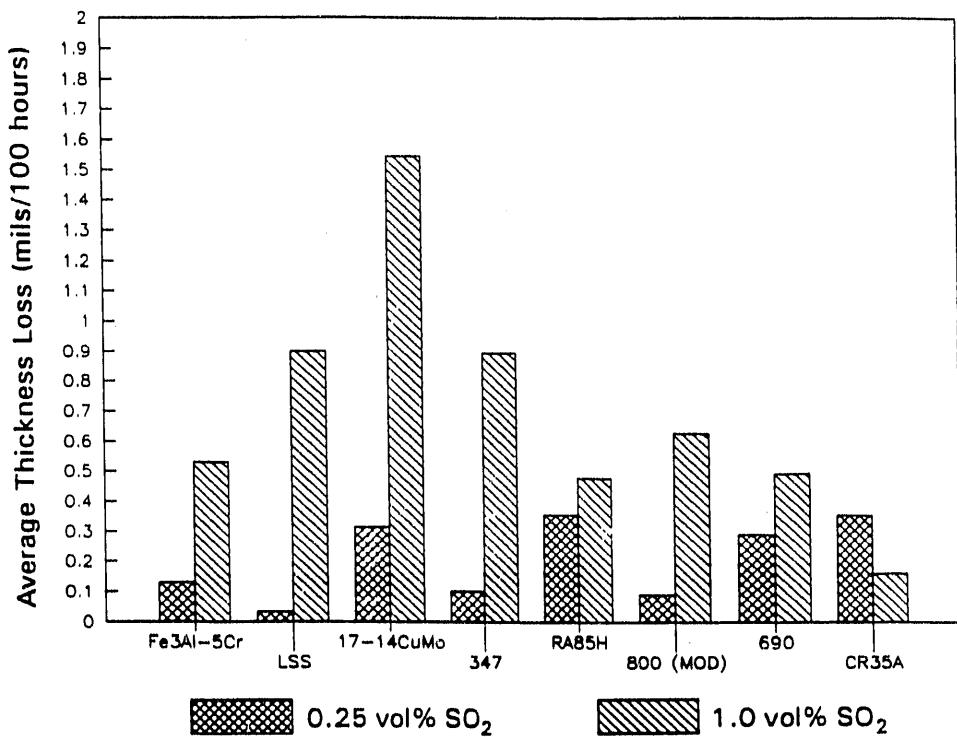
Figure 4.11 Average Thickness Loss Rates of Representative Alloys Coated With Ash Containing 10 wt% Alkali Sulfates and Exposed at 650°C for 800 Hours to Flue Gas Containing Either 0.25 or 1.0 vol% SO_2

The effects of increased SO₂ in the flue gas and a higher sulfate concentration in the coal ash are illustrated in Figures 4.11 through 4.14. Figures 4.11 and 4.12 display the effects of SO₂ concentration on the corrosion rates of alloys coated with 10 wt% sulfate coal ash and exposed for eight 100-hour cycles at 650 and 700°C respectively, with ash replenishment between cycles. Figures 4.13 and 4.14 show the effects of an increased sulfate concentration in the coal ash on the corrosion rates of alloys exposed to flue gas containing 0.25 vol% SO₂ and for 100 hours at 650 and 700°C respectively. An increase in both the SO₂ concentration in the flue gas and the sulfate concentration in the coal ash would be expected to produce a more aggressive environment. As shown in the figures, an increase in either the SO₂ level or the sulfate concentration will raise the corrosion rate.

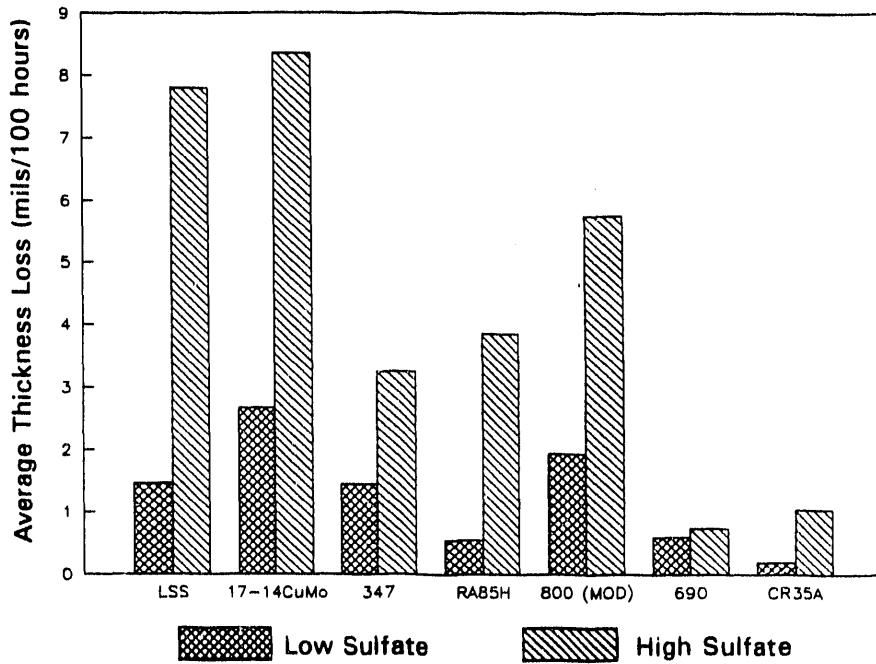
Figure 4.14 Average Thickness Loss Rates of Representative Alloys Coated With Ash Containing Either 10 or 75 wt% Alkali Sulfates and Exposed at 700°C for 200 or 800 Hours Respectively to Flue Gas Containing 0.25 vol% SO₂

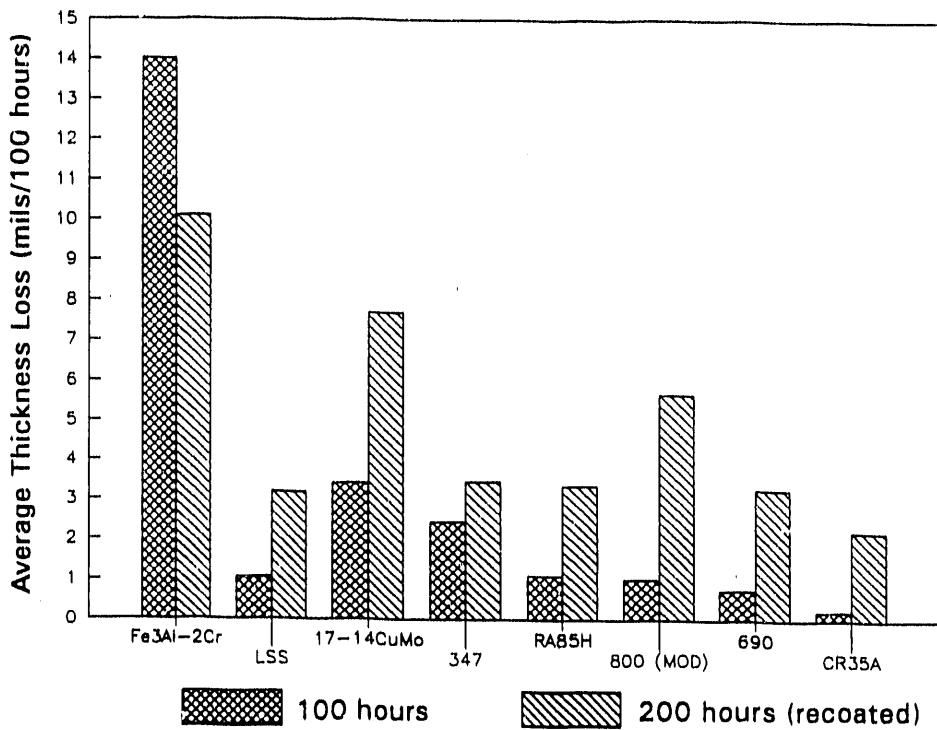
Figure 4.15 Average Thickness Loss Rates of Representative Alloys Coated With Ash Containing 75 wt% Alkali Sulfates and Exposed at 650°C for Either 100 or 200 Hours to Flue Gas Containing 0.25 vol% SO₂

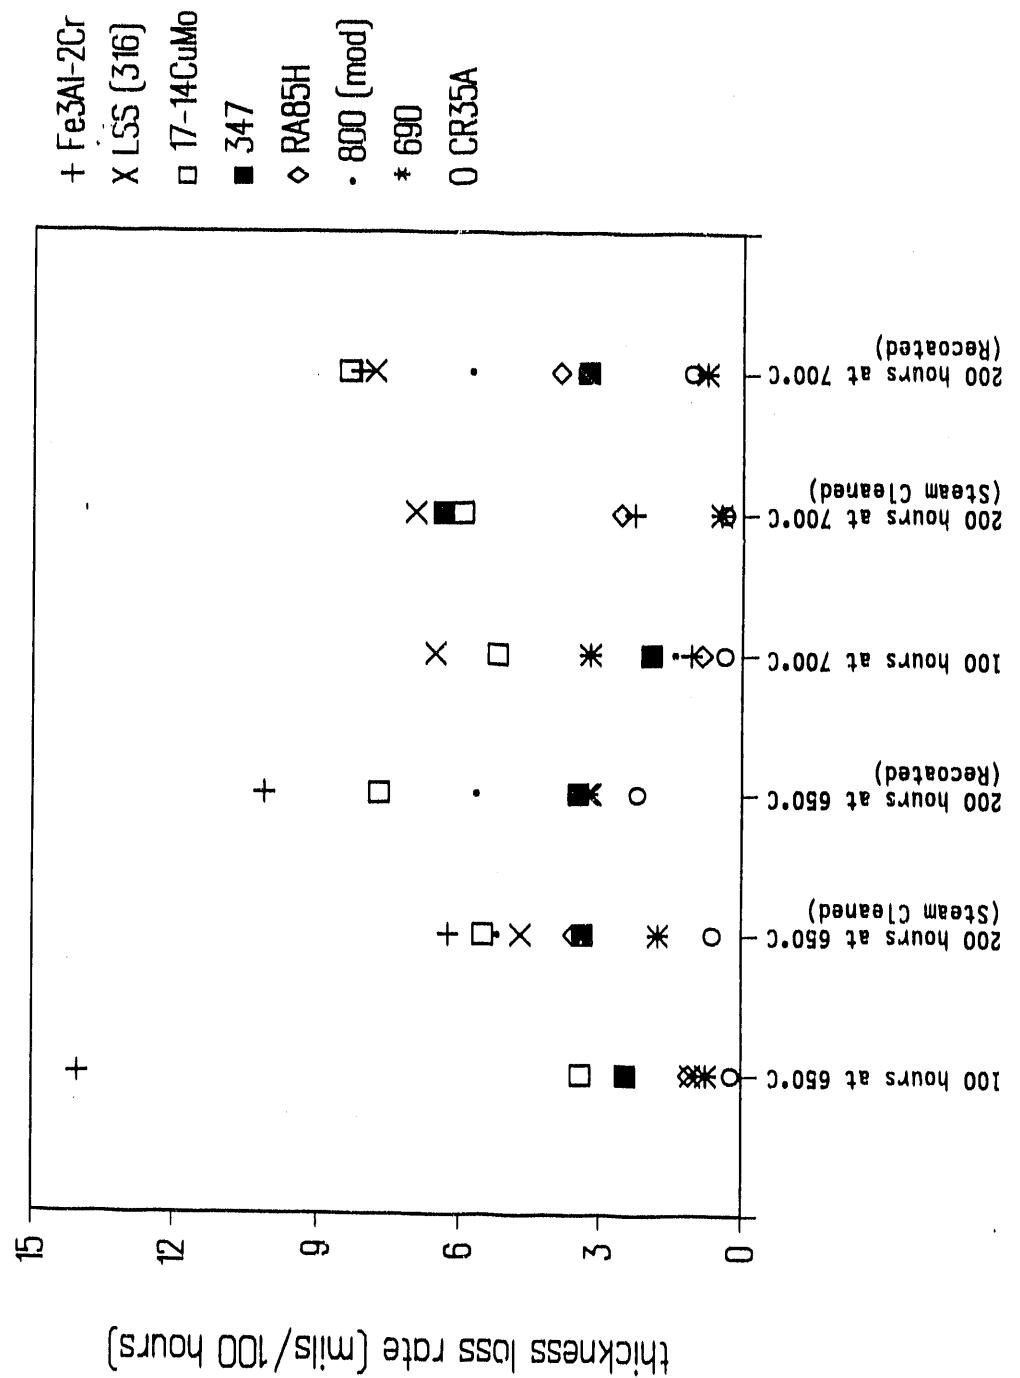
Figure 4.23 Summary of Average Thickness Loss Rates for Representative Alloys Coated With Ash Containing 75 wt% Alkaline Sulfates and Exposed to Flue Gas Containing 0.25 vol% SO_2

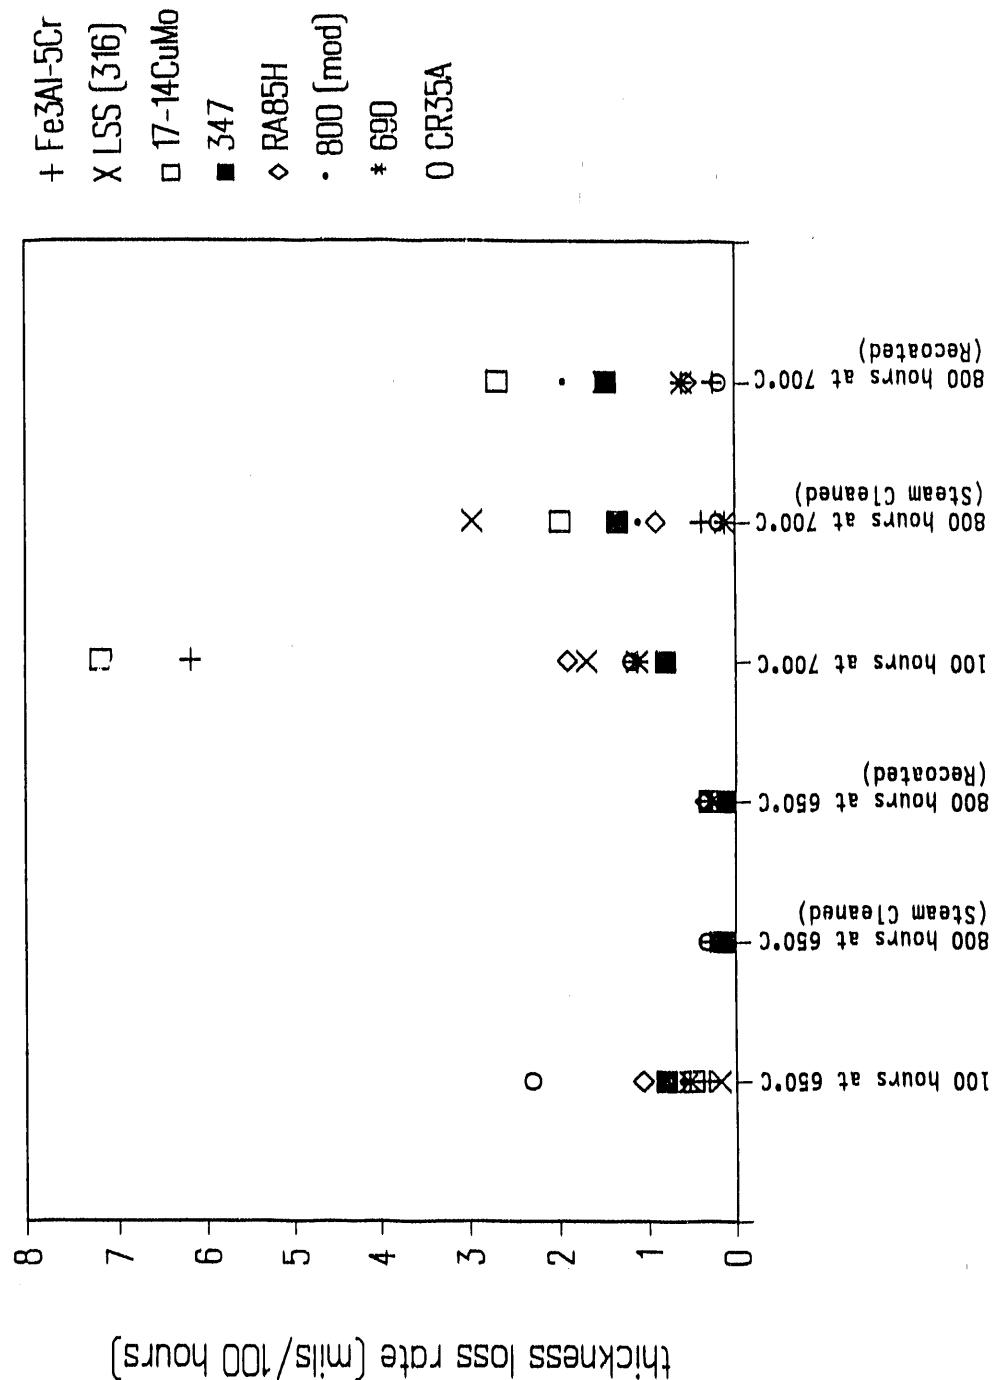
Figure 4.24 Summary of Average Thickness Loss Rates for Representative Alloys Coated With Ash Containing 10 wt% Alkali Sulfates and Exposed to Flue Gas Containing 0.25 vol% SO_2

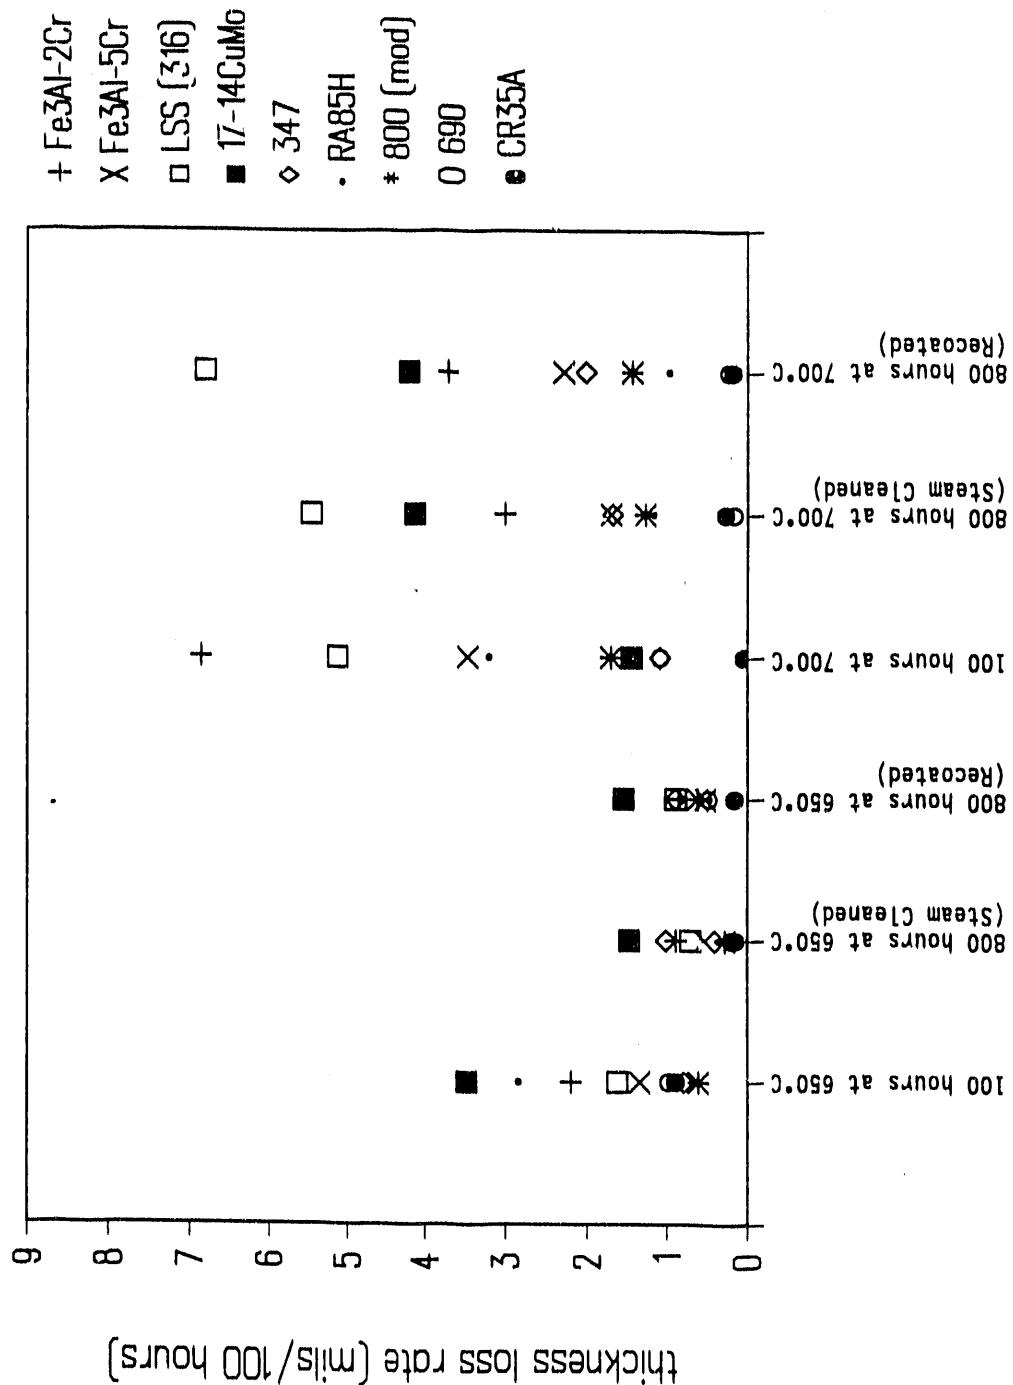
Figure 4.25 Summary of Average Thickness Loss Rates for Representative Alloys Coated With Ash Containing 10 wt% Alkaline Sulfates and Exposed to Flue Gas Containing 1.0 vol% SO_2

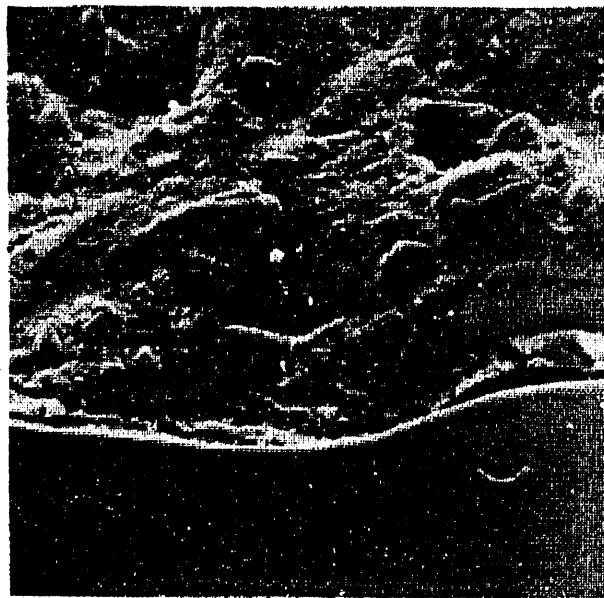
Figure 4.27 Corroded Surface of a 17-14 CuMo Specimen Coated With Ash Containing 10 wt% Alkali Sulfates After Exposure for 200 Hours at 700°C to Flue Gas Containing 1.0 vol% SO_2 . (Top area of image shows ash coating; bottom area is specimen.)

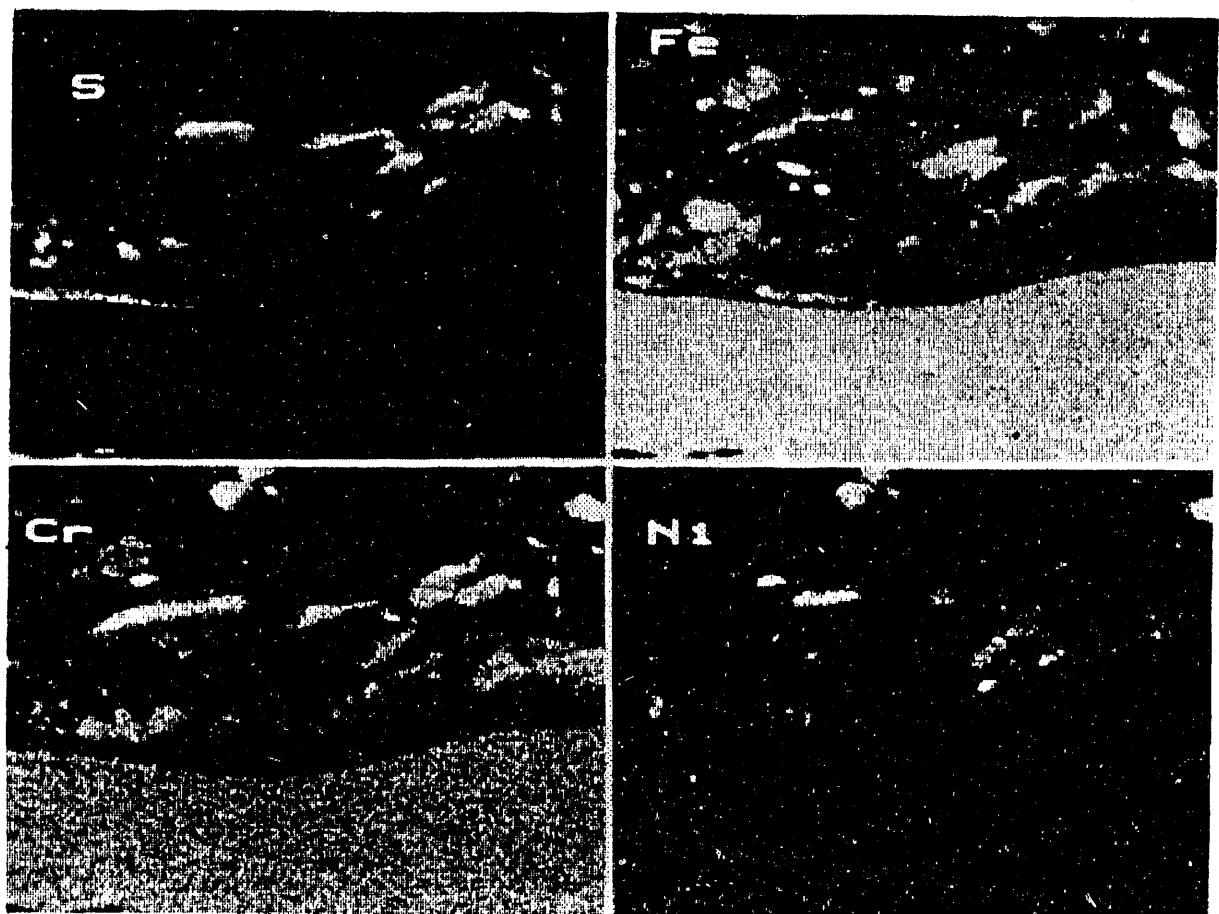
Figure 4.28 X-Ray Map of Corroded Surface of 17-14 CuMo Specimen Coated With Ash Containing 10 wt% Alkali Sulfates After Exposure for 200 Hours at 700°C to Flue Gas Containing 1.0 vol% SO_2

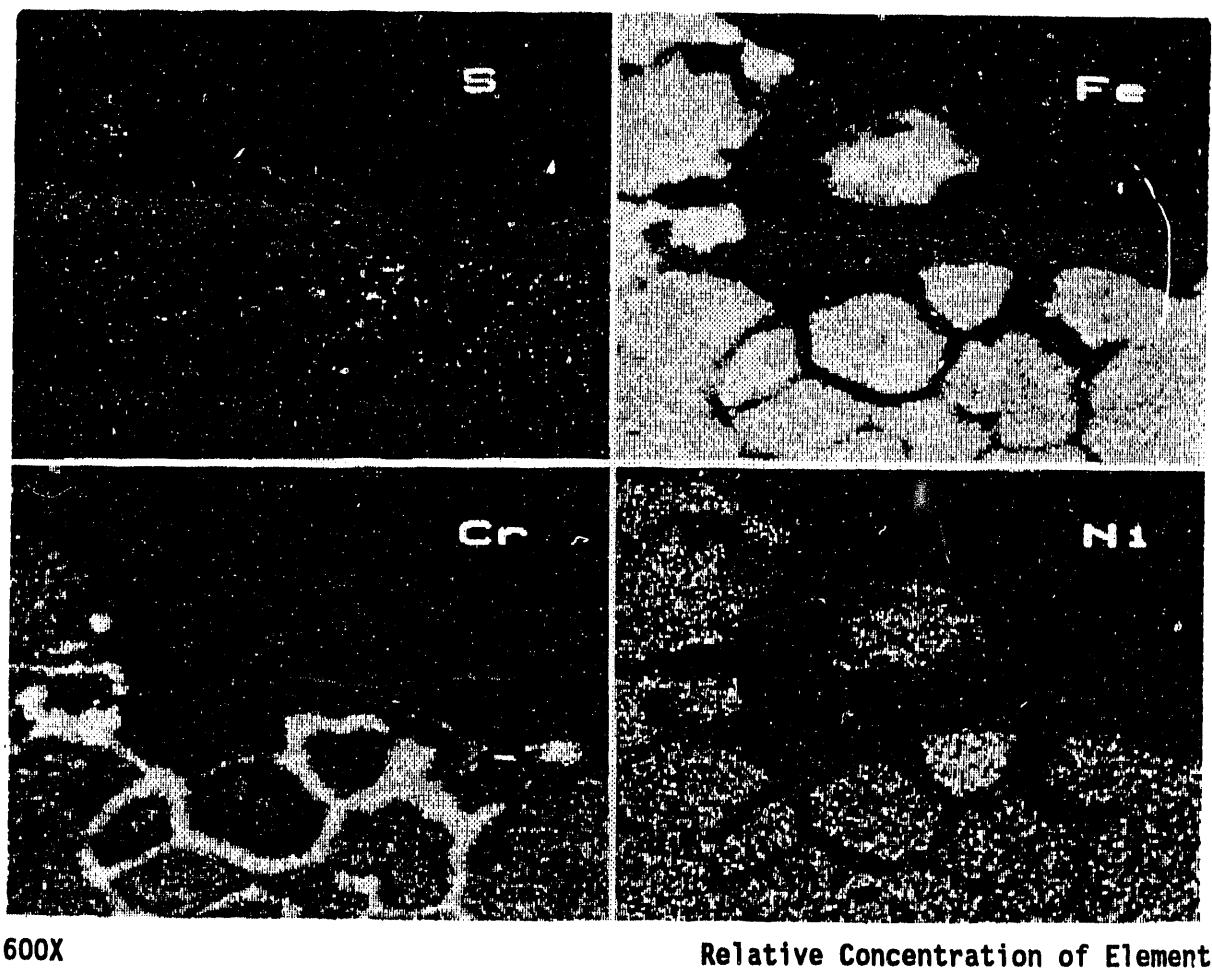
Figure 4.30 X-Ray Map of Corroded Surface of RA85H Specimen Coated With Ash Containing 10 wt% Alkali Sulfates After Exposure for 200 Hours at 700°C to Flue Gas Containing 1.0 vol% SO_2

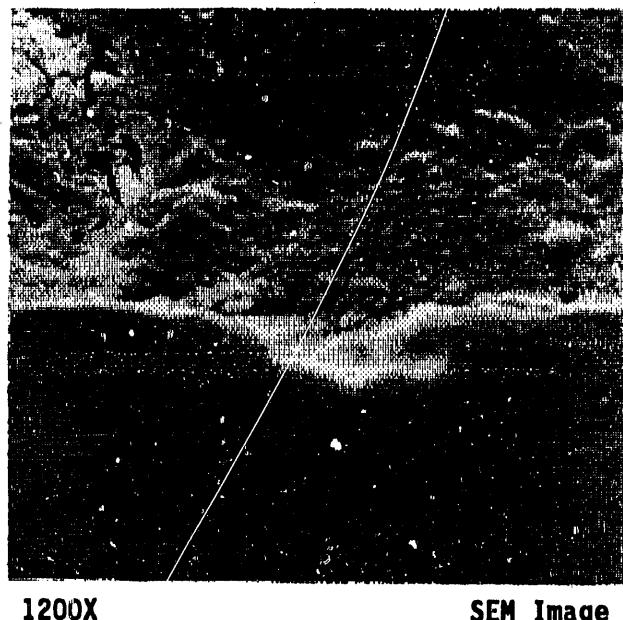
Figure 4.32 Corroded Surface of CR35A Specimen Coated With Ash Containing 10 wt% Alkali Sulfates After Exposure for 200 Hours at 700°C to Flue Gas Containing 1.0 vol% SO_2 . (Note beginning of pit in middle of photograph.)

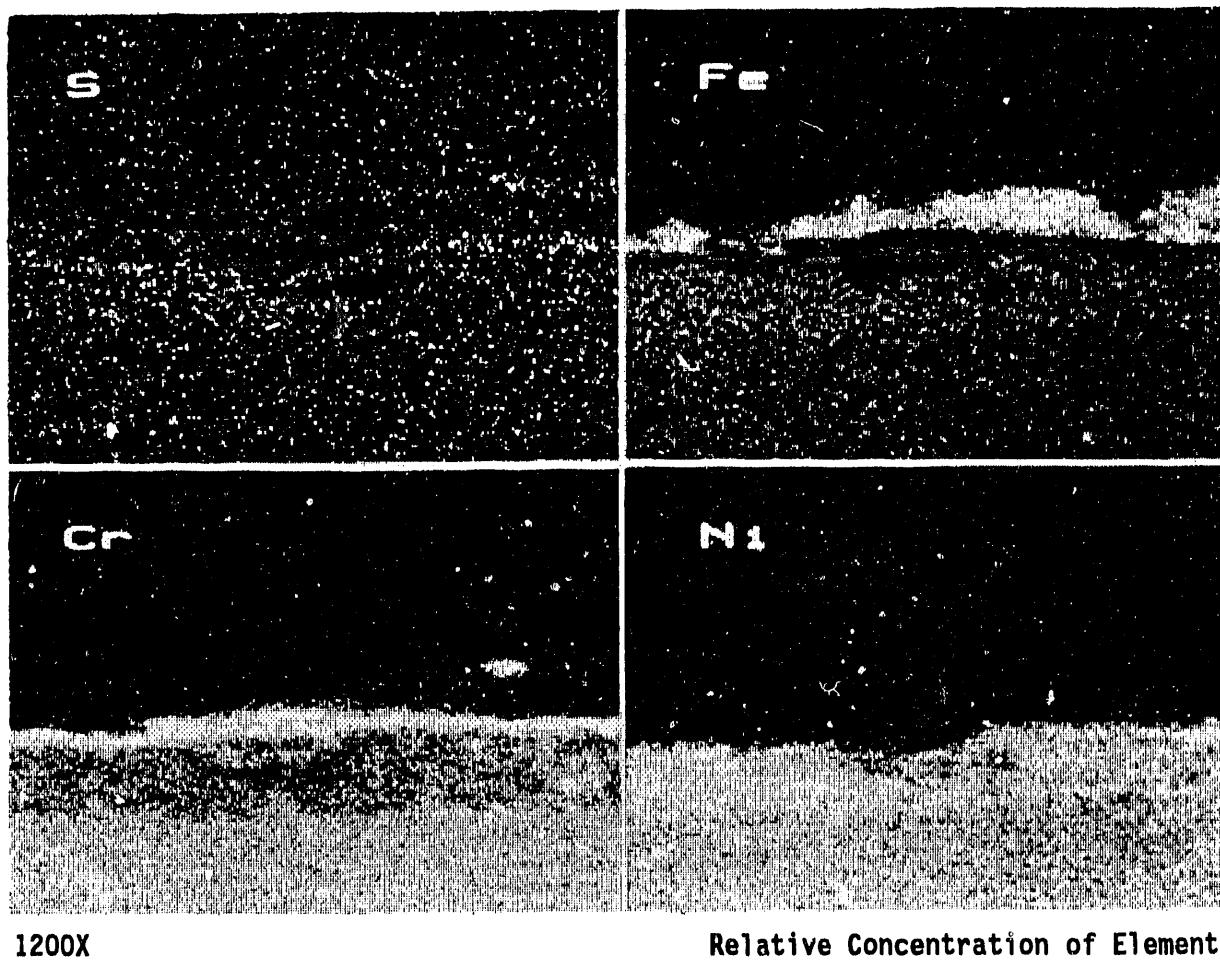
Figure 4.33 X-Ray Map of Corroded Surface of CR35A Specimen Coated With Ash Containing 10 wt% Alkali Sulfates After Exposure for 200 Hours at 700°C to Flue Gas Containing 1.0 vol% SO₂

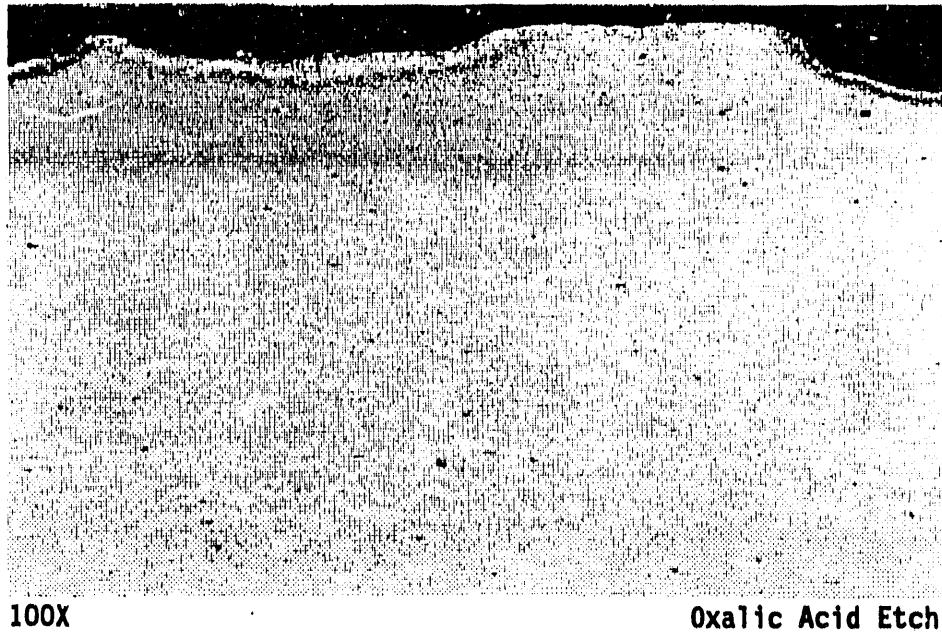
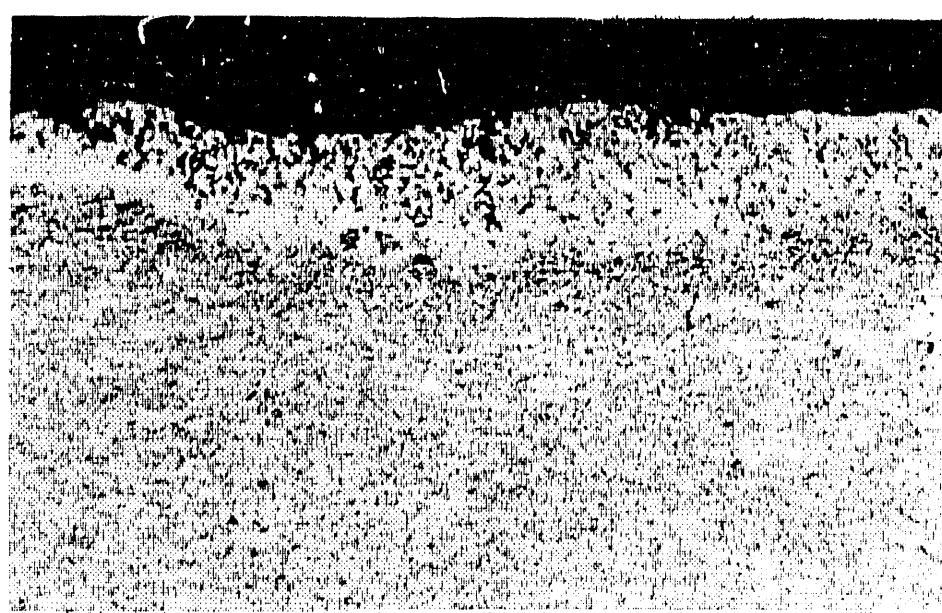
Figure 4.34 Corroded Surface of 690 Specimen Coated With Ash Containing 10 wt% Alkali Sulfates After Exposure for 800 Hours at 700°C to Flue Gas Containing 1.0 vol% SO_2 . (Note chromium depletion and oxidation/sulfidation on specimen surface.)

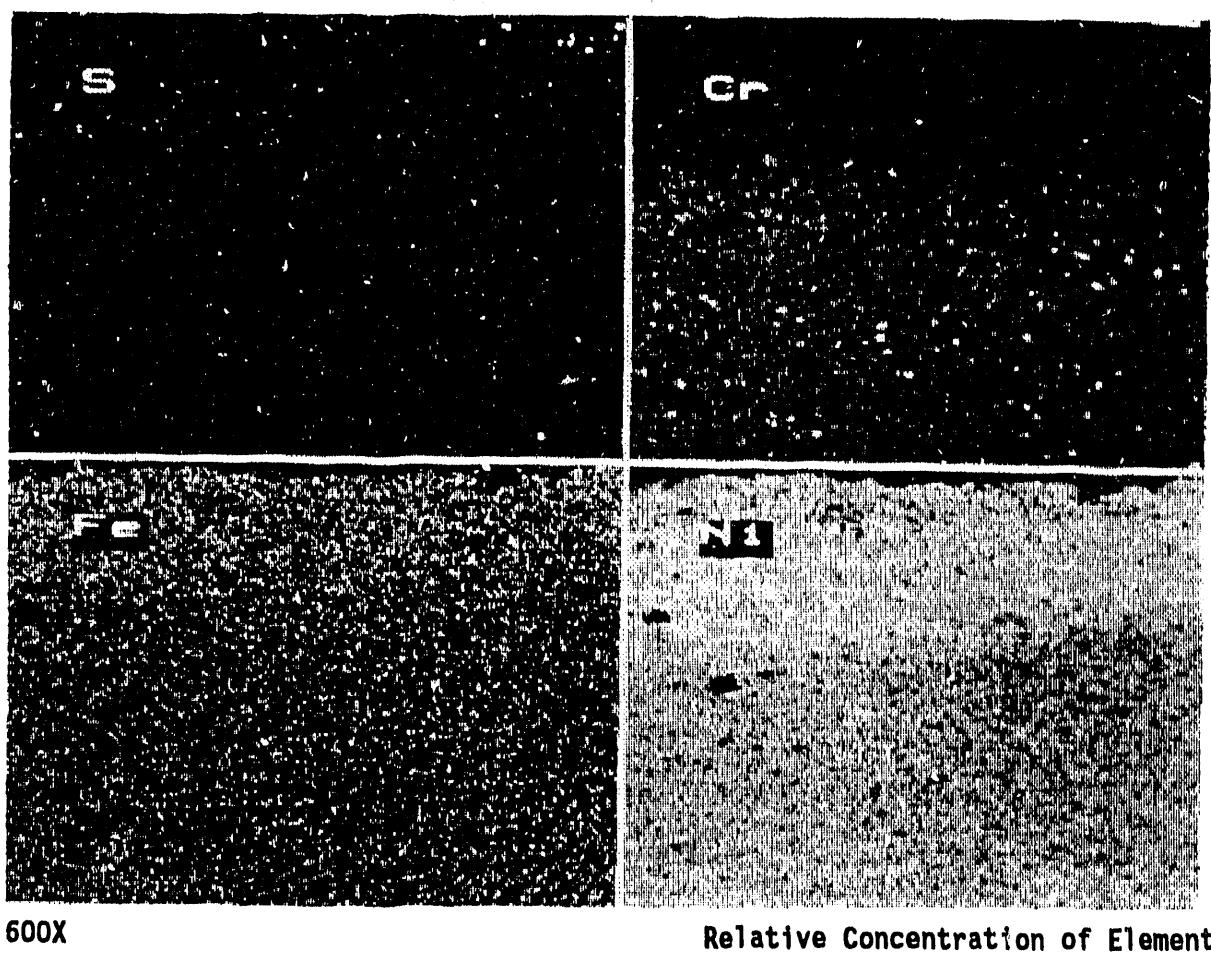
Figure 4.36 X-Ray Map of Corroded Surface of 690 Specimen Coated With Ash Containing 10 wt% Alkali Sulfates After Exposure for 200 Hours at 700°C to Flue Gas Containing 1.0 vol% SO_2

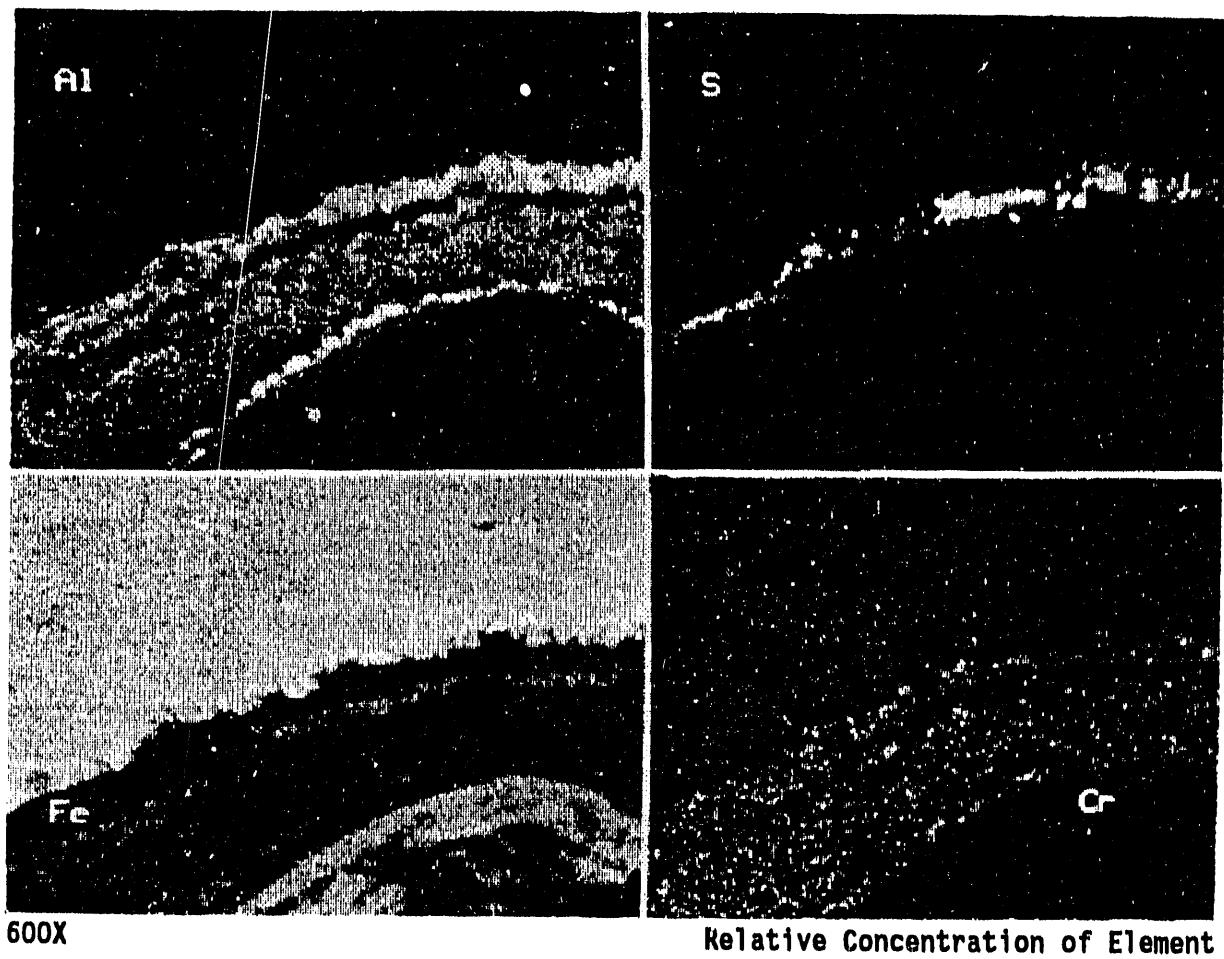
Figure 4.38 X-Ray Map of Corroded Surface of Iron Aluminide Specimen Containing 2% Chromium Coated With An Ash Containing 10 wt% Alkali Sulfates After Exposure for 200 Hours at 700°C to Flue Gas Containing 1.0 vol% SO₂
