INEL-96/0439

## **Innovative Subsurface Stabilization Project—Final Report**

**Idaho National Engineering Laboratory  
Environmental Restoration Technologies Department  
Lockheed Martin Idaho Technologies Company  
Idaho Falls, Idaho 83415**

**Prepared for the  
U.S. Department of Energy  
Assistant Secretary for Environmental Management  
Under DOE Idaho Operations Office  
Contract DE-AC07-94ID13223**

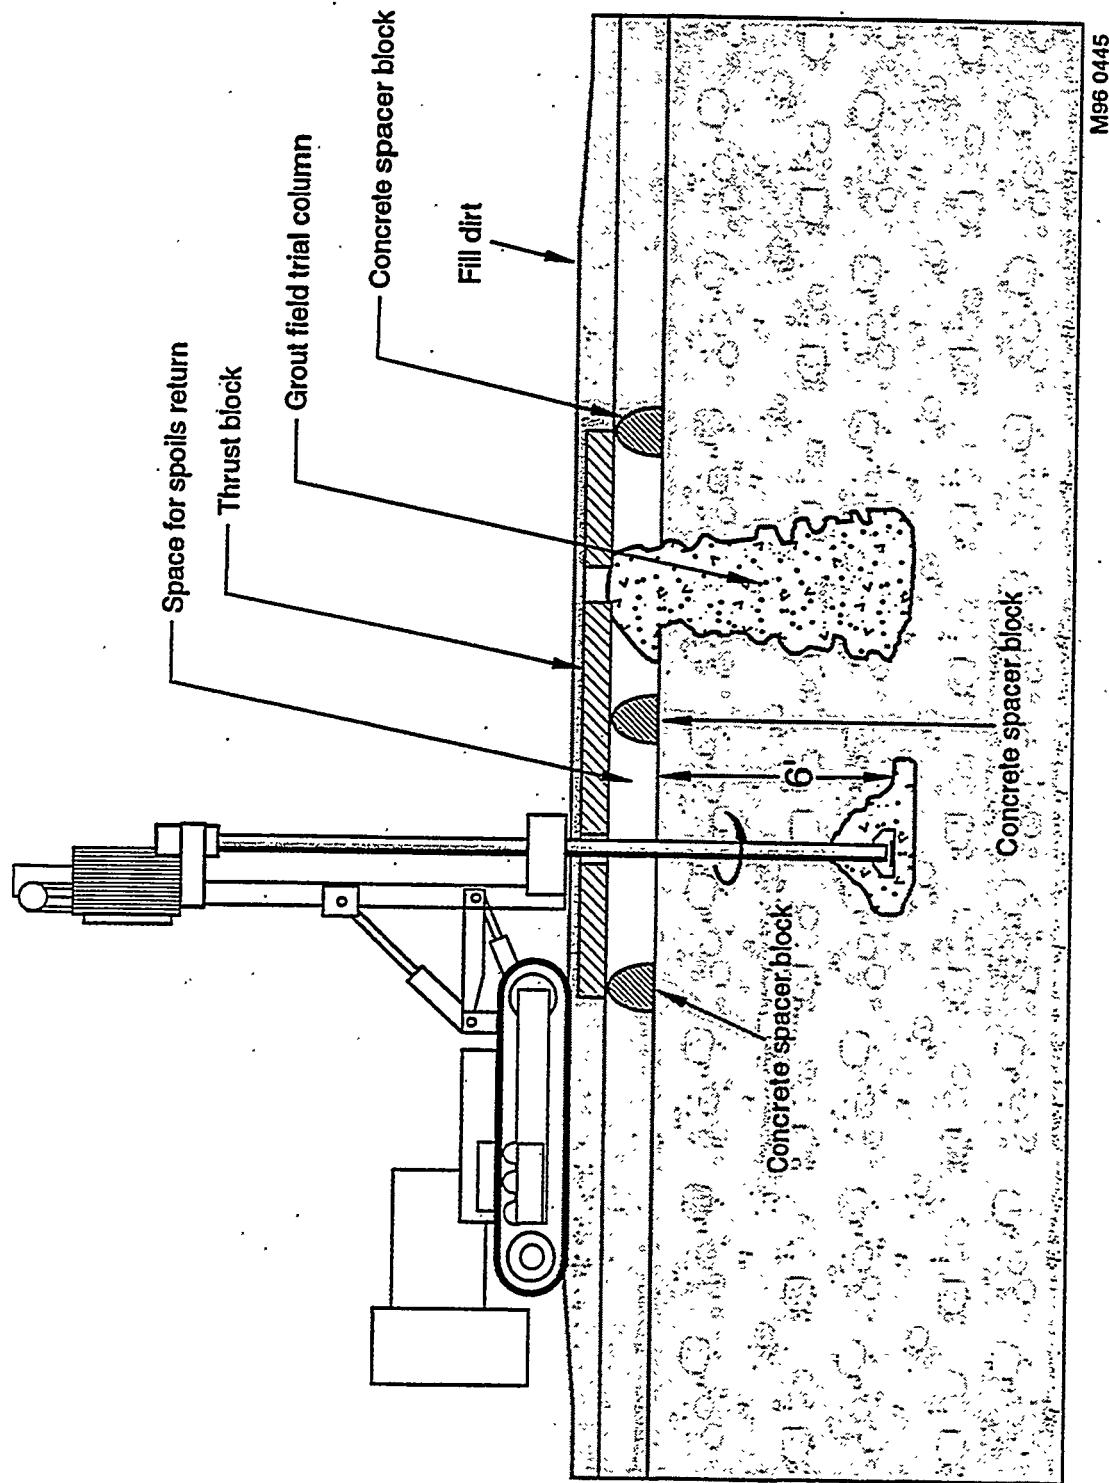
**Figure 19.** Schematic of field-trial grouting, showing thrust block with spacer blocks (Graphic M96 0445).

An INEL-designed thrust block was used to perform the field trials. The thrust block consisted of an 8-in.-thick reinforced concrete block placed on 8-in. concrete blocks to allow near-surface jet grouting and containment of the spoils returns. The thrust block was found to adequately perform the function of containing the returns with near-surface grouting. Two holes 5 in. in diameter penetrate the block as shown in Figure 30, which shows the 4-9/16-in. drill stem

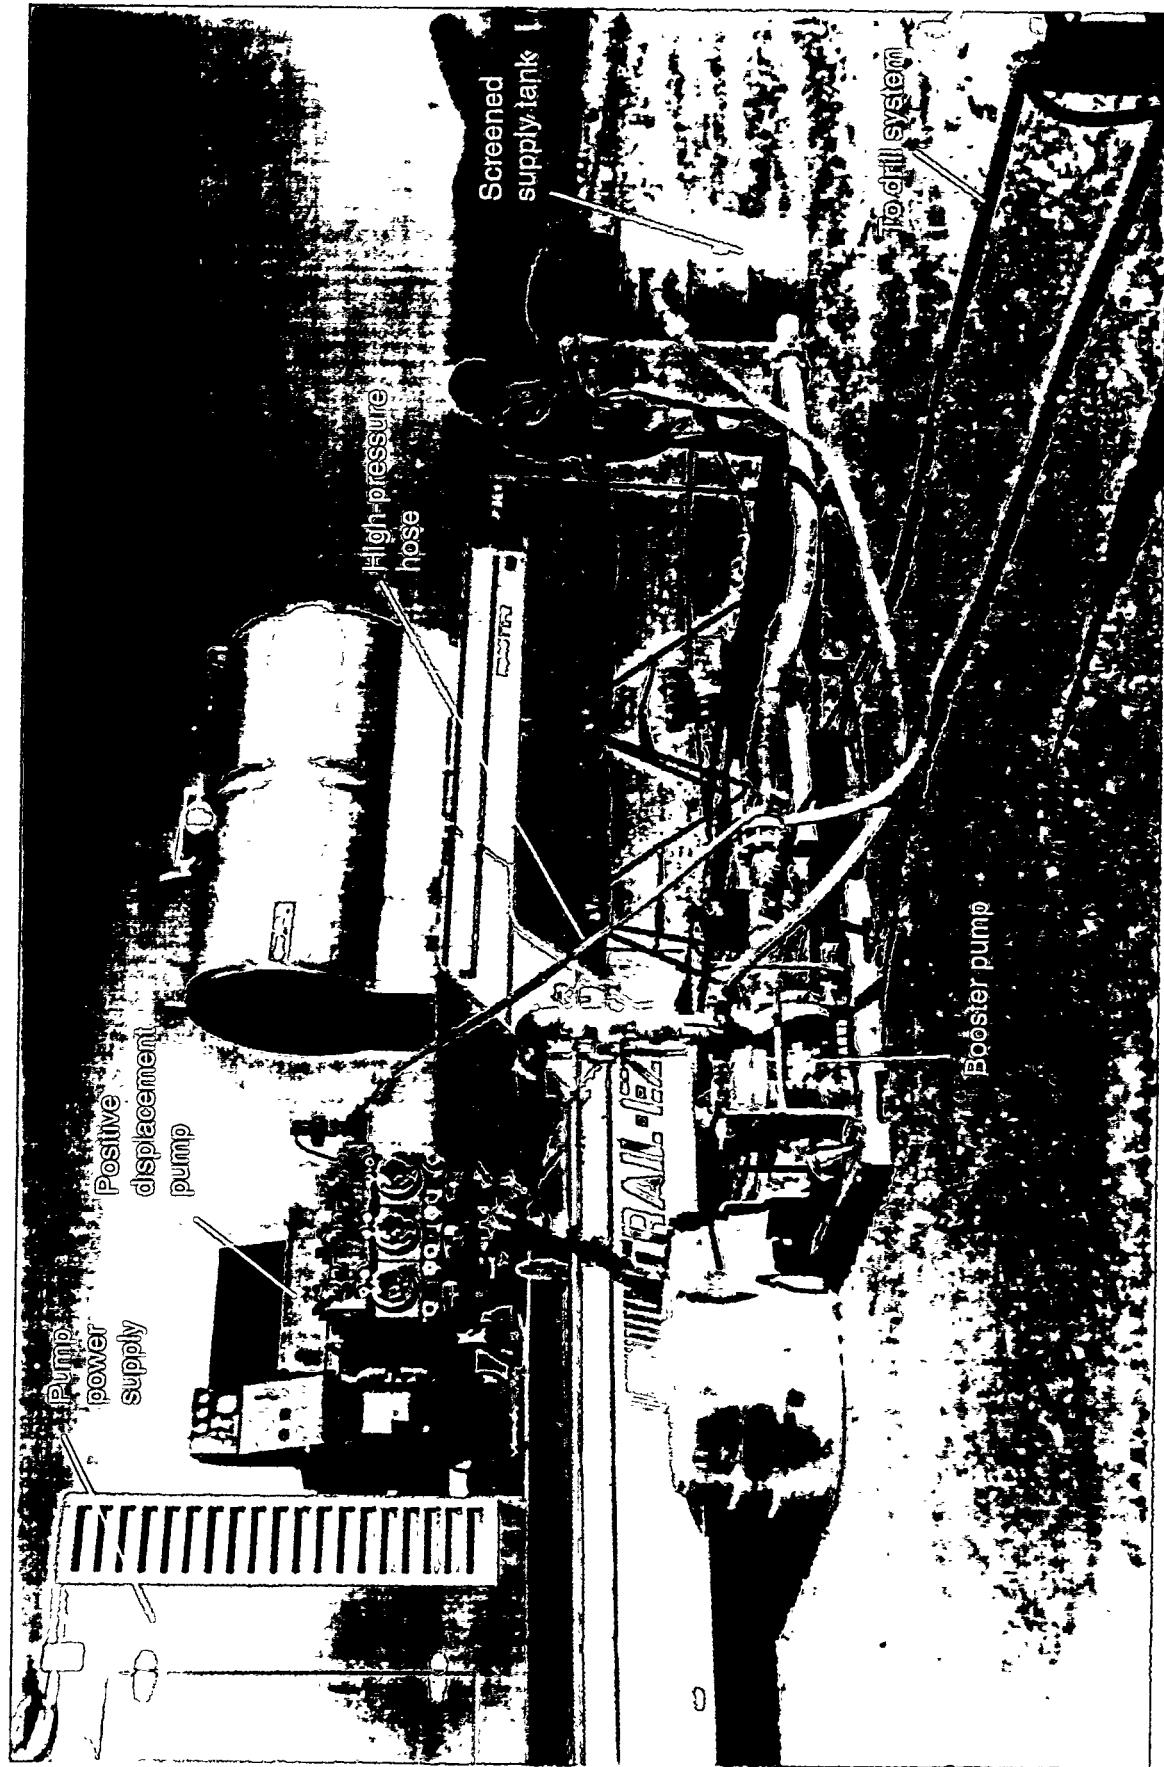
Figure 24. CASA GRANDE Jet 5 pump (Graphic M95 0469).

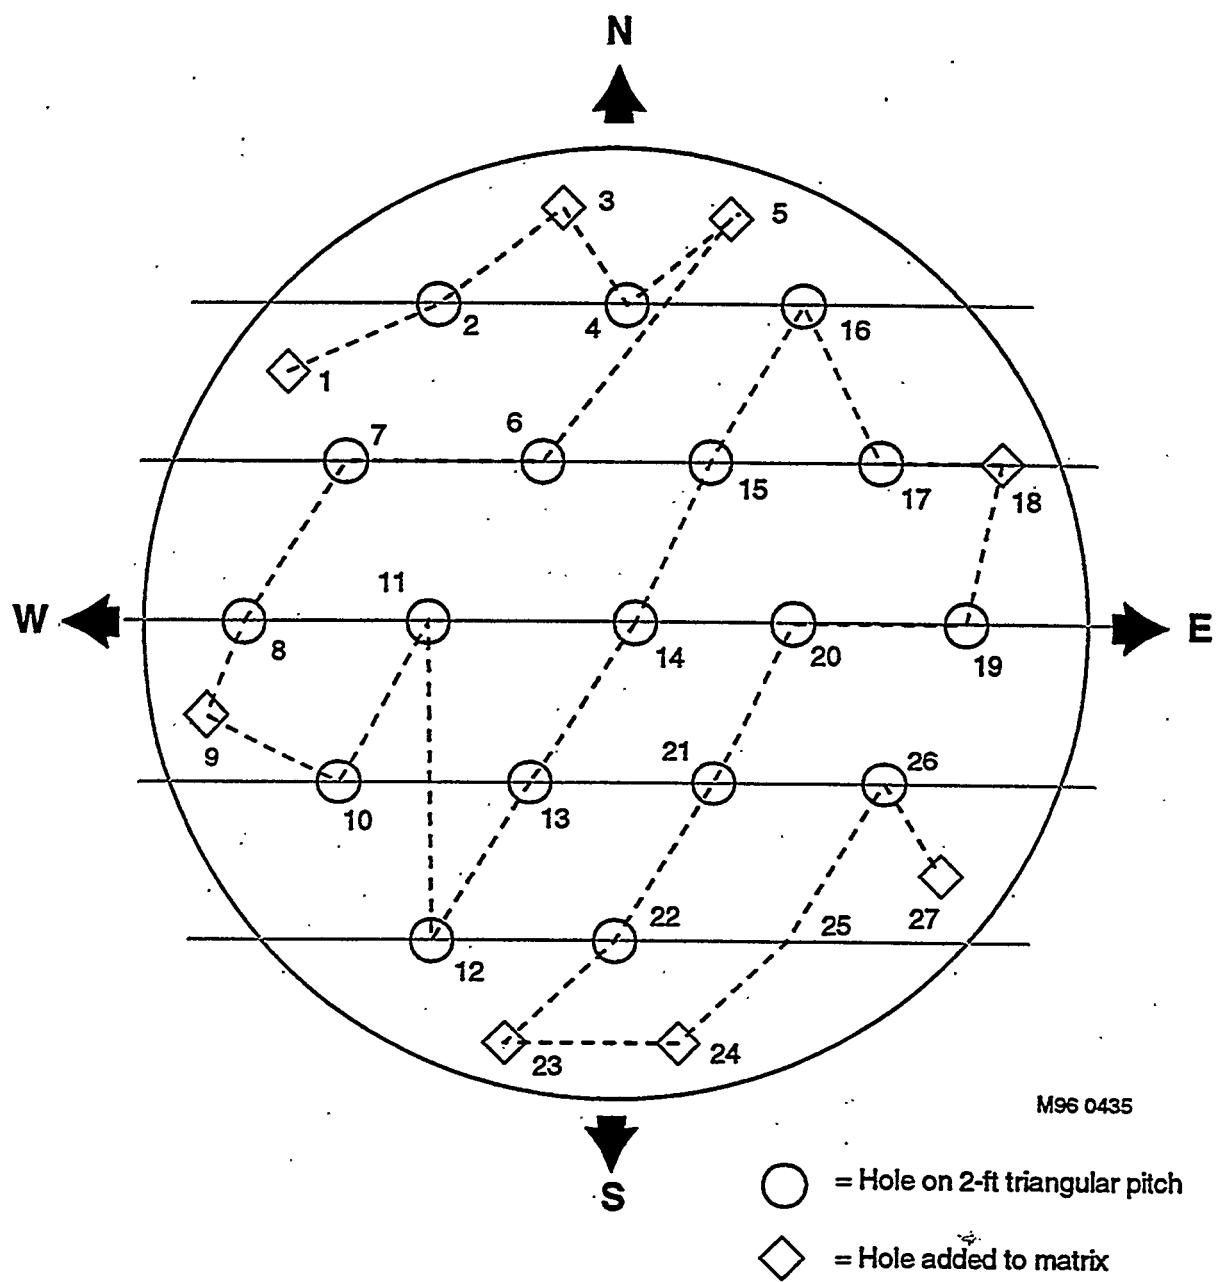
**Figure 28.** Orientation of grout holes for grouted field-scale permeameter (order of grouting) (Graphic M96 0435).

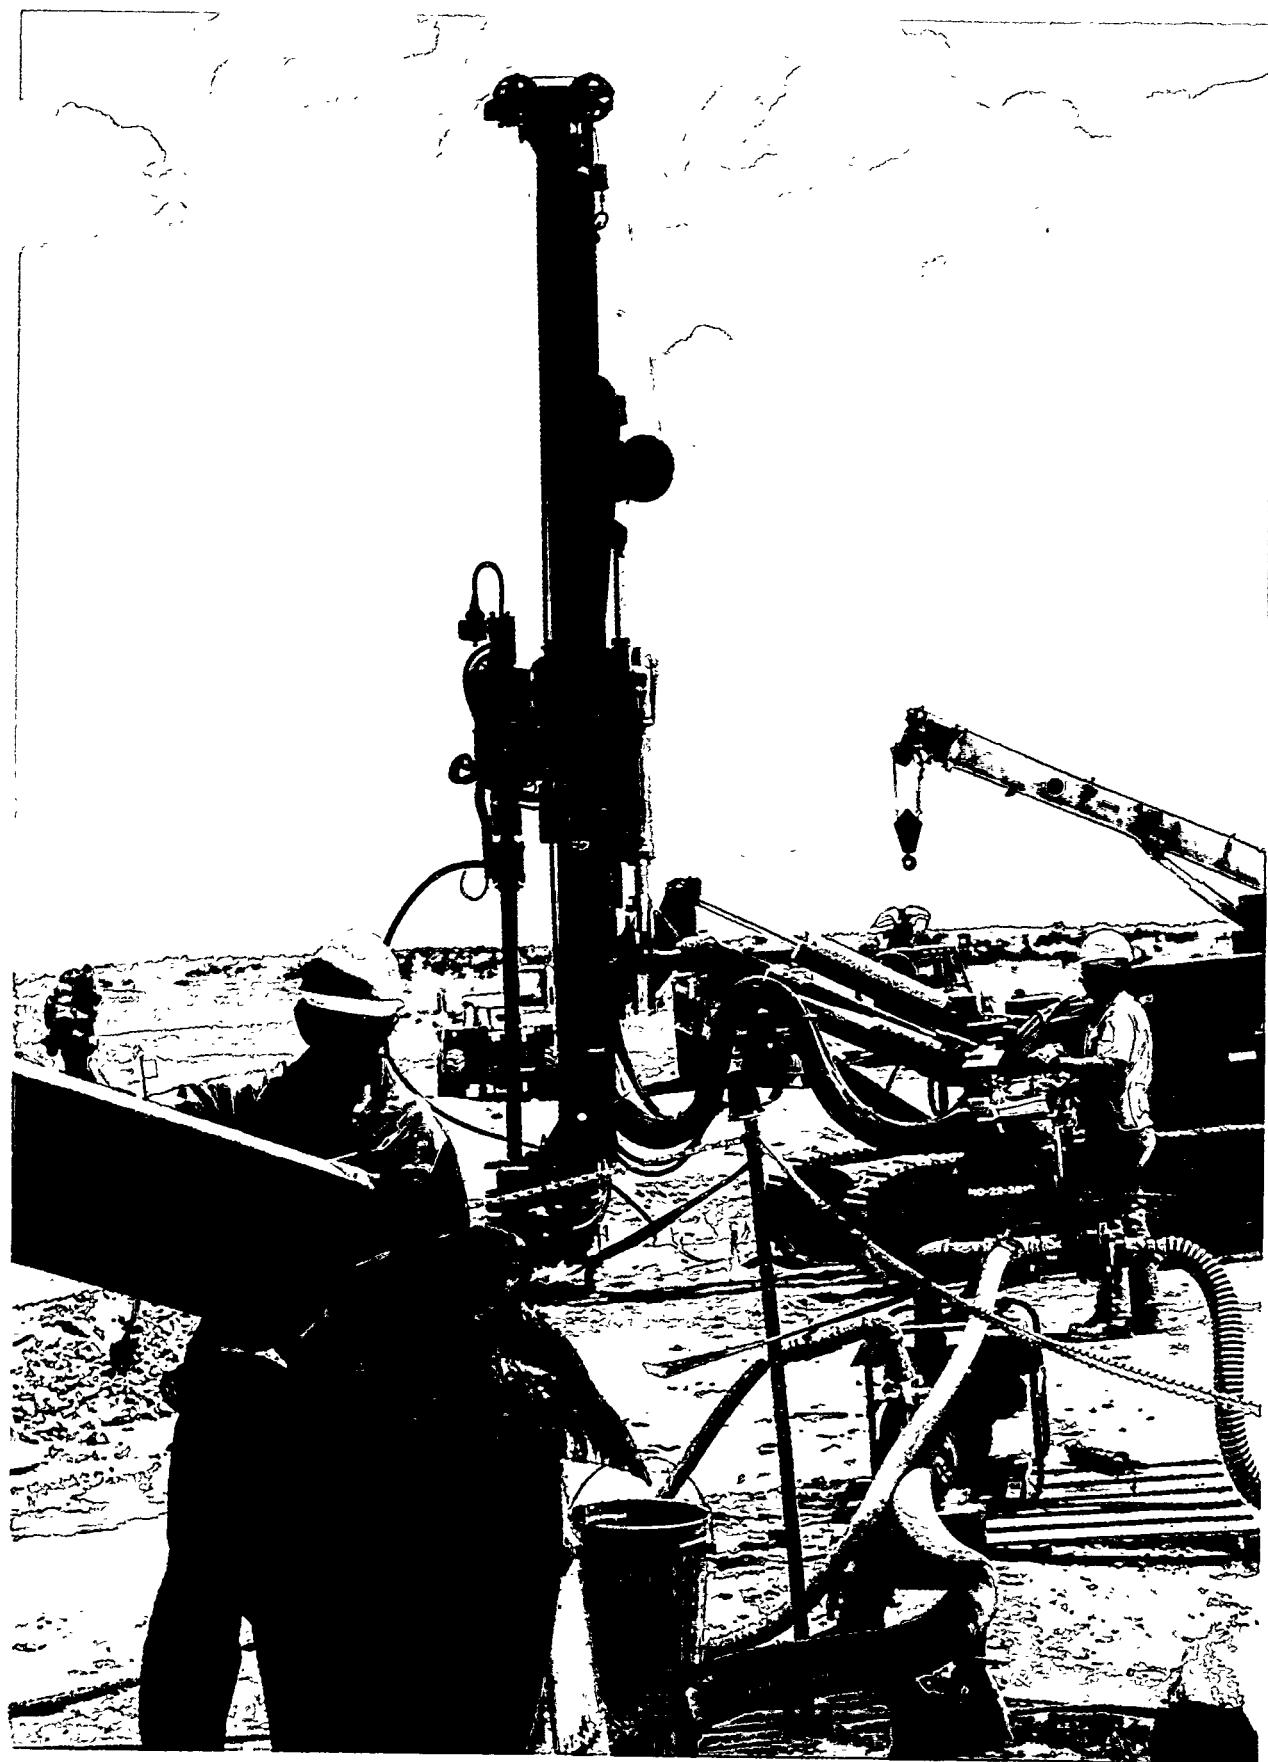
Figure 32. Grouting operation for TECT Pit A (Photo 96-512-1-2).

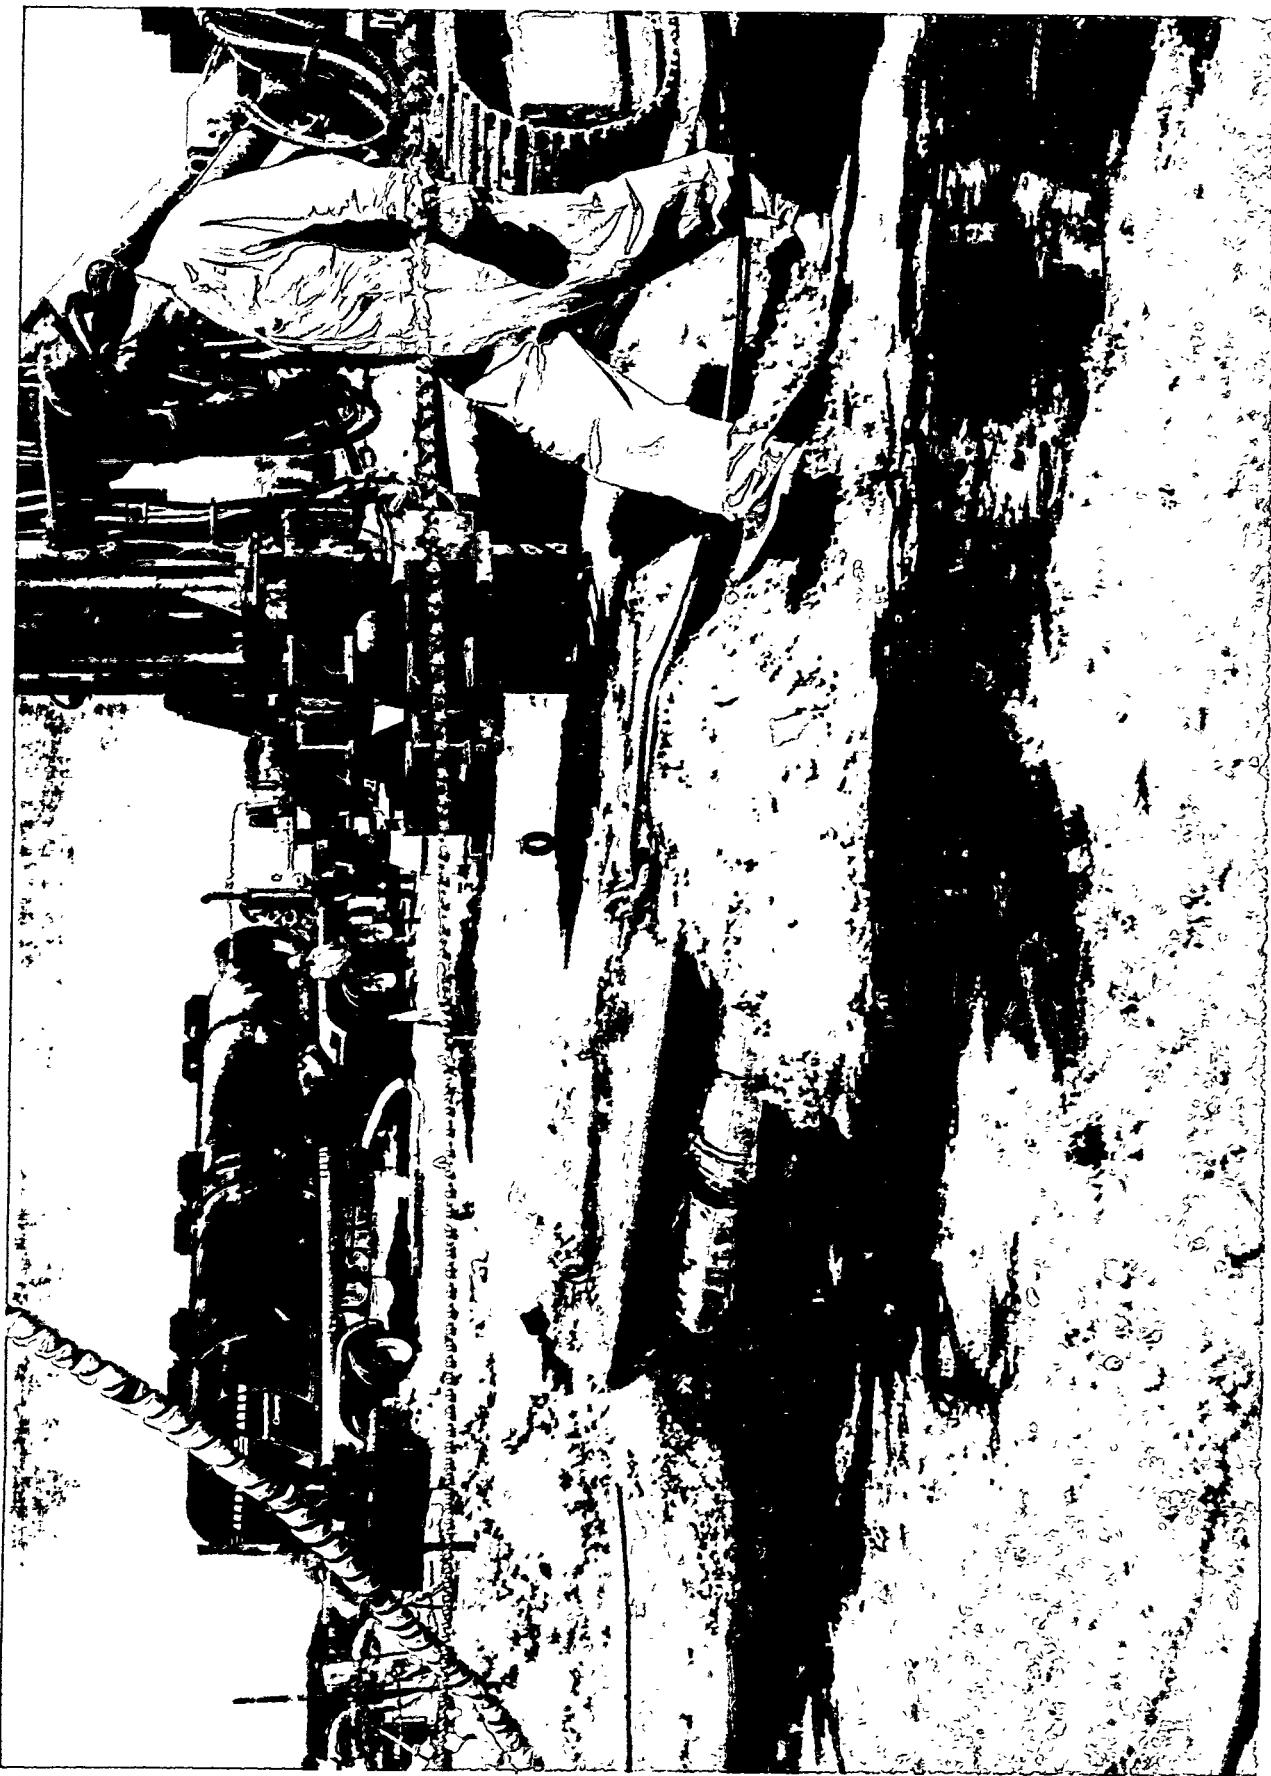
**Figure 39.** Paraffin grout emanating from an uncovered crack in the thrust block during the paraffin field trials (Photo 96-517-2-18).

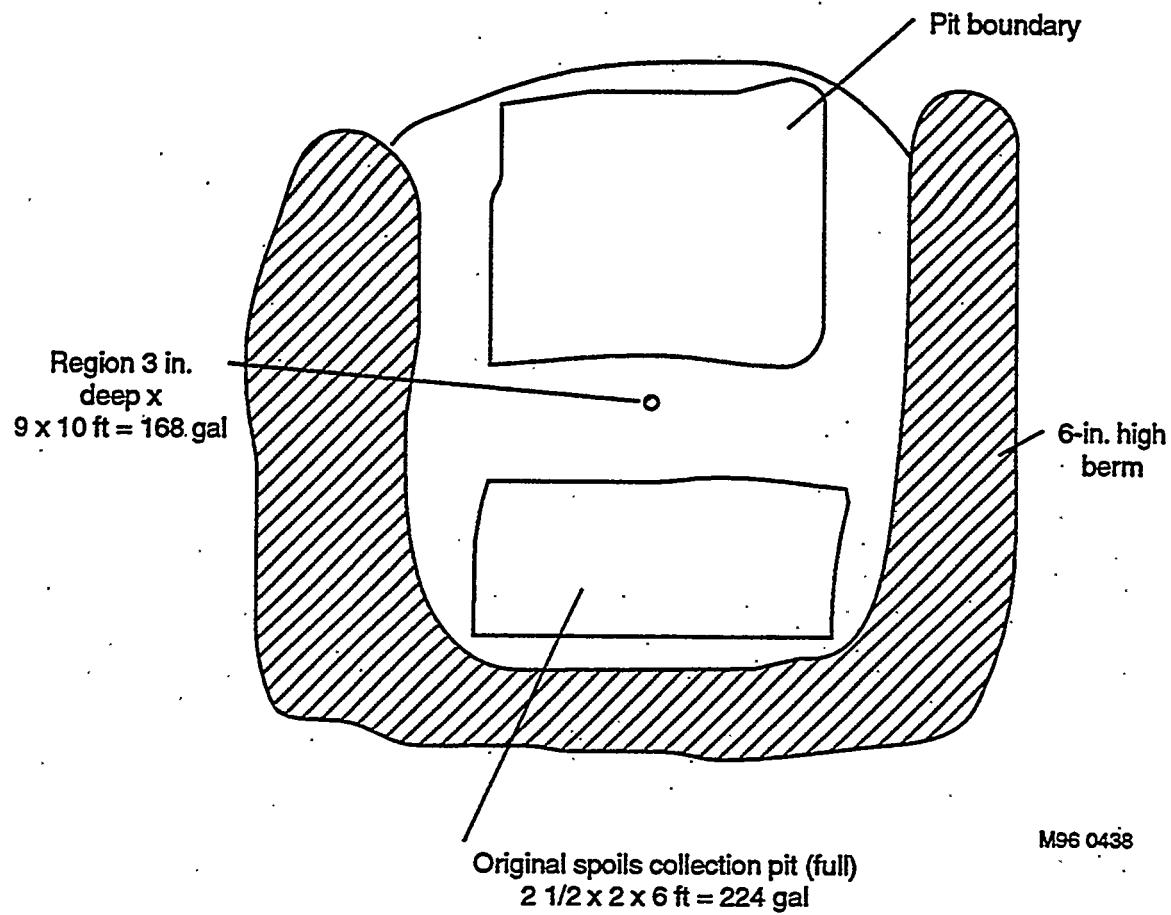
Total spoils returns for paraffin pit =  $224 + 168 = 392 \text{ gal}$

**Figure 40.** Spoils collection pit for paraffin (Graphic M96 0438).

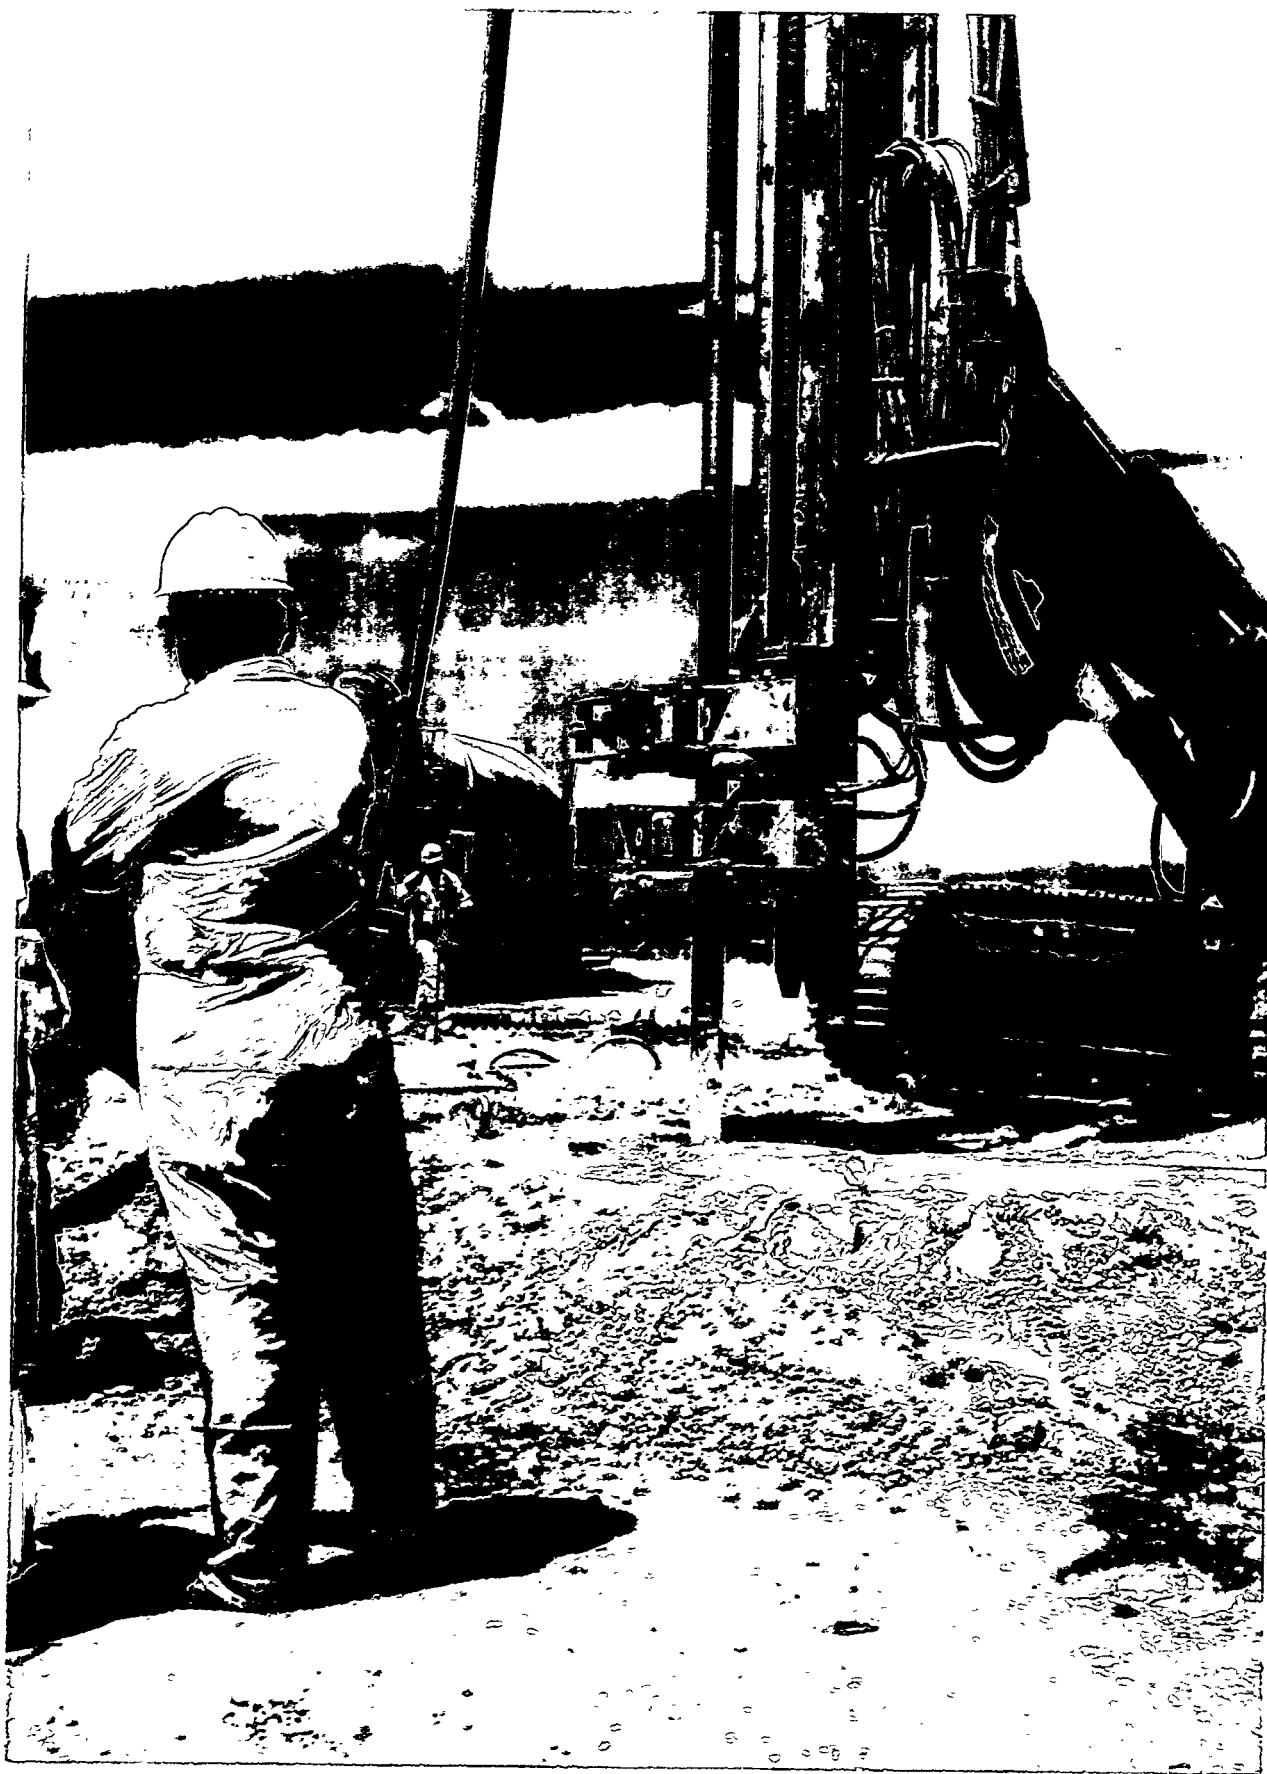
**Figure 48.** Line slurry flow completely plugged (Photo 96-529-2-1).

Basically, all of these attempts failed to allow a reasonable flow of the B side slurry, and the test was stopped. The problem was that the slaked lime slurry mixture too readily plated out or filter caked on surfaces. A good example of this is the solid residue on the coarse filter screen on the B pump intake shown in Figure 49. It was concluded that the slurry mix required adjustment and that a new nozzle design for two-phase injection was needed. It is not clear at this time whether the lime slurry mix used for this test would filter cake any injection system and nozzle design. It is speculated that there was a potential for injecting the B part lime slurry through the A side of the nozzle (or simply use the CASA GRANDE system in the single-phase orientation) into the waste, followed by total cleanout and immediate injection of the A side or ferrous sulfate solution into the just-grouted pit. This technique would double the amount of drilling and grouting time, and there is no guarantee that the nozzle would not plug in situ because of premature curing of the mixture. It was deemed impossible to mix the A and B component prior to grouting because of the lack of control of the cure time resulting in a "frozen" system. Other formulation of A and B or a combination with slower cure times may be possible.

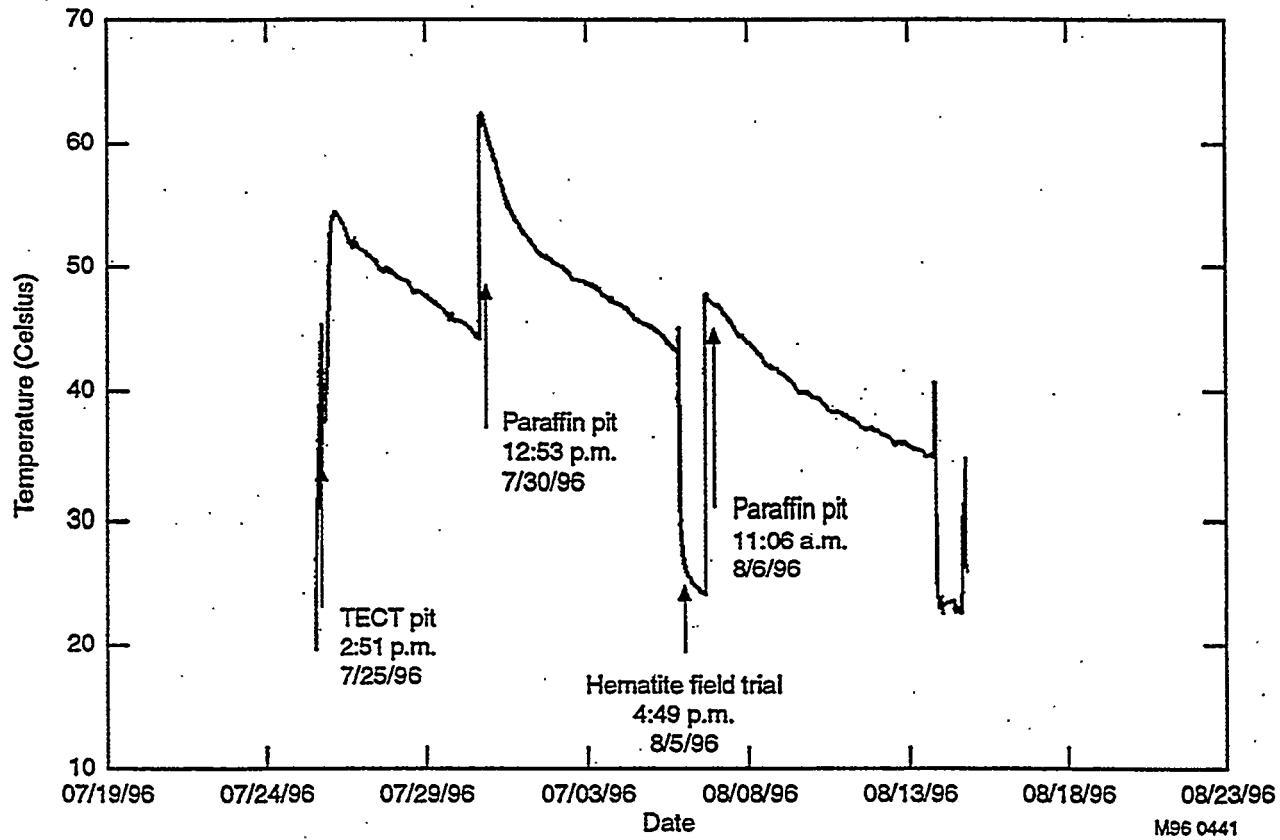
**Figure 52.** Temperature/time history of TECT/paraffin pit (Graphic M96 0441).

Figure 52 gives a temperature/time history of the TECT and paraffin pit and additionally the field trial hole for the hematite grout. Figure 52 shows that the TECT pit had a peak cure temperature of 55°C (131°F) and had decayed to 45°C (113°F) in 5 days. This is consistent with the Portland Type-1 cement data obtained in reference 1. The paraffin material does not cure. However, it solidifies as the soil/paraffin matrix cools. The peak recorded temperature was 64°C immediately upon insertion of the thermocouple, and cooling in the relative center of the pit at the bottom was 42°C (107°F) after 5 days and 36°C (97°F) after 14 days. This compares with the theoretical melting point of 49°C (120°F). There was minor evidence of curing in the hematite field trial hole, as the temperature (25°C [77°F]) elevated only a few degrees above the ambient temperature of 15°C (59°F).

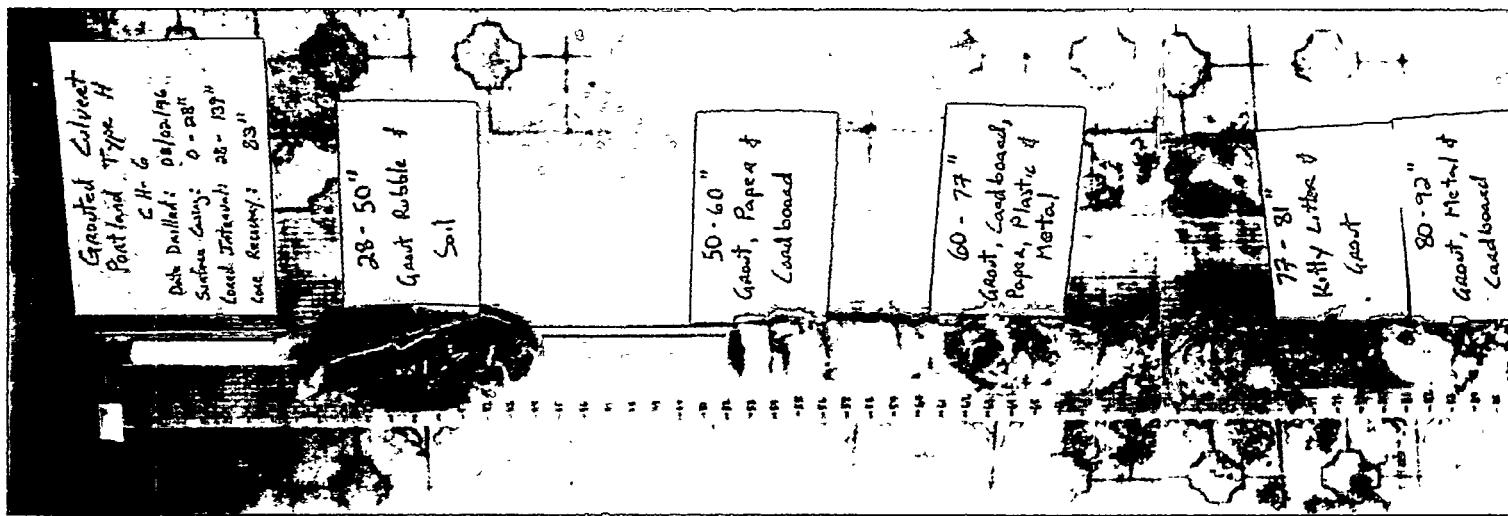
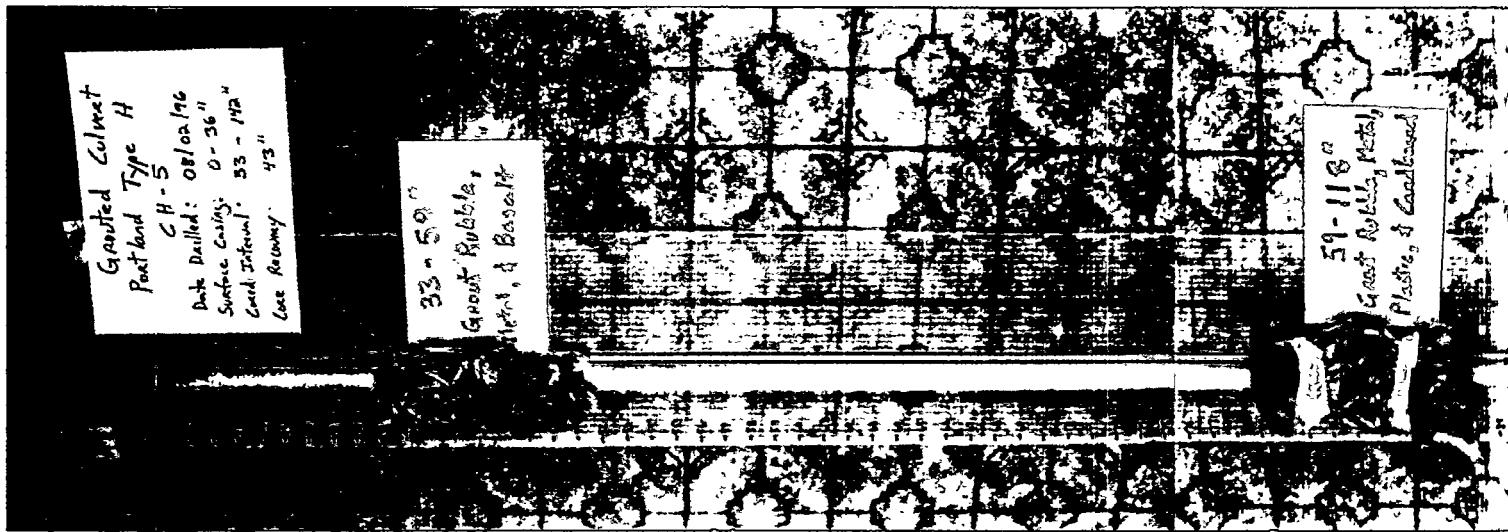
Figure 55. Core holes 5 and 6, grouted field-scale permeameter (Graphics M96 0458 and M96 0459).

Overall, the only explanation from the grouting data that accounts for the generally poor recovery of cores in the field-scale permeameter is this: In those regions where a drill stem refusal occurred (due to large metal objects in the pit), positions below the refusal do not receive as much grout. In addition, the coring process using water for cooling of the bit causes washout of the material—whether ungrouted soil or poorly cured grout—resulting in incomplete cores.

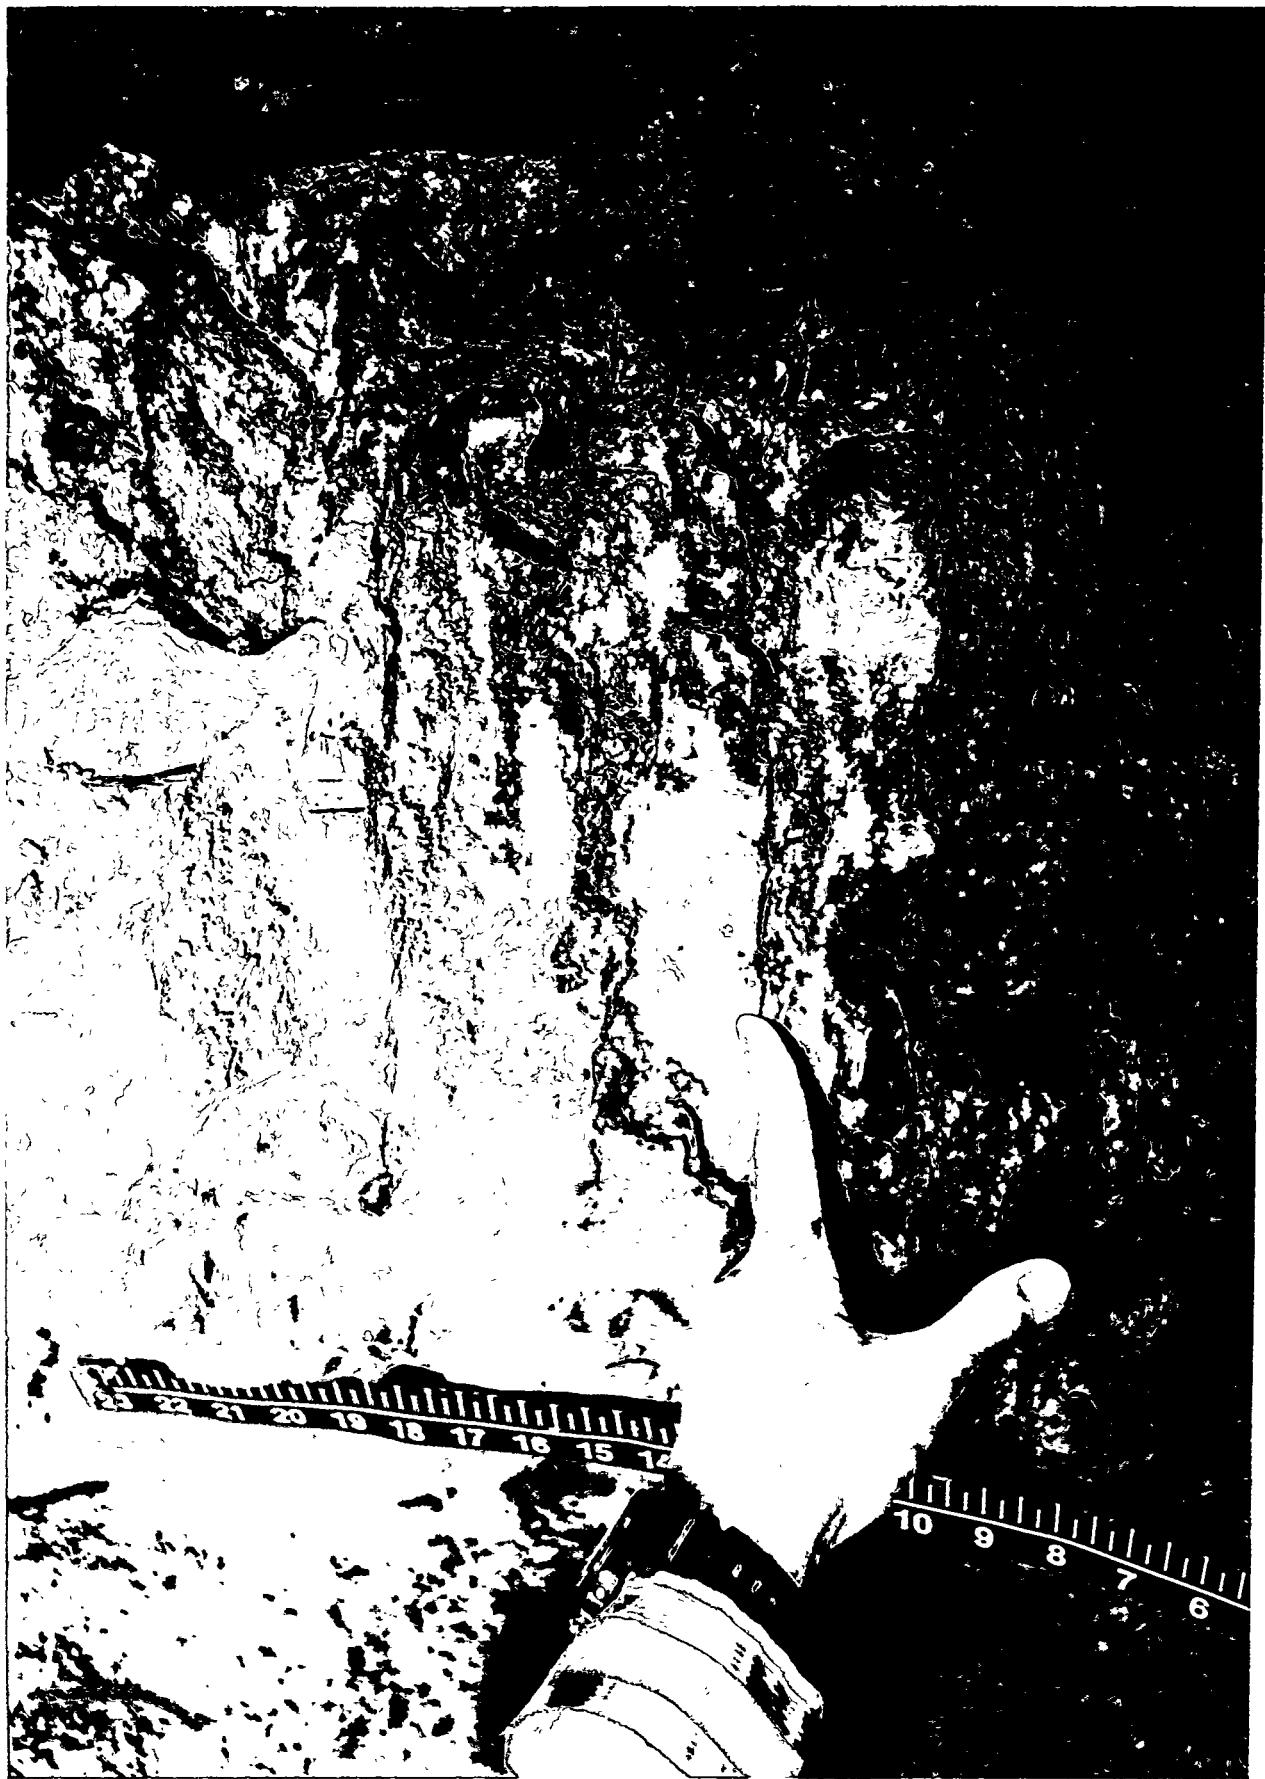
Figure 57. Drill stem hole 3 with blocked injector during field trials (Photo 94-715-2-1).

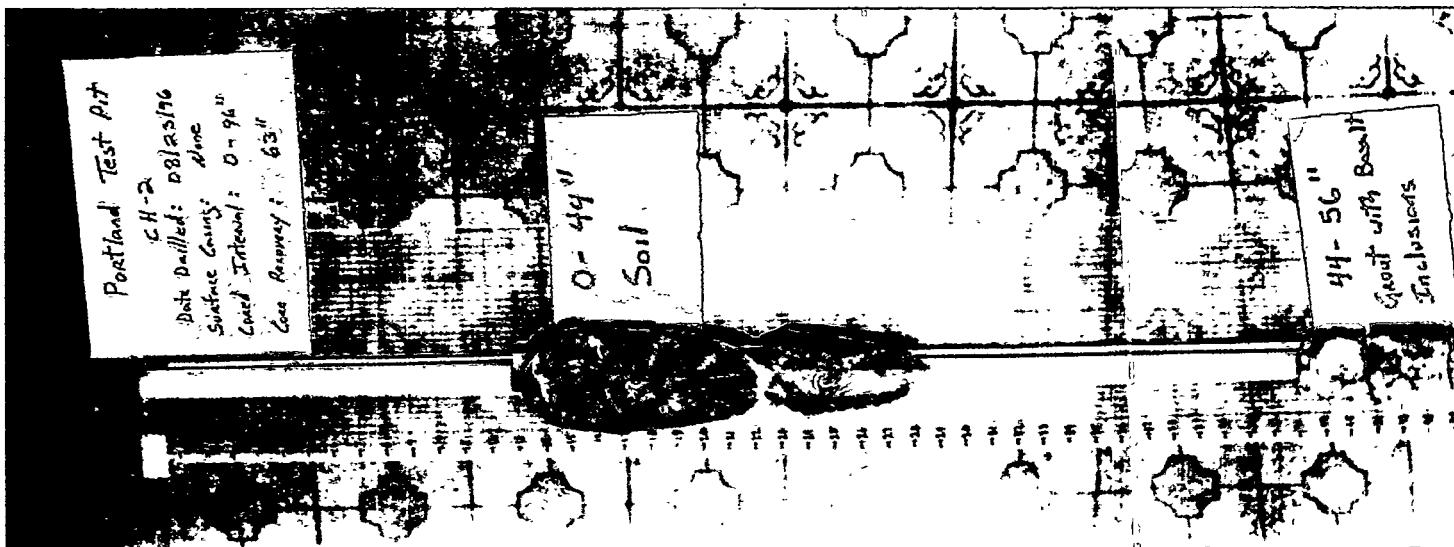
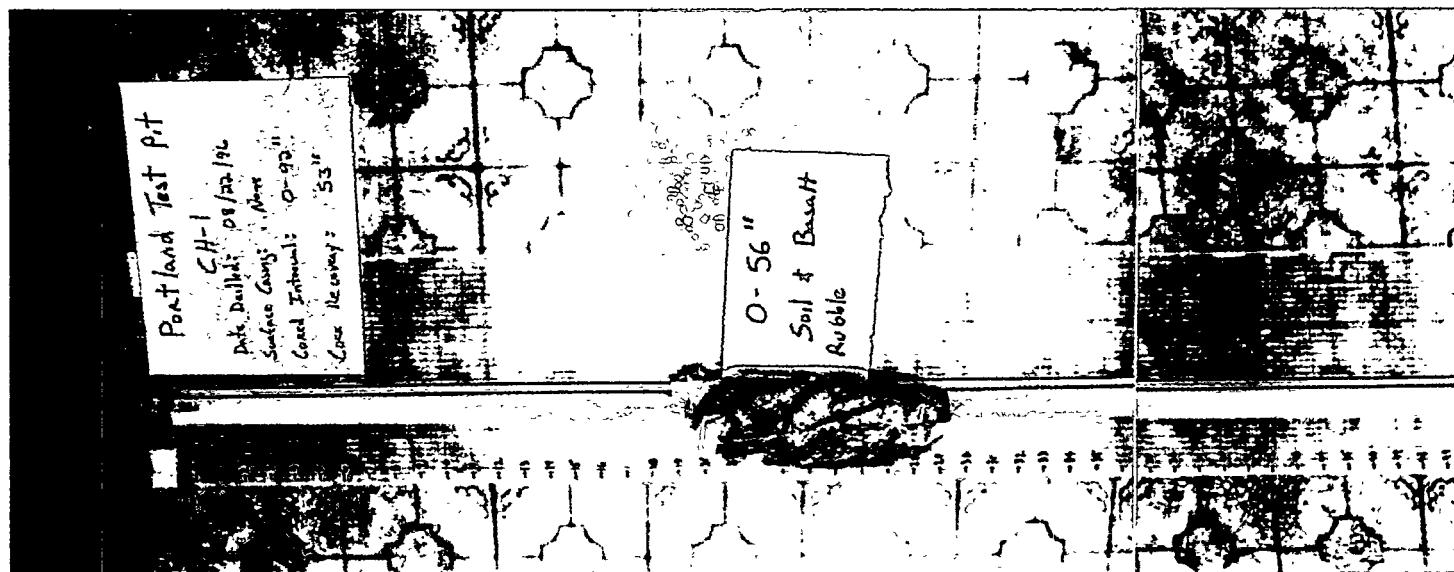
Figure 59. Core holes 1 and 2, Type-H pit (Graphics M96 0463 and M96 0462).

Since filter caking was common in the pump, nozzle, and lines during the Type-H grouting operations, it is possible that for both the field-scale permeameter and the Type-H pit that the nozzles alternated between plugged and unplugged conditions, resulting in many regions of ungrouted soil. These core data will be correlated with hydraulic conductivity testing using packer systems in a later section of this report. Also shown in Figure 59 (CH-1) is a region between 62 and 71 in. that is a solid cured mixture of kitty litter and Type-H cement, indicating that Type-H cement has the capability to incorporate and encapsulate organic sludges.
