INEL-96/0439

## **Innovative Subsurface Stabilization Project—Final Report**

**Idaho National Engineering Laboratory  
Environmental Restoration Technologies Department  
Lockheed Martin Idaho Technologies Company  
Idaho Falls, Idaho 83415**

**Prepared for the  
U.S. Department of Energy  
Assistant Secretary for Environmental Management  
Under DOE Idaho Operations Office  
Contract DE-AC07-94ID13223**

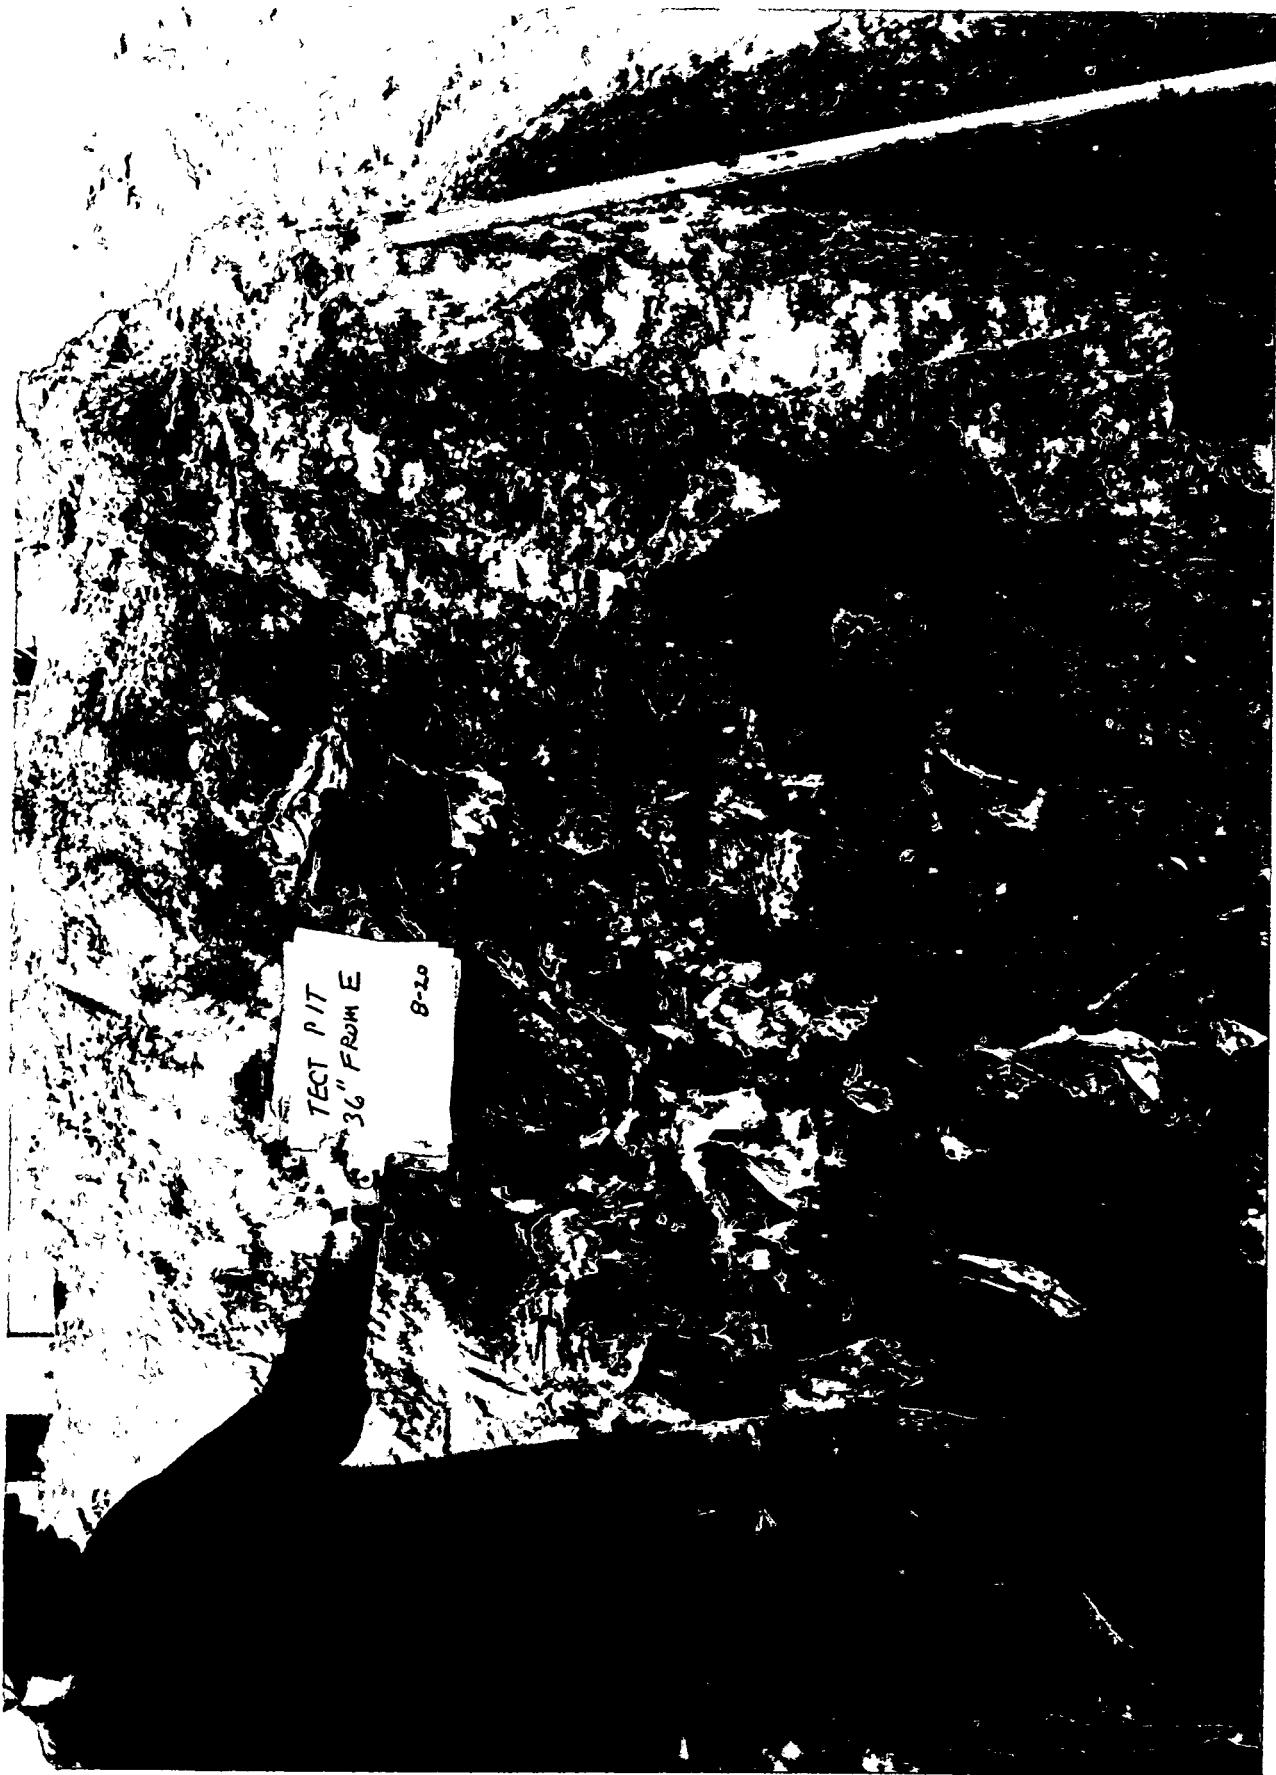
Figure 66. Overview of TECT pit at 36 in. from east face (Photo 96-587-9-22).

Figure 66 shows an overview showing that the drum containing office trash in Figure 62 was partially removed and the contents of the drum were still embedded in the face. This means that the TECT grout completely filled all interstitial positions in the drum and essentially glued the material together. However, when removing the material, the grout easily falls away from the

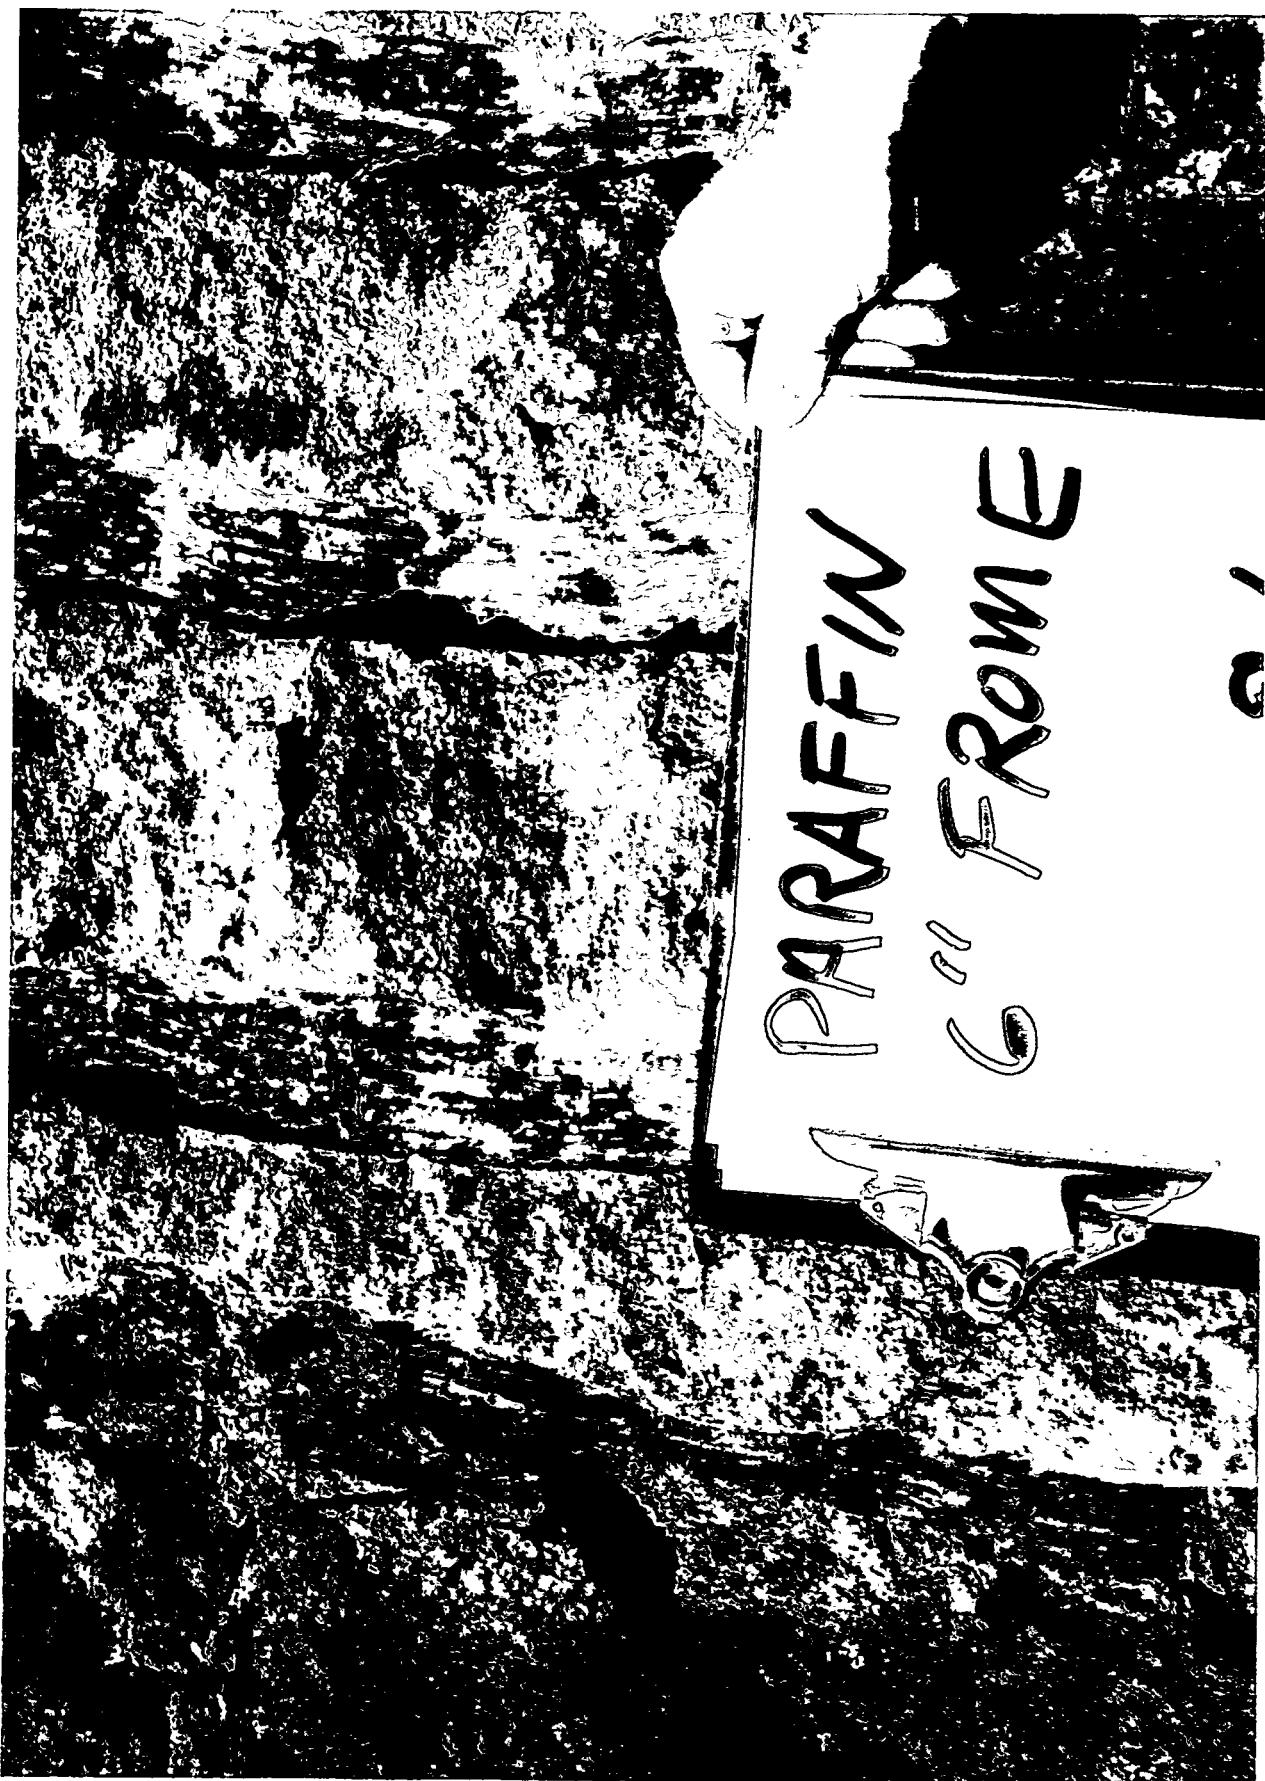
Figure 71. Paraffin pit detail at 6 in. from the east face (Photo 96-587-3-11).

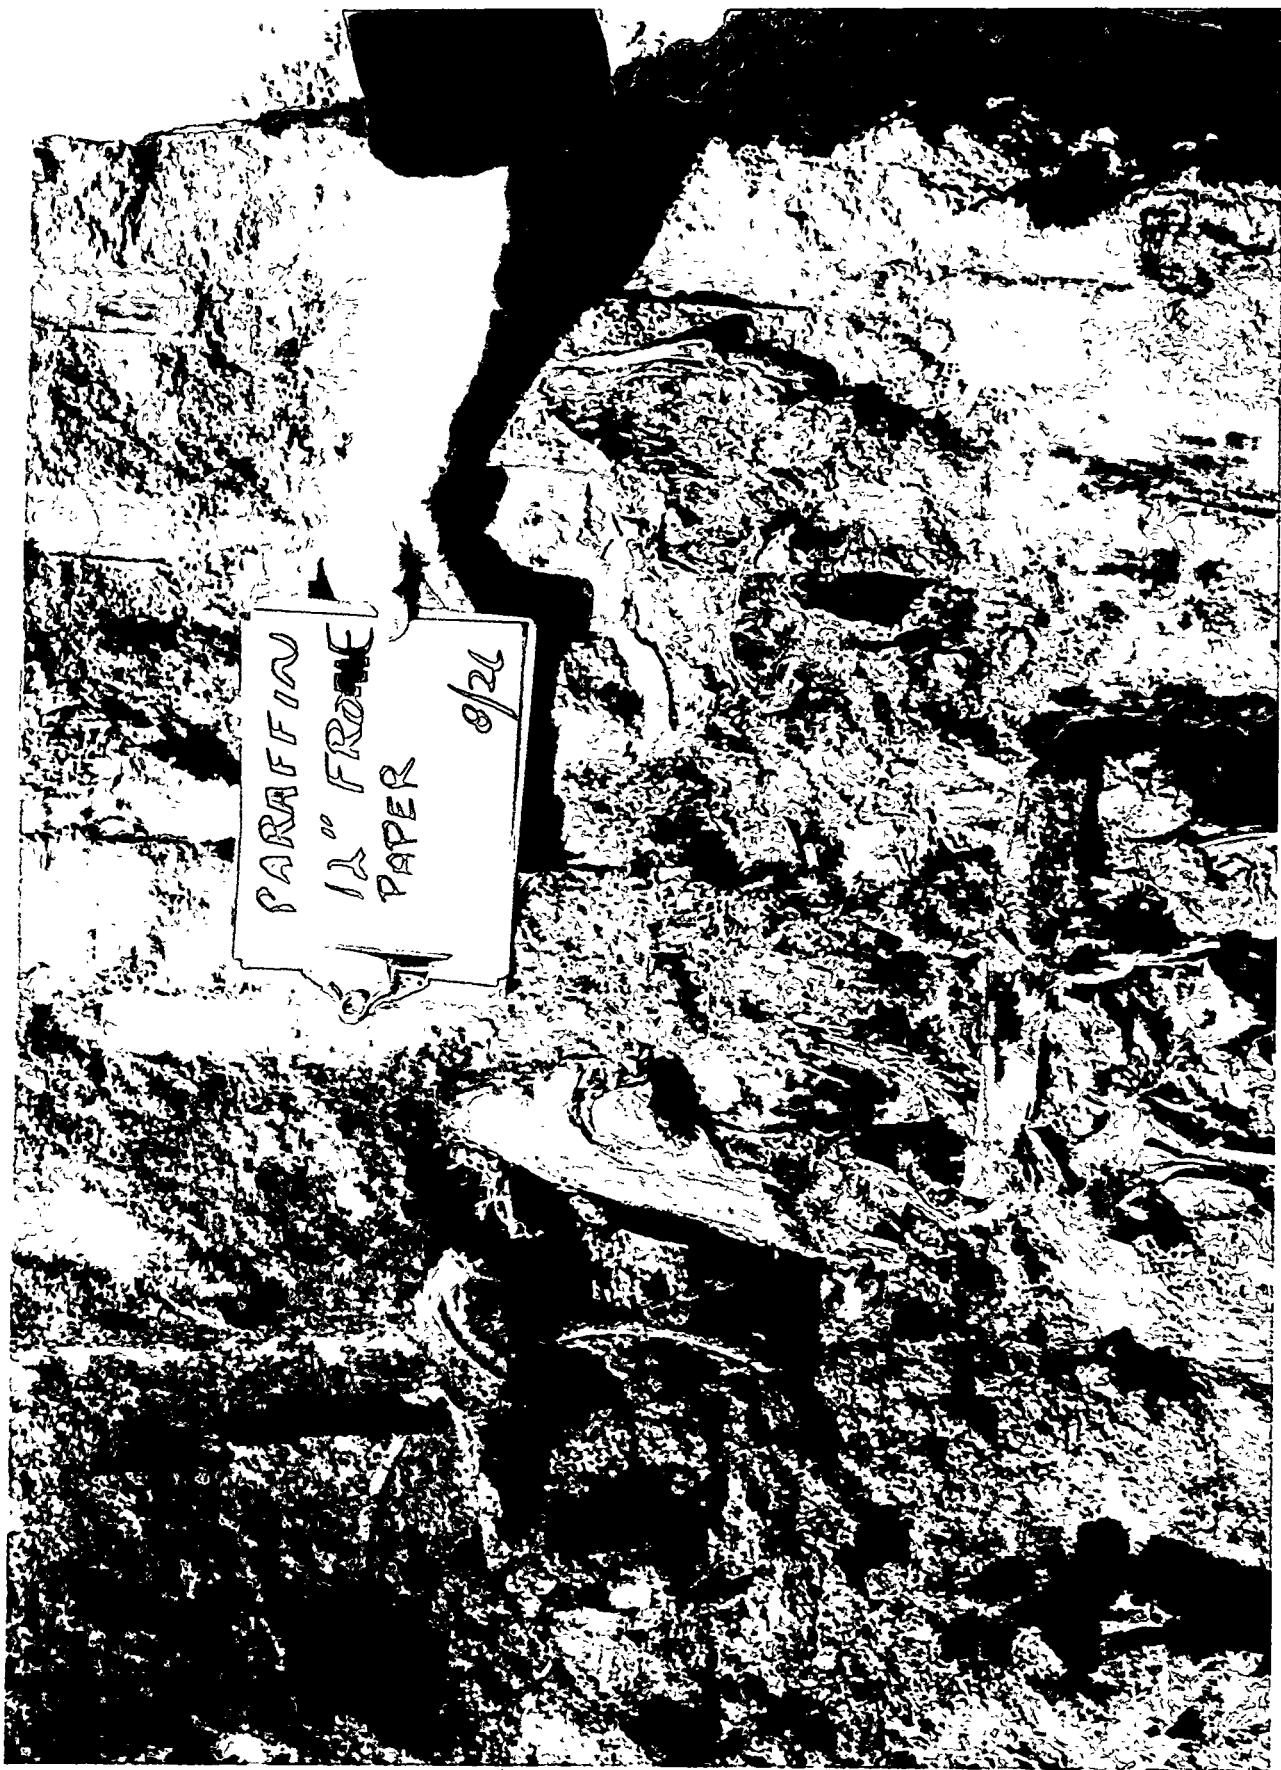
Figure 72. Paraffin pit detail at 12 in. from the east face (Photo 96-587-3-15).

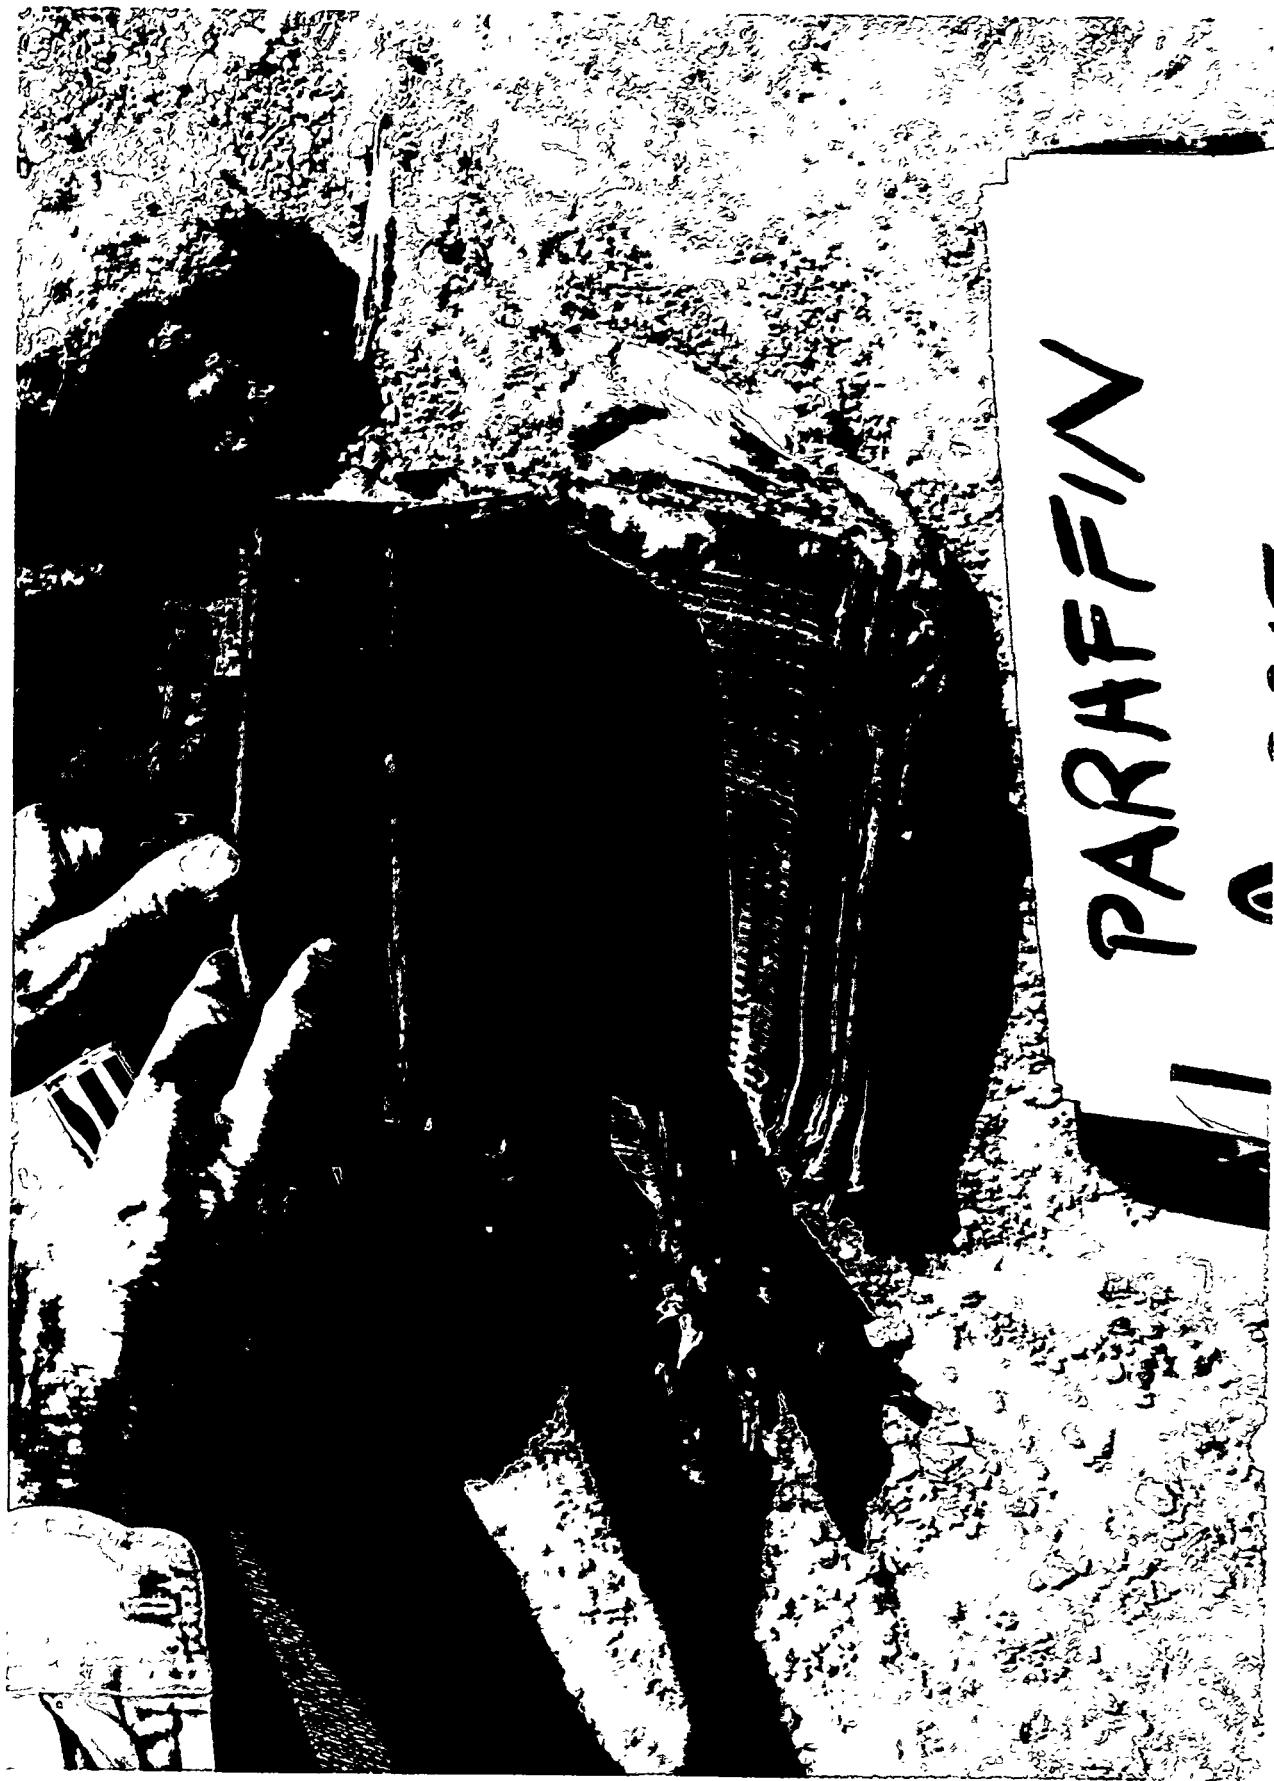
Figure 73. Detail of paper from paraffin pit (Photo 96-584-2-5).

An example of the paper from the pit is shown in detail in Figure 73 with a completely encapsulated piece. Figure 74 shows the face 18 in. from the east face, with the total monolithic

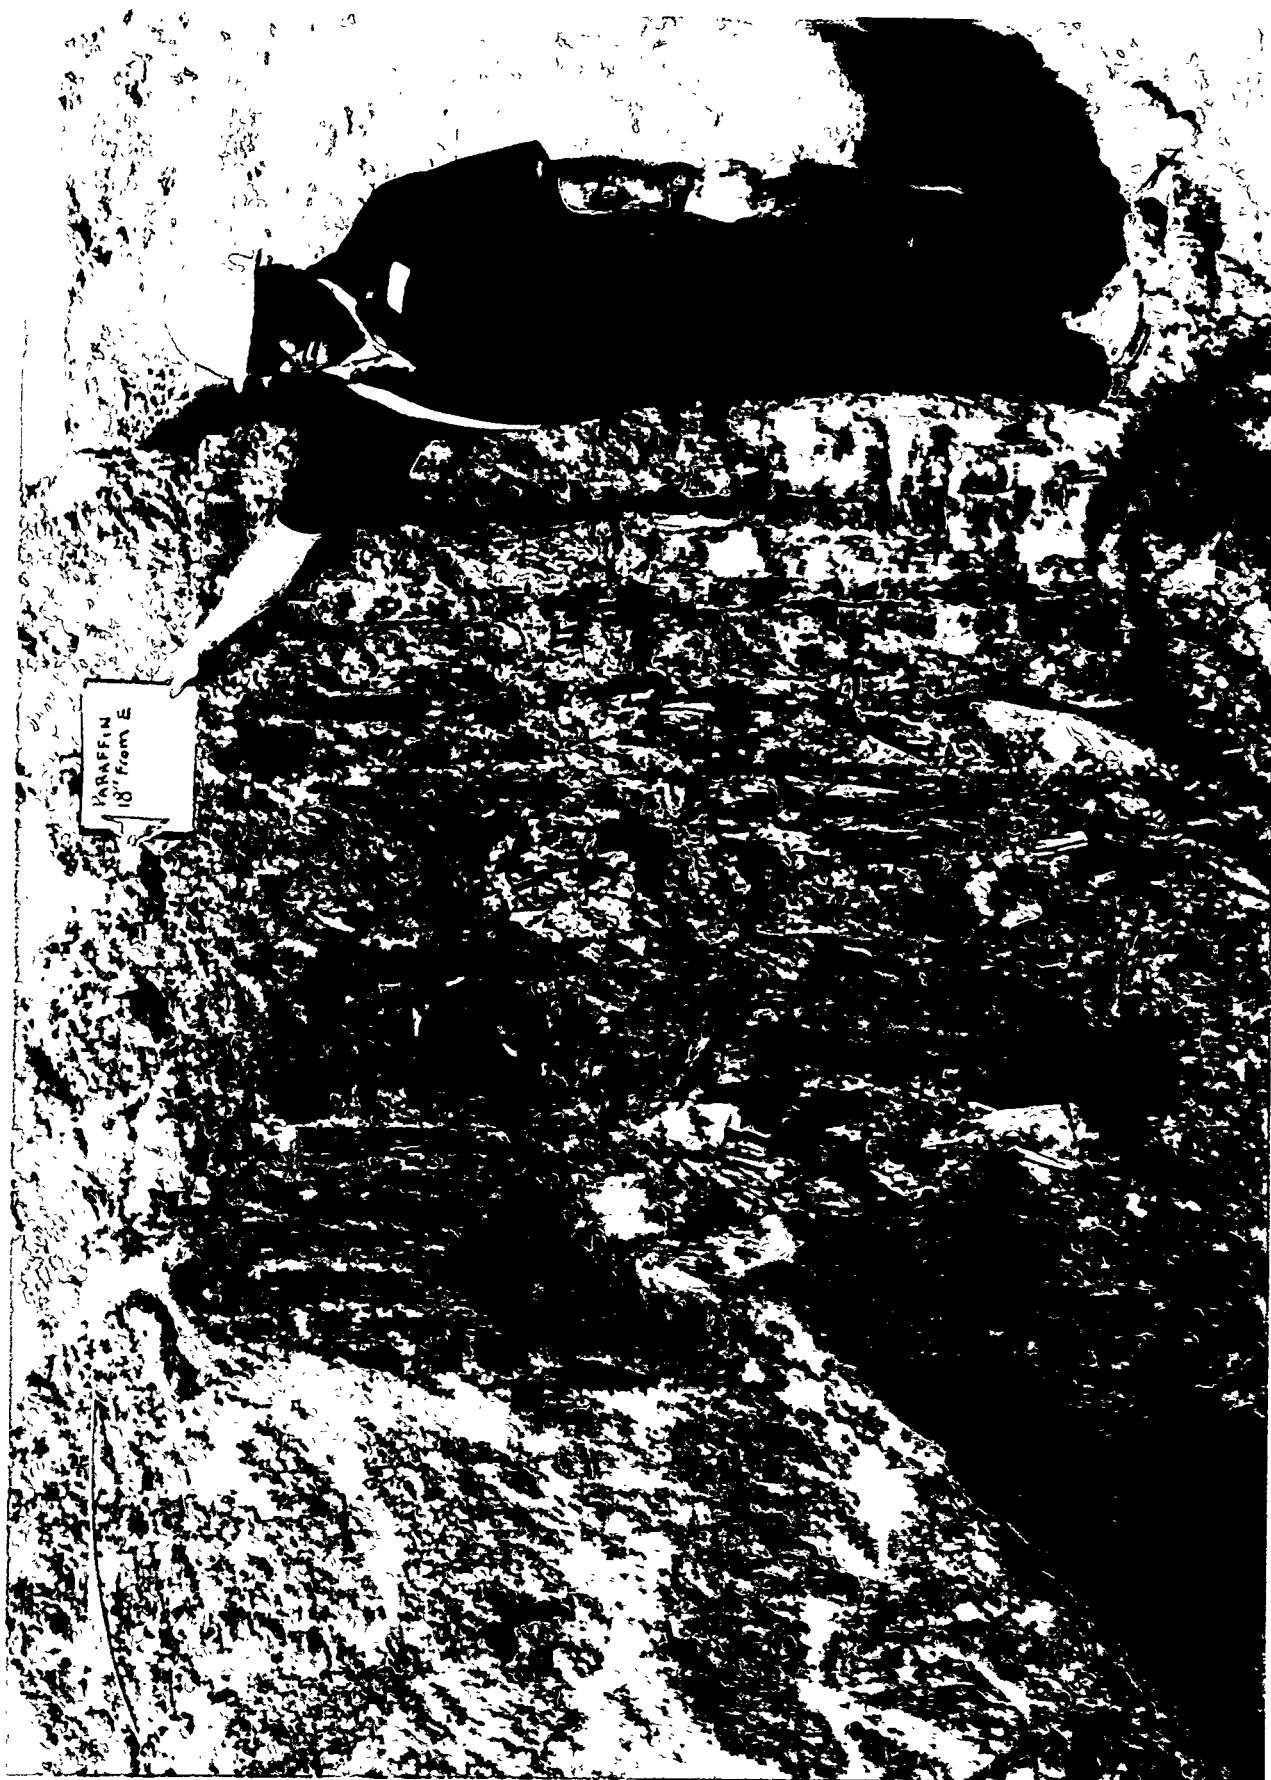
Figure 74. Paraffin pit 18 in. from the east face (Photo 96-587-3-17).

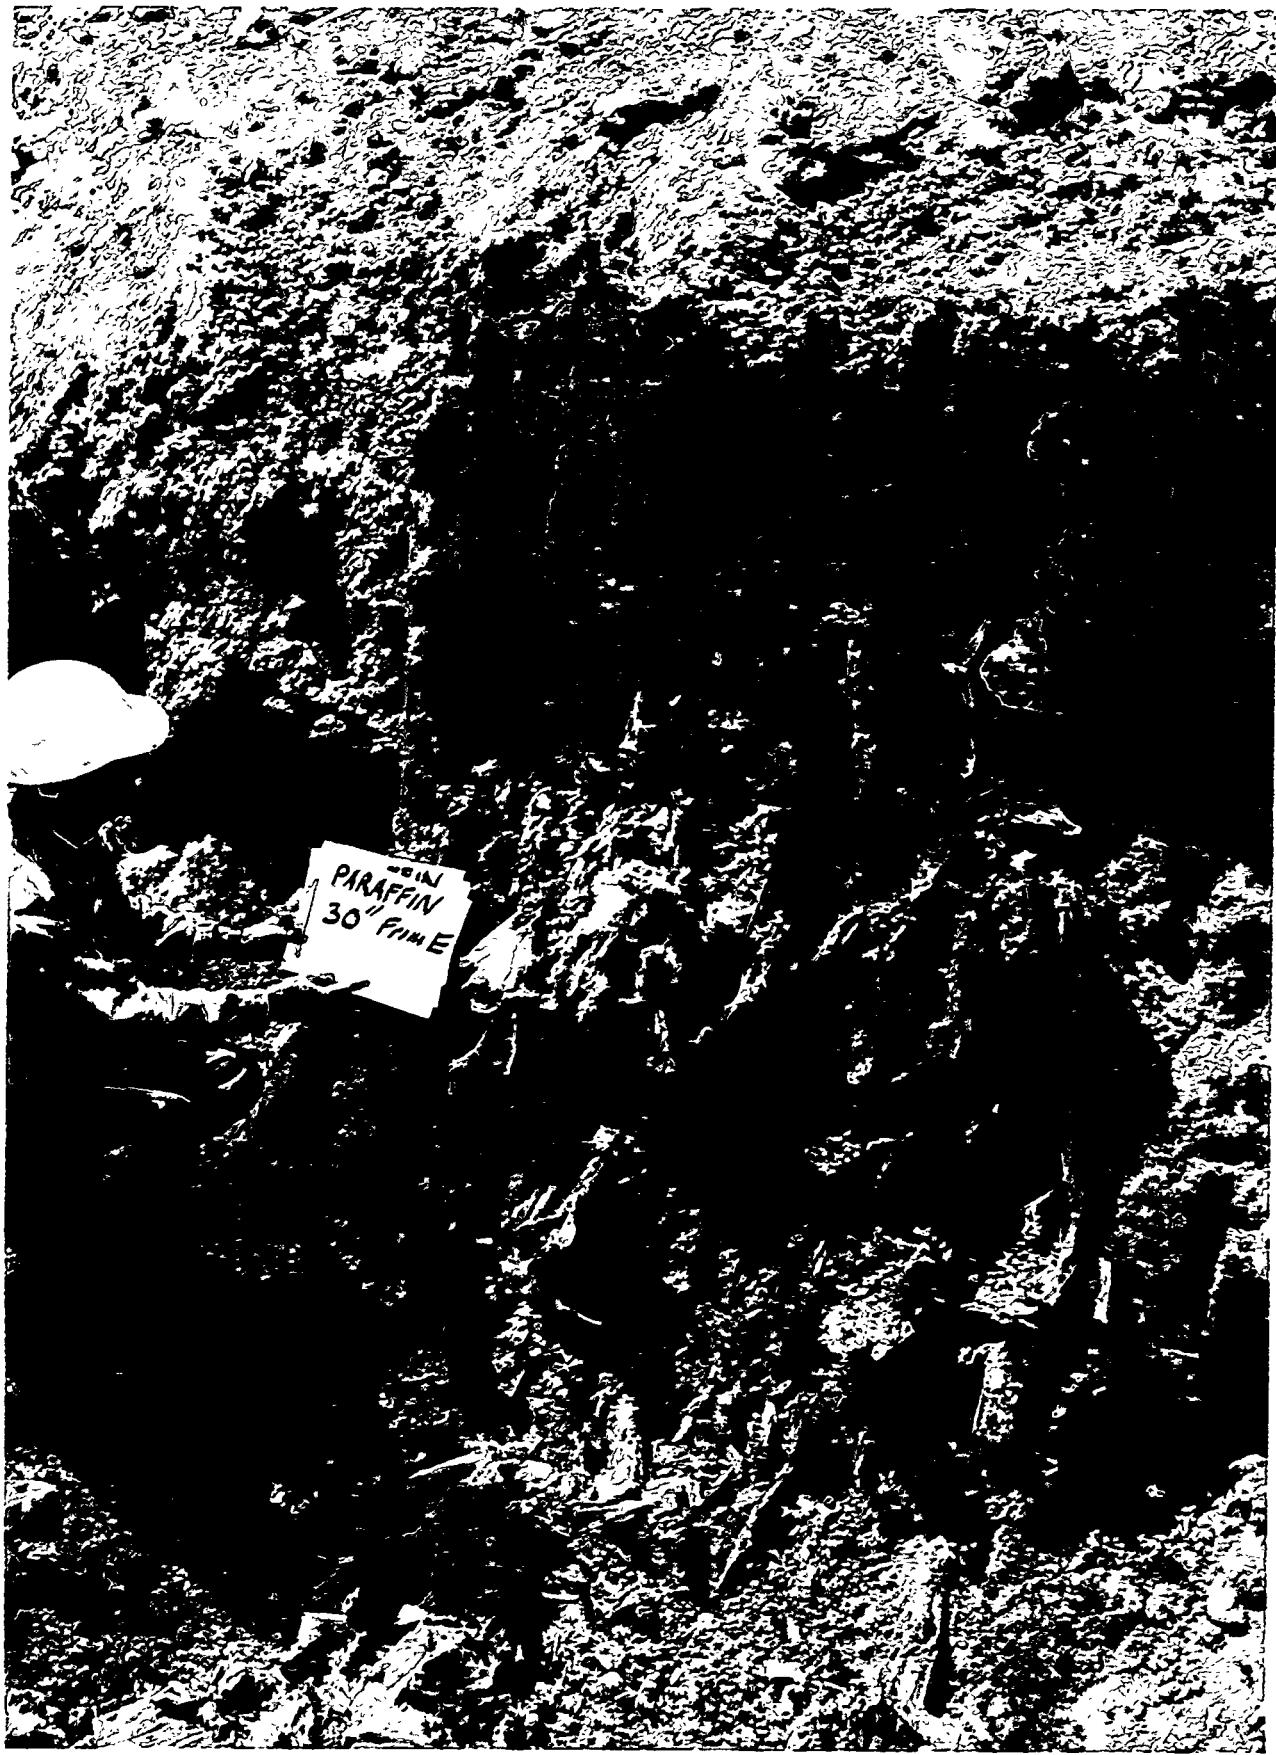
**Figure 75.** Paraffin pit 30 in. from the east face (Photo 96-584-1-3).

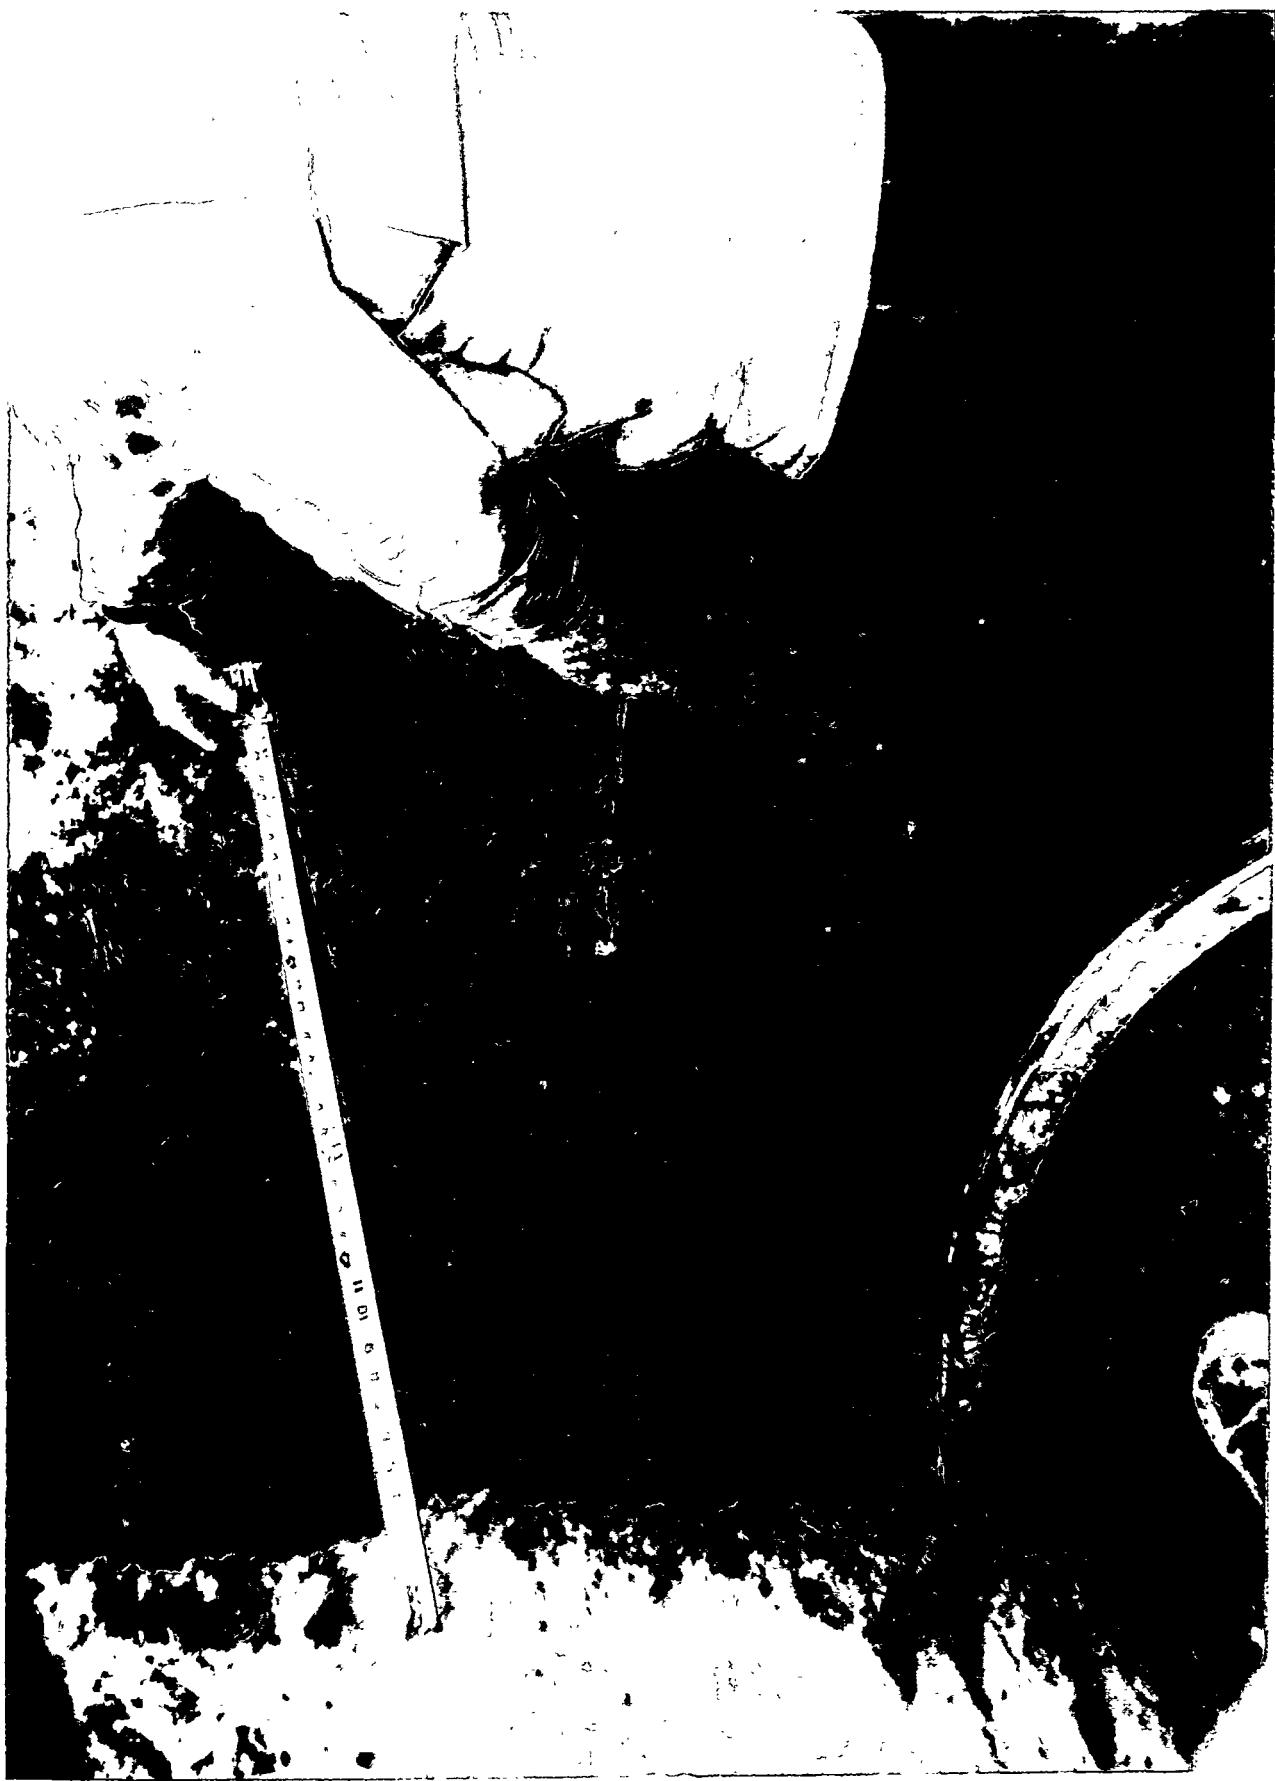
**Figure 83.** Region of porous soil outside Type-H pit (Photo 96-743-1-13).

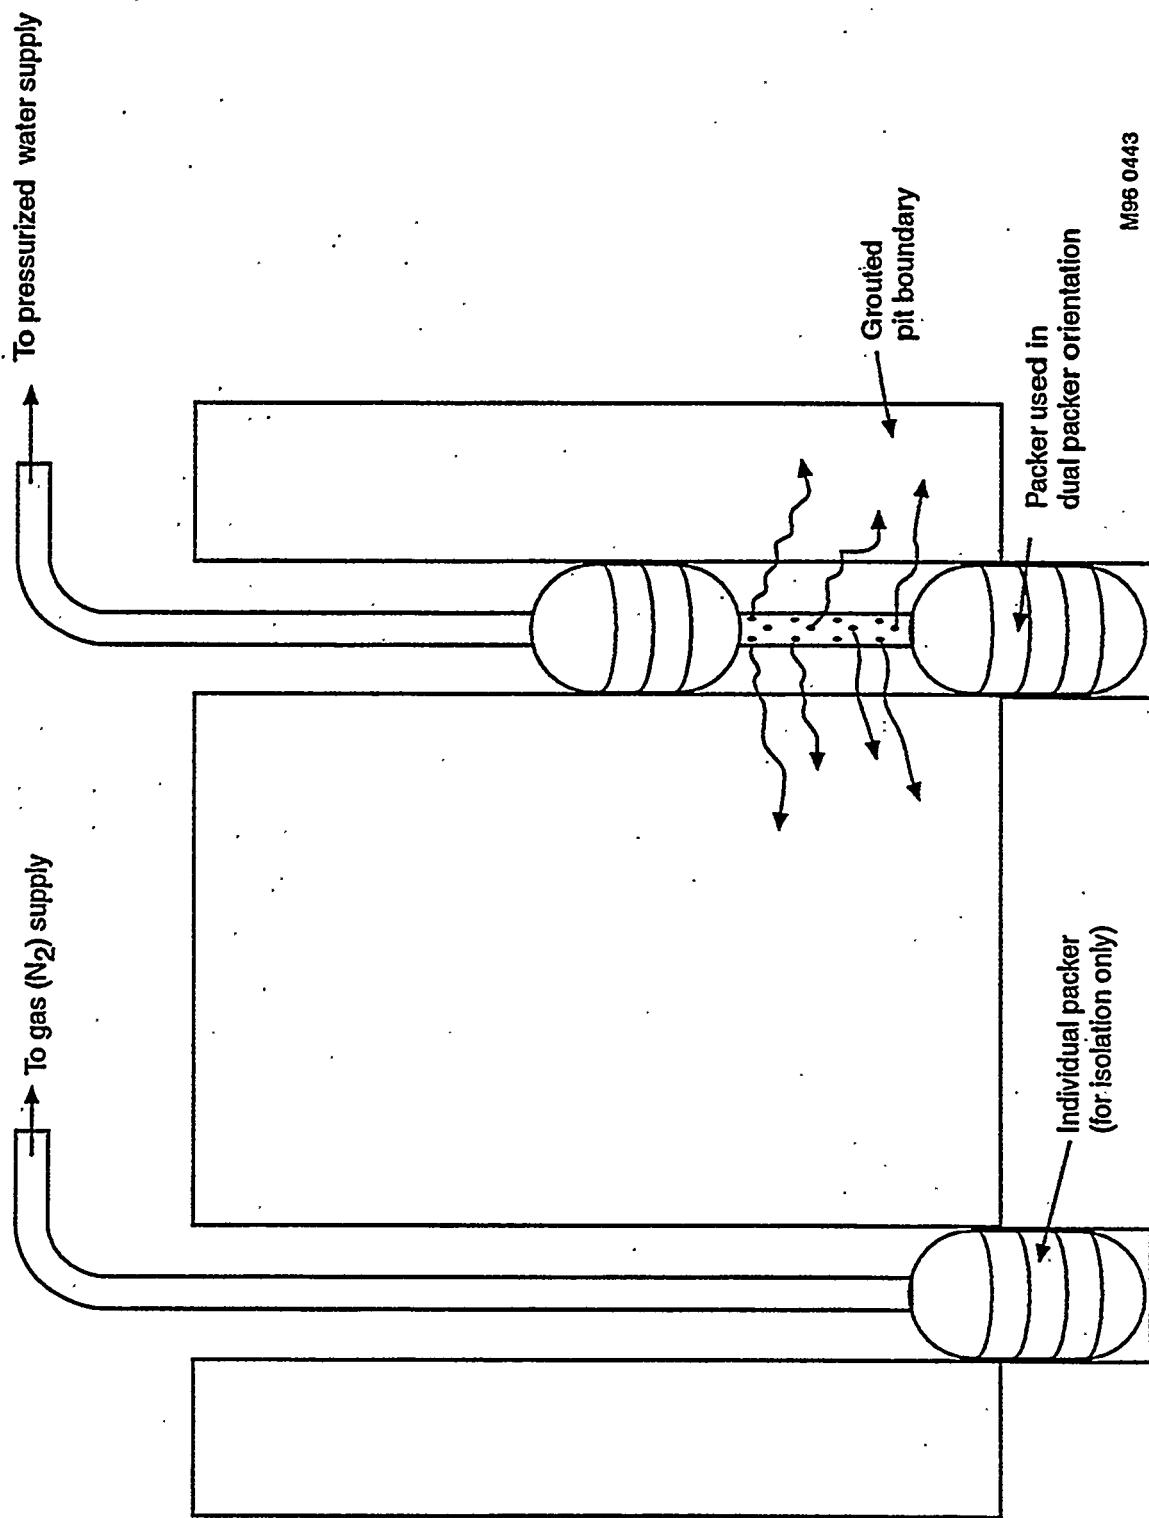
**Figure 84.** Schematic of packer system showing individual packer and a dual packer used in tandem to seal core holes that had penetrated the bottom of the grouted region (Graphic M96 0443).

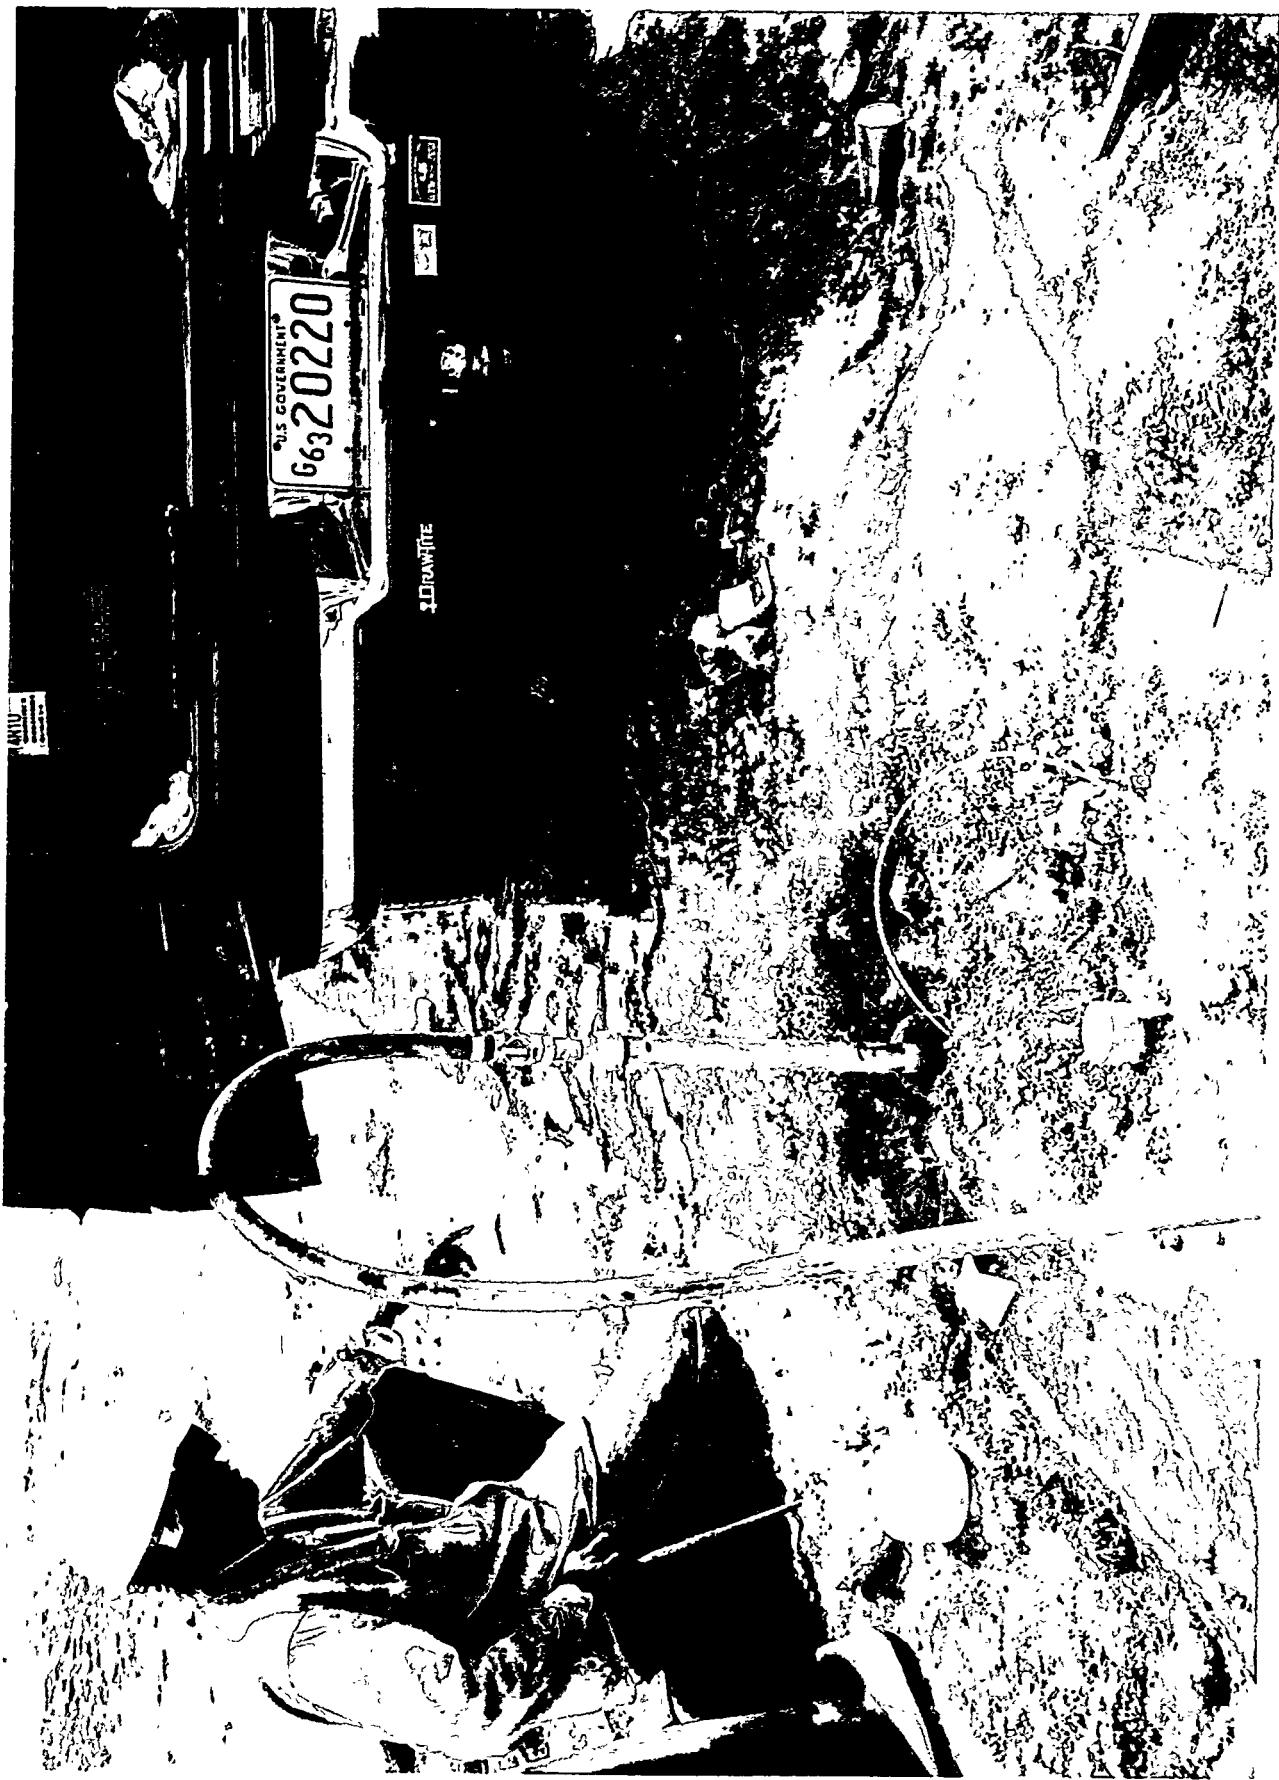
**Figure 86.** Core hole 2 in Type-H cement pit with water emanating from the top surface during packer testing (Photo 96-716-1-18).

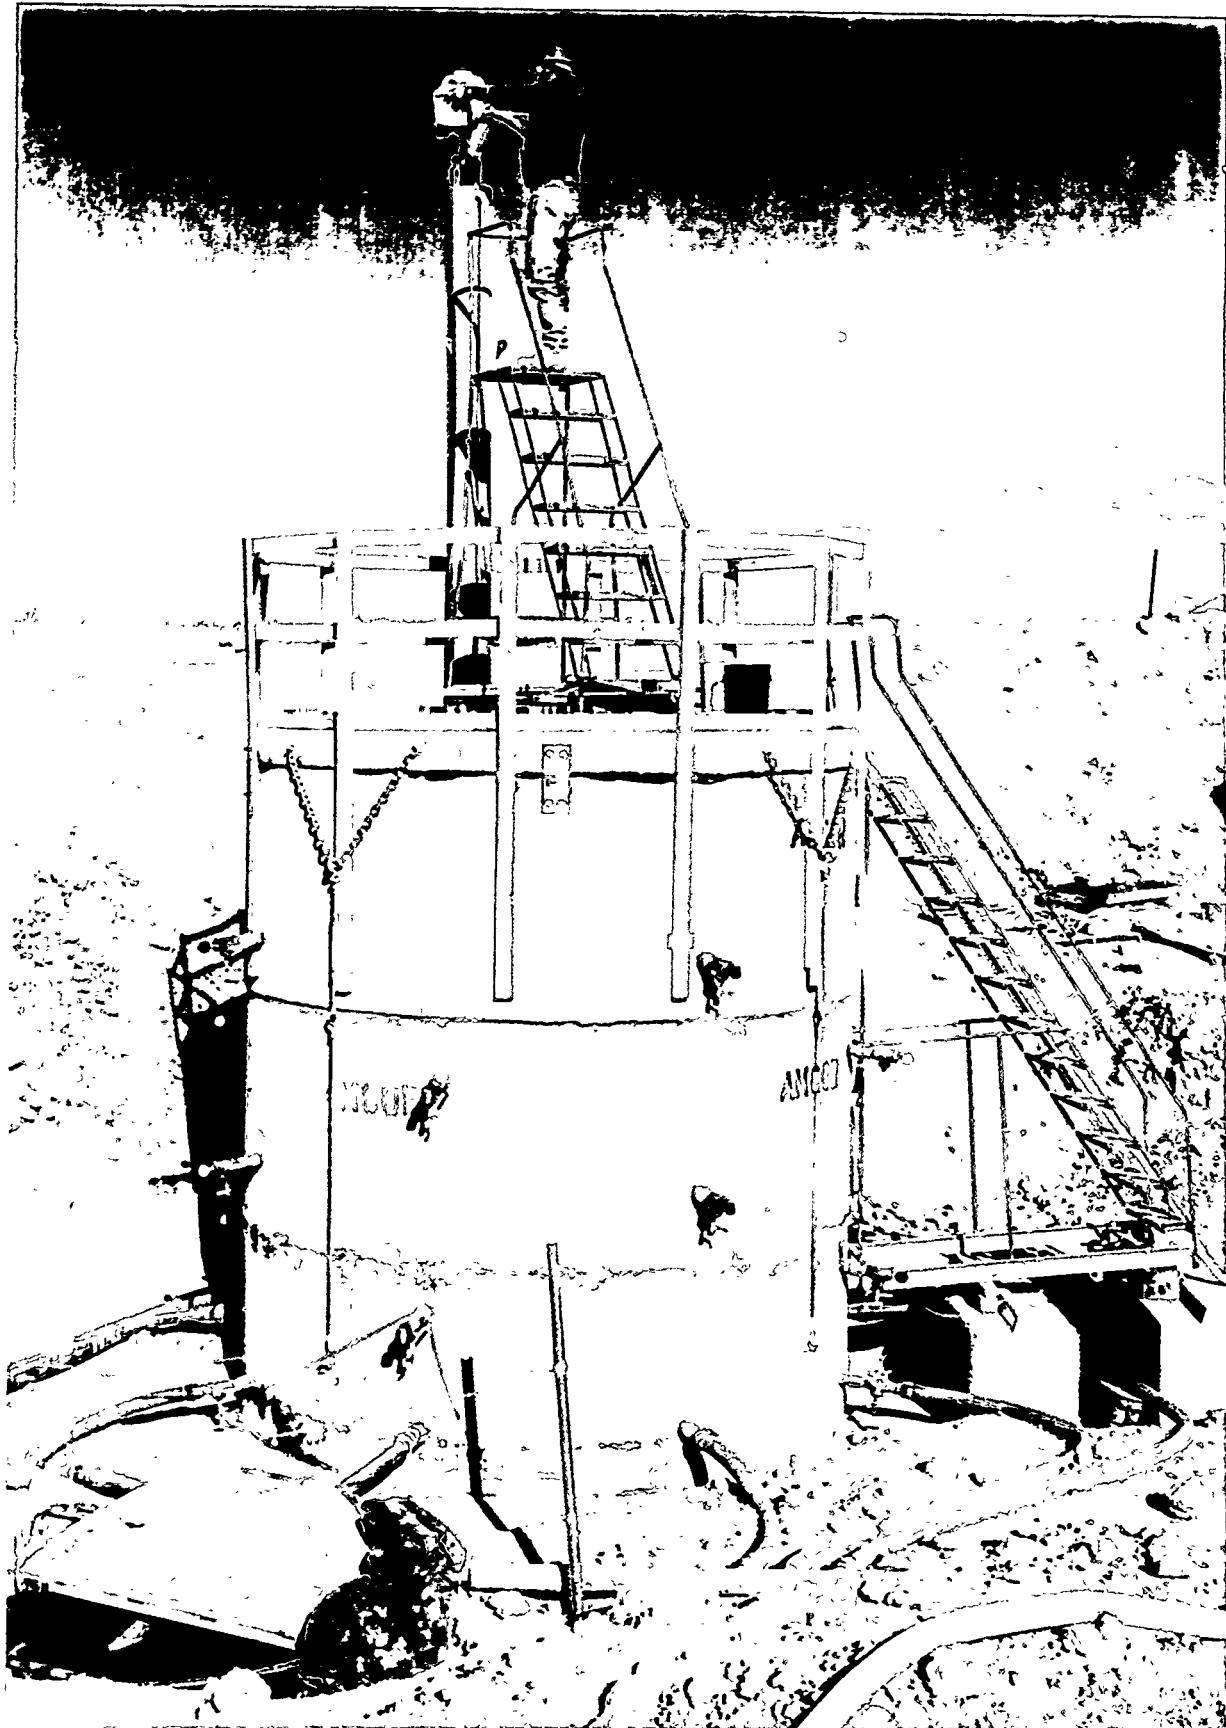
**Figure 87.** Completed ungrouted field-scale permeameter with lid tie-downs; worker shown introducing water to the head pipe (Photo 96-658-1-30).

After several attempts at sealing from the outside, it was discovered that the leakage was caused by the lid actually lifting at the exact pound force exerted by the water head (about 4 in. of head up the head pipe) applied over the entire surface area of the lid. The decision was made to apply a new seal of the tar-like material and tie the lid to the field-scale permeameter rings using both steel plate and a turnbuckle system. These systems are shown in Figure 87. Once tied
