INEL-96/0439

## **Innovative Subsurface Stabilization Project—Final Report**

**Idaho National Engineering Laboratory  
Environmental Restoration Technologies Department  
Lockheed Martin Idaho Technologies Company  
Idaho Falls, Idaho 83415**

**Prepared for the  
U.S. Department of Energy  
Assistant Secretary for Environmental Management  
Under DOE Idaho Operations Office  
Contract DE-AC07-94ID13223**

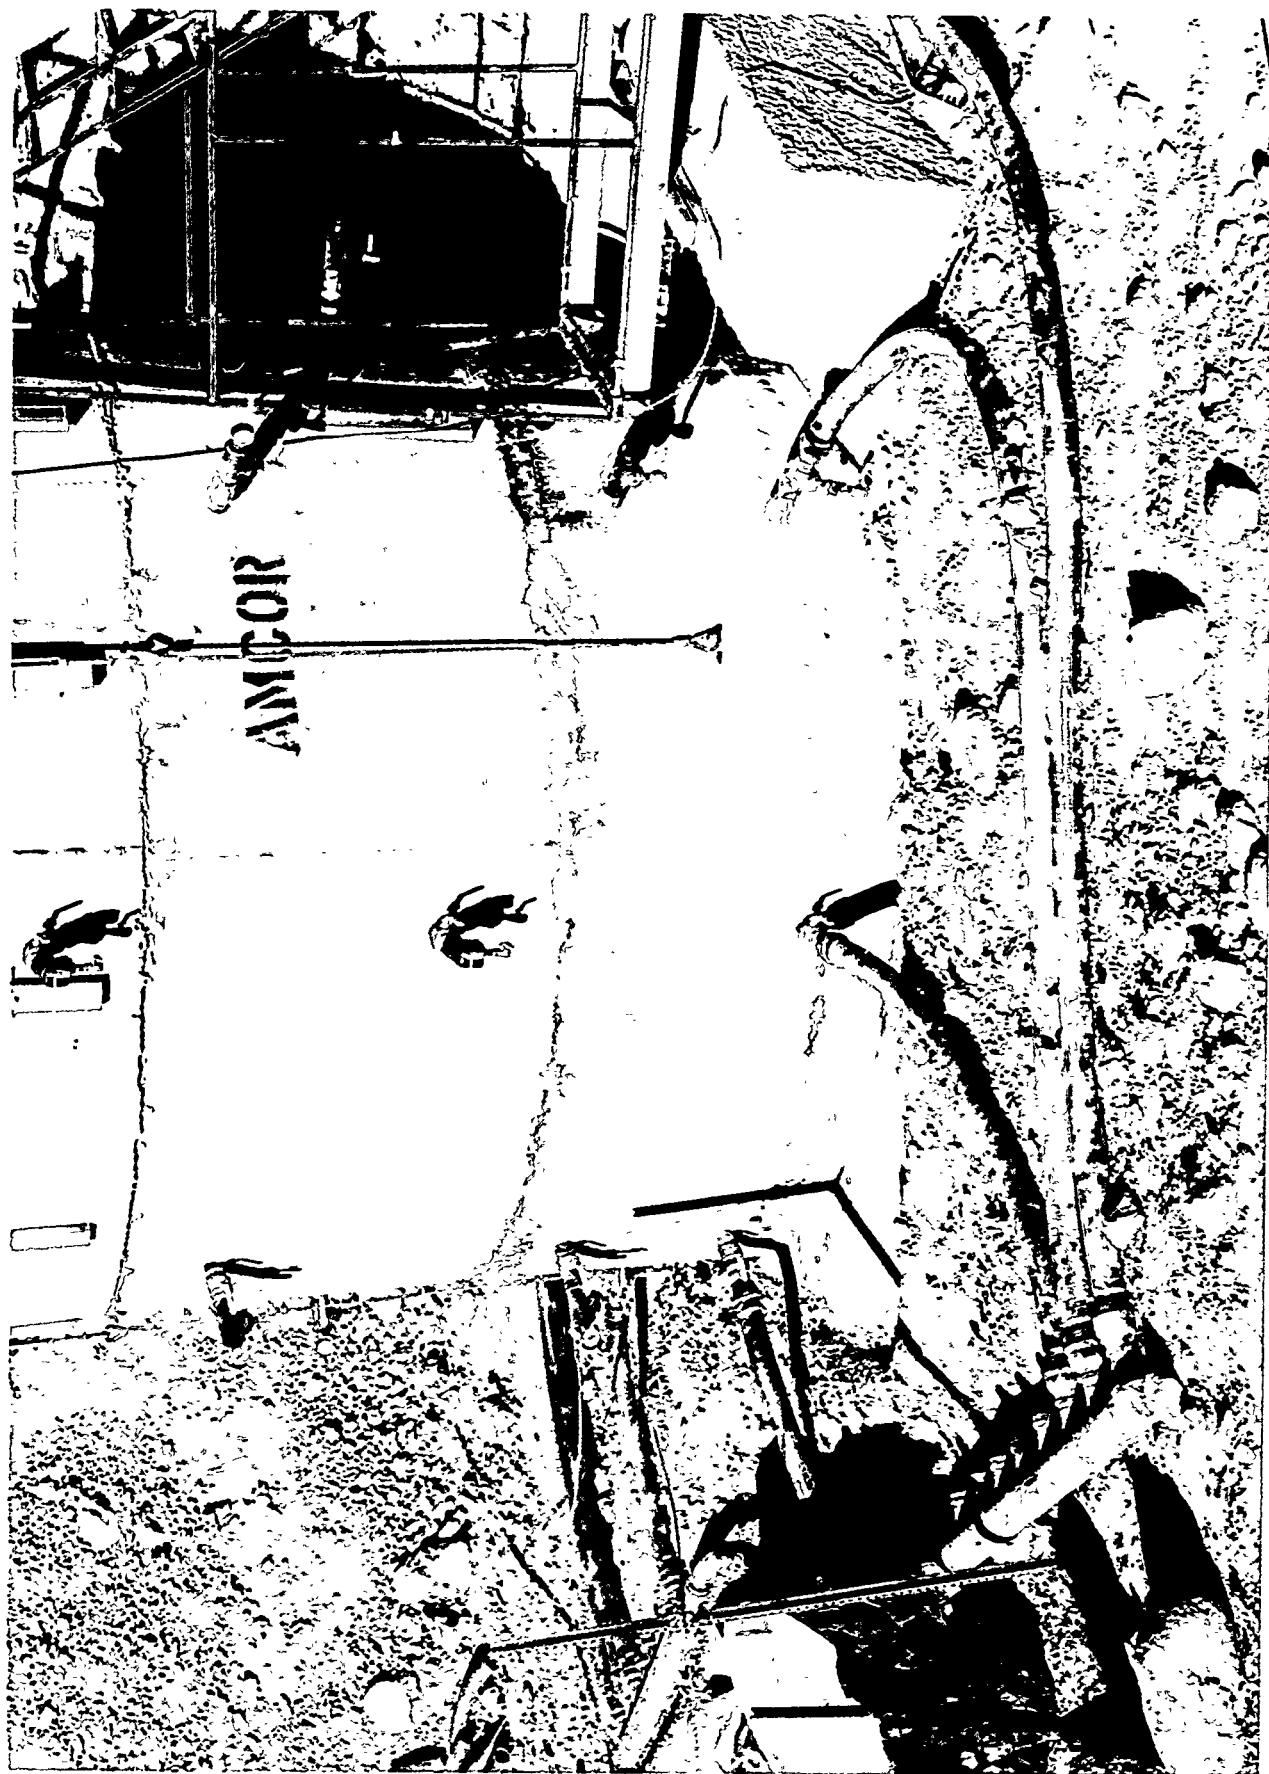
Figure 88. Details of ungrouted baseline field-scale permeameter collection system (Photo 96-638-1-27).

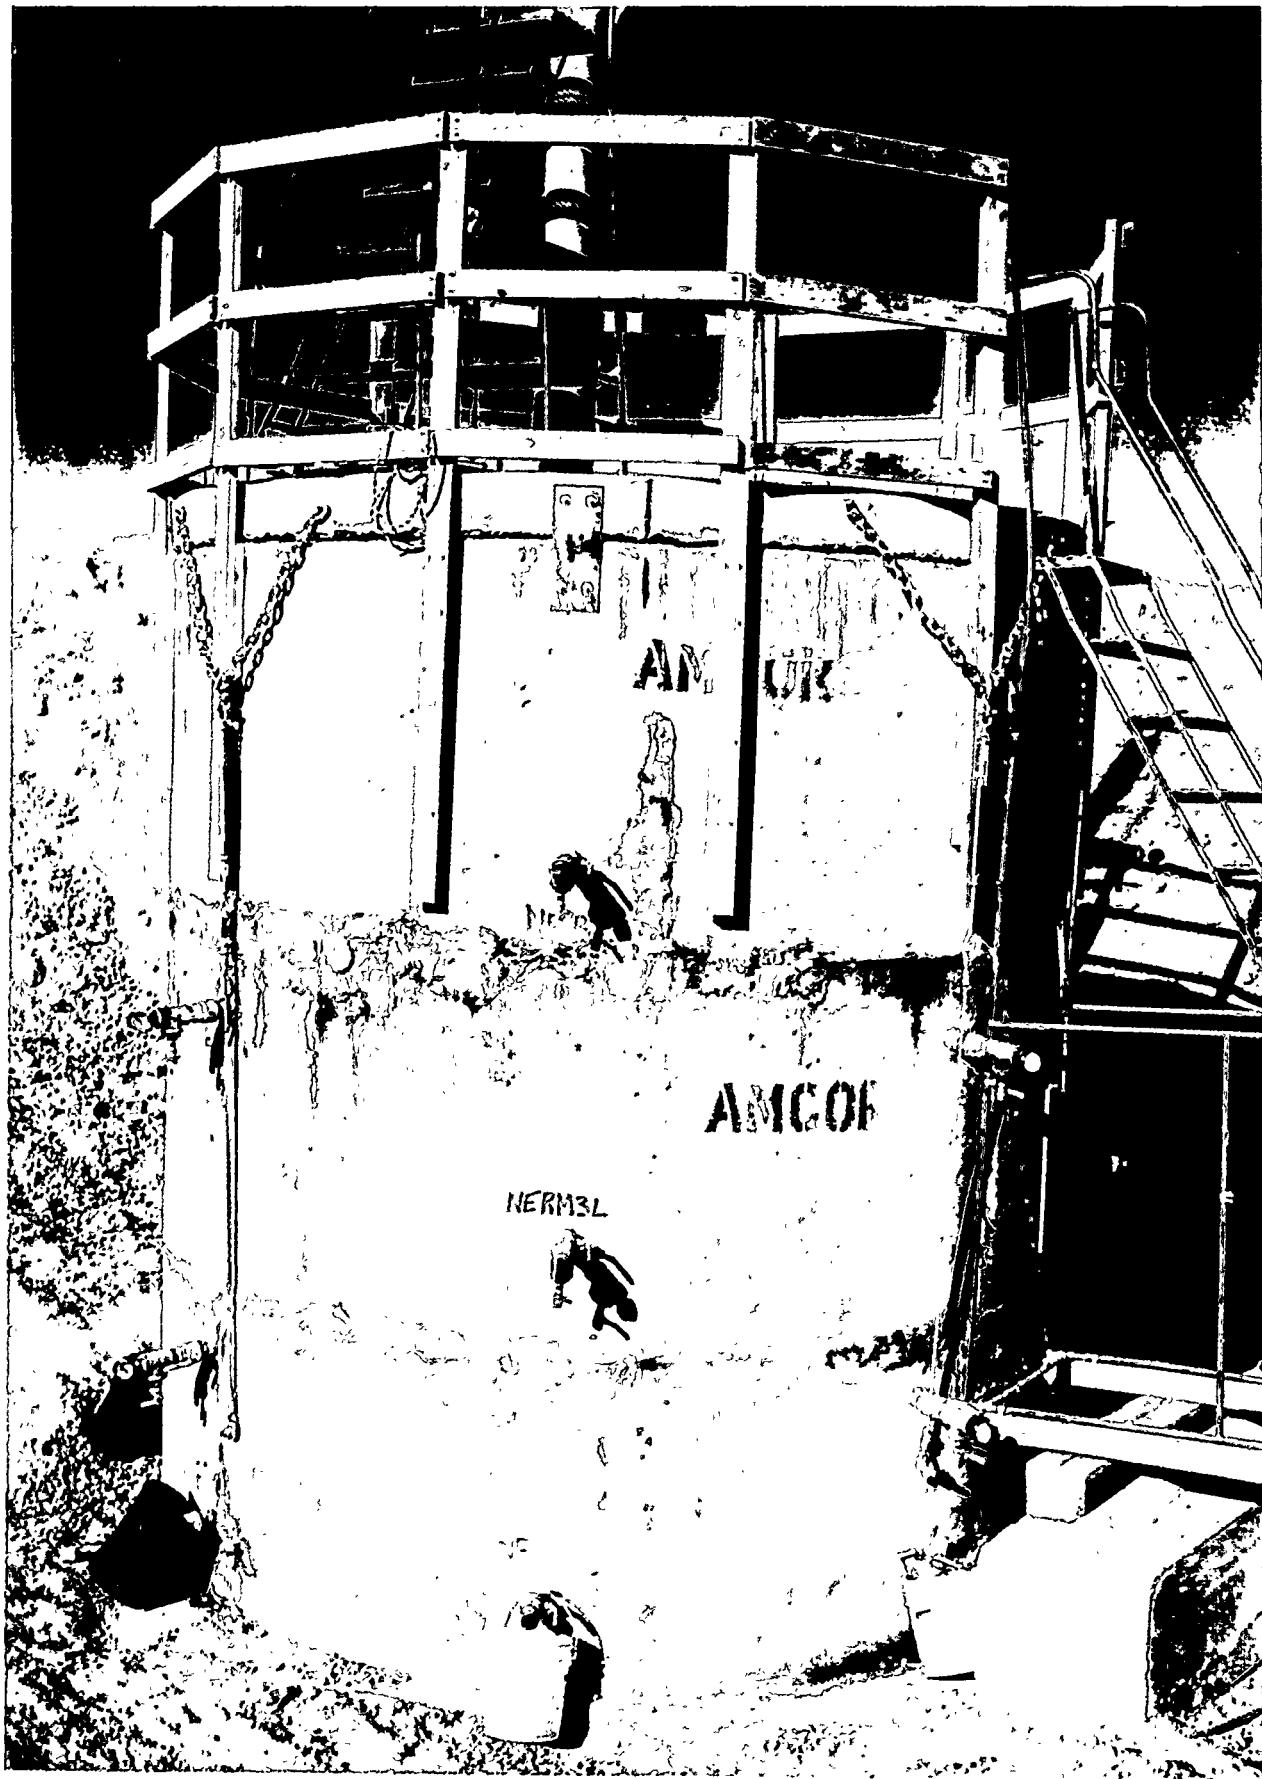
**Figure 89.** Completed grouted field-scale permeameter showing lid tie-downs and bucket collection system for grouted field-scale permeameter (Photo 96-658-1-24).

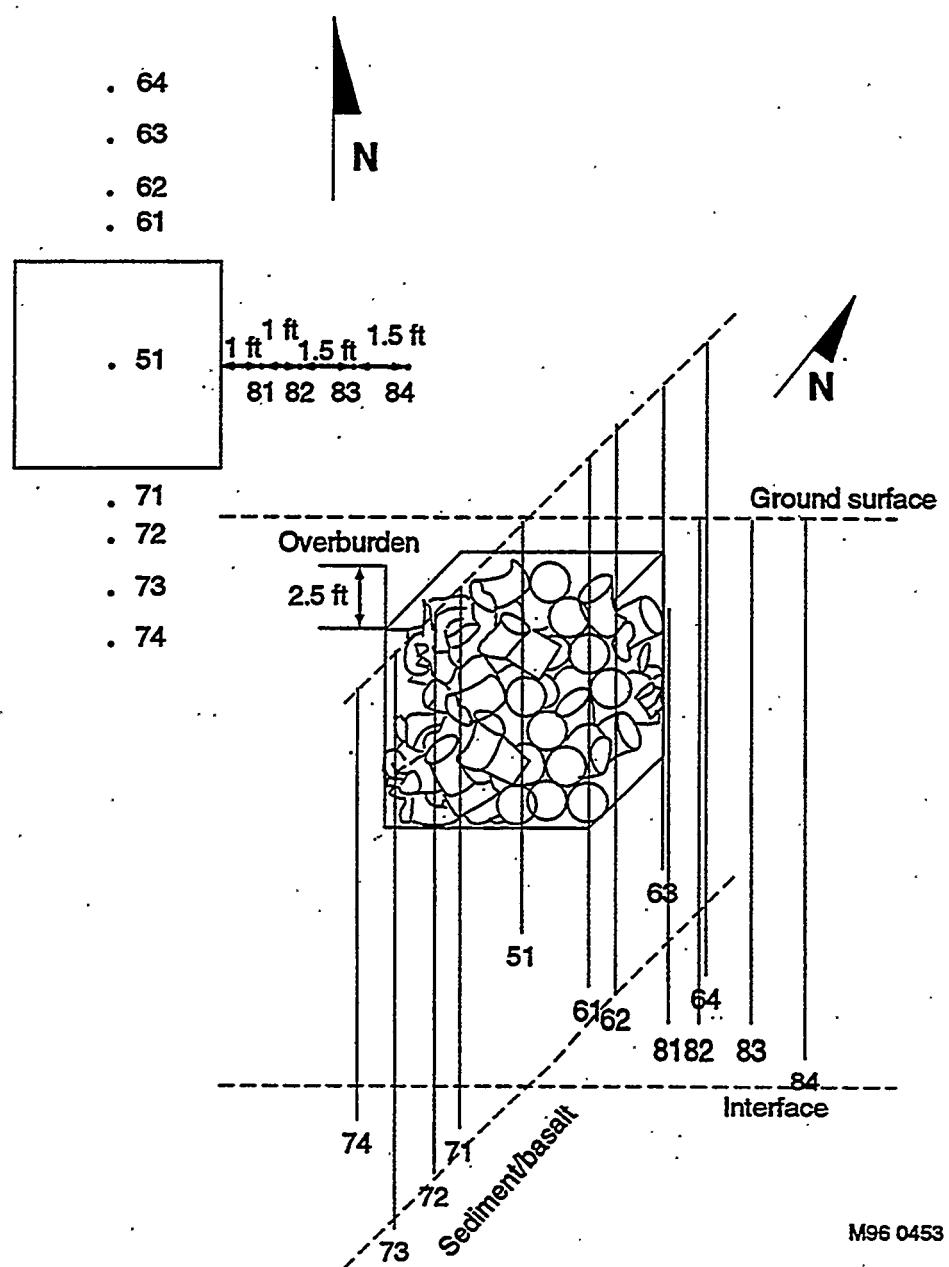
**Figure 91.** Plan-view and 3-D map of Pit D (Graphic M96 0453).

Moisture was monitored using the neutron probe. Thirteen neutron-probe access tube (NAT) holes were drilled in and near the pit (Figure 91). A set of four holes was located on each of three sides of the pit (north, east, and south) at distances of 1, 2, 3.5, and 5 ft from the closest pit perimeter (as shown in Figure 91). In addition, one hole was drilled through the waste at the center of the pit. All holes were drilled to the basalt. NAT holes were monitored before

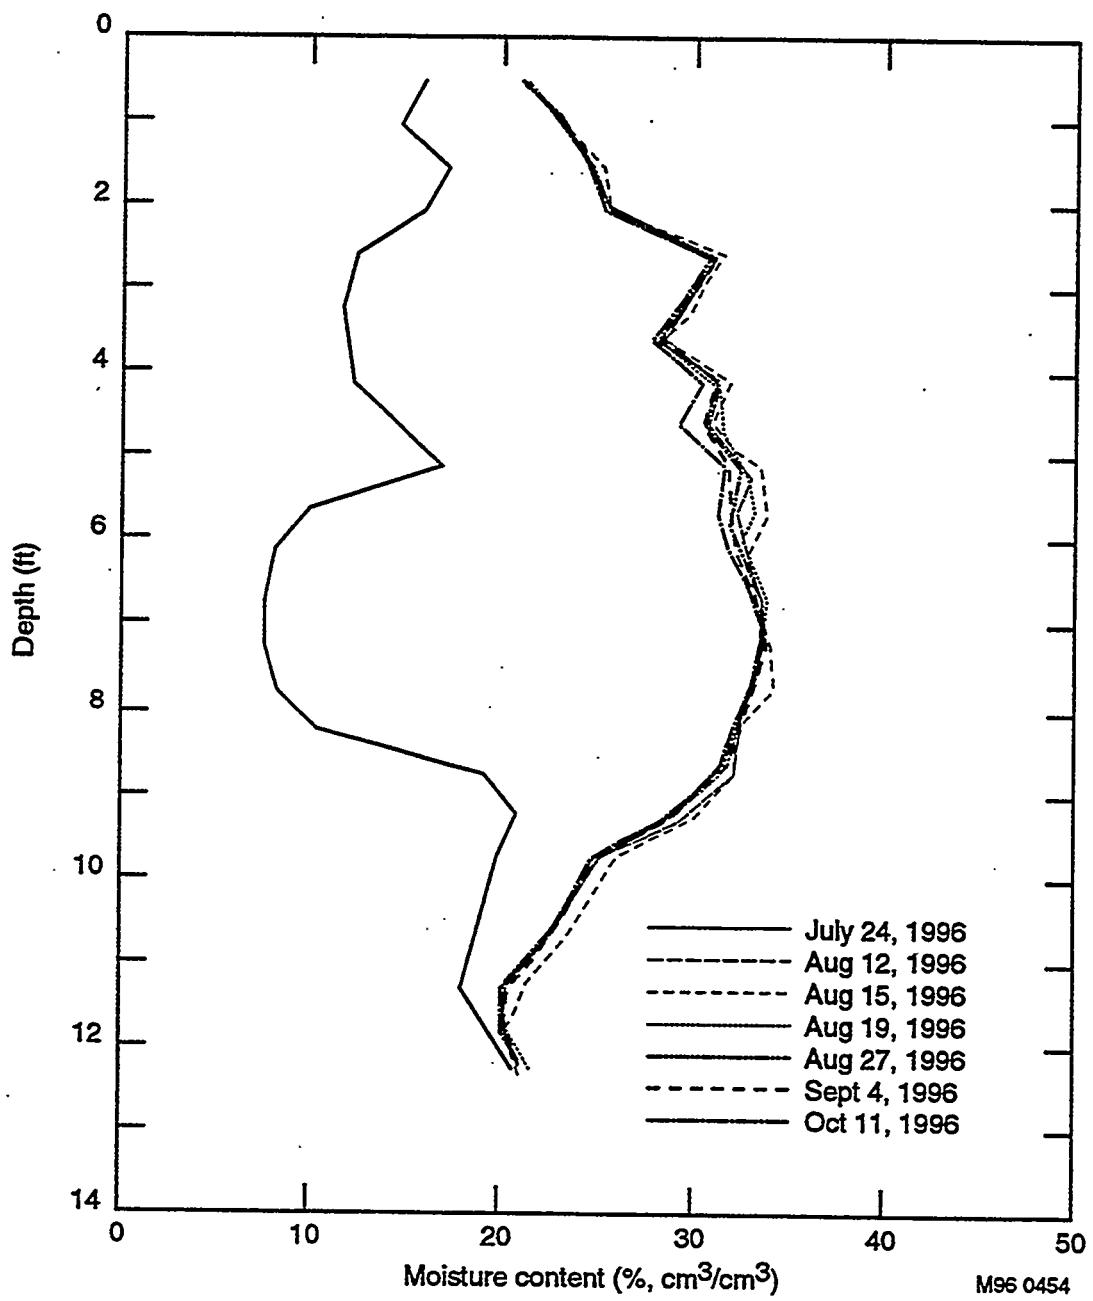
**Figure 92.** Moisture content profiles for NAT-51 (Graphic M96 0454).

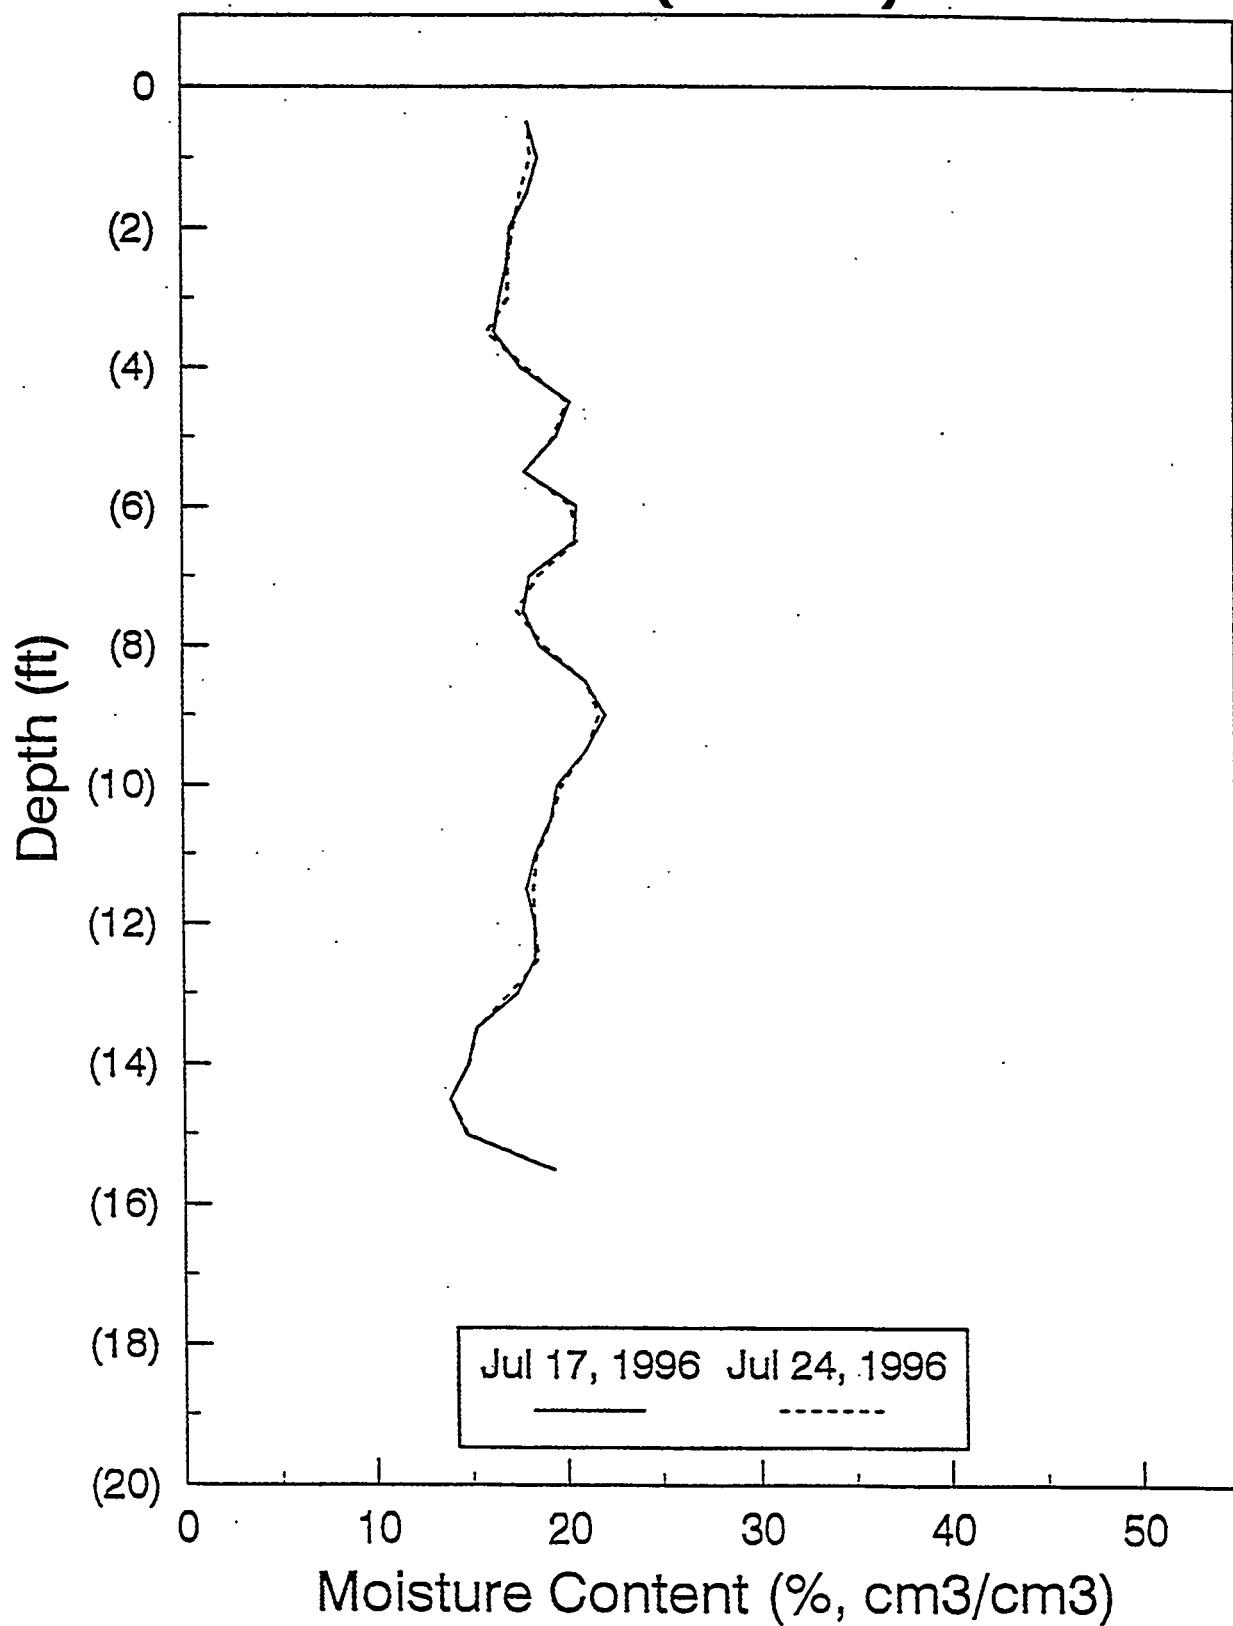
## NAT 63 (north)

Figure E-2. Baseline moisture content profiles for NAT-63.

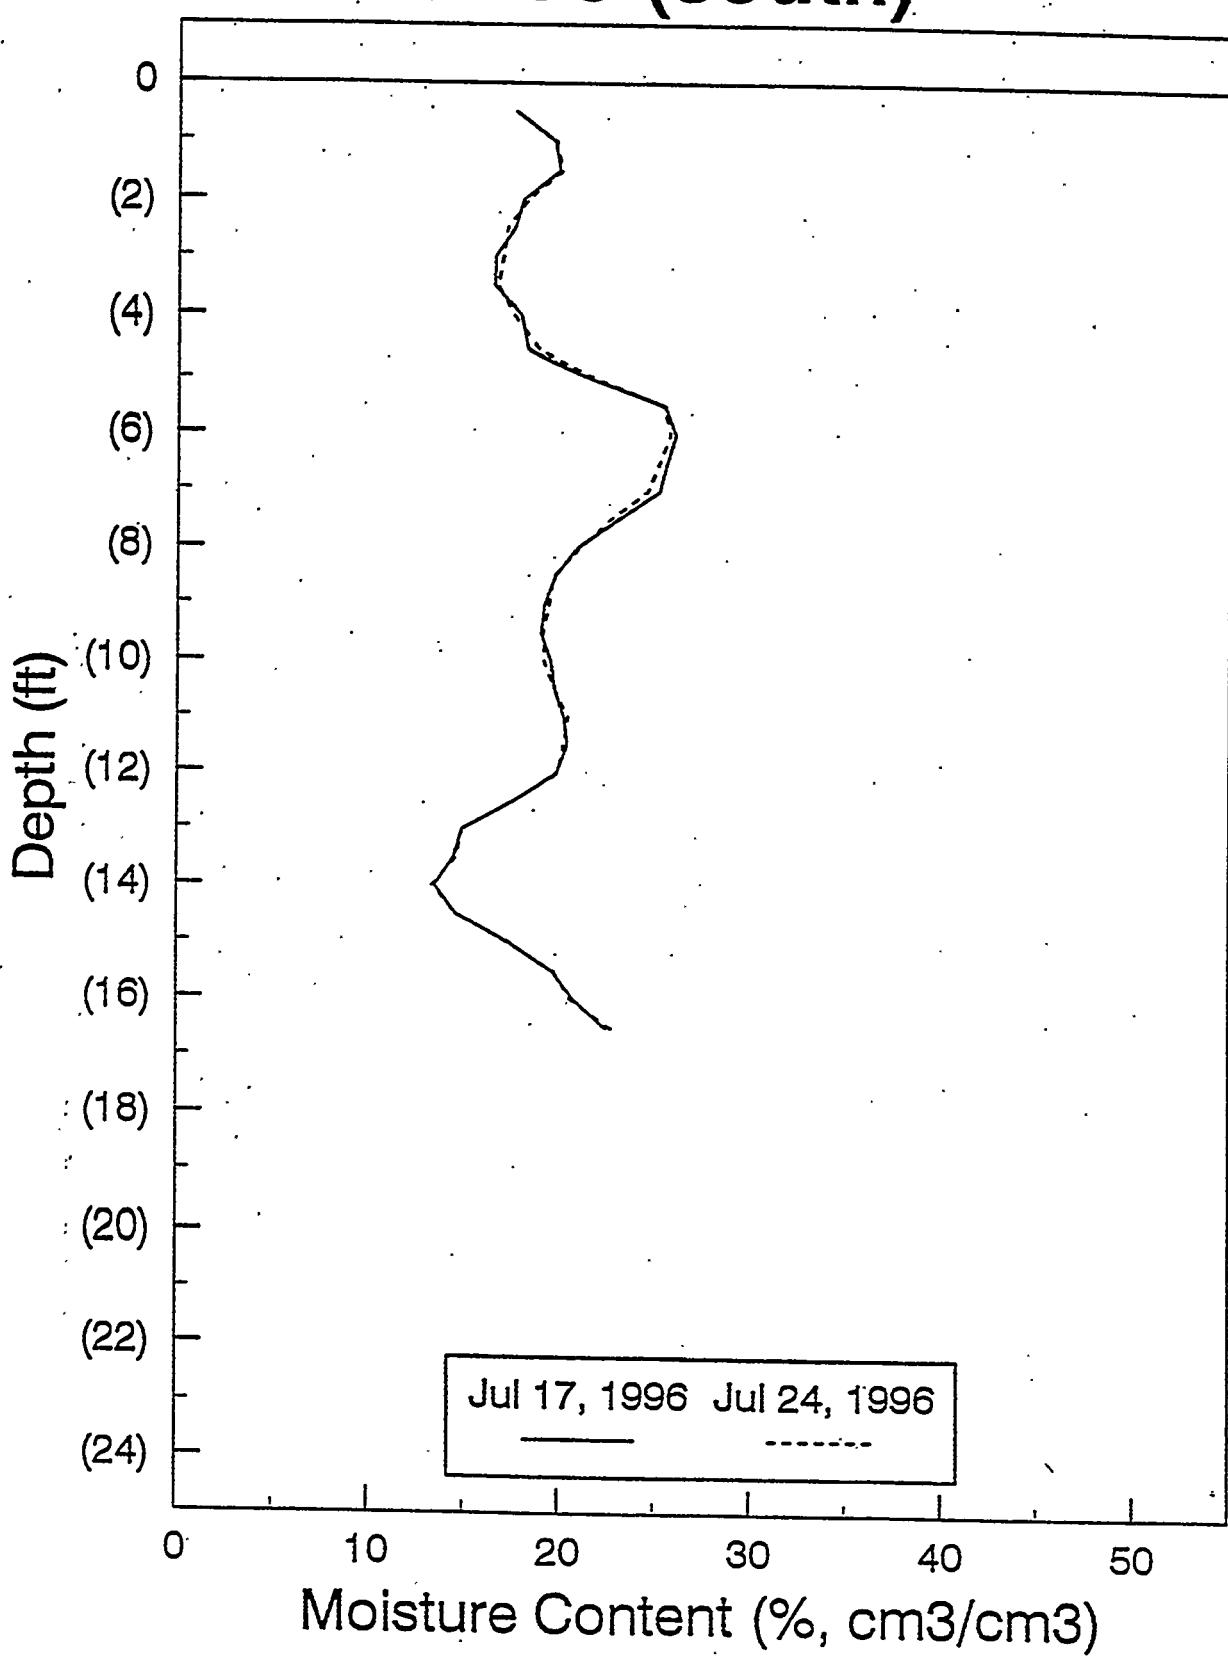
# NAT 73 (south)

Figure E-3. Baseline moisture content profiles for NAT-73.

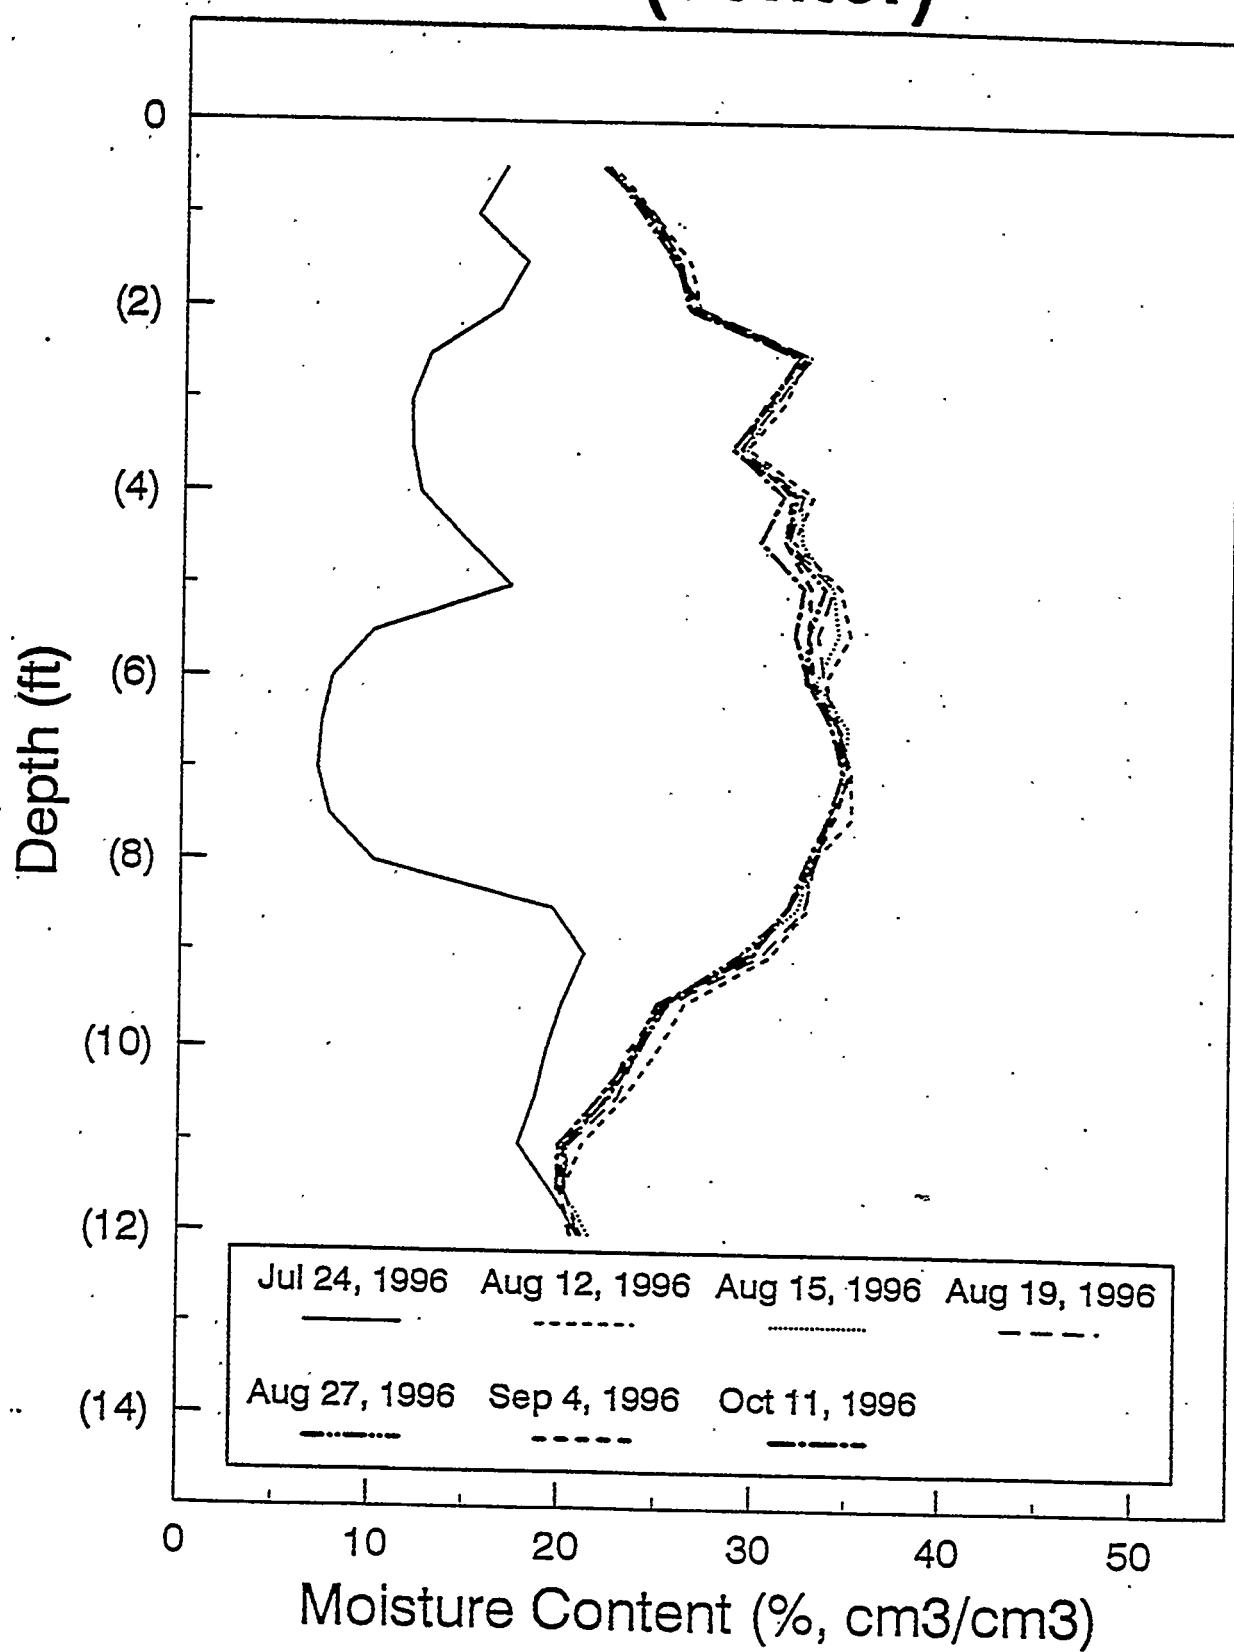
# NAT 51 (center)

Figure E-4. Moisture content profiles for NAT-51.

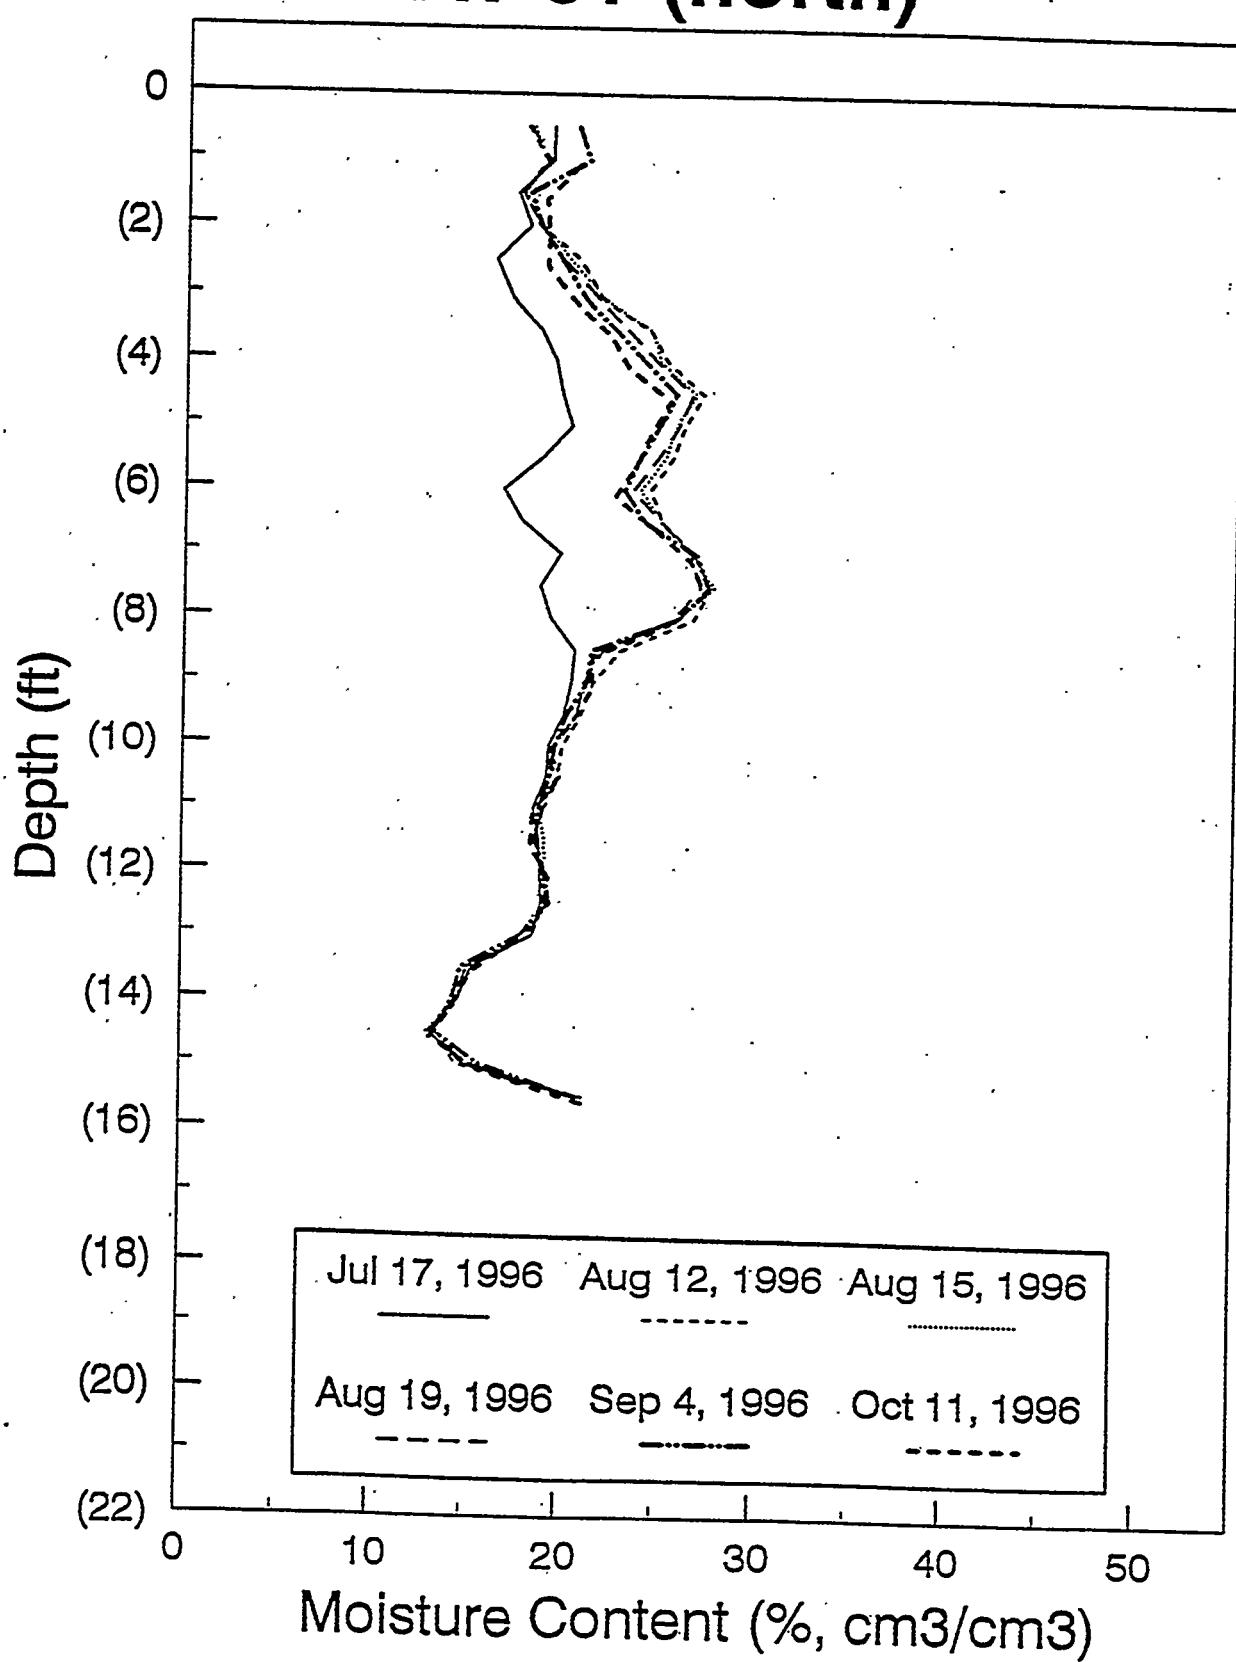
# NAT 61 (north)

Figure E-5. Moisture content profiles for NAT-61.

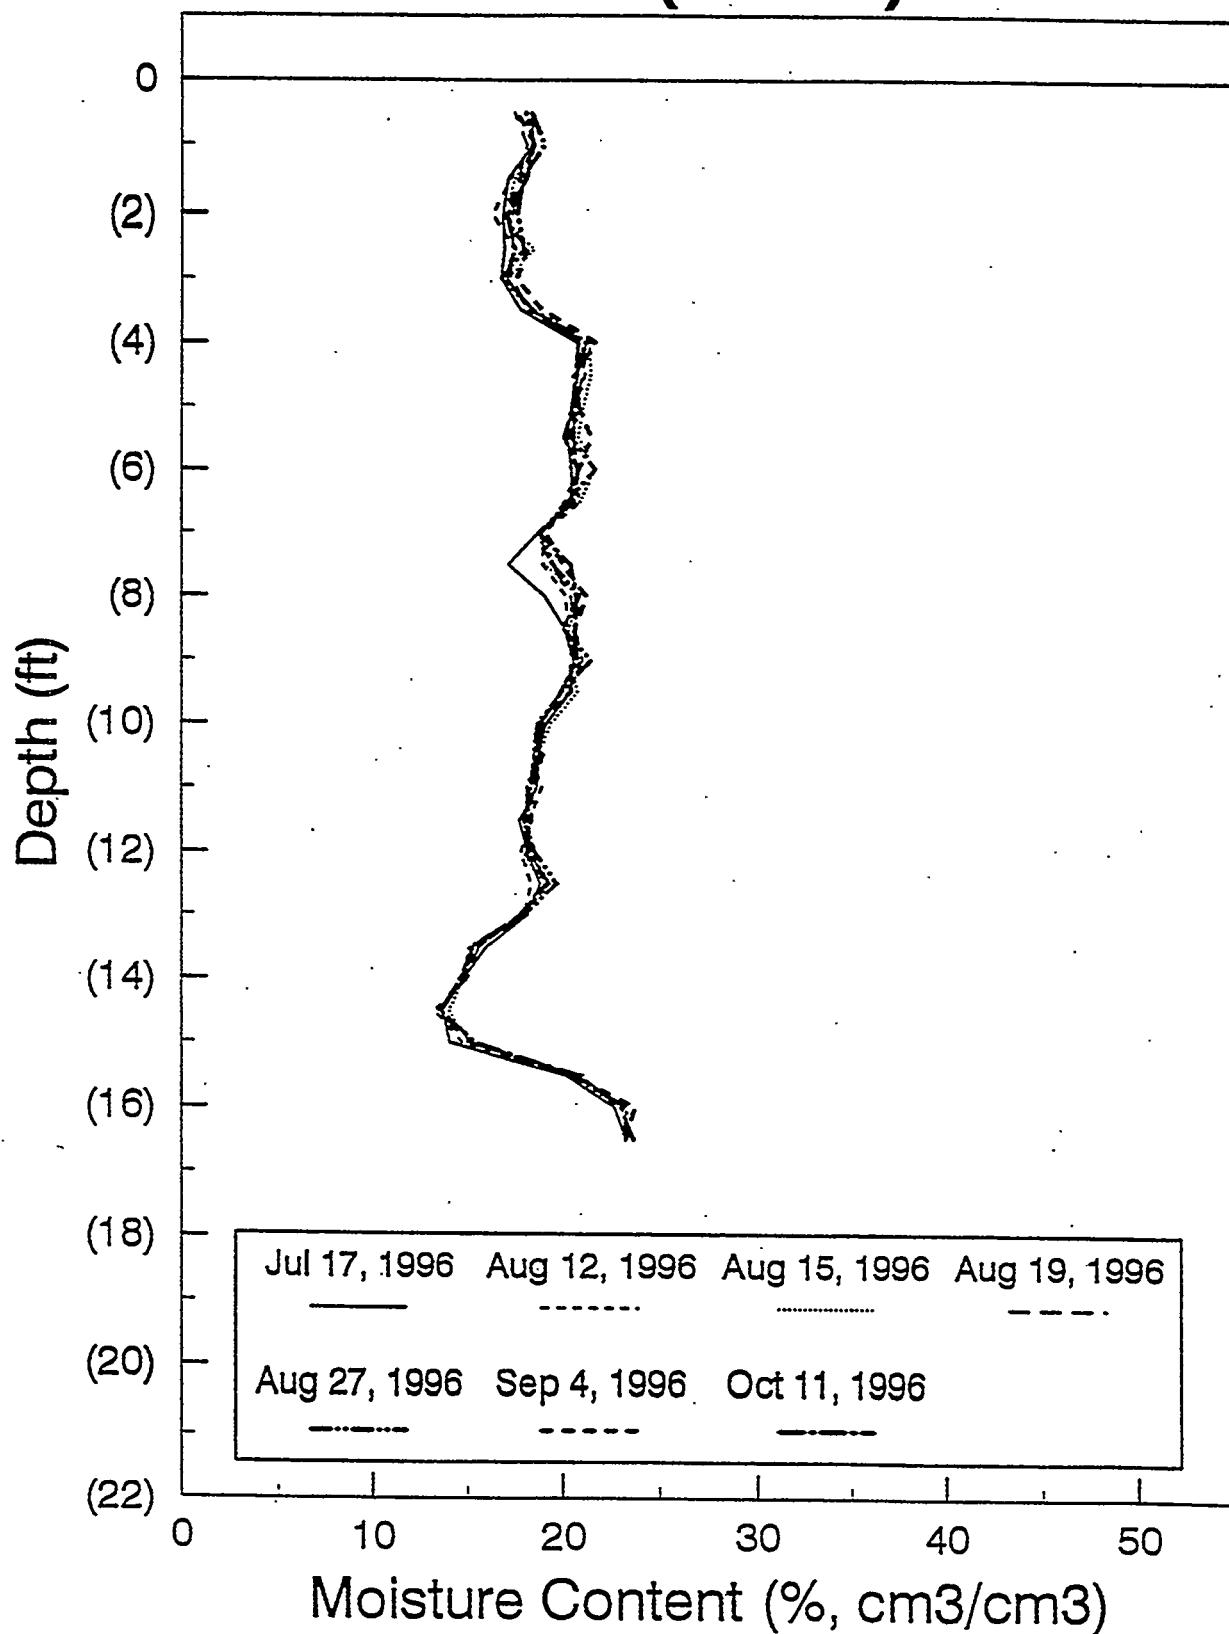
Figure E-6. Moisture content profiles for NAT-62.

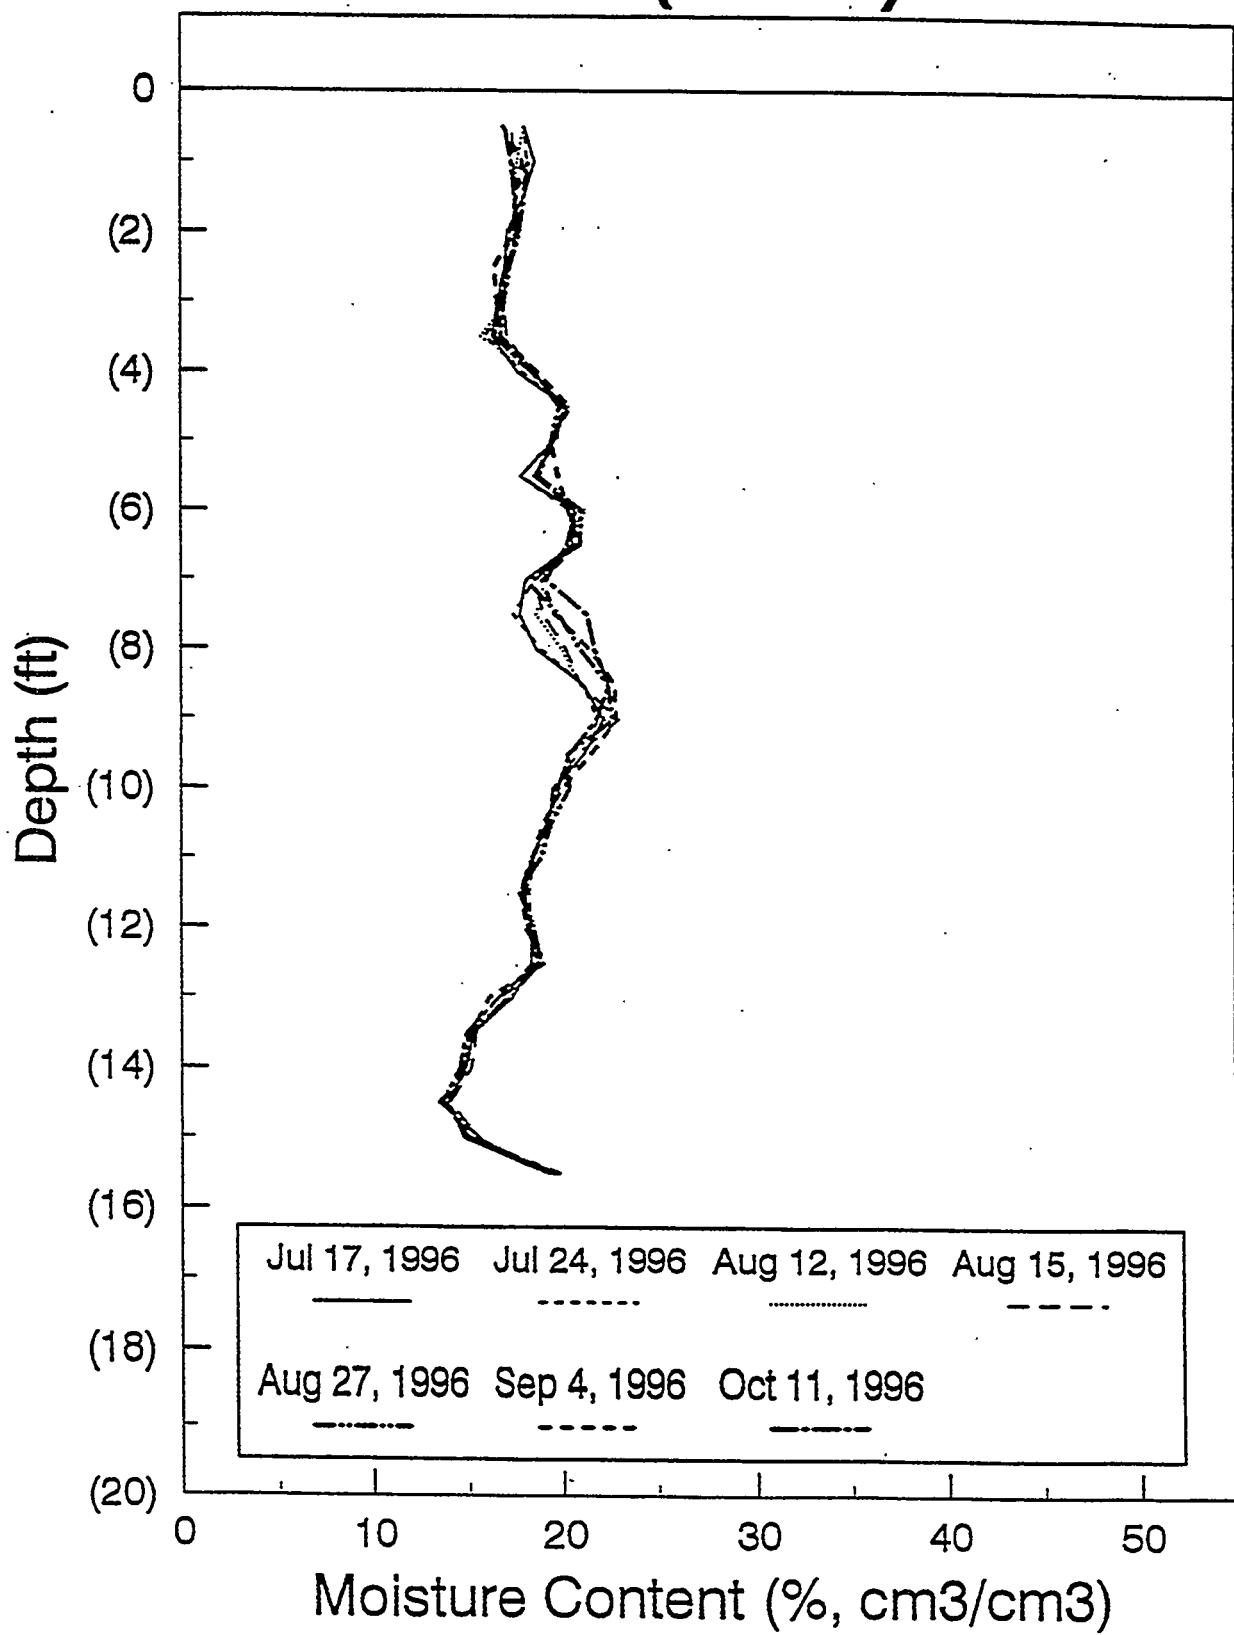
Figure E-7. Moisture content profiles for NAT-63.

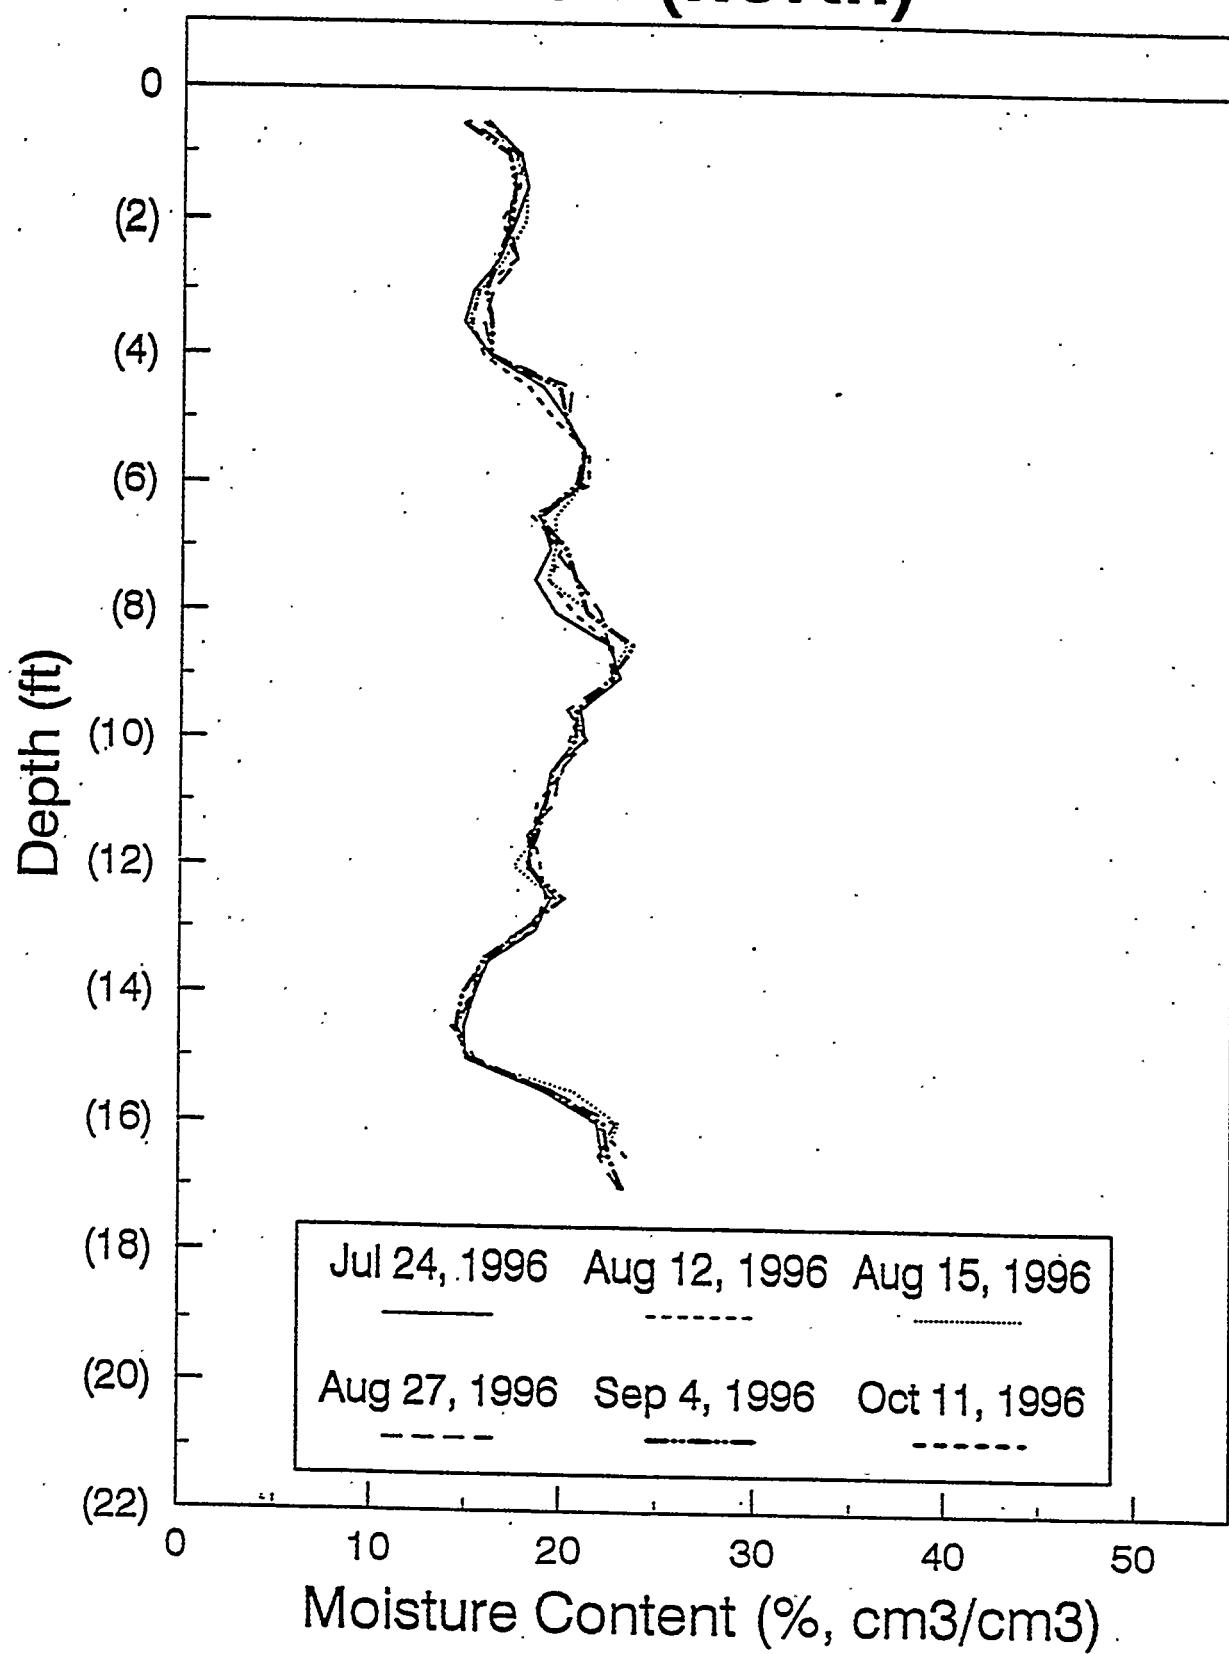
# NAT 64 (north)

Figure E-8. Moisture content profiles for NAT-64.
