INEL-96/0439

## **Innovative Subsurface Stabilization Project—Final Report**

**Idaho National Engineering Laboratory  
Environmental Restoration Technologies Department  
Lockheed Martin Idaho Technologies Company  
Idaho Falls, Idaho 83415**

**Prepared for the  
U.S. Department of Energy  
Assistant Secretary for Environmental Management  
Under DOE Idaho Operations Office  
Contract DE-AC07-94ID13223**

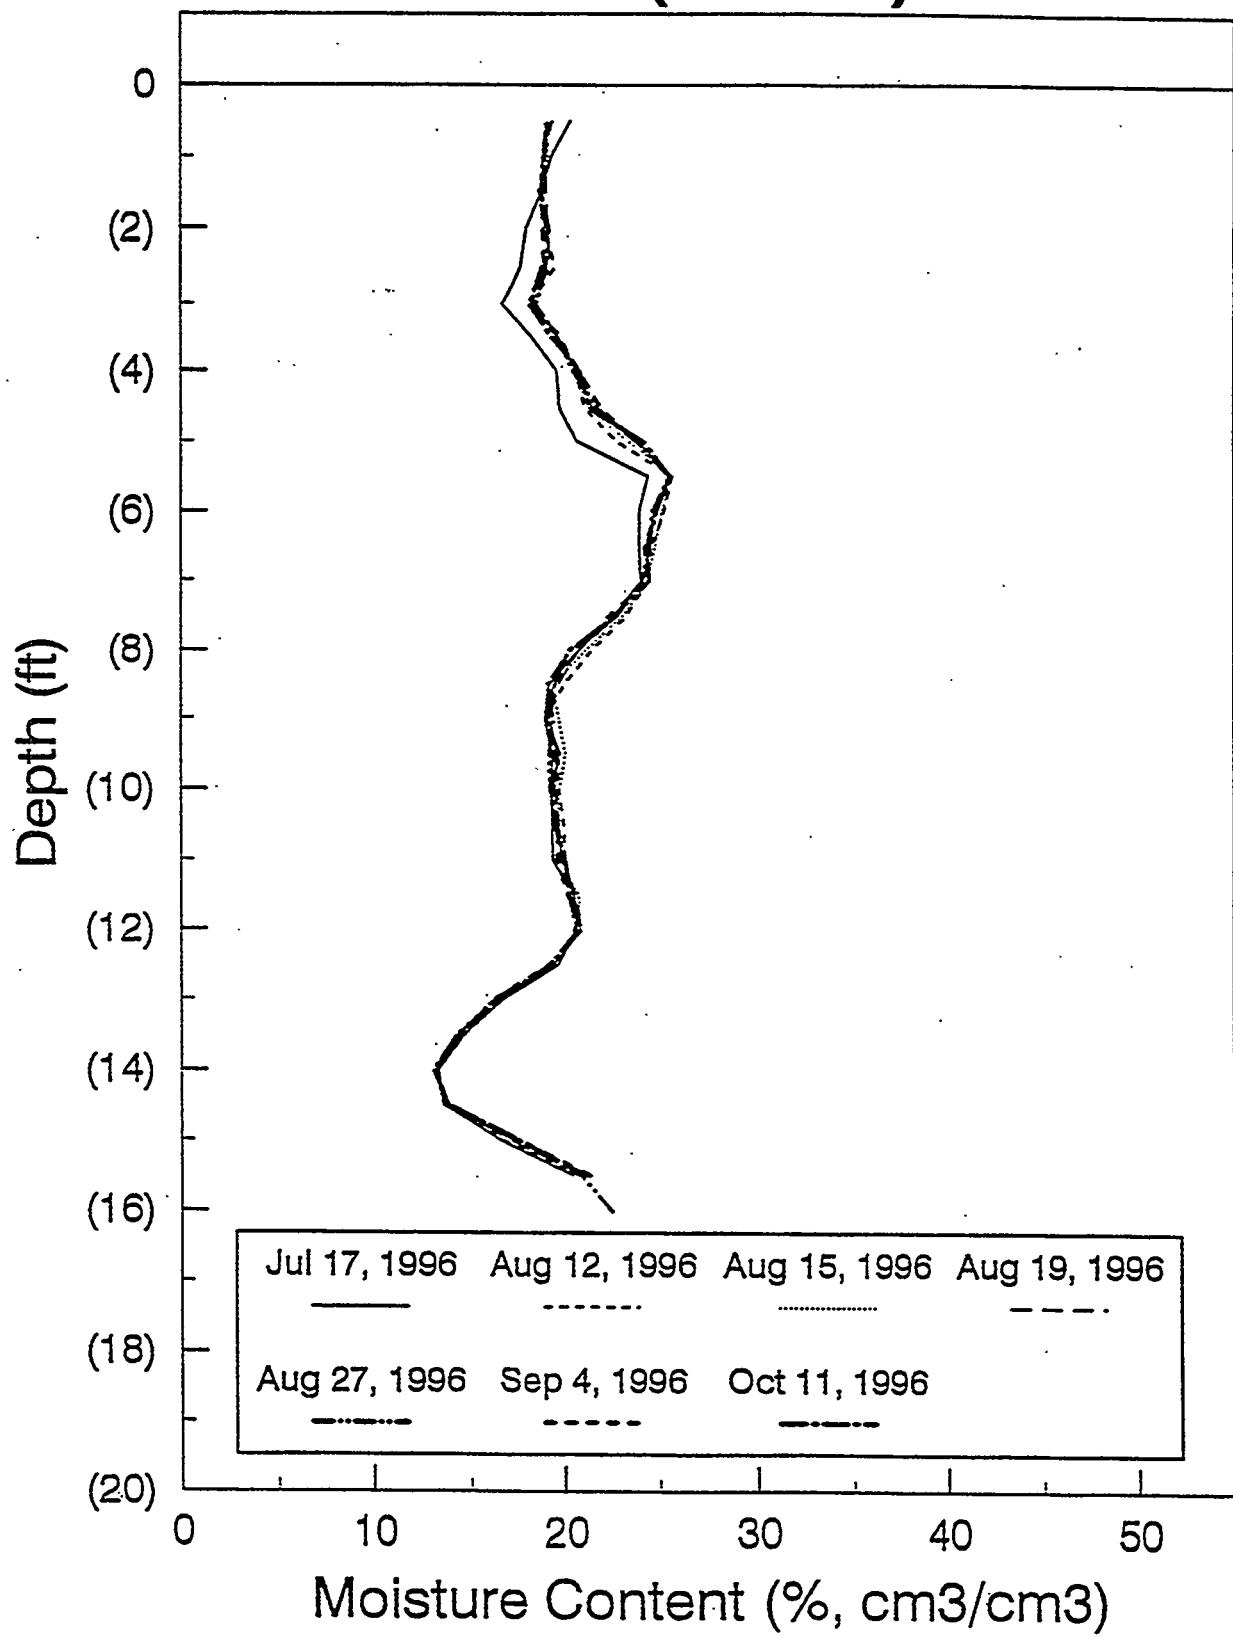
Figure E-9. Moisture content profiles for NAT-71.

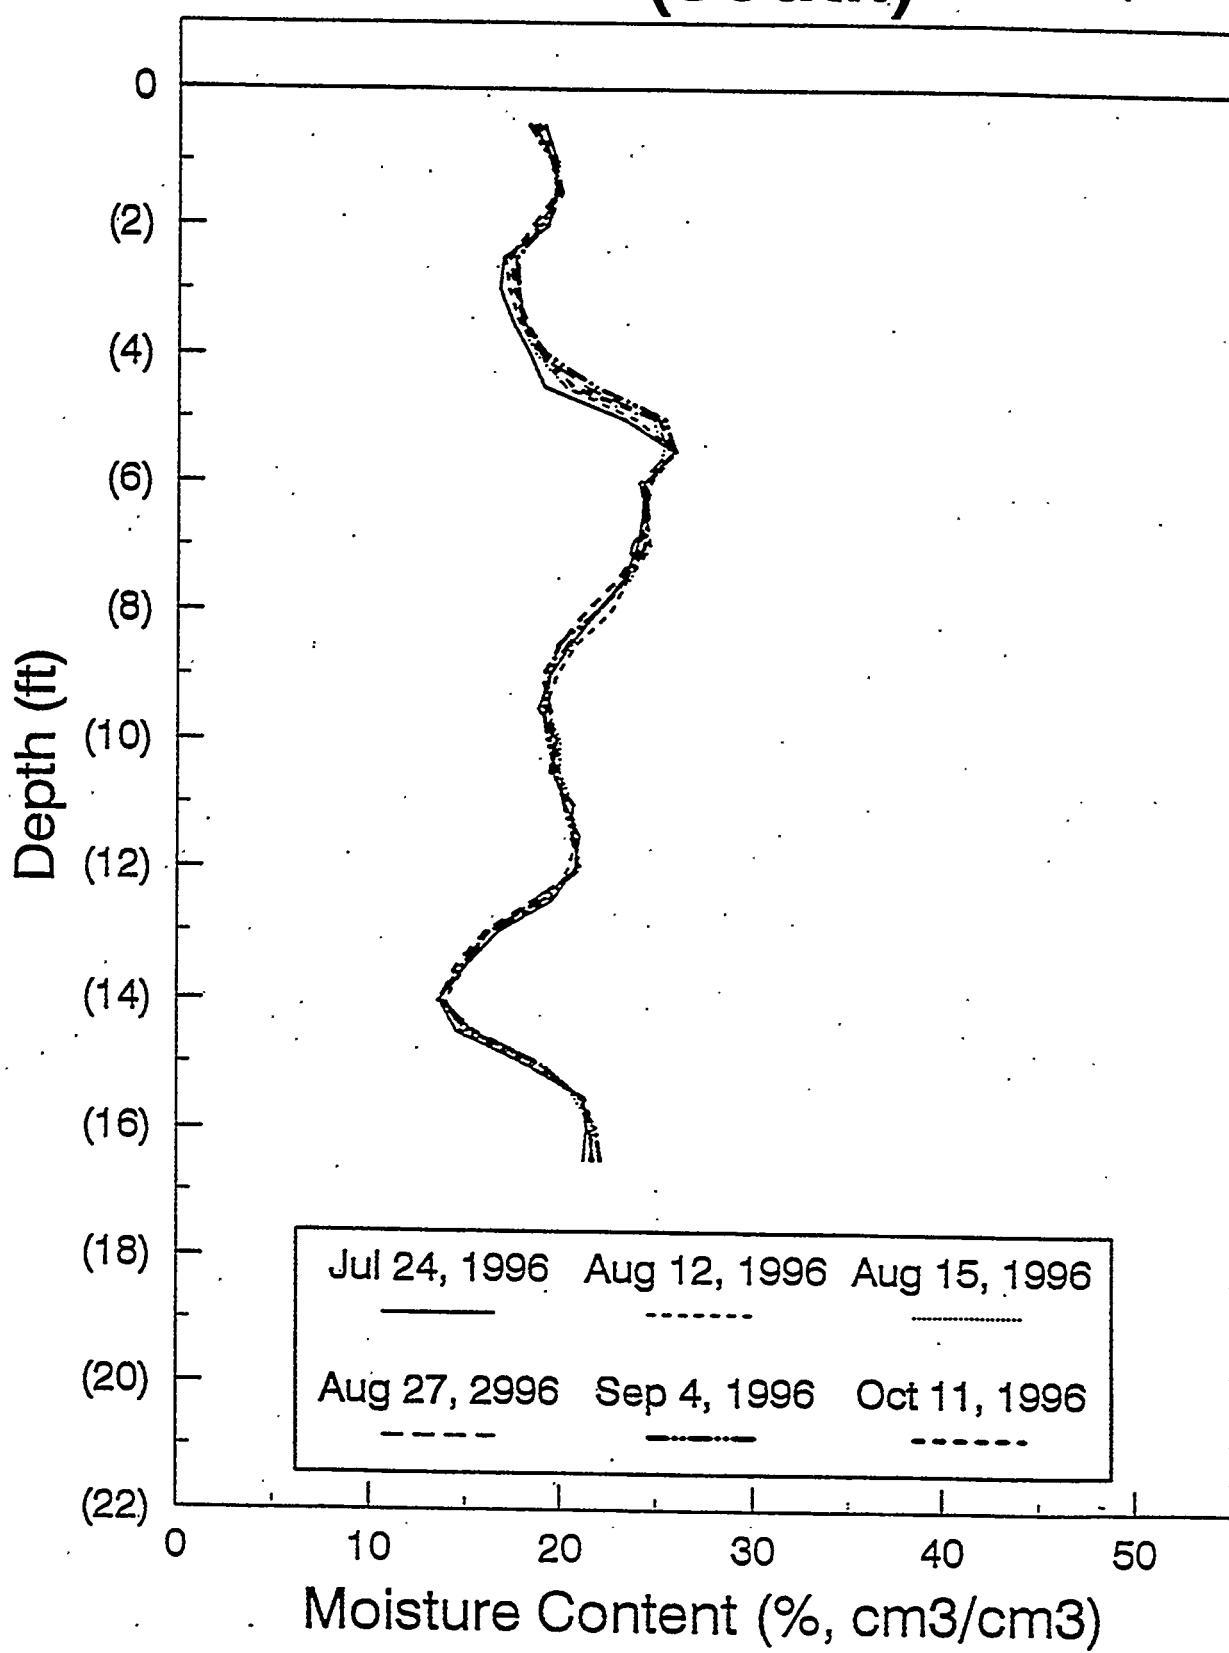
Figure E-10. Moisture content profiles for NAT-72.

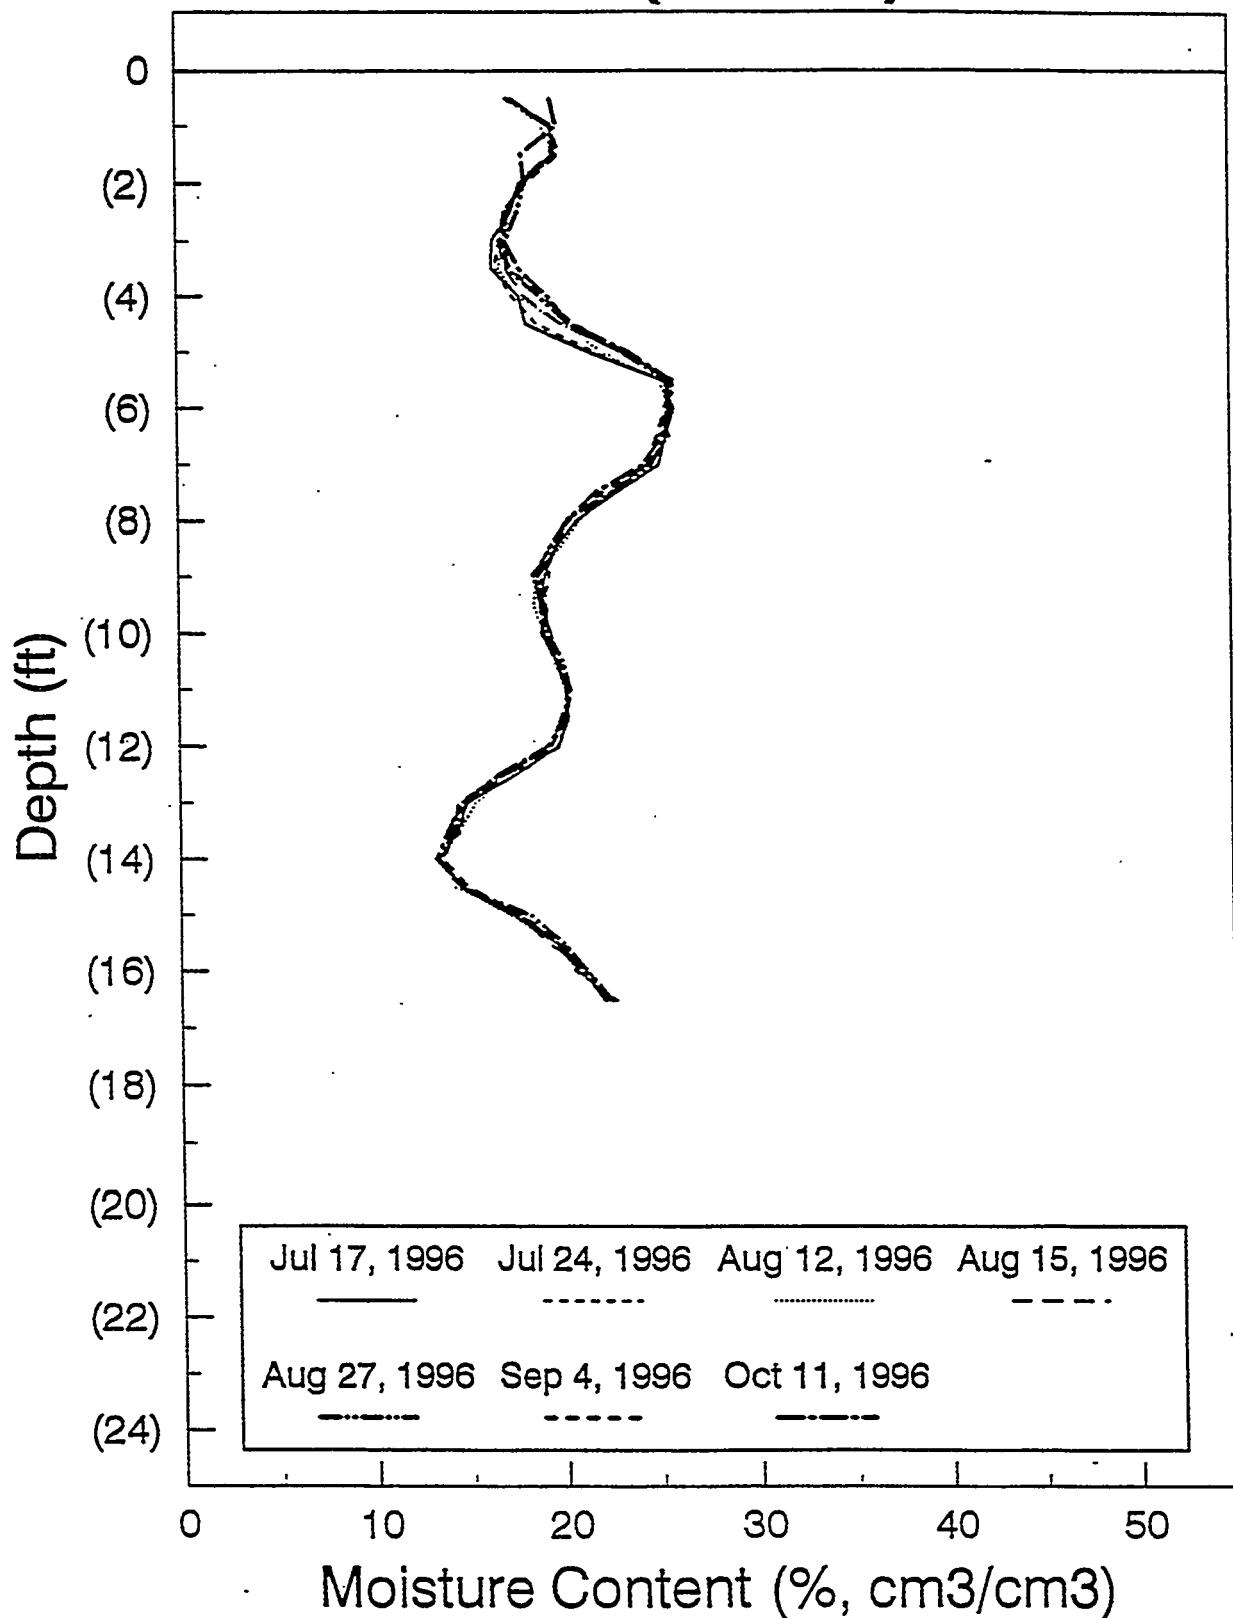
Figure E-11. Moisture content profiles for NAT-73.

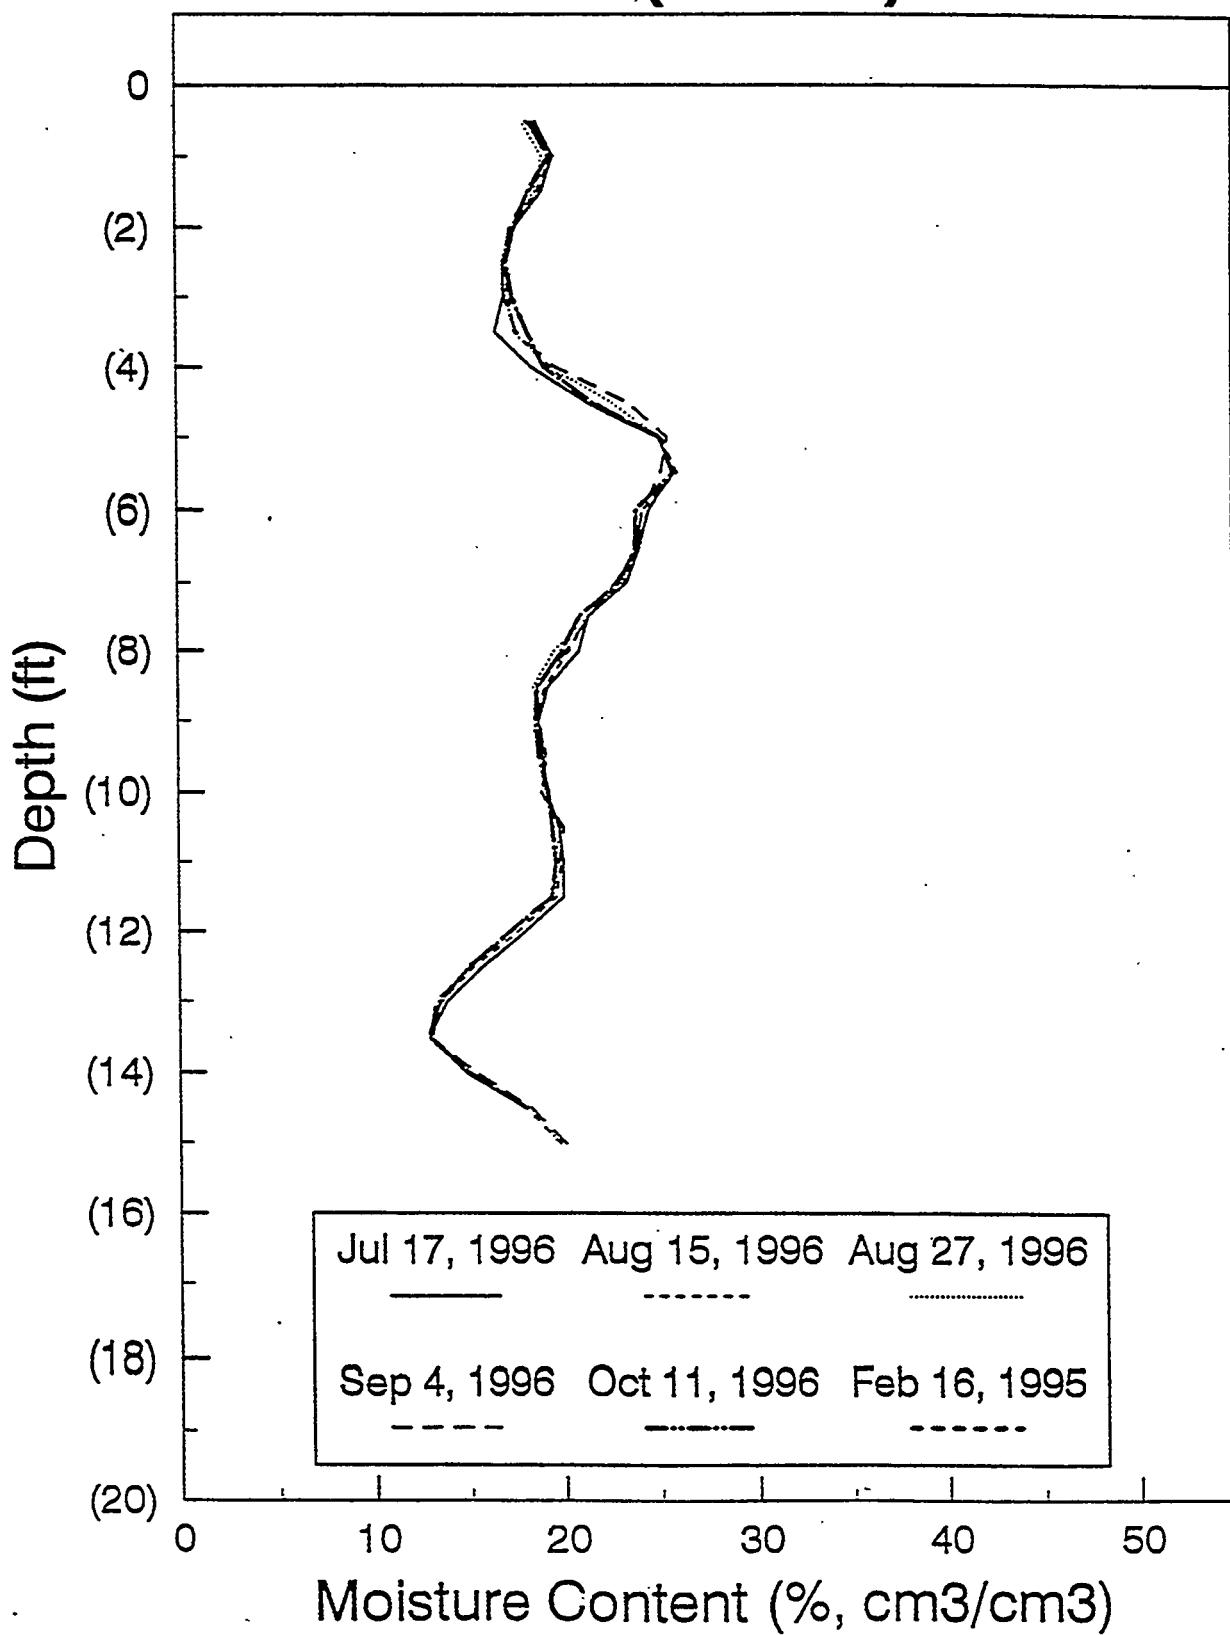
Figure E-12. Moisture content profiles for NAT-74.

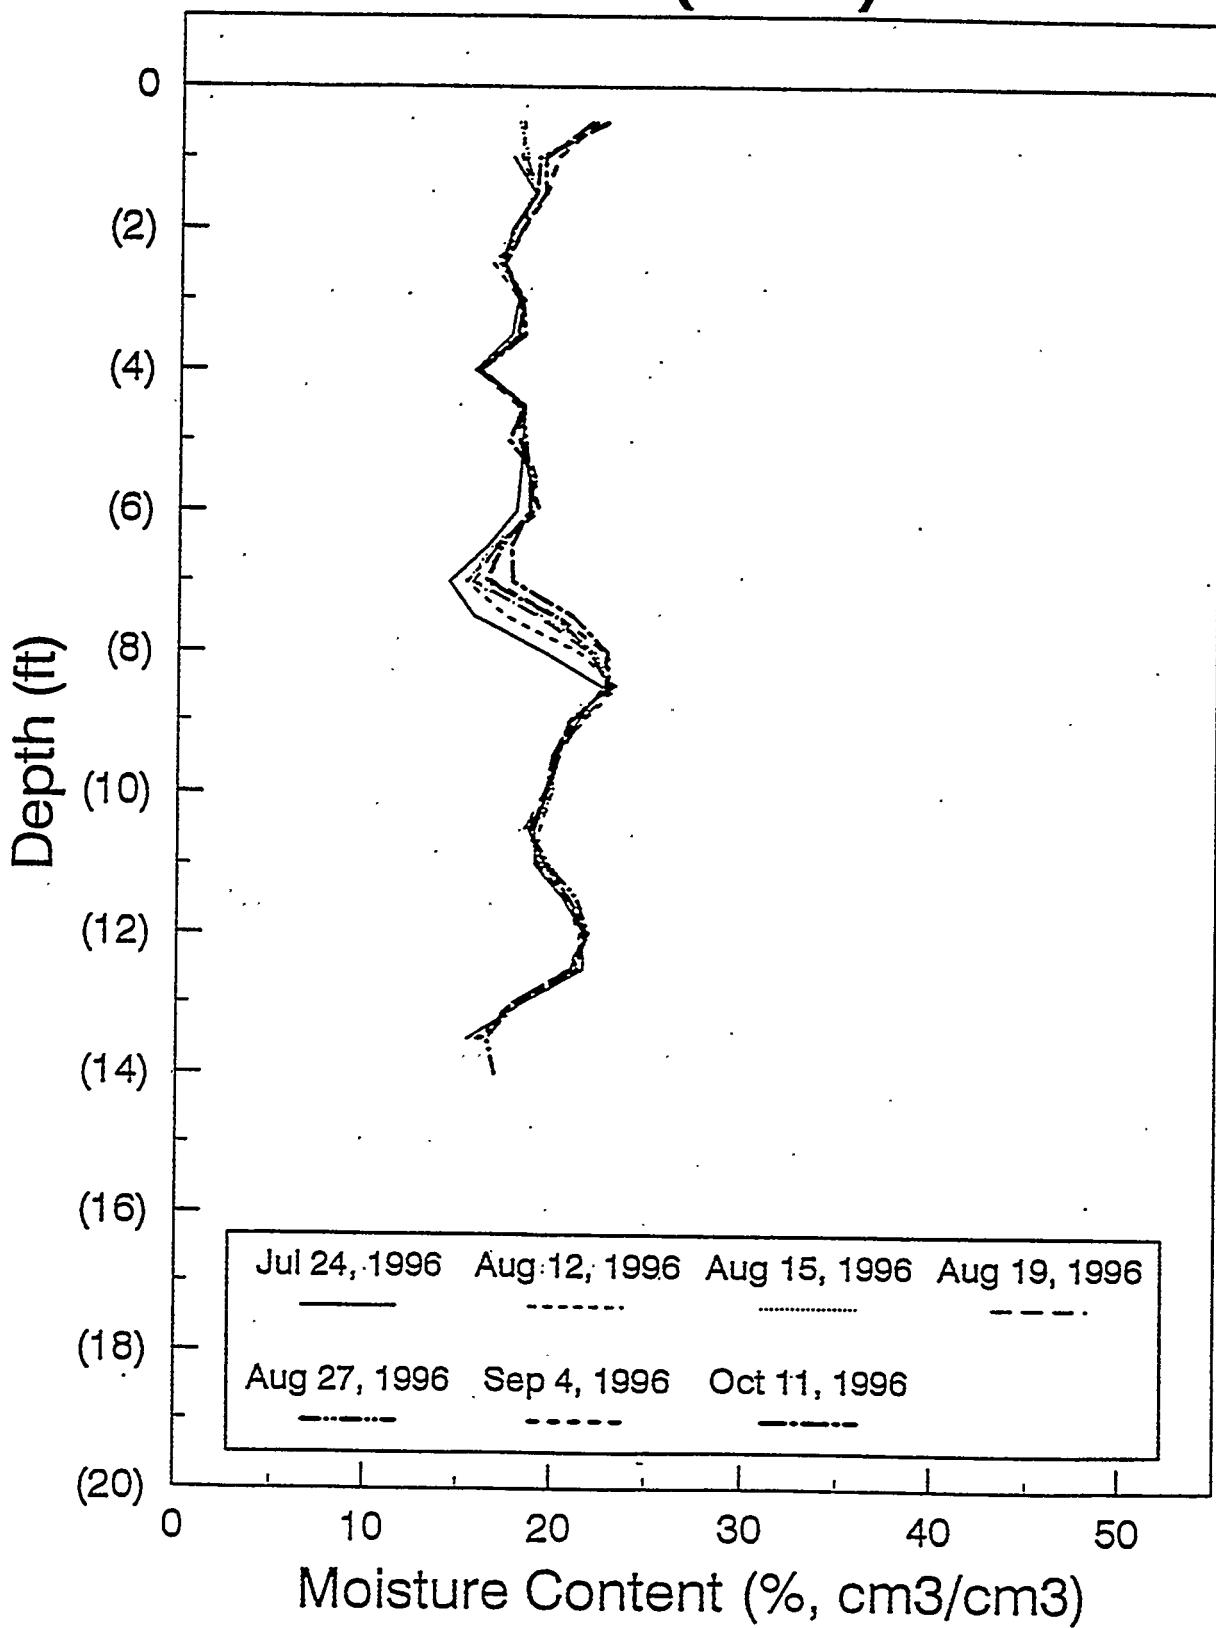
Figure E-13. Moisture content profiles for NAT-81.

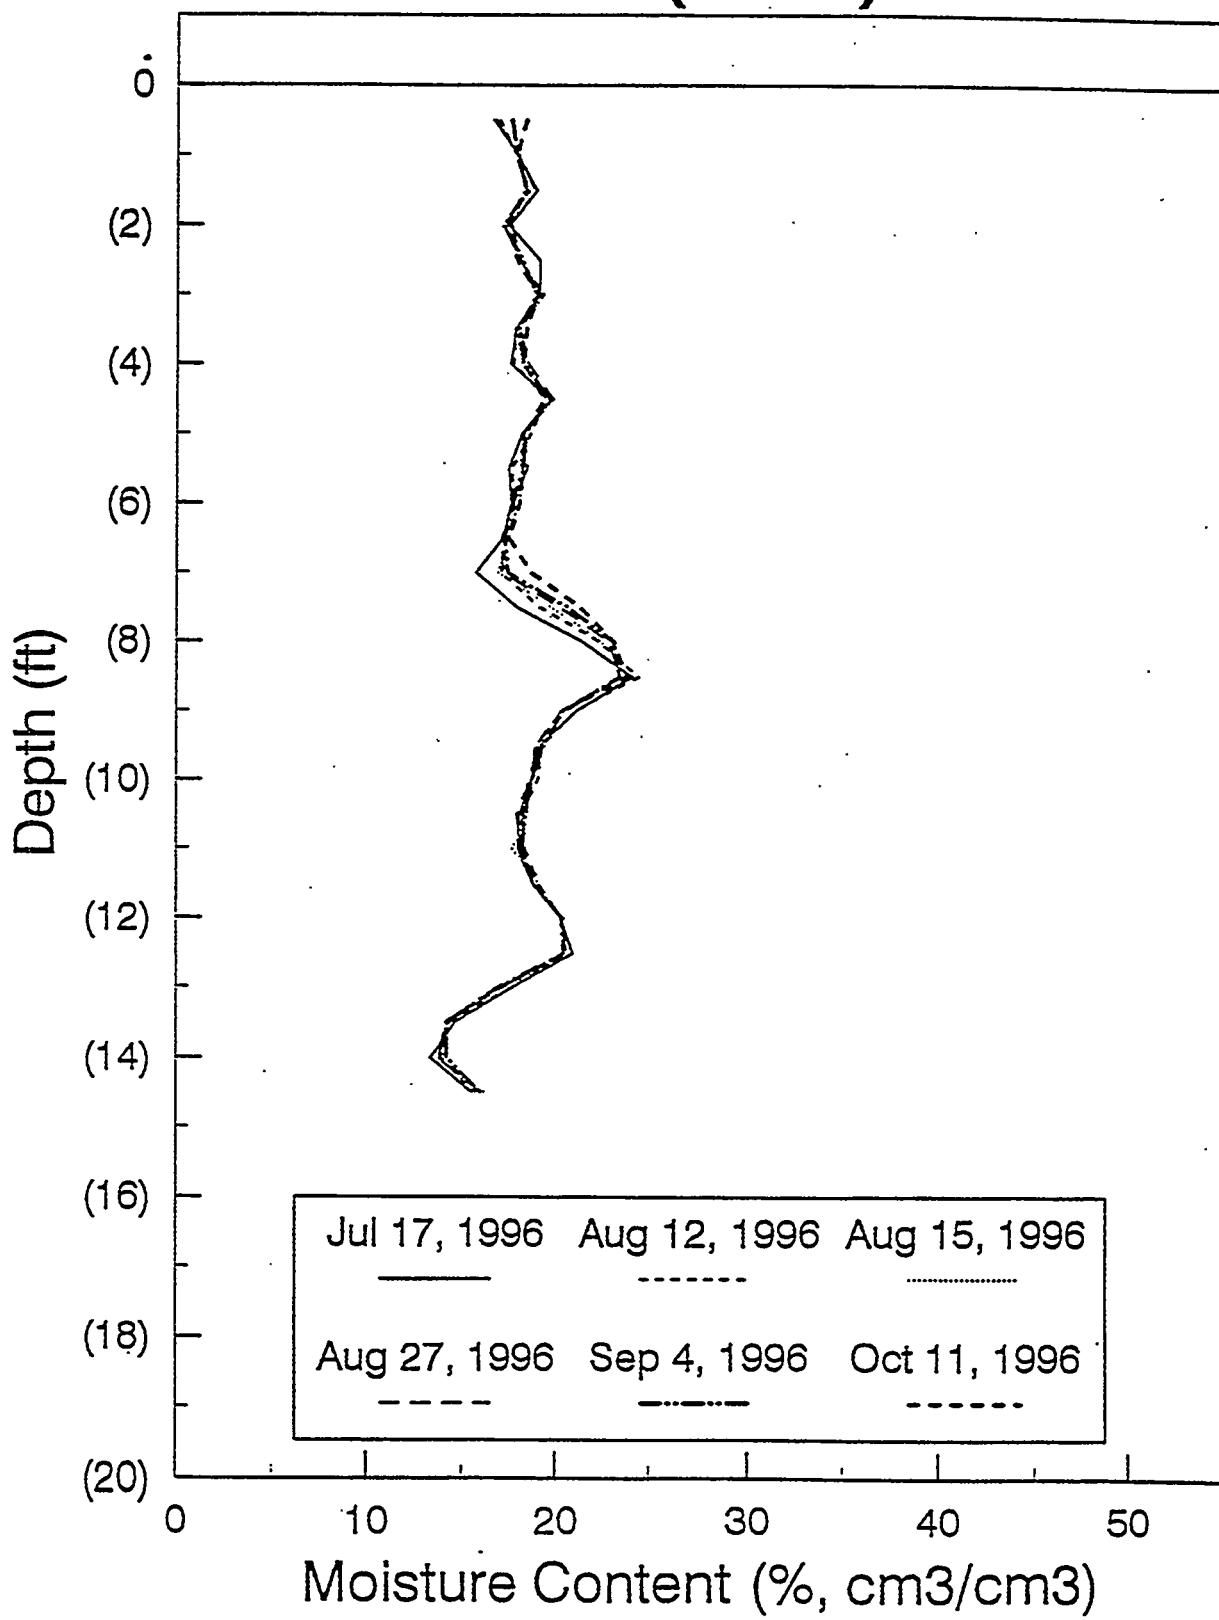
Figure E-14. Moisture content profiles for NAT-82.

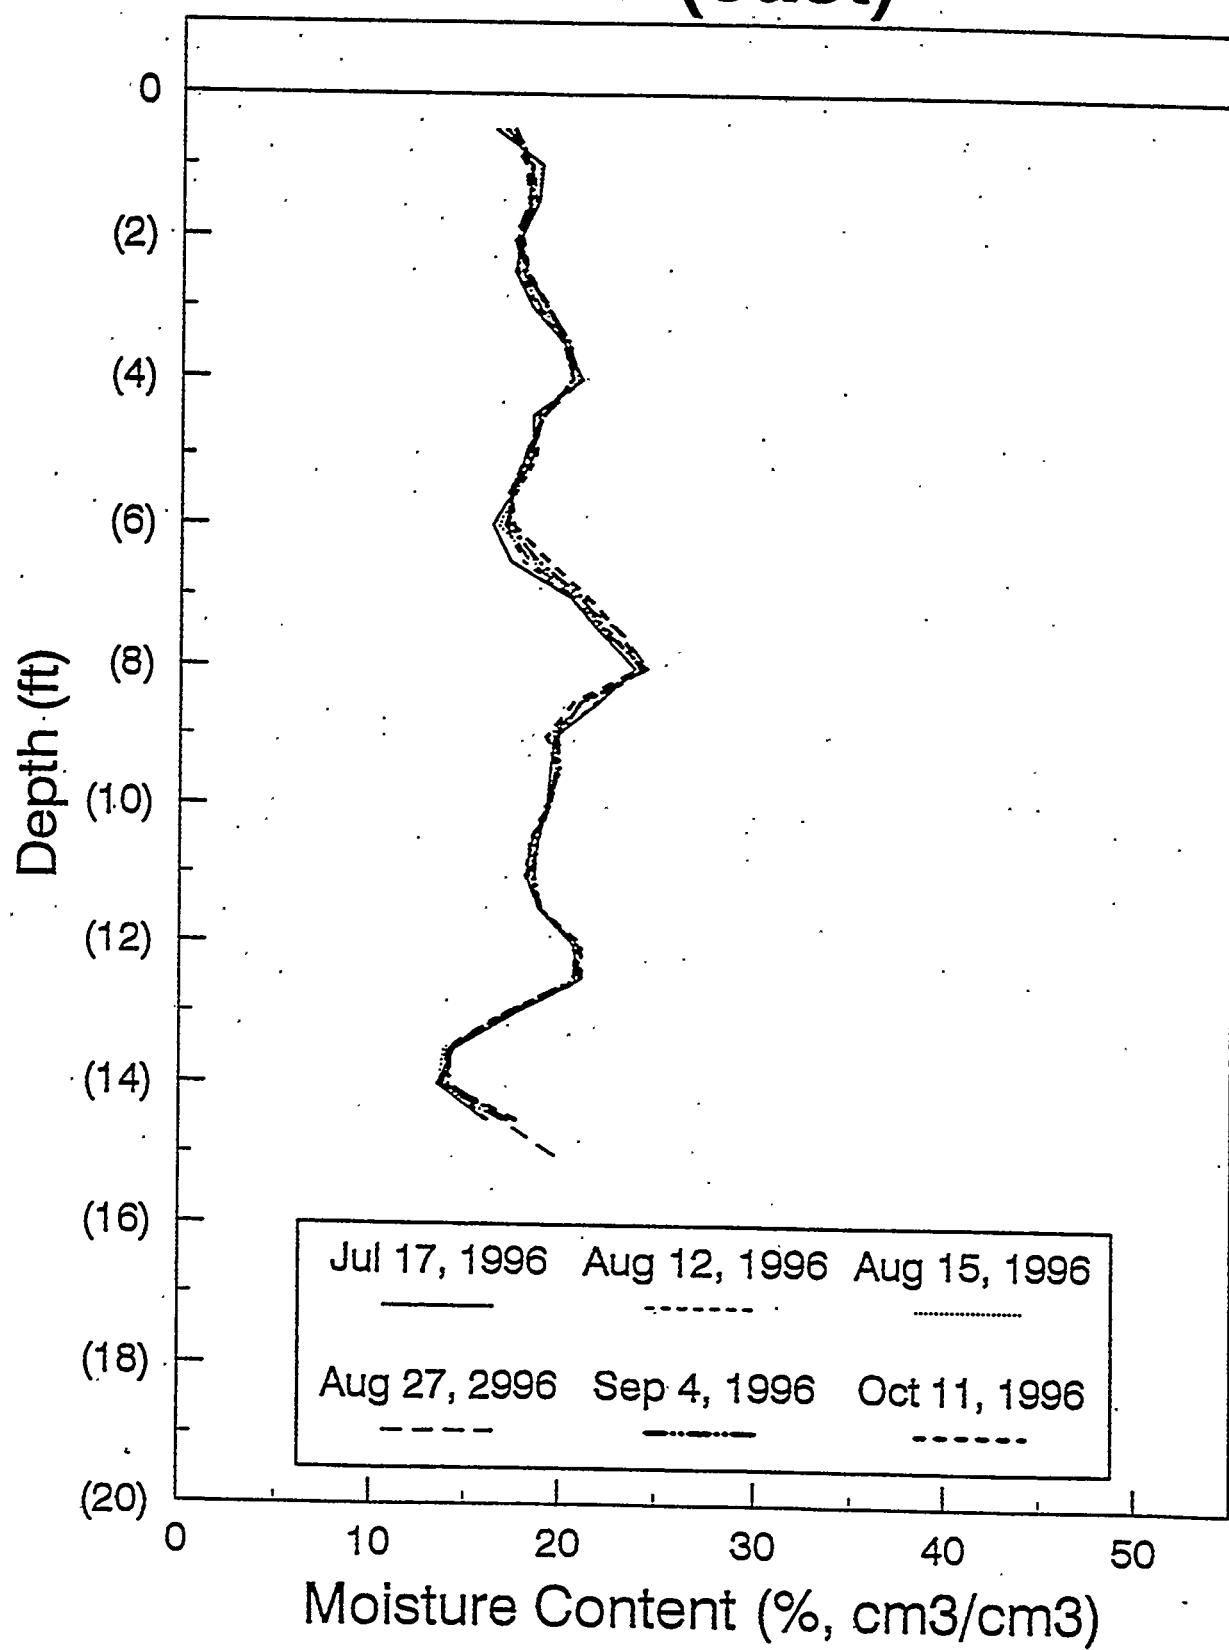
Figure E-15. Moisture content profiles for NAT-83.

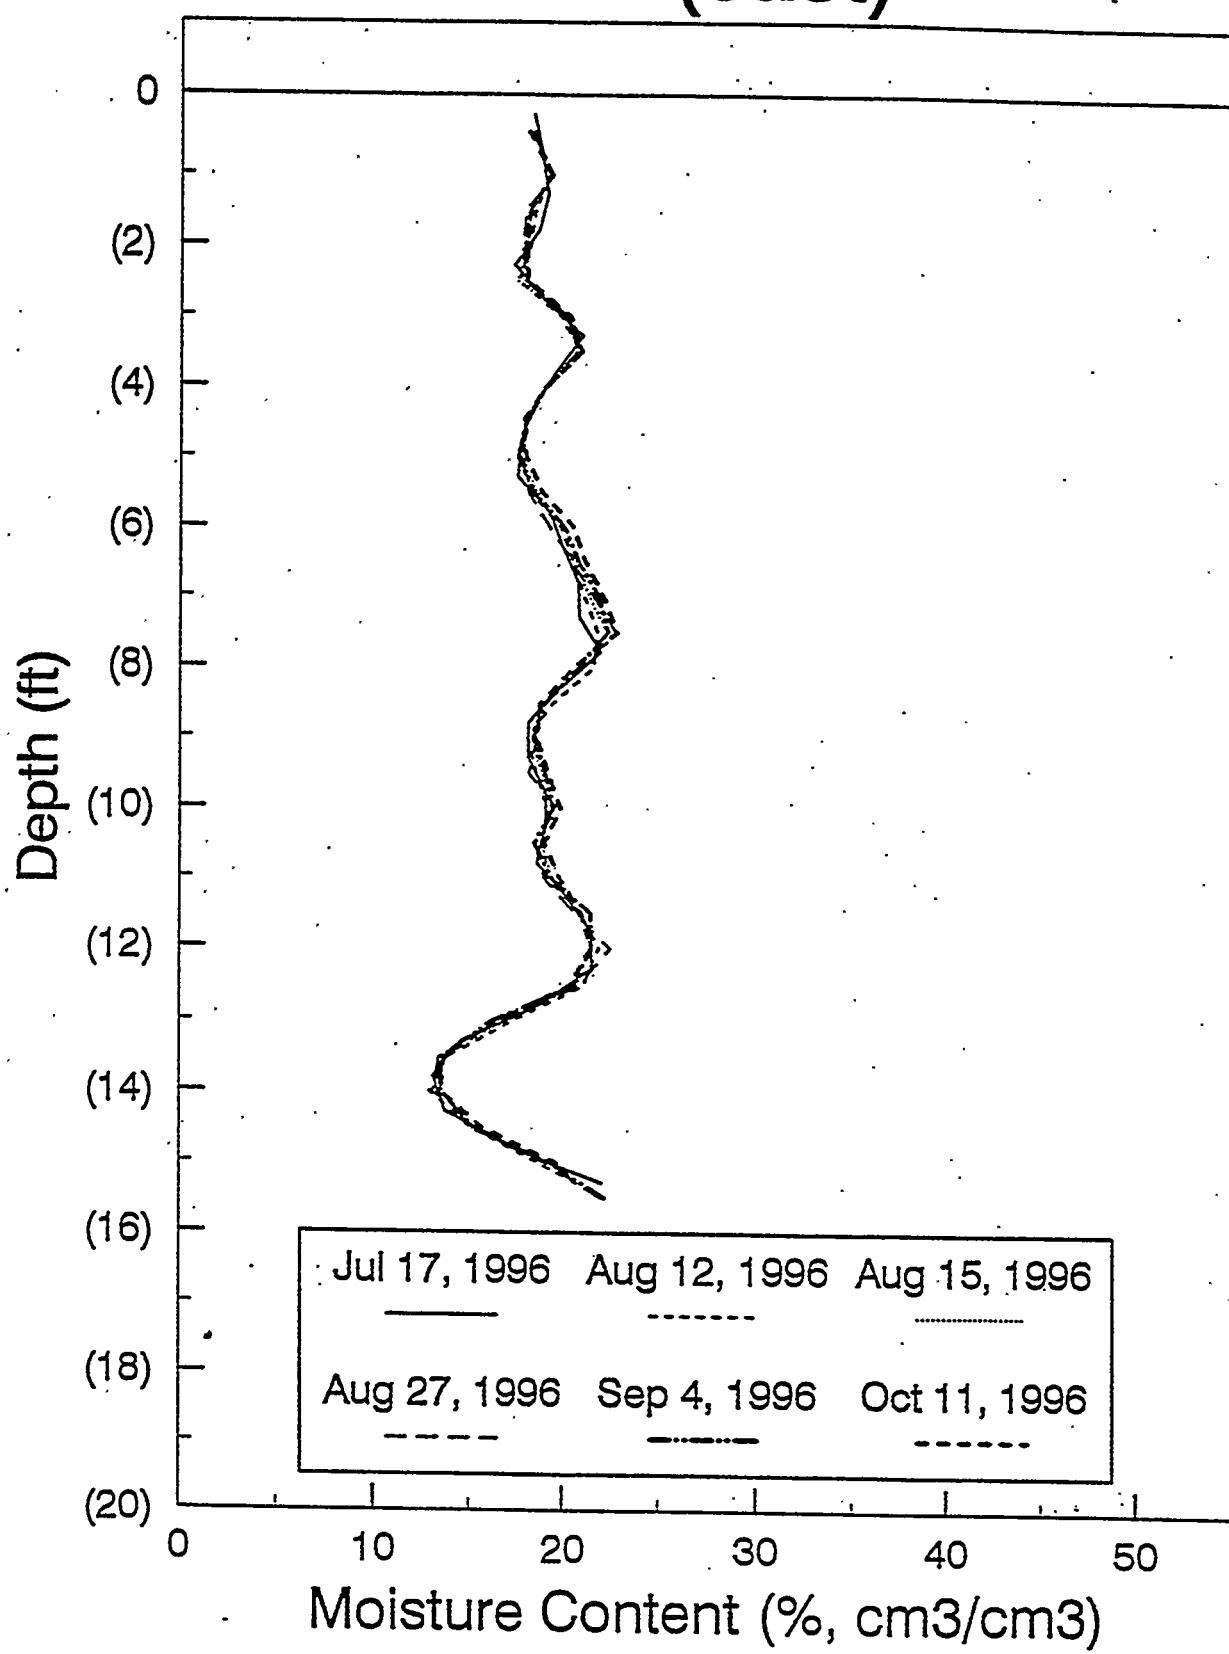
Figure E-16. Moisture content profiles for NAT-84.
