**PLEASANT BAYOU
GEOPRESSURED/GEOTHERMAL
TESTING PROJECT
BRAZORIA COUNTY, TEXAS**

FINAL REPORT

JULY 1985

**FENIX & SCISSON, INC.
1401 S. BOULDER
TULSA, OKLAHOMA 74119**

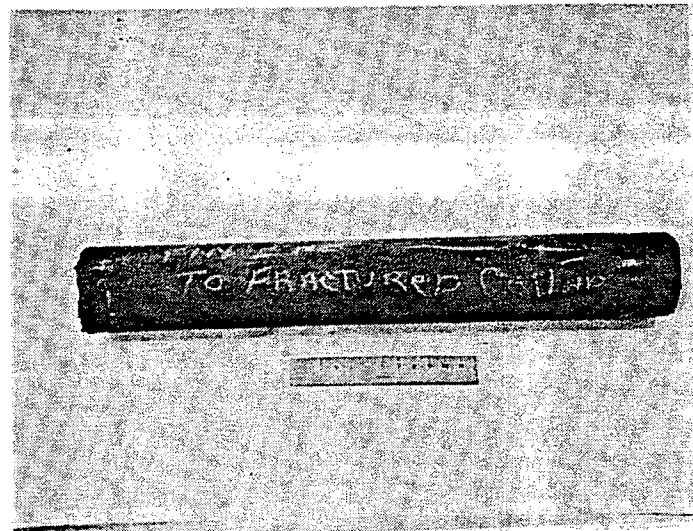
Figure 2-2. The Mating Mill-End of Tubing Which Fell from the Fractured Coupling.

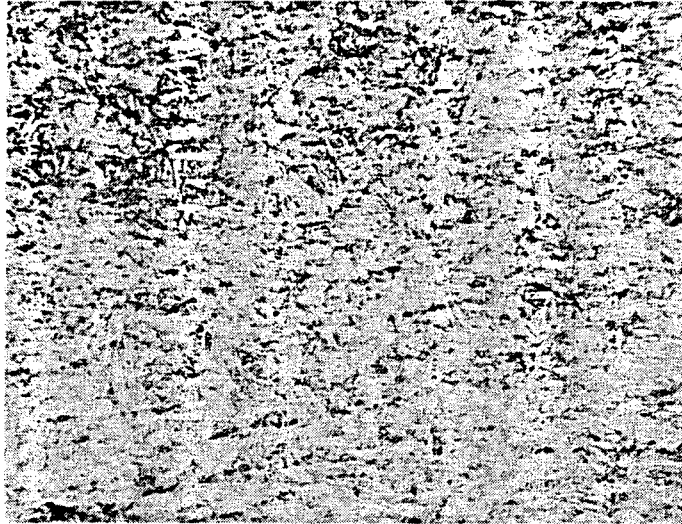
Magnification: 400X
Etch: 2% Nital

Figure 2-7. Photomicrograph from a Radial Section of the Failed Coupling. The microstructure is a finely divided, tempered martensite.

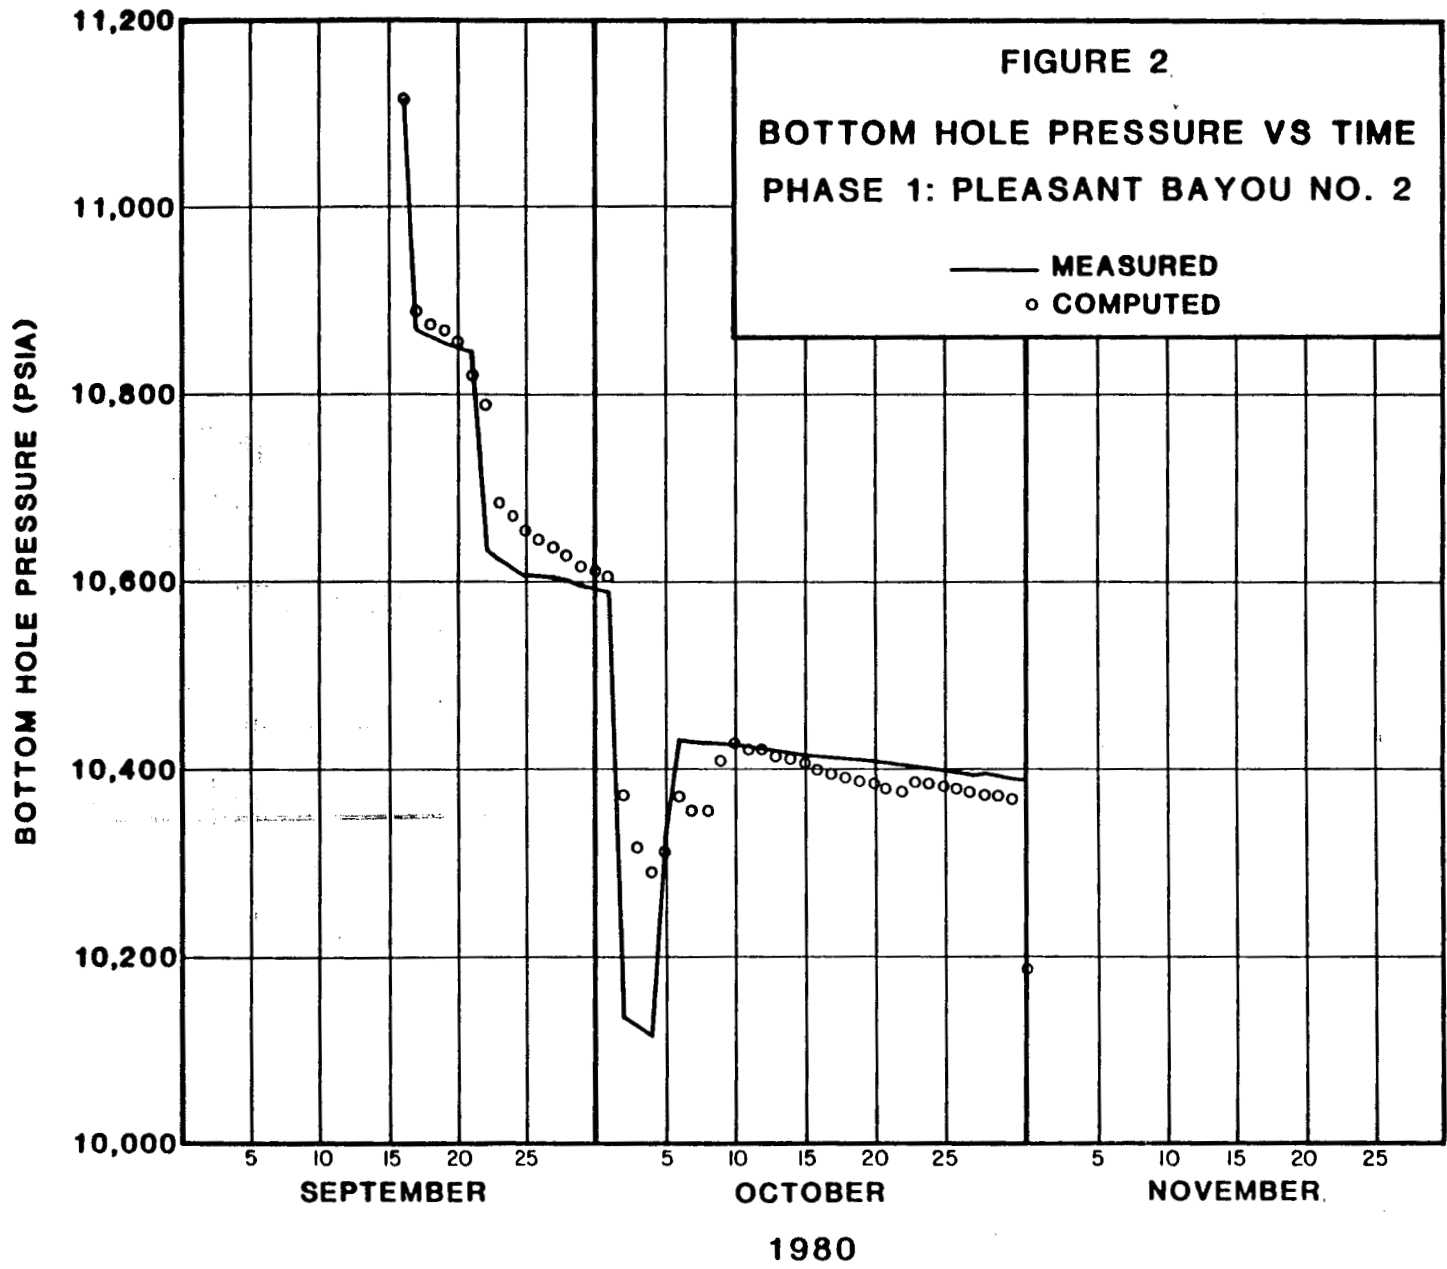
Figure 2. Bottomhole pressure vs time, Phase 1: Pleasant Bayou No. 2.

In working with the data and attempting the history matches, it became evident that the pressure performance of the phase-two test was influenced by either a wellbore phenomenon or some near-wellbore effects within the reservoir. These effects were manifested in a "skin effect" which appeared to increase as a function of time. When the skin effect at the wellbore was increased as a function of time, a satisfactory history match of all three phases was achieved using the aquifer description as shown in Figure 1. The measured and computed histories as a function of time are shown in Figure 2 through 5, inclusive.
