# Improved Ultrasonic Inspection Method for Stainless Steel Piping

NP-1153-SR  
Research Project 892

Special Report, August 1979

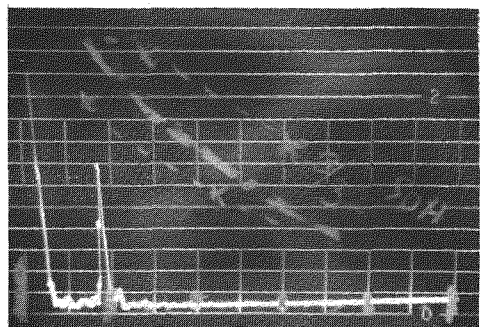
RESULTS WITH 1024A PARALLEL AND SKEWED  
Figure A2-3

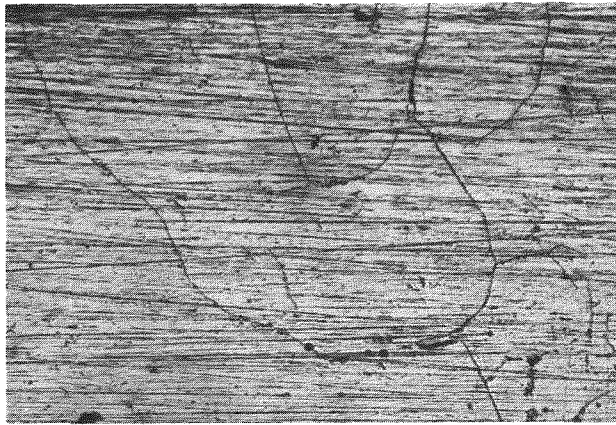
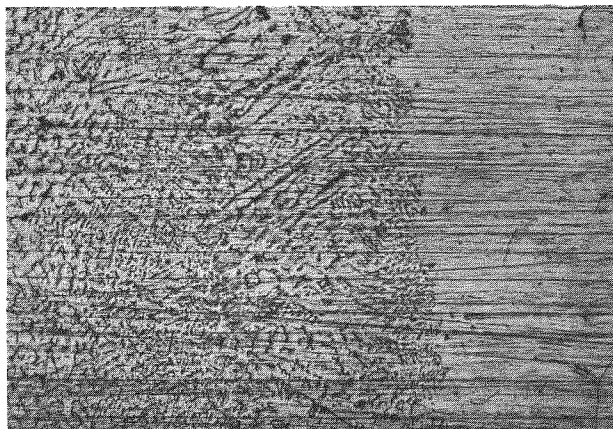
Base Metal

Weld Metal

Heat Affected  
Zone

FIGURE A3-3: MICROGRAPH OF 26 INCH PIPE MATERIAL
