NONDESTRUCTIVE EVALUATION TECHNIQUES
FOR
SILICON CARBIDE HEAT-EXCHANGER TUBING

ARPA/AFML Review of Progress in Quantitative NDE

ARGONNE NATIONAL LABORATORY, ARGONNE, ILLINOIS

NONDESTRUCTIVE EVALUATION TECHNIQUES FOR SILICON CARBIDE HEAT-EXCHANGER TUBING*

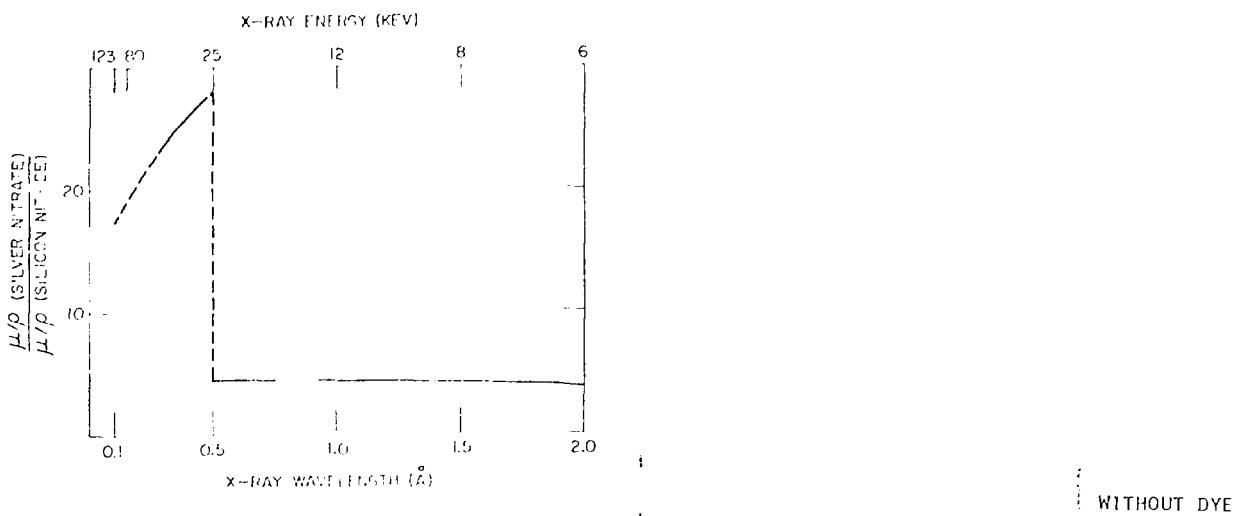
Fig. 1. Ratio of Mass Absorption Coefficients for Silver Nitrate and Silicon Nitride.

The dye-enhanced radiographic method is based on the filling of surface defects with a substance that will absorb penetrating radiation more effectively than the base material. Thus, surface defects, such as cracks and pitting, which are not generally revealed by ordinary radiography may become detectable when a dye is present. Dye enhancement has been most successfully used in conjunction with neutron radiography.⁵ However, x-radiography is a more convenient technique. For x-radiography, the most effective doping agent found in the present investigation was a solution of silver nitrate and water (equal parts by weight). Figure 1 shows the ratio of mass absorption coefficients for silver nitrate and silicon nitride as a function of x-ray energy and wavelength. Silver nitrate absorbs x-rays approximately 20 times more strongly than silicon nitride; the ratio for silver nitrate and silicon carbide is similar. The absorption edge for silver results in a peak in the ratio of mass absorption coefficients at an energy of about 75 keV. The best contrast for silicon carbide was obtained at an x-ray energy of about 50 keV. The results obtained with a CVD silicon carbide tube approximately 1 mm thick, examined by radiography and subsequent metallographic sectioning, are typical. The largest crack (50 μm through the wall) found after sectioning was revealed by ordinary radiography, but four other cracks were revealed only by dye-enhanced radiography. Since good photographic reproductions of these radiographs were not obtainable, a similar result obtained from a cracked flexiclass rod x-rayed with and without silver nitrate penetrant is shown in Fig. 2. The x-ray with the doping agent clearly shows numerous cracks that are not otherwise visible.

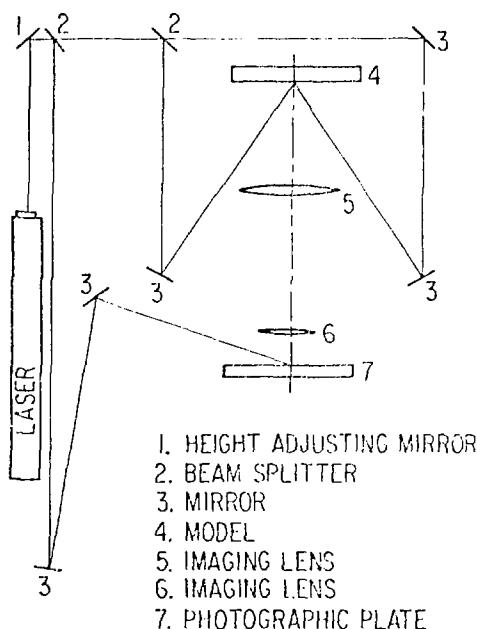
Fig. 3. Schematic Representation of Holographic Interferometry System.

The specific objective of the holographic interferometry effort is to assess the applicability of this technique to the detection of cracks in ceramic heat-exchanger tubing. Figure 3 shows a schematic representation of the optical system. Lens techniques are utilized to facilitate the application of double-base holography and to allow for reconstruction with a less coherent source when a reduction of the speckle noise is needed.

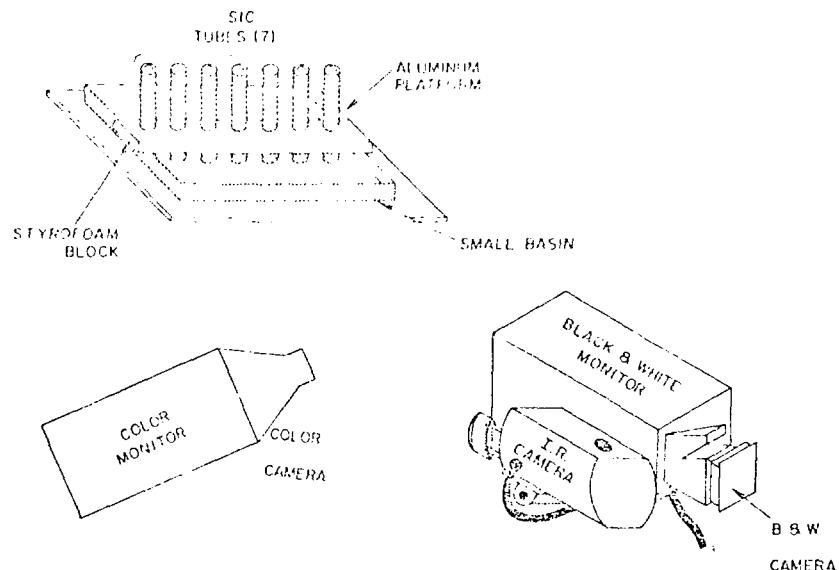
Fig. 6. Schematic of Infrared Scanning Apparatus

2. Experimental Measurements - Axial heat flow was examined in samples of silicon carbide heat-exchanger tubing to determine whether flaws in the tubes could be detected and to compare the thermal properties of different tubes. The experimental apparatus is shown in Fig. 6. Water flows into the basin and circulates freely to maintain a uniform temperature. A Styrofoam block holds the tubes in an upright position, with one end of each tube immersed in the water bath to a depth of ~ 3 cm. This allows simultaneous comparison of the temperature distributions produced by axial heat flow in several tubes. Data were obtained by making thermograms with an ACA Thermovision 750 IR camera, which is capable of resolving temperature differences of 0.2°C , and reading isotherm units from the color IR monitor. When quantitative measurements were made using the isotherm controls, a thermometer, with the mercury bulb sprayed with graphite, was heated with a heat gun to provide a reference temperature. Figure 7 shows a typical thermogram (initially in color) of the transient temperature distribution during axial heat flow. The different colors can be related to the surface temperature. As shown in Fig. 7, each tube had a unique heating rate. The temperature distribution in tube 4, which was severely cracked by thermal quenching, differs markedly from that of tube 3, which was not cracked. (Before tube 4 was cracked, the temperature distribution patterns in the two tubes were similar.) To examine the differential heating of the tubes more thoroughly, a series of thermograms were made with the tubes in different sequences. It was found that the Norton NC430 tubes always conducted heat better than the Carborundum Super KT tubes. To estimate the actual temperature differences between the tubes, ΔT (Δ tube), the scale on the left side of the thermogram in Fig. 7 was divided into 10 isotherm steps, each represented by a different color. The calibration curve for isotherm units vs temperature is linear in the $30\text{--}50^\circ\text{C}$ temperature region. This implies that the color scale in the thermogram covers a 2°C temperature range. Analysis of Fig. 7 indicates that the NC430 tubes are $\sim 1^\circ\text{C}$ hotter at midheight than the KT tubes. According to data supplied by the manufacturers, the thermal conduc-

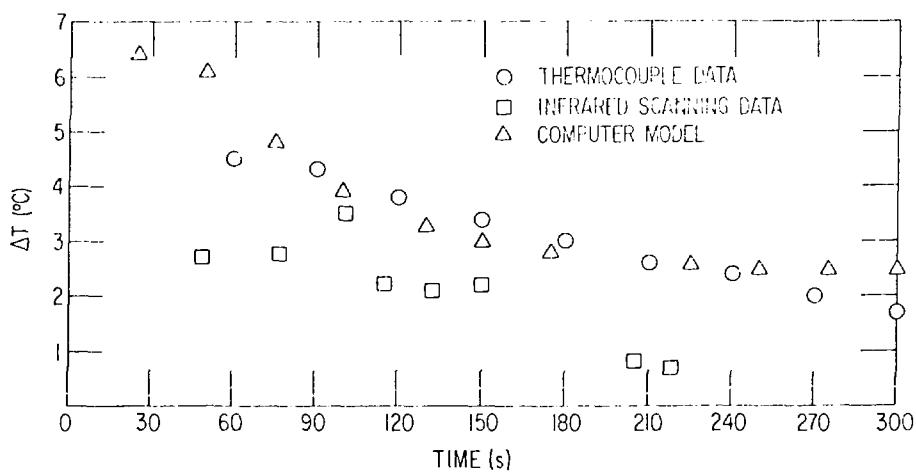
Fig. 8. Plot of $\Delta T(\Delta X)$ vs Time for Top and Middle Thermocouples, IR Data and Computer Model.

Three thermocouples were attached to tube 4 to obtain temperature-vs-time data at specific points along the tube. One thermocouple was attached to the top of the tube and the others 7.5 and 17.5 cm below the top using Hysol 820 conductive epoxy cement. Quantitative measurements made with the IR camera were compared with the thermocouple data, as well as with the computer-model predictions, to determine the adequacy of the IR camera for measuring temperature gradients. Figure 8 shows $\Delta T(t,x)$ for the top and middle thermocouples as a function of time. There was fair agreement with the computer-model predictions, the IR data, and the thermocouple data for elapsed times of ~ 100 s. For example, the value of $\Delta T(18)$, according to the thermocouples, is 3.5°C at 120 s. The IR data show a value of 2.2°C and the computer model shows a value of 3.3°C . However, as shown in Fig. 8, the IR scanning data show consistently smaller ΔT than the thermocouple and computer-model predictions. This can be attributed to the difficulty in reading the calibration curve on the color IR marker scale. The deviations from the model predictions for $t = 100$ s and $t = 250$ s are probably due to the inadequacy of approximating a hollow tube as a small-diameter rod and the difficulty in accounting for convective cooling (i.e., air natural convection) in determining θ .

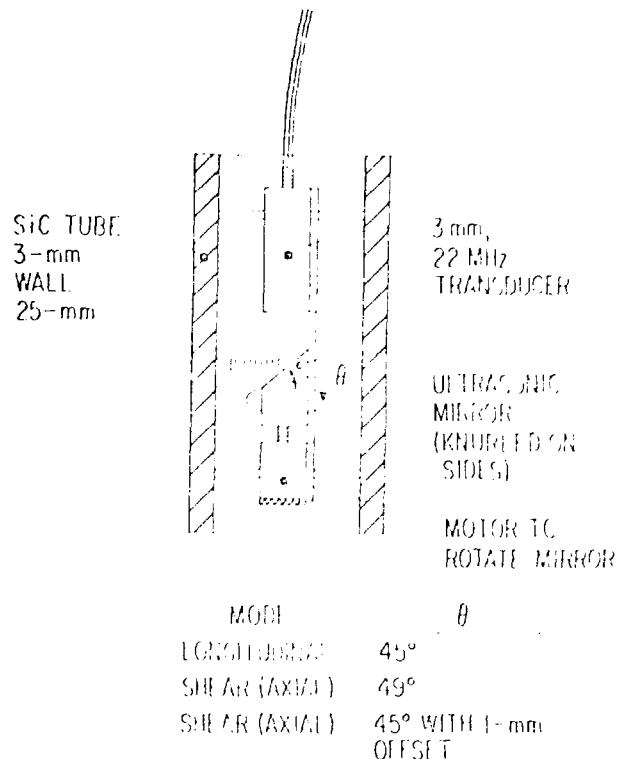
Fig. 9. Conceptual design for ultrasonic bore-icing inspection of silicon carbide tiles.

Efforts are underway to develop a transverse ultrasonic probe for silicon carbide tubes. The conceptual design for the ultrasonic inspection of straight tubes is shown in Fig. 9. A radio-frequency higher than that conventionally used for metal tubes is chosen in order that a resolution as small as ~ 100 μm can be resolved. The transducer is oriented parallel to the water-filled tube to generate waves axially down the tube. An acoustic mirror is placed below the probe to reflect the longitudinal beam to the wall for inspection of wall thinning or delaminations. For crack detection, the angle of incidence is adjusted so that longitudinal waves incident on the inner surface are mode converted to shear waves traveling axially down the tube. The beam would have to be offset about 1 mm to generate circumferential shear waves. In all cases, a motor rotates the mirror so that a 360° scan can be made at each axial location. It is anticipated that the axial motion of the probe will be controlled by a microprocessor and stepping motor and that data on signal amplitude versus position in the tube will be stored and displayed via a computer. In Fig. 10, the resolution achievable by the scheme described above is shown for longitudinal waves. Figure 10a shows the radio-frequency inner-wall reflection and backwall echo seen with a 20-MHz, 1/8-in.-diameter probe is used from the bore side with a 45° reflector. An "impulse"-type initial pulse is used. With a "tuned" initial pulse (Fig. 10b) and a different pulser-receiver used in the video-output mode, many more echos can be seen. The latter scheme may be more sensitive than the former for locating defects. The eval-
