**SHEATHED THERMOCOUPLES FOR CONTINUOUS MOLTEN STEEL
TEMPERATURE MEASUREMENT DURING THE LADLE TREATMENT PROCESS**

Final Report

By
R. Michael Phillipi

By
Vesuvius Crucible Co.
Pittsburgh, Pennsylvania

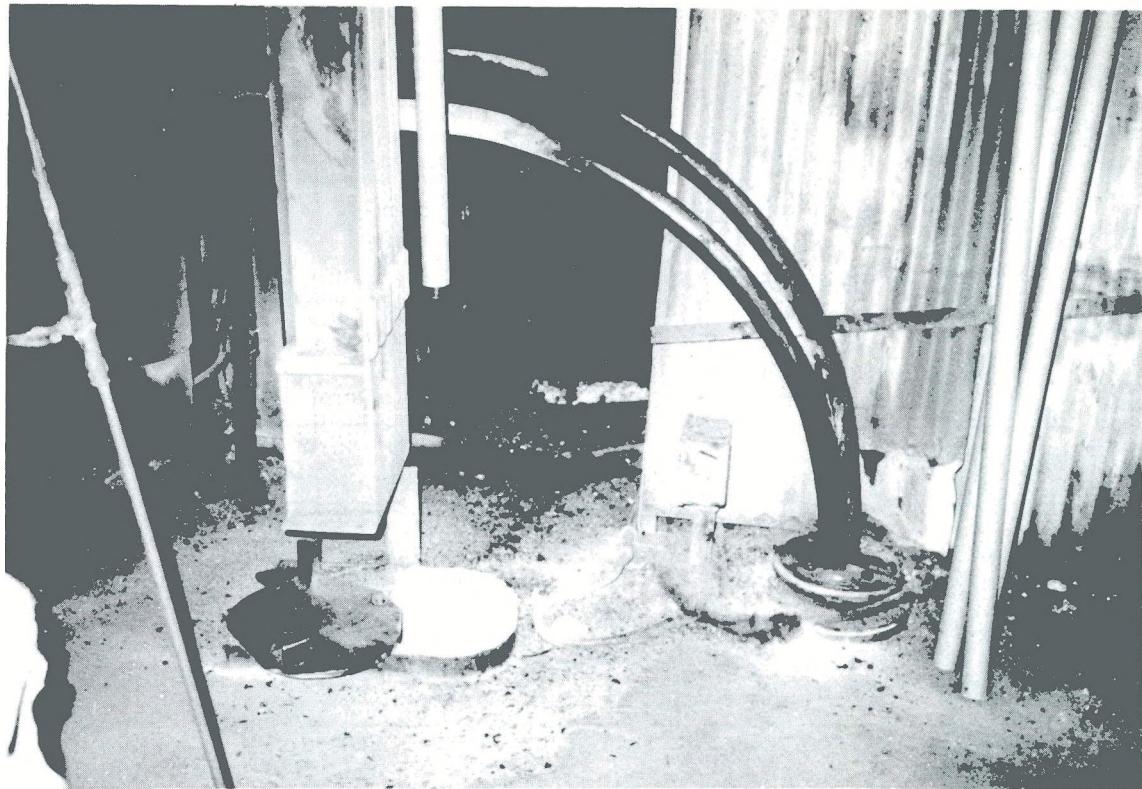
Figure 2(a). Ladle treatment platform and access port used for thermocouple testing.

Figure 2(a) shows the ladle treatment platform and the access port (approximately 45 x 30 cm) used during testing. In normal operation, this port is used for automatic disposable temperature measurements and metal sampling.

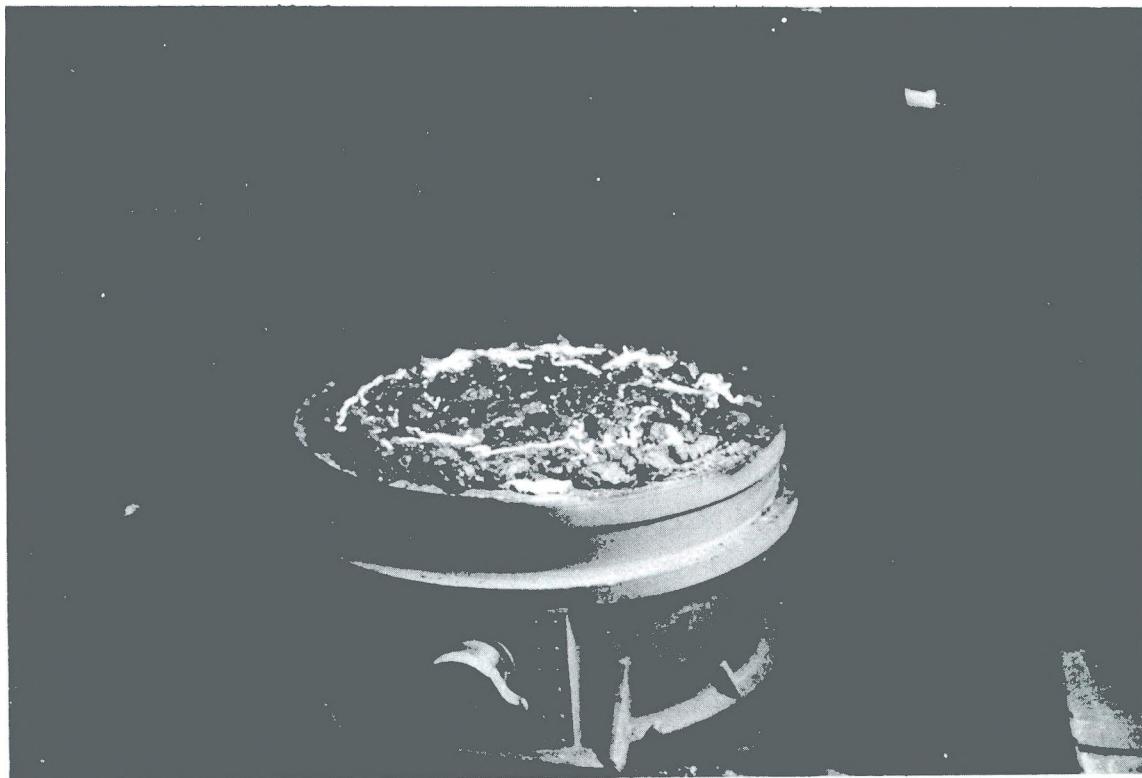
Figure 2(b). 270,000 kg ladle used at BSC's Sparrow Point Plant showing typical slag cover.

Figure 2(b) shows the 270,000 kg (300 ton) ladles used at BSC's Sparrows Point plant. Note the slag cover (approximately 20 cm) which varied in thickness during testing.

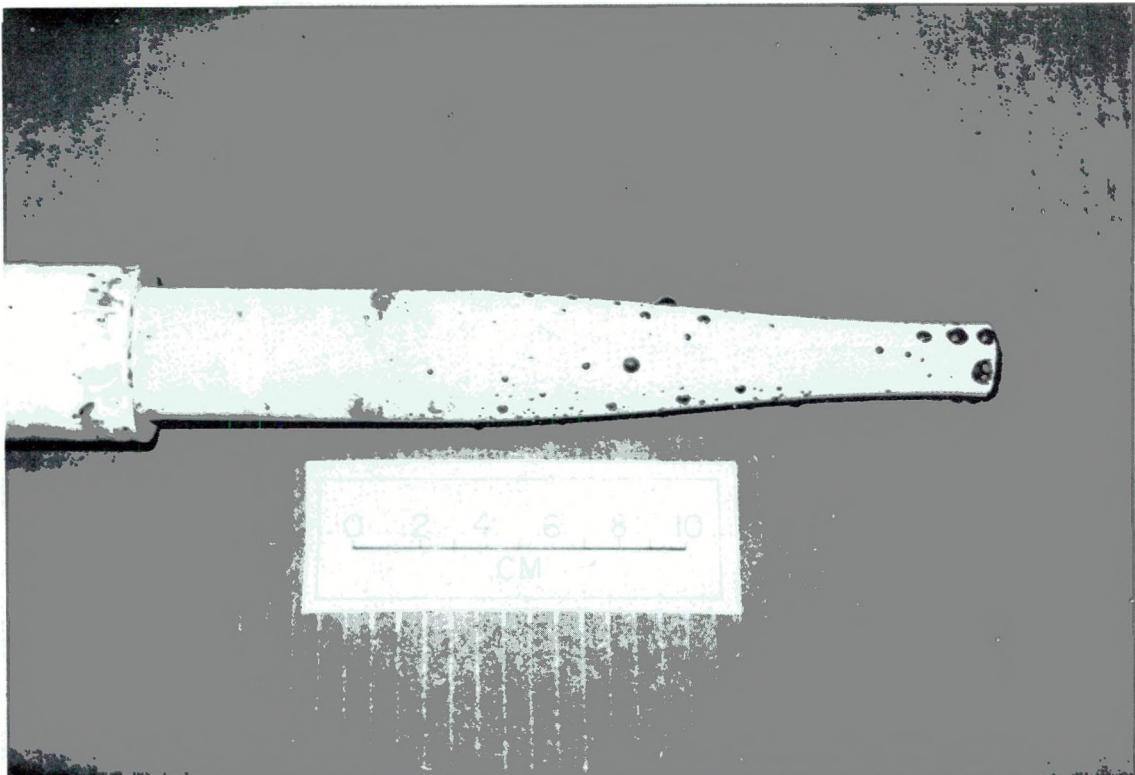
Figure 7(a). Segmented BN sheath showing slag wear after 6 minutes of immersion time.

Two designs of BN sheaths were tested (Figures 7 and 8). The unit shown in Figure 7 exhibited a time to equilibration of approximately 6 minutes and the poorest slag wear characteristics of all sheaths tested, with failure from slag line erosion occurring at 6 minutes. Evaluation of thermal shock properties resulting from repeated immersions was not possible because of premature failure. The cost of BN is somewhat prohibitive as well, being in excess of \$2000 for the unit shown in Figure 7. To reduce cost and improve slag wear properties, a hybrid design (Figure 8) was constructed and tested. This unit showed improved wear characteristics, and based on the erosion present at 12 minutes of immersion time a 20 minute lifetime was projected. Total cost of BN required for this unit was approximately \$700.

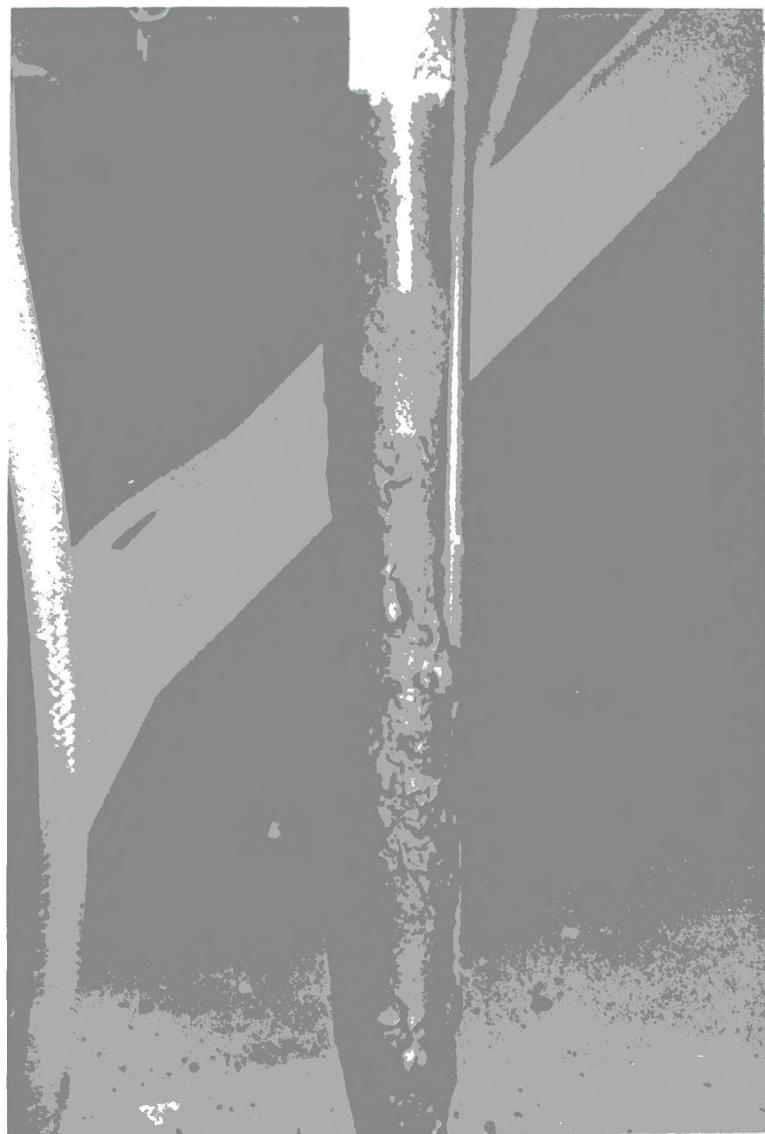
Figure 14(a). (left) M-G sheath with attached slag thought to be responsible for extended response time on subsequent immersion.

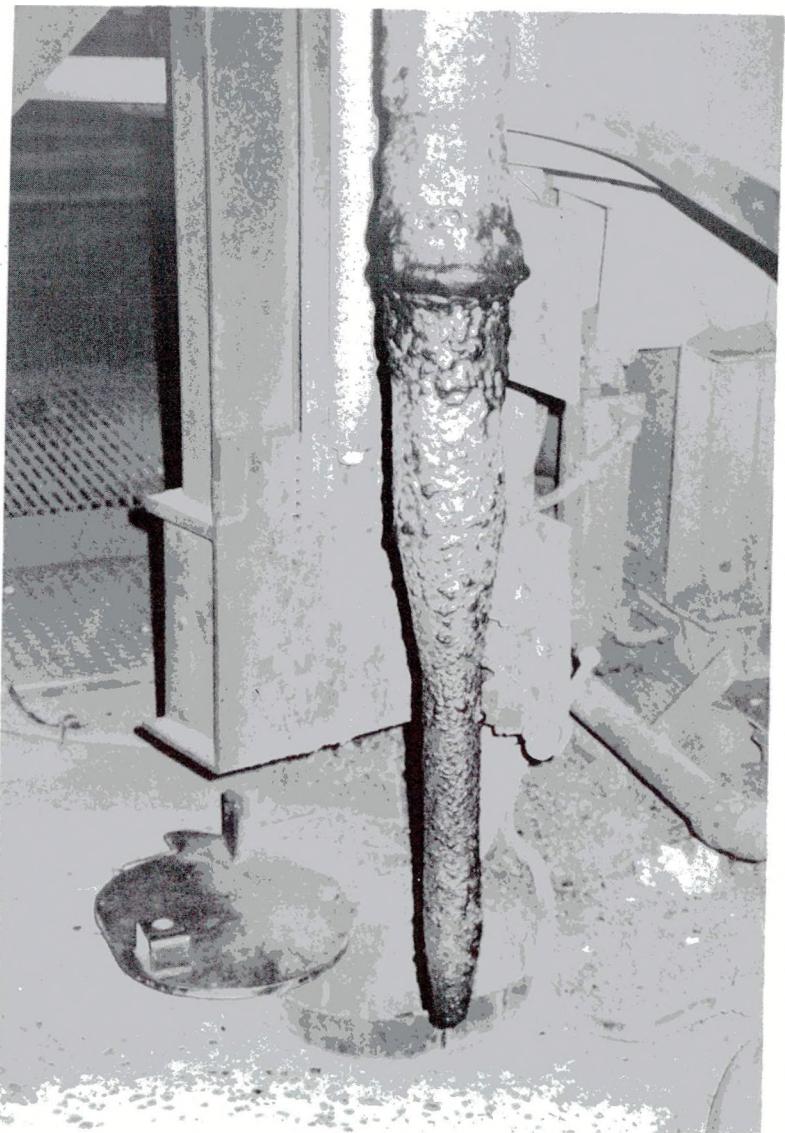
Figure 18(b). M-G sheath after immersion showing attached slag.

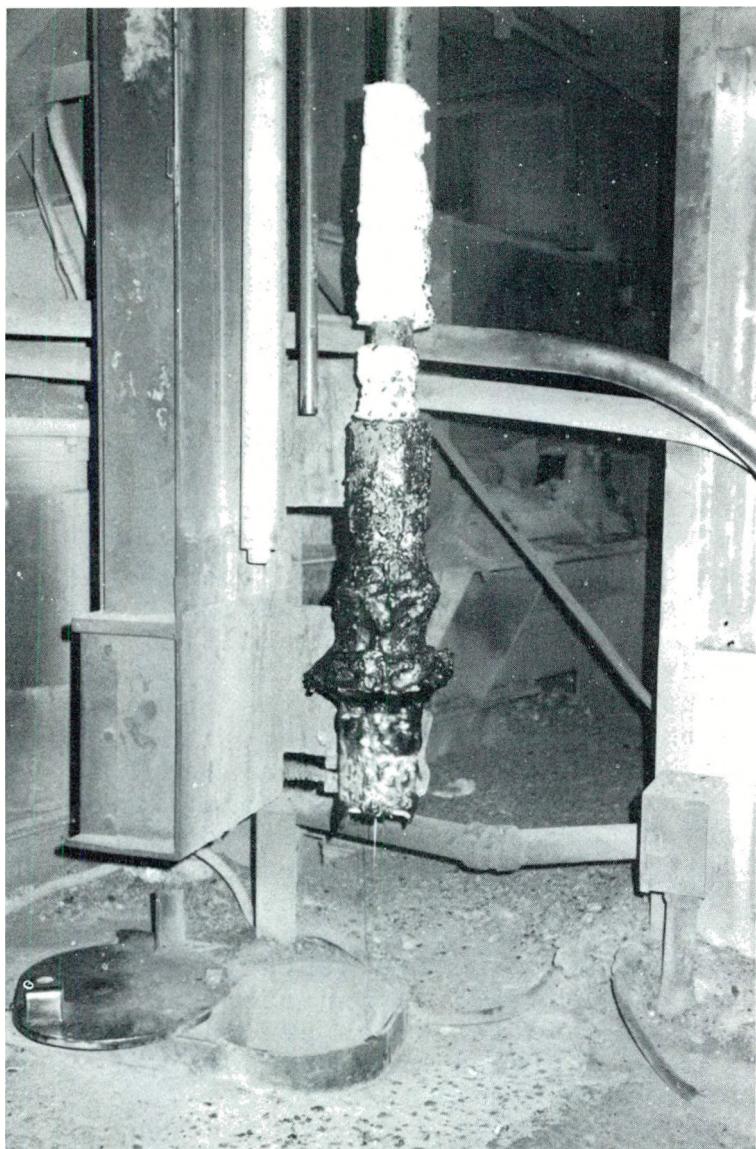
Figure 19. Failed M-G sheath after 59 minutes of immersion time. No slag line erosion was visible.
