EPRI NP-3040
Project S183-2
Final Report
May 1983

Neutralization of Tubesheet Crevice Corrosion

Prepared by
Westinghouse Electric Corporation
Pittsburgh, Pennsylvania

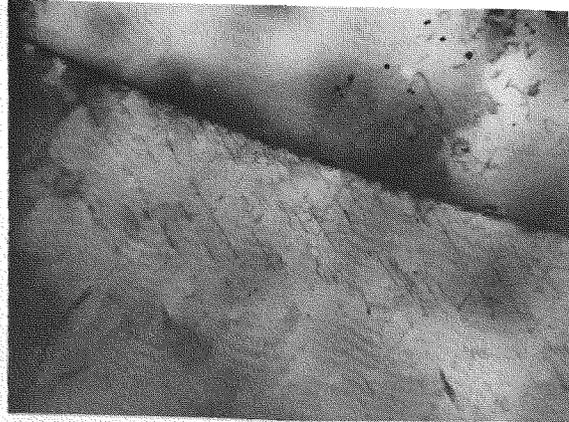
6 mm from weld

Figure 4-53. SEM photographs at the ID (right) and at ~ 0.43 mm (left) from the ID at distances of 1.7 mm (bottom) and 7.8 mm (top) from the bottom weld on longitudinal section of the bottom weld of the capsule.

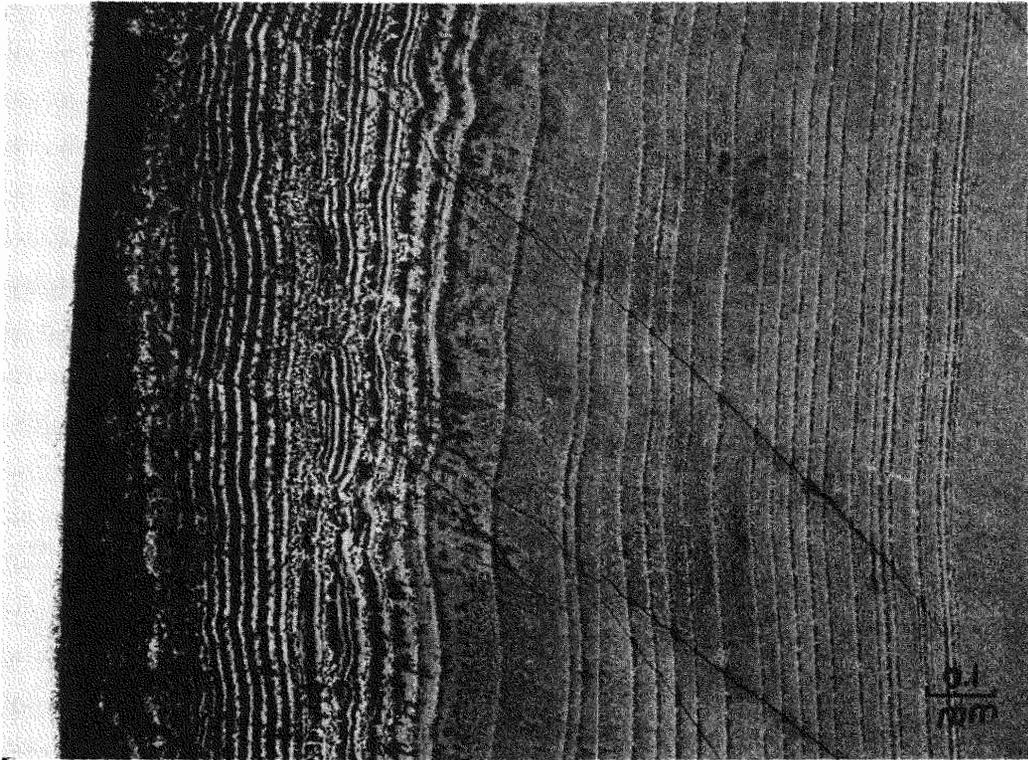
Inconel 600

Steel

Figure 4-61 shows an enlargement of an area within the steel corrosion product near carbon steel surface of the same specimen shown in Figure 4-60. The enlargement and the elemental mapping of the area was performed on the electron beam microprobe. An enlargement and elemental maps of an area near the tube surface is shown in Figures 4-62 and 4-63. Unlike previous studies of actively denting or bulging specimens produced in acidic-chloride environments (8), which showed that chloride was localized in the coarse grained oxide near the carbon steel surface, there is no distinct association of any elemental species in the banded structure. However, if hydroxide ions, by analogy, were concentrated in these bands, the electron beam microprobe analysis (EMA) technique would not detect them because it is insensitive to light elements such as oxygen and hydrogen.

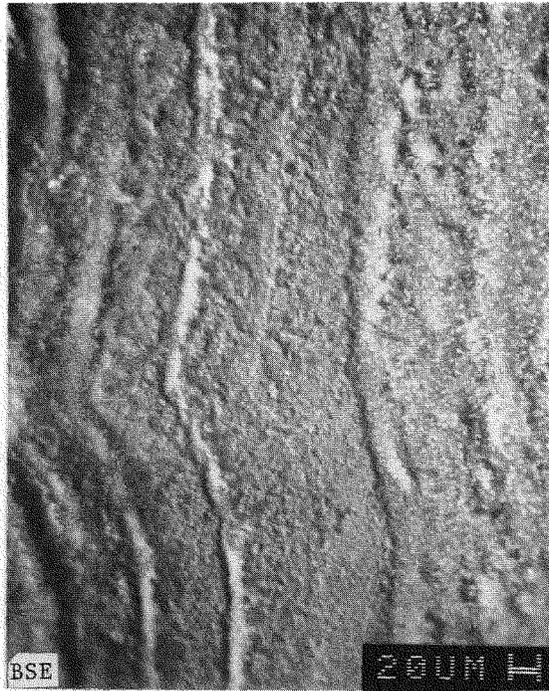
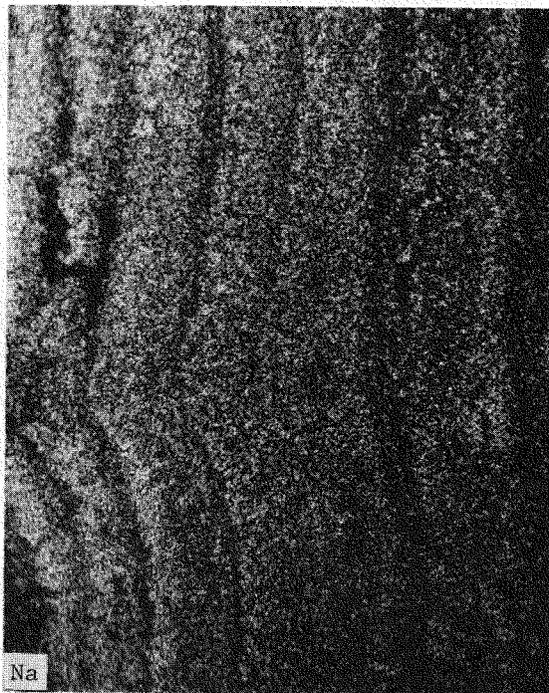
Figure 4-62. EMA area scans in deposit next to the Alloy 600 tube of Capsule AR-8

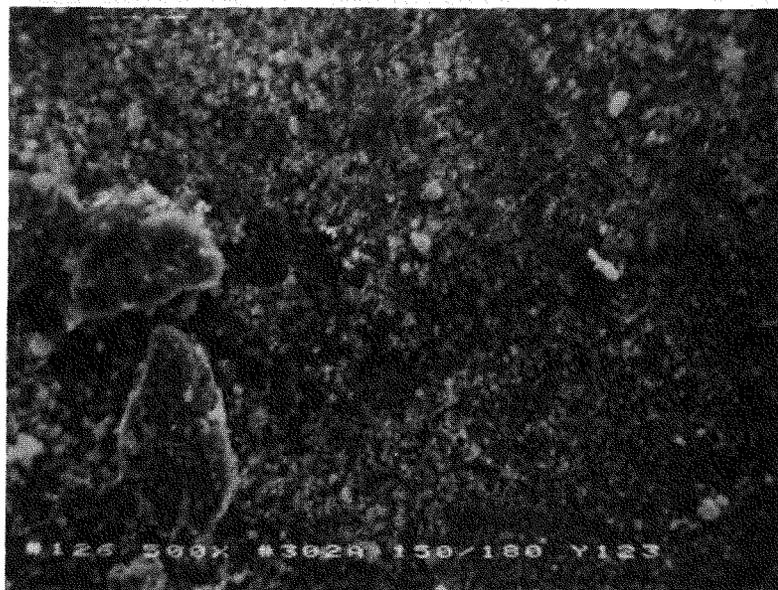
(B) 500X*Plate 126

Figure A-9. Tube Area at Bottom of Sludge Cup.

Figure A-10. EDAX of Area Shown in Plate 126 – Figure A-9

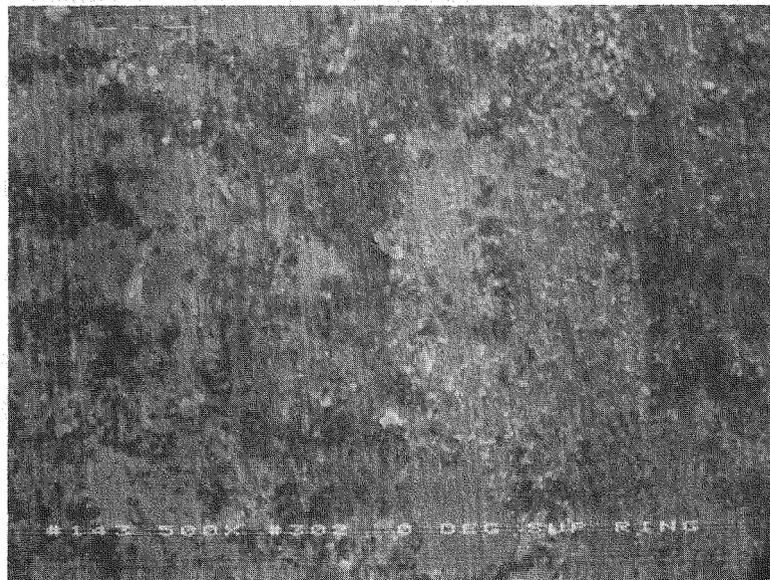
(B) 500X*Plate 143

Figure A-25. Tube Deposits Above Support Ring Crevice

Figure A-26. EDAX of Area Shown in Plate 143 - Figure A-25
