**Thermal Damage Study of Beryllium Windows  
Used as Vacuum Barriers  
in Synchrotron Radiation Beamlines**

**F. R. Holdener, G. L. Johnson,  
V. P. Karpenko, and P. K. Wiggins**

**Lawrence Livermore National Laboratory**

**September 17, 1987**

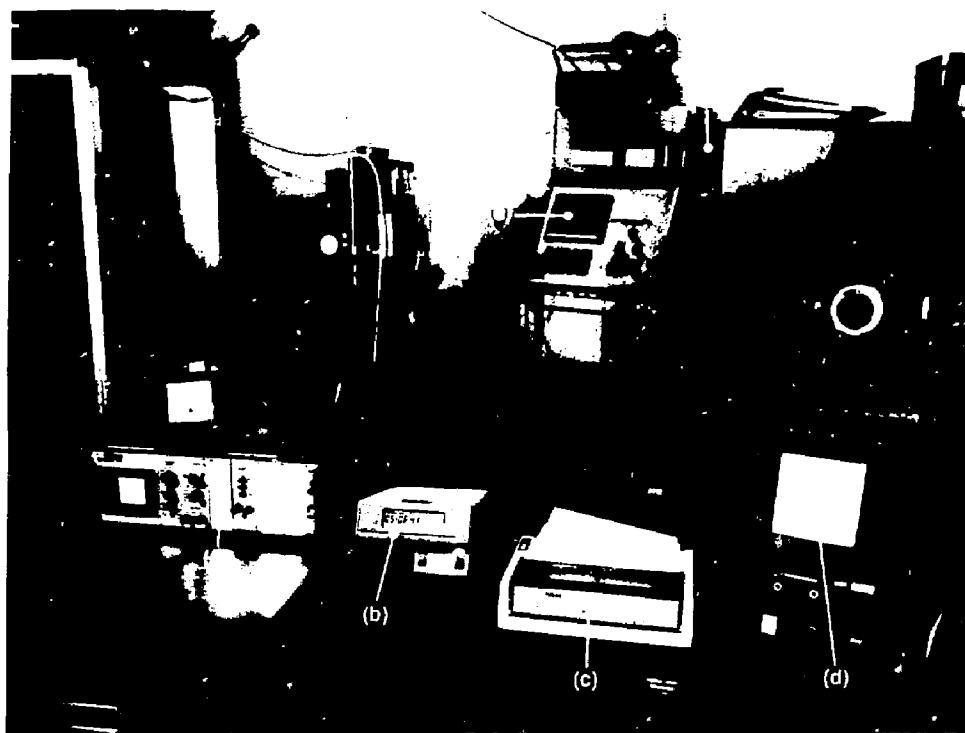
Figure 11A. Photograph of Be window test instrumentation showing: (a) AGA camera console, (b) Hanzon 4000 series digital temperature readout/data logger, (c) HP Thinkjet printer connected to Hanzon, (d) color monitor for AGA camera, (e) large console in center is X-Y-Z CNC control console, (f) large console to the right is the controller for the Raytheon laser with system parameters listed in Table 2.

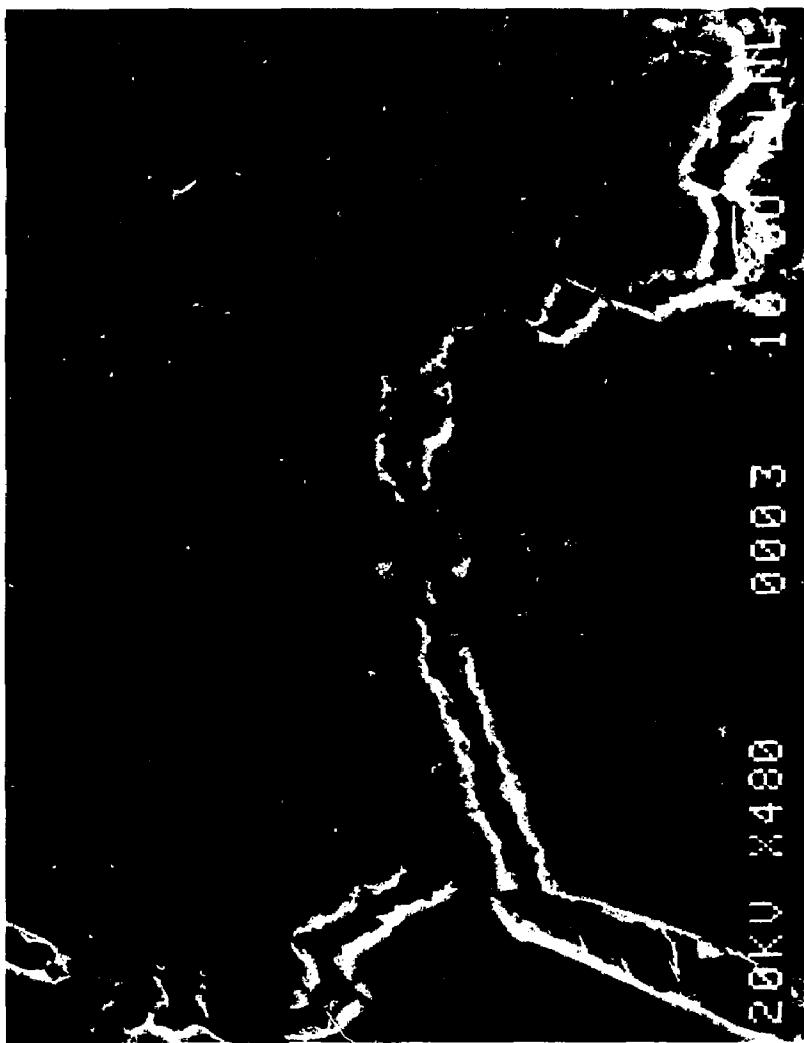
Figure 14B. Enlarged 750X SEM of front surface of Be window 2A after 181 min of laser impingement for a total of 1,086,000 pulses. Vertical crack with a smaller horizontal crack intersection shown with view rotated 30 deg from horizontal.

The Be window accommodates the large thermal/mechanical stresses by growing/stretching. Pretest/posttest measurements show approximately 78% vertical curvature growth of window 2B at its center. A crack along the long axis of window 2A was first observed after the first 30-min run just below the beam illumination profile where the thermal gradient was the greatest. Window failure happened immediately after beam shutdown after three hours of running or approximately 1,000,000 pulses (two runs at 30 min and two runs at 60 min) and subsequent cooling. Failure was noted by the rise in pressure on the vacuum side of the window. Although horizontal cracks were observed before failure, inspection after failure revealed a small vertical crack on the front and rear surface of the window. None of the horizontal cracks appeared on the rear of the window.

Scanning electron microscope (SEM) photographs and micrographs (figure series 13A-E and 14A-J) show cross sections of the crack topography. The Be beneath the beam pattern shows an elevated temperature quasi-cleavage failure, while just outside the material failed by intergranular cleavage.
