**Cesium Chloride  
Compatibility Testing  
Program Annual Report  
Fiscal Year 1985**

**G. H. Bryan**

**March 1986**

PNL-5730  
UC-70

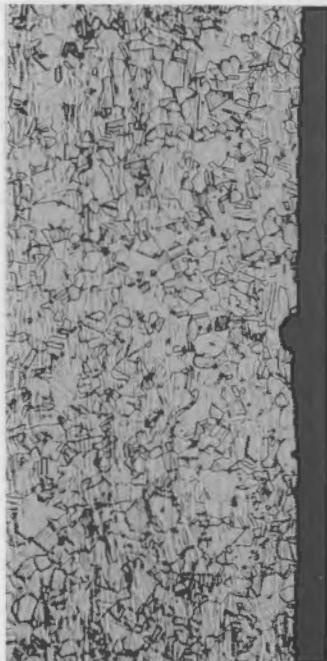
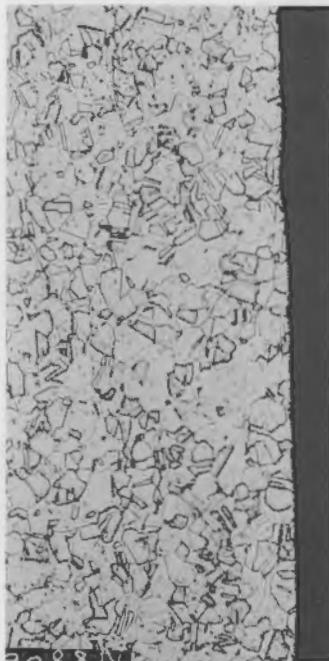
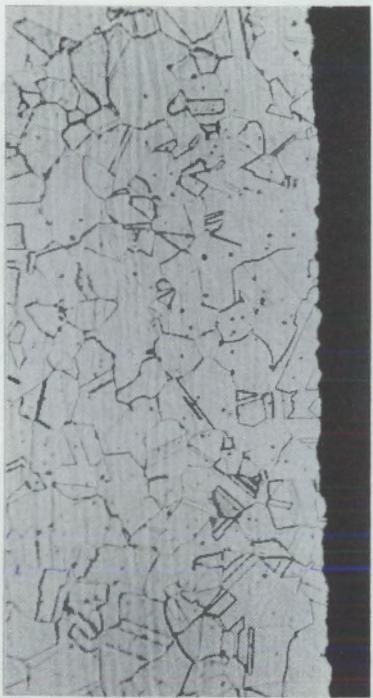
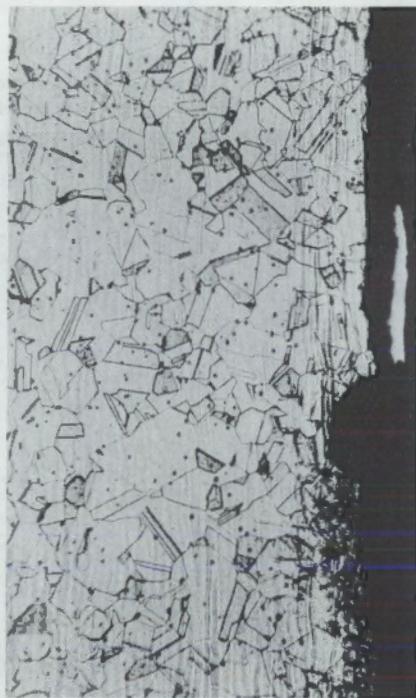
FIGURE 5. Micrographs of Samples Taken From the Pool Cell Capsules

Estimates of the metal corrosion in the 18 capsules examined in FY 1985, based on the photomicrographs, are given in Table 2. Table 2 also shows the thermal power and  $^{137}\text{Cs}$  content of each capsule at the time of loading and its storage time. Because of the limited attack observed in most of the storage capsules, the photomicrographs should provide a reliable measure of the metal corrosion. Micrographs from several of the capsules, showing the different levels and types of attack found, are shown in Figure 5.

Evaluation of the micrographs from the 20 storage capsules examined in FY 1984 and FY 1985 shows that, on an overall basis, metal corrosion by the chloride is quite low. The corrosion in the capsules appears to involve a general surface attack and pitting. There was little indication of grain boundary attack in most of the capsules. In those capsules where the pitting depth was greatest, the general surface attack appeared to be reduced significantly. The general nature of the pitting appears to be similar to pitting observed in Series 300 stainless steel exposed to aqueous halide solutions.

There appears to be little correlation between the depth of the metal corrosion and the storage time in the pool. At least half of the storage capsules examined, some with storage times greater than eight years, exhibited no more corrosion than the "zero-time" capsules. This would indicate that for these capsules, at least, most of the corrosion probably occurred during the loading operation. Attempts to use curve fitting to identify a probable rate equation were largely unsuccessful. For every rate equation evaluated (i.e., linear, logarithmic, parabolic, etc.) the coefficient of determination had a value of less than 0.05 indicating a very poor fit with the experimental data. Again, a more extensive examination of the capsules may have produced more uniform data and permitted identification of the applicable rate equations.

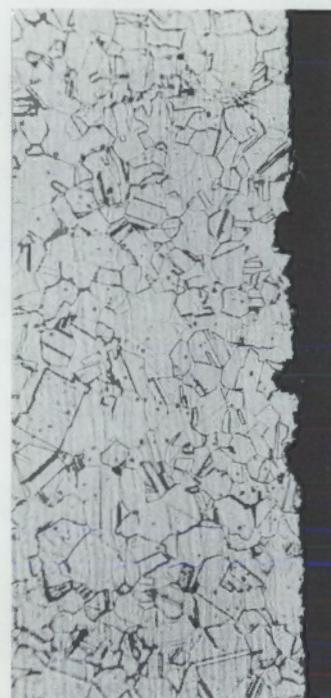
Capsule No. C-17  
Storage Time 8.9 yr

FIGURE 5. (contd)

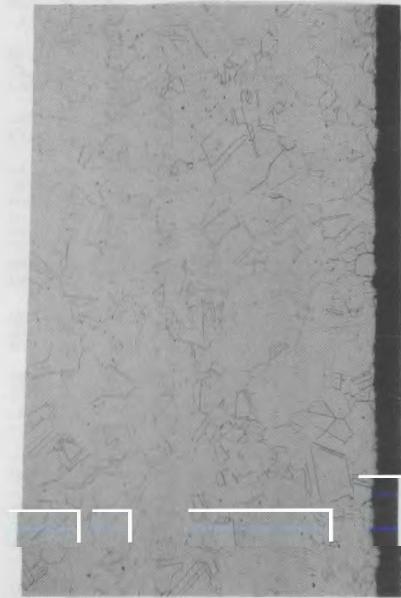
FIGURE 6. Micrographs of Samples Taken From the Storage Capsules Examined In FY 1984

For comparison purposes, results obtained from the two storage capsules examined in FY 1984 are presented in Table 3. Micrographs of samples taken from these capsules are shown in Figure 6. Each of the capsules were sampled at four locations (Bryan 1984). The sample rings taken from the 18 capsules examined in FY 1985 were removed from the canister of the capsule, a location slightly above where the No. 2 rings were cut from the capsules examined in FY 1984 (and the two "zero-time" capsules).

Capsule No.	Storage Time, yr	Depth of Attack, (a) $\mu\text{m}$ (mils)			
		Ring No. 1	Ring No. 2	Ring No. 3	Ring No. 4
C-312	5	16 (0.6)	25 (1.0)	20 (0.8)	18 (0.7)
C-67	8	12 (0.5)	16 (0.6)	14 (0.6)	18 (0.7)

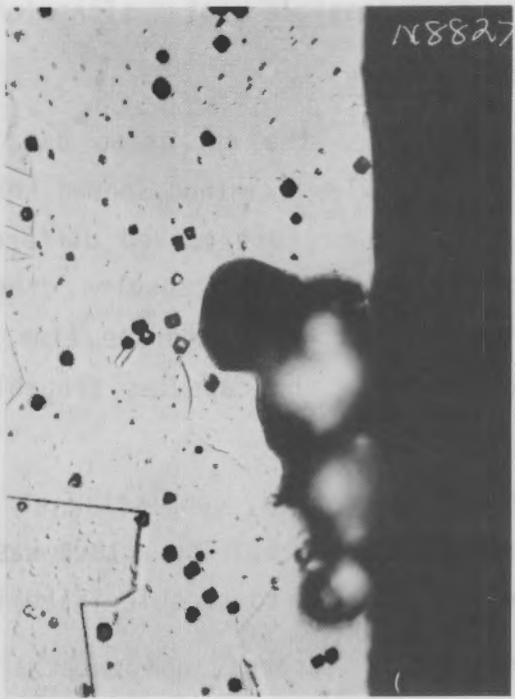
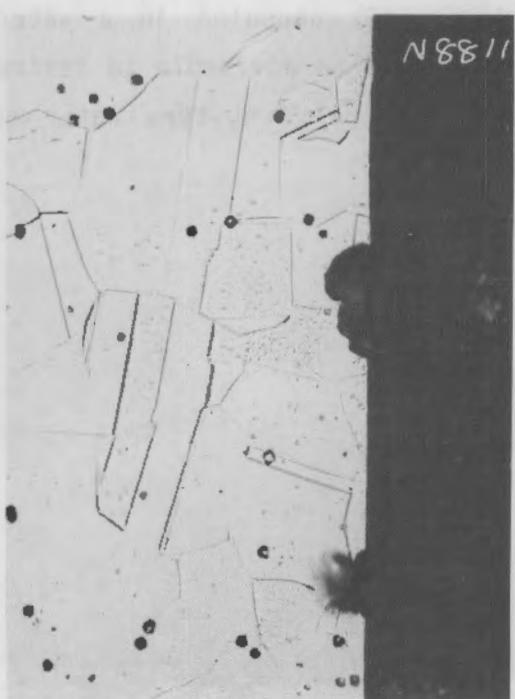
**FIGURE 7.** Micrographs Showing Pitting Corrosion on the Outer Surface of Samples Taken from the Inner Storage Capsules

Each sample taken from the 18 inner capsules was also examined for corrosion on the outer surface. Of the 18 samples examined, only four exhibited significant corrosion on the outer surface. In each of the four cases the attack consisted of isolated pitting to depths up to 60  $\mu\text{m}$  (2.4 mil). There was little indication of grain boundary attack or general surface corrosion. Micrographs of the four samples exhibiting the pitting attack are shown in Figure 7. (The dark spherical blotches shown in the micrographs are etchant marks and not part of the metal microstructure.) The nature of the pitting is markedly different from that observed on the inner capsules examined at ORNL. Considering the differences in pit morphology and the pit locations,<sup>(a)</sup> it is unlikely that the pitting observed on the storage

capsules can be attributed to the electropolishing operation. To date, however, other possible explanations for the pitting have not been identified.

Pitting corrosion was observed on the outer surfaces of some of the WESF inner capsules shipped to ORNL for examination. Work carried out at PNL in FY 1984 showed that the pitting could be attributed to problems with the electropolishing operation that was used to decontaminate the inner capsule after filling (Bryan 1985). Specifically, it was determined that the pitting was caused by a nonuniform current distribution at the support rack/capsule contact, which formed localized hot spots. The high temperature caused the phosphoric acid electrolyte to become more concentrated through boiling, and the concentrated boiling phosphoric acid caused a high localized rate of corrosion that produced the pit.

External corrosion, consisting of isolated pitting, was observed on some of the storage capsules. The attack was limited, however, and does not appear to represent a threat to capsule integrity.
