Stainless Steel Round Robin Test: Centrifugally Cast Stainless Steel Screening Phase

Prepared by D. J. Bates, S. R. Doctor, P. G. Heasler, E. Burck

Pacific Northwest Laboratory
Operated by
Battelle Memorial Institute

NUREG/CR-4970
PNL-6266
PISC III Report No. 3
SP.I 87.24
R5

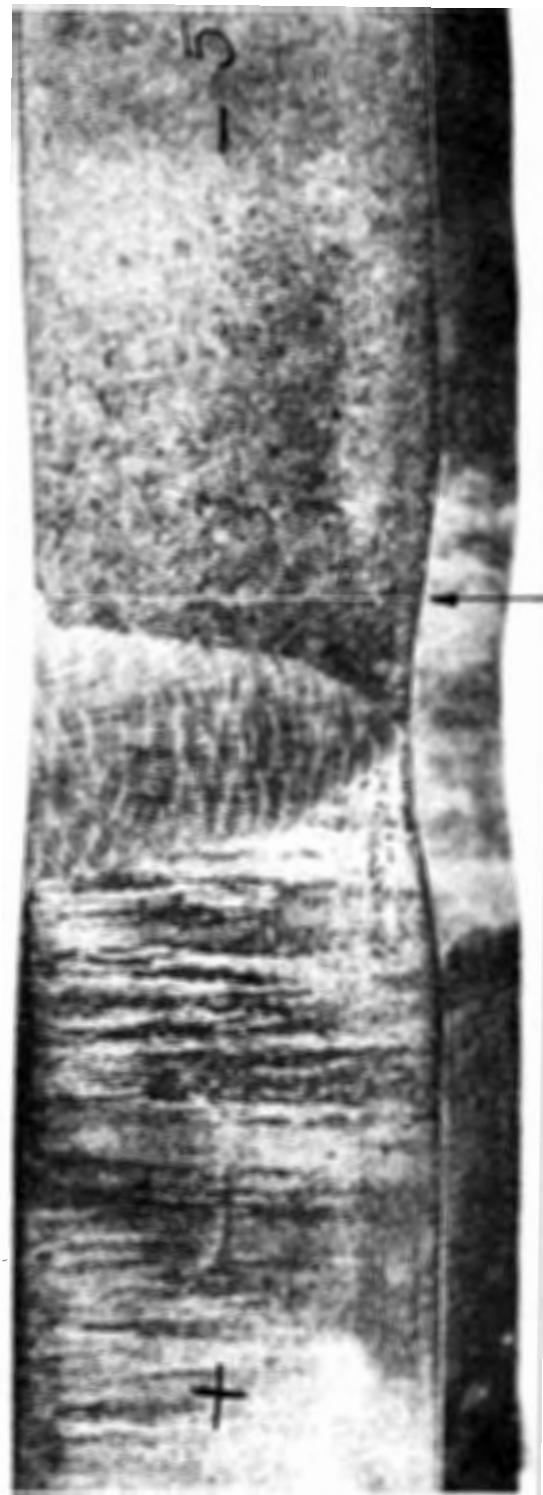
SPECIMEN: 5 SCRIBE LINE SCALE: 1:1

Fig. 4 Macrograph of the welding zone of specimen No. 5.

FIG. 4-MACROGRAPH OF THE WELDING ZONE OF SPECIMEN N°5

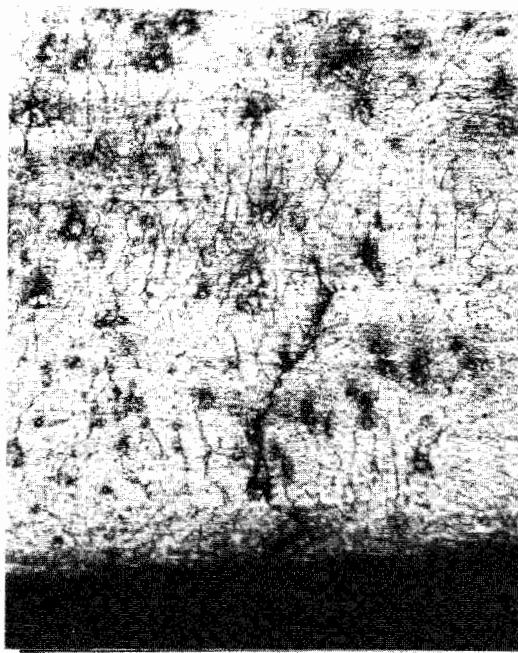
CRACK A X40

Fig. 21 Details ABCDEF of crack zone of Fig. 19 (scale x40).

FIG. 21- DETAILS A B C D E F OF CRACK ZONE OF FIG.19

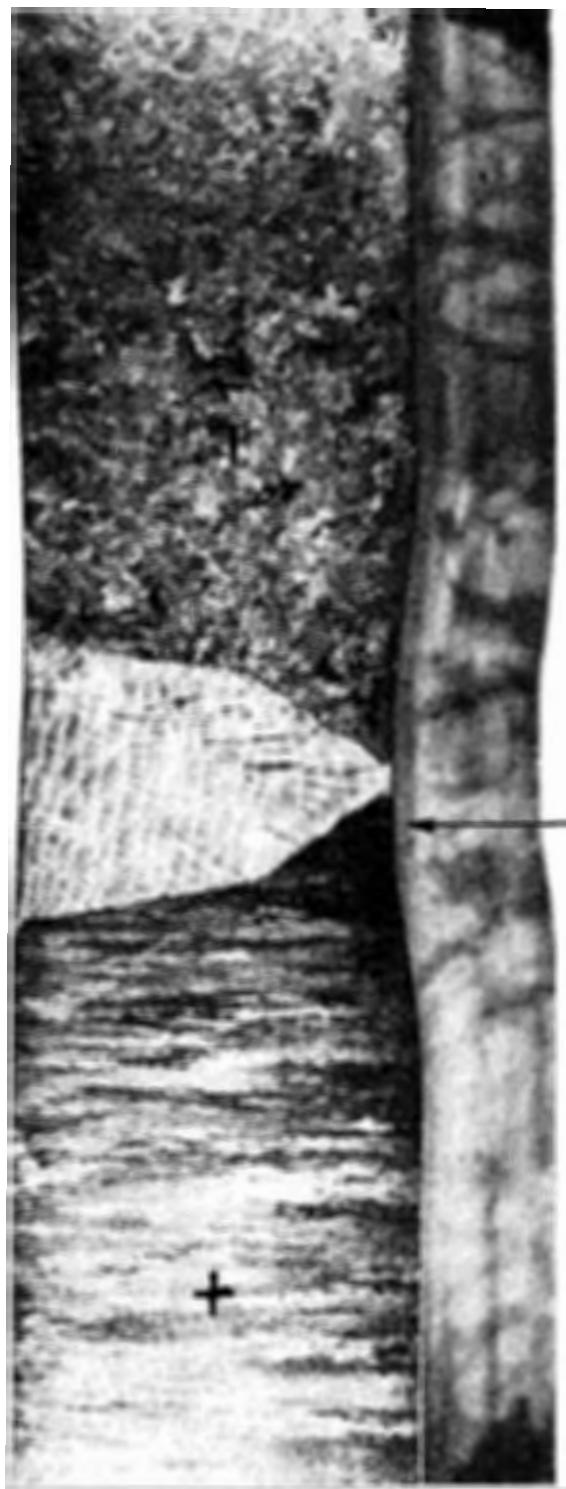
SPECIMEN: 12 SCRIBE LINE SCALE: 1:

Fig. 28 Macrograph of the welding zone of specimen No. 12.

FIG.28-MACROGRAPH OF THE WELDING ZONE OF SPECIMEN N°12

- Fig. 26 shows the results of the dye penetrant examination,
- Fig. 27 shows graphically the summary of all US inspection results and the cutting scheme,
- Fig. 28 shows the macrograph of the welding zone,
- Fig. 29 shows the cutting scheme of specimen No. 12 as also indicated in Fig. 27.

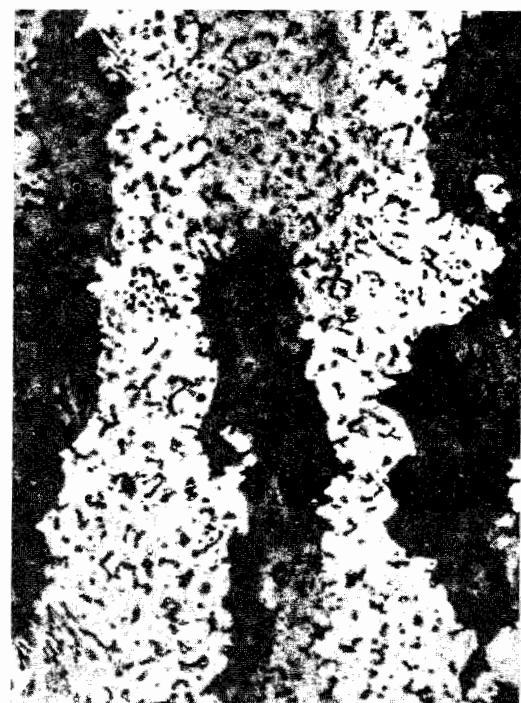
DETAIL D x40

Fig. 33 Metallographic inspection of face X = +15 (slice 130B/end).

FIG. 33 METALLOGRAPHIC INSPECTION OF

Fig. 33 Metallographic inspection of face X = + 15mm

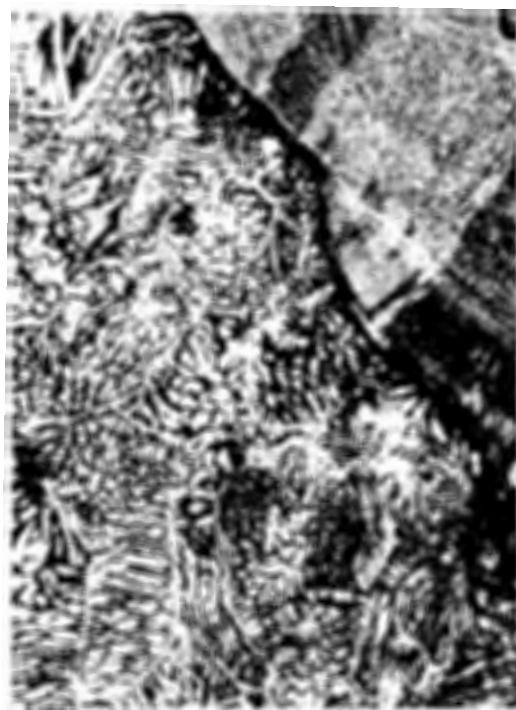
DETAIL E x20

Fig. 34 34a and b Metallographic inspection of face Y = 130B

FIG.34 METALLOGRAPHIC INSPECTION OF FACE Y-130 B

Fig. 34
and 34a+b Metallographic inspection of face Y = 130B ~~mm~~.
