SAND--85-2712C

USE OF AN ACOUSTIC BOREHOLE TELEVIEWER TO INVESTIGATE
CASING CORROSION IN GEOTHERMAL WELLS

Charles C. Carson
Sandia National Laboratories
P. O. Box 5800
Albuquerque, New Mexico 87185

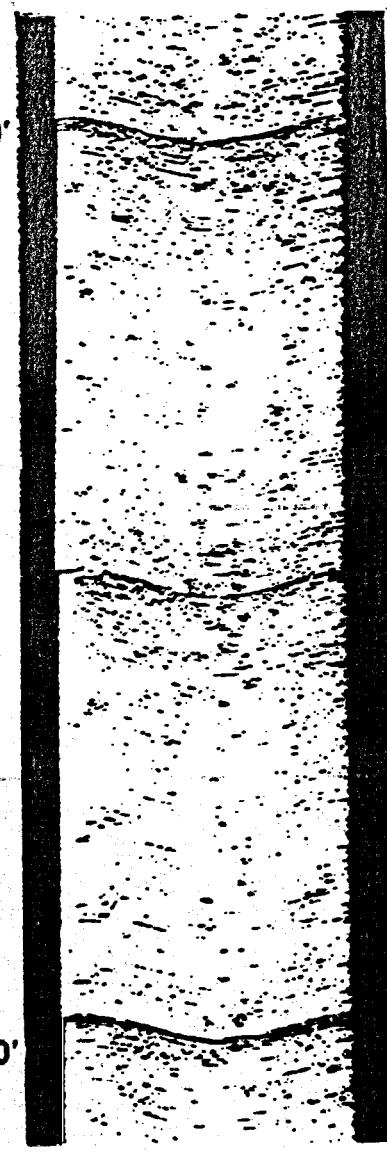
FIGURE 7 - Televiewer Log Showing Minor Corrosion.

Figure 7 shows a section of one of the wells where there appears to be minor corrosion and surface roughness. In the amplitude chart, several spots of decreased reflectivity can be seen as dim regions within the bright vertical stripe. (The stripe itself shows strong reflections from

one side of the borehole and indicates that the tool was not centered in the hole. The azimuth of the stripe corresponds to either the near side or the far side of the casing -- depending on how far off center the tool was located.) The decreased reflectivity, or scattering of the acoustic wave, indicated by these dark spots is attributed to surface roughness caused by corrosion. The spots are not as obvious on the caliper chart, but several can be identified.
