ORNL/TM-6970

Materials Analyses of Ceramics for Glass Furnace Recuperators

MATERIALS ANALYSES OF CERAMICS FOR GLASS FURNACE RECUPERATORS

Date Published: November 1979

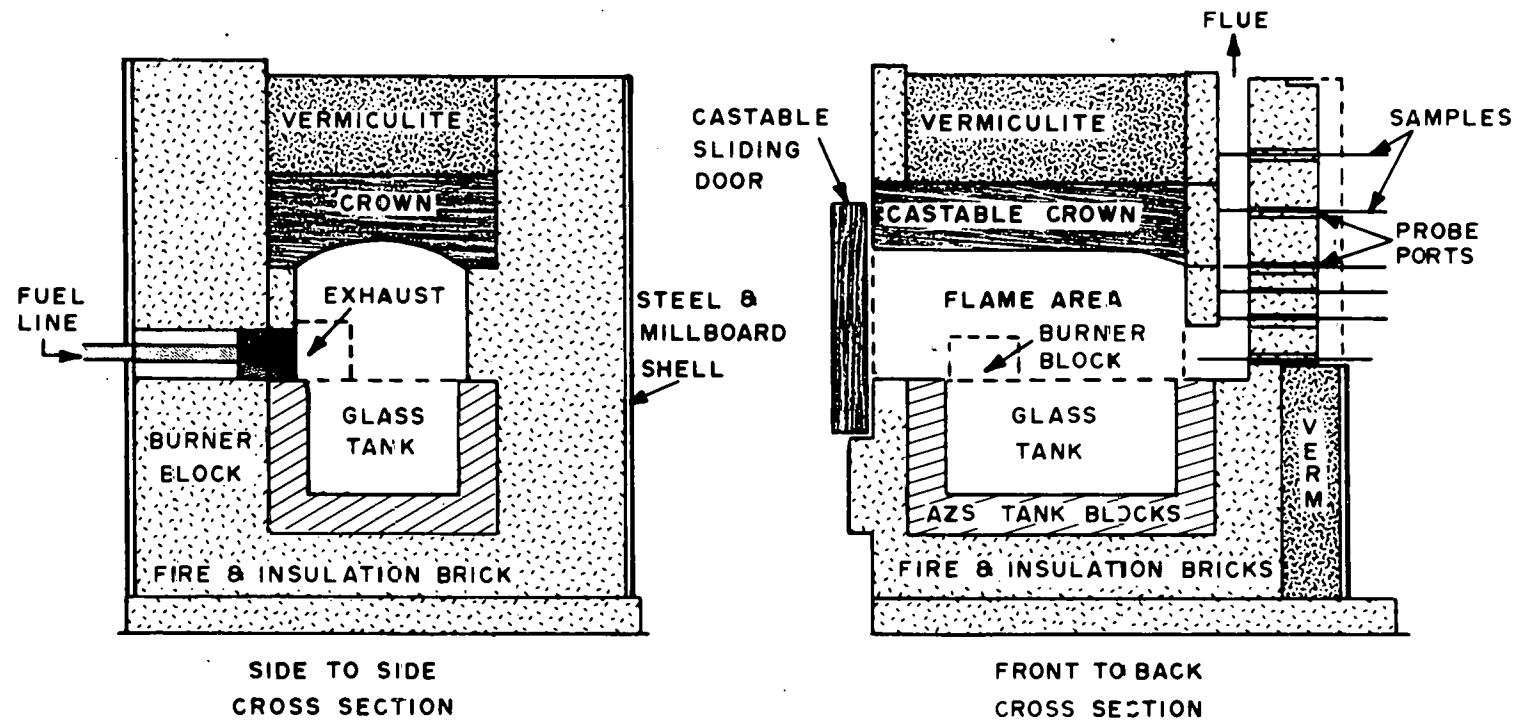
Fig. 1. Cross Sections of the Special Day Tank Furnaces Used at Millcreek Glass for Material Tests.

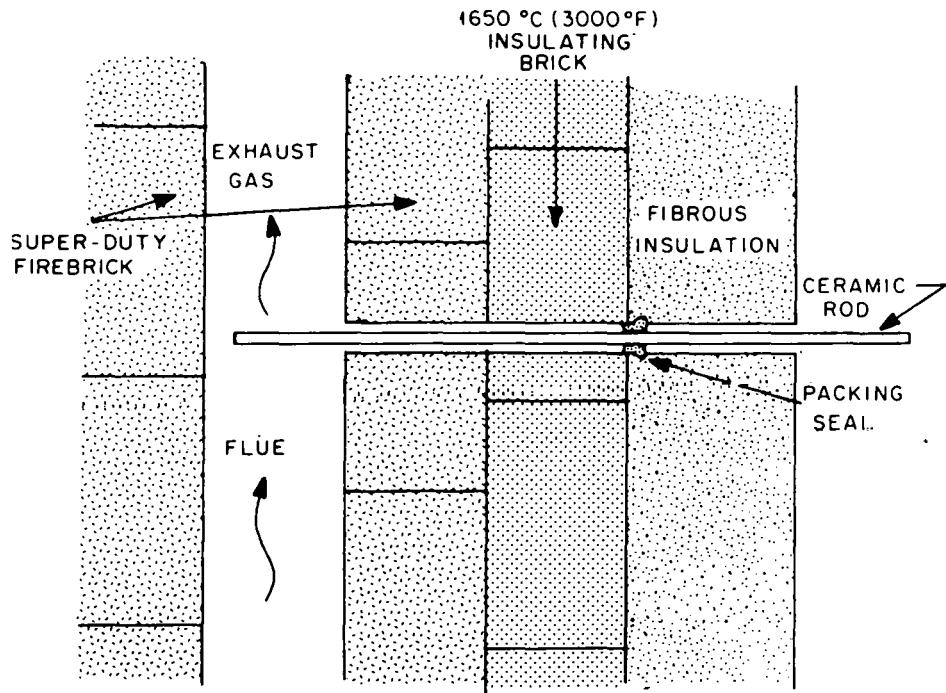
ORNL-DWG 79-10755

Fig. 2. Detail of Recuperation Material Coupon Furnace Exhaust Test Configuration.

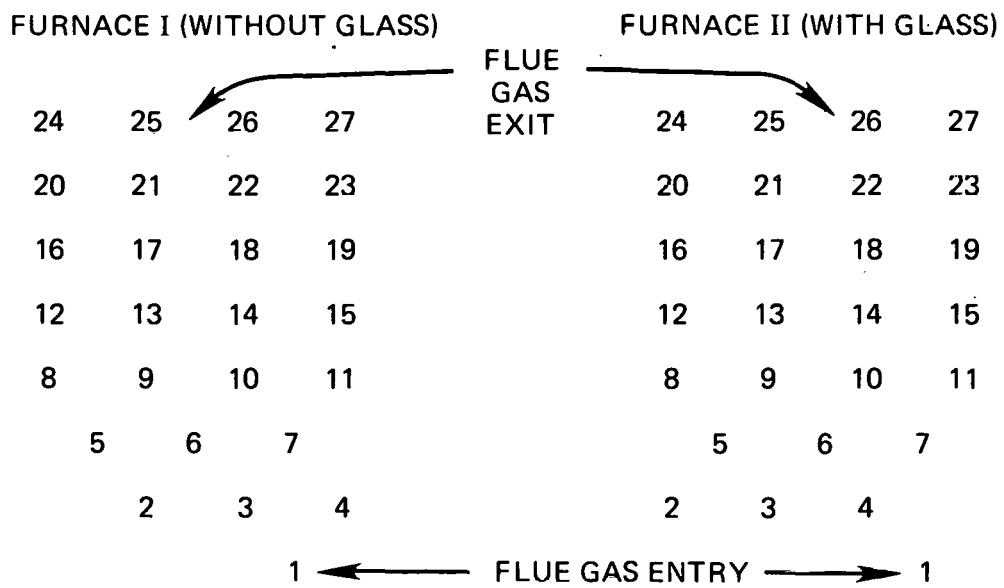
ORNL-DWG 79-14704

Fig. 3. Flue Gas Port Arrangement.

Scanning electron microscopy was also used to investigate the region 5 mm from the exposed end of sample NC-430-2. This region resembled a solid white foam, as shown in Fig. 11. Figure 11(a) shows the blistering of the surface and the open holes through the coating to the underlying material, presumably SiC. Figure 11(b) at higher magnification (1000 \times) shows the glassy appearance of the coating and (c) the energy-dispersive x-ray analysis of this region. The high concentrations of Si, Na, Ca, and K are expected from the glass composition used in the furnace. The white cellular deposit was apparently the result of a significant amount of glass batch carryover during the test. This sample was very close to the flue entry in a region with possible flow stagnation (port 2), as shown in Fig. 3 (p. 7).

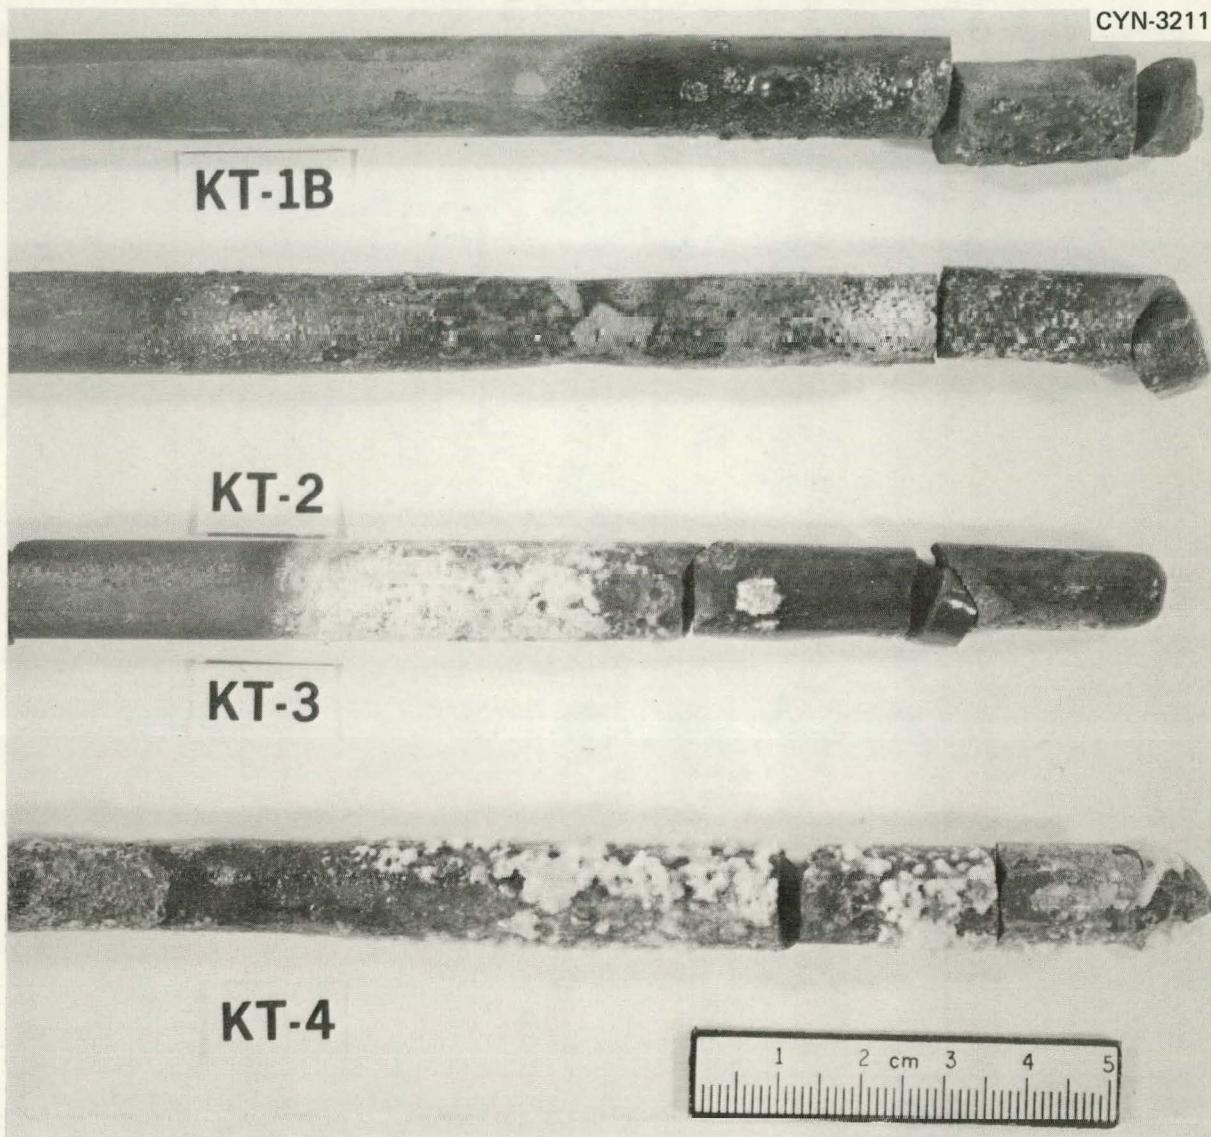
CYN-3211

Fig. 5. Close-Up of Reaction Bonded (Siliconized) Silicon Carbide Exposed to Glass Furnace Environment.

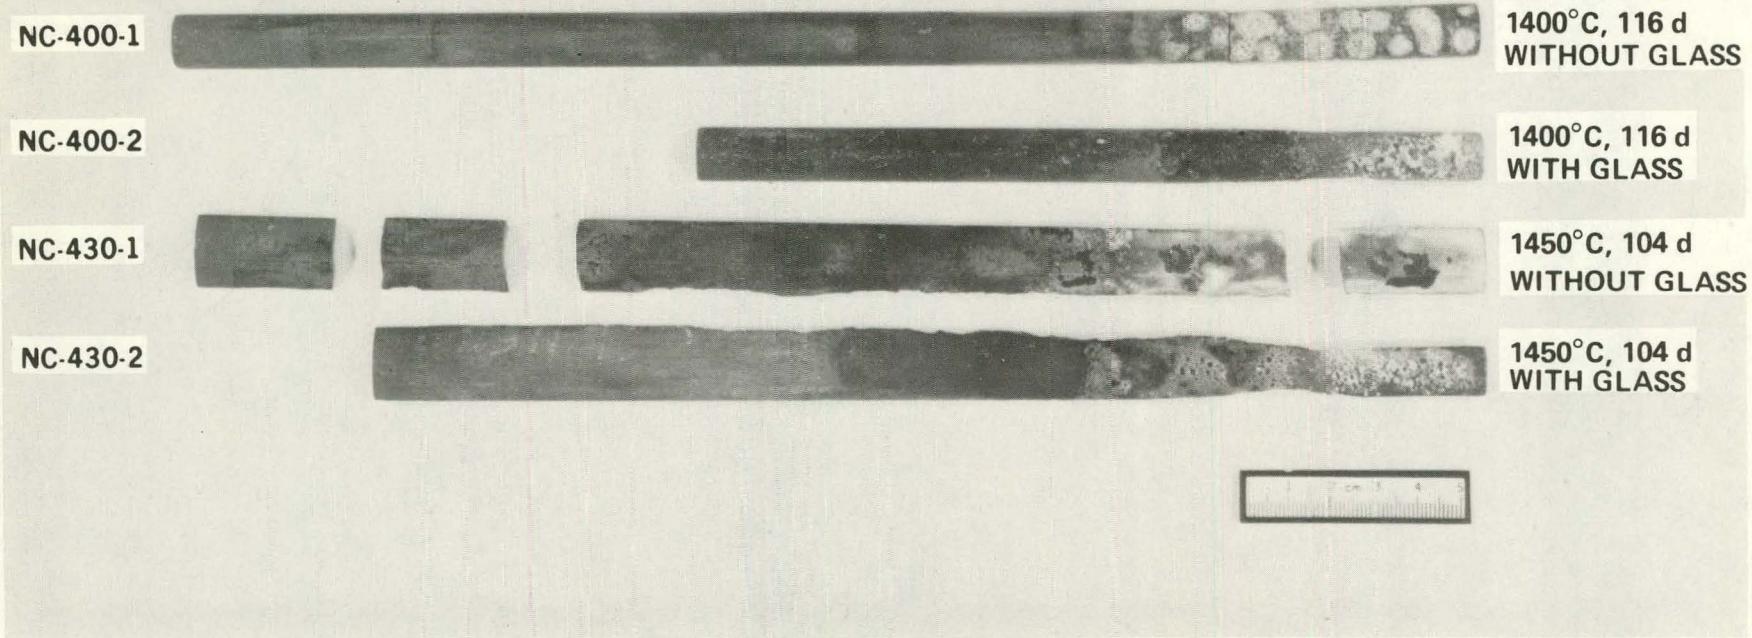
CYN-3195.

Fig. 6. Recrystallized and Reaction Sintered (Siliconized) Silicon Carbide Exposed to Glass Furnace Environment.

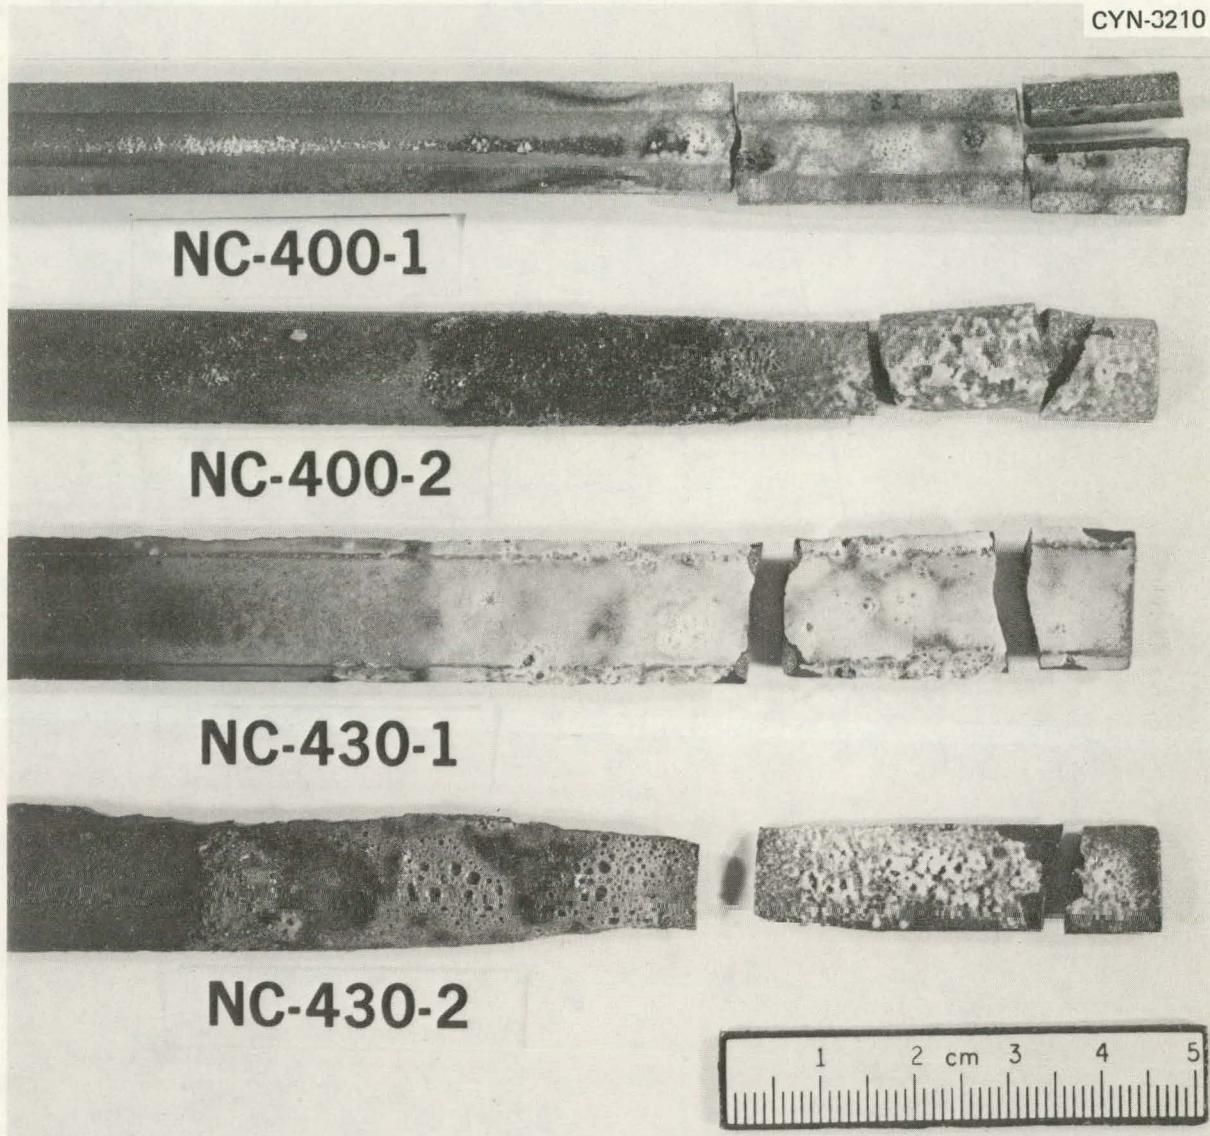
CYN-3210

Fig. 7. Close-Up of Recrystallized and Reaction Sintered (Siliconized) Silicon Carbide Exposed to Glass Furnace Environment.

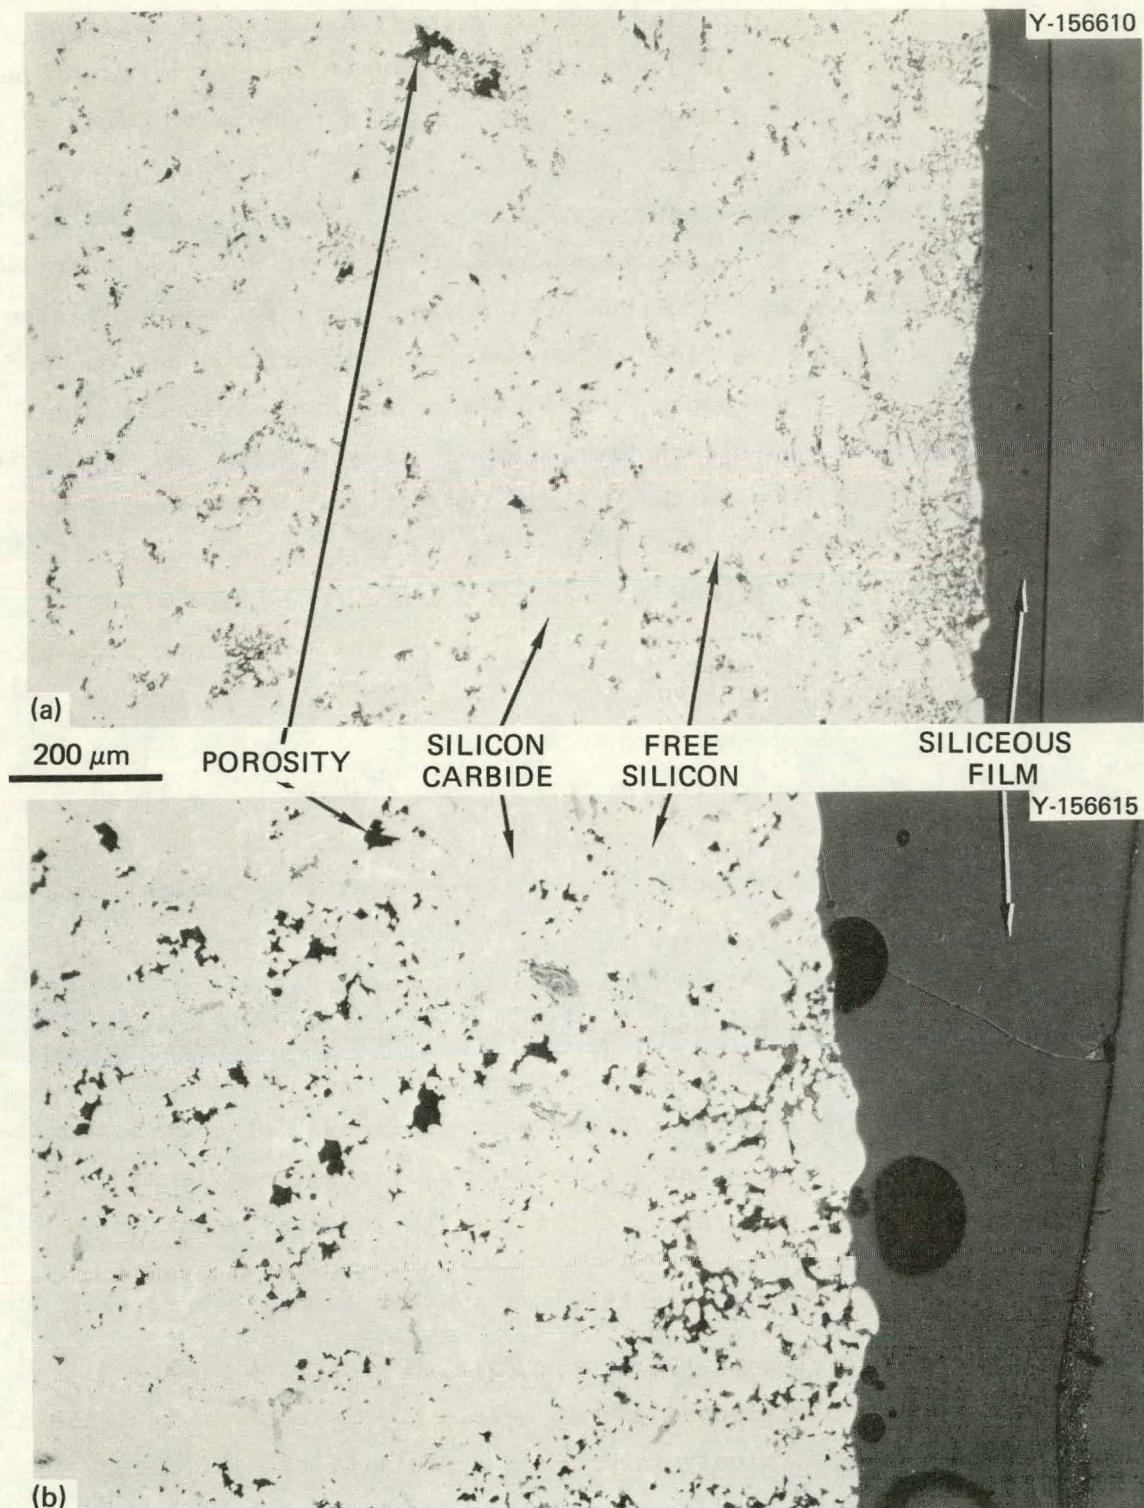
Fig. 8. Microstructure of Siliconized Silicon Carbide Exposed to Furnace Flue Atmosphere with No Glass in the Furnace. (a) NC-430-1, 104 d at 1450°C (2650°F) in test port 2. (b) KT-1B, 116 d at 1340°C (2450°F) in port 13.

Microstructures of cross sections of these two samples taken about 20 or 25 mm from the exposed end are shown in Fig. 8. This region was located approximately in the middle of the flue gas duct and would thus be minimally influenced by the refractory walls and edge effects. For this reason, this portion of each specimen was given major emphasis throughout this study unless specifically mentioned otherwise. The more extensive porosity and microstructural disruption of the KT material at the glass-SiC interface region relative to the NC-430 silicon carbide would appear to make it less desirable for application in this environment. This behavioral difference was surprising because the NC-430 material was exposed to somewhat higher temperatures and was

in the form of a curved thin flat section rather than a solid cylinder like the KT specimen. Sample location in the test furnace flue might be a possible cause of the difference in behavior. The NC-430 was in port 2 (at a higher temperature), which is essentially open to the furnace exhaust, while the KT sample was located in port 13, where the flow is interrupted by several other specimens between the port and flue entry. Assuming that the convex side of the NC-430 was facing downward into the exhaust system, the concave side would experience deposition and condensation from the flow disturbance on the downstream lower velocity side. Only the concave side of this specimen showed discoloration and deposition of extraneous material, while the convex side was primarily covered with glass and cristobalite. The downstream side would therefore appear to be more subject to chemical attack because of the higher concentration of deposits on this surface. Material deposited on the downstream side of the sample in port 2 (NC-430) completely covered the exposed portion of another sample located further downstream in port 13 (KT-1B). This increased availability of corrosive foreign material on the silicon carbide at a point in the flue considerably downstream from the location of maximum gas temperature would be expected to increase chemical attack on the silicon carbide.

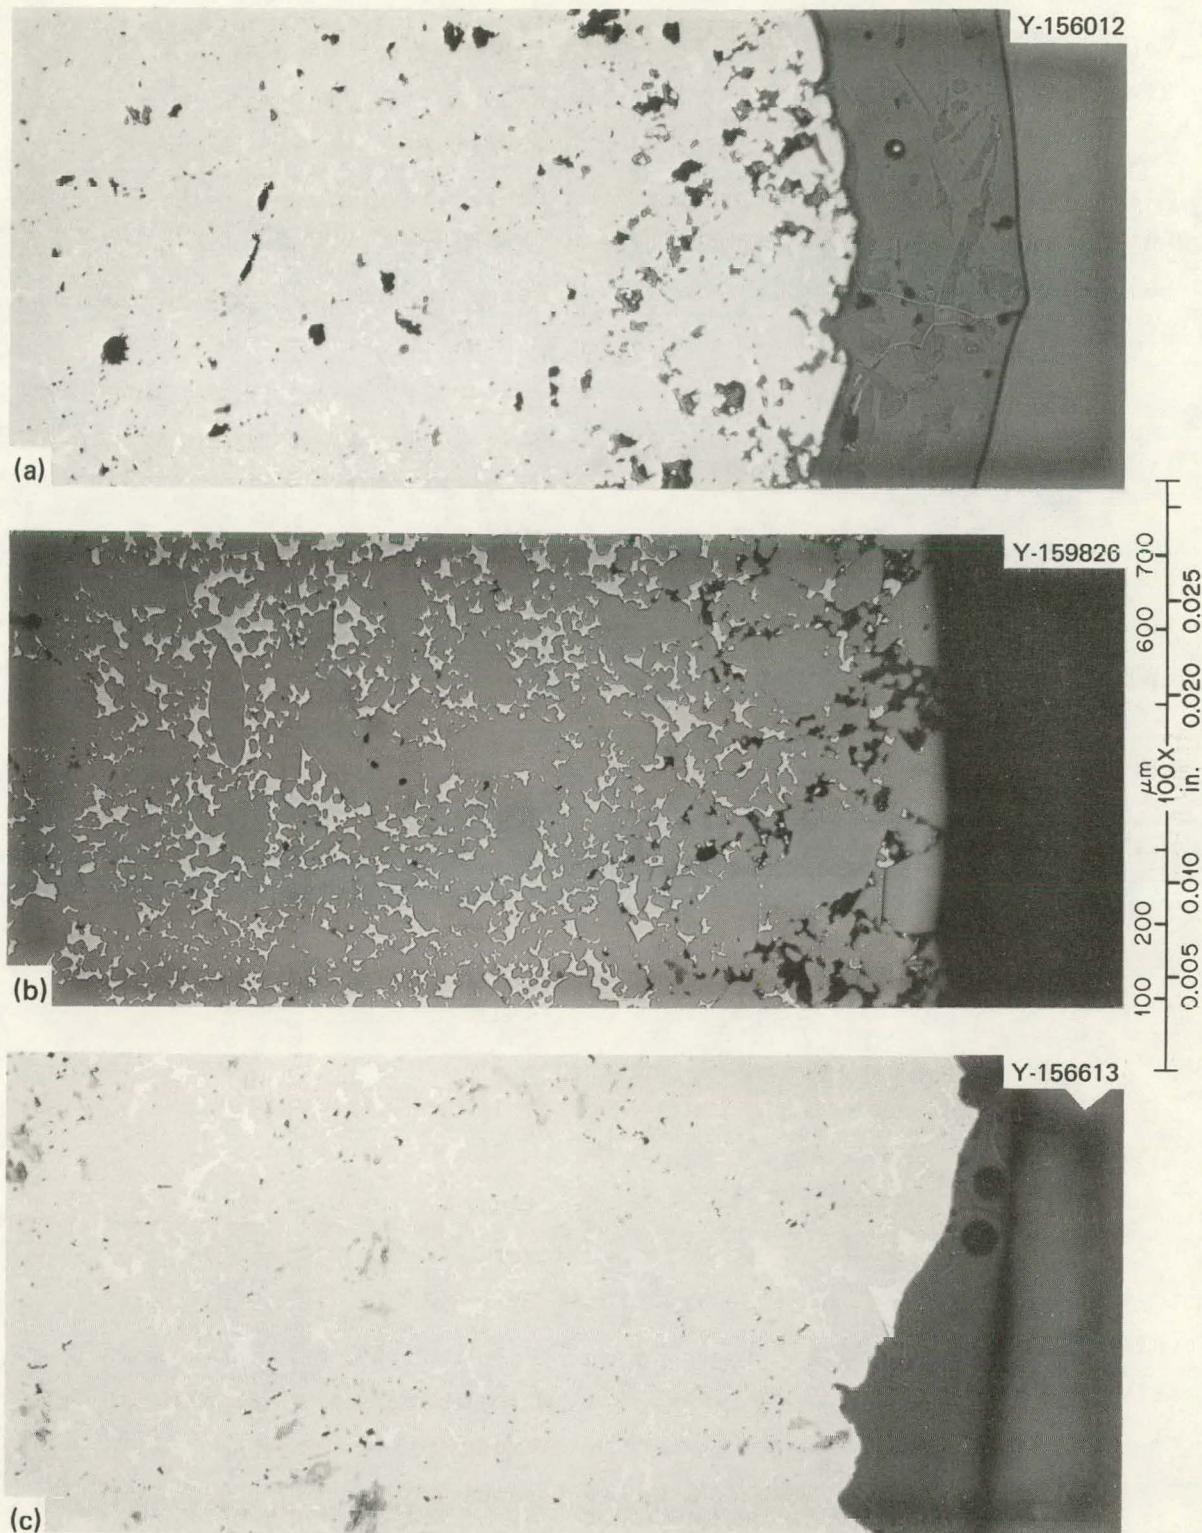
Fig. 9. Microstructure of Siliconized Silicon Carbide Exposed to Furnace Flue Atmosphere with Glass in the Furnace. (a) KT-4 at 1550°C (2800°F) for 69 d. (b) KT-2 at 1350°C (2450°F) for 48 d. (c) KT-3 at 1225°C (2250°F) for 69 d.

The microstructure of the siliconized silicon carbide exposed to glass is shown in Figs. 9 and 10. Comparison of these figures indicates that the attack on the free silicon present as a second phase in this material increases with increasing temperature in the range 1350 to 1550°C (2450–2800°F). The disappearance of the free silicon (mp 1410°C) secondary phase and its replacement by glass or porosity is significantly more extensive at higher temperatures (>1410°C) and is much worse for the KT material than for the NC material. Comparison with Fig. 8(a) also indicates that the microstructure of the KT silicon carbide may be disrupted more extensively than that of NC-430 silicon carbide during long-term flue tests in the furnace containing no glass.

The most striking observation, however, is that the sample exposed to the lowest temperature (1225°C) did not show the characteristic removal of the free silicon phase, but showed a roughly uniform removal of silicon and silicon carbide from the sample at an appreciable rate. The conclusion is that two very different degradation mechanisms are operative in this type of silicon carbide, depending upon the temperature. Fairly rapid reaction and corrosion occur at low temperatures and much slower corrosion occurs at higher temperature, with the microstructural degradation of the free silicon secondary phase having little apparent effect on the bulk corrosion or surface recession rate.

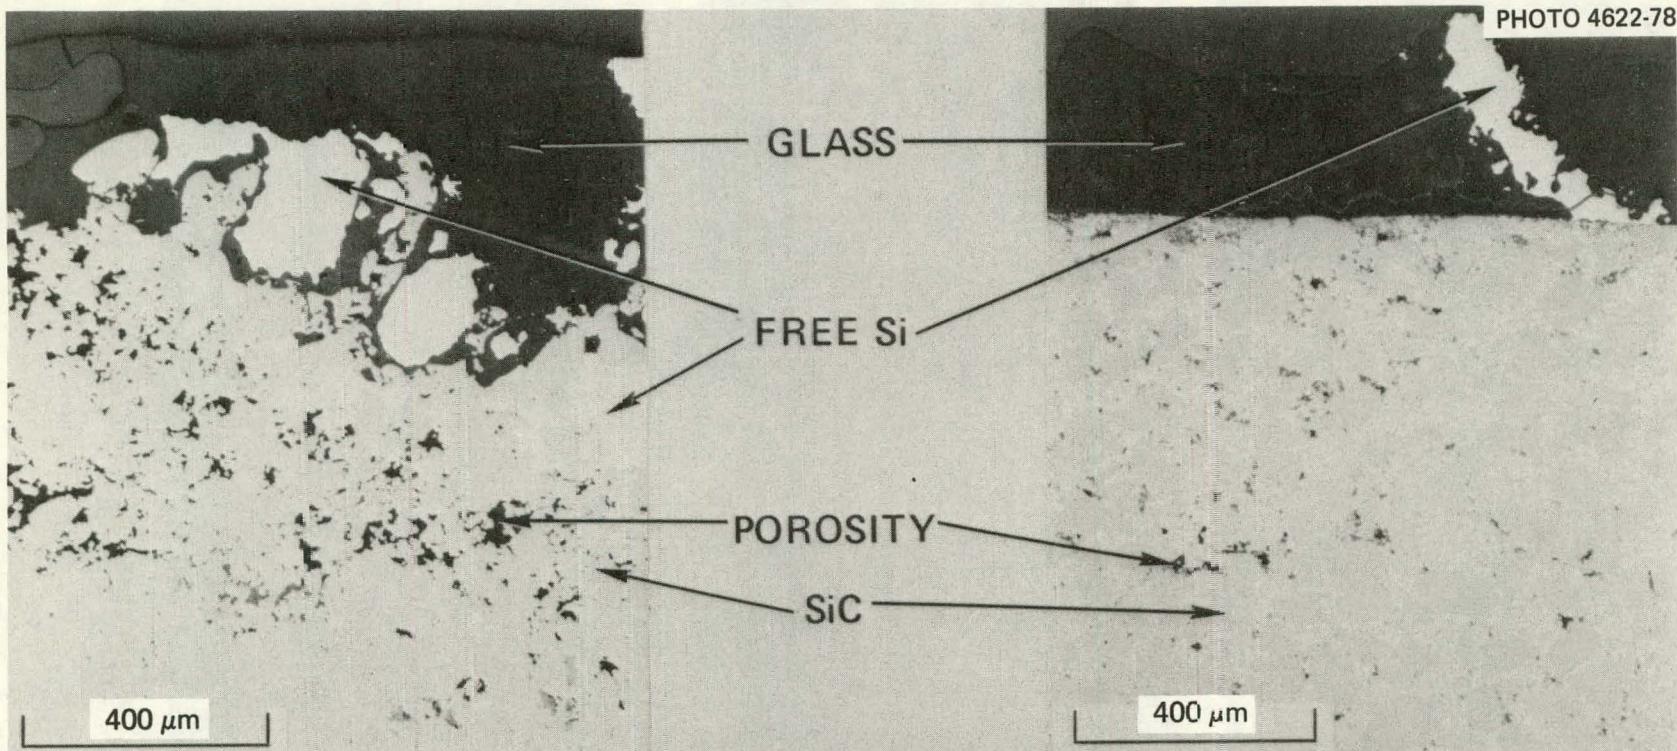
Fig. 10. Comparison of Microstructure of Two Types of Siliconized Silicon Carbide Exposed to Furnace Flue Atmosphere with Glass in the Furnace. Left: specimen KT-2 exposed 47 d at 1350°C (2450°F) and 48 d at 1425°C (2600°F). Right: specimen NC-430-2 exposed 104 d at 1450°C (2650°F).

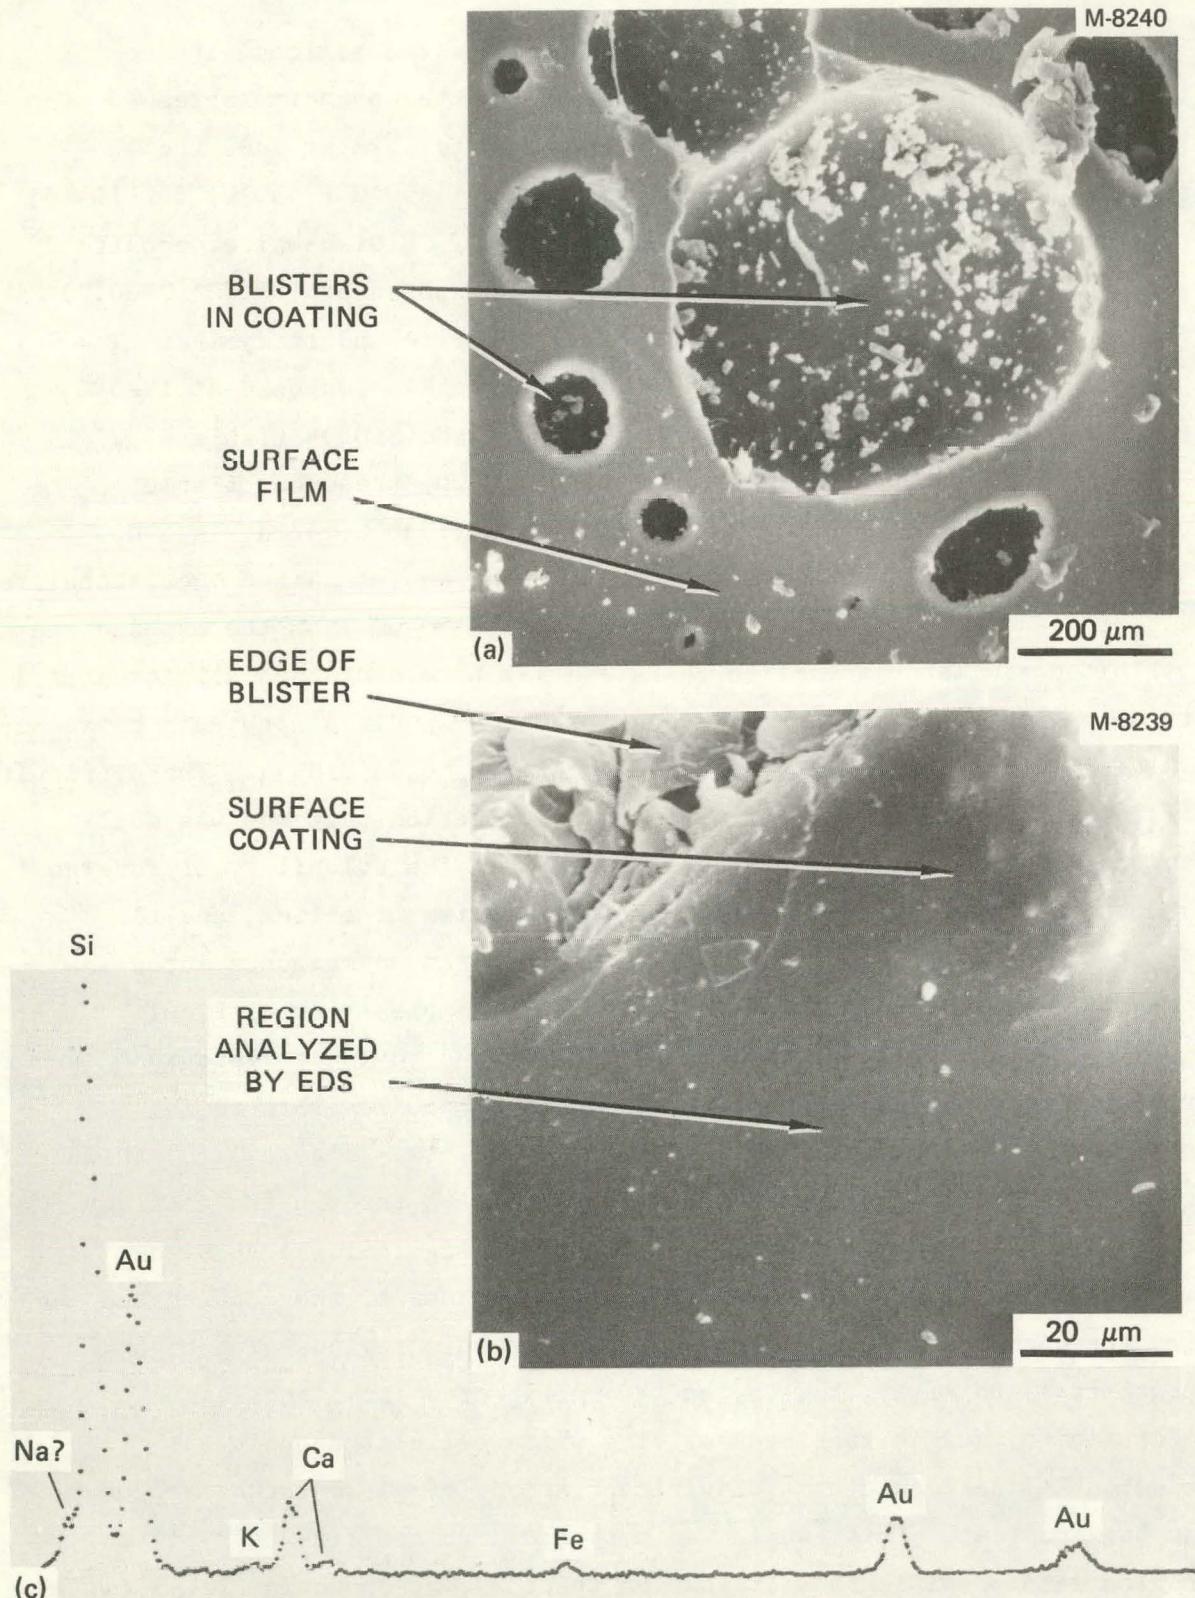
Fig. 11. Scanning Electron Micrographs and Microcomposition of the Glassy Surface on Siliconized Silicon Carbide (NC-430-2) Exposed to Glass Furnace Exhaust at 1450°C for 104 d. (a) Holes in glassy layer. (b) High magnification. (c) Microcomposition by energy-dispersive x-ray spectroscopy (EDS). Gold peaks are from conductive coating, not part of specimen.

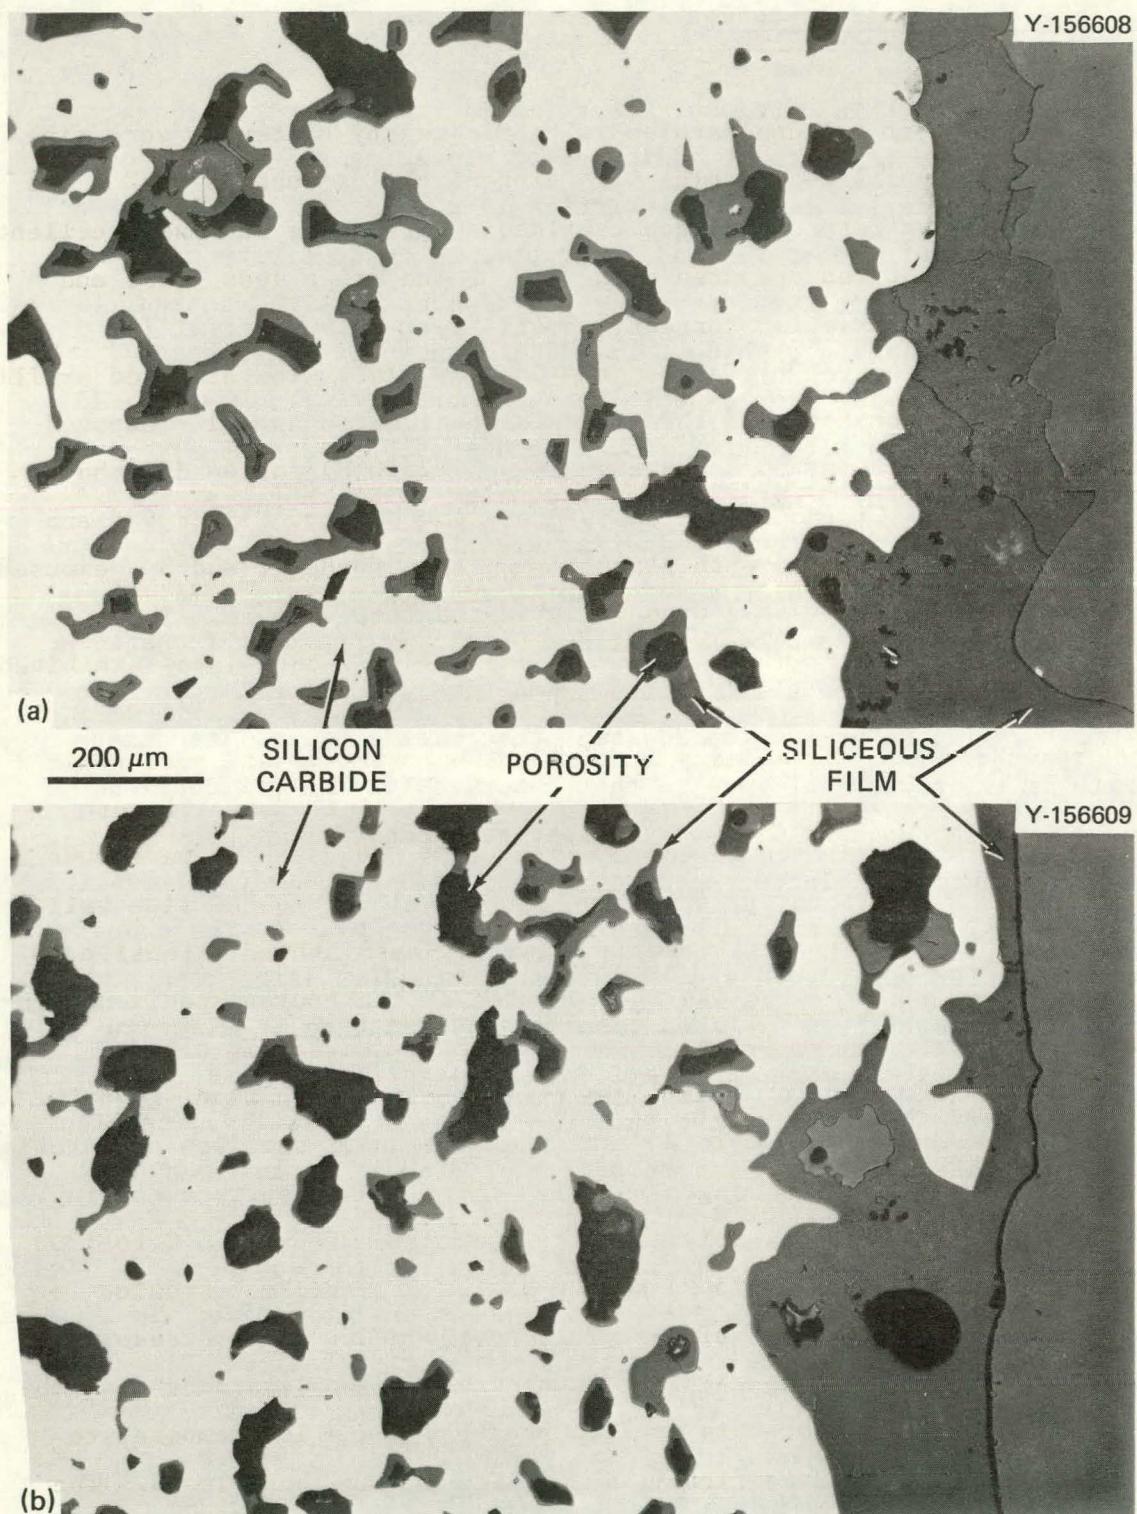
Fig. 12. Microstructure of Recrystallized Silicon Carbide Exposed at 1400°C (2550°F) for 116 d. (a) NC-400-1 exposed without glass in the furnace. (b) NC-400-2 exposed with glass in the furnace.

Representative microstructures are shown in Fig. 12 (NC-400-1 and NC-400-2). The microstructures are somewhat similar. An amorphous surface coating penetrated easily into the extensive large open porosity present in this silicon carbide. The material exposed to glass in the furnace [Fig. 12(b)] shows more evidence of significant dissolution and possible reprecipitation at the interface between the silicon carbide and the surface coating. Relicts of a second phase in the amorphous surface coating are visible in both samples.

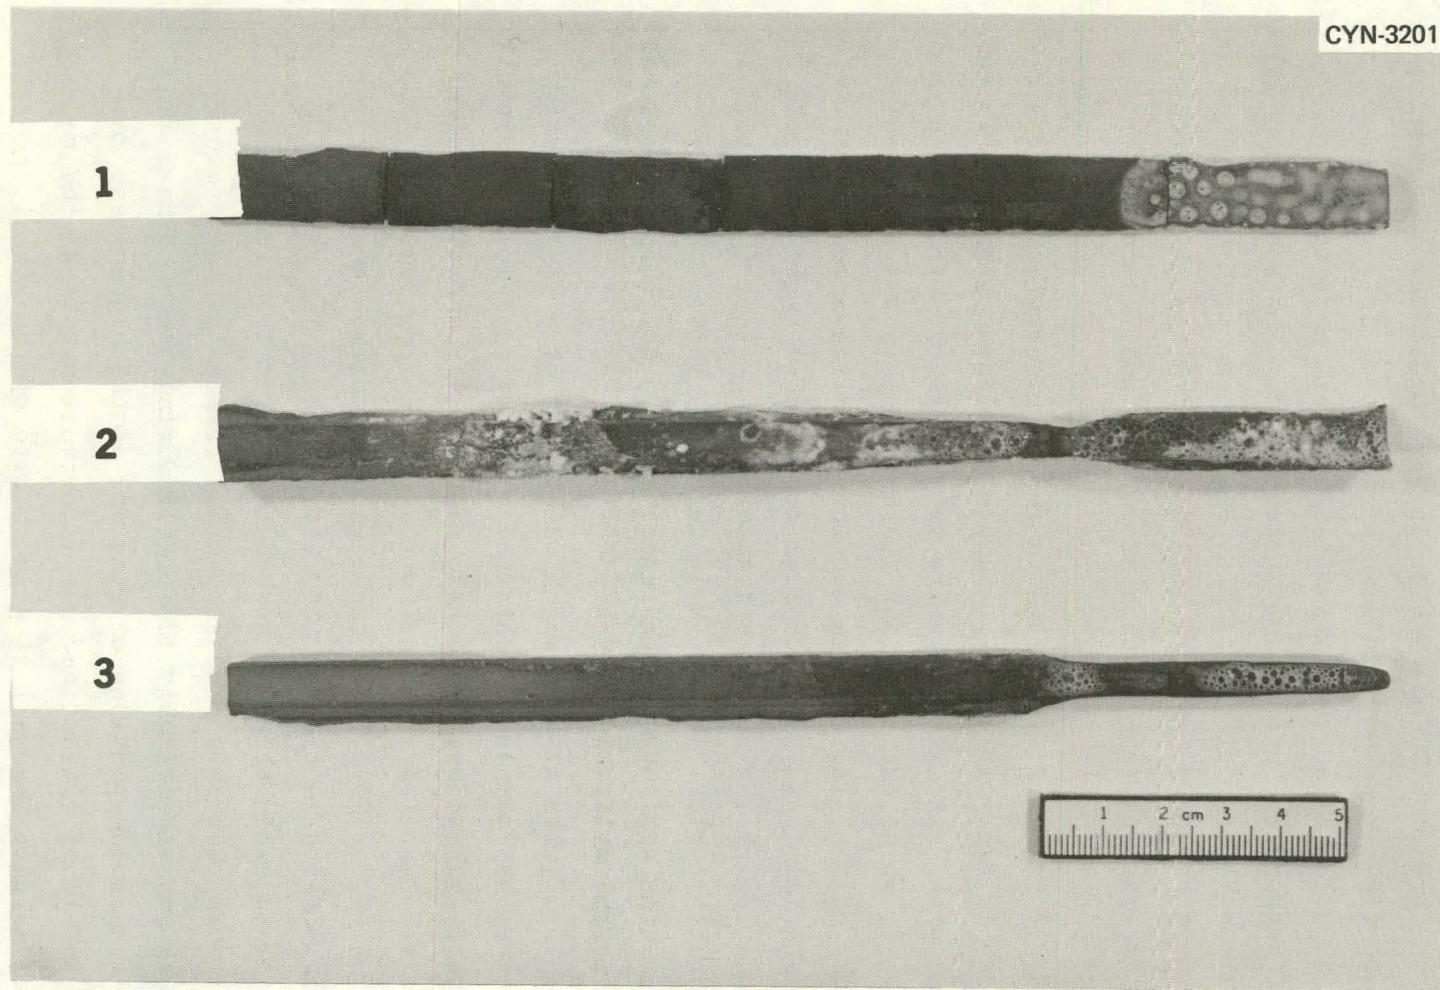
Fig. 13. Sintered α -Silicon Carbide Subjected to Glass Furnace Exposure Testing.

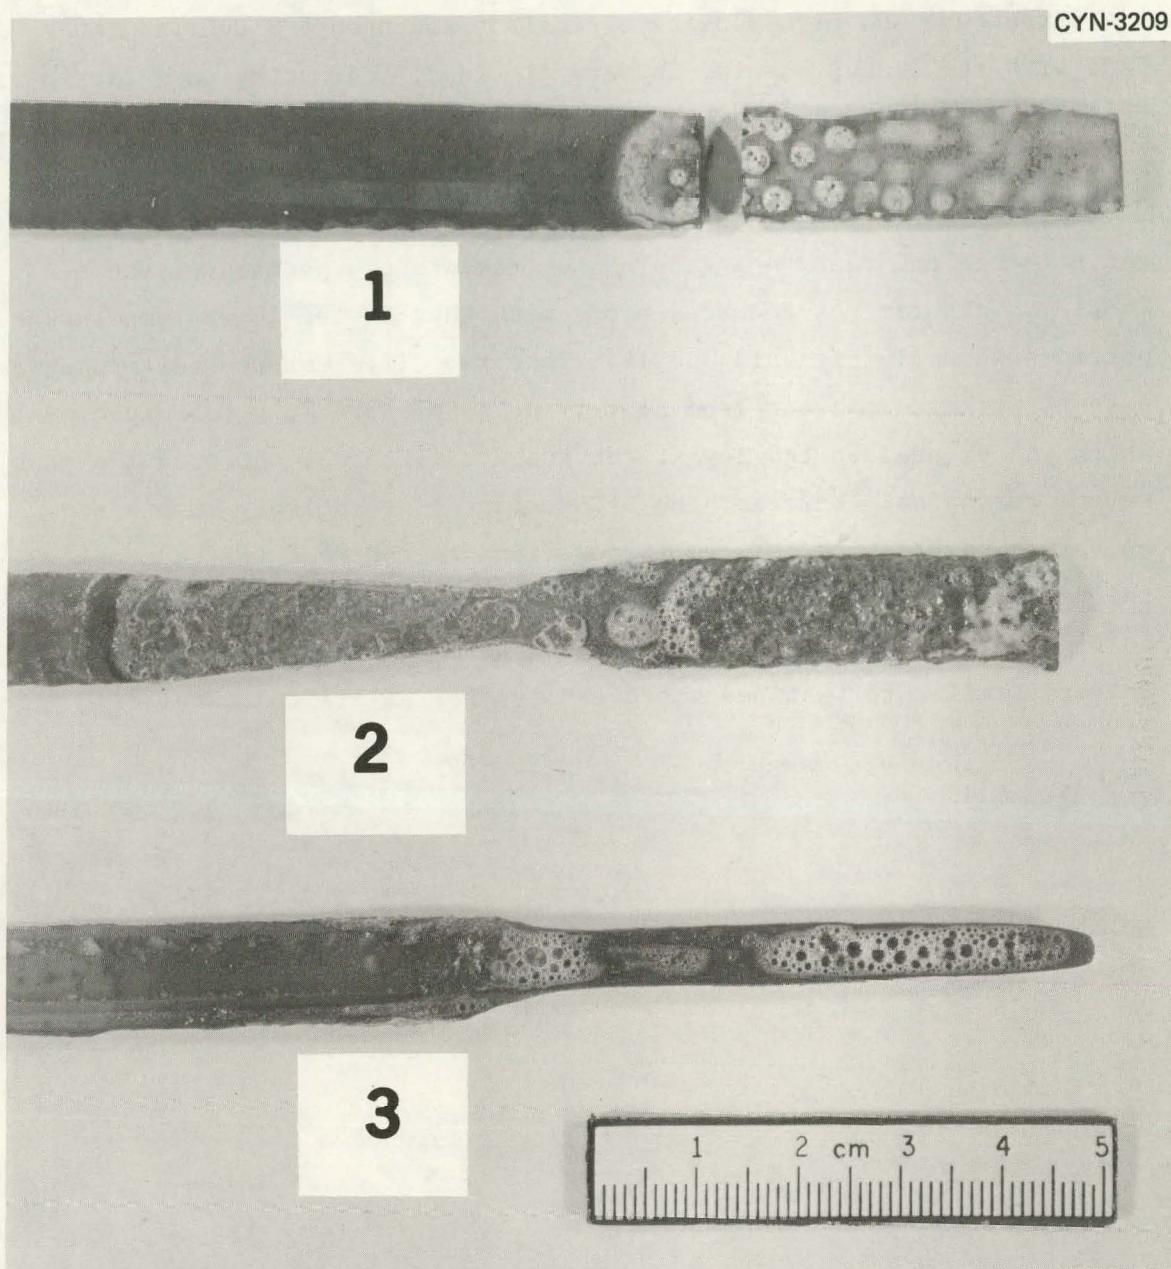
Fig. 14. Close-Up of Sintered α -Silicon Carbide Subjected to Glass Furnace Exposure Testing.

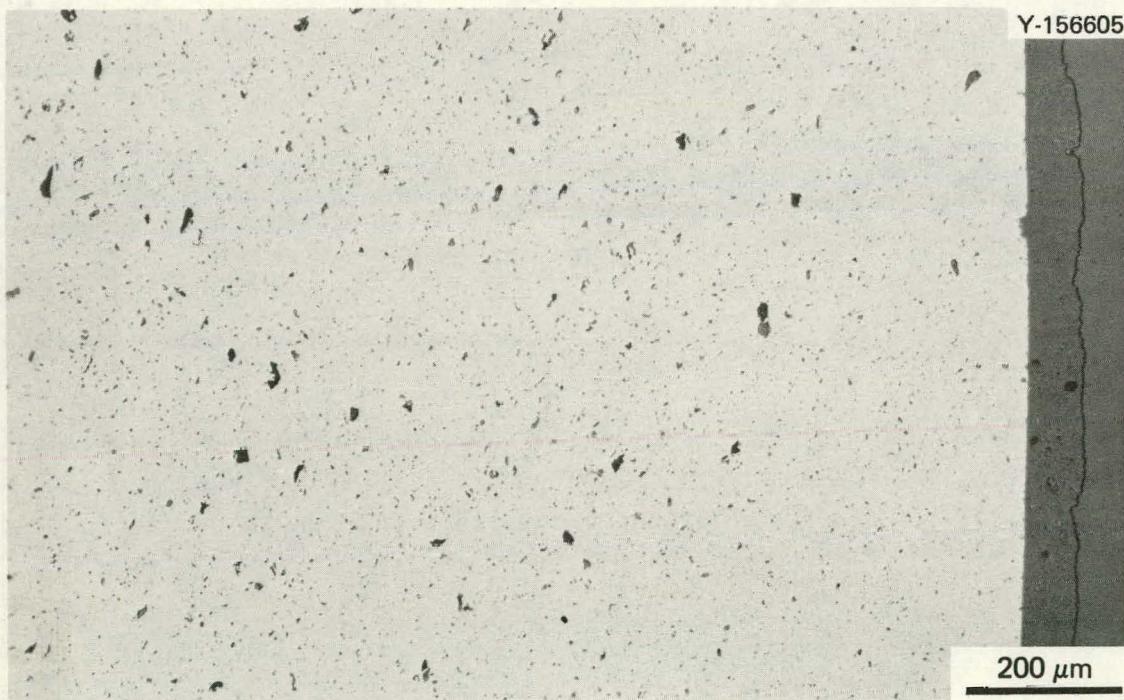
Fig. 15. Microstructure of Sintered α -Silicon Carbide (Sample 1) Exposed at 1425°C (2600°F) for 36 d and 1450°C (2650°F) for 44 d with No Glass in the Furnace.

The micrograph, Fig. 15, of sample 1 shows the very fine grained microstructure and high density typical of sintered α -SiC. The interface with the glassy coating is very distinct, indicating that little penetration or attack occurs at these temperatures (1425–1450°C) without glass in the furnace.

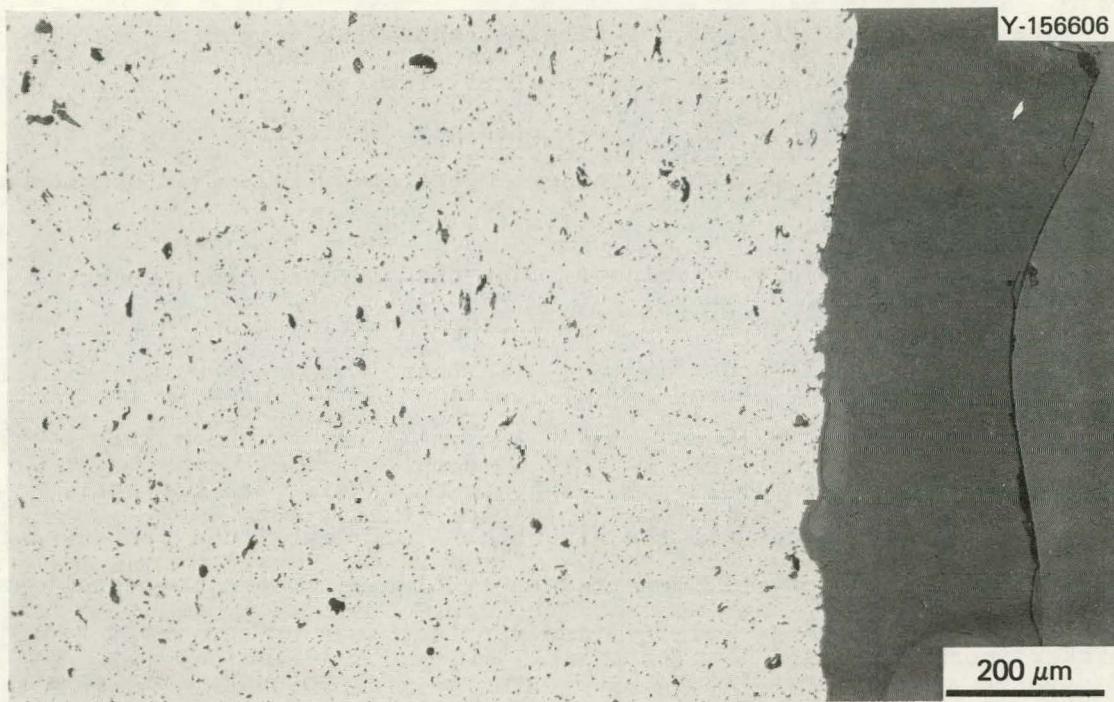
Fig. 16. Microstructure of Sintered α -Silicon Carbide (Sample 2) Exposed at 1450°C (2650°F) for 4 d and 1550°C (2800°F) for 17 d with Glass in the Furnace.

Figure 16 of sample 2 indicates that the sintered alpha material was attacked and removed in the higher temperature portion of the sample. This removal occurred along with that in the lower temperature portions shown in Figs. 13 and 14. That two different removal processes were at work is apparent from Fig. 17 of sample 3. This test specimen, which was exposed to the lowest temperature (1225°C), suffered the most severe corrosion. However, the SiC surface is relatively smooth and contained only a very thin amorphous film, in contrast to the much thicker amorphous coating and roughened SiC surface seen on sample 2 in Fig. 16. This mass removal behavior as a function of temperature is very similar to that described earlier for KT silicon carbide.

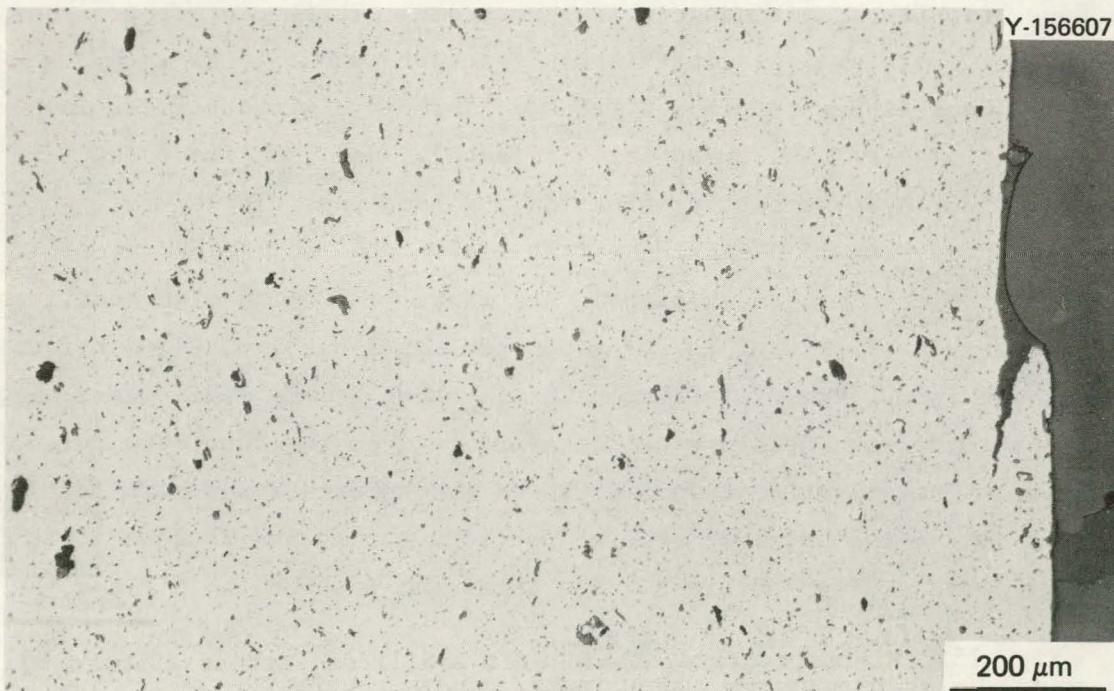
Fig. 17. Microstructure of Sintered α -Silicon Carbide (Sample 3) Exposed at 1225°C (2250°F) for 18 d with Glass in the Furnace.
