ORNL/TM-6970

Materials Analyses of Ceramics for Glass Furnace Recuperators

MATERIALS ANALYSES OF CERAMICS FOR GLASS FURNACE RECUPERATORS

Date Published: November 1979

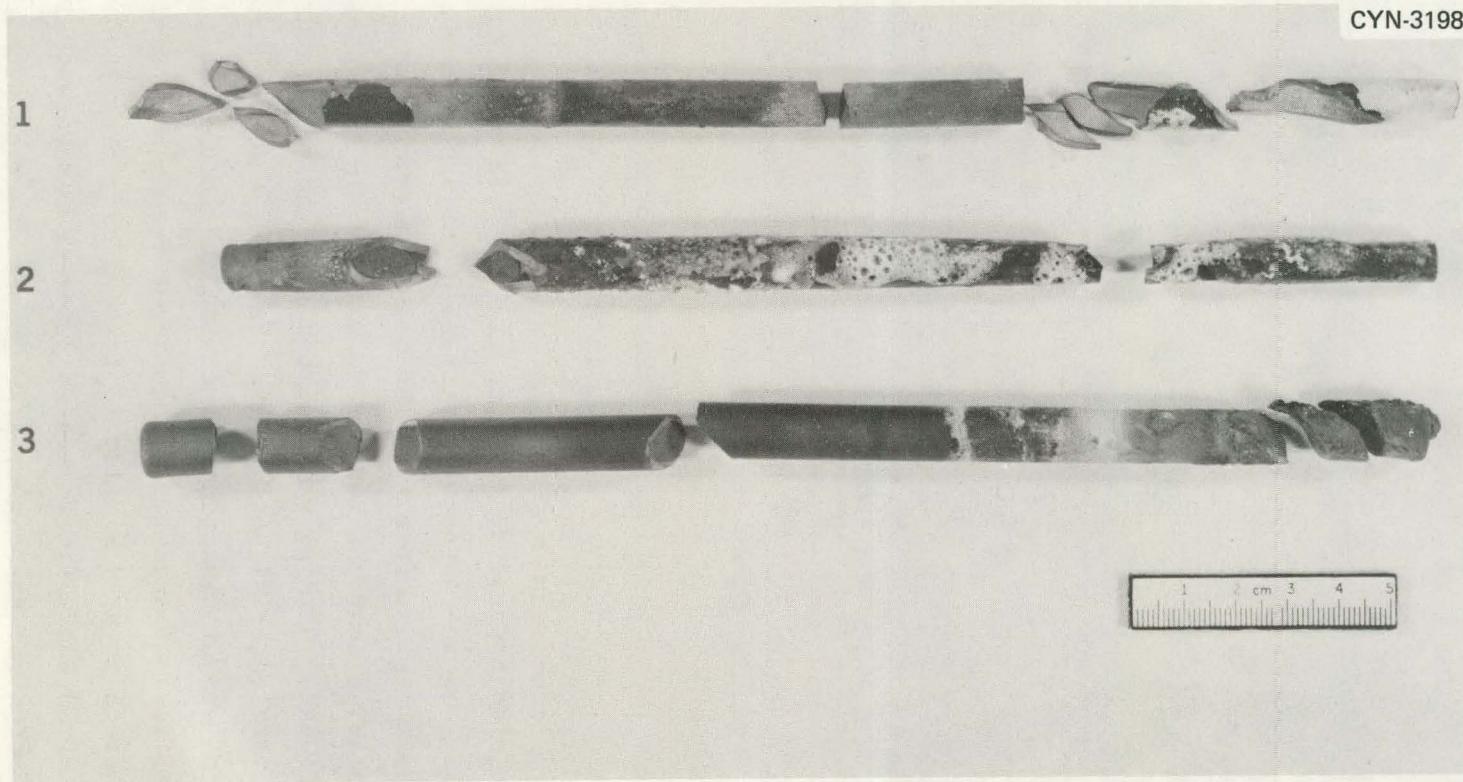
Fig. 18. Chemically Vapor Deposited Silicon Carbide Exposed to Glass Furnace Testing.

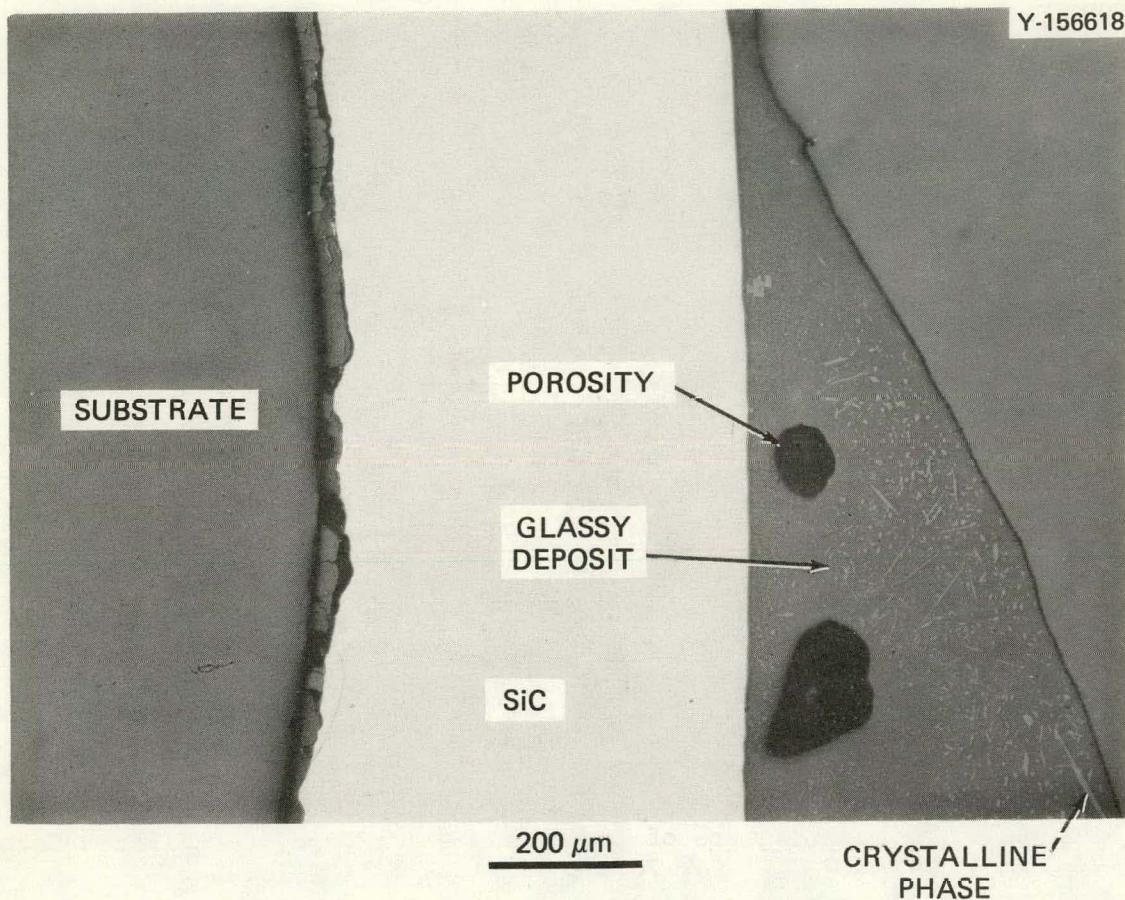
Fig. 19. Microstructure of CVD Silicon Carbide Exposed at 1550°C (2800°F) for 116 d with No Glass in the Furnace.

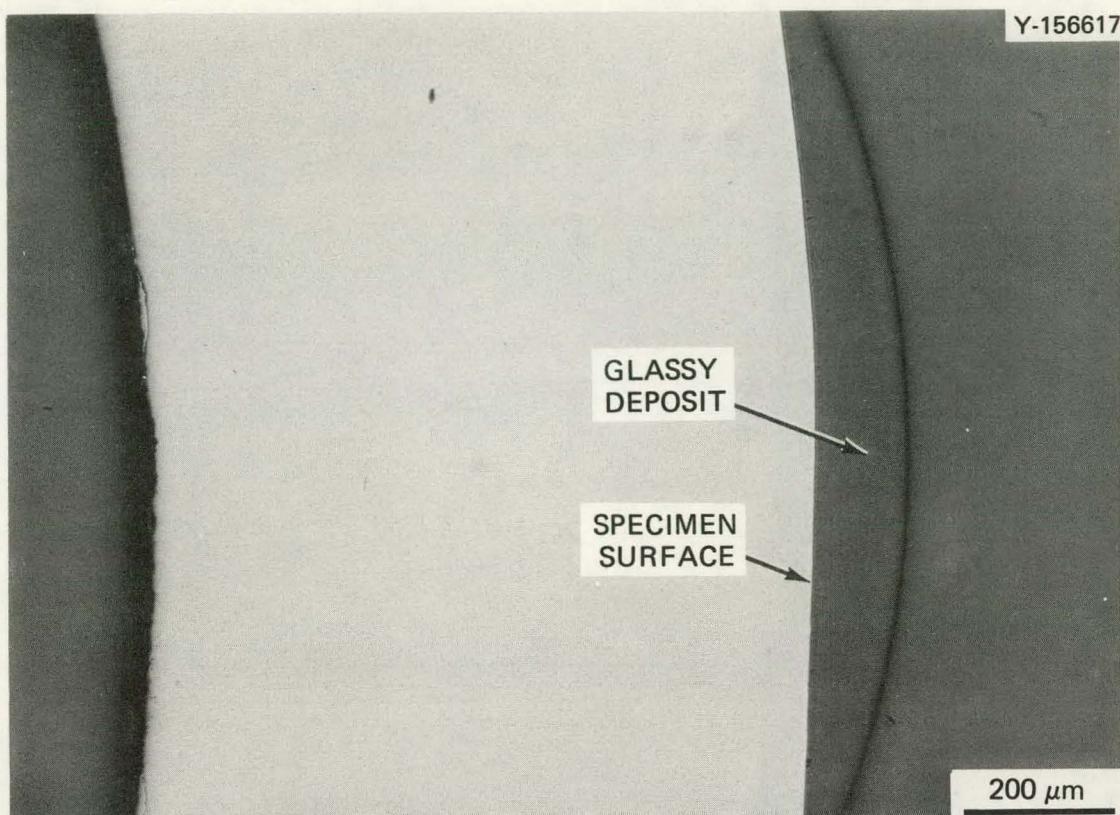
Fig. 20. Microstructure of Chemically Vapor Deposited Silicon Carbide Exposed at 1550°C (2800°F) for 70 d with Glass in the Furnace.

Sample 2 was also exposed to flue gas at 1550°C (2800°F) for 70 d, but with glass in the furnace. After 48 d the specimen showed some decrease in diameter. After 70 d the sample was corroded into two parts at a location near the supporting wall, where the specimen temperature was lowest. Glazing was apparent over the entire surface. Even with this severe material loss during the test, the microstructure in Fig. 20 shows a very distinct interface with the surface coating. The large material loss of this CVD SiC during the test when glass was present in the furnace is very similar to that already described for samples of siliconized and α -SiC tested at lower temperatures. There is no obvious explanation for the higher mass losses observed with the CVD

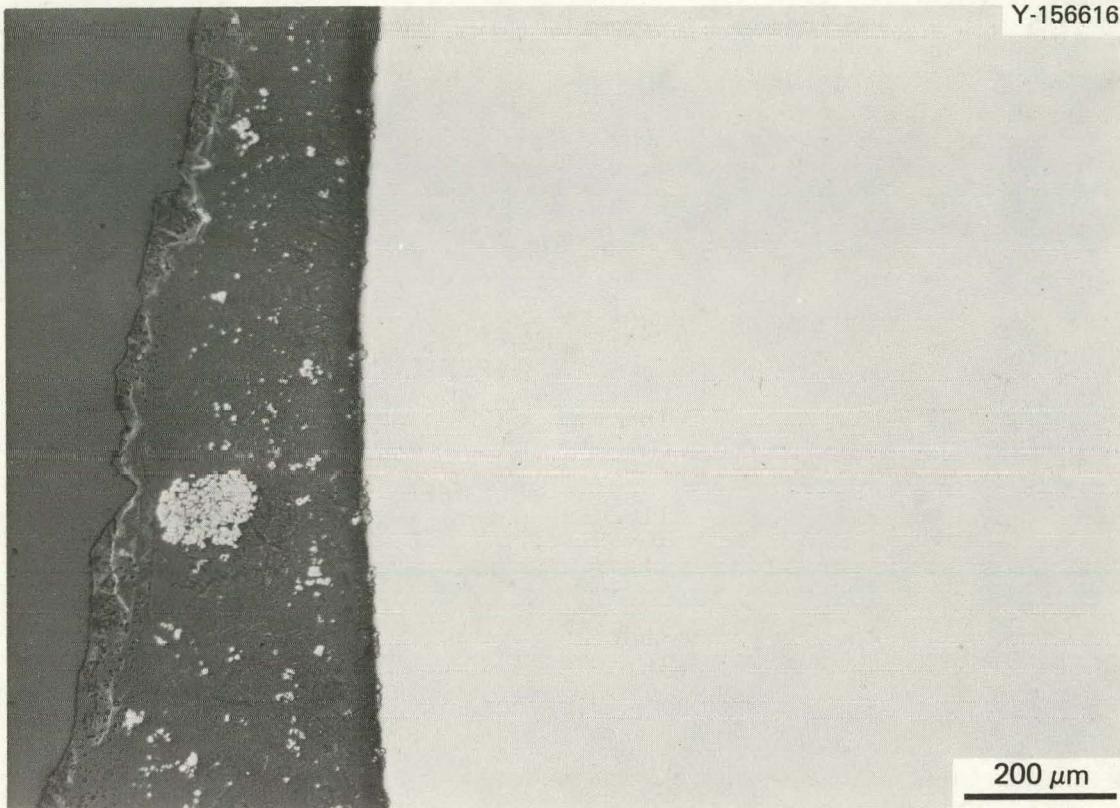
Y-156616

Fig. 21. Microstructure of Chemically Vapor Deposited Silicon Carbide Exposed at 1225°C (2250°F) for 92 d with Glass in the Furnace.

SiC at temperatures higher than those seen for the other types of SiC in these tests. This behavior is seen in sample 3, which at low temperatures [1225°C (2250°F)] for 92 d without glass underwent little mass loss or dimensional change. This is a contrast to the behavior of sintered α -SiC with glass in the furnace at a similar test temperature. The microstructure seen in Fig. 21 shows several phases present in the surface coating and well-developed crystals located in the coating, particularly near the SiC-coating interface. The interface is fairly distinct with some possible sites of exaggerated attack visible in the ceramographic sections.

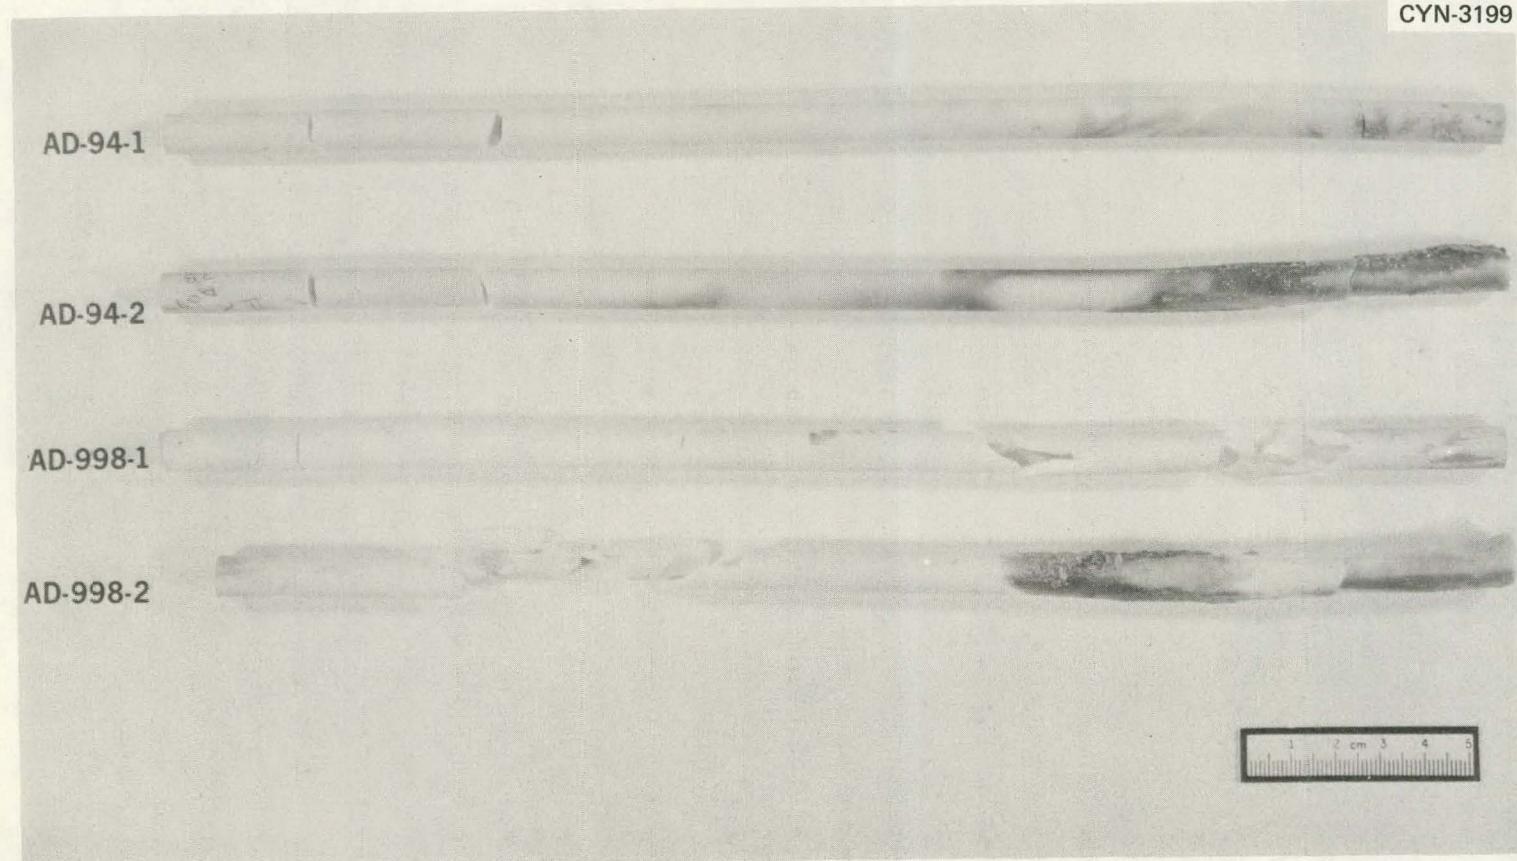
Fig. 22. High-Purity Alumina Ceramic Specimens Exposed to Glass-Furnace Off-Gas Atmosphere.

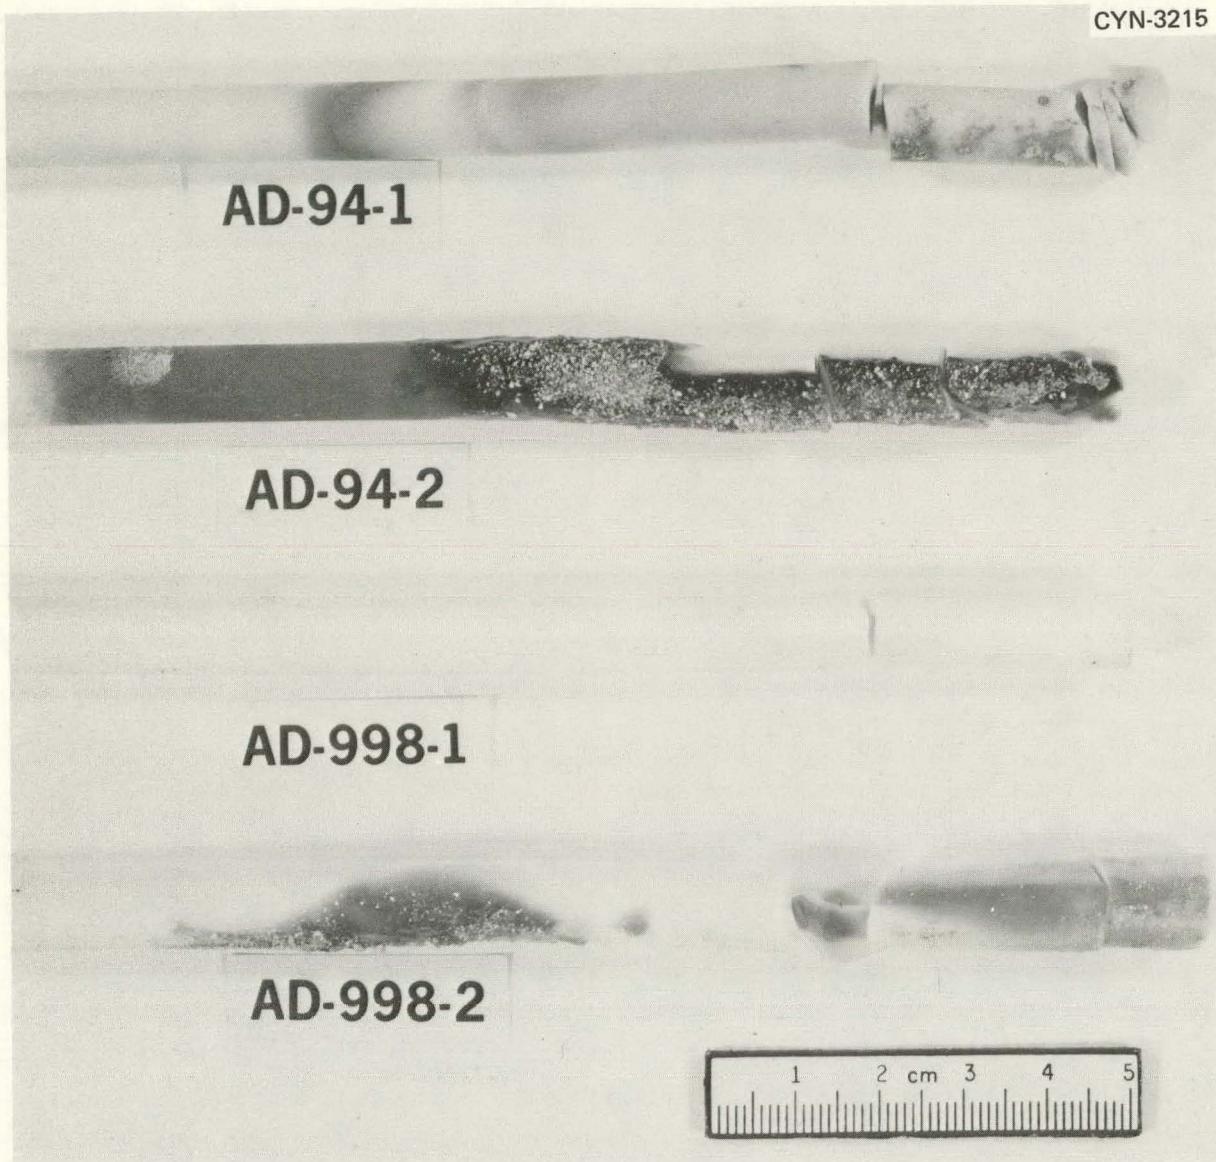
Fig. 23. Close-Up of High-Purity Alumina Ceramic Specimens Exposed to Glass Furnace Off-Gas Atmosphere.

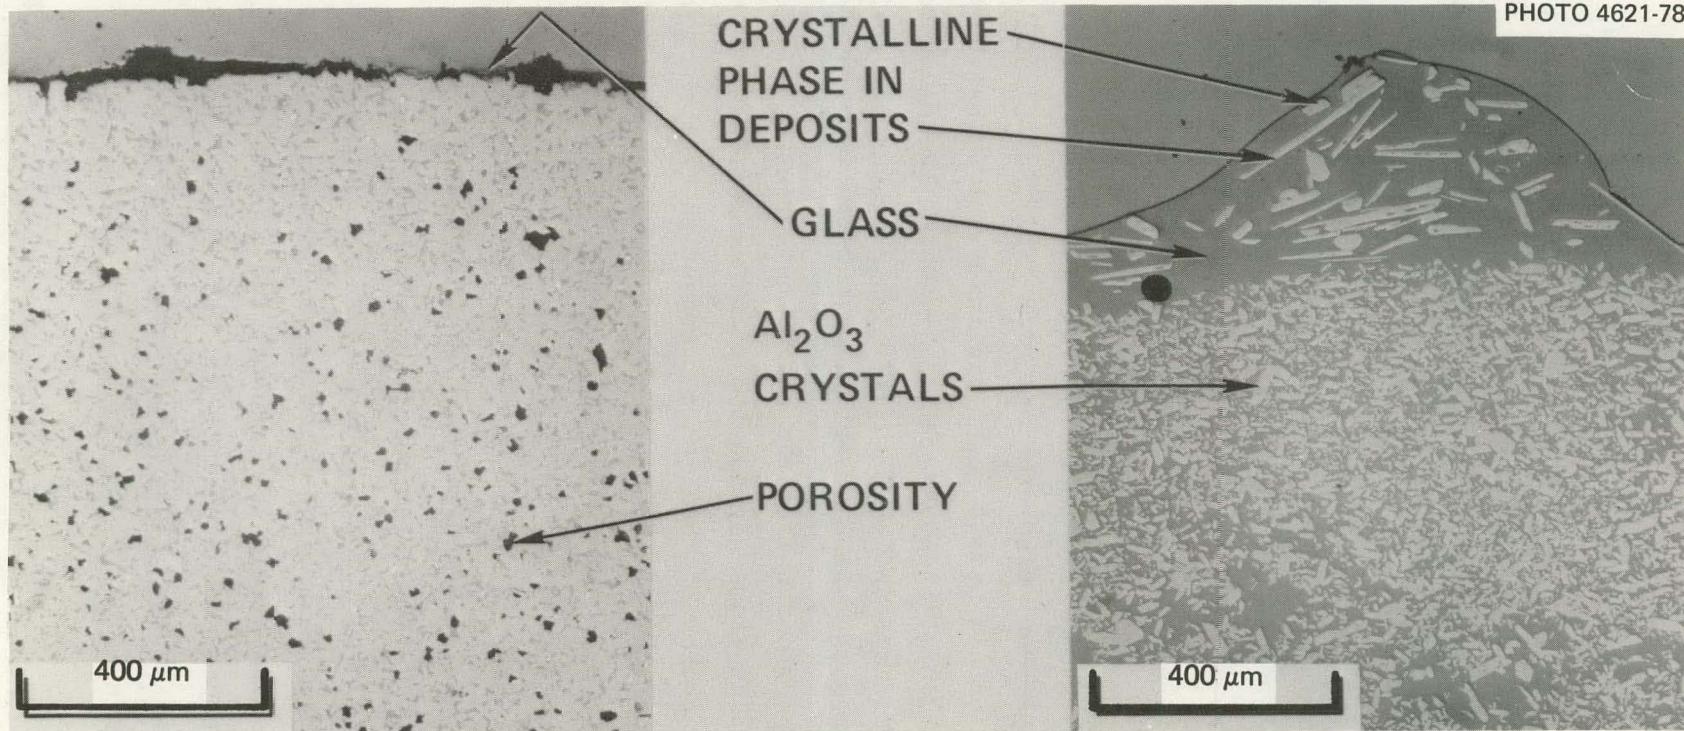
Fig. 24. Microstructure of Alumina Porcelain AD-94 Exposed at 1450°C (2650°F) for 8 d and 1400°C (2550°F) for 109 d. Left: without glass in the furnace. Right: with glass.

The microstructures of these two samples are shown in Fig. 24. The sample tested without glass (AD-94-1) retained the characteristic microstructure of a high-alumina ceramic, consisting of small alumina grains surrounded by a siliceous bonding phase and small scattered porosity. A significant change was apparent in the sample tested with glass in the furnace. An amorphous phase from the surface, probably an alkali

silicate melt, completely penetrated the ceramic, separated the individual grains, and filled the available porosity. The lack of a discrete interface between the original specimen and the surface deposit illustrates the extensive penetration of the melt into the alumina ceramic microstructure. As the crystals observed in the surface deposit have a morphology unlike that found in the bulk ceramic, they apparently developed upon cooling and are not discrete corundum crystals removed from the matrix. The AD-94-2 specimen would be expected to have very poor high-temperature mechanical properties as a result of the presence of this extensive and continuous amorphous material. This ceramic would, therefore, be an unlikely candidate for structural use in recuperators for this application.

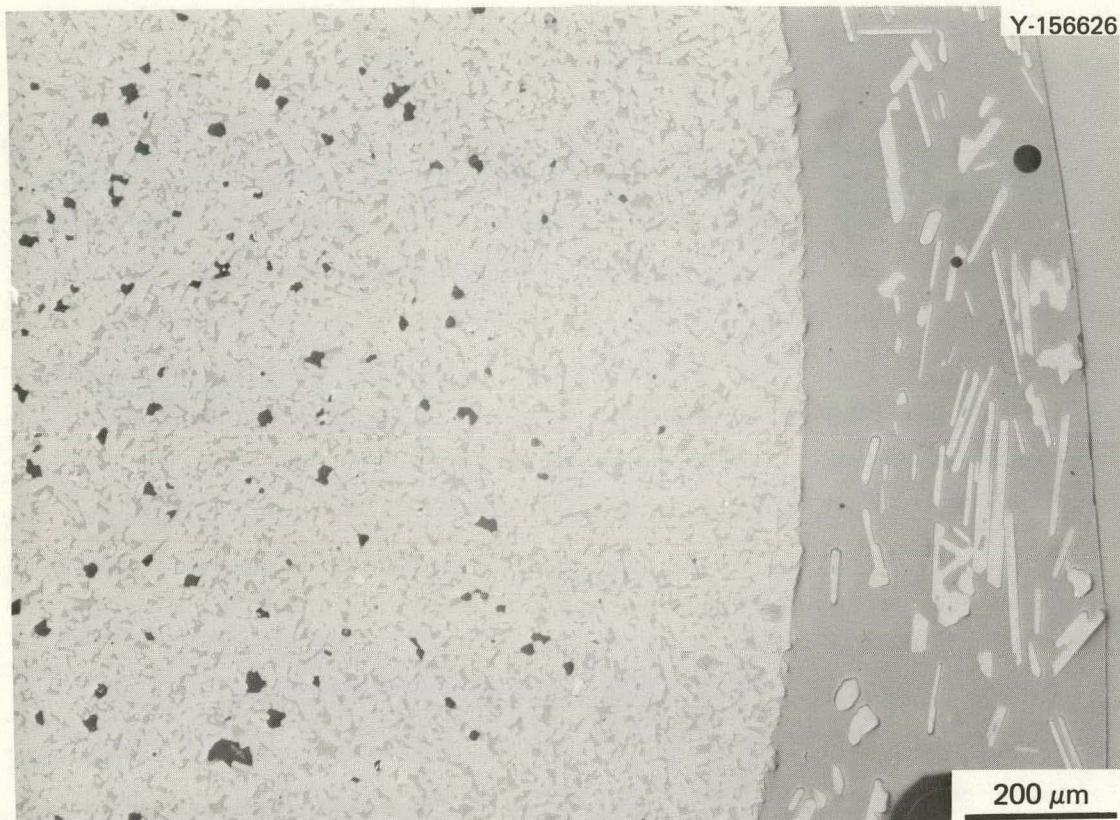
Fig. 25. Microstructure of High-Purity (99.8 wt %) Alumina (AD-998-2) Exposed at 1450°C (2650°F) for 85 d with Glass in the Furnace.

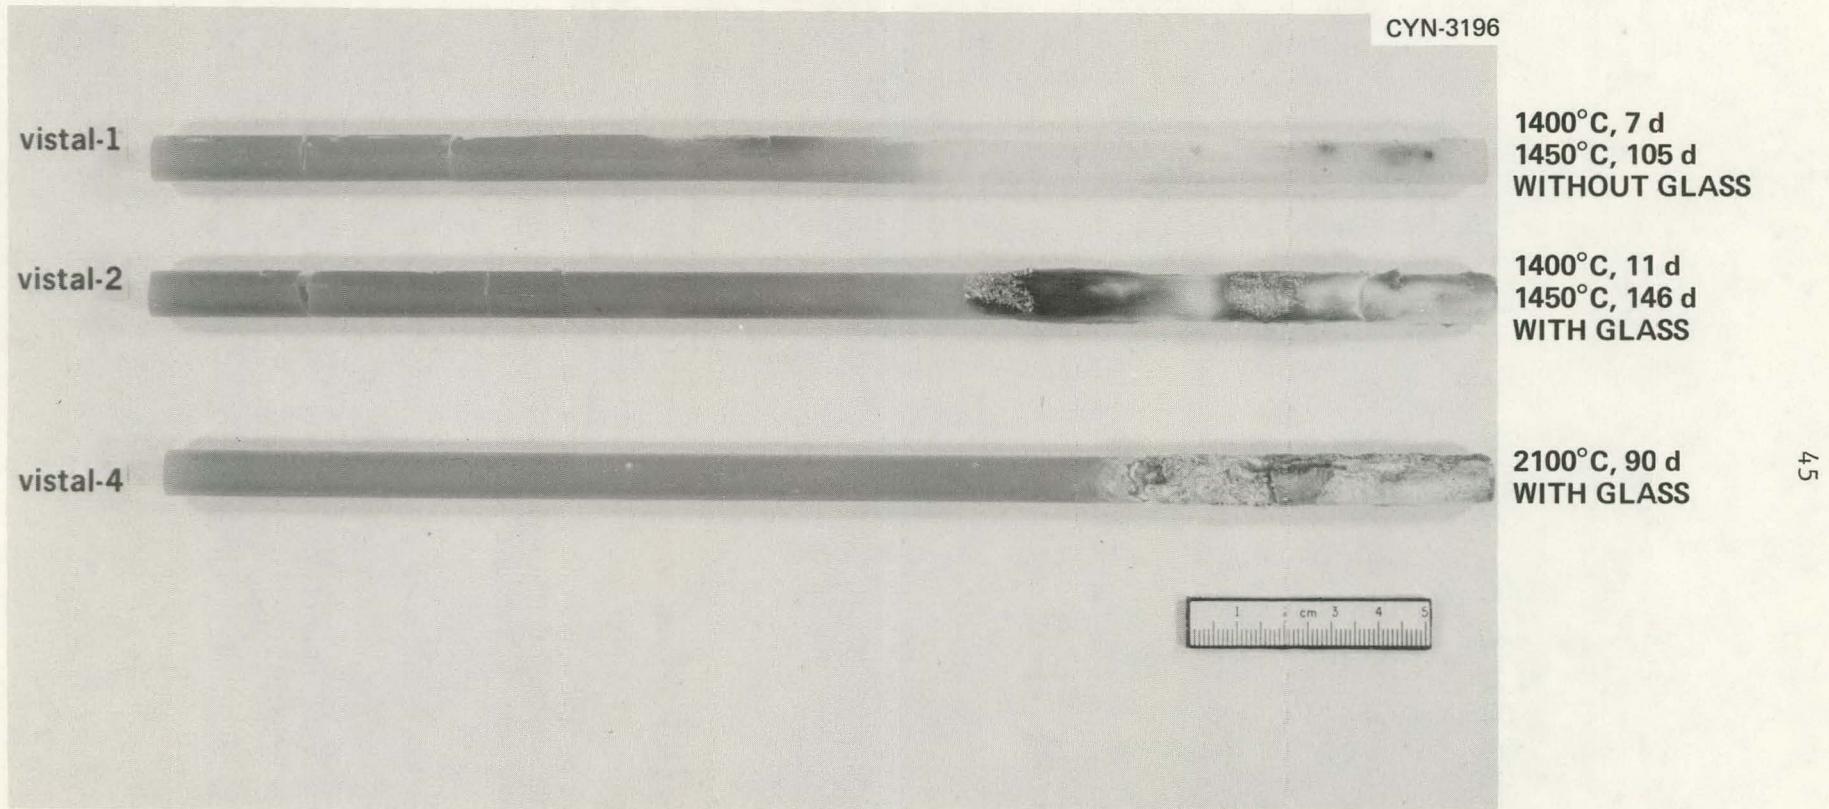
Fig. 26. High-Purity (Vistal) Alumina Exposed to Glass Furnace High-Temperature Exhaust Stream.

Three samples of an alumina ceramic having the highest initial density and purity (Vistal) were tested. Their post-test appearance is shown in Figs. 26 and 27. The Vistal 1 sample, exposed at 1400°C (2550°F) for 7 d and then at 1450°C (2650°F) for 105 d without glass exhibited the best behavior of all the ceramic materials tested under these conditions. Negligible corrosion occurred, and only a loss of the surface finish was observed, in addition to a slight discoloration that was probably attributable to iron. The Vistal 2 sample was exposed at 1400°C (2550°F) for 11 d and 1450°C (2650°F) for 146 d with glass in the furnace. Some slumping was observed along with 5% reduction in diameter near the flue wall. The microstructure of the Vistal 1 sample is shown

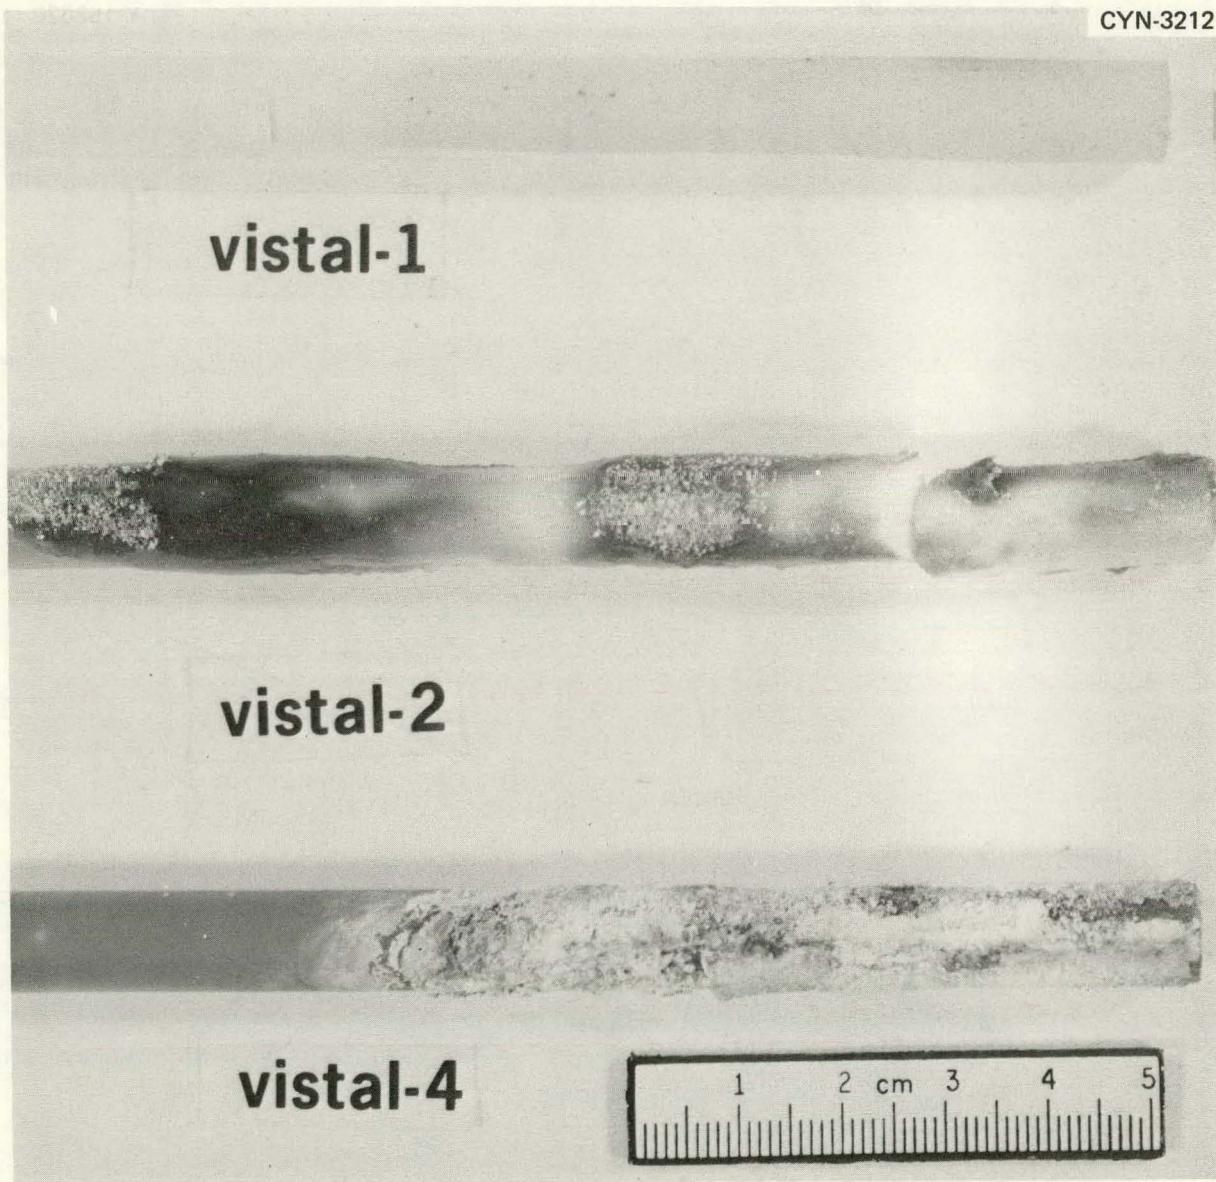
CYN-3212

Fig. 27. Close-Up of High-Purity (Vistal) Alumina Exposed to Glass Furnace High-Temperature Exhaust Stream.

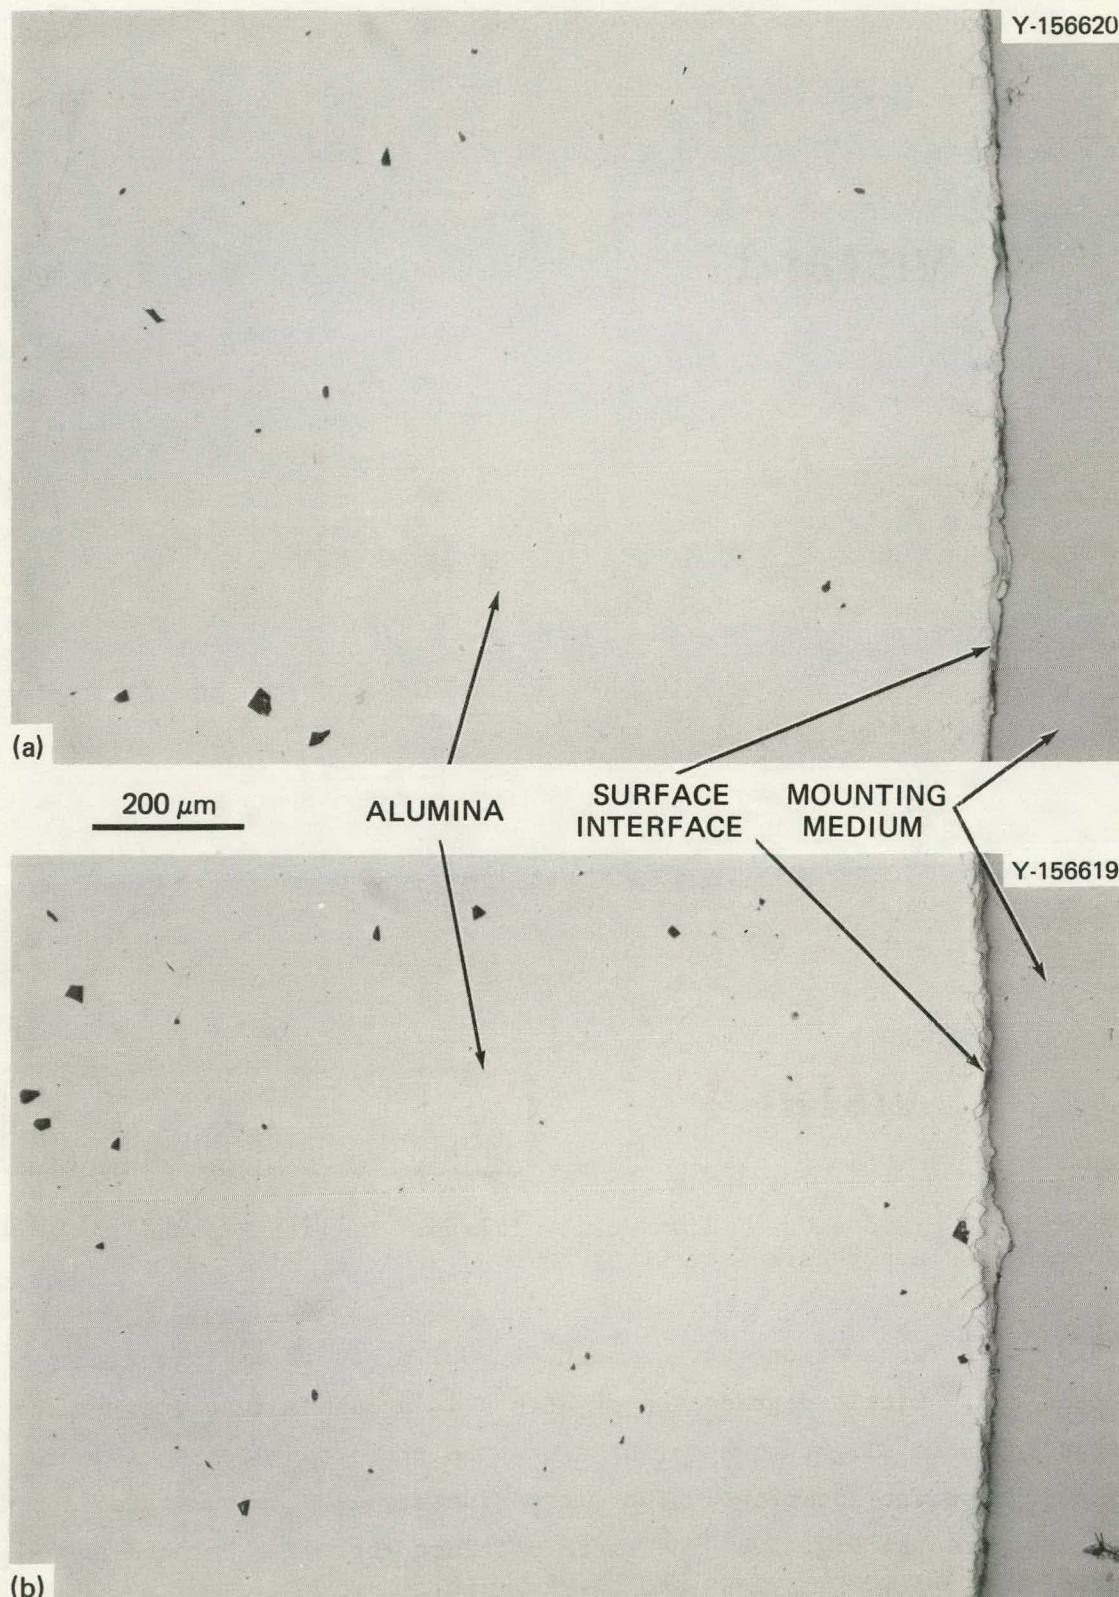
Fig. 28. Microstructure of High-Purity (Vistal) Alumina Exposed at 1400°C (2600°F) for 7 d and 1450°C (2650°F) for 105 d with No Glass in the Furnace. (a) 35 mm from exposed end. (b) 0.1 m from exposed end.

in Fig. 28. Two sections were examined: 0.1 m and 35 mm from the exposed end. Little degradation or attack is apparent in either region except for some slight penetration along the grain boundaries close to the Al_2O_3 -deposit interface. The microstructure of samples Vistal 1 and 2 are compared in Fig. 29. The sharp distinct interface between the Al_2O_3 and the deposit in sample 2 is readily visible. The relatively low concentration of crystalline phase in the deposits also indicates less

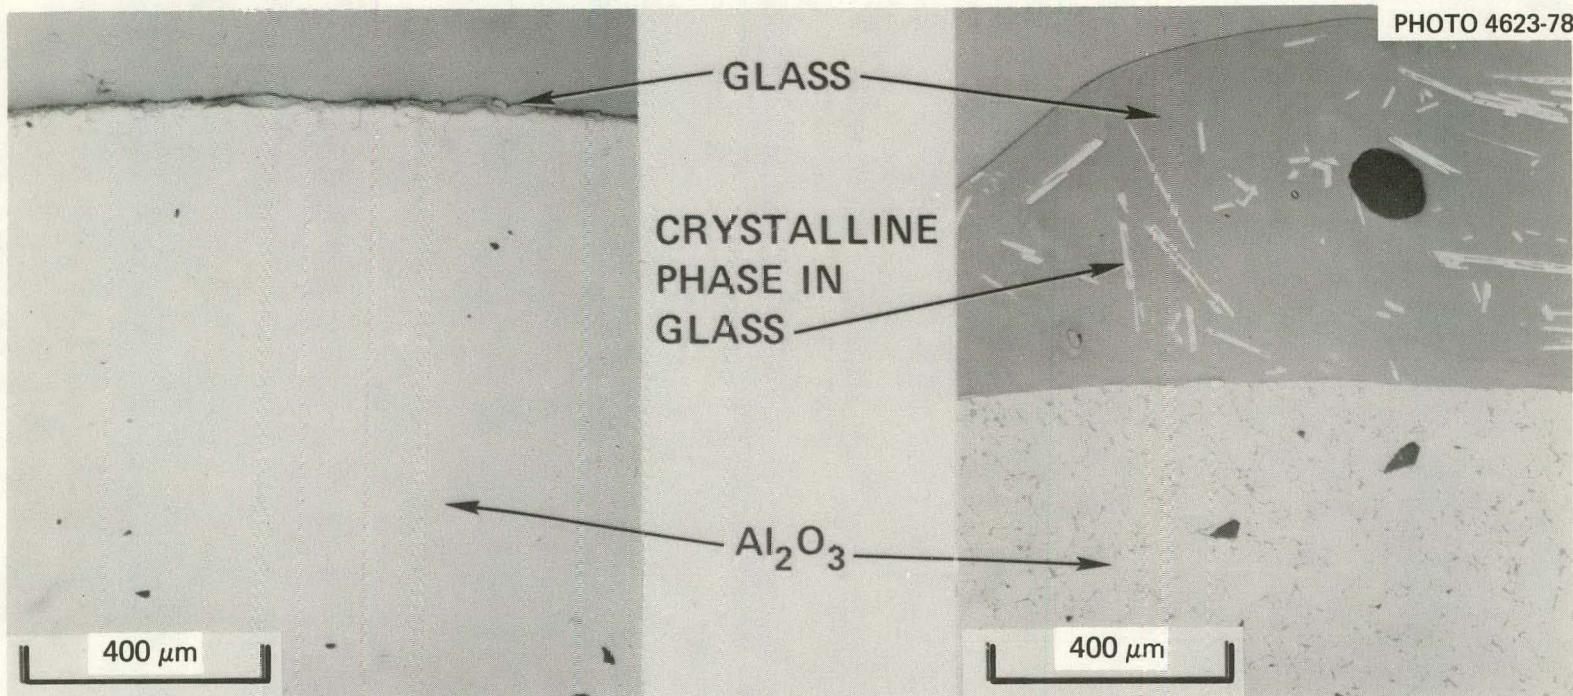
Fig. 29. Microstructure of High-Purity Vistal Aluminas Exposed to Glass Furnace High-Temperature Exhaust Stream. Left: specimen 1 exposed 7 d at 1450°C and 105 d at 1450°C without glass in the furnace. Right: specimen 2 exposed 11 d at 1400°C and 146 d at 1450°C with glass.

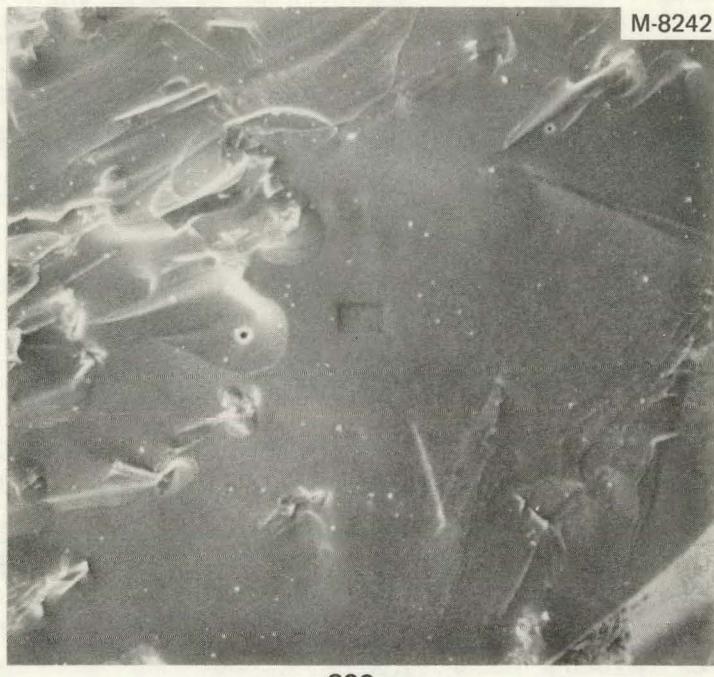
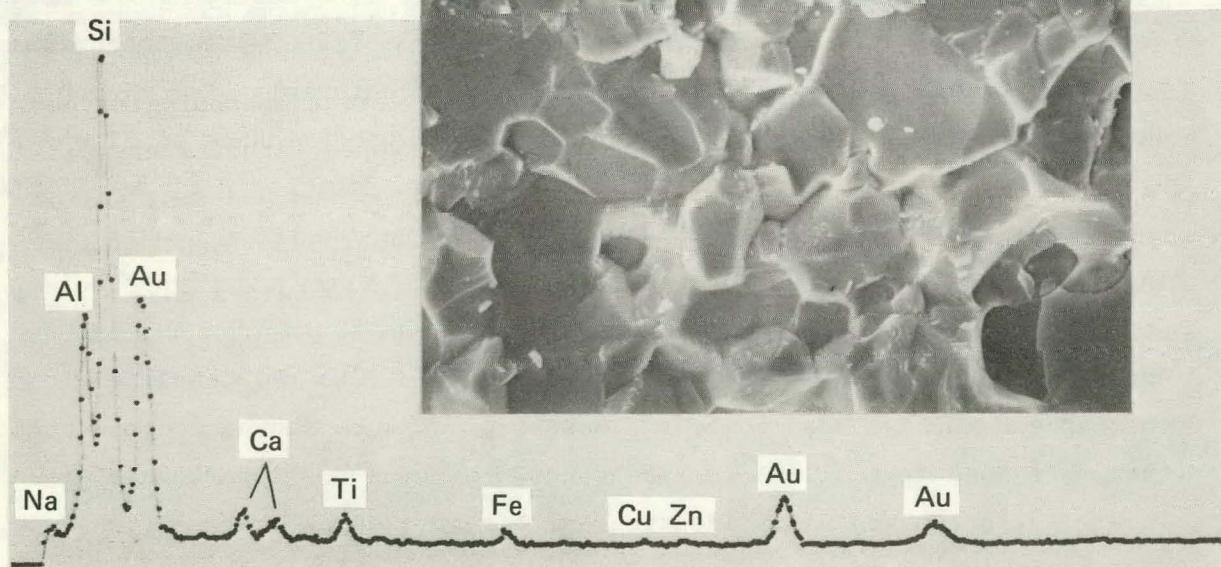
INTERFACE WITH
GLASSY DEPOSIT

CROSS SECTION
OF BULK MATERIAL

Fig. 30. Scanning Electron Micrographs and Microcompositional Analysis (EDS) of High-Purity Alumina (Vistal 2) Exposed to Glass Furnace Environment at 1450°C for 146 d and 1400°C for 11 d. Gold peaks in EDS are from conductive coating, not part of specimen.

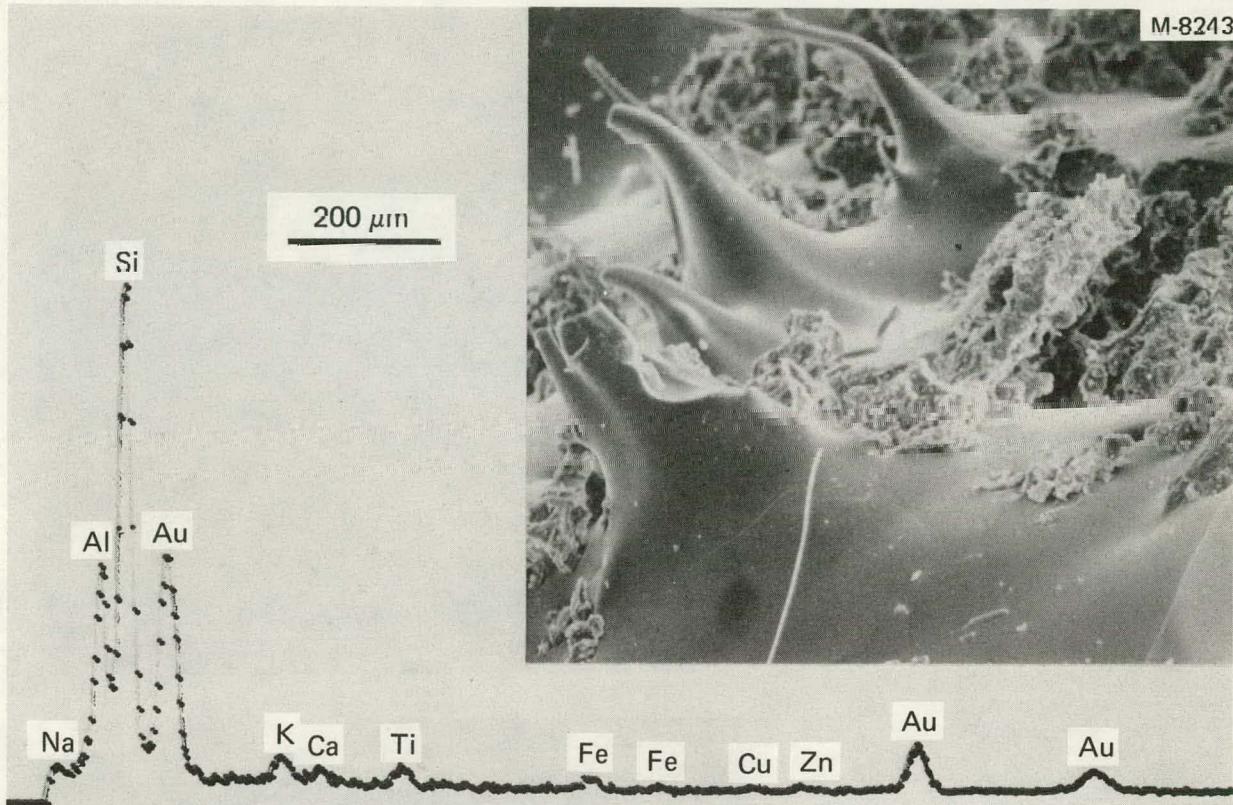
M-8243

Fig. 31. Scanning Electron Micrograph and Microcompositional Analysis of Surface of High-Purity Alumina (Vistal 2) Exposed to Glass Furnace Environment at 1450°C for 146 d and 1400°C for 11 d.

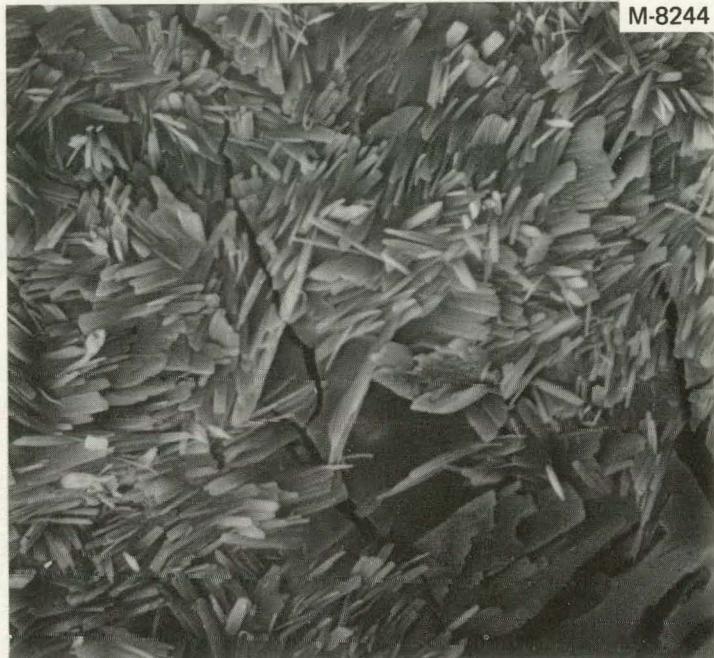
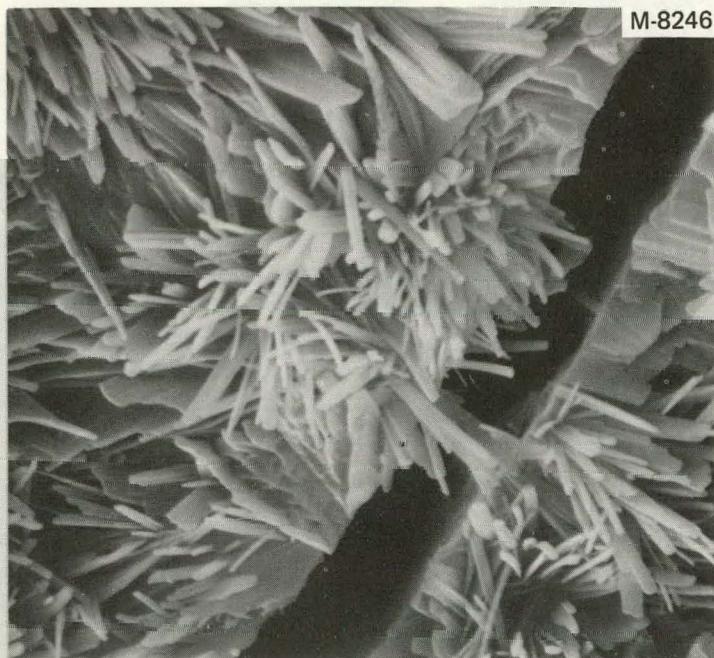
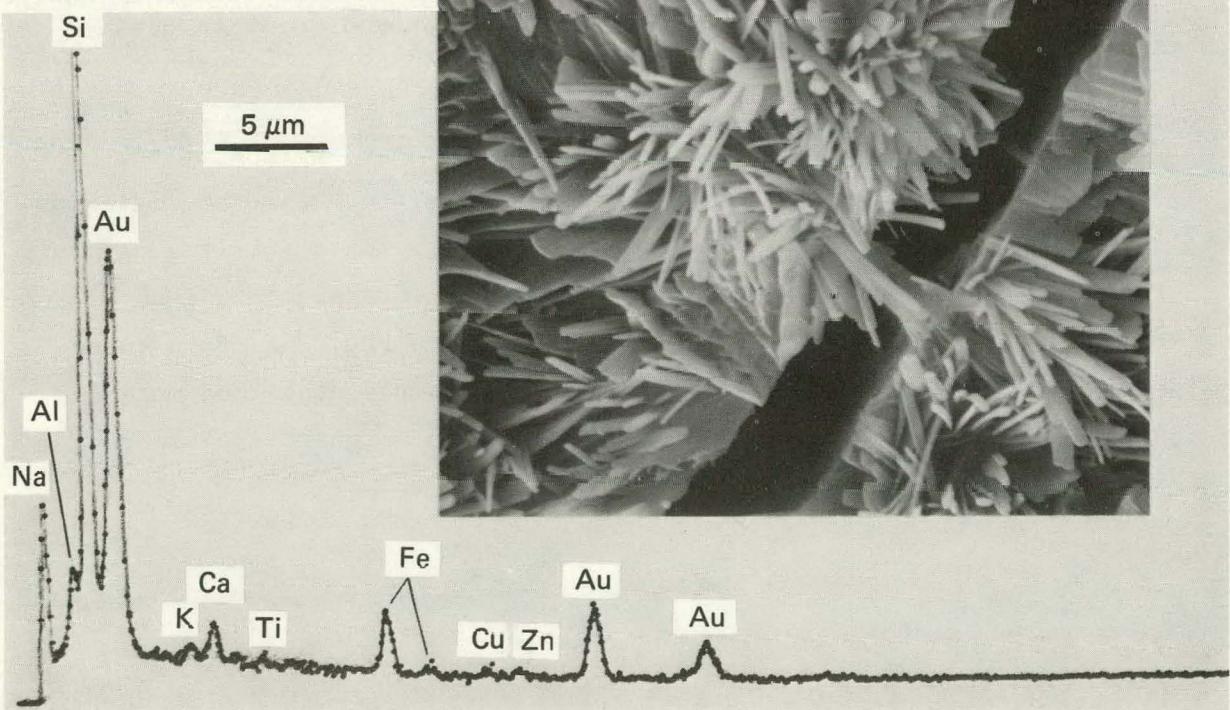
Fig. 32. Scanning Electron Micrographs and Microcompositional Analysis (EDS) of Lathlike Crystals on High-Purity Alumina (Vistal 4) Exposed to Glass Furnace Environment at 1150°C for 90 d. Gold peaks are from conductive coating, not specimen.

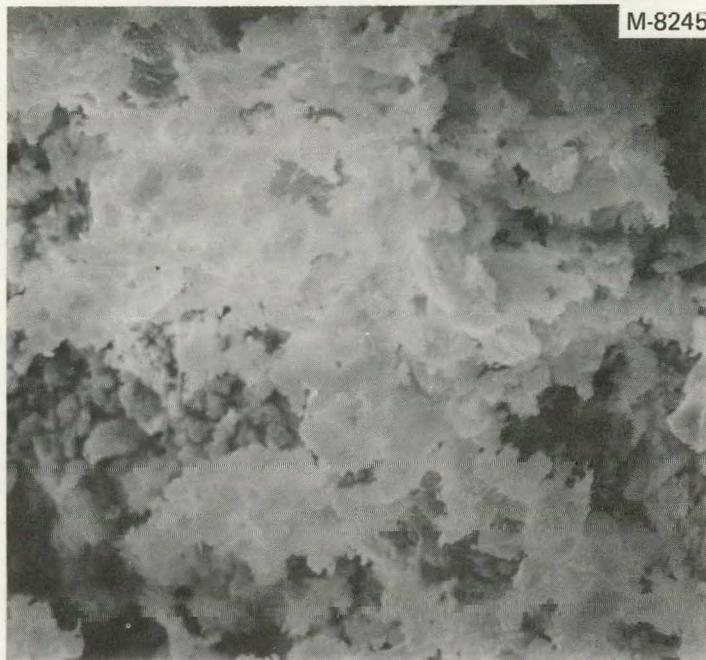
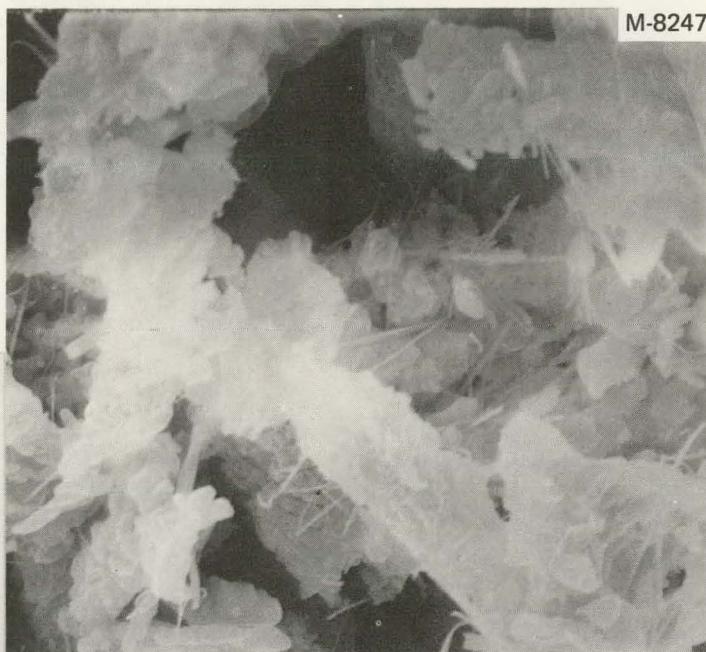
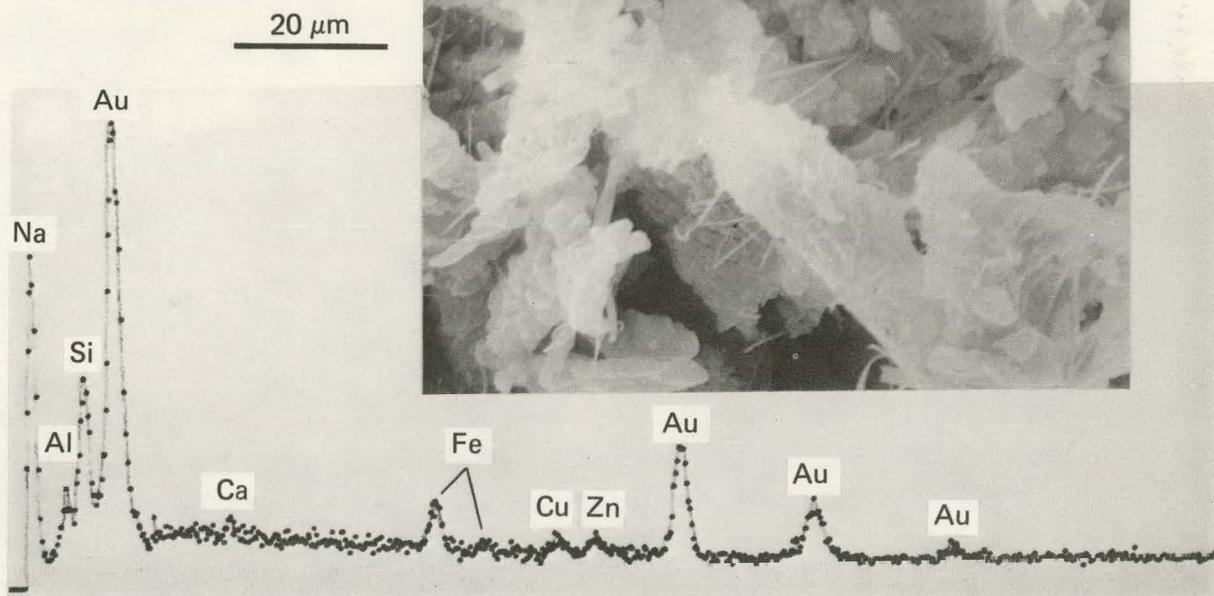
Fig. 33. Scanning Electron Microscope and Microcompositional Analysis (EDS) of Poorly Developed Surface Features on High-Purity Alumina (Vistal 4) Exposed to Glass Furnace Environment at 1150°C for 90 d. Gold lines are from conductive coating, not specimen.
