ORNL/TM-6970

Materials Analyses of Ceramics for Glass Furnace Recuperators

MATERIALS ANALYSES OF CERAMICS FOR GLASS FURNACE RECUPERATORS

Date Published: November 1979

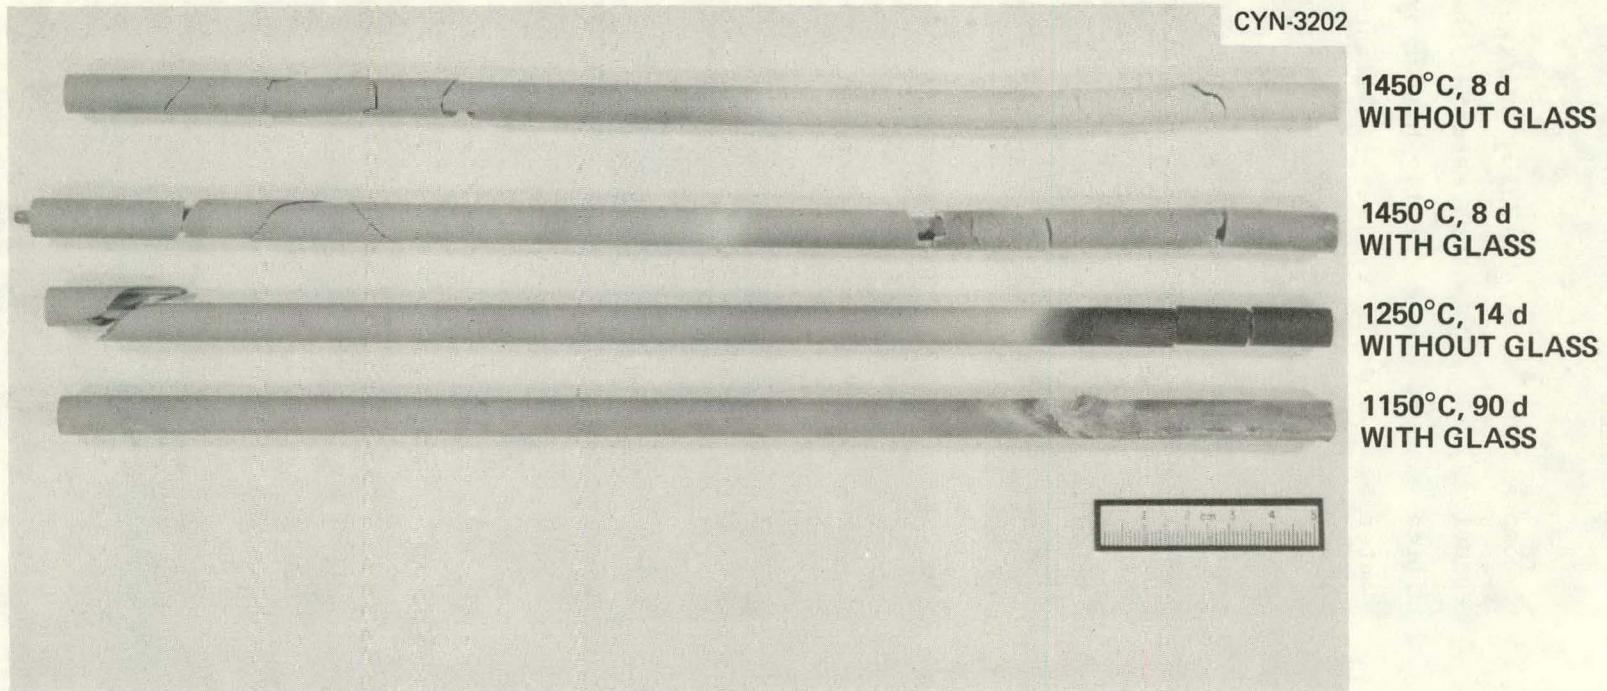
Fig. 34. Mullite Exposed to Glass Furnace High-Temperature Exhaust Stream.

Four mullite samples were exposed in the test matrix and are shown after testing in Figs. 34 and 35. Mullite-1 was exposed at 1450°C (2650°F) for 8 d without glass in the furnace but underwent such major deformation that it was withdrawn from the test. Mullite-2 was exposed under the same thermal conditions but with glass in the furnace. Major deformation was again observed and, in addition, crystalline growth was visible in the material. This glazing and crystal growth are particularly visible in Fig. 35.

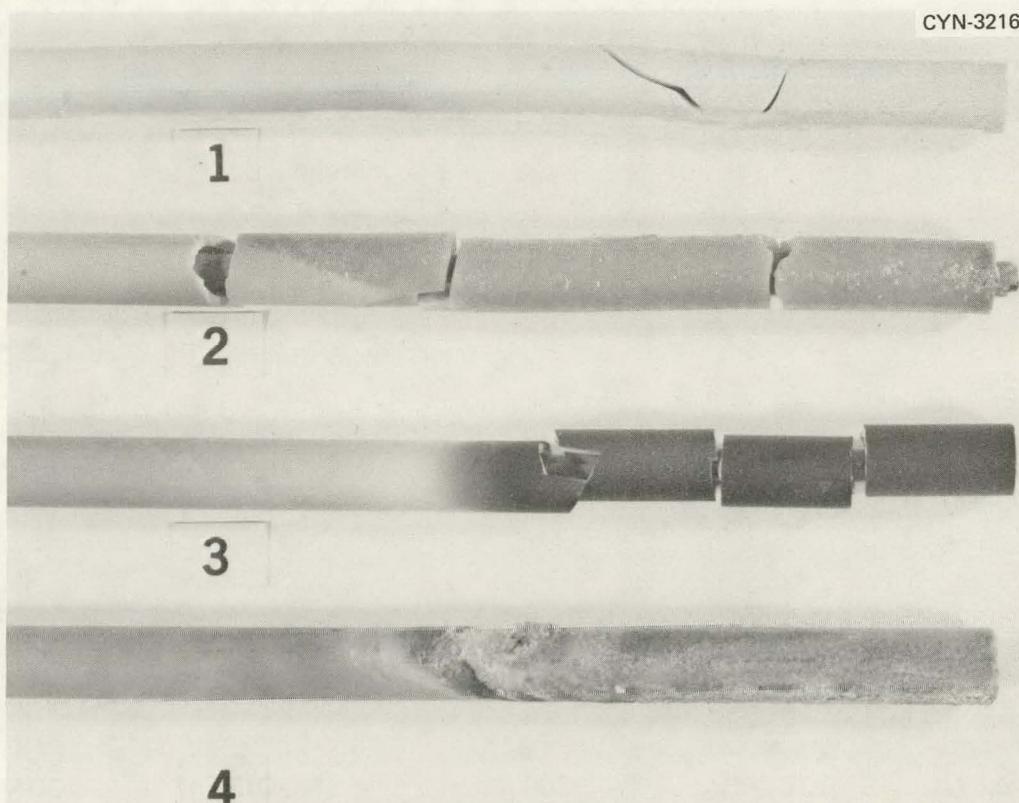
Fig. 35. Close-Up of Mullite Exposed to Glass Furnace High-Temperature Exhaust Stream.

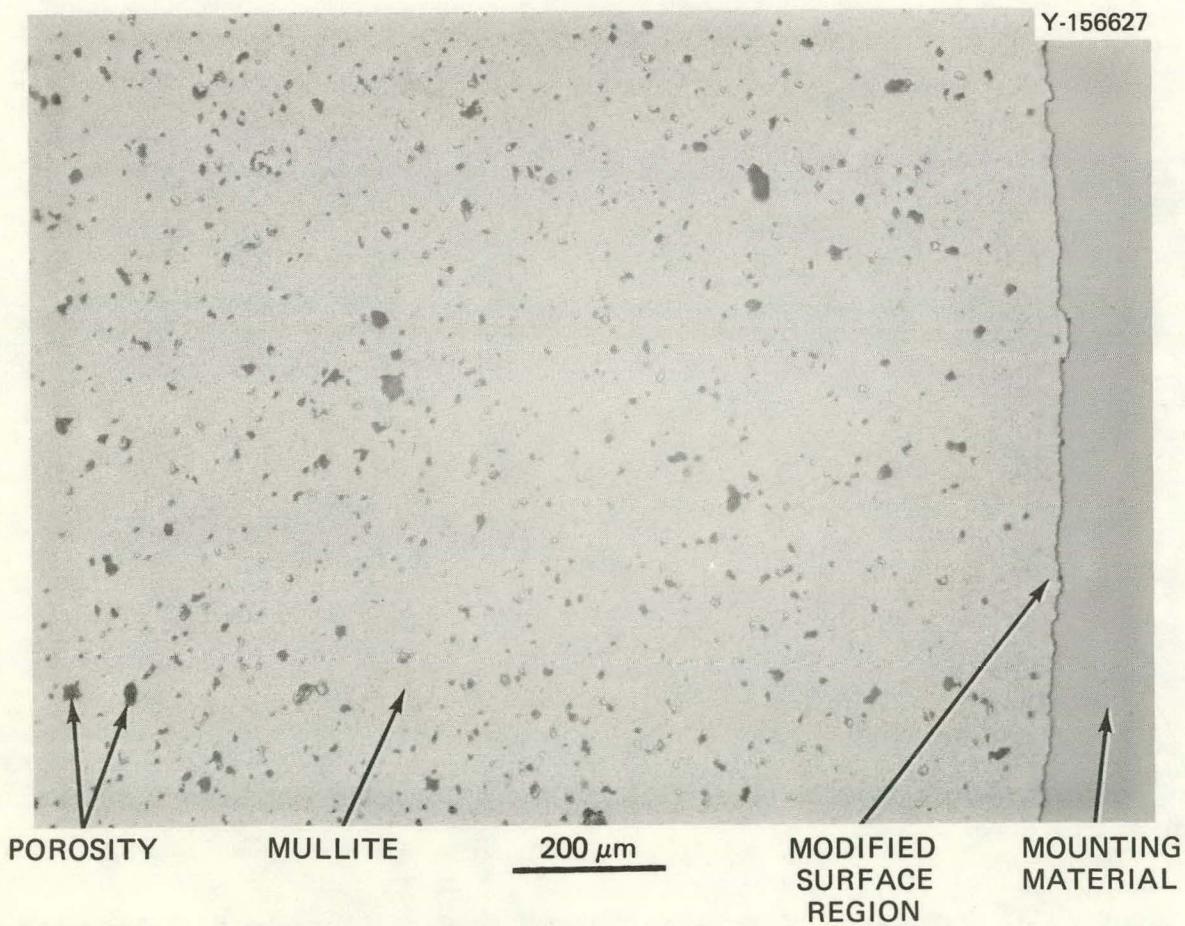
Fig. 36. Microstructure of Mullite (Sample 1) Exposed at 1450°C for 8 d with No Glass in the Furnace.

Ceramography of the Mullite sample 1 (Fig. 36) revealed little microstructural alteration during the relatively short high-temperature exposure. The very fine microstructure including small evenly distributed porosity is representative of ceramic bodies of this type. Only in the outer 20 μm was there an apparent increase in grain size during the test. The microstructure of the mullite sample 2 exposed to the same thermal conditions as sample 1 but with glass in the test furnace was significantly different, as is apparent in Fig. 37 of sections taken

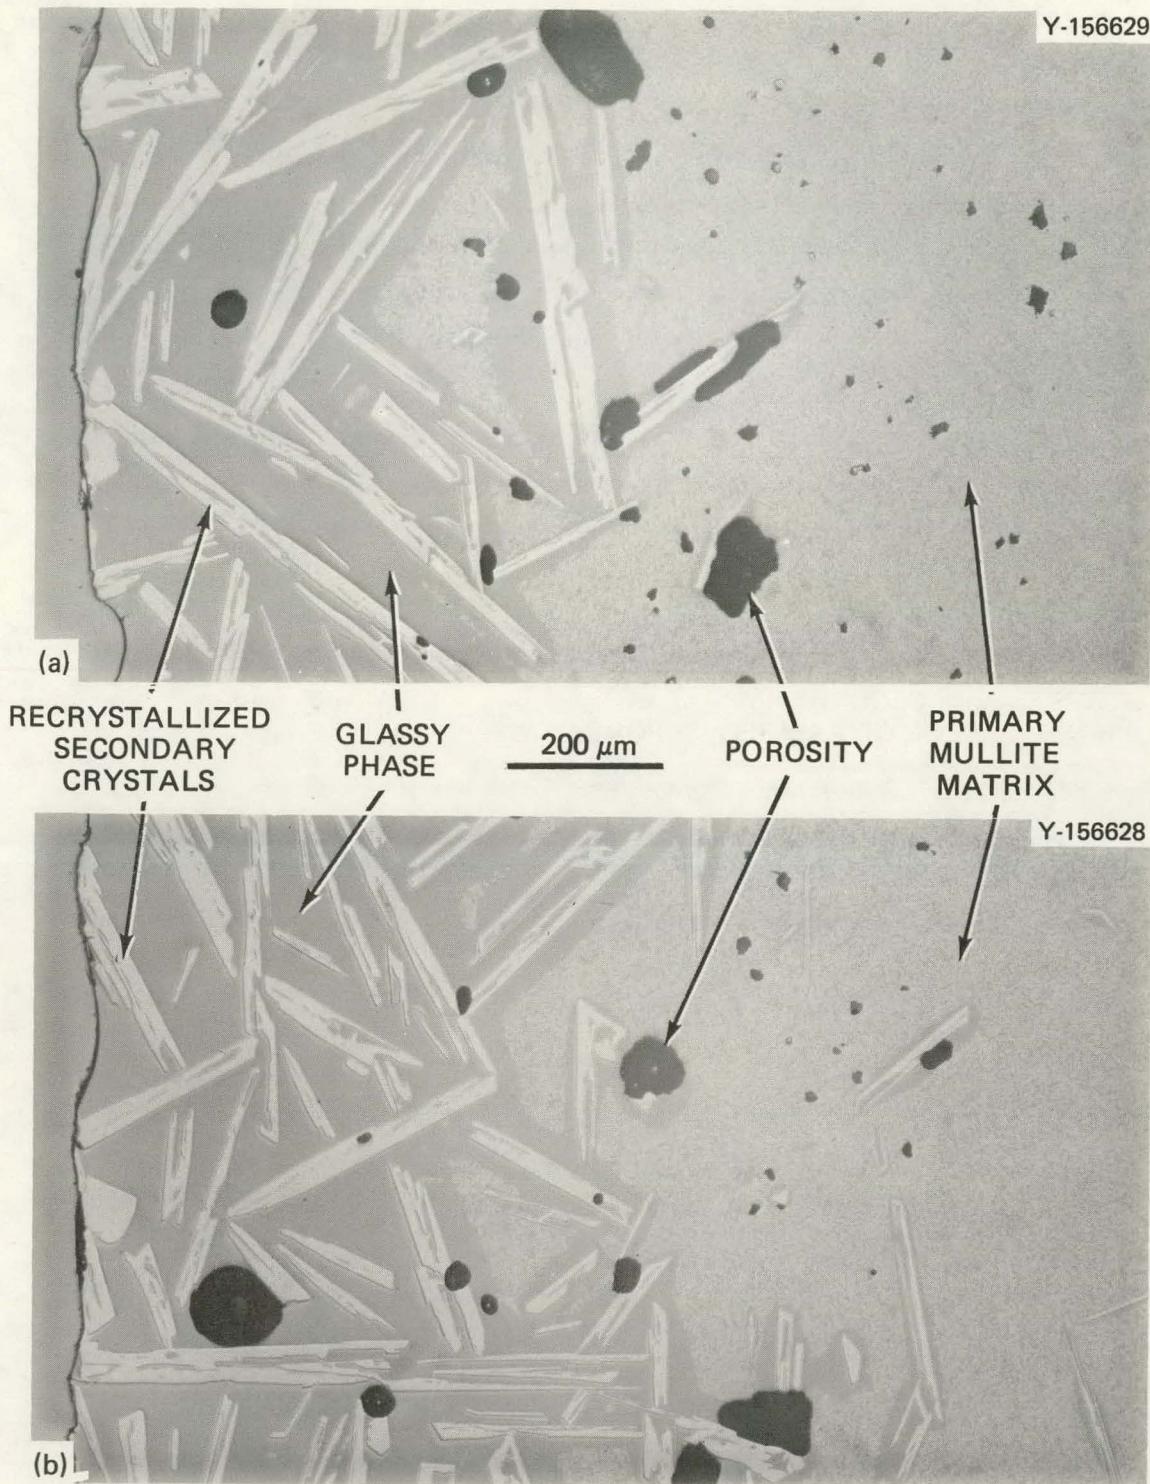
Fig. 37. Microstructure of Mullite (Sample 2) Exposed at 1450°C for 8 d with Glass in the Furnace. (a) 25 mm and (b) 50 mm from exposed end.

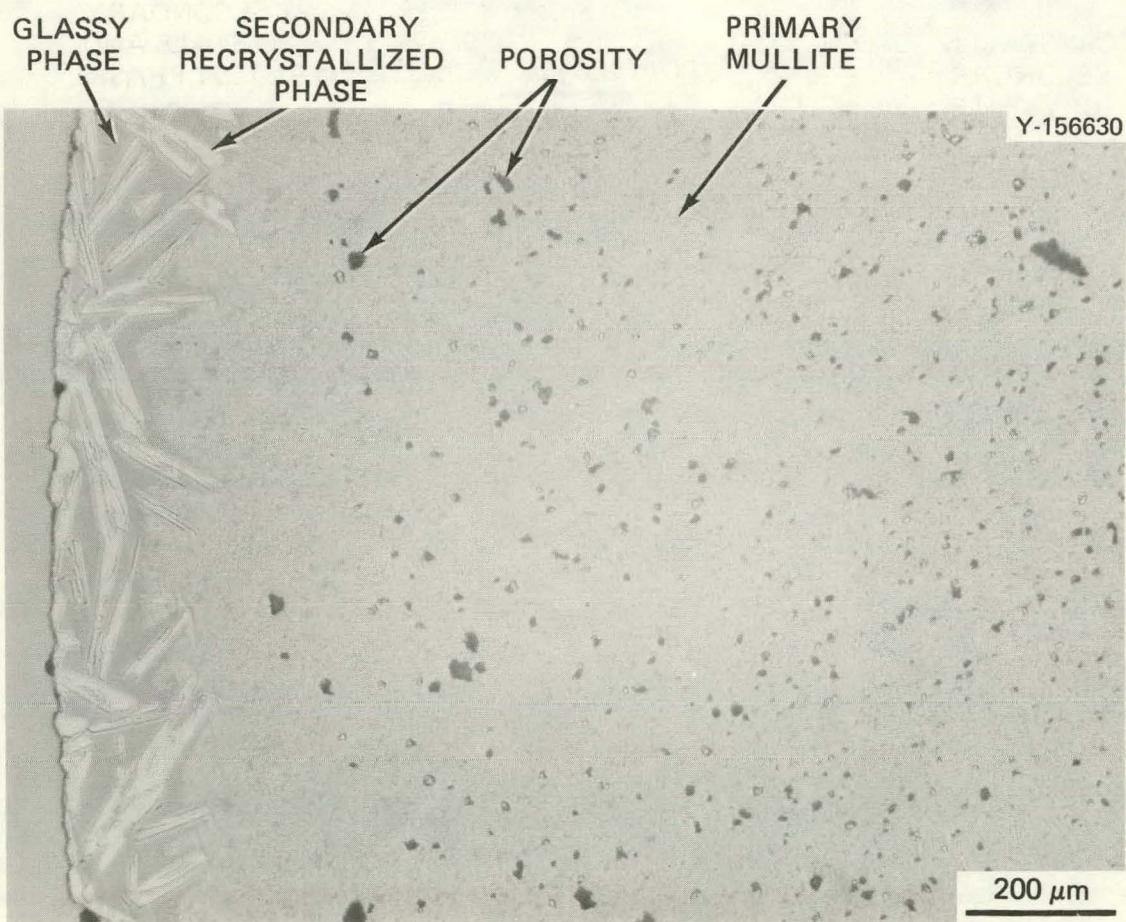
Fig. 38. Microstructure of Mullite (Sample 3) Exposed at 1250°C for 14 d with No Glass in the Furnace.

The microstructure of the Mullite sample 3, which was exposed at a temperature 200°C (350°F) lower than sample 1 for 14 d without glass in the furnace, shows changes similar to those in samples 1 and 2. In sample 3, the outer 200 to 300 μm had changed, as shown in Fig. 38.

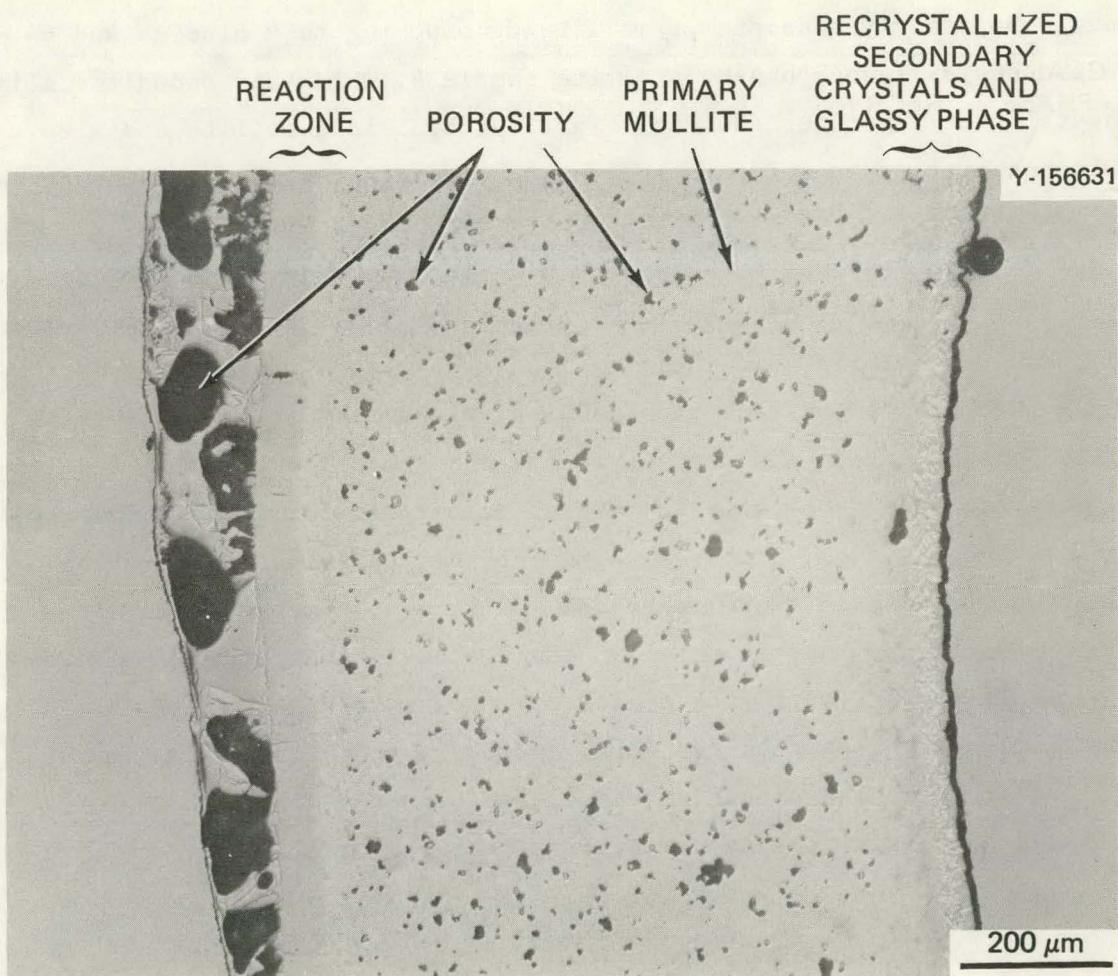
Fig. 39. Microstructure of Mullite (Sample 4) Exposed at 1150°C for 90 d with Glass in the Furnace.

Microstructural examination of mullite sample 4, which was exposed at 1150°C with glass, is shown in Fig. 39. The inside wall of the hollow tube specimen is in the initial stages of the changes noted in the previous two figures. The exterior wall shows the formation of an amorphous region about 100 μm thick in the bulk material adjacent to the interface with

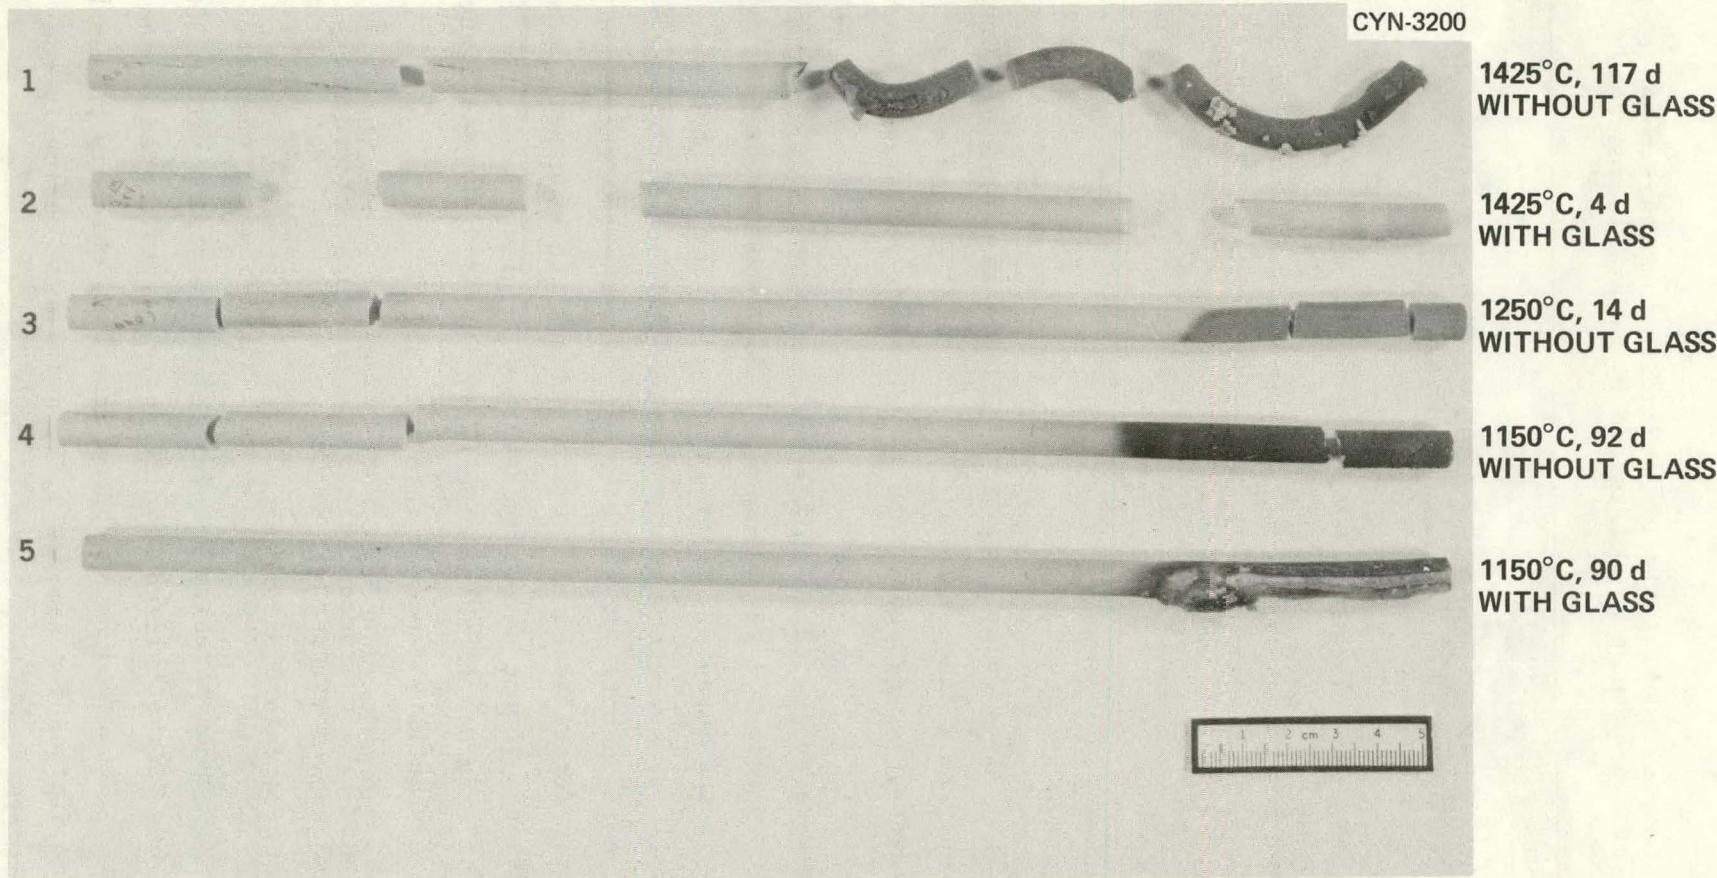
Fig. 40. Cordierite Exposed to Glass Furnace High-Temperature Exhaust Stream.

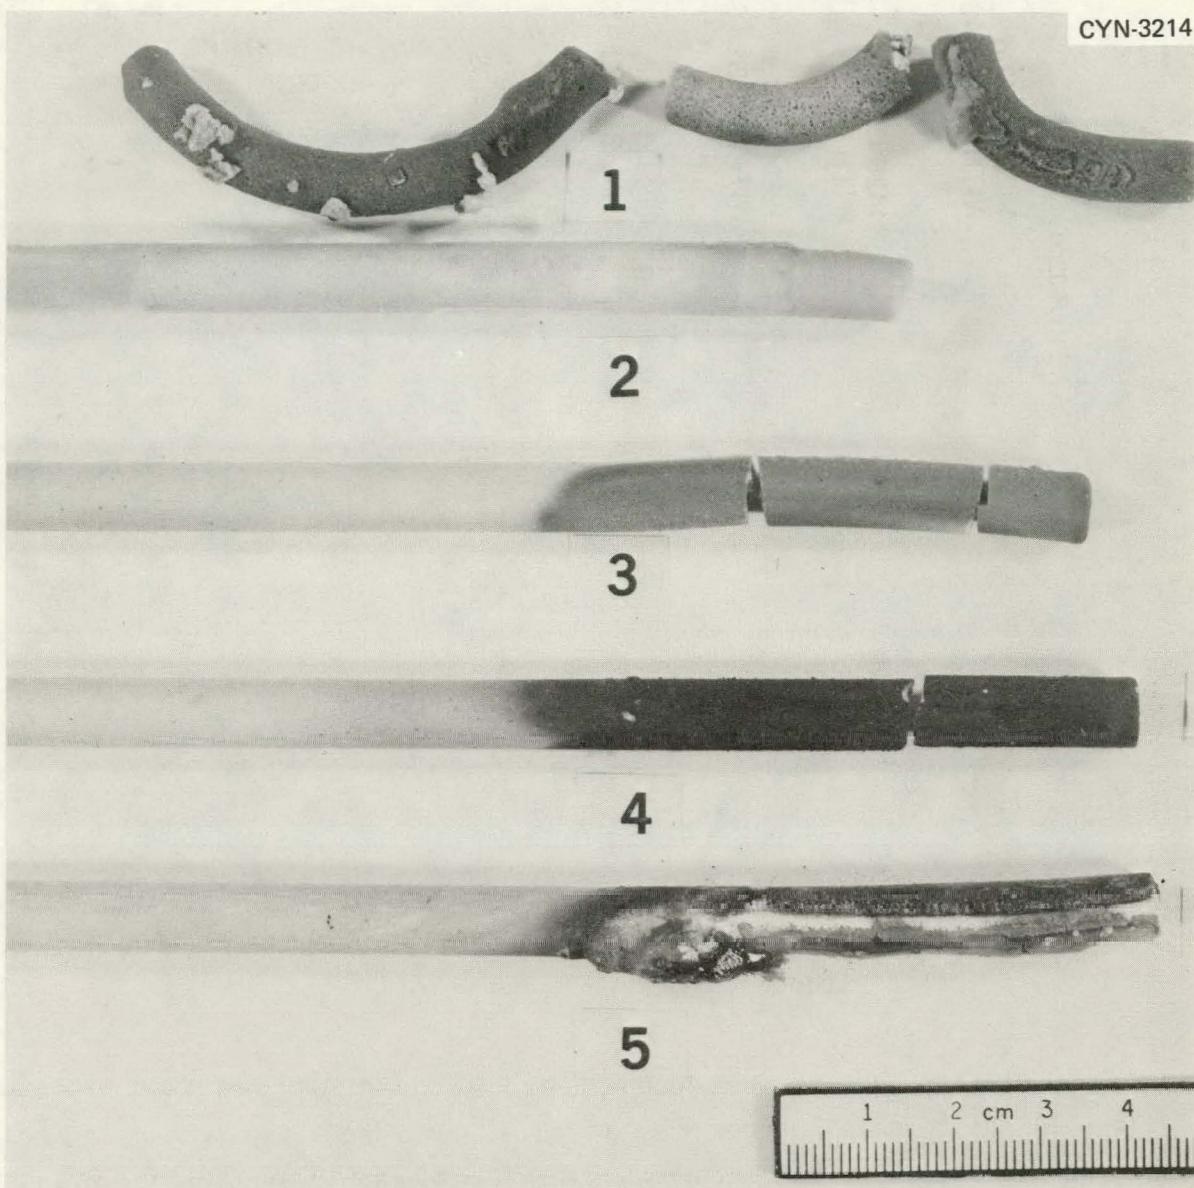
Fig. 41. Close-Up of Cordierite Exposed to Glass Furnace High-Temperature Exhaust Stream.

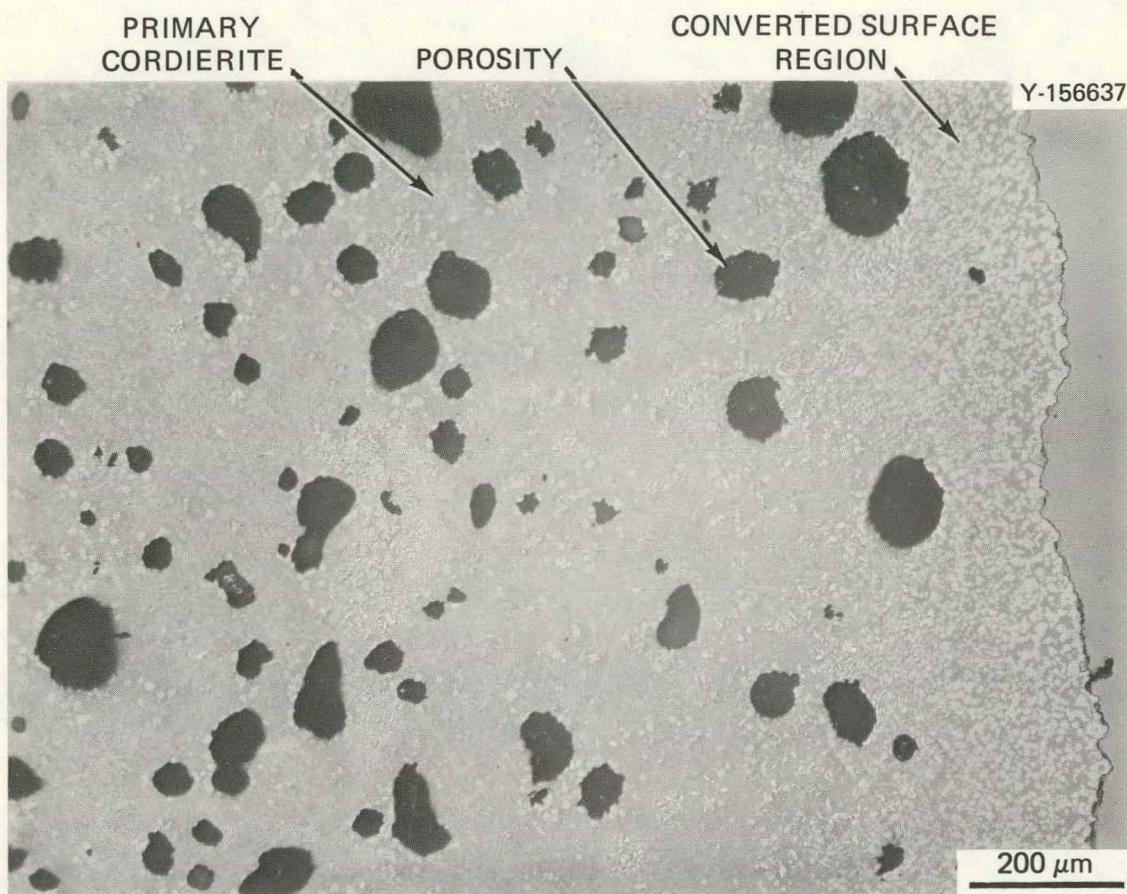
Fig. 42. Microstructure of Cordierite (Sample 3) Exposed at 1250°C (2300°F) for 14 d Without Glass in the Furnace.

Specimen 3 was exposed at 1250°C (2300°F) for 14 d without glass in the furnace and showed blistering, darkening, expansion, and bloating with concomitant curvature development. Its microstructure is shown in

Fig. 42. The very fine characteristic microstructure of cordierite ceramics, consisting of almost indistinguishable crystalline features and widely dispersed fine porosity, has been significantly changed. Large, almost continuous porosity has formed, and a region within 300 μm of the surface has recrystallized significantly, as evidenced by the equiaxed crystals surrounded by amorphous material, which is presumably a glass. The conditions for samples 1, 2, and 3 were obviously too severe for cordierite ceramics.

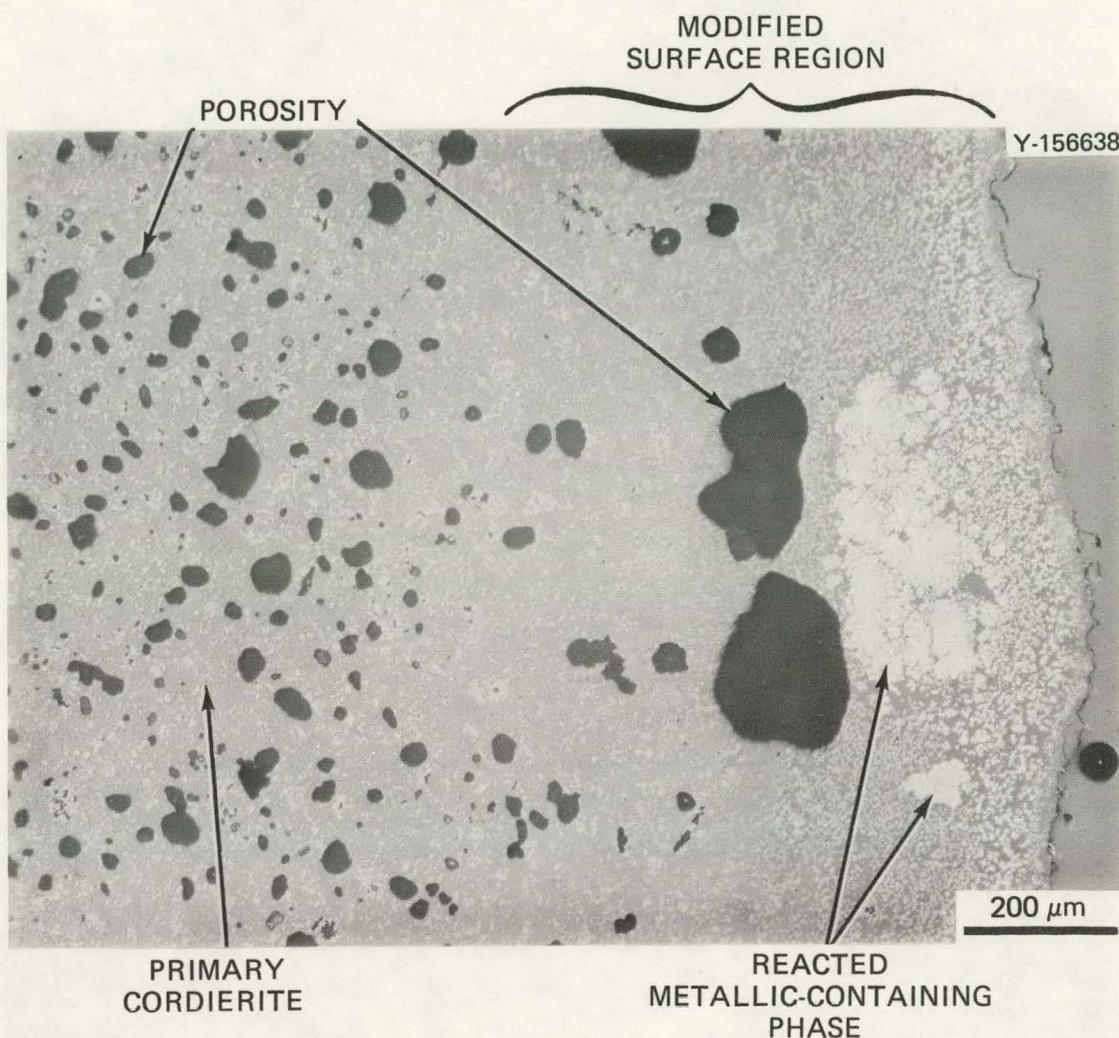
Fig. 43. Microstructure of Cordierite (Sample 4) Exposed at 1150°C (2100°F) for 92 d Without Glass in the Furnace.

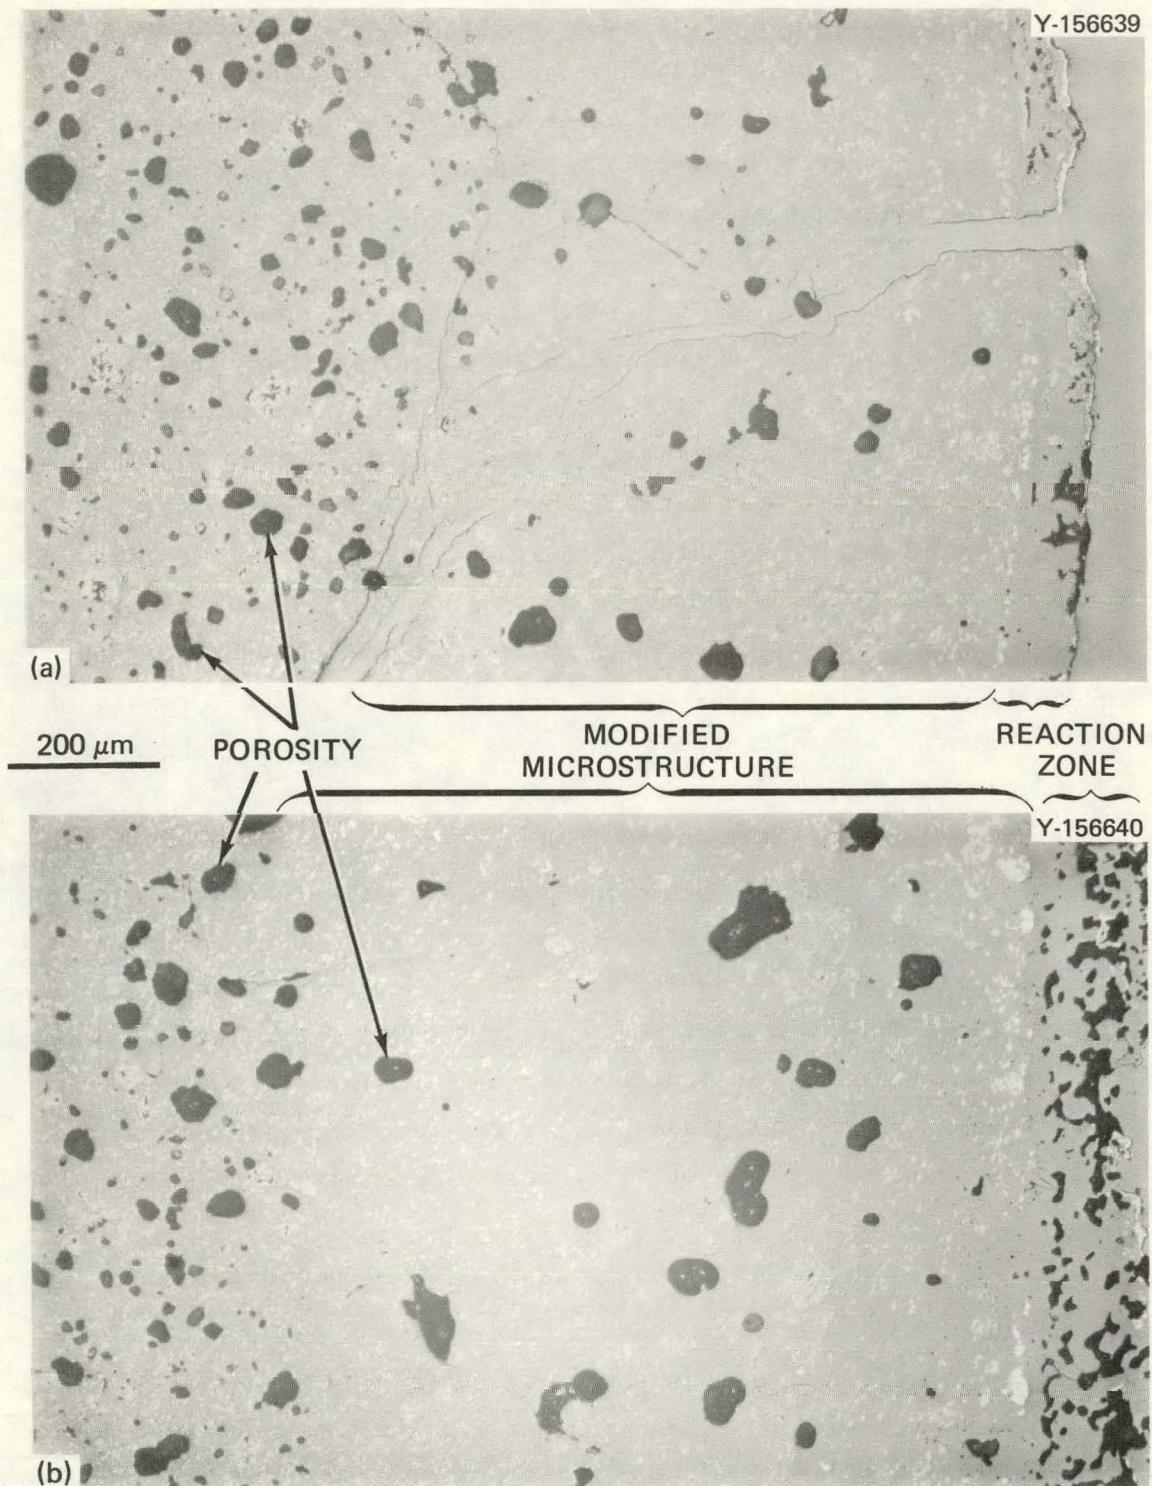
Fig. 44. Microstructure of Cordierite (Sample 5) Exposed at 1150°C (2100°F) for 90 d. (a) Section A, 50 mm from the exposed end. (b) Section B, 15 mm from the exposed end.

The final specimen, cordierite 5, was also exposed at 1150°C (2100°F) for 90 d but with glass in the furnace. It was significantly deformed, with substantial deterioration on the side toward the furnace. Two metallographic sections were analyzed: (A) 50 and (B) 15 mm from the

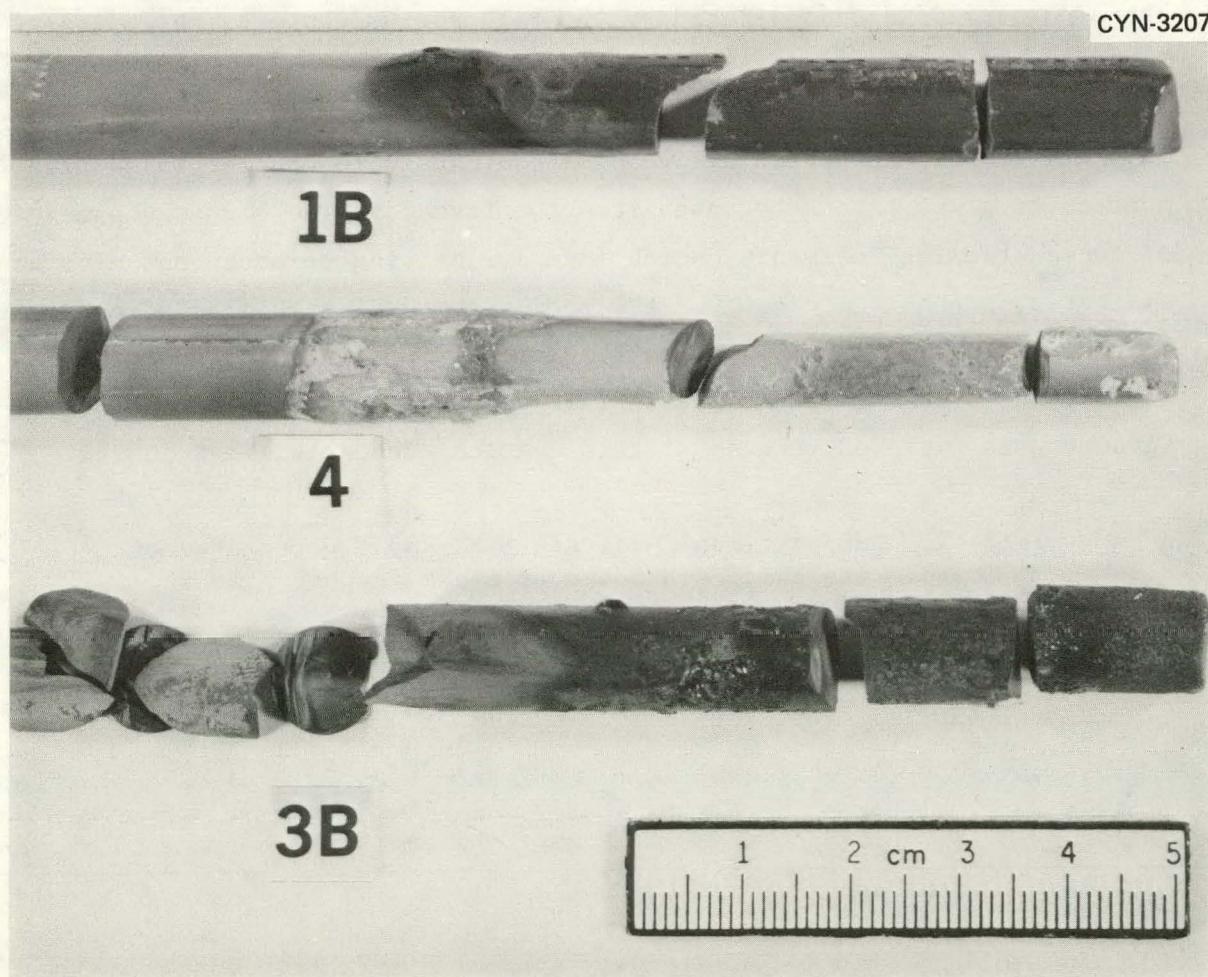
Fig. 45. Close-Up Silicon Nitride Exposed to Glass Furnace High-Temperature Exhaust Flue.

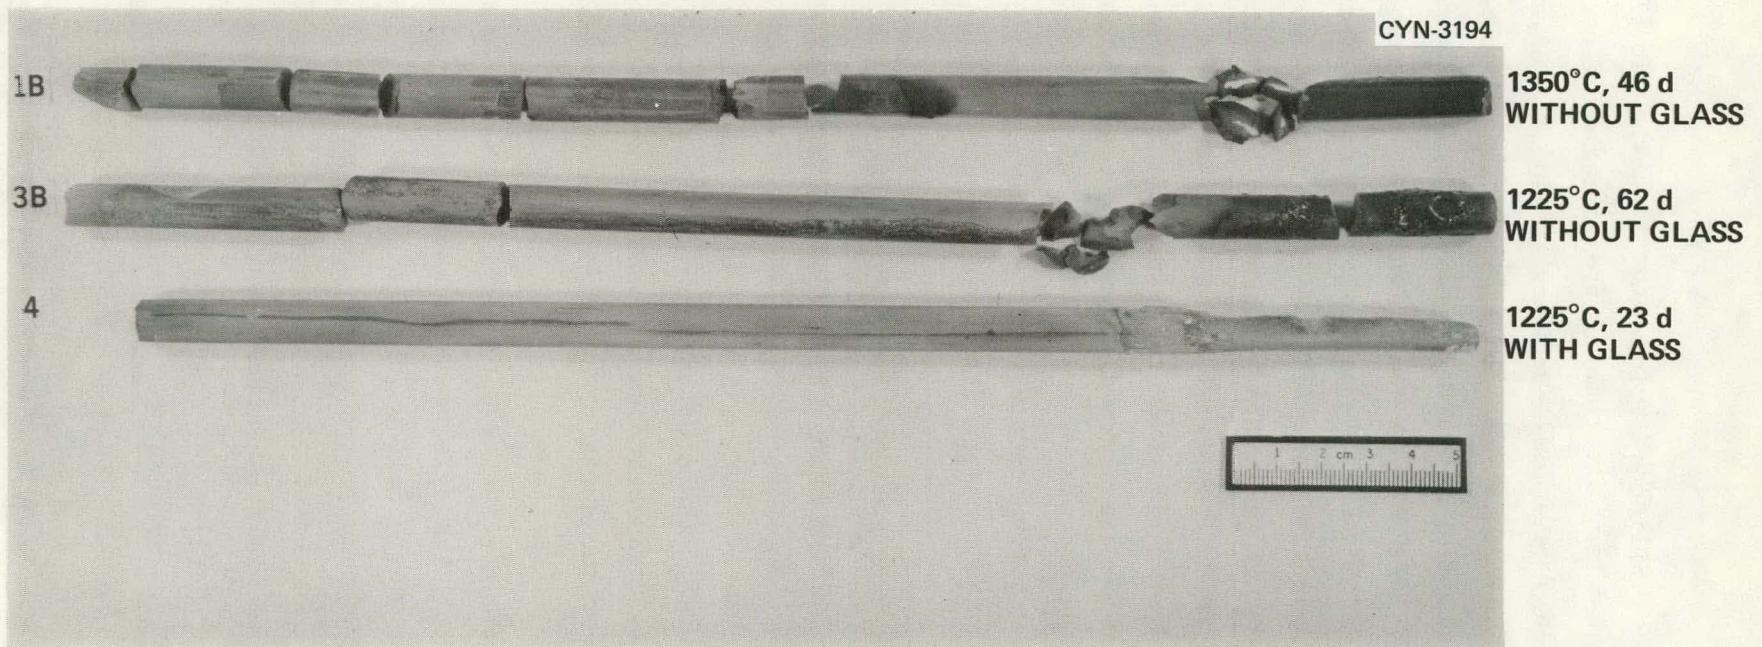
Fig. 46. Silicon Nitride Samples Tested in Glass Furnace High-Temperature Exhaust Flue.

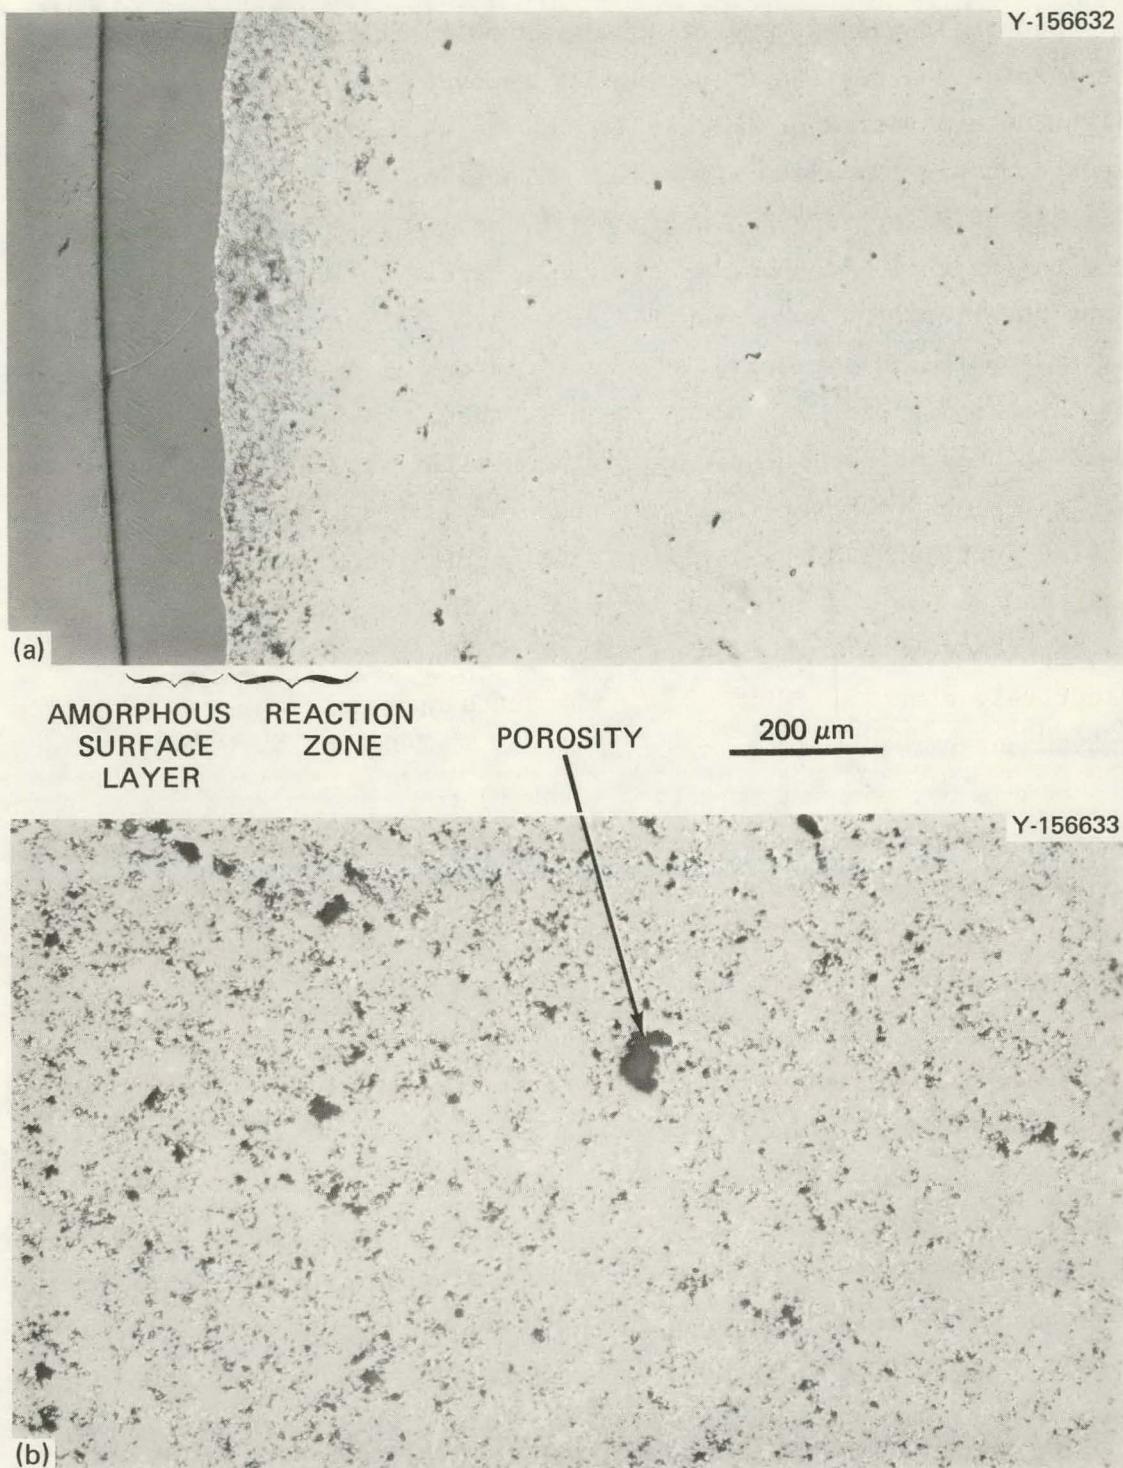
Fig. 47. Microstructural Variation in Silicon Nitride Cylindrical Test Specimen (Sample 1B) Exposed at 1350°C (2450°F) for 46 d Without Glass. (a) Outside surface of rod. (b) Center of rod.

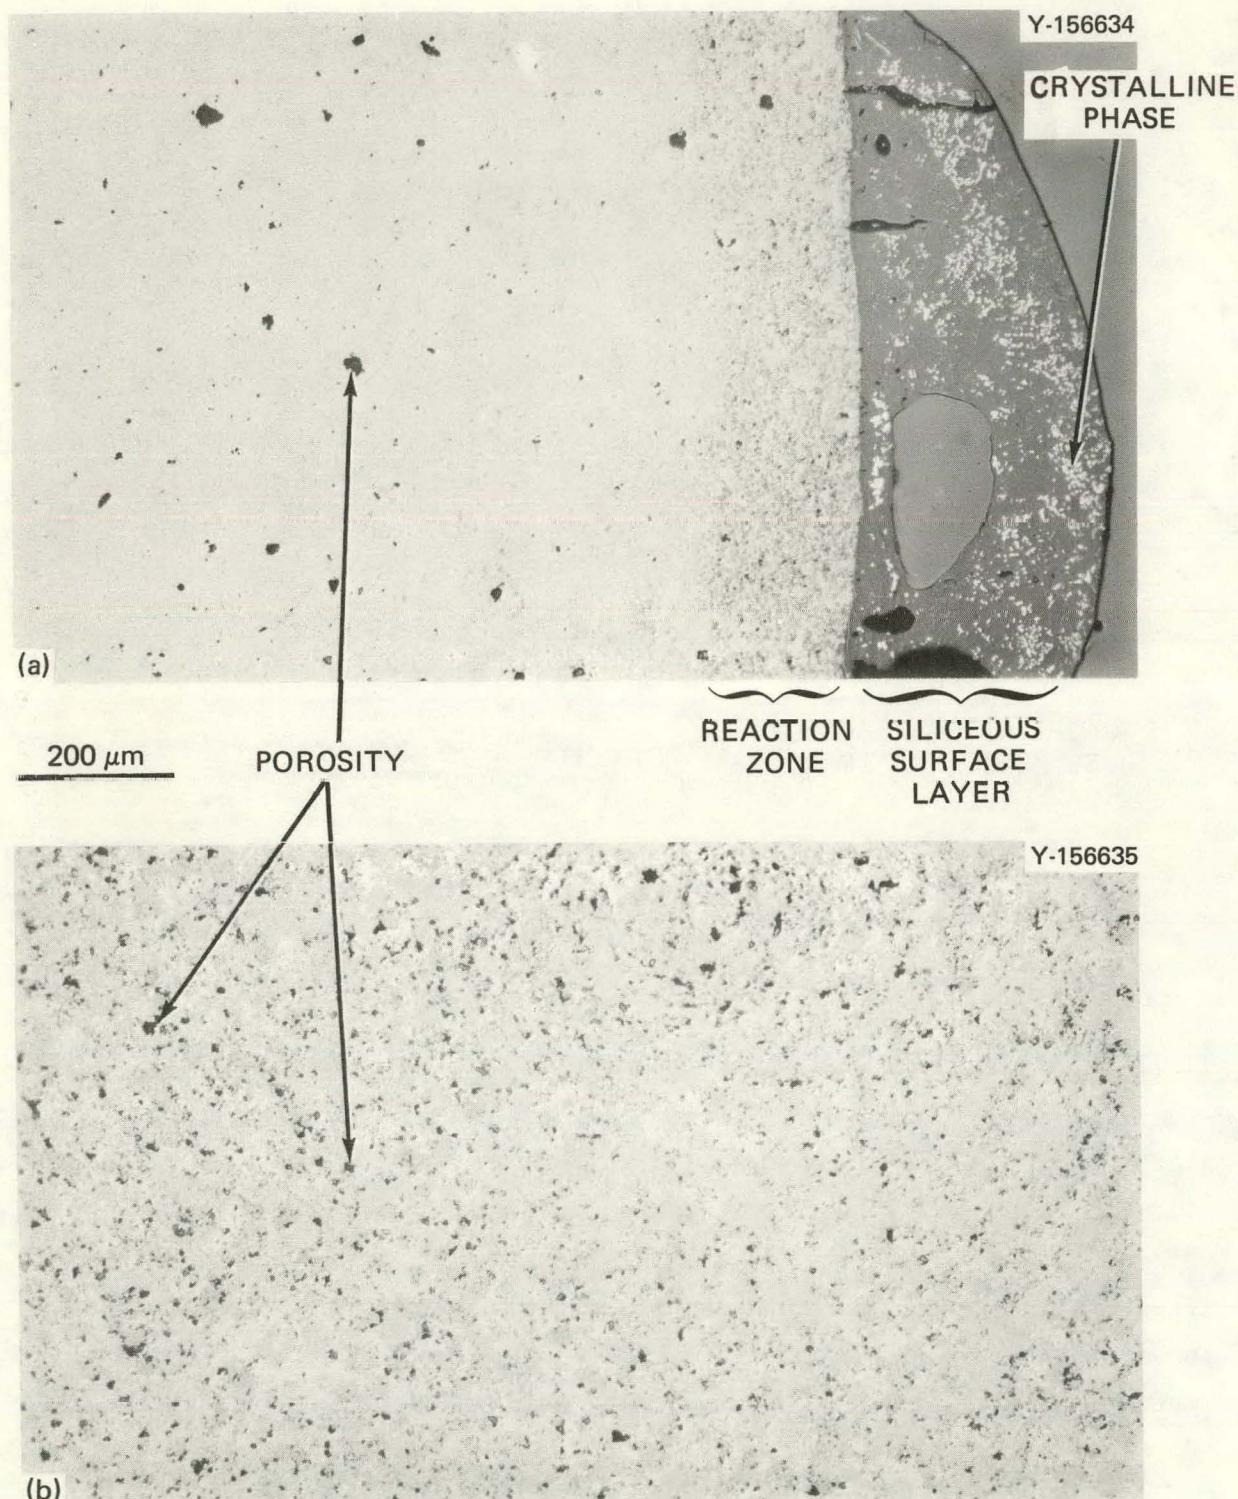
Fig. 48. Microstructural Variation in Silicon Nitride Cylindrical Test Specimen (Sample 3B) Exposed at 1225°C (2250°F) for 62 d Without Glass. (a) Outside surface of rod. (b) Center of rod.

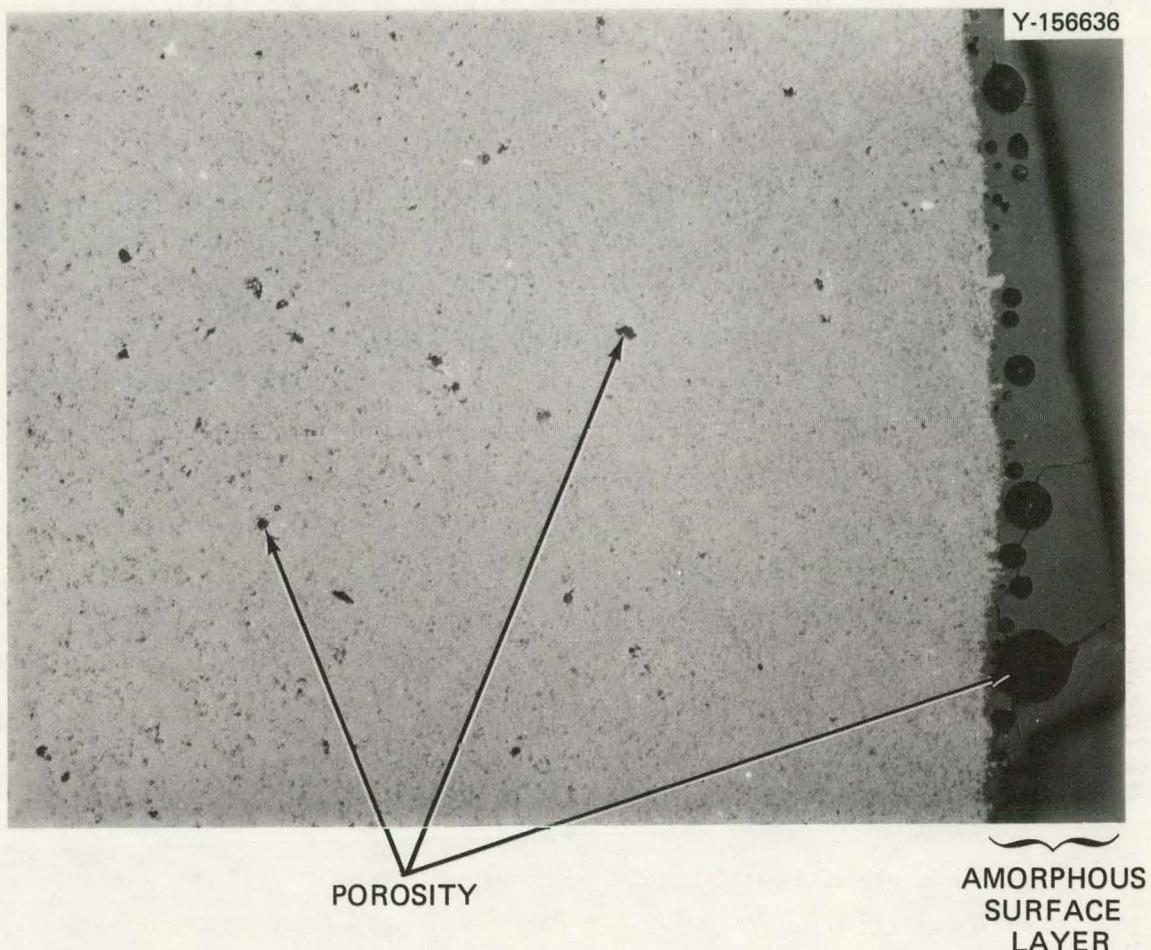
Fig. 49. Microstructure of Silicon Nitride (Sample 4) Exposed at 1225°C (2250°F) for 23 d with Glass in the Furnace.
