SAND90-2926 • UC-706

1990 Sandia Rocket-Triggered Lightning Field Tests at Kennedy Space Center, Florida

Richard J. Fisher, George H. Schnetzer

1990 SANDIA ROCKET-TRIGGERED LIGHTNING FIELD TESTS AT KENNEDY SPACE CENTER, FLORIDA

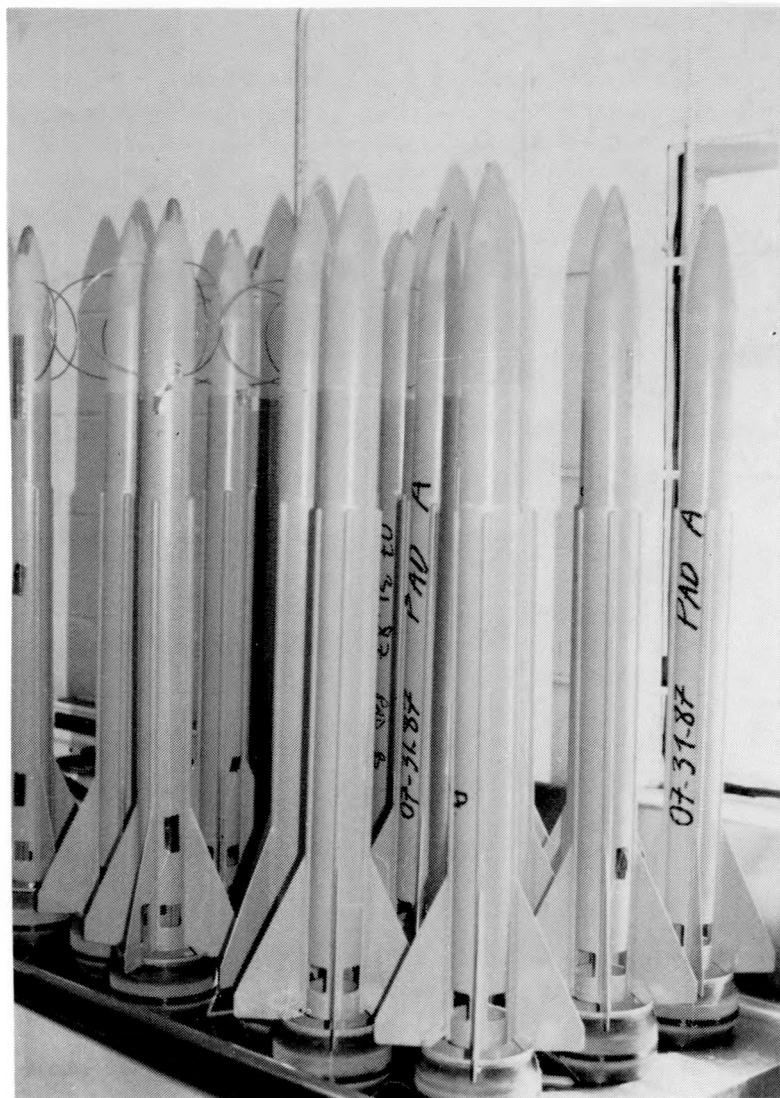
Figure 10. CENG Rocket Assemblies Prior to Installation of Propellant Cartridges (Specifications are presented in Appendix A.)

Because of the demonstrated effectiveness and reliability of the system described above, arrangements have been made to procure complete rocket units from CENG for use during the 1991 tests in Alabama. During the 1990 KSC activities, Sandia personnel received training from CENG on the handling and assembly of the rockets and on their launching procedures. A summary of the rocket specifications is given in Appendix A.

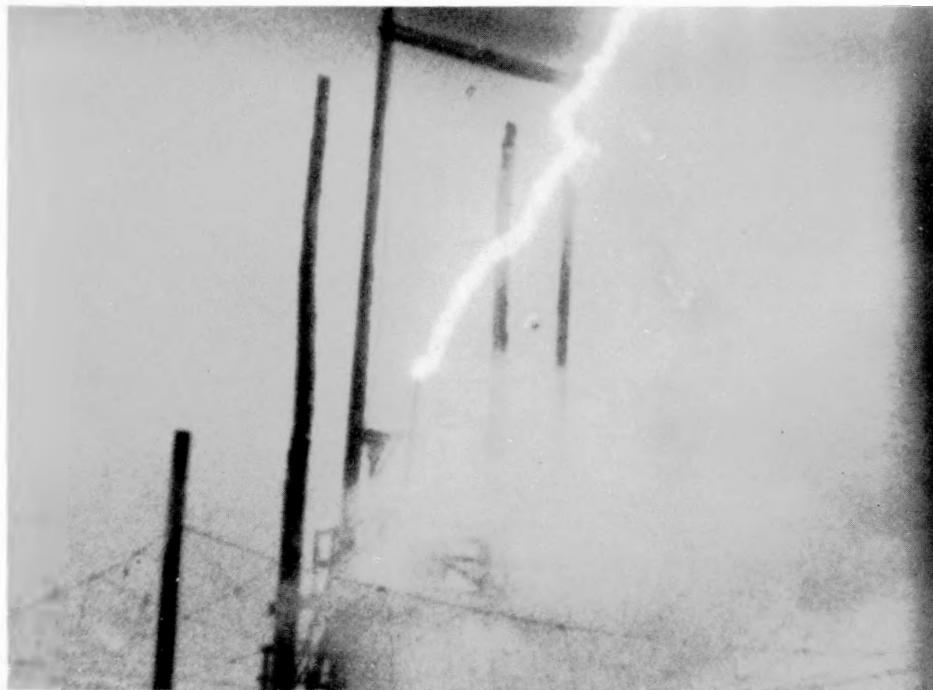
Figure 19. Triggered Lightning Stroke Jumps to the Top of an Upright Metal Sample

On occasion in the past, one or more strokes of a triggered flash had been observed to attach to the side of strike poles below their tops. To prevent this in the present experiment, each of the strike poles was fitted with a dielectric jacket from just below the brass fixture to the top of the hinging mechanism at the bottom of the pole. This jacket consisted of a 2-in polyvinyl chloride (PVC) pipe of ~3/16-in wall thickness.
