# Hydrogen-Fueled Postal Vehicle Performance Evaluation

R.A. Hall

June 15, 1979

Prepared for  
U.S. Department of Energy  
and  
U.S. Postal Service  
Through an agreement with  
National Aeronautics and Space Administration  
by  
Jet Propulsion Laboratory  
California Institute of Technology  
Pasadena, California

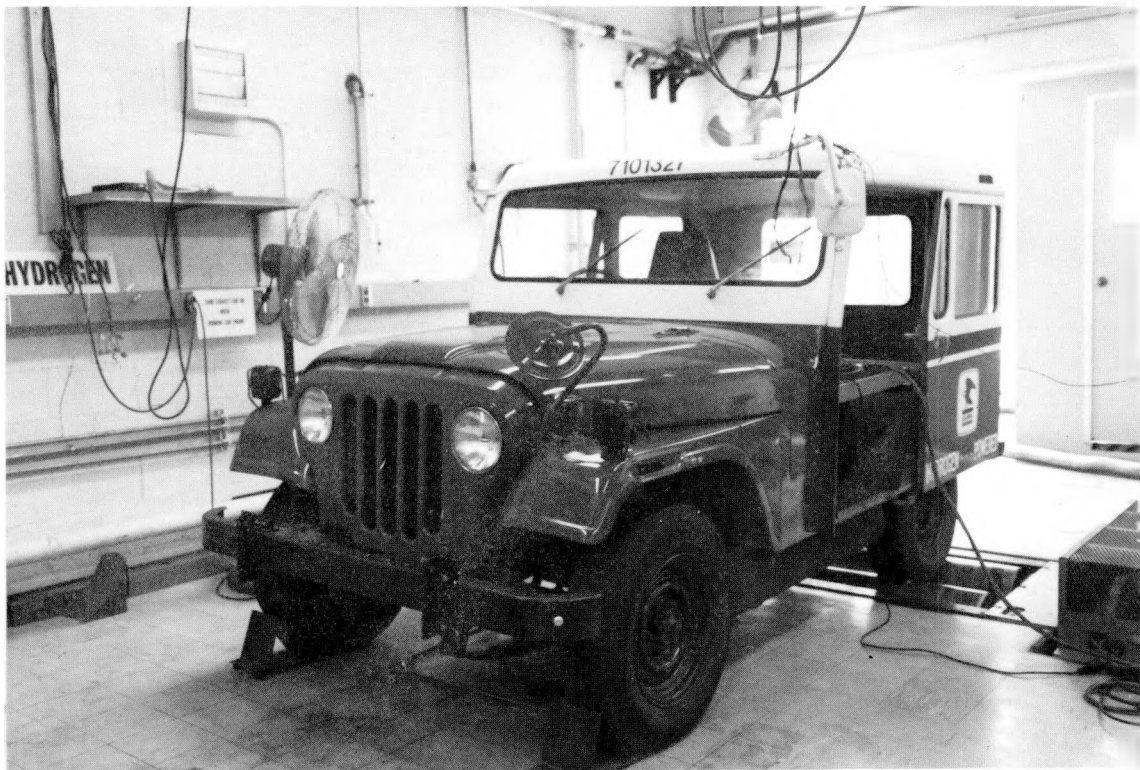
The vehicle (Figure 1) is basically a 1977 Jeep model DJ-5F Dispatcher 100 with an AMC 232 CID six cylinder engine and automatic three-speed transmission. The rear axle and suspension system have been modified: (1) The rear axle is equipped with a Trac-lok differential and 4.89 gears. The 4.89:1 axle ratio was installed in place of the original 3.07:1 ratio to allow the engine to operate in an adequate power-producing region at normal vehicle speeds. The transmission shift program appears to have been altered to allow the vehicle to shift at normal speeds, compensating for the 4.89 gears installed in the differential. (2) The suspension system has been modified to support the added fuel tank weight. The original shock absorbers have been replaced with air shocks, and additional leaves added to the rear springs to provide a 900-pound increase in the vehicle load capacity.

Figure 1. USPS Hydrogen-Fueled Jeep Delivery Vehicle  
on JPL Chassis Dynamometer

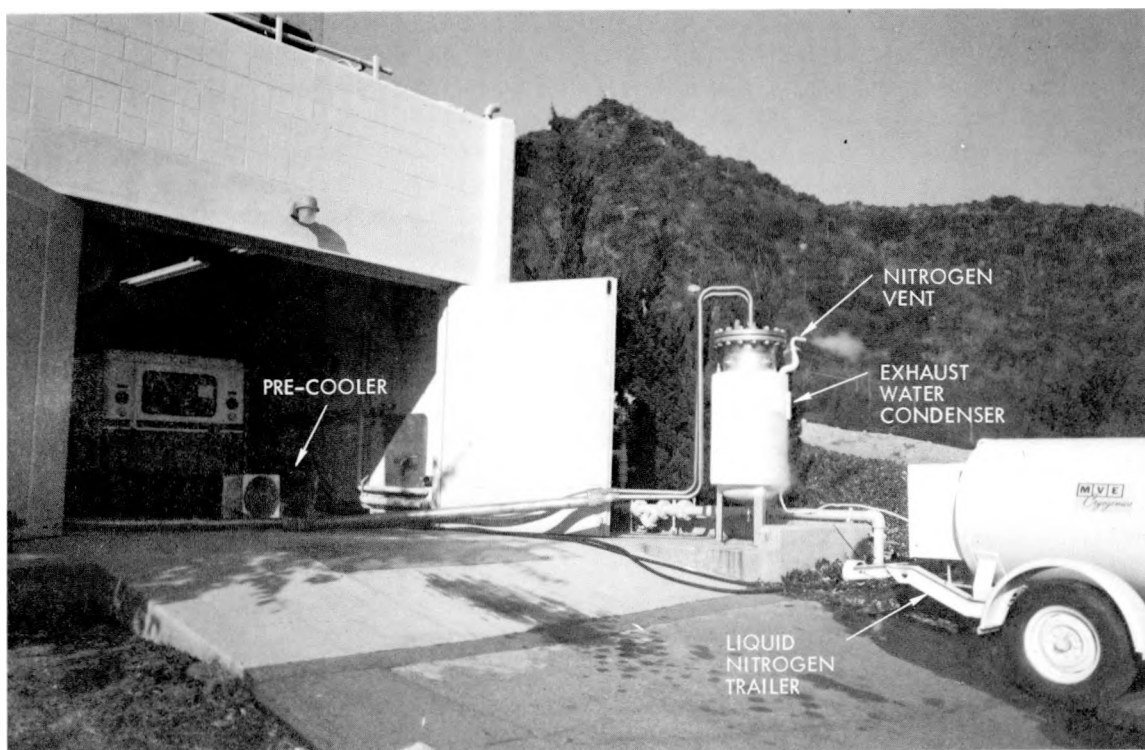
Since the principal product of combustion from hydrogen and air is water, there is a considerable amount of water in the vehicle exhaust. For complete combustion, it can be shown that up to 9 pounds of water can be produced from the combustion of 1 pound of hydrogen. It was determined that for a complete Urban Driving Cycle, the total amount of water in the exhaust would be excessive for the capabilities of the Constant Volume Sampler (CVS) and other exhaust instruments. Therefore, the vehicle exhaust was cooled and sufficient water condensed such that the remaining exhaust stream, when at room temperature, was above its dew point. The postal vehicle, installed on the chassis dynamometer with its exhaust connected to two coolers, is shown in Figure 2. The first heat exchanger is a liquid-to-gas heat exchanger. Tap water was used for the liquid, and the gas (vehicle exhaust) temperature was reduced to approximately 225-250°F. Minimal condensation occurred in the first heat exchanger and in the plumbing between it and the second heat exchanger. The second heat exchanger shown in Figure 2 consists of a pressure vessel surrounded by a closed outer cylinder. Liquid nitrogen was used to fill the outer cylinder, and the majority of the vehicle exhaust water was allowed to condense in the inner vessel. The vehicle exhaust leaving the second heat exchanger ranged from 80-125°F. The side effects of this technique are discussed in Section IV.

Figure 2. Exhaust Cooling System for Hydrogen USPS Jeep Tests

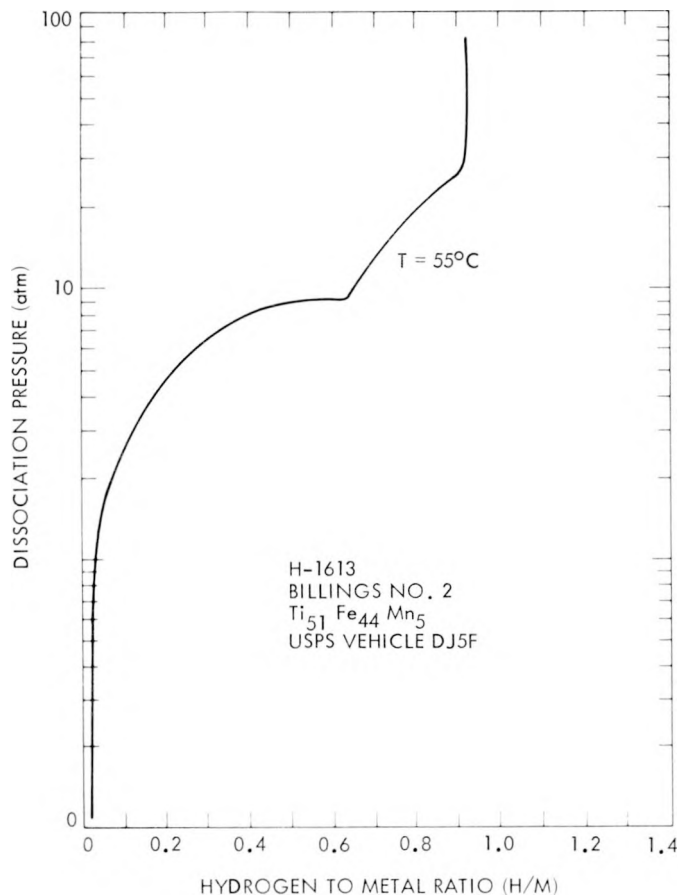
The ratio of hydrogen mass to hydride mass is nearly constant when the vehicle tank pressure is near 500 psig (a constant temperature is also assumed). This is illustrated in Figure 3 (by one isotherm) by the nearly vertical hydrogen/hydride ratio at 34 atm (500 psig). Small variations in the final vehicle tank pressure following refueling do not appreciably change the mass of hydrogen contained in the vehicle.

Figure 3. Hydride Dissociation Pressure Equilibrium Curve (reproduced from Hydrogen Fueled Vehicle-Hydride Storage System, Project 6120, final report to the U. S. Postal Service, by V. Anderson, Billings Energy Corp., July 31, 1978)

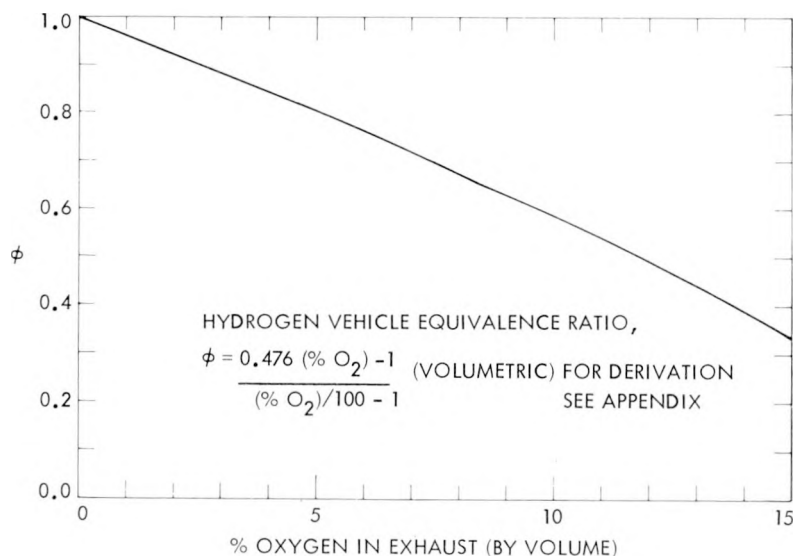
Since the test vehicle experienced a considerable number of flashbacks, and the Urban Driving Cycle  $\text{NO}_x$  emissions were high, it was suspected that the vehicle was operating at an equivalence ratio\* which would aggravate these conditions. An investigation of the approximate equivalence ratio at typical steady-state level-road load (LRL) conditions was performed. The approximate equivalence ratio was determined from measurements of the vehicle exhaust oxygen content. The relationship of theoretical exhaust oxygen content to combustion equivalence ratio is illustrated in Figure 4. The measured

Figure 4. Equivalence Ratio vs. Exhaust Oxygen Volume for Hydrogen and Air Combustion

oxygen by volume in the exhaust was 3.6% at 15 mph LRL, 3.8% at 30 mph LRL, and 4.9% at 40 mph LRL. These correspond to equivalence ratios of 0.85, 0.86, and 0.81, respectively. Indeed, the vehicle was operating in the equivalence ratio region near maximum NO<sub>x</sub> production, and flashback susceptibility. Further investigation of the trade-offs between emissions, flashback susceptibility, efficiency, and performance is recommended. Previous JPL experience with hydrogen-fueled vehicles has demonstrated more satisfactory results where the engine operates in the equivalence ratio region of 0.60 to 0.70.

The equivalence ratio at which the test vehicle operates was determined by measuring the oxygen content of its exhaust. The steady-state equivalence ratio was determined to be approximately 0.81 to 0.86. This is the region of maximum oxides of nitrogen production, and possibly in the region of maximum susceptibility of flashbacks. It is recommended that operation of the vehicle be investigated at lower equivalence ratios. Lower oxides of nitrogen and less susceptibility to flashbacks should be experienced if the equivalence ratio is changed to be in the region of 0.6 to 0.7.

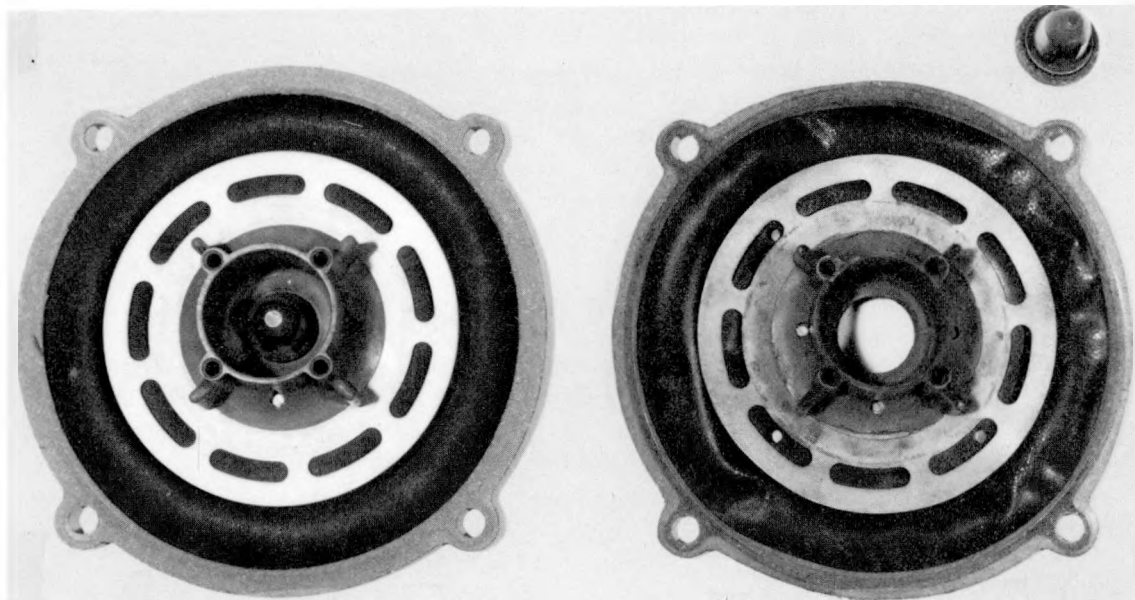
While being prepared for the Urban Driving Cycle tests, the vehicle was exposed to some 45 to 57 mph conditions during practice runs. Severe flashbacks were experienced followed by an audible leaking of hydrogen to the atmosphere from one or both of the hydrogen pressure regulators. A leak test revealed that the leak was in the area where the regulator diaphragm is secured by the two halves of the body. Regulator repair kits were provided by Billings (Impco Kits) and were installed by JPL personnel. The carburetor diaphragm was also replaced at this time because of prior experience, but the removed diaphragm did not have a broken casting, as did all the other replaced carburetor diaphragms.

ORIGINAL CONDITION

FAILURE OBSERVED AFTER  
SEVERE FLASHBACKS

Figure 5. USPS Hydrogen Jeep - Carburetor Diaphragms

Aside from the above-mentioned carburetor/diaphragm repair work, little maintenance was performed during the evaluation. During the checkout and preparation phase of the evaluation and prior to any of the PSDC or Urban Driving Cycles, a Billings representative twice verified proper vehicle performance. The first time that the JPL operation was inspected by the Billings representative, the problem with the carburetor diaphragm was discussed and JPL personnel were shown how to change the diaphragm. The first broken carburetor diaphragm was replaced at this time.

The second time the Billings representative visited JPL, four carburetor diaphragms had been broken and the Billings representative installed new spark plugs, adjusted the water injection system, arranged the spark plug wires (to avoid potential cross-firing), checked the ignition spark timing, and checked the vehicle coolant and crankcase levels. The Billings representative monitored a practice PSDC test, during which the fifth carburetor diaphragm was changed. Following this practice test, the vehicle was declared by Billings to be operating as designed and ready for evaluation. The tune-up parameters were not adjusted again during the evaluation.

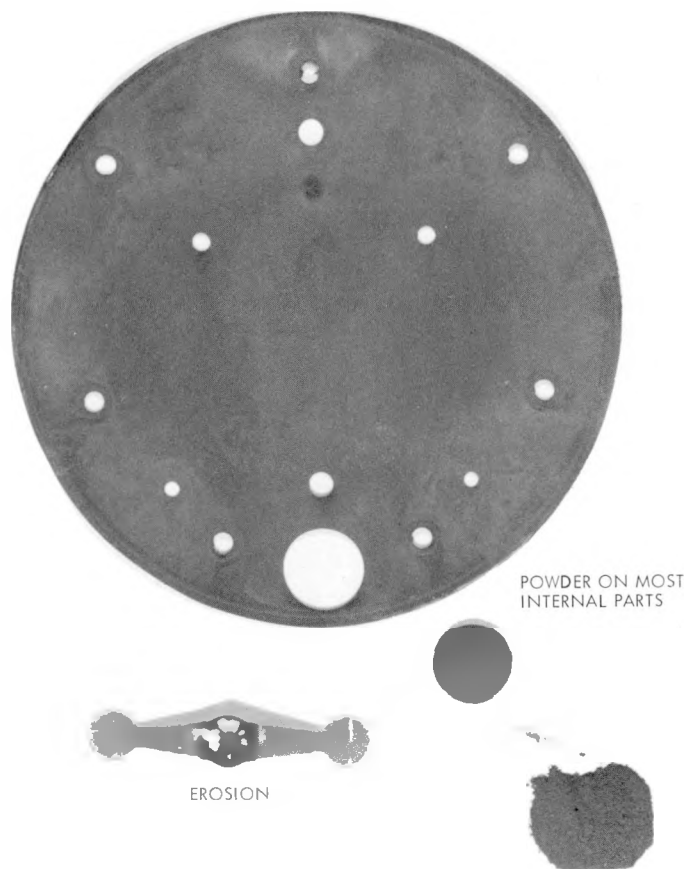
POWDER ON MOST  
INTERNAL PARTS

EROSION

During the repair of the regulators, it was noted that the inside regulator surfaces were covered with a fine, dark-gray powder. A flow valve in one of the regulators was severely eroded such that it could no longer seal. These conditions are illustrated in Figure 6. A portion of the powder recovered from the regulators was sent to Billings and they concluded that the powder was iron-titanium hydride. The hydride is evidently not being held in the tanks. This should be noted as a potentially serious problem. Premature engine wear may result from relatively small amounts of the iron-titanium.

Iron-titanium hydride was found in the fuel system. The source of this should be found and corrected. Wear in the engine should be measured to determine if the iron-titanium hydride has caused any engine damage.
