DOE/UMT-0205
PNL-4049
UC-70

Accelerated Aging Tests of Liners for Uranium Mill Tailings Disposal

November 1981

Pacific Northwest Laboratory
Operated for the U.S. Department of Energy
by Battelle Memorial Institute

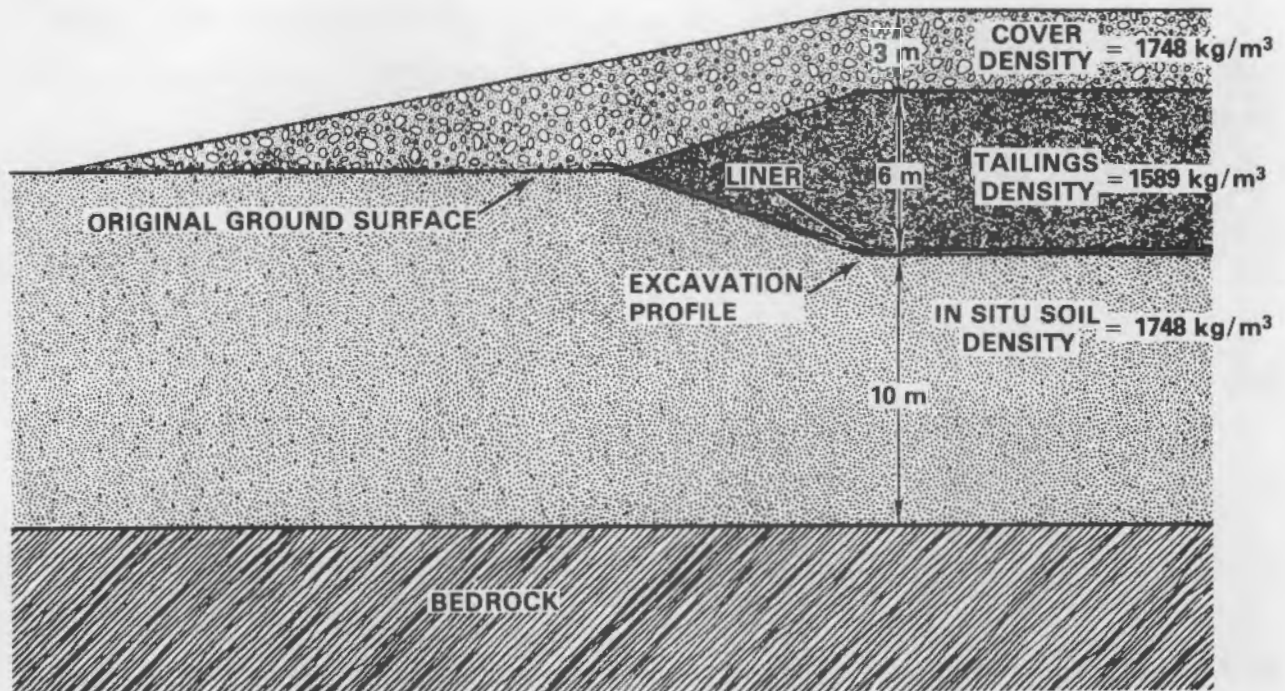
FIGURE 1. Typical Disposal Site for Predicting Subsidence

Figure 1 is a model of a typical disposal site. From this model, anticipated subsidence was calculated to be 33 cm. Assuming a 3:1 excavation slope with a tailings depth of 6 m, the maximum elongation a liner must withstand is 0.035 cm/cm, or 3.5%. This value was duplicated in the accelerated tests for both clay, and asphalt and synthetic liners.

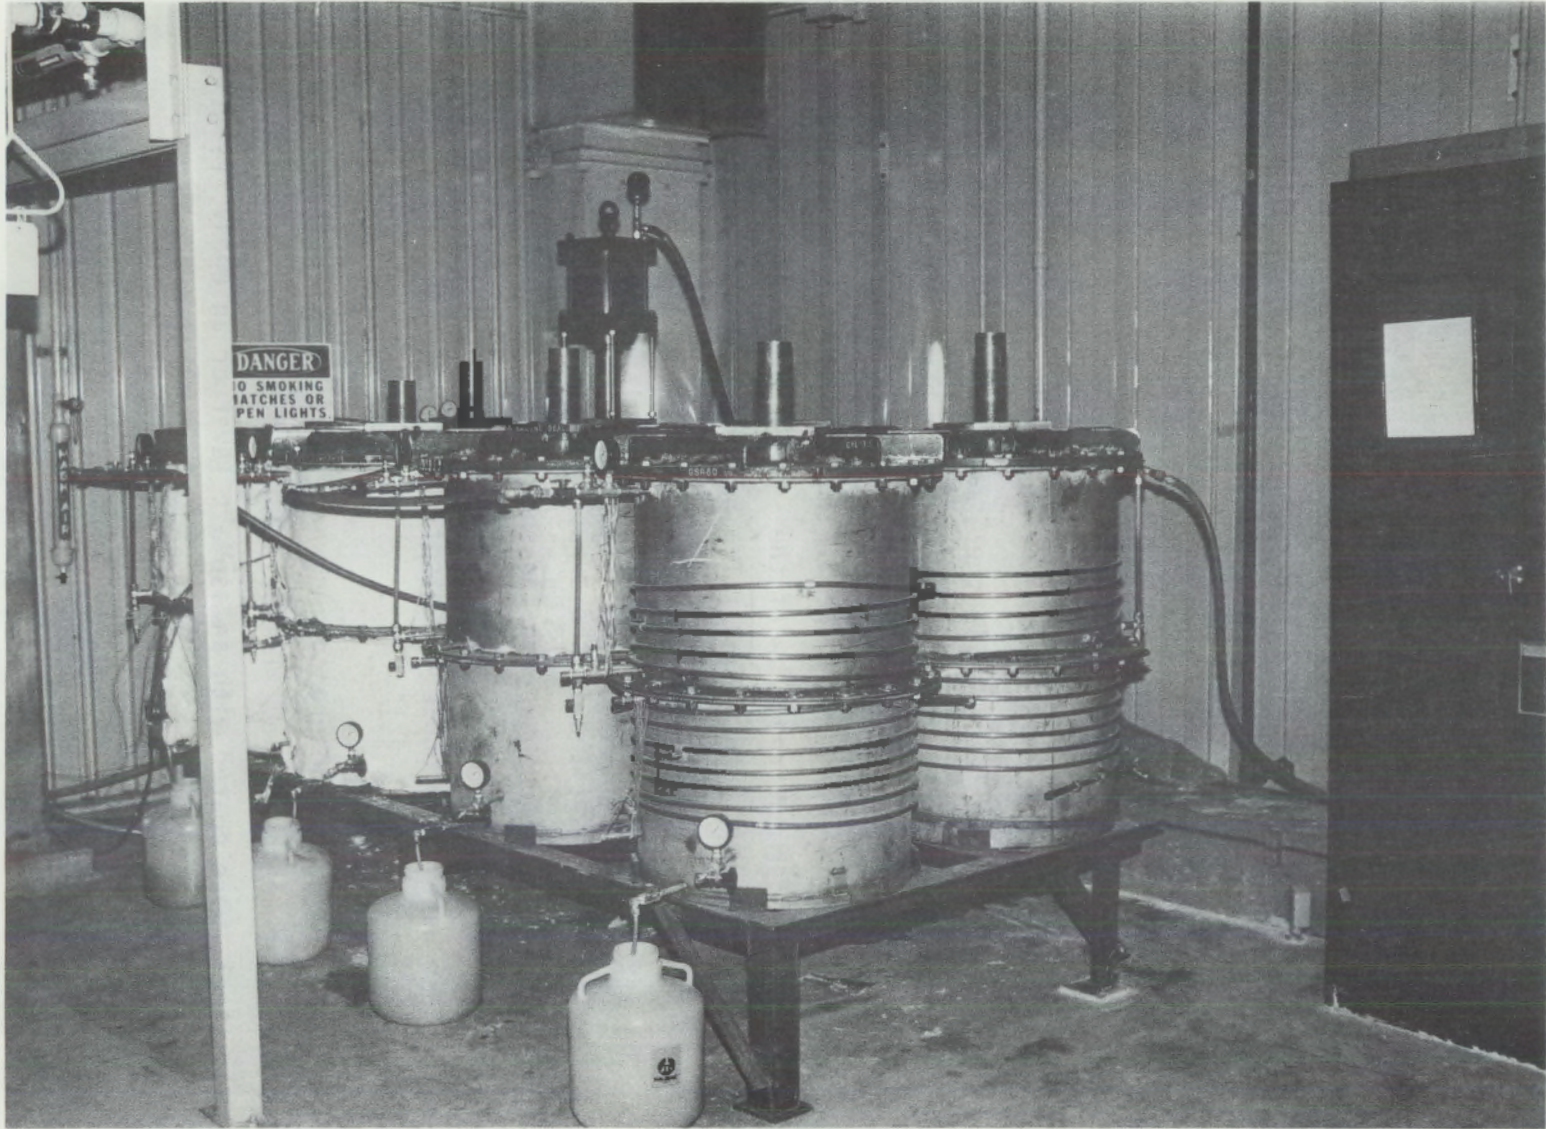
FIGURE 2. Accelerated-Aging Laboratory Apparatus

Eight sealed columns were fabricated for liner testing to produce a controlled environment in which the liners were exposed to accelerated aging conditions. The liner exposure columns, shown in Figure 2, were constructed of 61-cm (24-in.) 304L stainless steel pipe. The columns were designed to simulate expected field conditions and to expose the candidate liners to the accelerated-aging mechanisms described earlier. The design features of the columns are depicted in Figure 3.

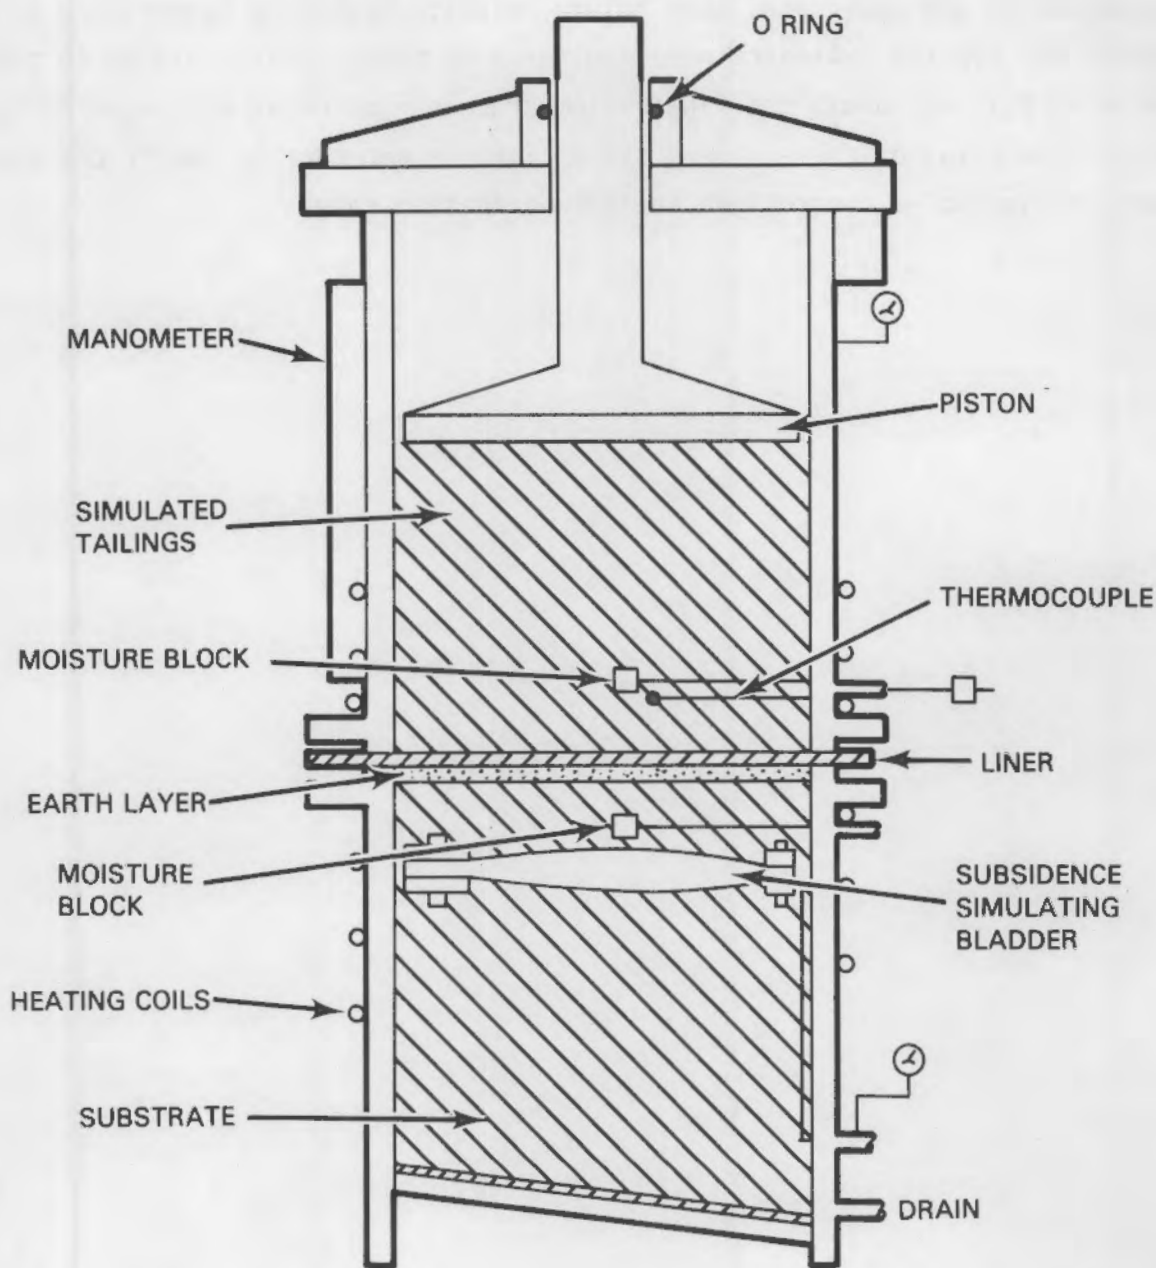
FIGURE 3. Construction Details of Liner Exposure Columns

The characteristics of an impoundment that must be simulated in the exposure columns include the forces exerted by the tailings above the liner; the pressure head of tailings leachate in the impoundment, if any; and subsidence of the supporting substrate. The weight of the tailings above the liner was duplicated by applying a representative force on the simulated tailings in the column with the piston shown in Figure 3. The piston was fabricated with perforated plating to permit free flow of the simulated leachate while the desired load was applied to the sand. The head of tailings leachate above the liner was simulated by applying gas pressure to the test cylinder above the liner. The effects of ground subsidence were simulated by a collapsible, water-filled bladder installed in the supporting sand beneath the liner. The bladder was constructed from two hypalon sheets clamped at the edges with polyvinyl-chloride rings. The space between the hypalon sheets was filled with sufficient water to produce the displaced volume required to model the subsidence.

The bottom of each exposure column was sloped to direct the fluid passing through the liner to the drain. The welded bottoms of the column, constructed of carbon steel, were coated with an asphalt layer or an epoxy resin for corrosion protection.

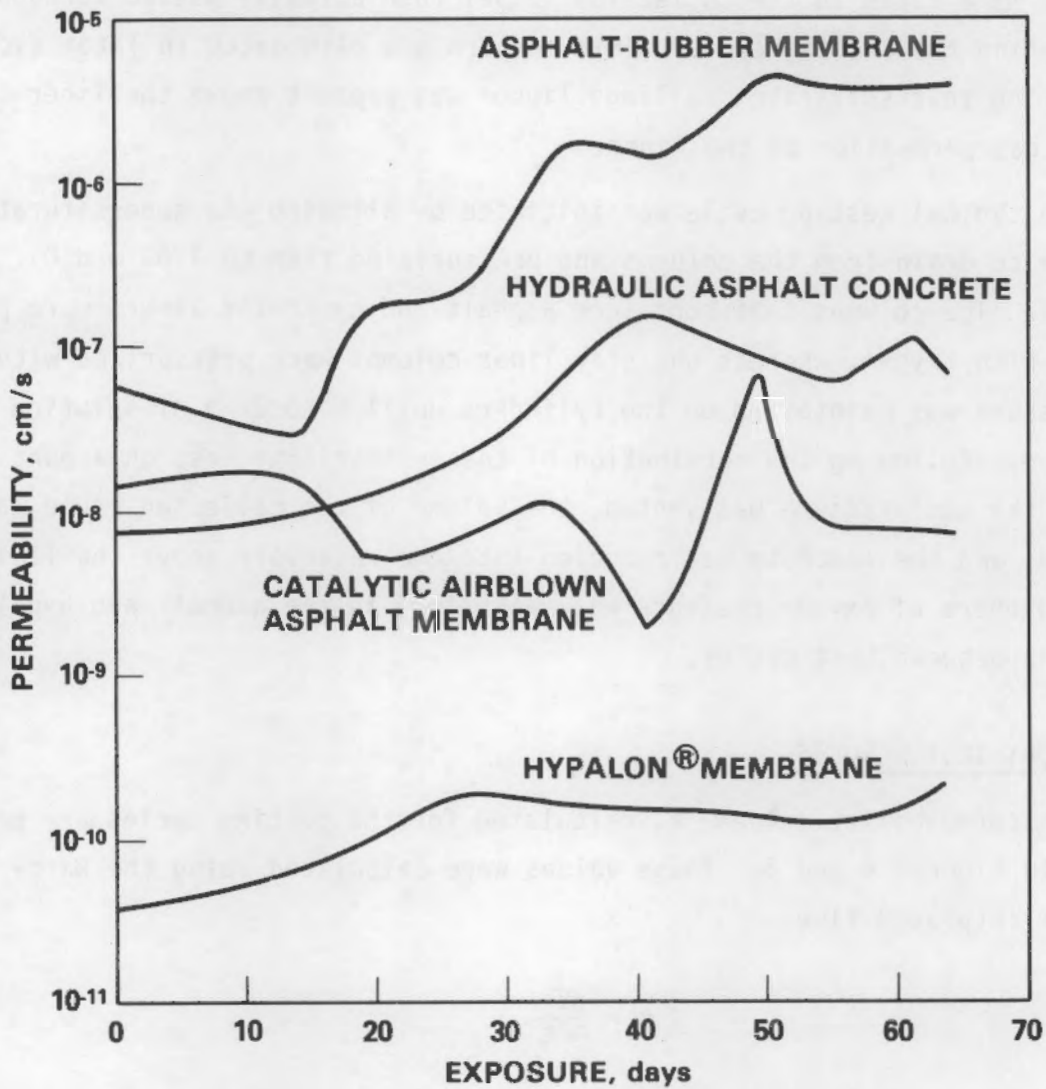
FIGURE 4. Permeability Performance of the Asphalt and Hypalon Liners During the Laboratory Testing Period

When comparing the effectiveness of liner materials of different thicknesses, it is not sufficient to compare final permeabilities. First, the change of permeability with exposure time indicates the relative stability of the liners. Second, a liner 10 to 20 cm thick in the field, such as a soil amended with bentonite, need not be as impermeable as a thin membrane to be an effective leachate barrier. Therefore, the liners were also compared by averaging the final three permeabilities and dividing by the liner field

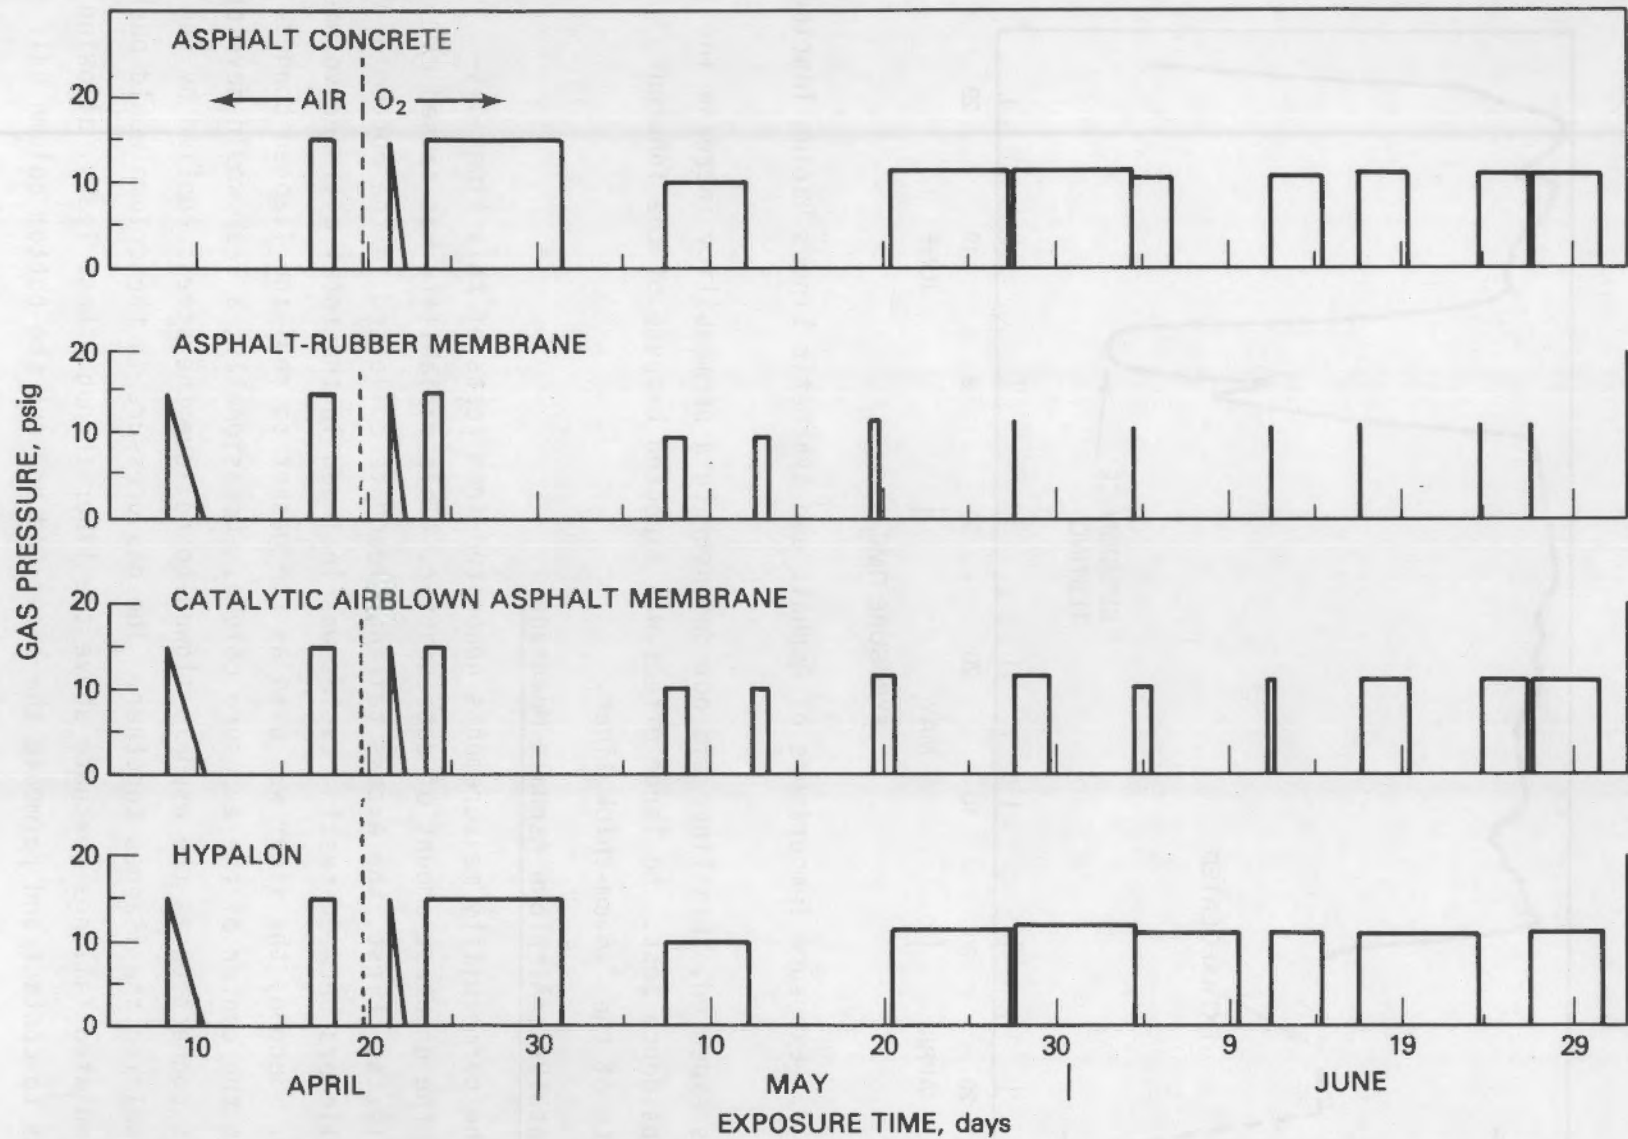
FIGURE 6. Oxygen Pressure to Which Asphalt and Synthetic Liners were Exposed During Testing

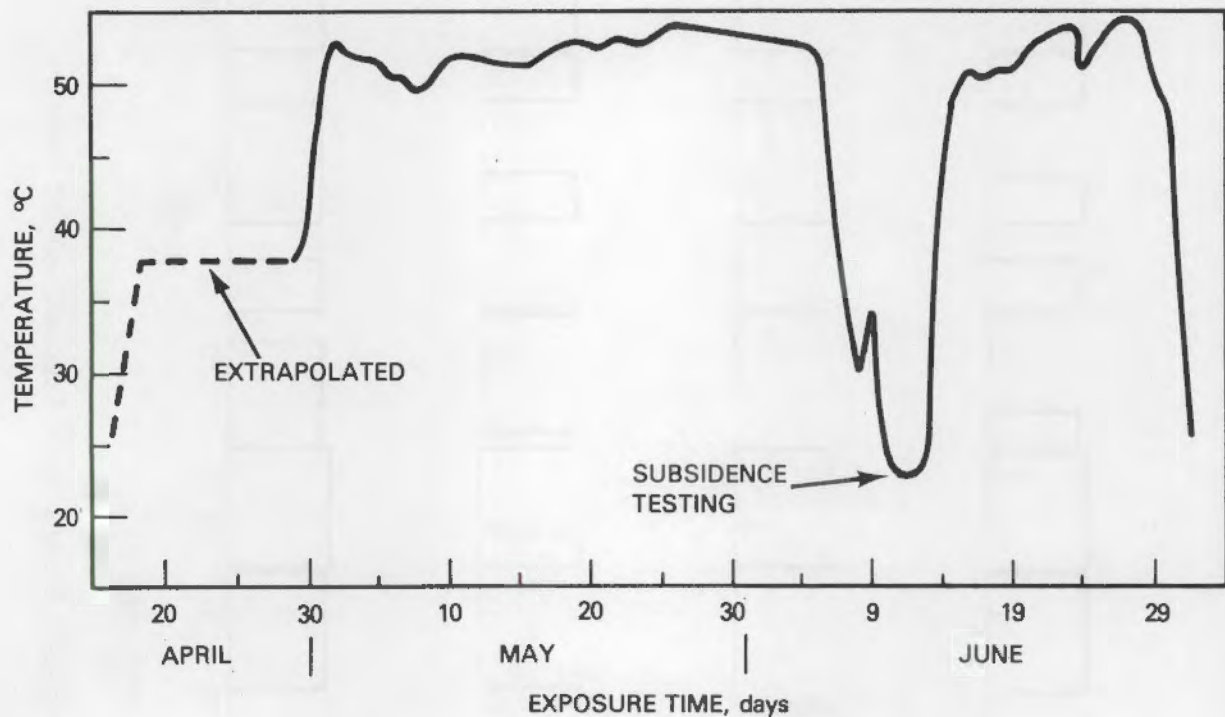
FIGURE 7. Exposure Temperature of Asphalt and Synthetic Liners During Testing

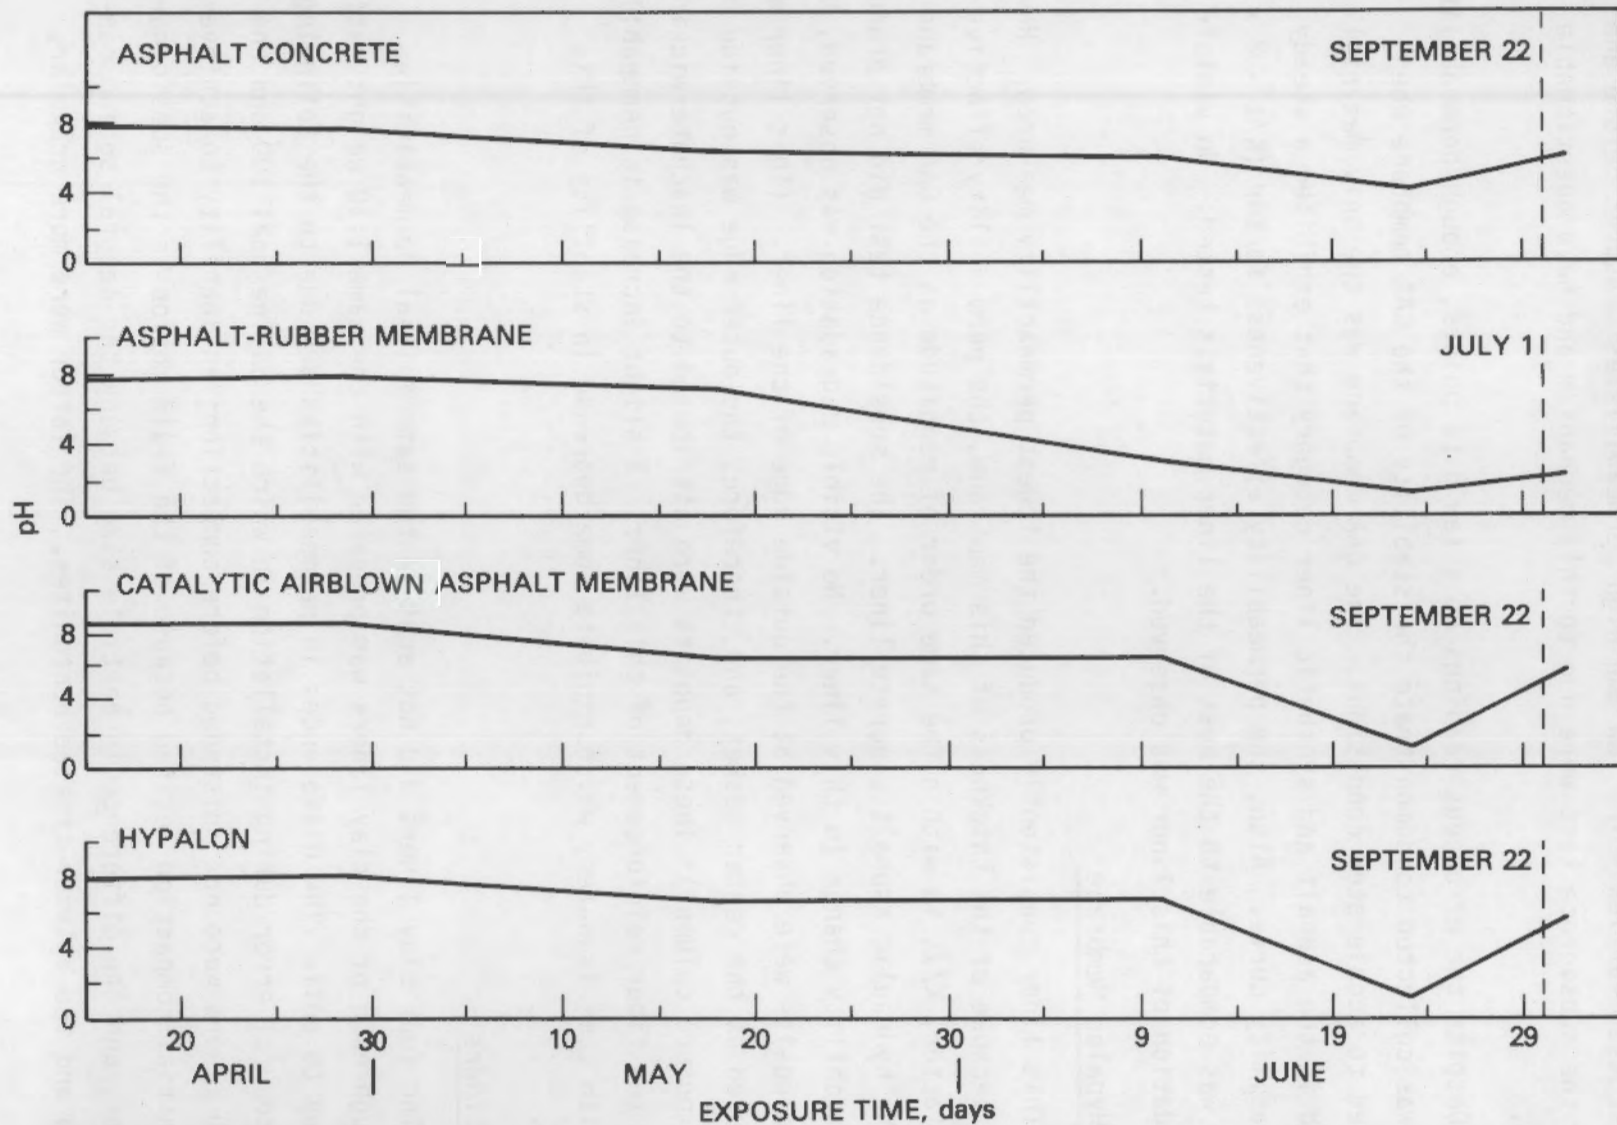
FIGURE 8. Acidity Concentration During Testing of Asphalt and Synthetic Liners (includes pH values measured after test completion, June 30)

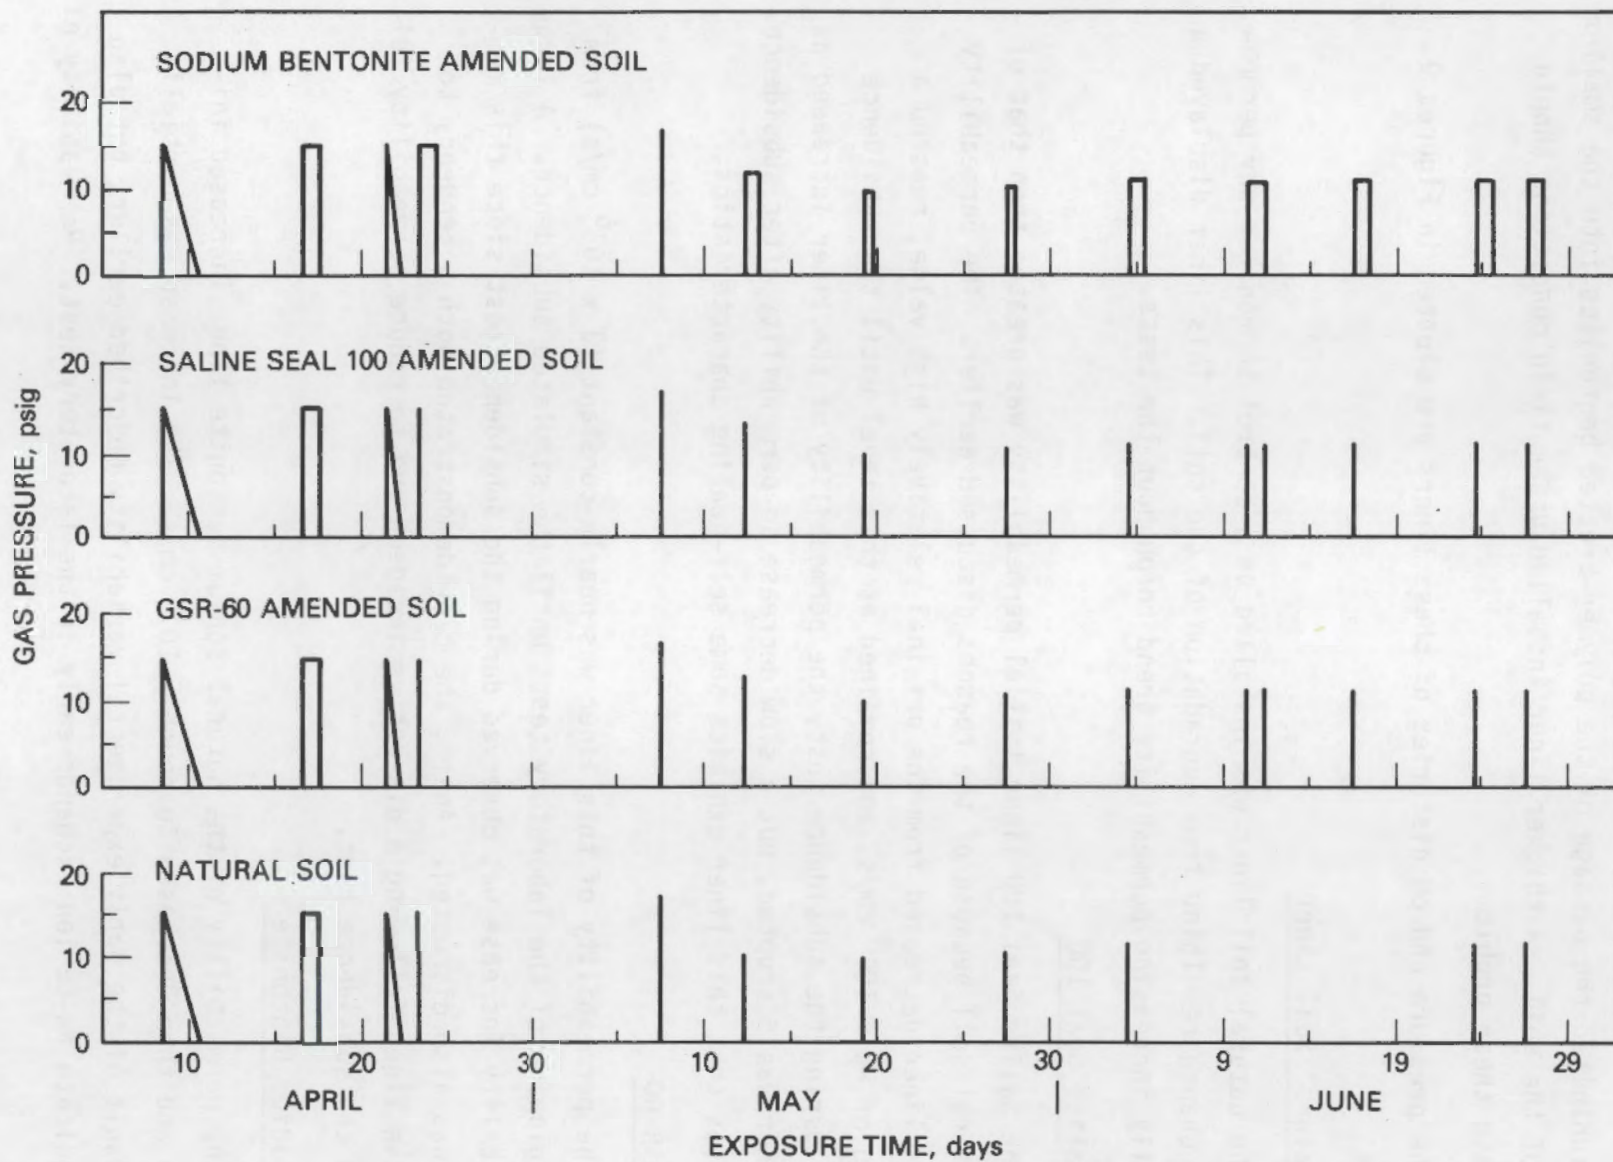
FIGURE 9. Pressure History During Testing of Clay Liners

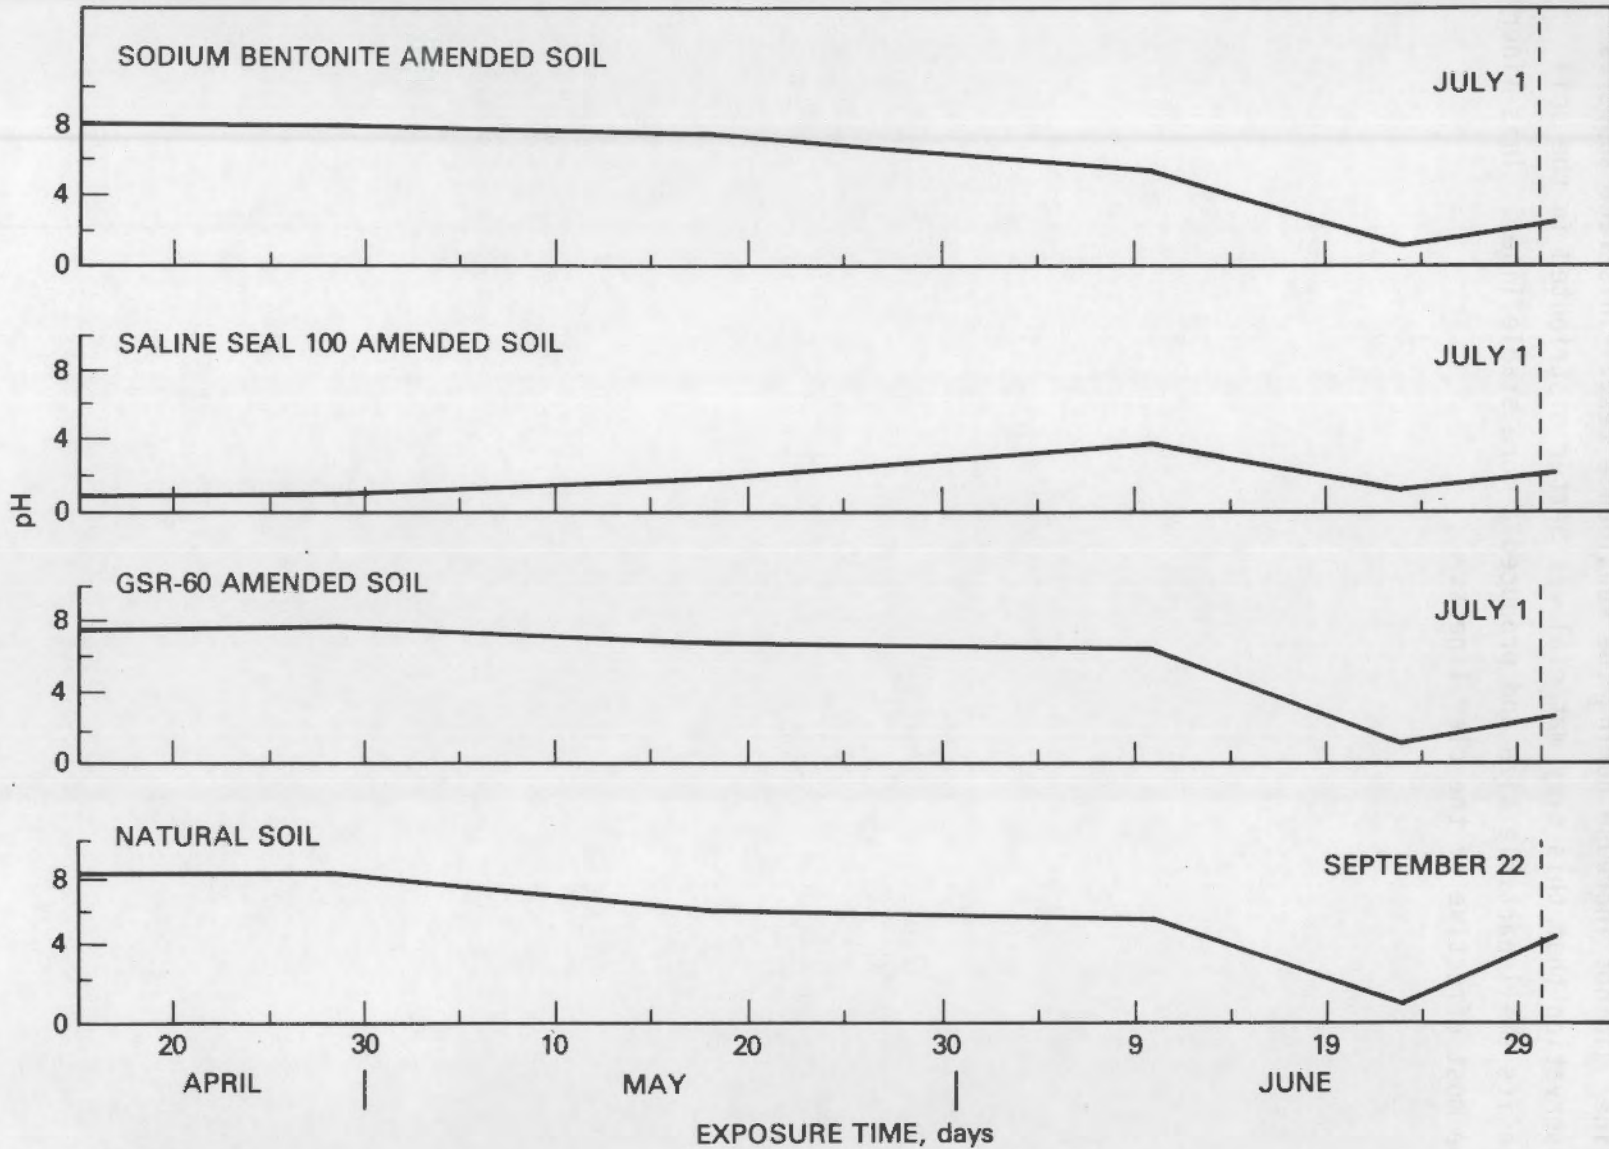
FIGURE 10. Acidity Concentration During Testing of Clay Liners (includes pH values measured after test completion, June 30)
