RADIOLOGICAL CHARACTERIZATION OF THE TAN-IET FACILITY

APPLIED PHYSICS BRANCH
PHYSICS DIVISION

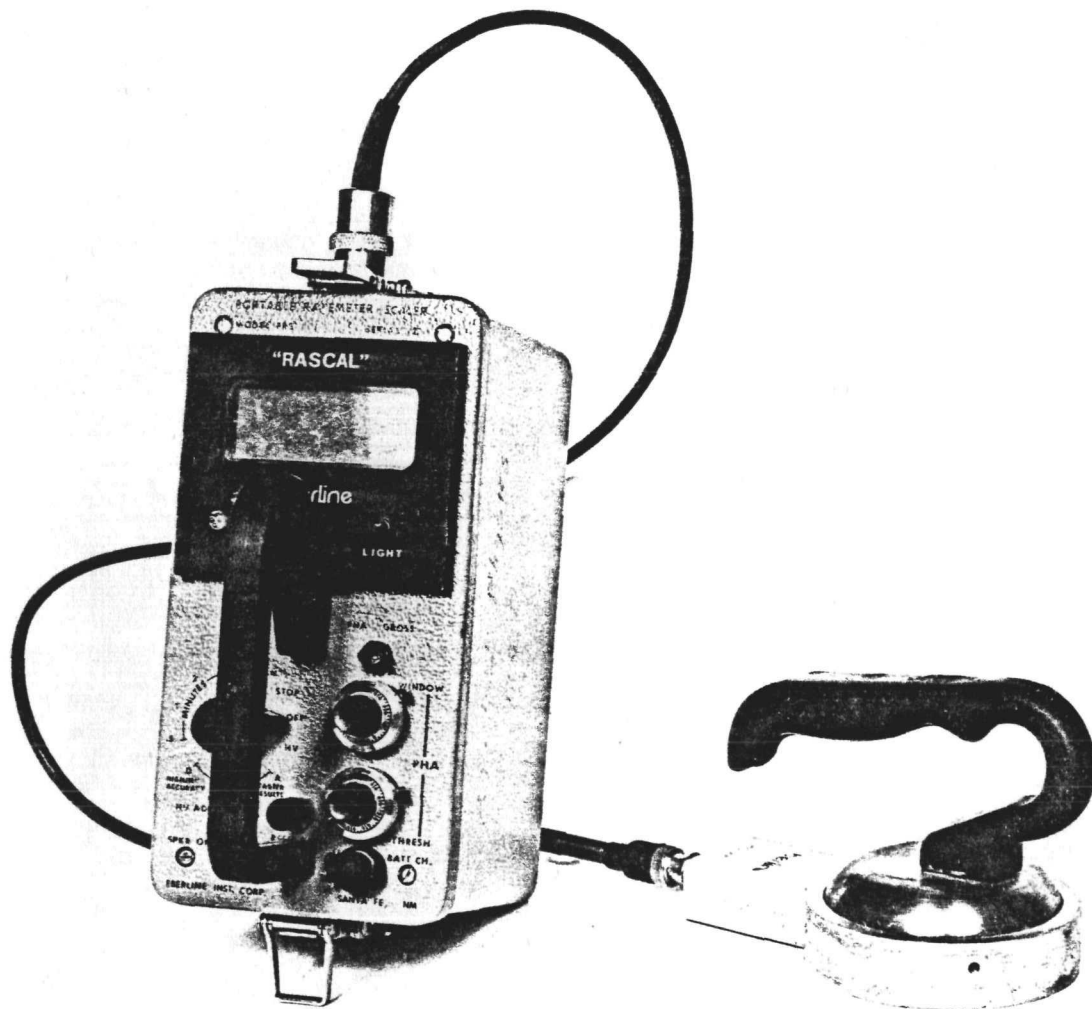
Figure 3. Eberline PRS-1 (RASCAL) Ratemeter with HP 210 GM Detector.

This instrument was used for the beta-gamma radiation survey of the entire site surface.

The beta-gamma 'walk-over' survey of the IET site was performed using the 'Rascal' survey meter, Figure 3. The averaged counts/30 sec for each 25' grid square were recorded on the grid maps (expanded views) as gross counts/30 sec and are not corrected for background.

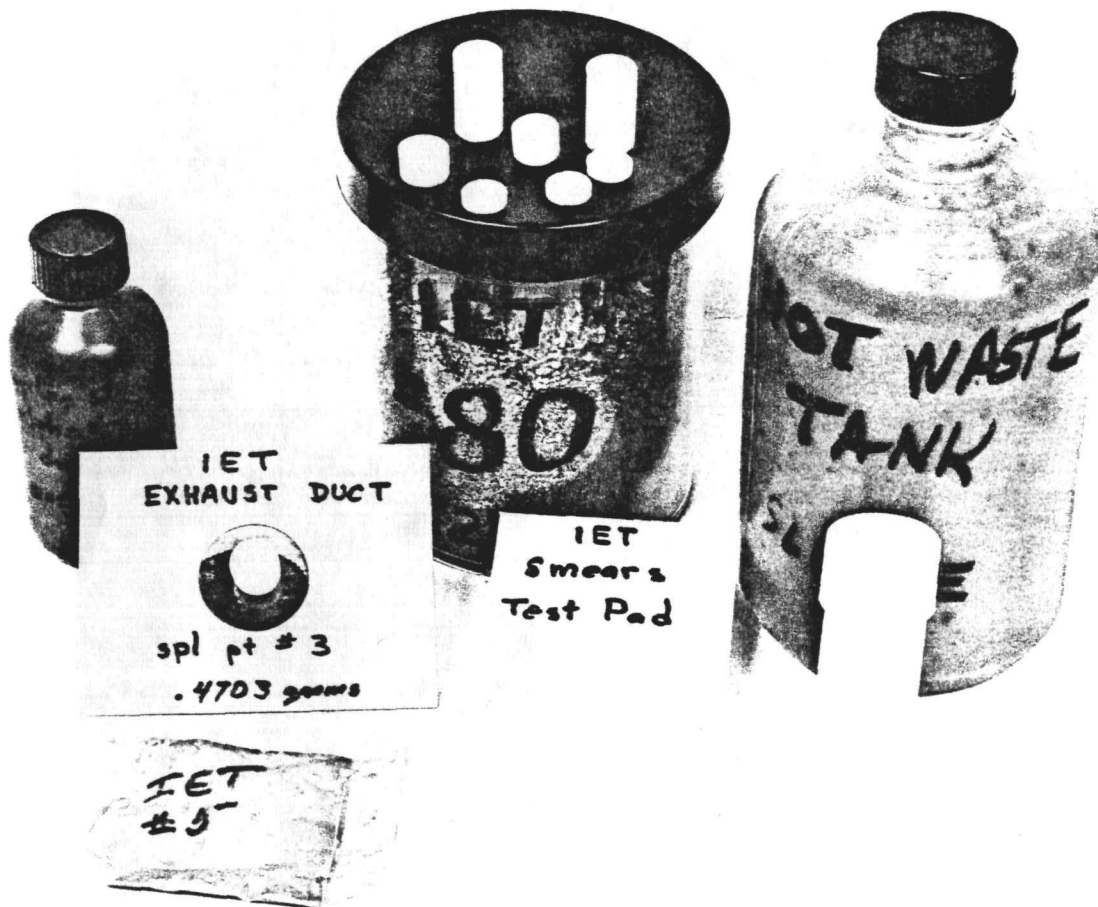
Figure 7. Typical Type Samples Collected and Analyzed by the Radiation Measurements Laboratory (RML) for TAN-IET.

Gamma-ray analyses were done on samples of liquid, solid, sludge, scrapings, soil, etc., using the latest computer analysis routines. See Figure 7 for typical type samples collected at the IET and analyzed at the RML. Samples indicating the presence of ^{235}U and ^{137}Cs were further analyzed for fissile material content (^{235}U equivalent) by delayed neutron counting² at the Coupled Fast Reactivity Measurements Facility (CFRMF) and ^{90}Sr in the RML chemistry laboratories.
