CREVICE CORROSION AND METAL-ION CONCENTRATION  
CELL-CORROSION RESISTANCE OF  
CANDIDATE MATERIALS FOR OTEC HEAT EXCHANGERS

Parts I and II

LOCALIZED CORROSION EVALUATIONS  
OF CANDIDATE MATERIALS IN LOW  
VELOCITY SEAWATER AT AMBIENT TEMPERATURES

CREVICE CORROSION EVALUATIONS OF STAINLESS  
ALLOYS IN CONTROLLED TEMPERATURE,  
FILTERED SEAWATER.

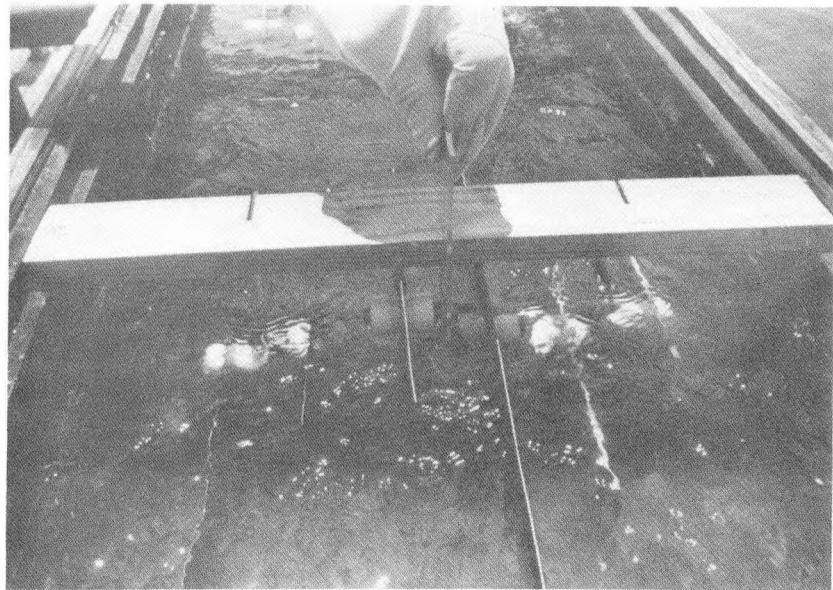
79075-9

Figure 3. Position of crevice test specimens in 0.5 m/sec. flowing seawater trough. Copper base alloys were located downstream of the titanium, stainless alloy and aluminum alloy specimens.

Marine growths and other deposits were kept to a minimum by periodic underwater cleaning with a nylon gloved hand and foam brushes.

Specimens were exposed in once through, unfiltered seawater at a nominal velocity of 0.5 m/sec for six months. The mean seawater temperature for the test period was 24.2°C. The routine seawater hydrology data for the ambient conditions are summarized in Table II. The specimens were exposed vertically on non-metallic supports as shown in Figures 2 and 3.

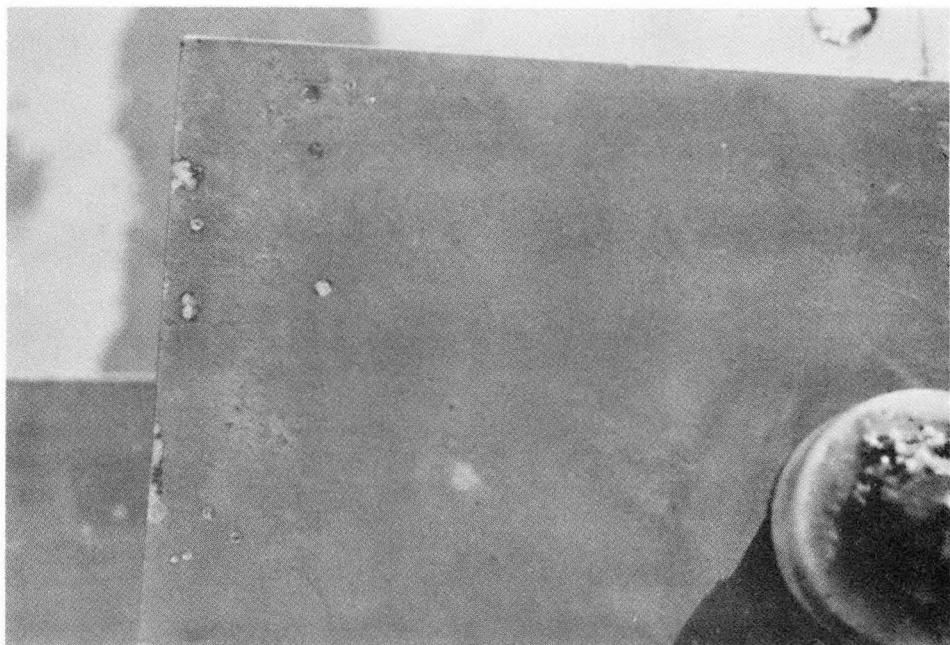
**Figure 12. Localized attack detected on surfaces of C72200 test panels.**
