**LA-10630-PR
Progress Report**

**Space Nuclear Safety Program
September 1984**

I. GENERAL-PURPOSE HEAT SOURCE (GPHS)/SAFETY VERIFICATION TEST (SVT) SERIES

A. SVT-10 Postmortem Examination (T. George)

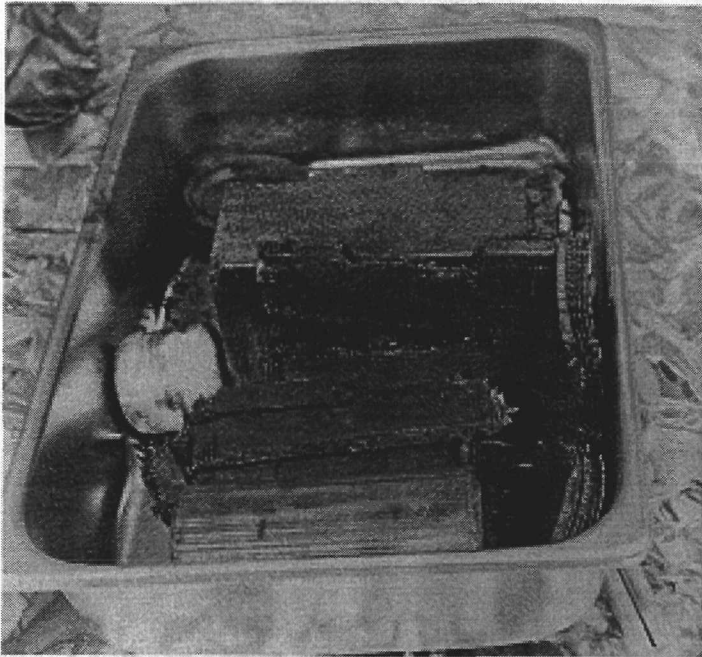
Fig. 2. The SVT-10 test assembly was badly broken up.

tube was removed, and the inner nickel can (a thermal radiation shield) was extracted with tongs. The impact assembly and loose components were then extracted and placed on a bed of solid CO₂ (Fig. 2). As in previous SVT impacts, a significant amount of debris remained in the catch tube (Fig. 3). The largest pieces of graphite were removed from the catch tube; the remaining debris was washed down and packaged for ²³⁸Pu analysis.

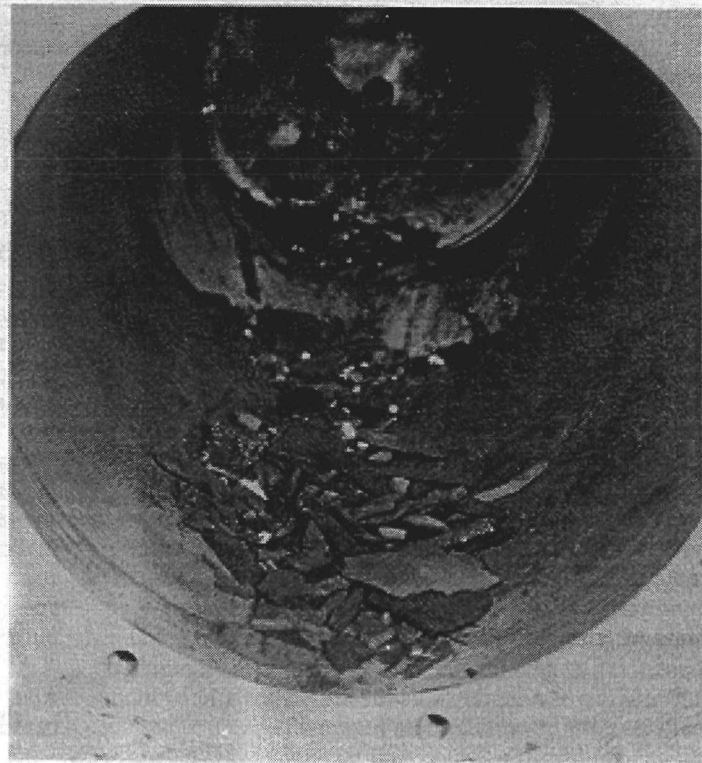
Fig. 3. A significant amount of debris remained in the SVT-10 catch tube after the impact assembly was removed.

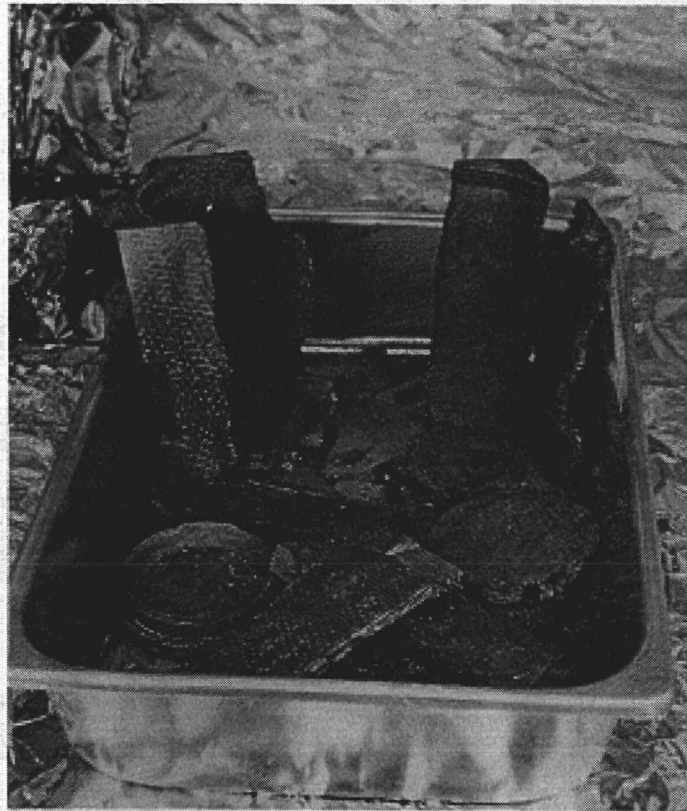
Fig. 4. The SVT-10 aeroshell was completely destroyed.

The SVT-10 aeroshell was completely destroyed by the impact (Fig. 4). The aeroshell walls fractured along the axial contact lines of the impact shells. Both graphite impact shells (GISs) were released into the catch tube.

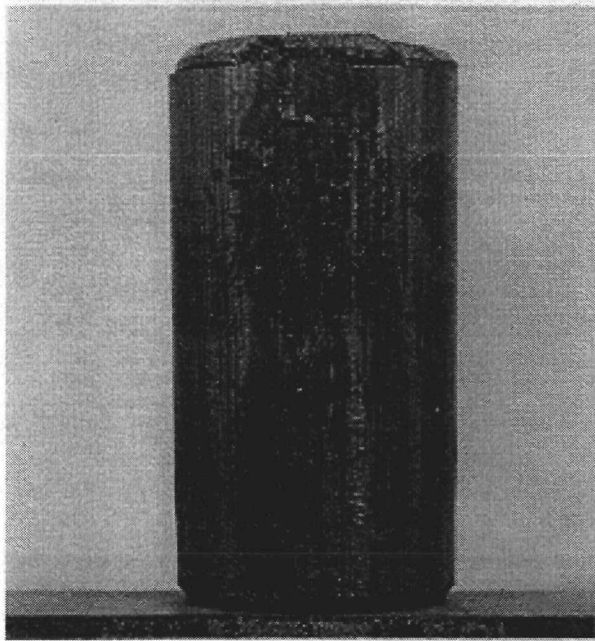
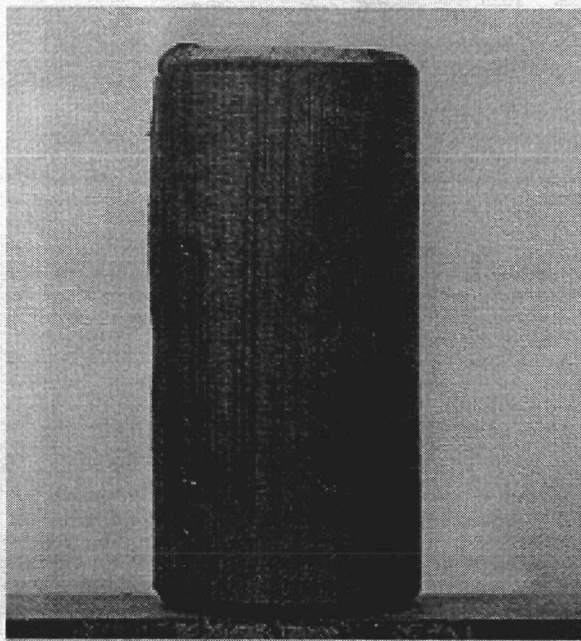
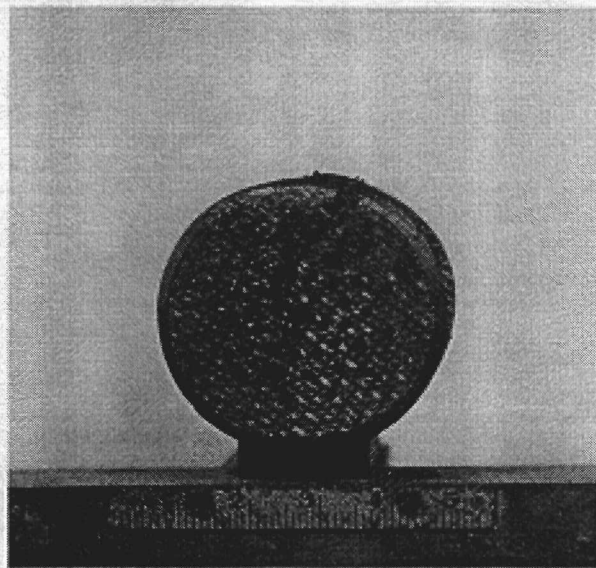
Fig. 5. The primary GIS sustained only minor damage. (a) Impact face, (b) profile, and (c) closure end; all at 1X.

Impact shell damage was moderate (Figs. 5 and 6). Thin longitudinal cracks ran the length of the prime GIS impact face, and a wide axial crack extended over 75% of the impact face on the secondary GIS. The cap of the secondary GIS was removed, and FC-152 was released into the catch tube.

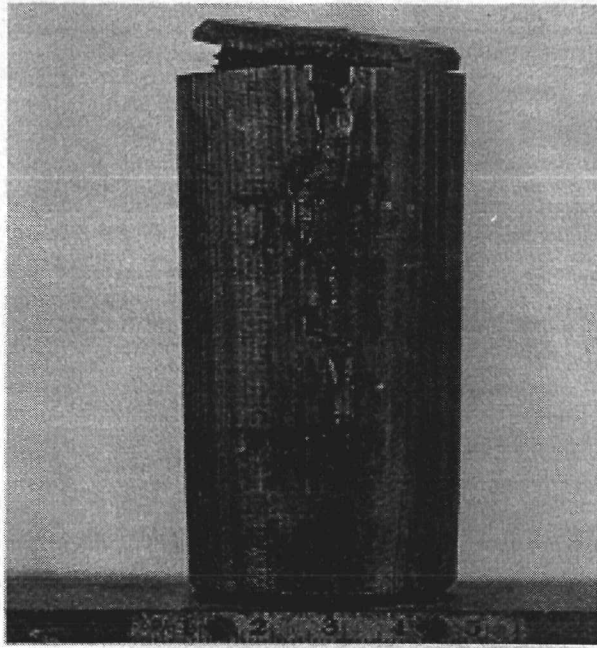
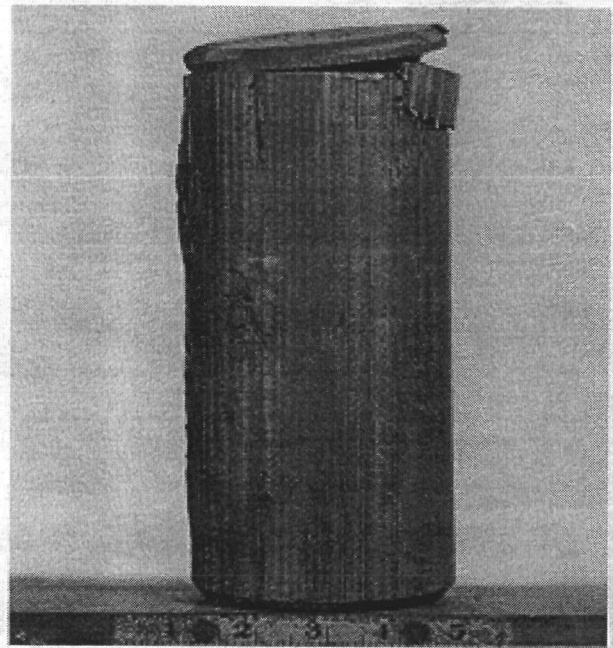
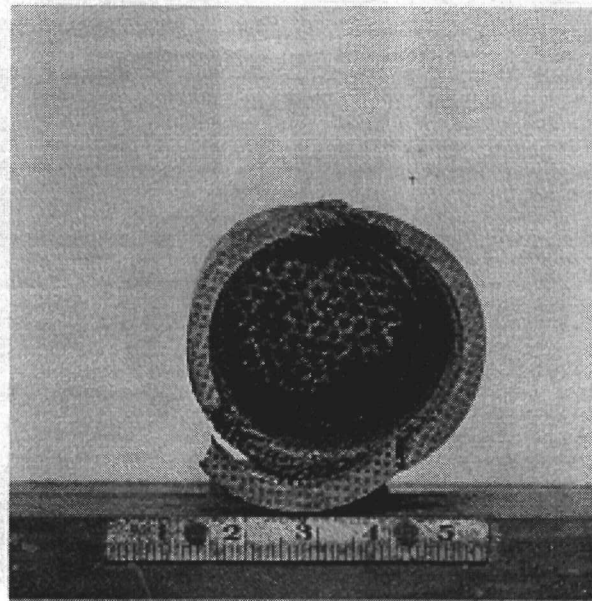
Fig. 6. The secondary GIS sustained moderate damage. (a) Impact face, (b) profile, and (c) closure end; all at 1X.

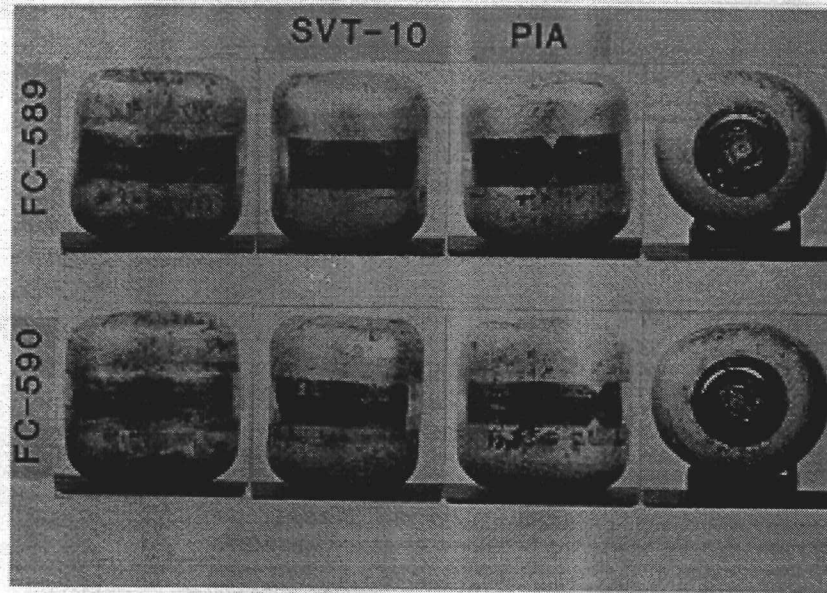
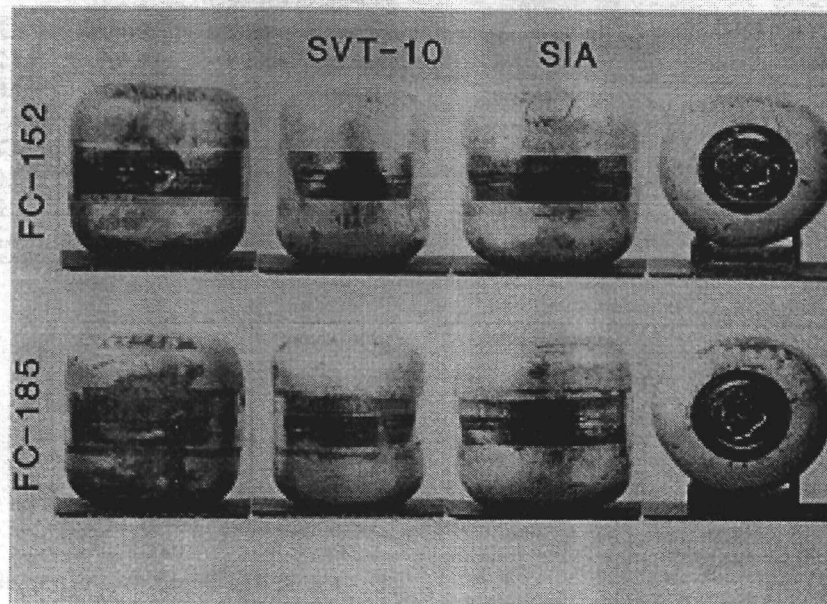
Fig. 7. The SVT-10 capsule deformations were minor. (a) Clads contained within the primary GIS, and (b) clads contained in the secondary GIS.

The fuel capsules were extracted from the GISs, photographed, and measured. Side and end views of each capsule are shown in Fig. 7. Capsule dimensions and calculated gross strains are listed in Tables III and IV.

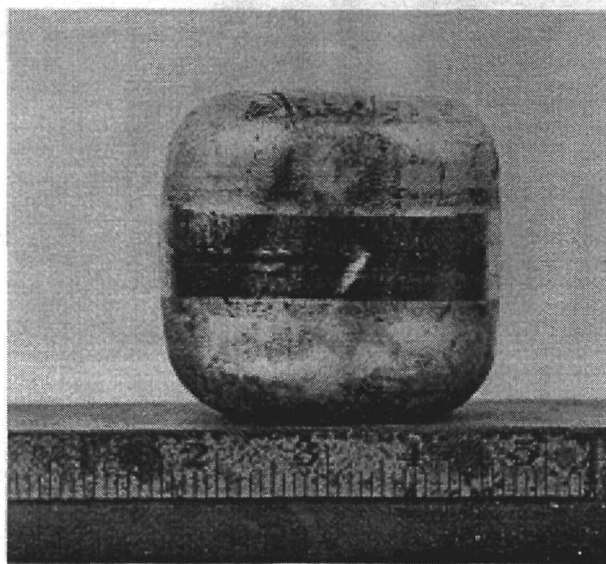
Fig. 8. The impact face of capsule FC-152 contained a deep crease; 1.5X.

deformations were relatively small. Although capsule FC-152 was released into the catch tube, it did not appear to be significantly more deformed than capsule FC-185 (which remained in the GIS). A sharp crease on the FC-152 impact face (Fig. 8) was apparently caused by the random breakup and the subsequent displacement of a large fuel fragment.

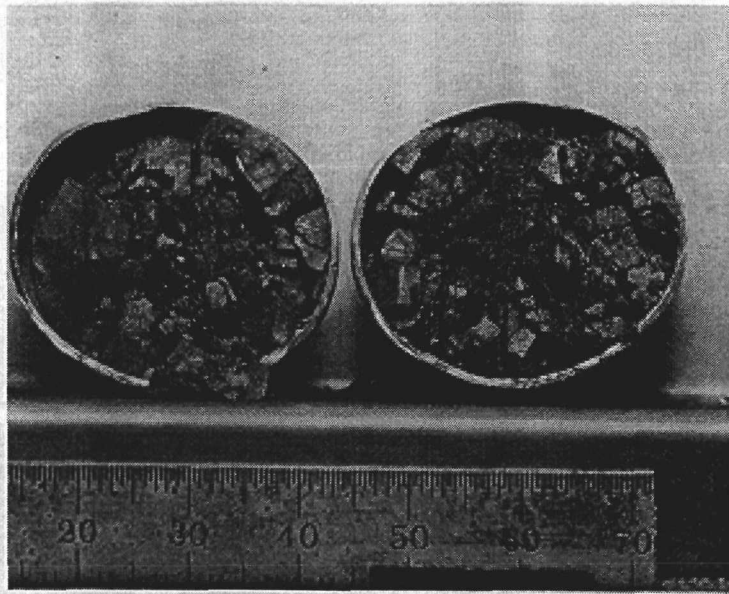
Fig. 9. The fuel in capsule FC-185 fractured in a brittle manner; 1.5X.

Following macroscopic examination, the fueled clads were defueled and then sectioned to provide specimens for metallography. An abrasive cutting wheel was used to make a small circumferential slit 8-10 mm above the weld (blind cup) on capsules FC-185 and FC-589. The capsules were pried open with a small screwdriver and the patterns of fuel fracture were photographed (Figs. 9 and 10).

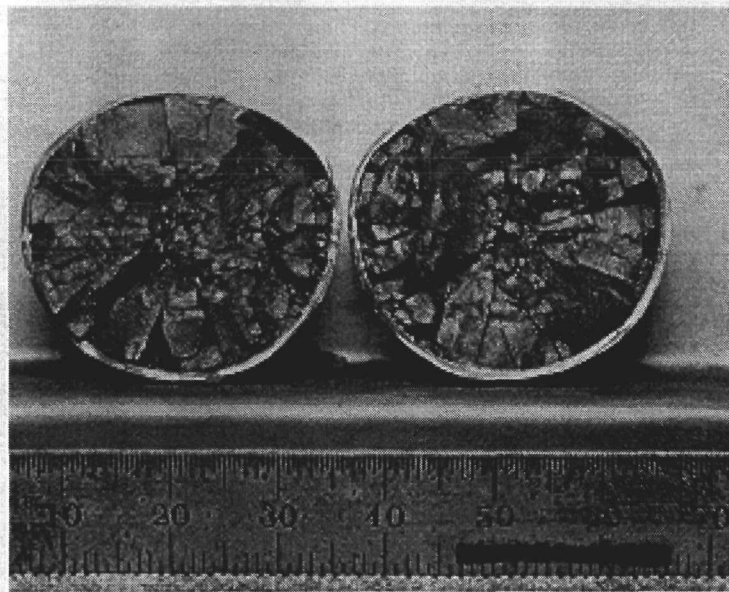
Fig. 10. Capsule FC-589 as-opened; 1.5X.

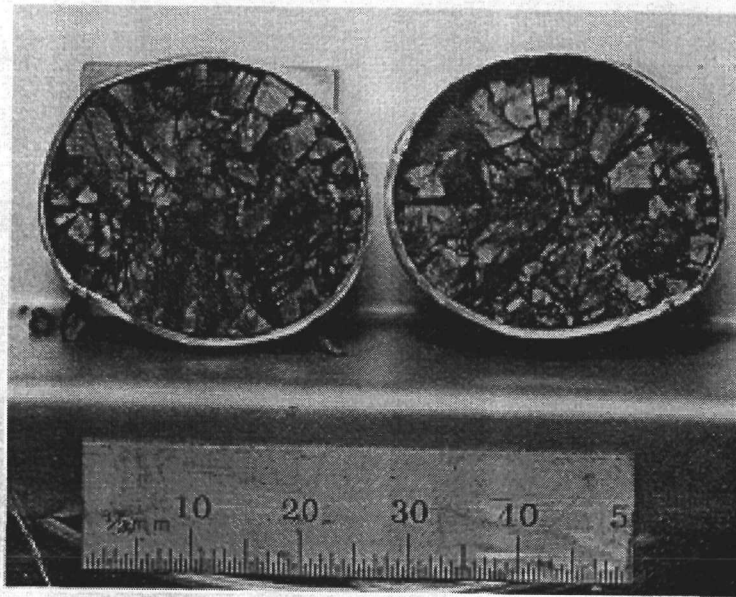
Fig. 11. The fuel in capsule FC-152 fractured in an unusual manner, with a well-defined shear plane running 45° to the impact face; 1.5X.

To determine the quantity of respirable fuel particles produced by the impact, we selected FC-152 and FC-590 for particle size analyses. The capsules were transferred to a glovebox train used for fines analysis and were opened underwater (to prevent the loss of small fuel fragments). The patterns of fuel breakup (Figs. 11 and 12) were similar to those observed in the other clads. The fuel in capsule FC-152 was particularly interesting because it fractured along a plane 45° to the impact face (Fig. 11).

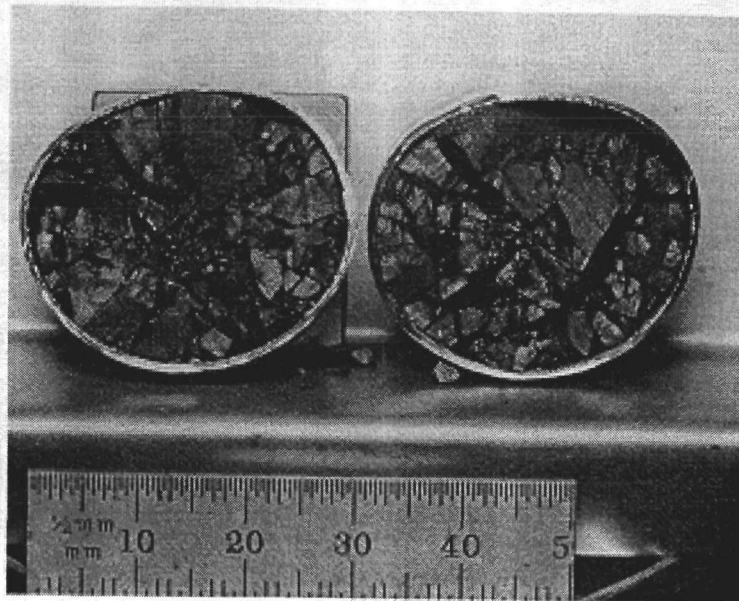
Fig. 12. The fuel in capsule FC-590 fractured in a much more random manner; 1.5X.

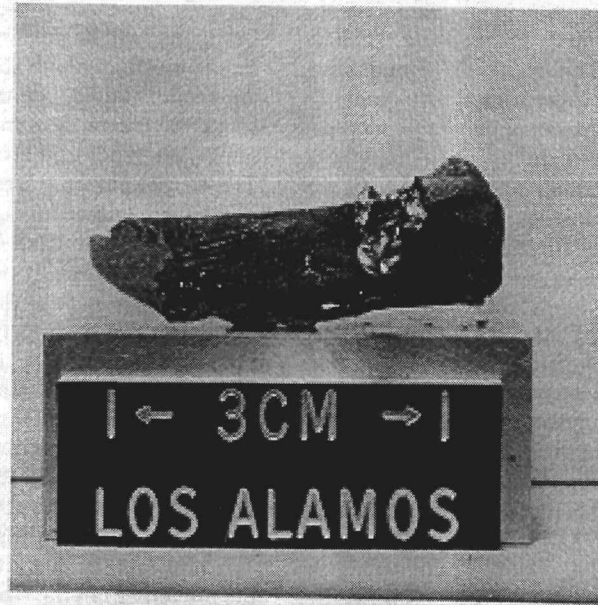
Fig. 13. The intermetallic compound that remained attached to the aluminum bullet was sectioned for metallography; 1.5X.

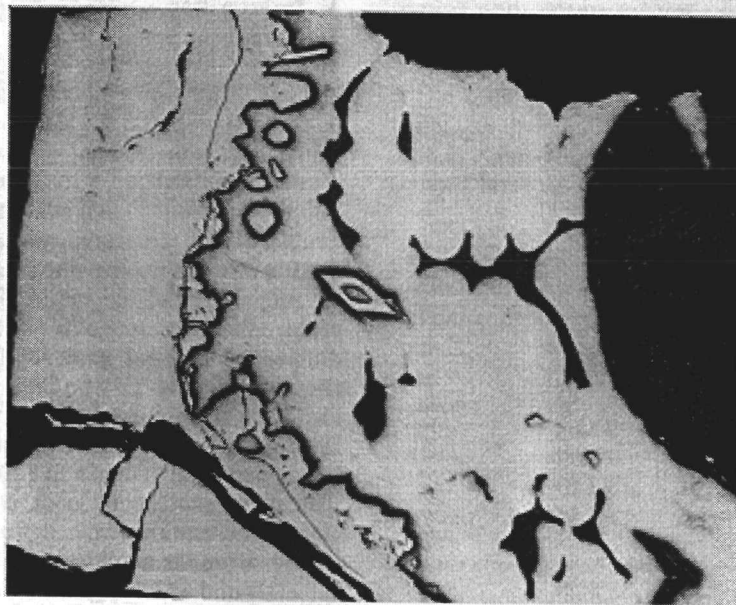
Fig. 14. Several phases appeared to be present in the intermetallic deposit; 40X.

Metallographic examination of a section removed from the intermetallic compound attached to the aluminum bullet revealed a number of interesting features. At least five phases appear to be present on the deposit cross section (Fig. 14). After metallographic examination, the section was submitted for microprobe analysis of the apparent phase regions.
