GEAP-23773-2  
MARCH 1979

**DEMONSTRATION OF FUEL  
RESISTANT TO  
PELLET-CLADDING INTERACTION  
PHASE I FINAL REPORT**

### PHASE I Final Report

NUCLEAR ENERGY ENGINEERING DIVISION • GENERAL ELECTRIC COMPANY  
SAN JOSE, CALIFORNIA 95125

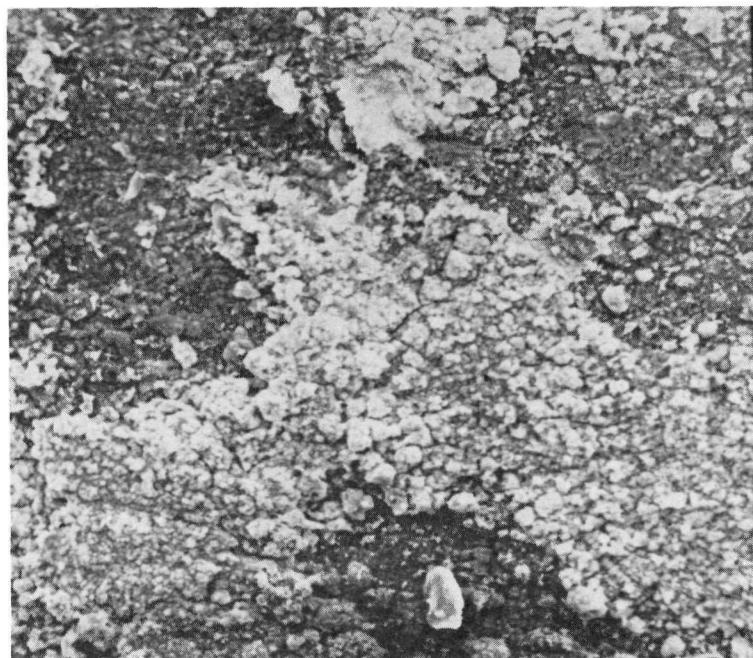
Figure 4.3-17. Heavy Deposits on Cu-Barrier Surface at Pellet Interface Location (CC-44A, G)
