DOE/MC/10263-1342
(DE83010249)

**SURFACE FEATURES ASSOCIATED WITH LINEAMENTS,
EGSP AREA (COTTAGEVILLE FIELD, WEST VIRGINIA)**

By
Carroll F. Knutson

By
GeoEnergy Corporation
Las Vegas, Nevada

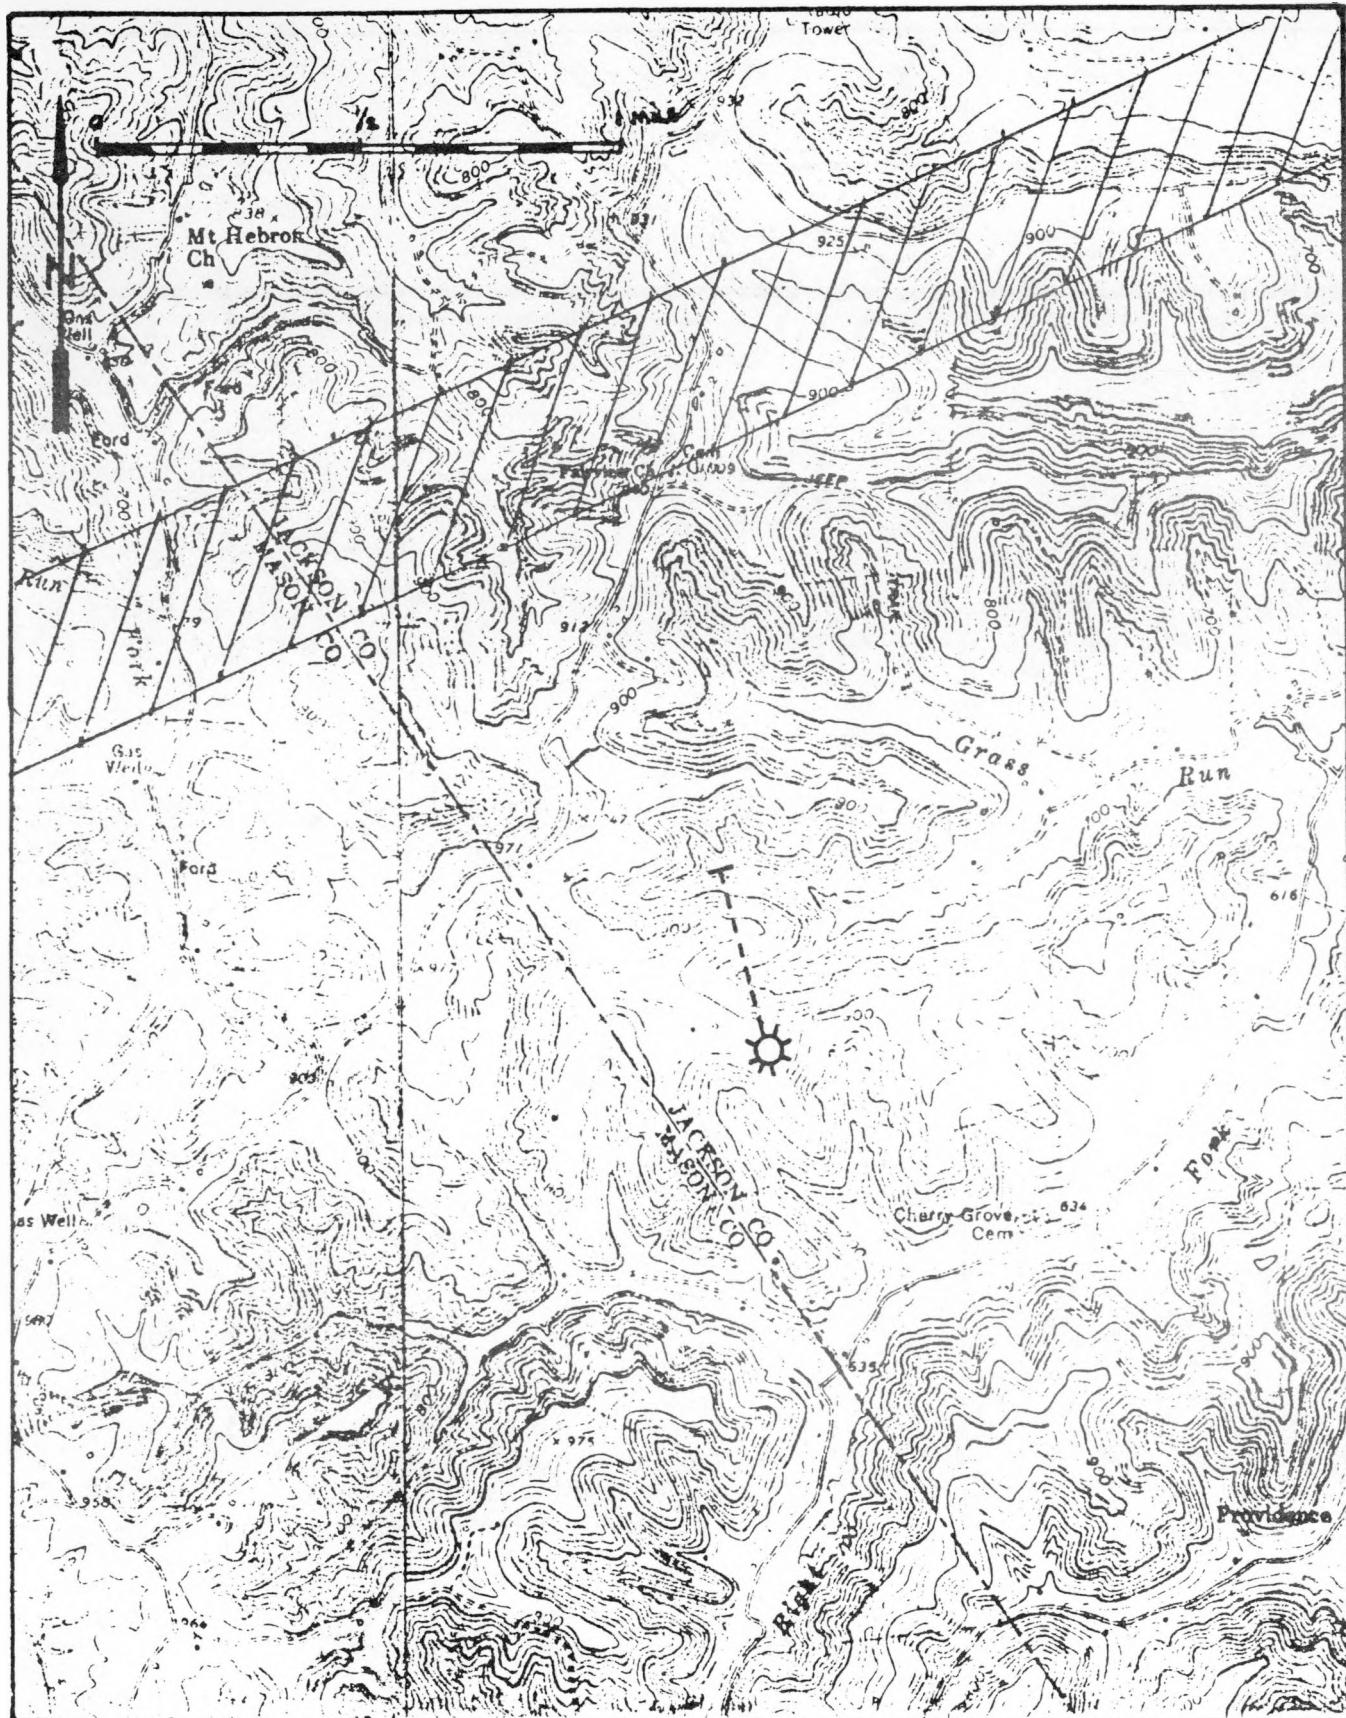
FIGURE 2. ERIM Enhances Prominent Lineament (Jackson et al, 1979)

- Figure 1 ERIM prominent "visual" lineaments*
- Figure 2 ERIM "prominent enhanced lineaments"
- Figure 3 ERIM "tenuous" lineaments*
- Figure 4 Composite lineaments from Rabchevsky's 1975 ERTS study
- Figure 5 Composite lineaments from Rabchevsky's 1975 U2 study

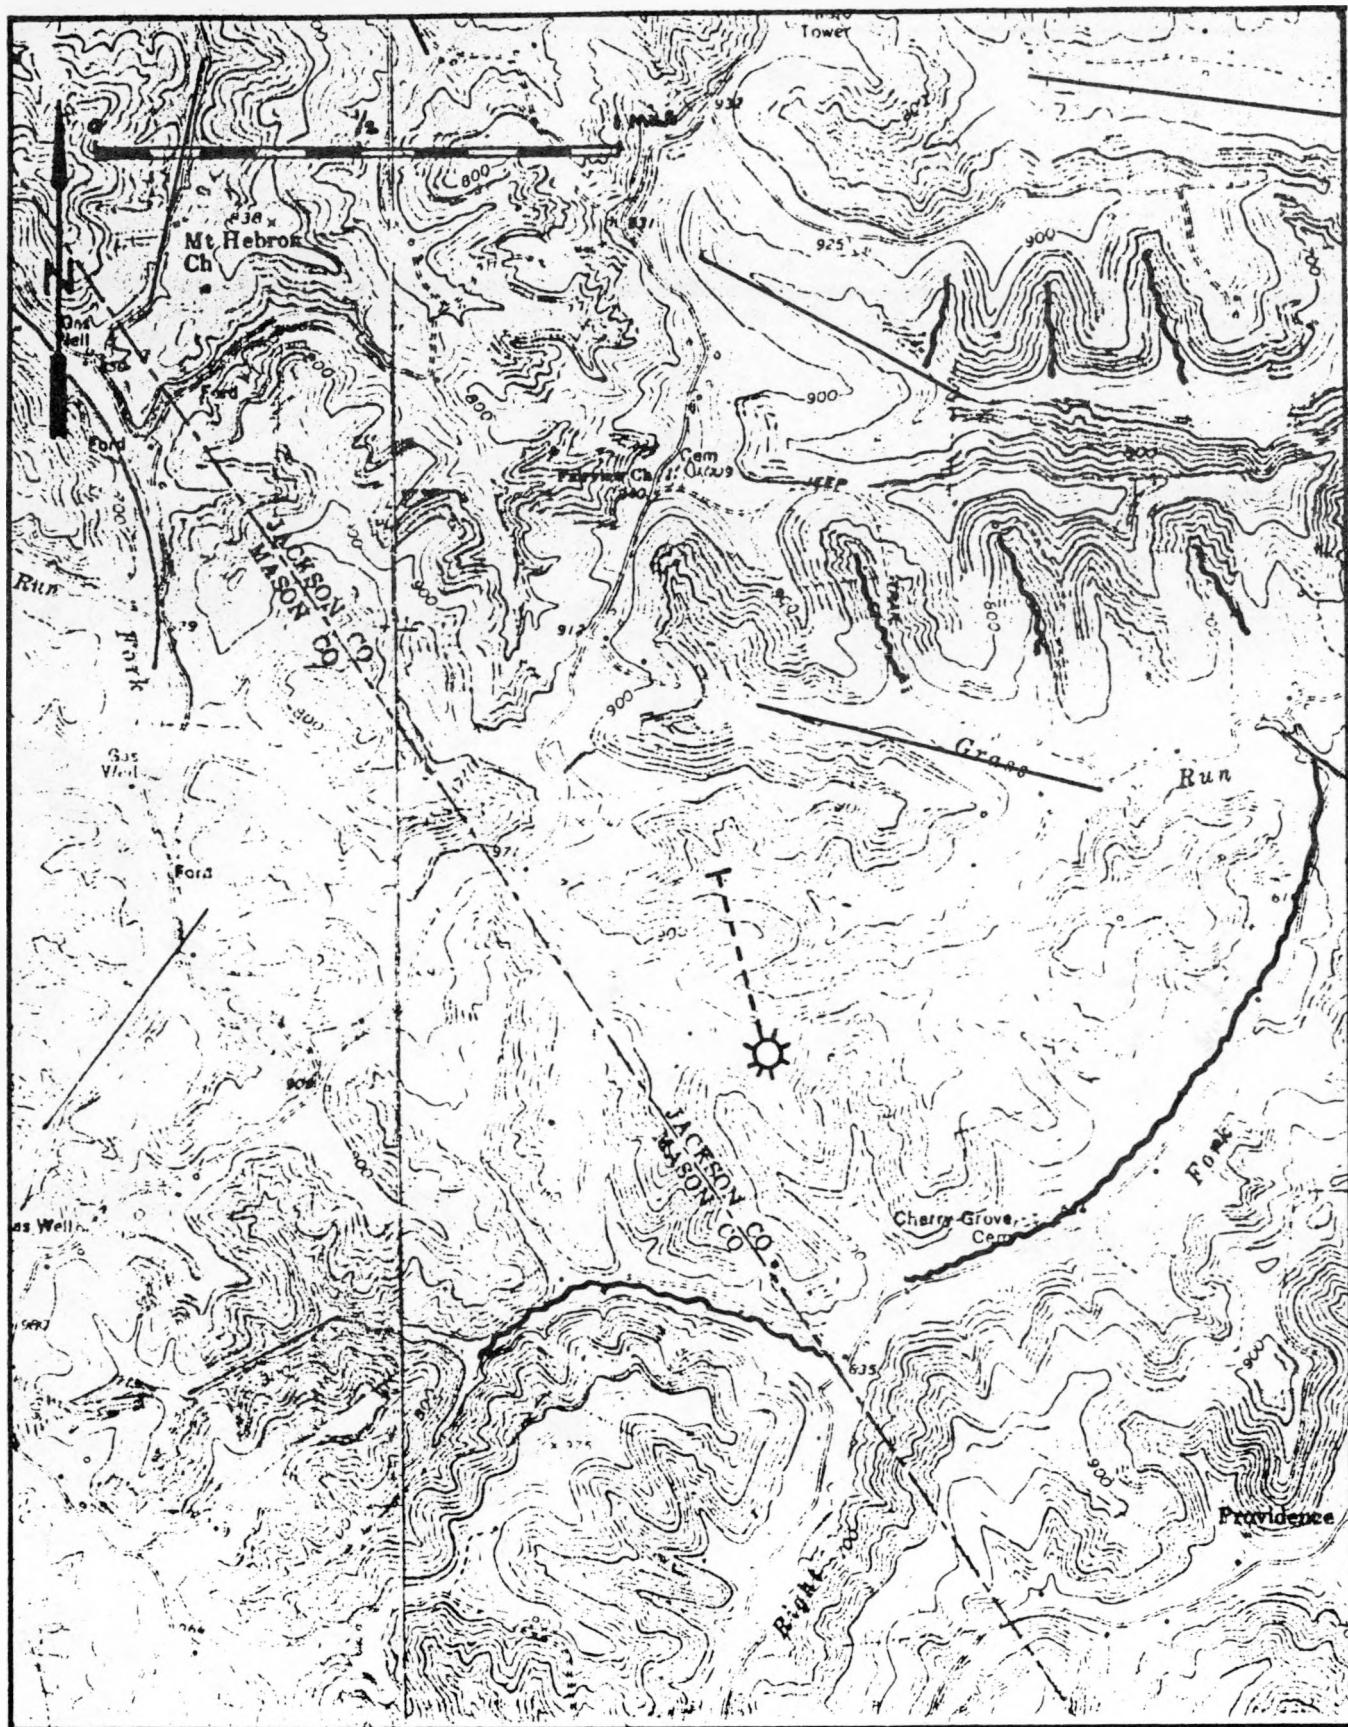
FIGURE 8. Lineaments From Jones and Rauch's Low Altitude Aerial Photo Study (1978)

Figure 8 Lineaments from Jones and Rauch 1978 (1)

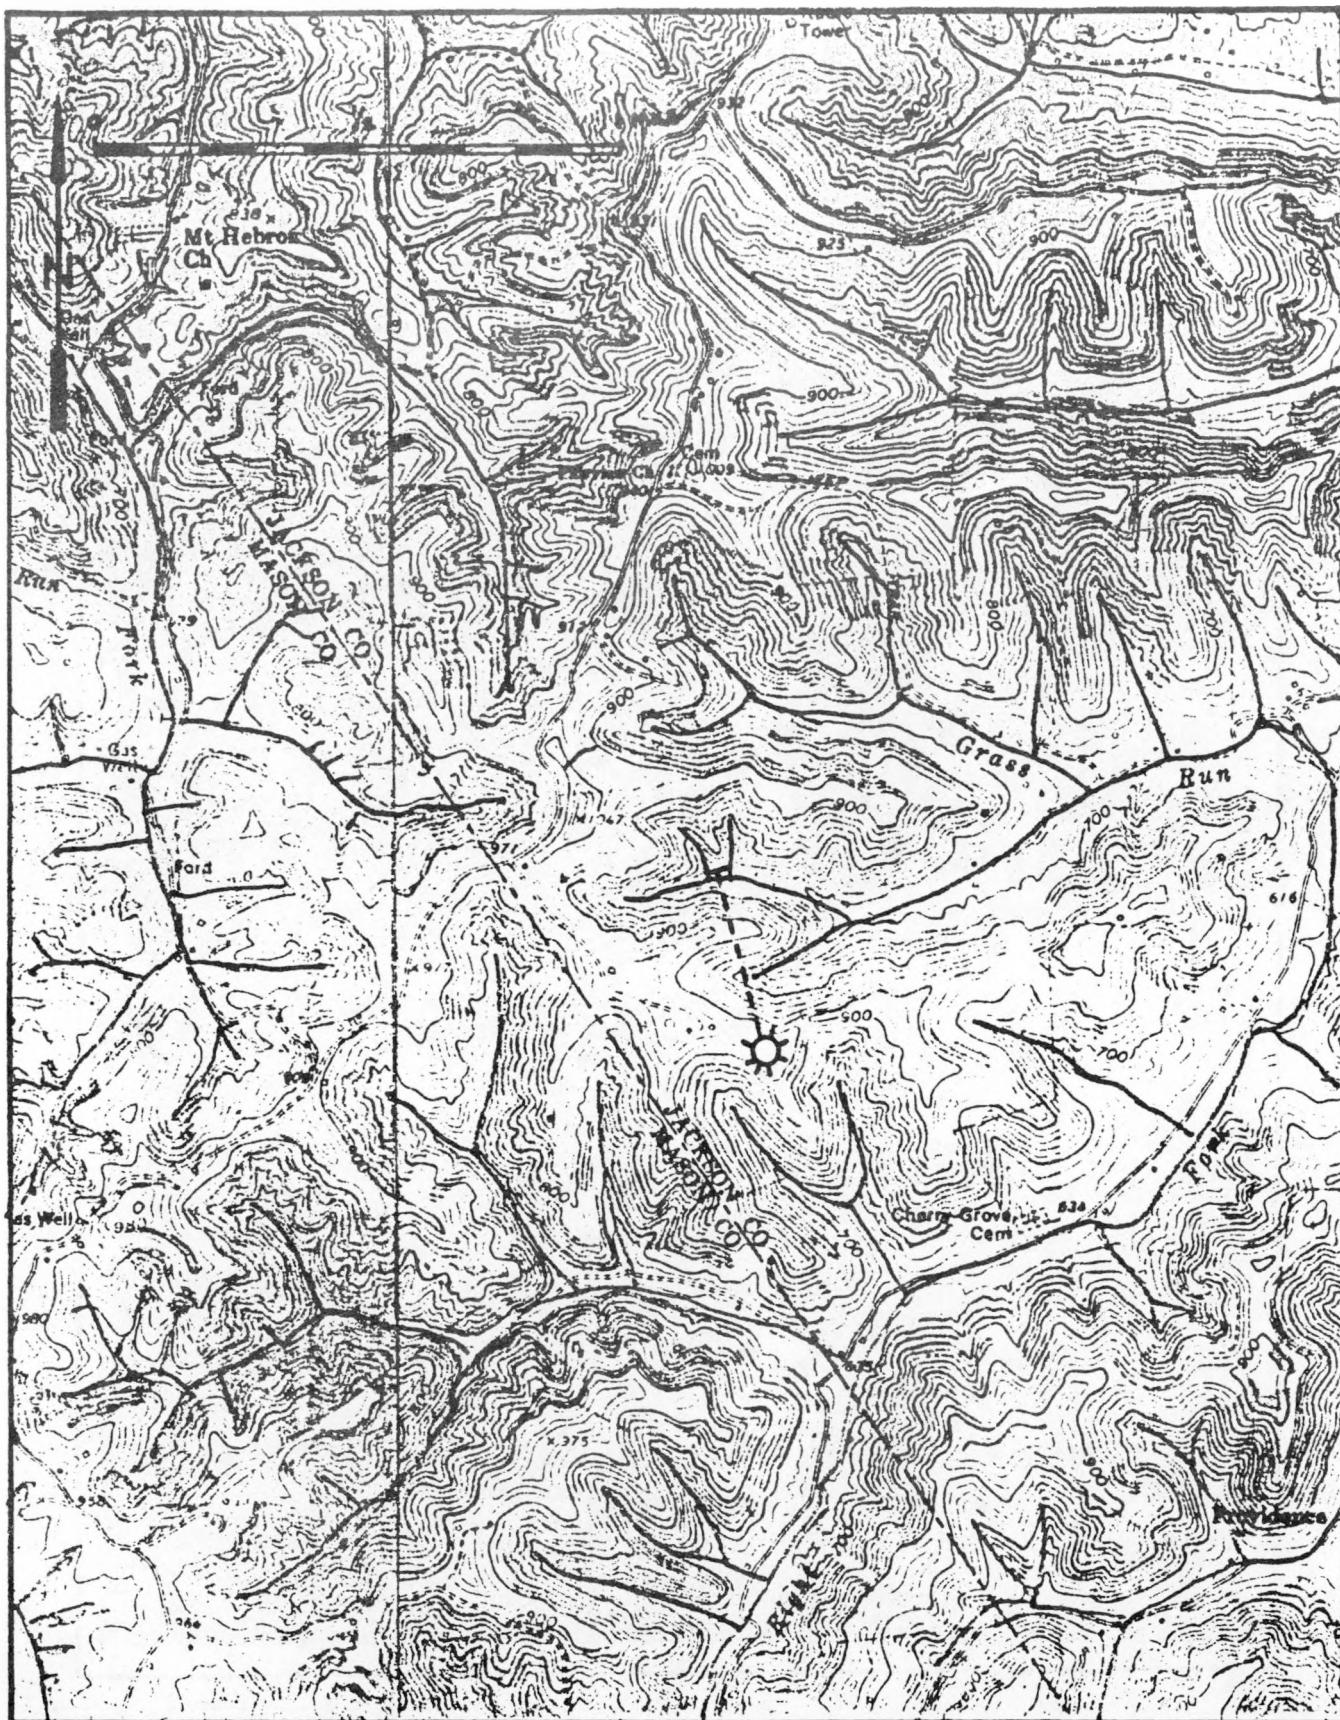
FIGURE 9. Drainage Map.

The streams can be considered to be affected by the structural features producing the lineaments, hence these straight line stream segments are an additional lineament presentation, see Figure 9.

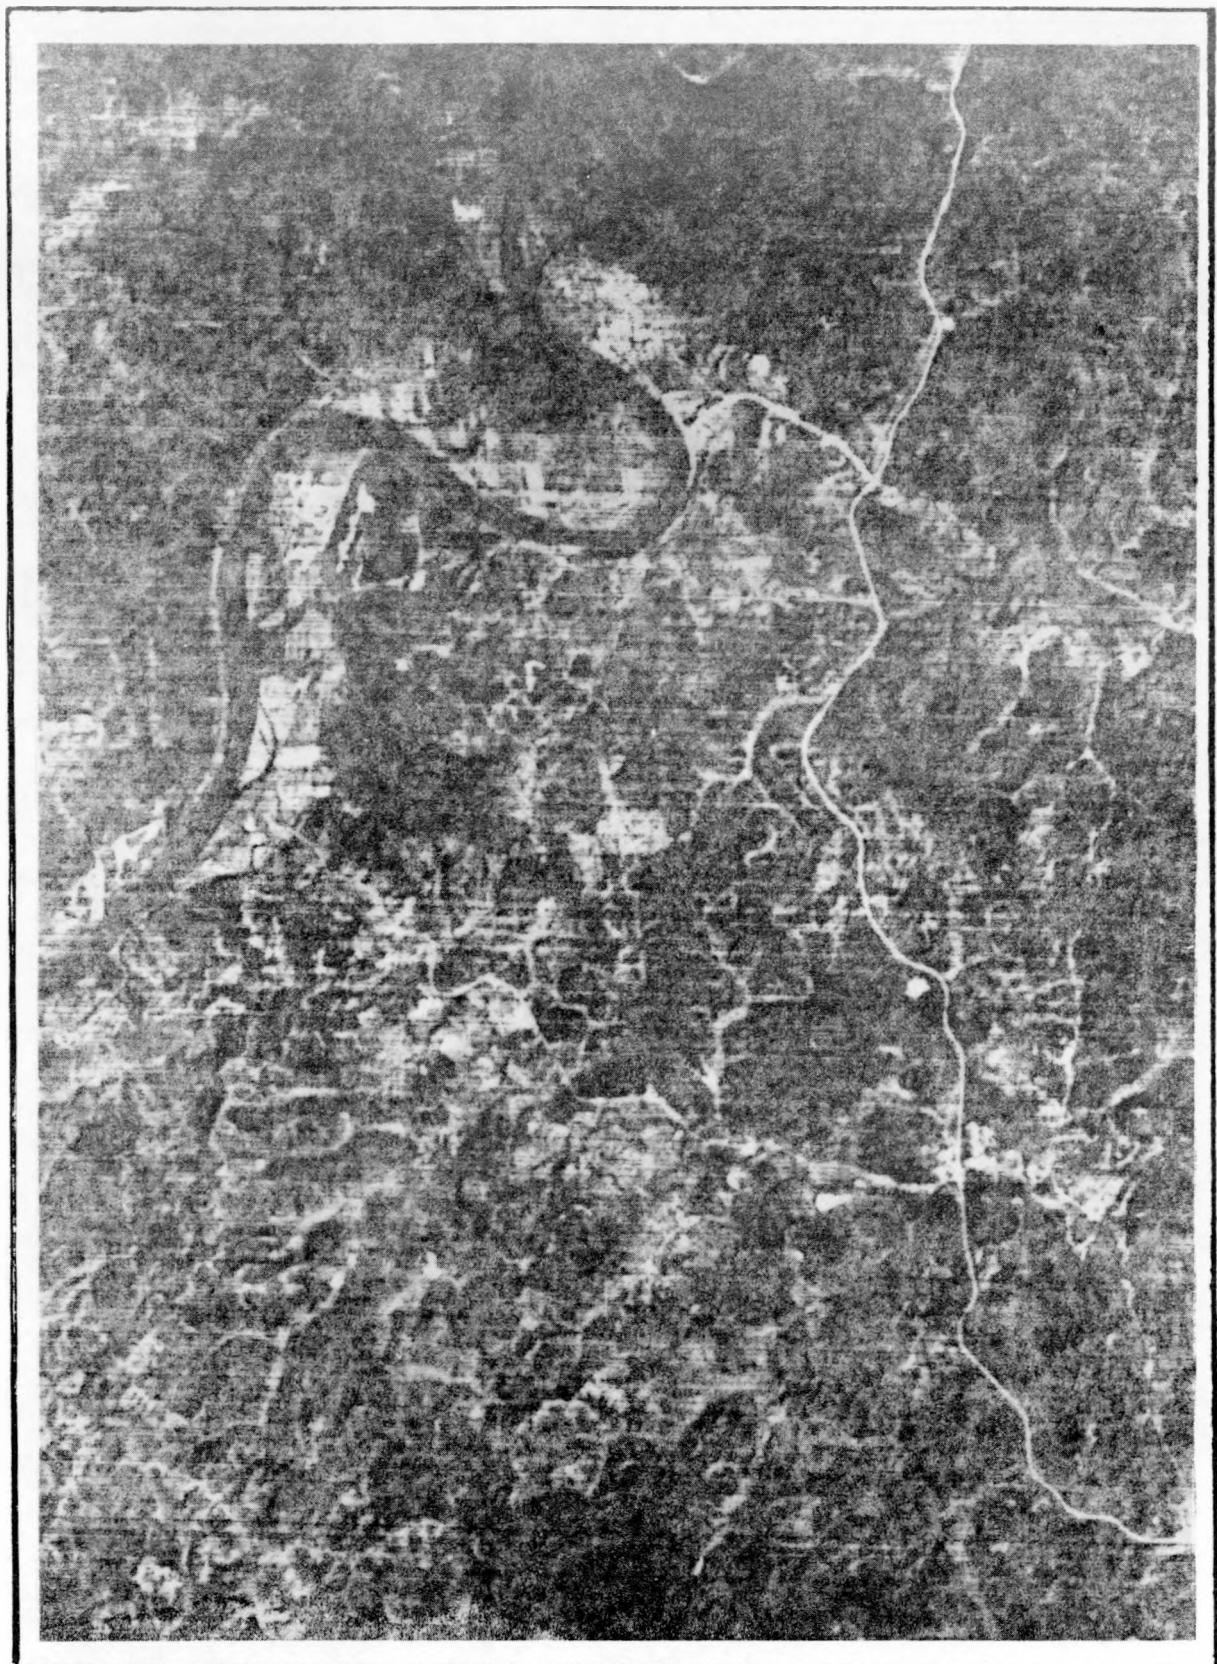
FIGURE 10. ERTS Imagery Of Cottageville Area - Showing
East West Scan Lines

One problem that is apparent in utilizing the small scale satellite imagery is that original output must be so complexly processed that many critical features may be lost. A case of throwing the baby out with the bathwater. A "lightly" processed image of the Cottageville area is presented as Figure 10. It is probable that the processing required to take out the prominent east—"artifac" lineaments would also remove any "real" east west lineaments.

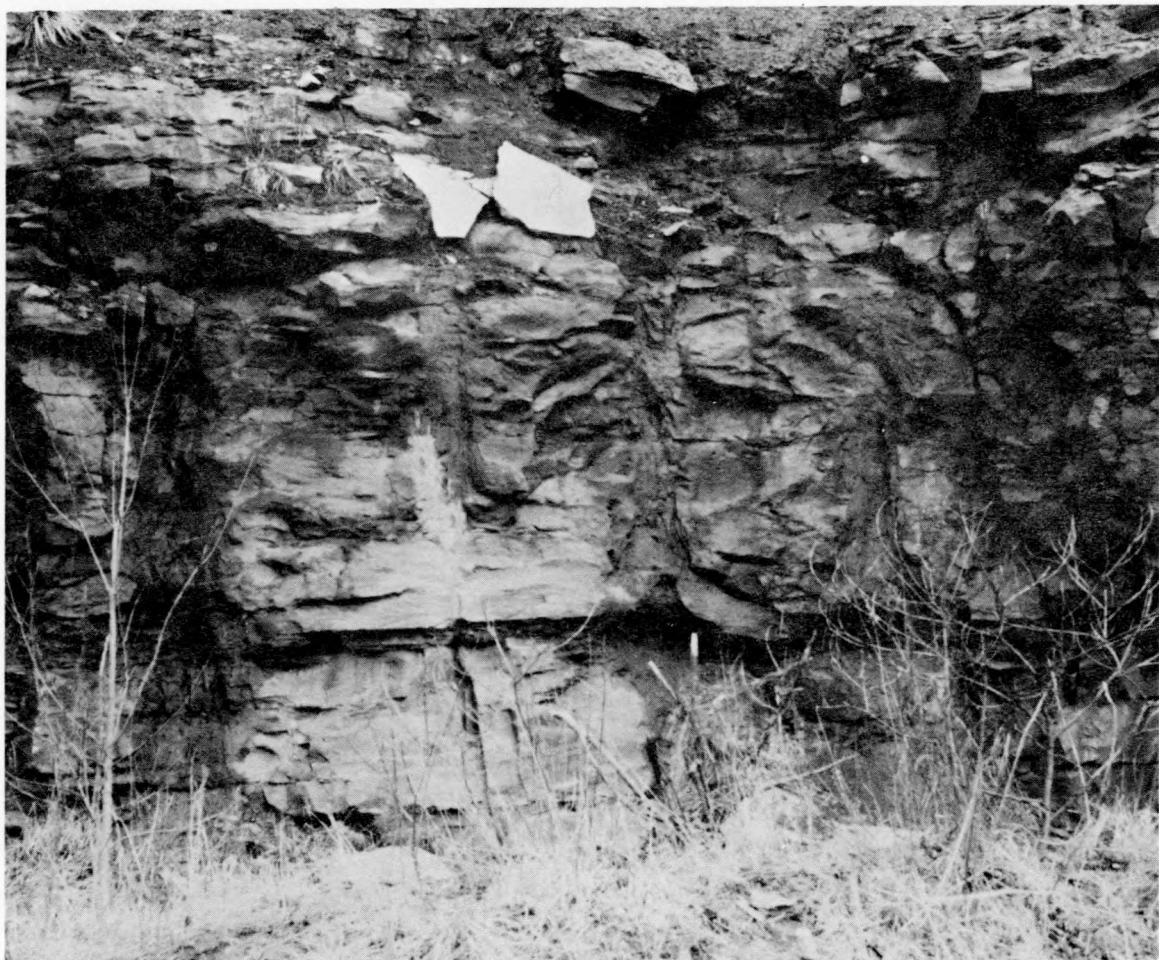
FIGURE 12. Water Flowing Through Fractured Zones Has Discolored Sandstone. South-east Portion Of Cottageville Field, West Virginia

One interesting surface feature is the occurrence of fracture zones that are conduits for near-surface water flow. One of these zones located within the boundary of the Cottageville Field area is shown in Figure 11. Another illustration of water flow in parallel systematic fracture zones is shown in Figure 12. The moving water has reduced the iron oxide coating in the generally buff colored sandstone and these conduits appear as green stained zones. The orientation of the zone depicted in Figure 10 is North 10 west and north 60 east for the zones shown in Figure 12.

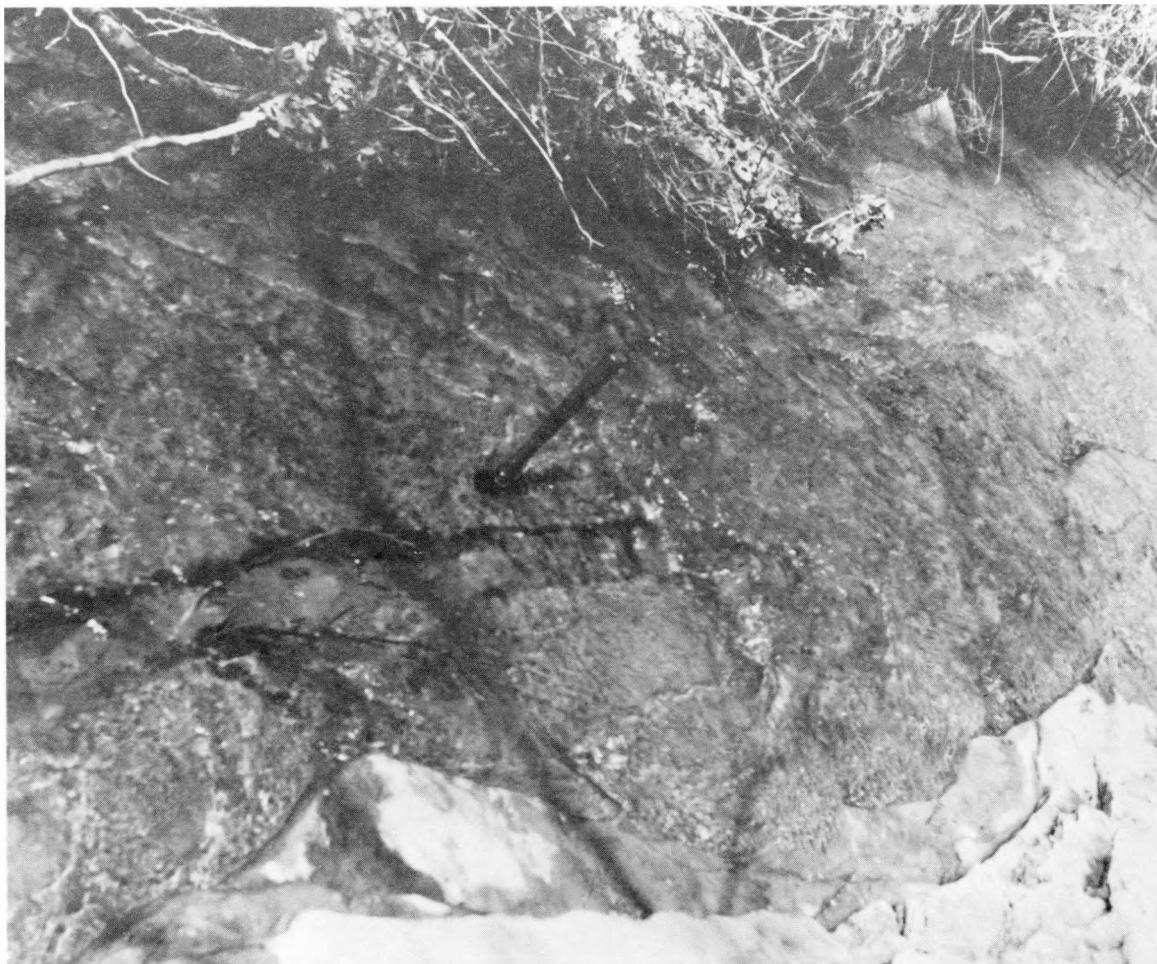
FIGURE 13. Joint Set In Sandstone. Fractures are parallel with Stream Direction (Hammer handle 1/3 mi. long)

The orientation of stream segments was frequently seen to parallel one of the joint or fractures direction. Figures 13 and 14 present examples of joints in creek bottoms that are parallel with the stream directions. Thus, a working hypothesis is that the joints exhibit some control on stream orientation.

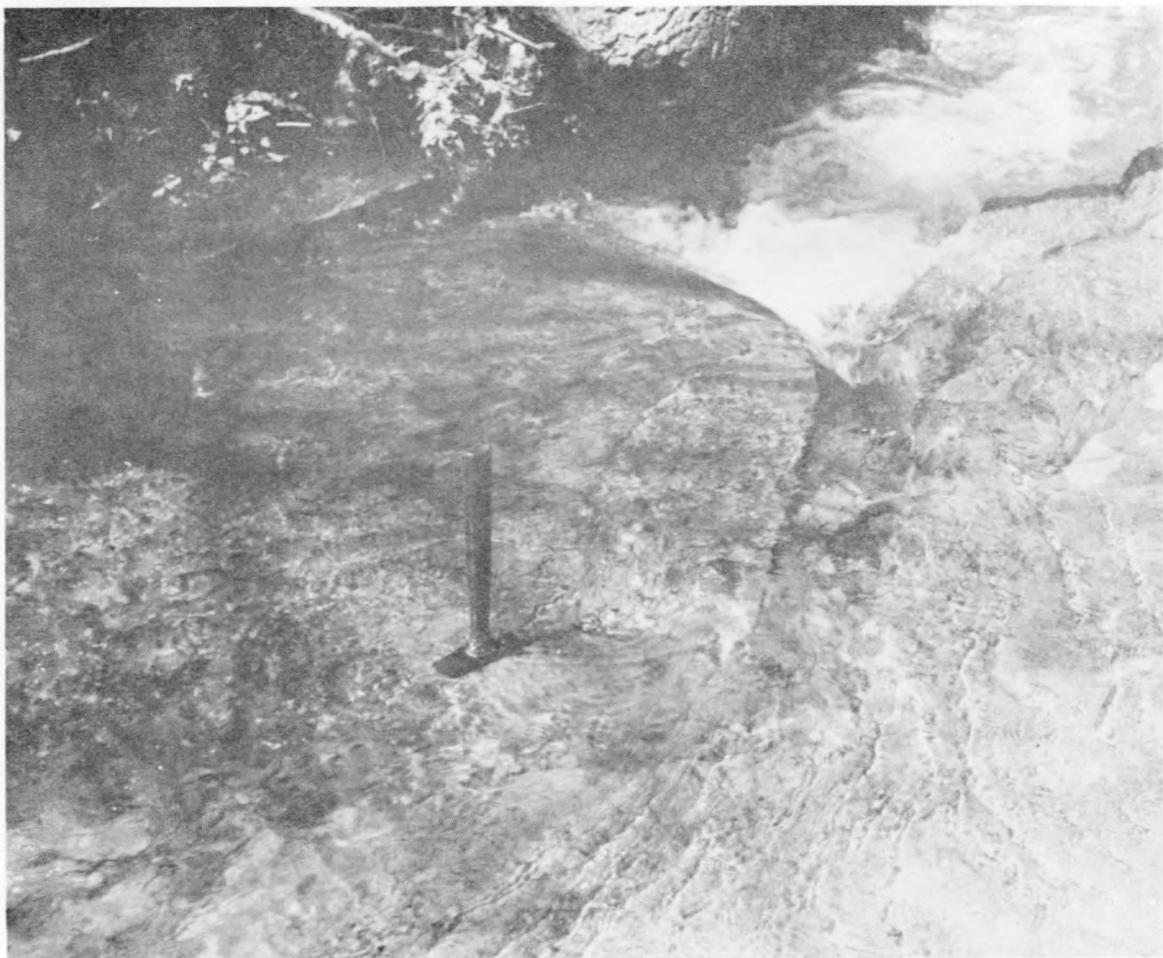
FIGURE 14. Fractured Sandstone Layer In Bottom Of Stream.
Joint set parallel to stream direction near top
of picture and oblique joint sets near hammer.
(Handle 1/3 mi. long)

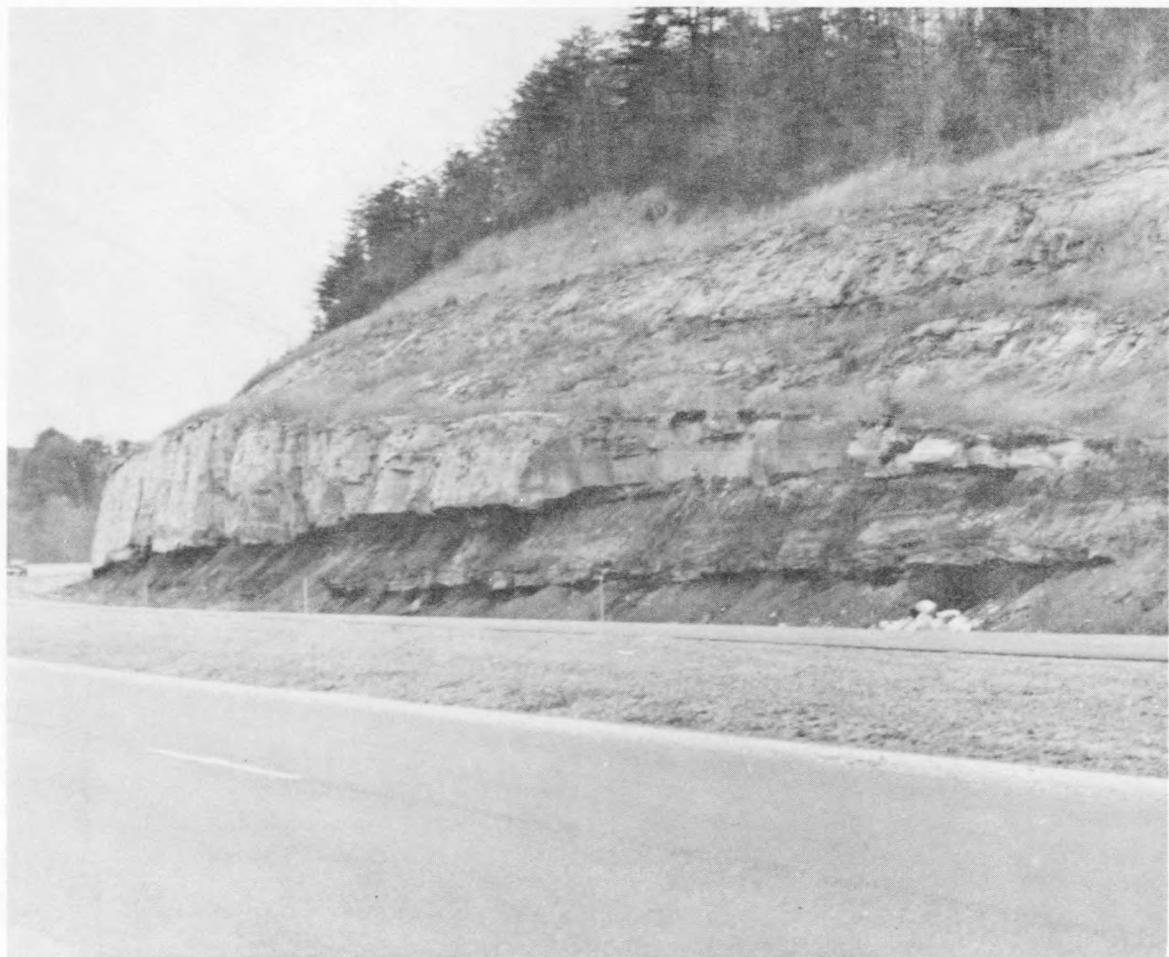
FIGURE 16. Edge Of Massive Sandstone Lense Exposed In Roadcut
Near Cottageville Field, West Virginia.

The topography is an expression of the lithology of the surface beds as well as such features as structure, jointing, faulting, impressions from former features that have been removed by erosion, etc. The topography in the Cottageville area is affected by the massive sandstone beds that are more erosion resistant than the associated siltstones and shales. The sandstones are discontinuous; and, other things being equal, erosion tends to proceed more rapidly along the margins rather than in the massive central portions of the beds. Figure 16 shows the edge of a sandstone bed in a roadcut near Cottageville Field, West Virginia.

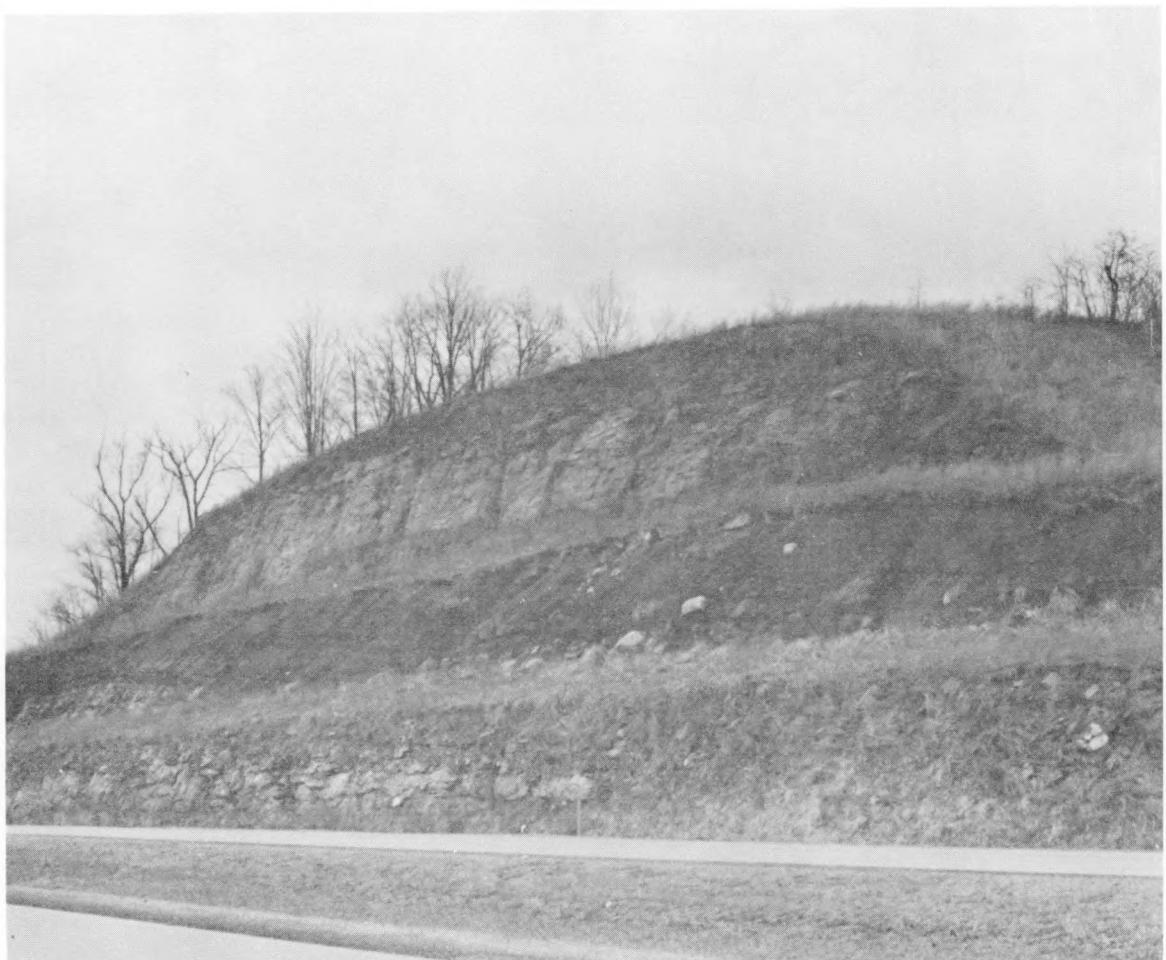
FIGURE 17. Massive Sandstone Bed Capping Ridge Near Cottageville Field, West Virginia.

Thus, there is a tendency for the ridges to be capped with massive sandstone, Figure 17. The ridge orientation is frequently affected by the joint directions or by erosion preferentially proceeding along fractured zones such as those shown in Figure 9 and 10.
