**THE CORROSION RESISTANCE OF METALLIC SOLAR ABSORBER
MATERIALS IN A RANGE OF HEAT TRANSFER FLUIDS**

By
A. J. Brock
E. F. Smith, III

**Olin-Metals Research Laboratory
New Haven, Connecticut**

The Corrosion Resistance of Metallic
Solar Absorber Materials in a Range
of Heat Transfer Fluids

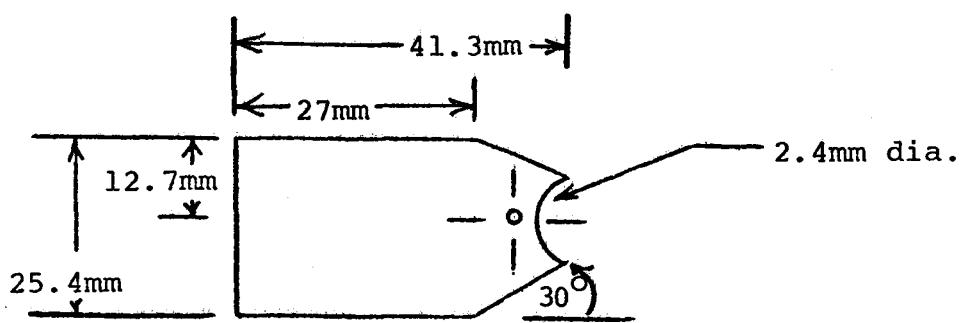
Figure 1. Sample geometry used in solar energy corrosion test program.

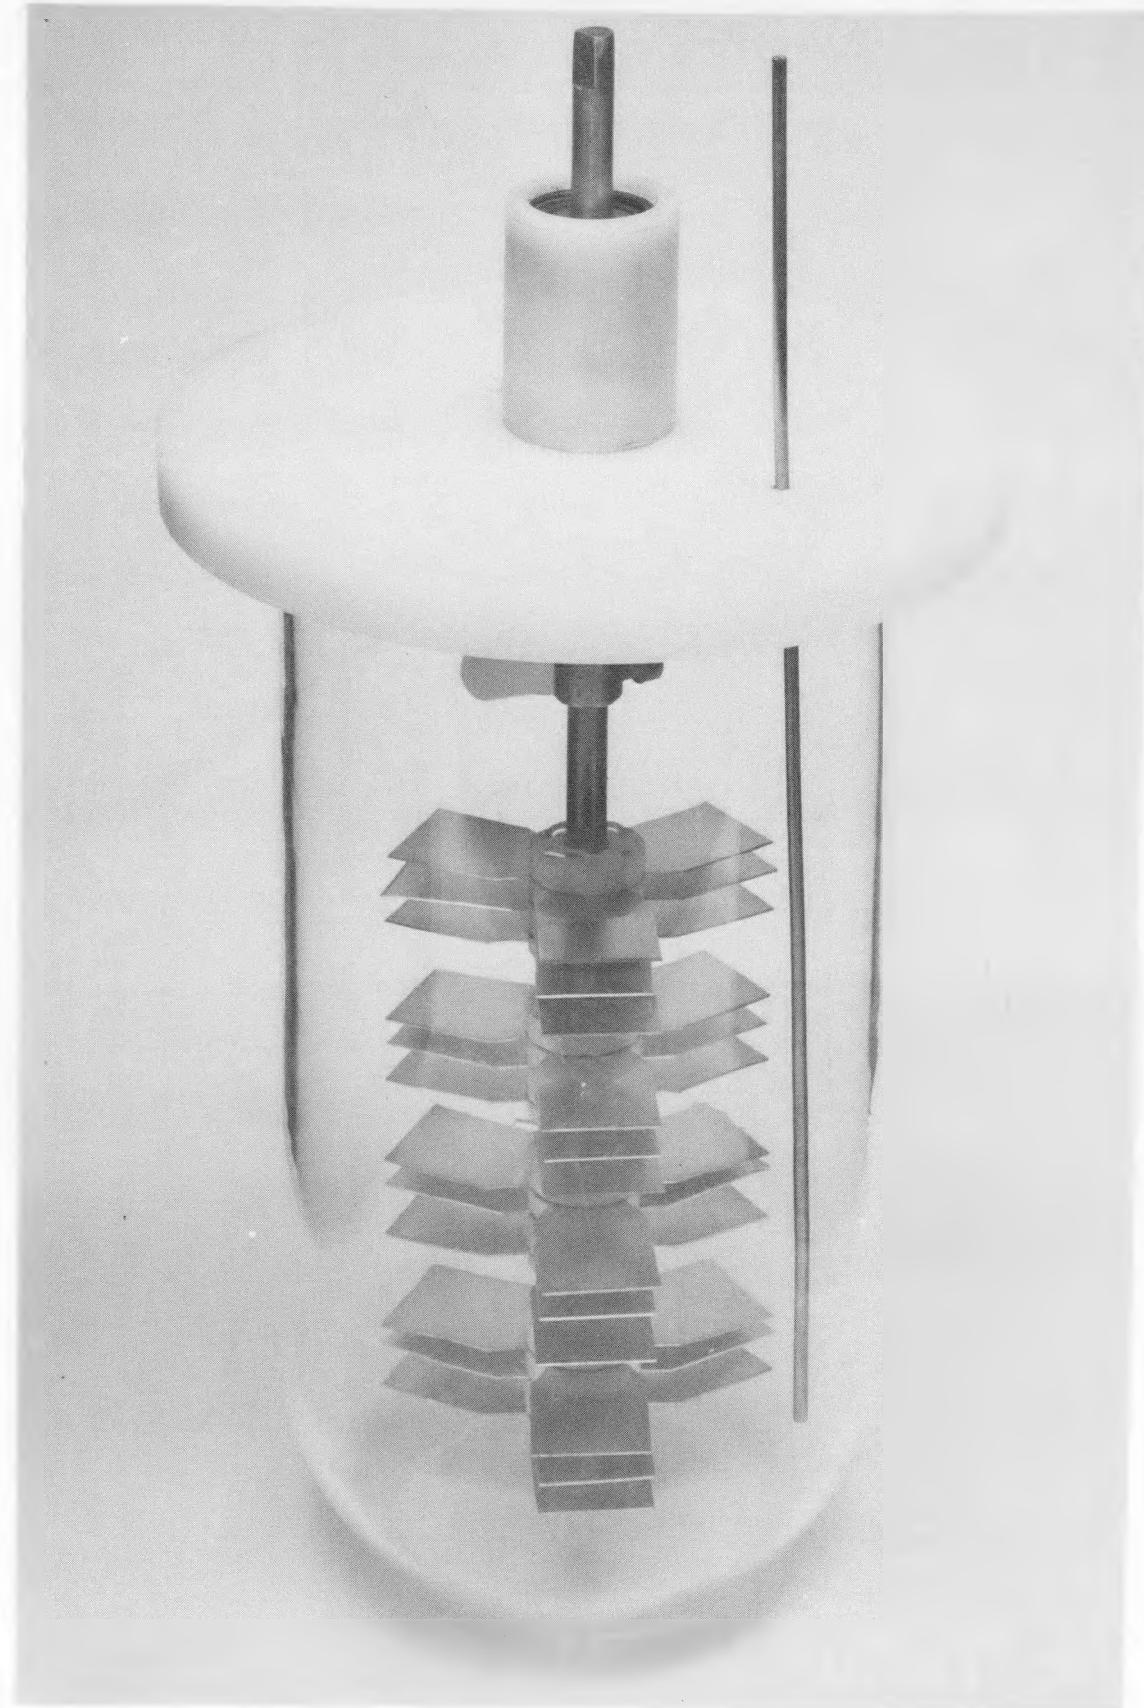
Figure 2. Assembled test cell used in solar corrosion test program.

The titanium shaft extended through a nylon cover via a stainless steel collar to a right angled gear drive. The whole cell was immersed in a large controlled temperature bath capable of holding 20 cells. The total apparatus is shown schematically in Figure 3. A central drive shaft caused simultaneous rotation of all the titanium shafts at a rate such that the average velocity at the end of each sample was 4 fps. For systems simulating draindown, a hollow titanium tube was incorporated into each cell. Silicone tubing connected to this, passed through a peristaltic pump into an individual storage tank. Operation of the pump permitted draining of the fluid into the storage tank or vice versa, and was intended to simulate the daily fluid stoppage typical of a draindown system. The tank was filled with an inhibited propylene glycol solution. This solution was circulated through an electric heater in order to heat the

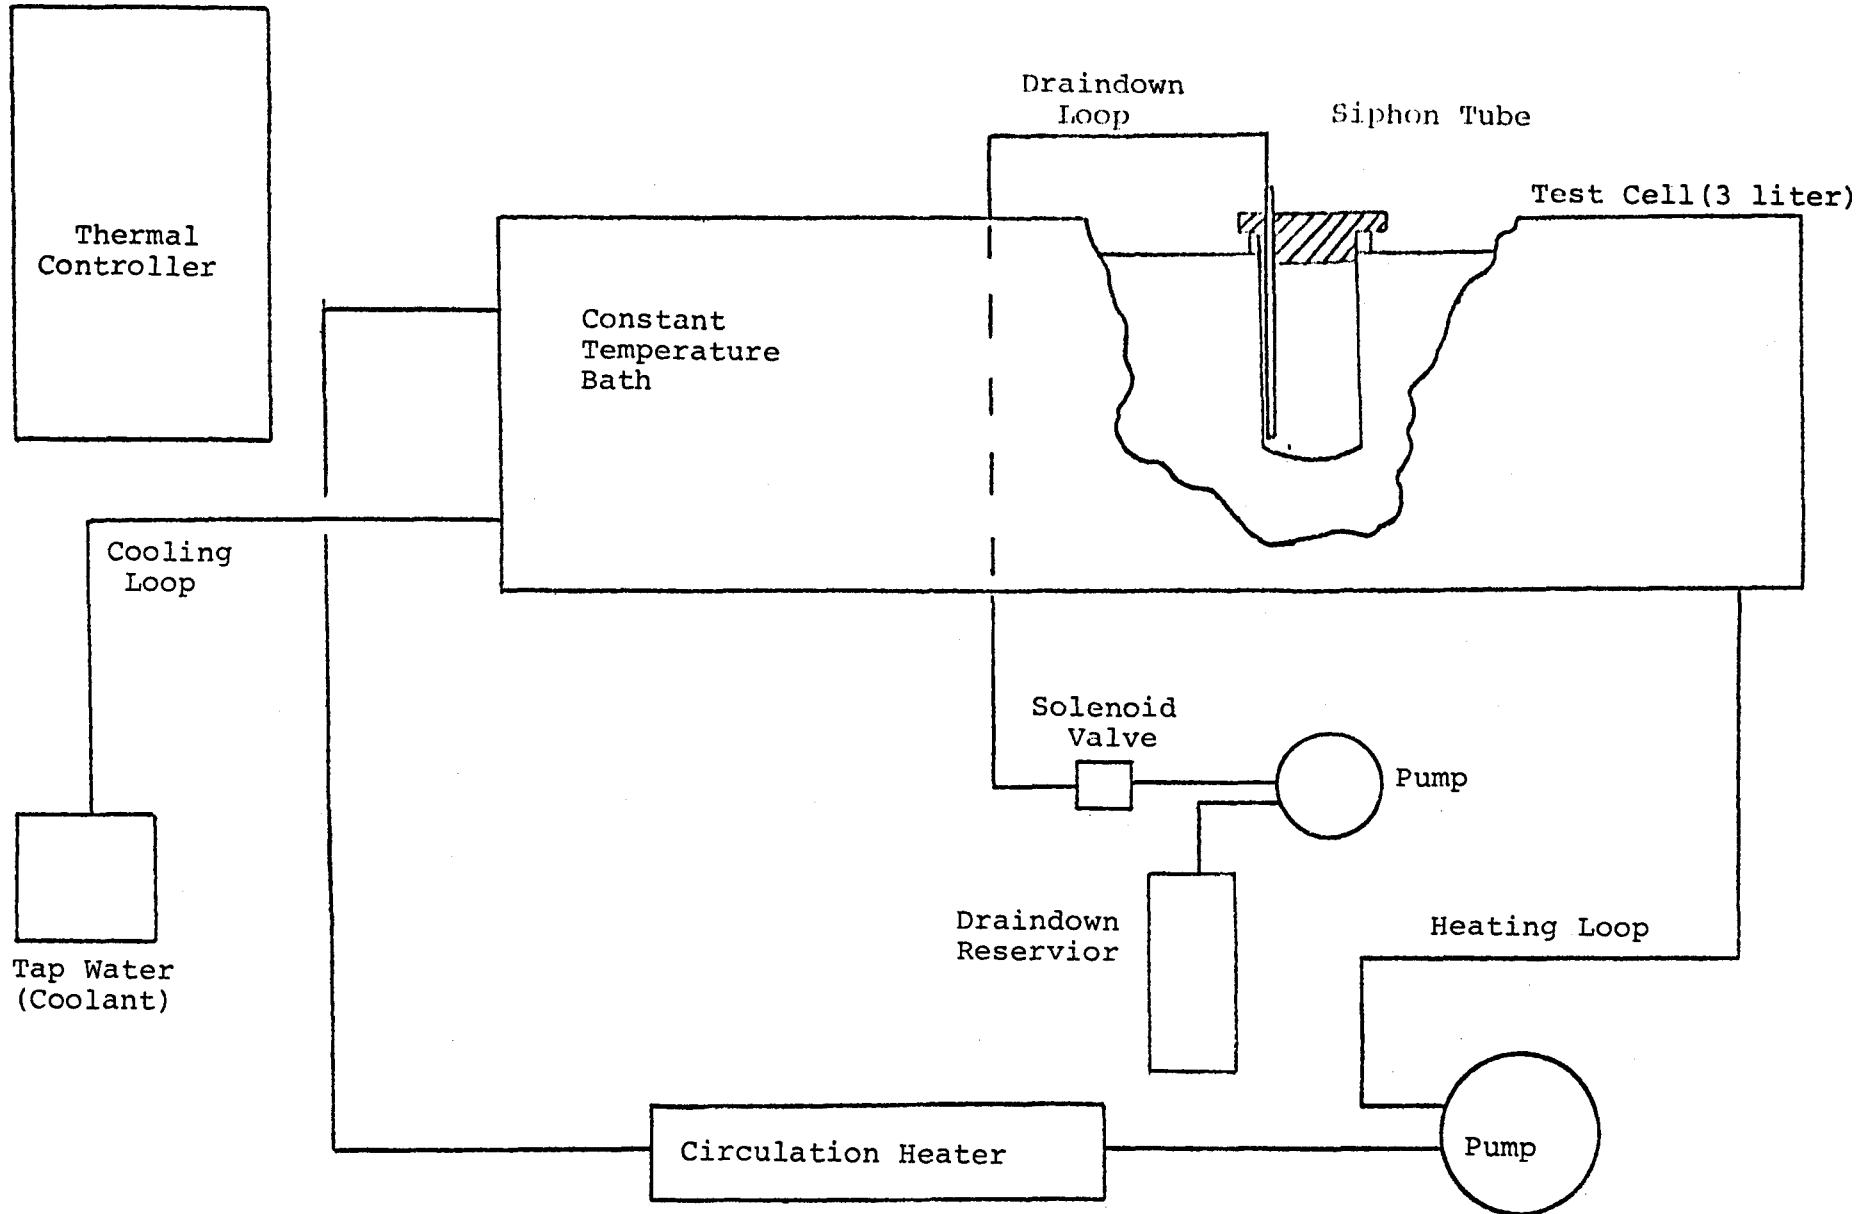
Figure 3. Schematic drawing of temperature control equipment used to establish the desired thermal profile.

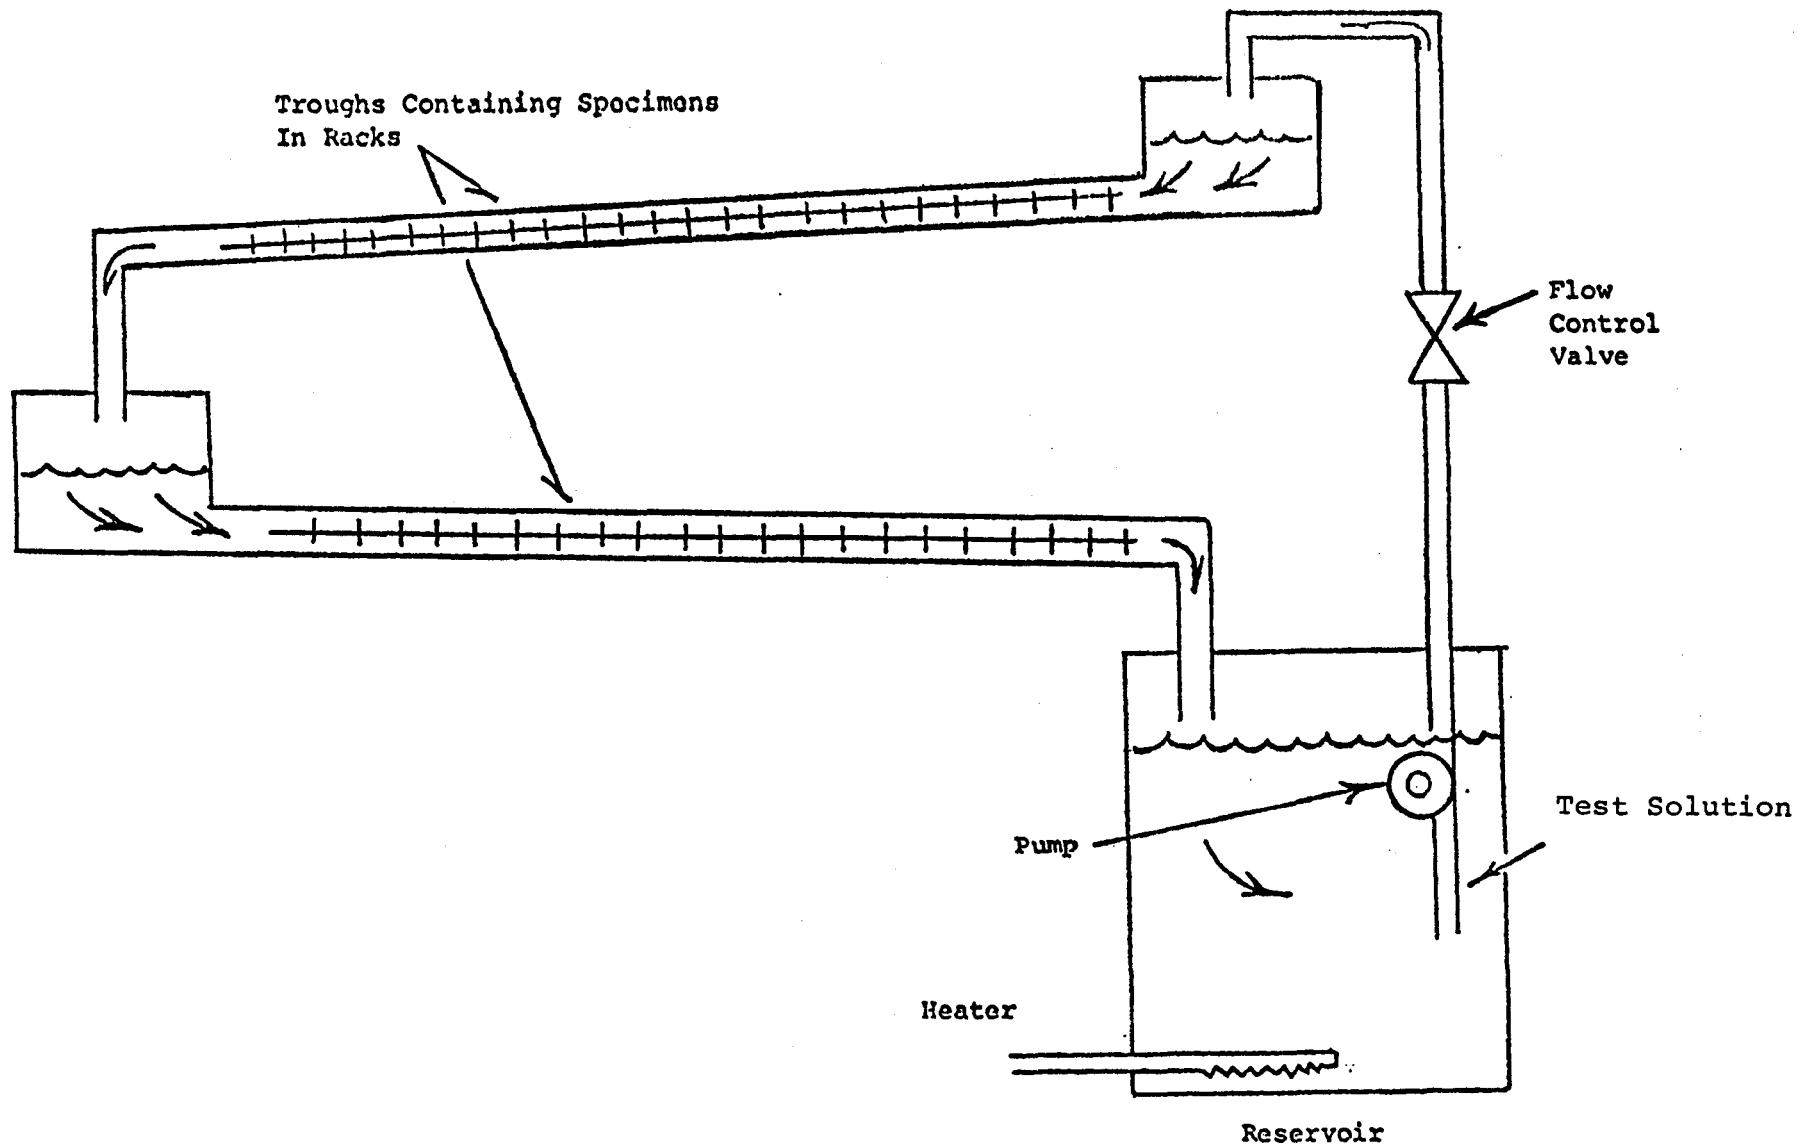
Figure 4. Apparatus used to test effect of chloride ion concentration on corrosion of copper and stainless steel.

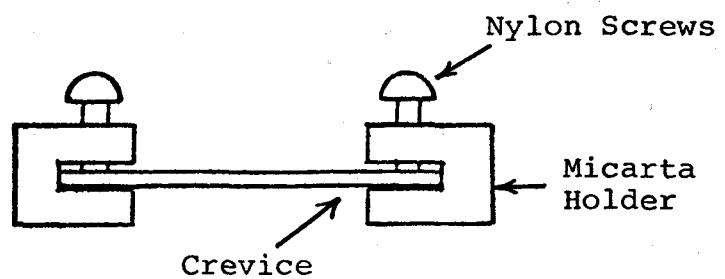
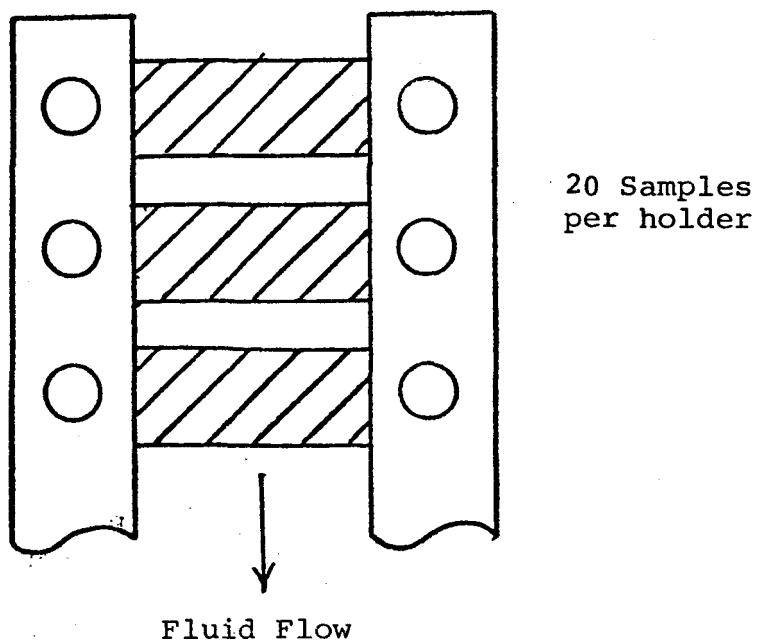
Figure 5. Sample holder used in test loops for evaluating effect of chloride ion on the corrosive attack in copper and stainless steel.

The samples were fixed into micarta holders as illustrated in Figure 5. Each sample holder contained 20 samples. The assembly was located in the inclined PVC troughs. Water was pumped from the reservoir into the heater tank and allowed to flow over the samples at a linear flow rate of 4 fpm. The volumetric flow rate was sufficient to cause complete immersion of the samples. The apparatus operated in a two part cycle. Flow of water at 104°F was allowed to occur for 8 hrs. The flow was then turned off and the samples left for 16 hrs exposed to the atmosphere.

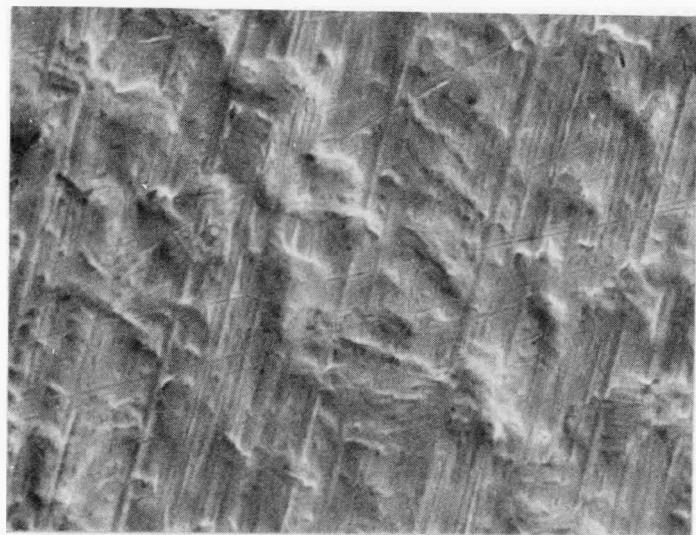
Figure 31. Scanning Electron Micrograph of Cu Alloy 122 Prior to Testing.
Magnification 1000X.

Figures 31 to 40 show representative scanning electron micrographs of the metal surfaces after testing in various solutions. The micrographs for Cu alloy 122, Figures 31 to 36, illustrate various degrees of surface roughening due to general corrosion. Figures 37, 39, and 40 illustrate pitting of Al alloy 1100, mild steel, and stainless during immersion in selected solutions. Figure 39 illustrates severe intergranular corrosion of Al alloy 1100 following exposure for 180 days in Sunsol 60.

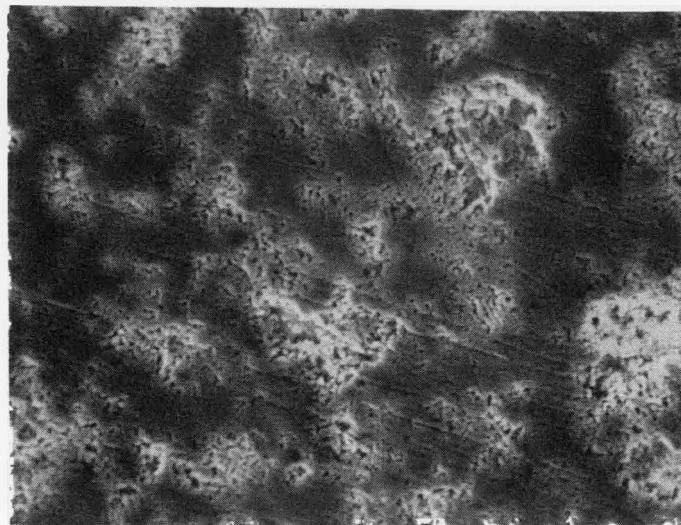
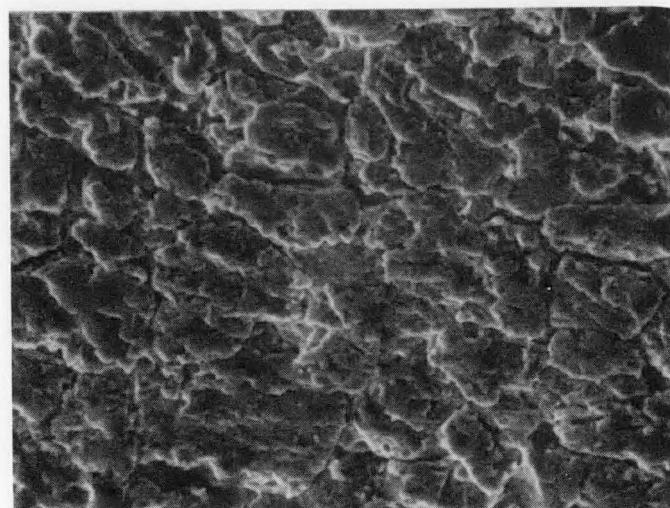
Figure 32. Scanning Electron Micrographs of Cu Alloy 122 after immersion with Stainless Steel Samples only for 6 months in a) New Haven Tap Water and b) in New Haven Tap Water with Solder Flux. Magnification = 1000X.

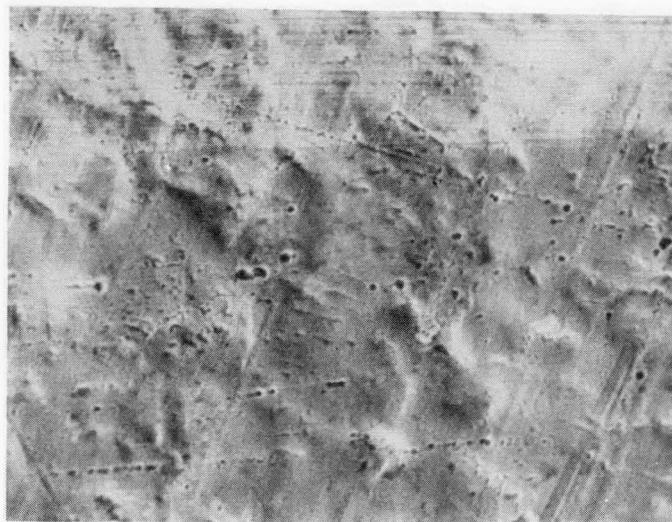
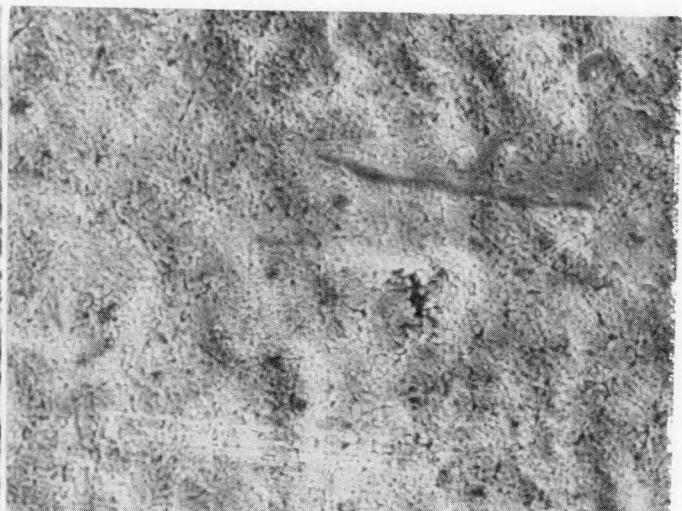
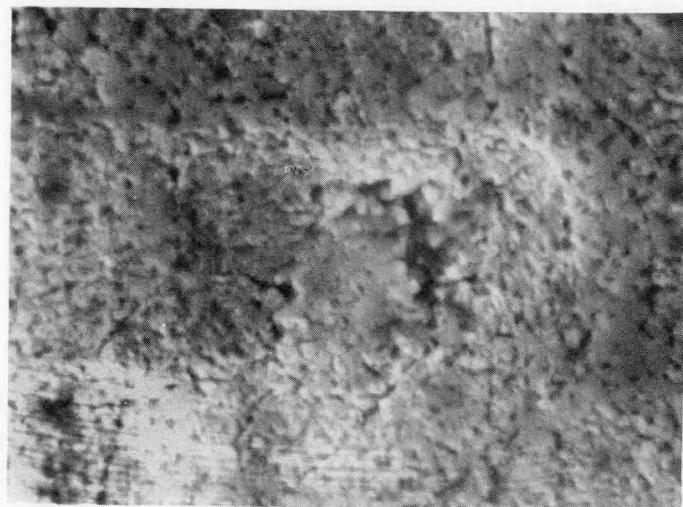
Figure 33. Scanning Electron Micrographs of Cu Alloy 122 after a) 2 months and b) 6 months in Homestead Domestic Water at 1000X. c) shows detail of b) at 2000X.

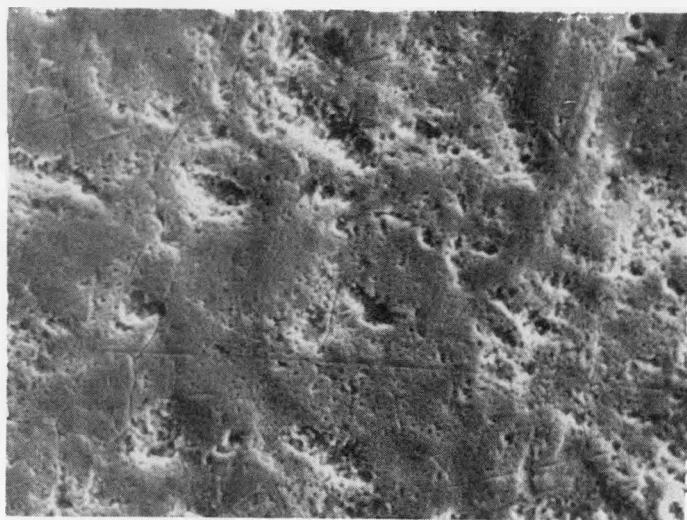
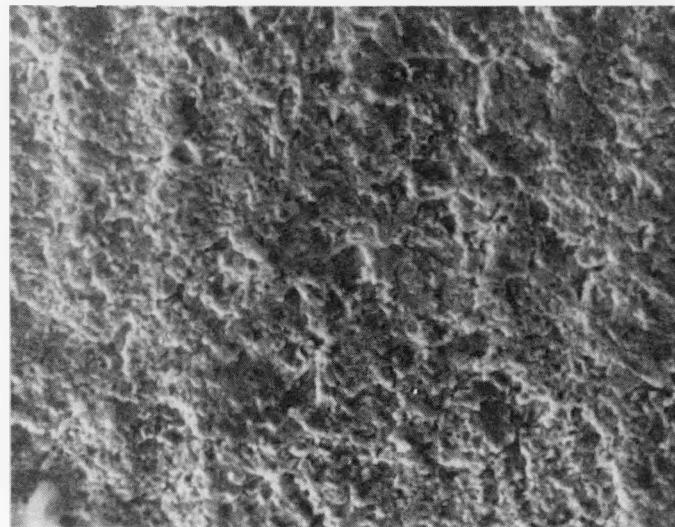
Figure 34. Scanning Electron Micrographs of Cu Alloy 122 after a) 2 months and b) 6 months in Nellis Domestic water at 1000X.

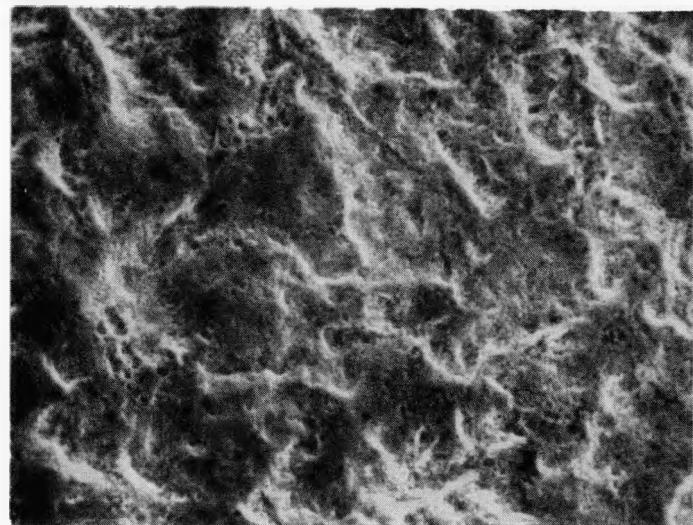
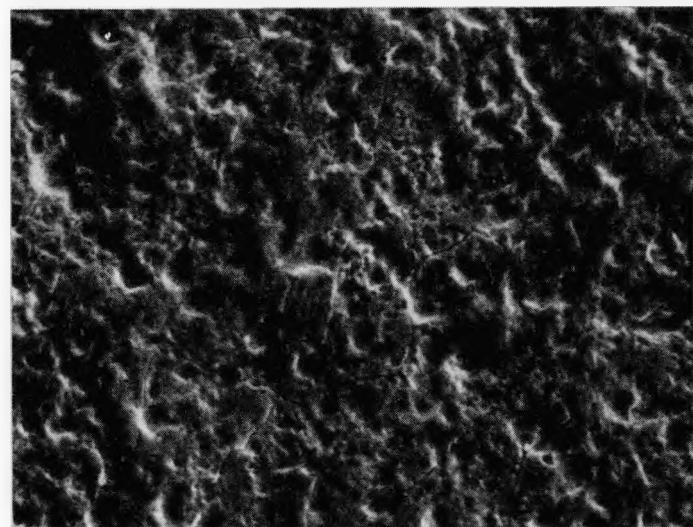
Figure 35. Scanning Electron Micrographs of Cu Alloy 122 after a) 2 months and b) 6 months in Dowfrost at Los Alamos. Magnification = 1000X.

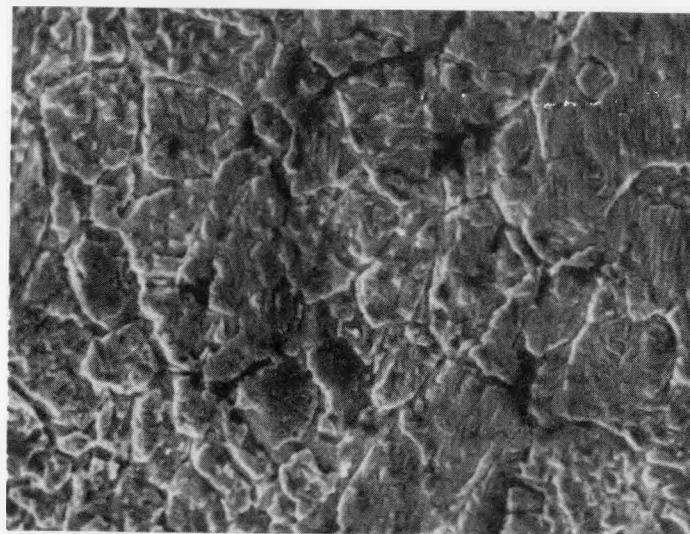
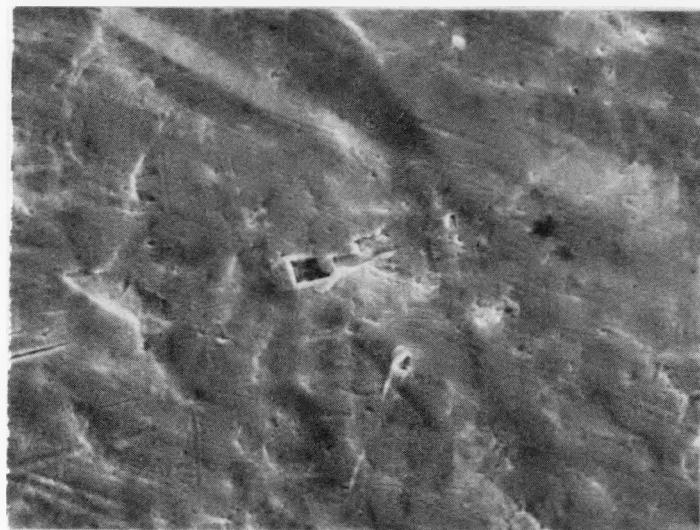
Figure 36. Scanning Electron Micrograph of Cu Alloy 122 after Immersion for 6 months in a) Degraded Propylene Glycol and b) Prestone II. Magnification = 1000X.

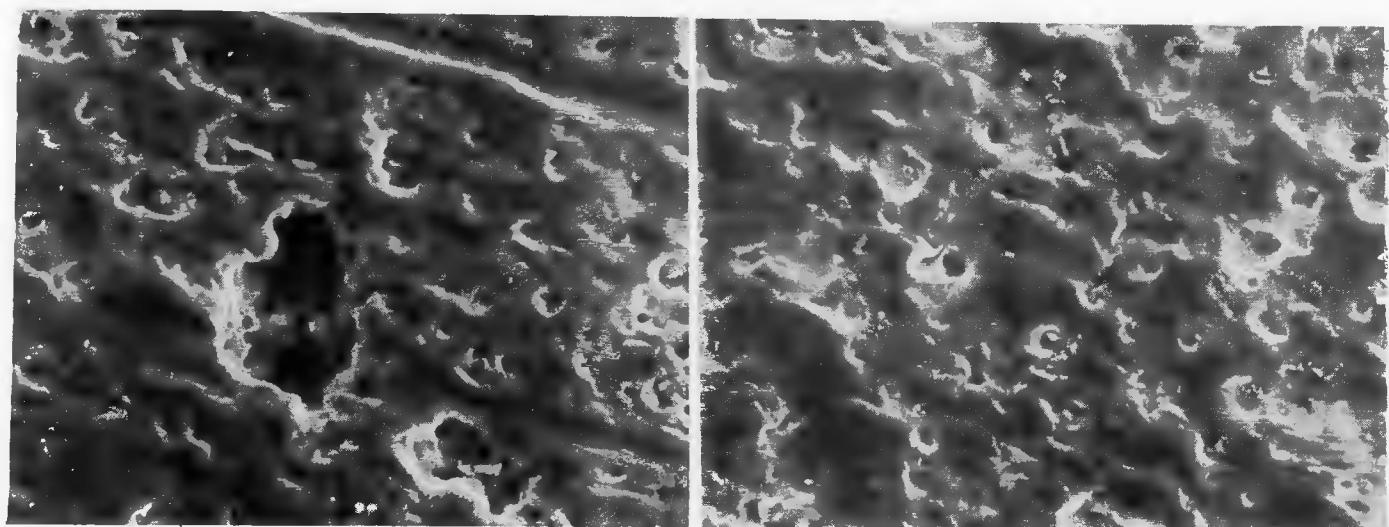
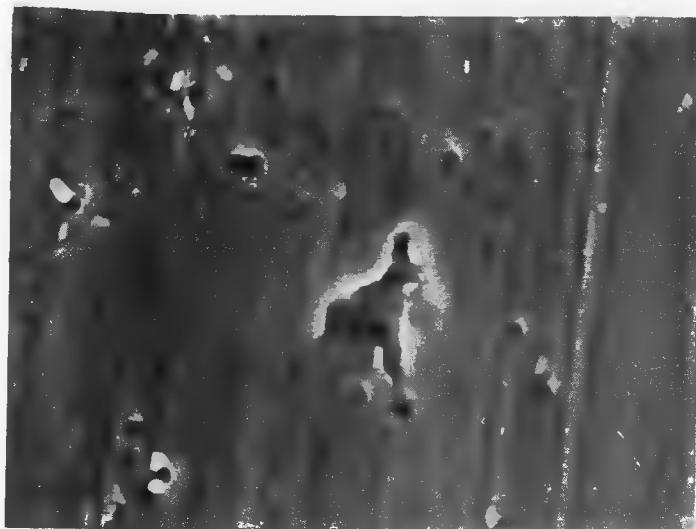
Figure 37. Scanning Electron Micrographs of Al Alloy 1100 after Exposure for 6 months in a) Climax A and b) Prestone II at Magnification of 500X and c) Union Carbide Silicone at 1000X.

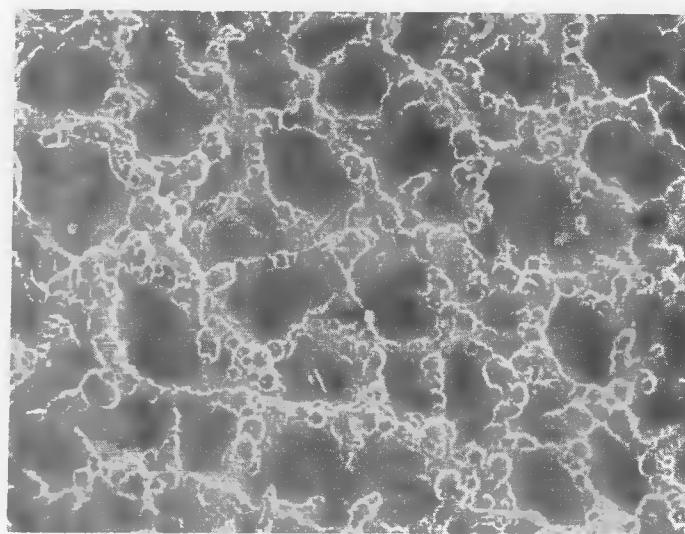
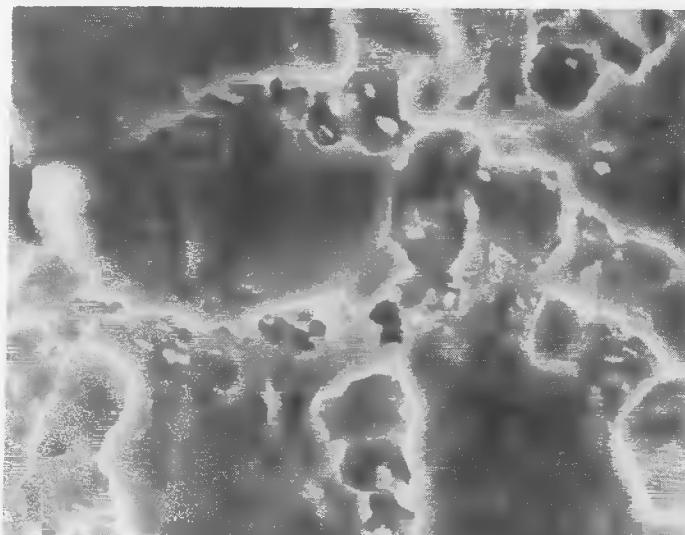
Figure 38. (a) Scanning Electron Micrograph of Al Alloy 1100 after 6 months in Sunsol 60 showing Intergranular Corrosion at 200X. (b) shows details of (a) at 1000X.

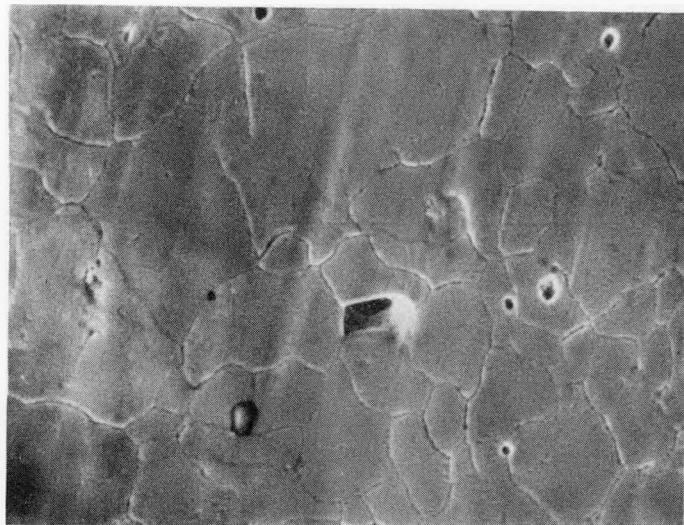
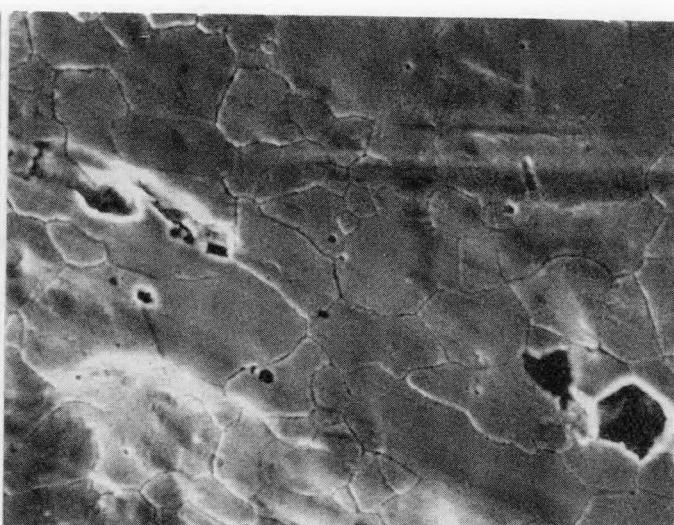
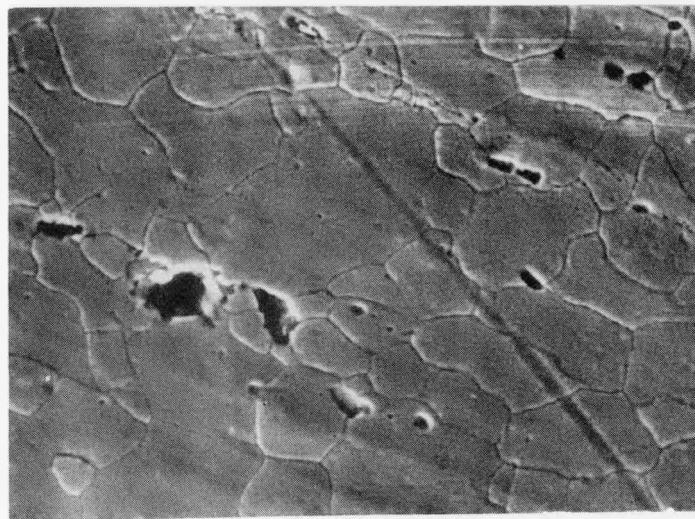
Figure 39. Scanning Electron Micrographs of Mild Steel Samples Showing Pits formed after Immersion for 6 months in a) Prestone II, b) Nutek 835 and c) Olin X-M. Magnification = 1000X.

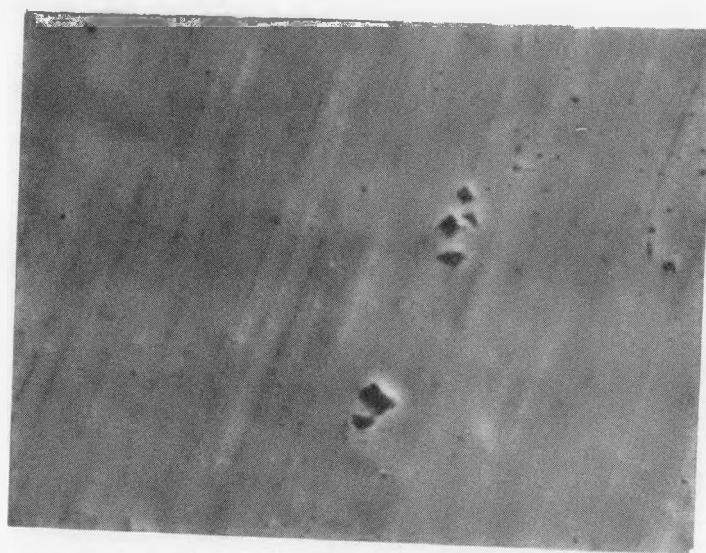
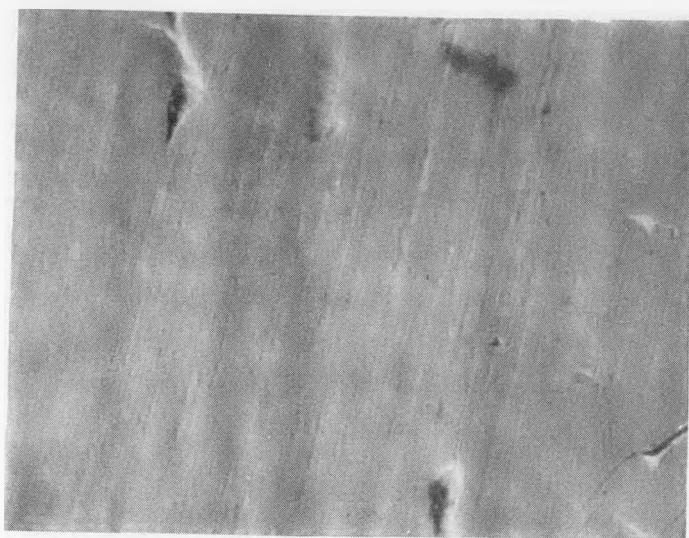
Figure 40. Scanning Electron Micrographs of Stainless Steel after Immersion for 6 months in a) Nellis Domestic Water and b) NPL fluid showing small pits in crevice region. Magnification = 2000X.

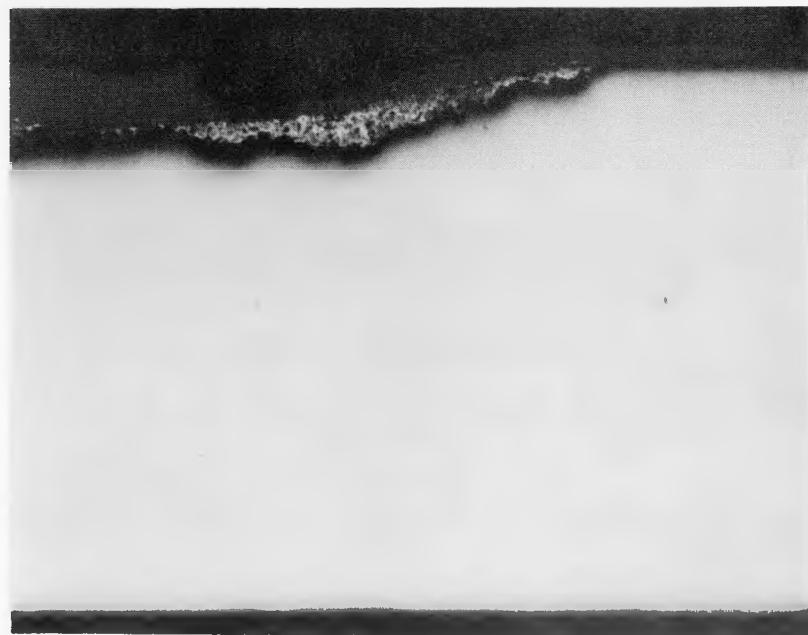
Figure 41. Optical Micrograph of Cu Alloy 122 after Immersion for 180 days in New Haven tap water with Solder Flux present showing corrosion in crevice. Magnification = 200X.

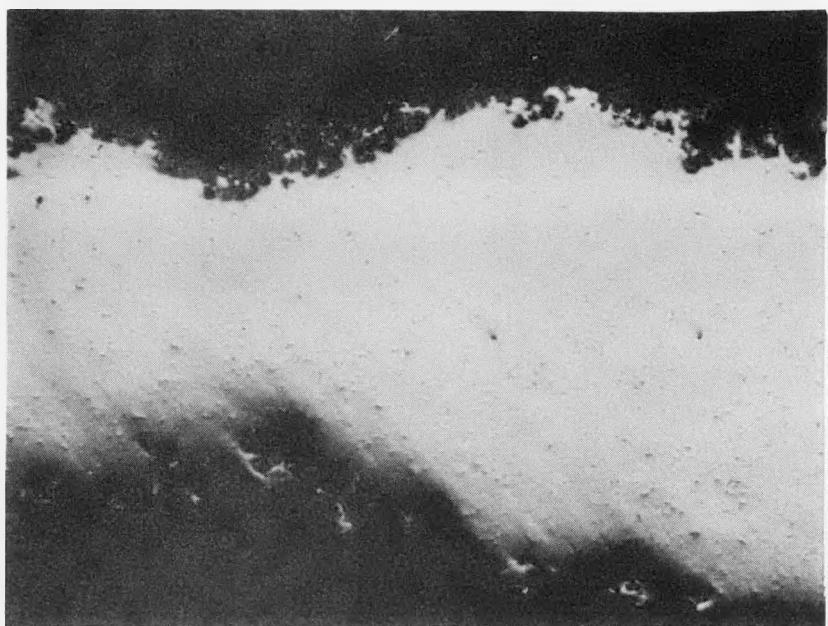
Figure 42. Optical Micrographs of Al Alloy 110 after immersion for 180 days in Degraded Propylene Glycol. Note Severe Pitting and Accelerated Corrosion in Crevice. Magnification = 100X.

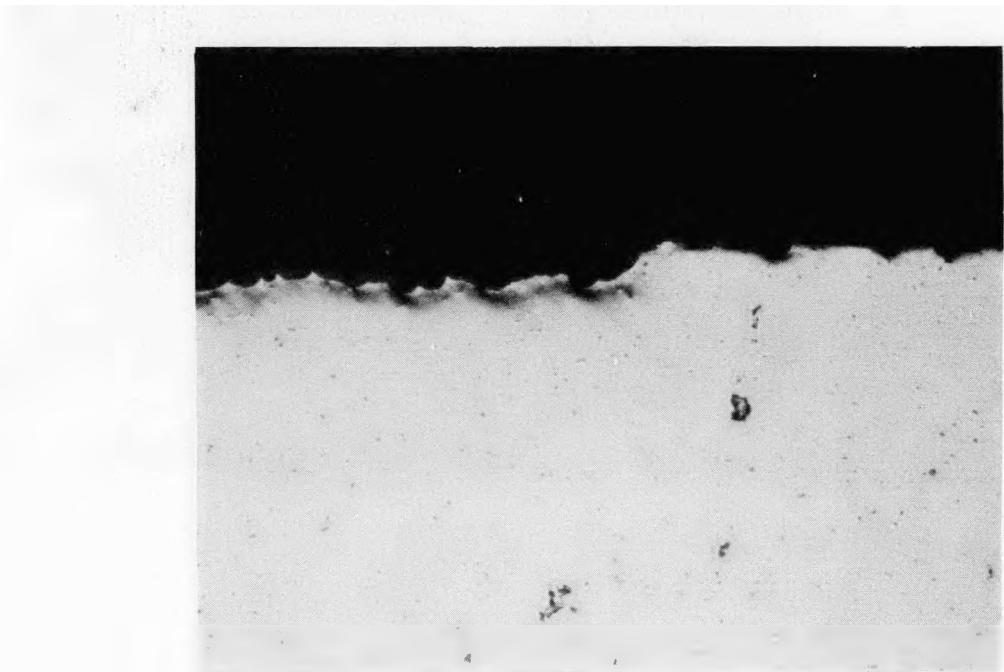
Figure 43. Optical Micrograph of Al Alloy 1100 after 180 days Immersion in Sunsol 60 Illustrating Crevice Corrosion. Magnification = 200X.

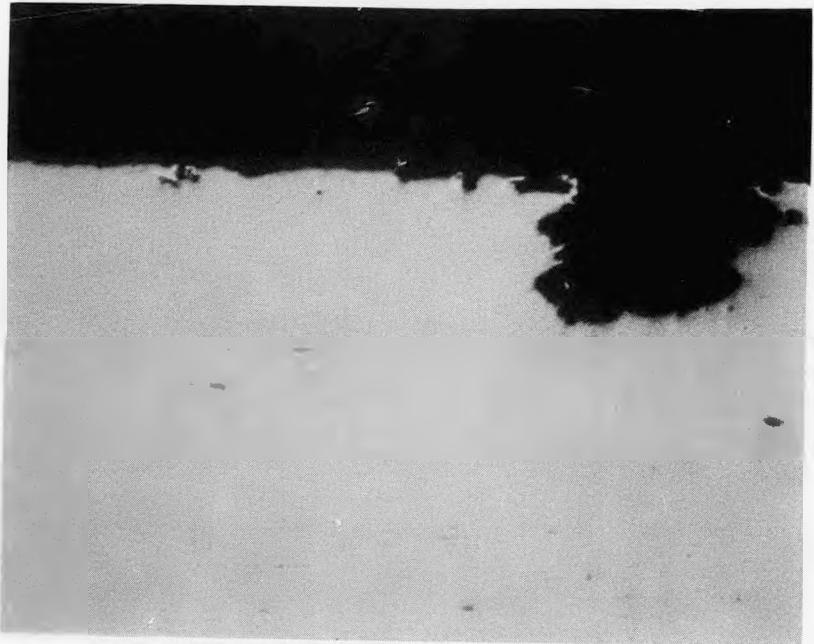
Figure 44. Optical Micrograph of Mild Steel showing large pit in crevice region formed during immersion for 180 days in degraded propylene glycol solution with reserve alkalinity adjusted to 10. Magnification = 200X.
