MICROSTRUCTURAL EFFECTS IN ABRASIVE WEAR

Quarterly Progress Report
for the period 15 September 1978 - 15 December 1978

Nicholas F. Fiore, Thomas H. Kosel, Stephen Udvardy and
William Konkel

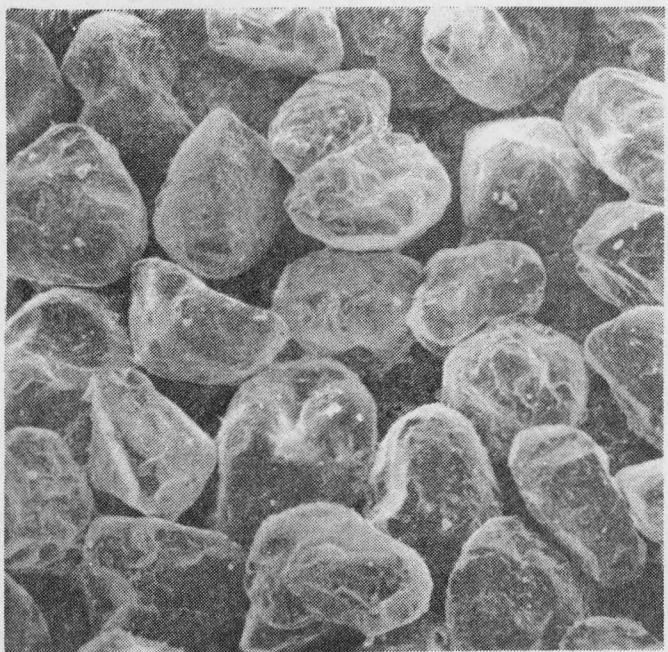
Figure 6. 60X SEM micrographs of new and used RWAT abrasives. (a) New SiO_2 , (b) SiO_2 , used twice, (c) new Al_2O_3 , and (d) Al_2O_3 , used twice.

Since the RWAT test was designed to simulate abrasion under conditions which do not lead to degradation of the abrasive particles, it was felt that it was necessary to further investigate the degradation of the abrasive by the RWAT. Therefore, part of the effort this quarter was spent in an attempt to determine the nature of the degradation of the abrasive by the application of SEM. Low-magnification SEM micrographs of the new and used SiO_2 and Al_2O_3 abrasives are shown in Figure 6. The difficulties in determining the underlying cause of the reduction in the abrasiveness of these particles by SEM observations is evident. Individual particles vary so much that small overall changes in the average particle size and shape may not be distinguished. The problem is really a statistical one, and although relatively small changes in size distribution can be examined by sieve analysis of very large numbers of particles, no comparably

simple method exists for the determination of small differences in average shape.

Higher magnification observations of the SiO_2 abrasives revealed some areas in which local melting of the abrasive may have occurred, since it appeared that the material had been made to flow. However, it is felt that investigation of this possibility using the SEM would be very time-consuming. Any possible tendency toward rounding of the sharp edges of the Al_2O_3 particles is obscured by the large shape variations from particle to particle. The effects of the abrasion testing on the abrasives might be better characterized by using the same abrasive repeatedly in order to accentuate the shape and size changes so that they would be more readily distinguishable in the SEM.

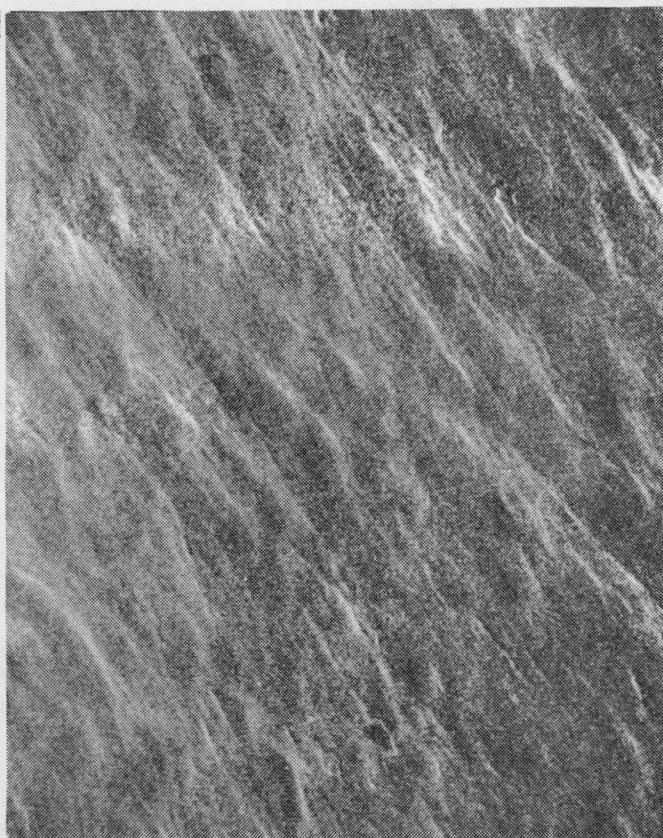
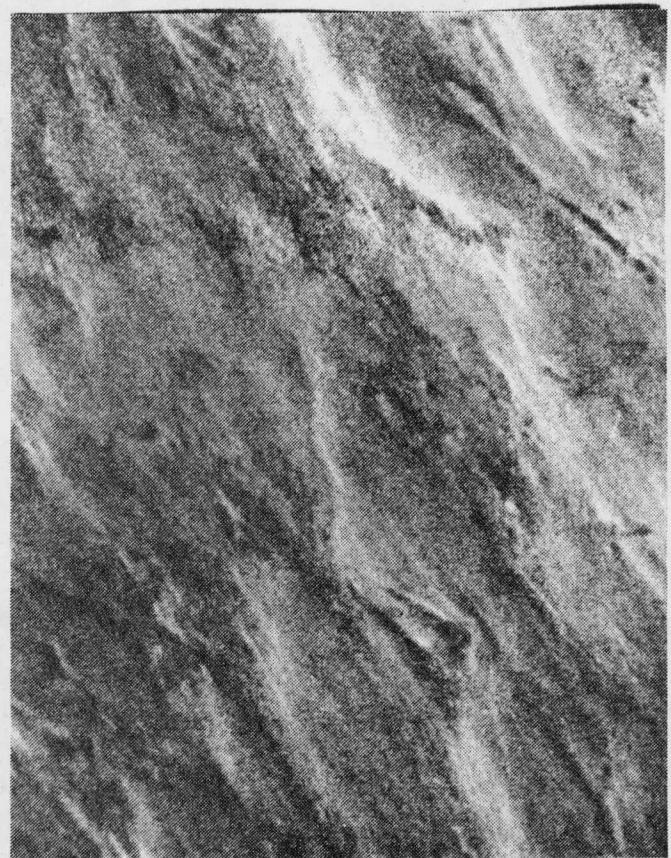
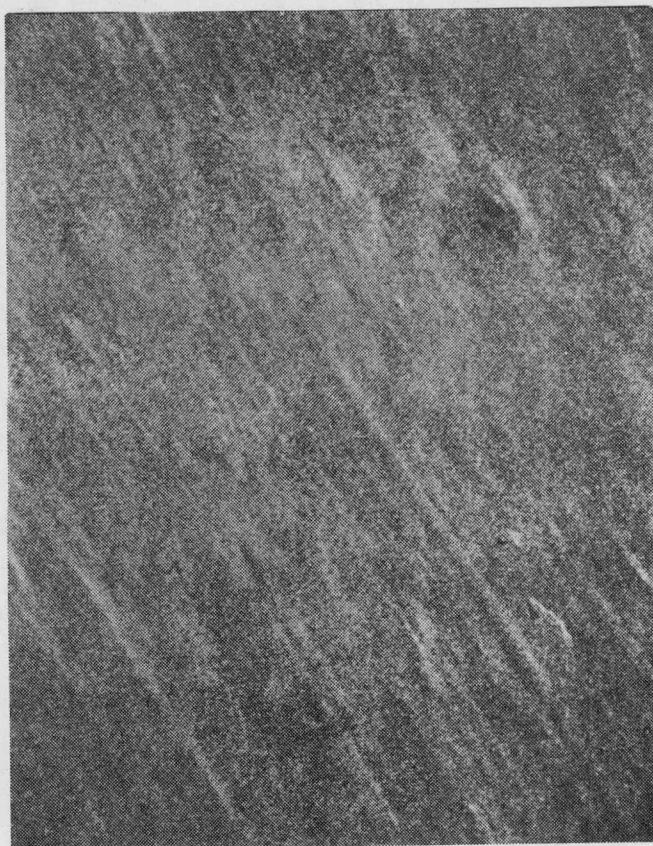
Figure 8. SEM micrographs of SiO_2 RWAT wear scar of Ni-Hard 4 alloy with 5% γ . a) 500X, entrance region; b) 1500X, entrance region; c) 500X, central region.

Figures 8 through 11 show SEM micrographs of the SiO_2 RWAT wear scars for the Ni-Hard 4 specimens. Each figure shows at 500 and 1500X what often is termed the entrance region of the wear scar, where the abrasive first contacts the sample. Also shown are 500X micrographs of the central region of the scars. In each case, the entrance region of the wear scar contains raised areas which

can be seen by comparison with the optical micrographs of Figure 1 to be of similar size and shape to the large carbides present in these alloys. Since the carbides are the hardest phase in the alloy it is concluded that they wear less rapidly than the matrices and therefore protrude from the surface in the entrance region. As will be seen, this conclusion is reinforced by the SEM/EDXS analysis of the Stellite 6 alloy, which indicates that carbides protrude from the RWAT wear scars.

The central region of the wear scar is much smoother and has less well-defined protrusions than the entrance region. It is of interest to note that the protrusions which do appear are most pronounced for the specimen with 40 percent retained austenite. Since this microstructure exhibited the highest RWAT wear rate, it might be supposed that a greater wear rate of the matrix was responsible. However, in view of the variations in contrast from one micrograph to the next, this is a tentative conclusion under further investigation.

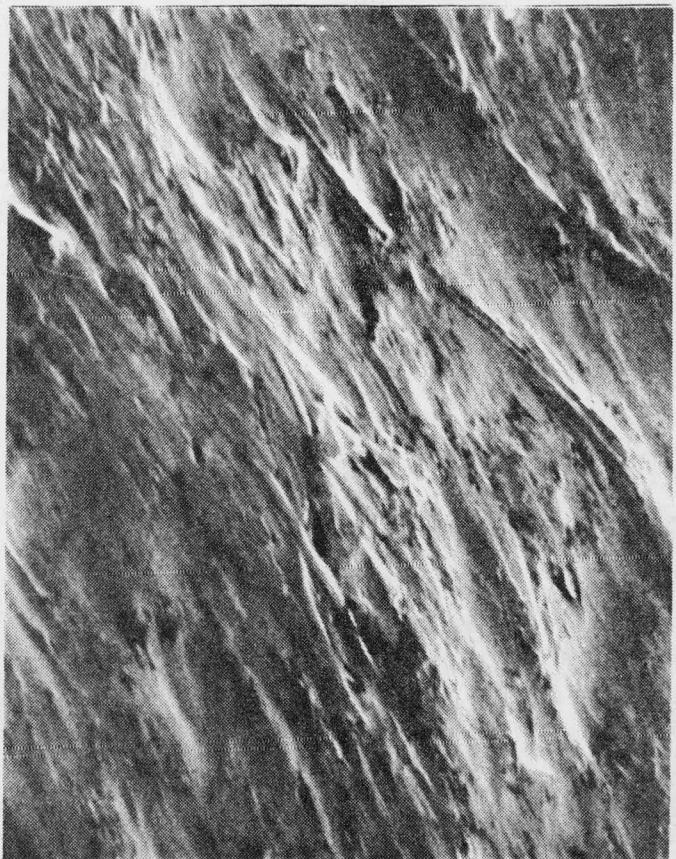
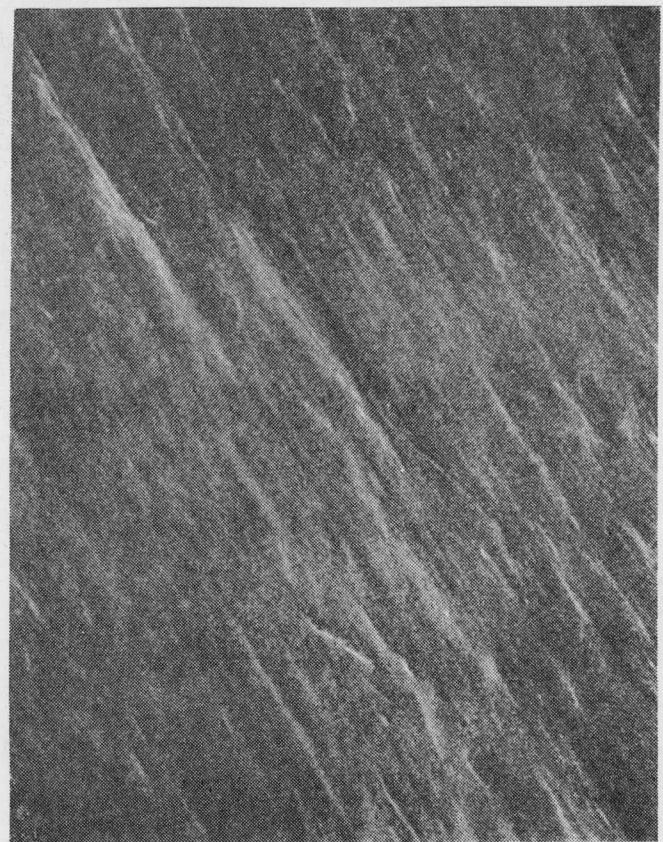
Figure 9. SEM micrographs of SiO_2 RWAT wear scar of Ni-Hard 4 alloy with 20% γ . a) 500X, entrance region; b) 1500X, entrance region; c) 500X, central region.

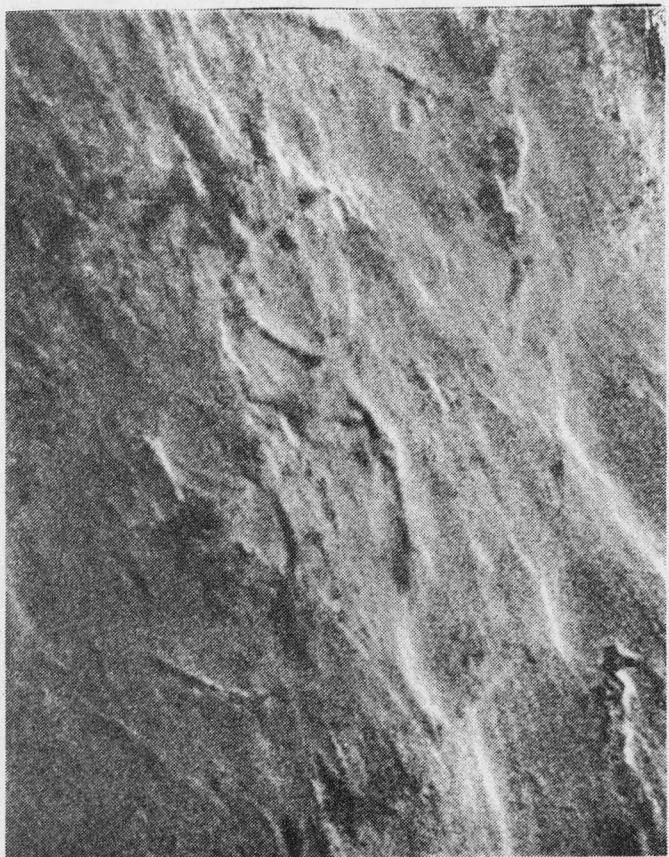
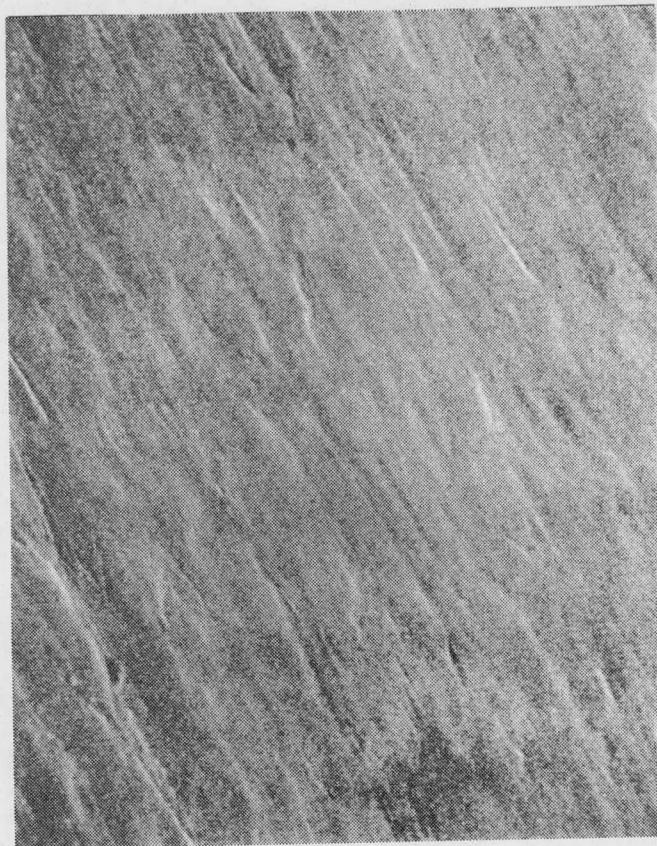
Figure 10. SEM micrographs of SiO_2 RWAT wear scar of Ni-Hard 4 alloy with 40% γ . a) 500X, entrance region; b) 1500X, entrance region; c) 500X, central region.

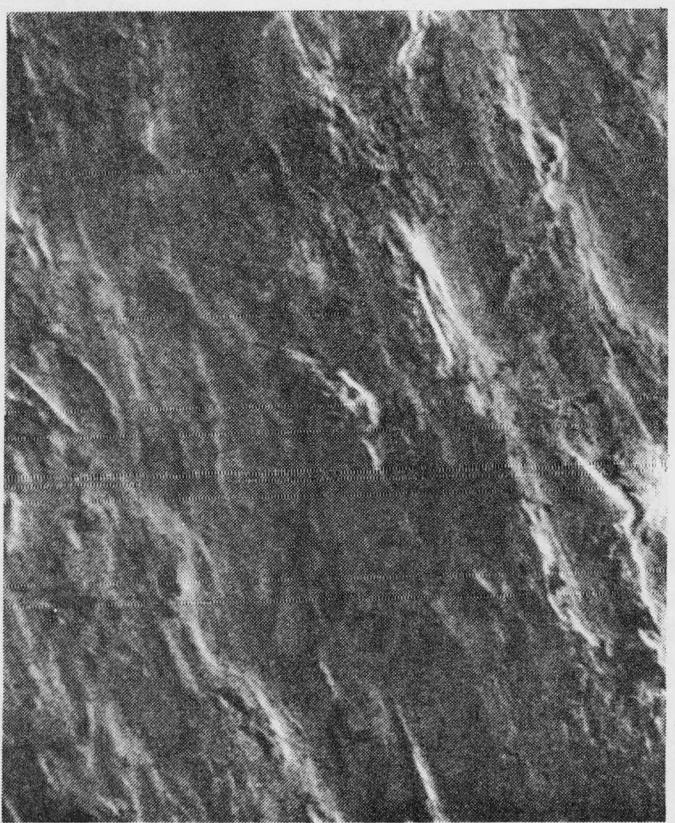
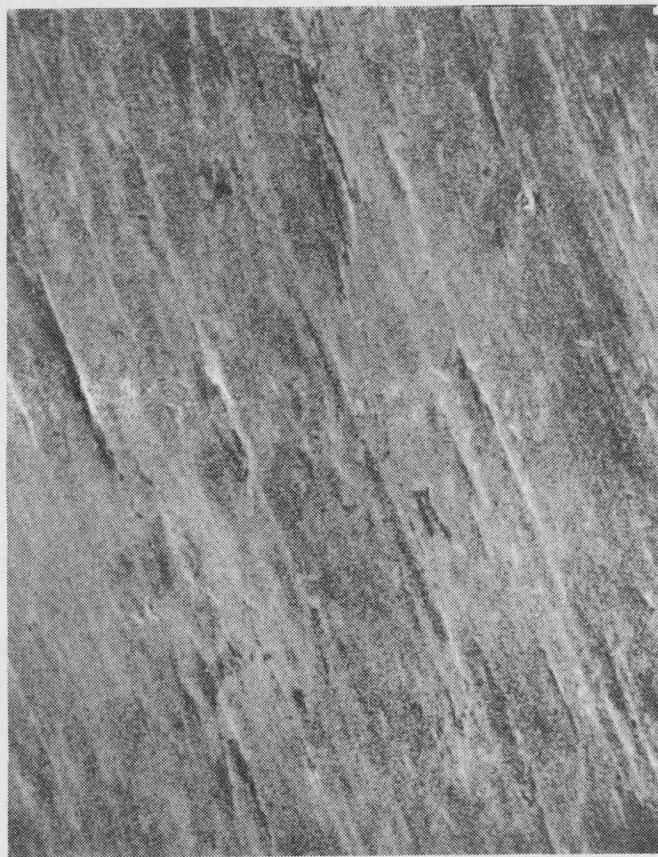
Figure 11. SEM micrographs of SiO_2 RWAT wear scar of Ni-Hard 4 alloy with 85% γ . a) 500X, entrance region; b) 1500X, entrance region; c) 500X, central region.
