NUREG/CR-3923

Test Series 1: Seismic-Fragility Tests of Naturally-Aged Class 1E Gould NCX-2250 Battery Cells

Lloyd L. Bonzon, Donald B. Hente

Sandia National Laboratories
Albuquerque, New Mexico 87185
Operated by
Sandia Corporation
for the
U.S. Department of Energy

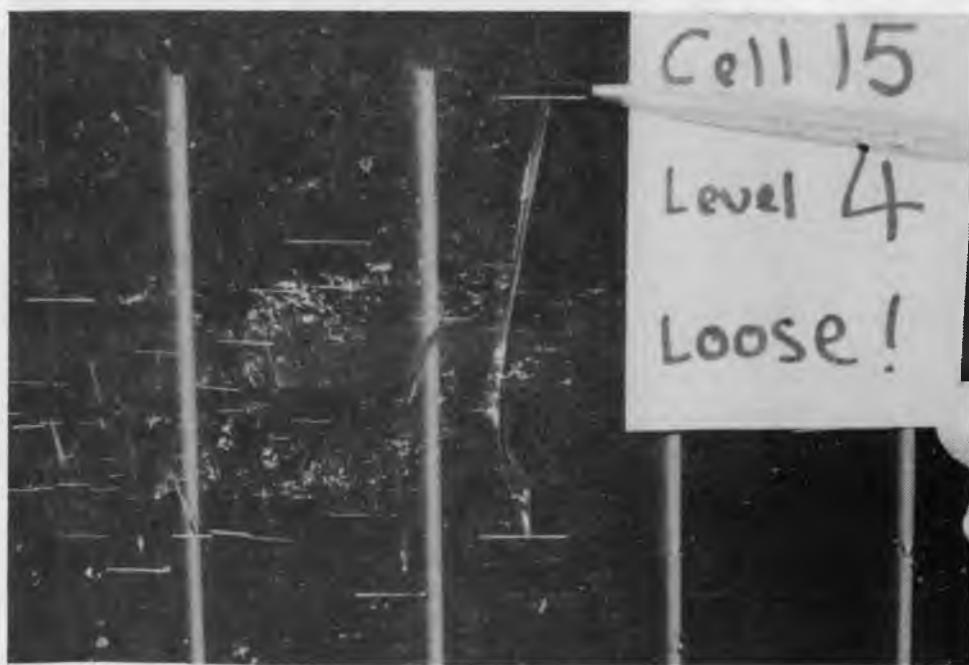
FIGURE 01B

Growth of cracks in all jars as a result of seismic testing. The side cracks were originally due to the clamping in a battery rack. The crack indicated was lengthened using trichlorethylene 2 from its original length marked. The small amount of growth at the pencil was due to vibration.

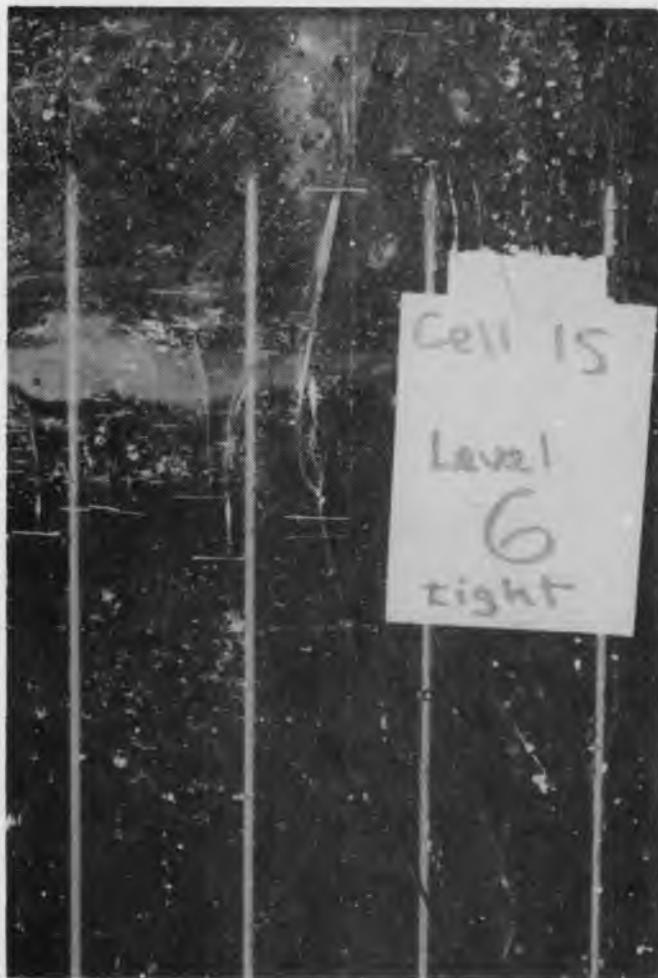
Figure 01B2

The crack above grew at the larger seismic levels. Note that the smaller cracks did not appear to grow significantly.
