FINAL REPORT

**Wire Rope Improvement
Program**

September 1981

**Pacific Northwest Laboratory
Operated for the U.S. Department of Energy
by Battelle Memorial Institute**

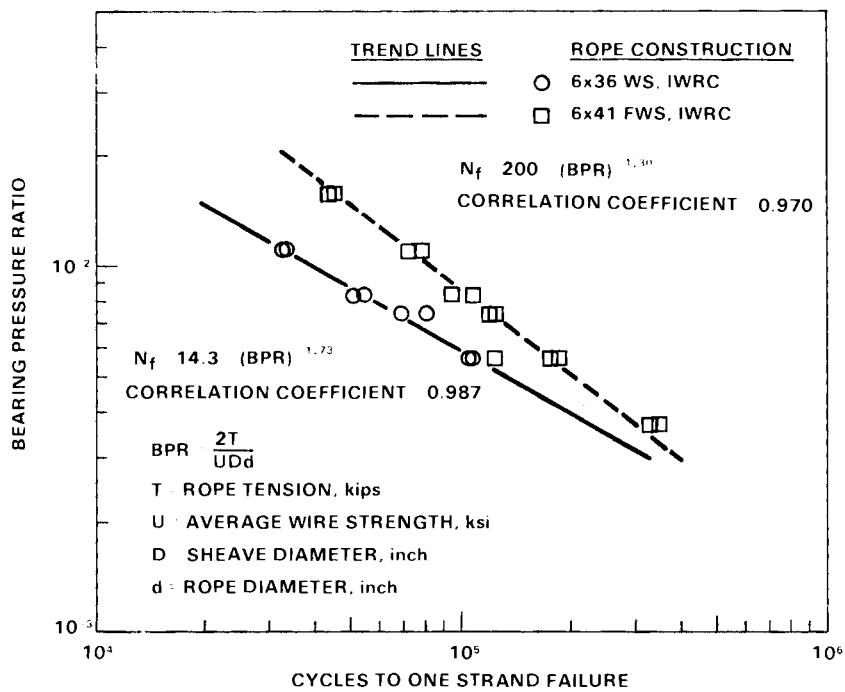
FIGURE 3. Cycles to Failure as a Function of Bearing Pressure Ratio for Two 3/4-Inch Diameter Rope Constructions

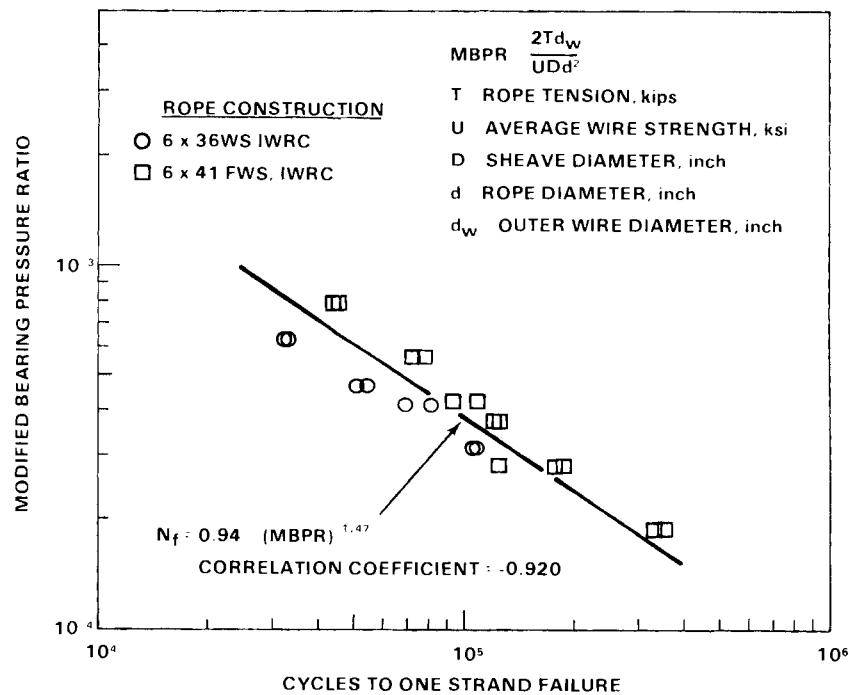
FIGURE 4. Cycles to Failure as a Function of the Modified Bearing Pressure Ratio for Two 3/4-Inch Diameter Rope Constructions

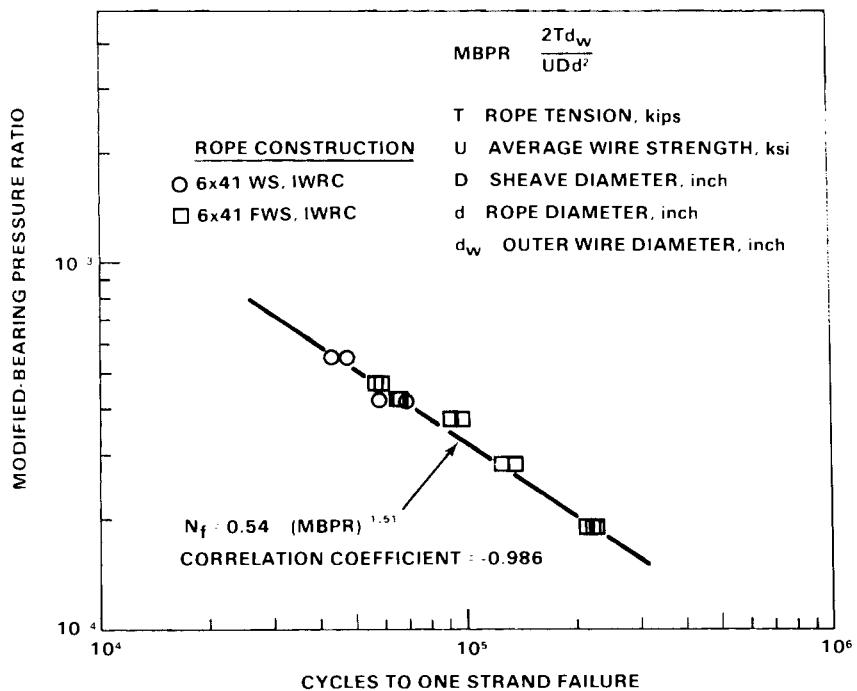
FIGURE 5. Cycles to Failure as a Function of the Modified Bearing Pressure Ratio for Two 1-1/2-Inch Diameter Rope Constructions

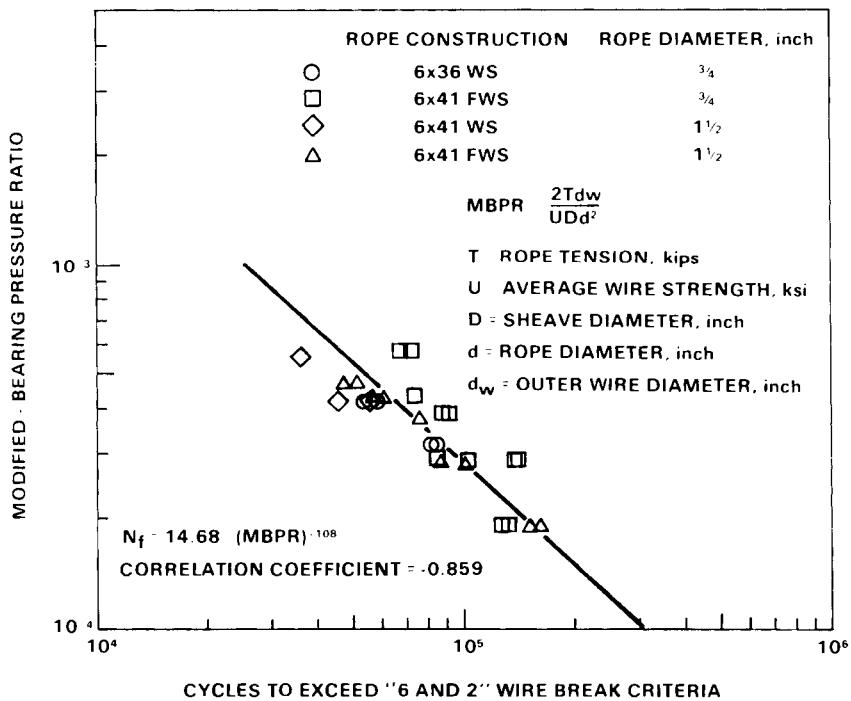
FIGURE 6. Cycles to Retirement Criteria as a Function of the Modified Bearing Pressure Ratio for Four Rope Constructions

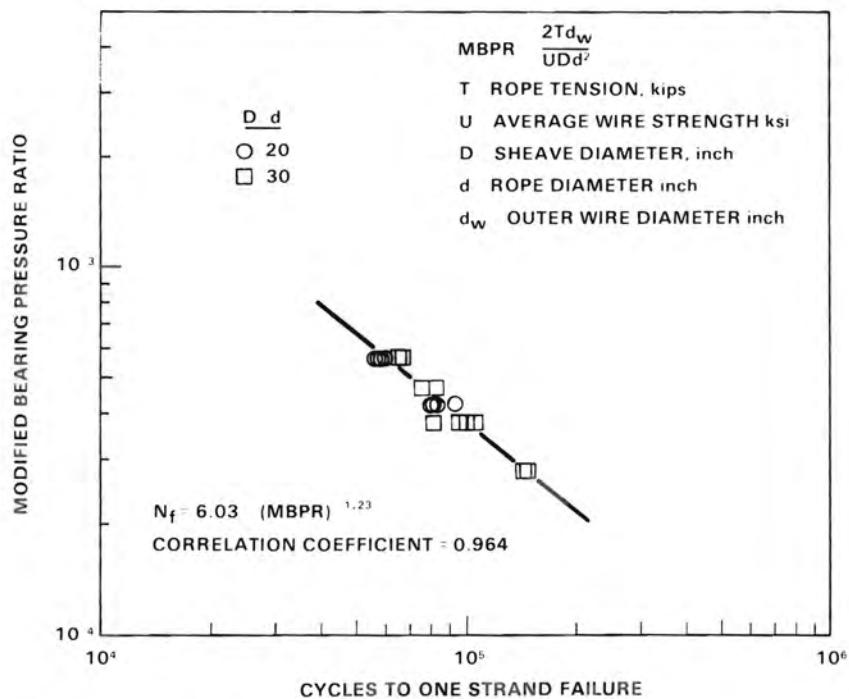
FIGURE 7. Cycles to Failure as a Function of the Modified Bearing Pressure Ratio for 3/4-Inch Rope on Unhardened, No Initial-Oversize Sheaves

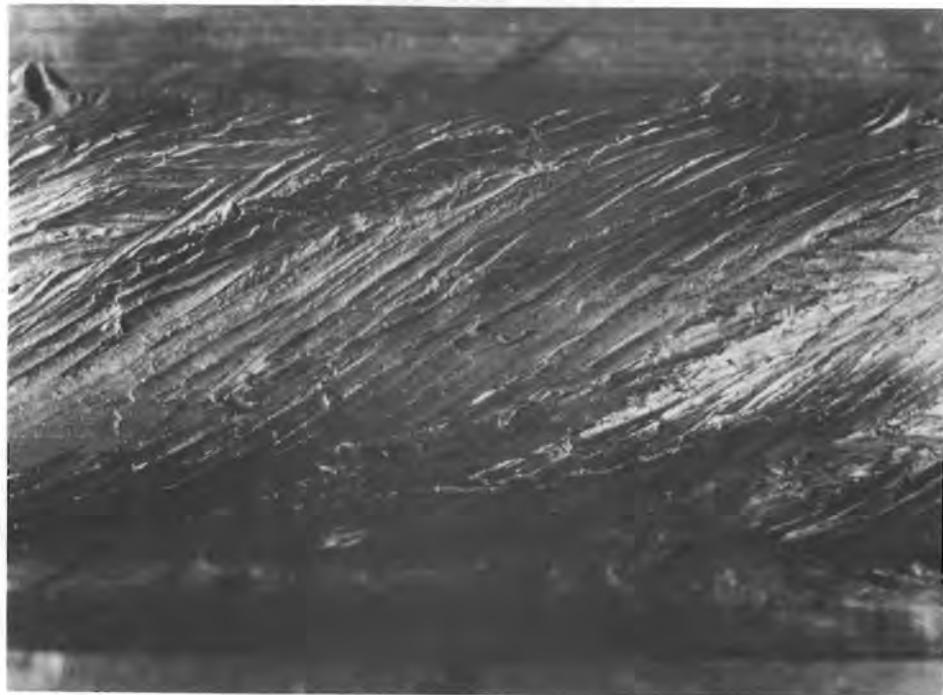
FIGURE 8. Groove of Unhardened D/d = 20 Sheave After 250,000 Bending Cycles

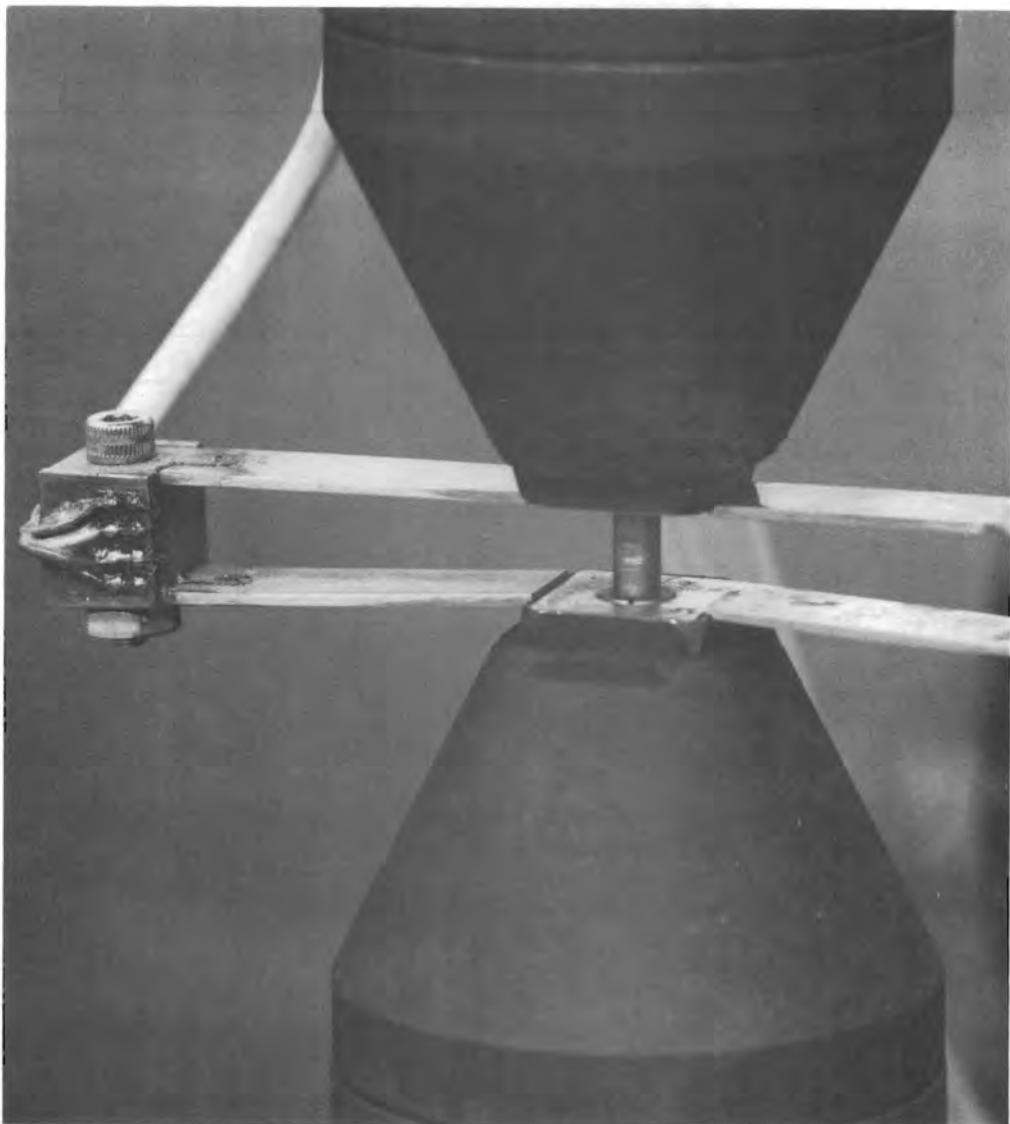
FIGURE 9. Initial Axial-Strain Controlled Fatigue Setup
For Single Rope Wires

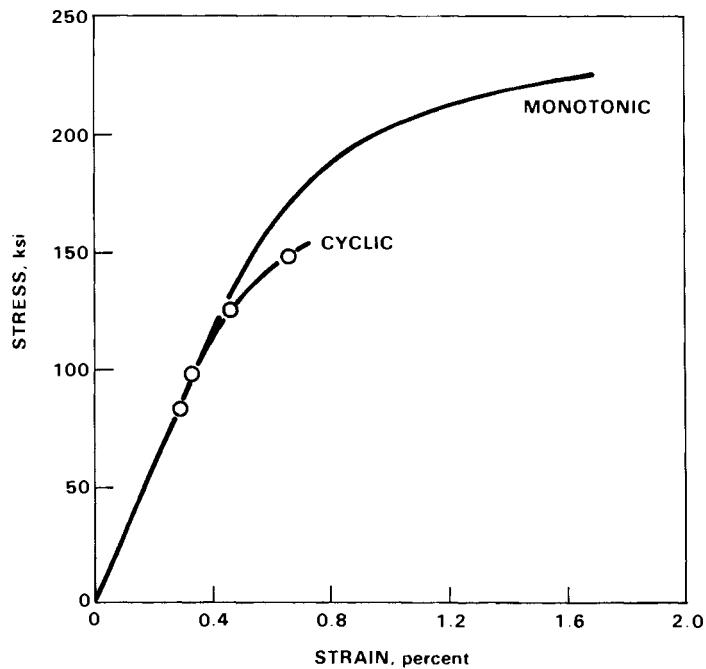
FIGURE 10. Cyclic and Monotonic Stress-Strain Curves for a 0.153-Inch Diameter Wire, Manufacturer H

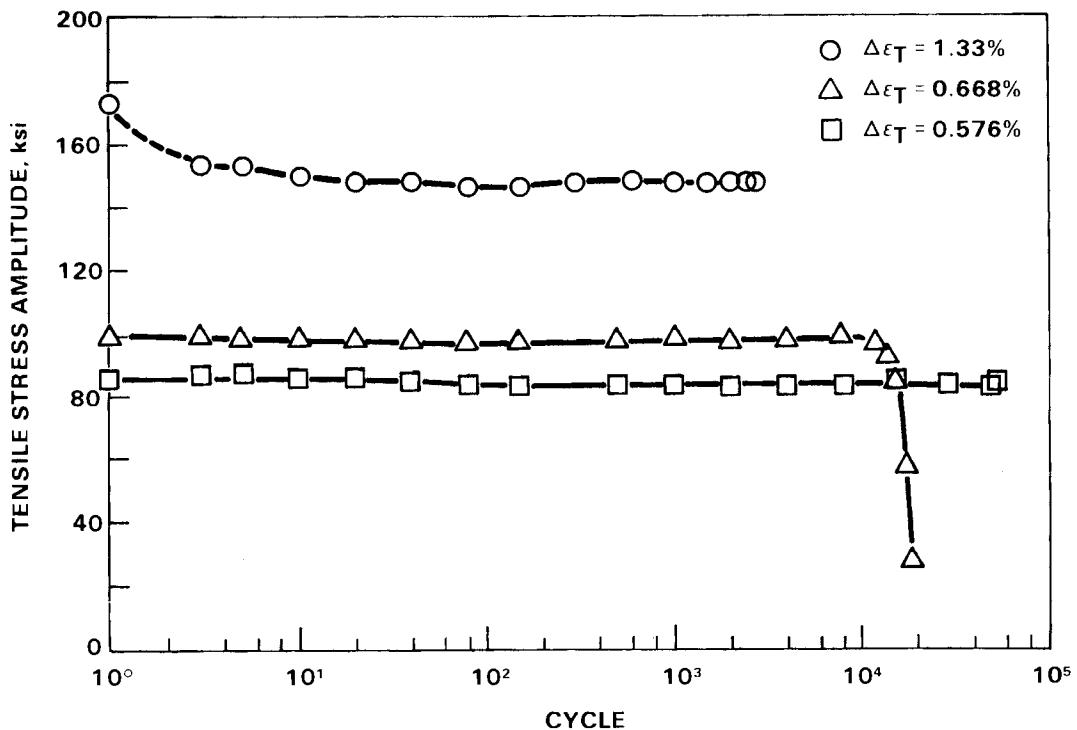
FIGURE 12. Tensile Stress Amplitude Versus Cycles for a 0.153-Inch Diameter Wire, Manufacturer H

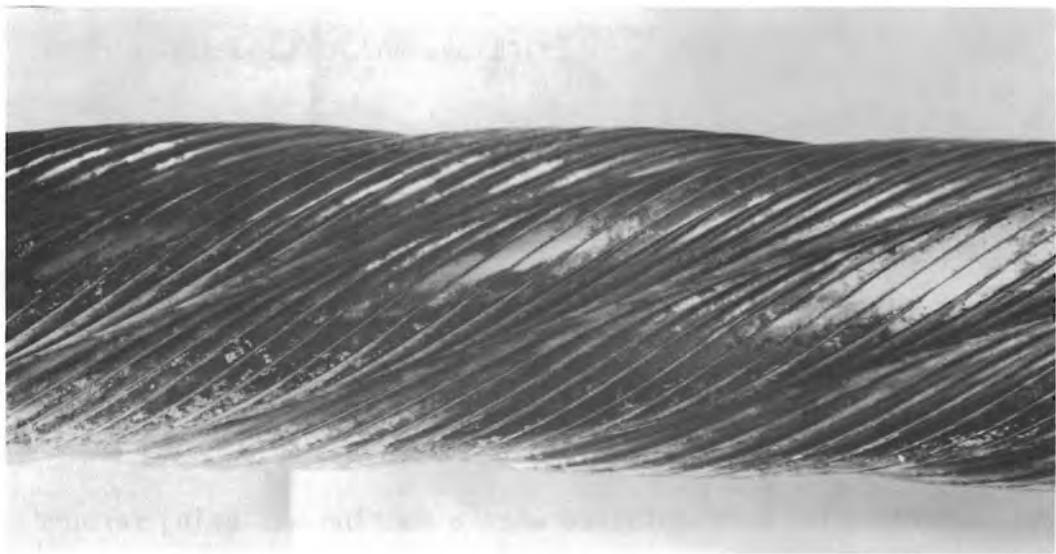
FIGURE 13. Field Sample After Cleaning Showing Outer Wire Wear

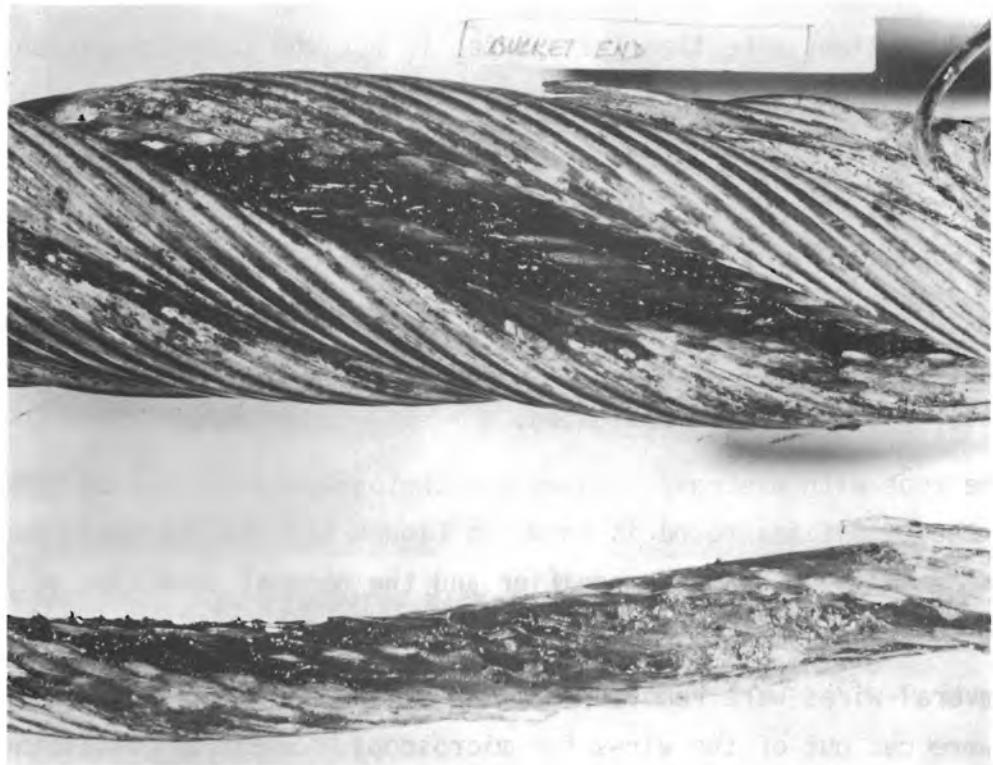
FIGURE 14. Field Sample with Strand Removed to Show Condition of Lubricant

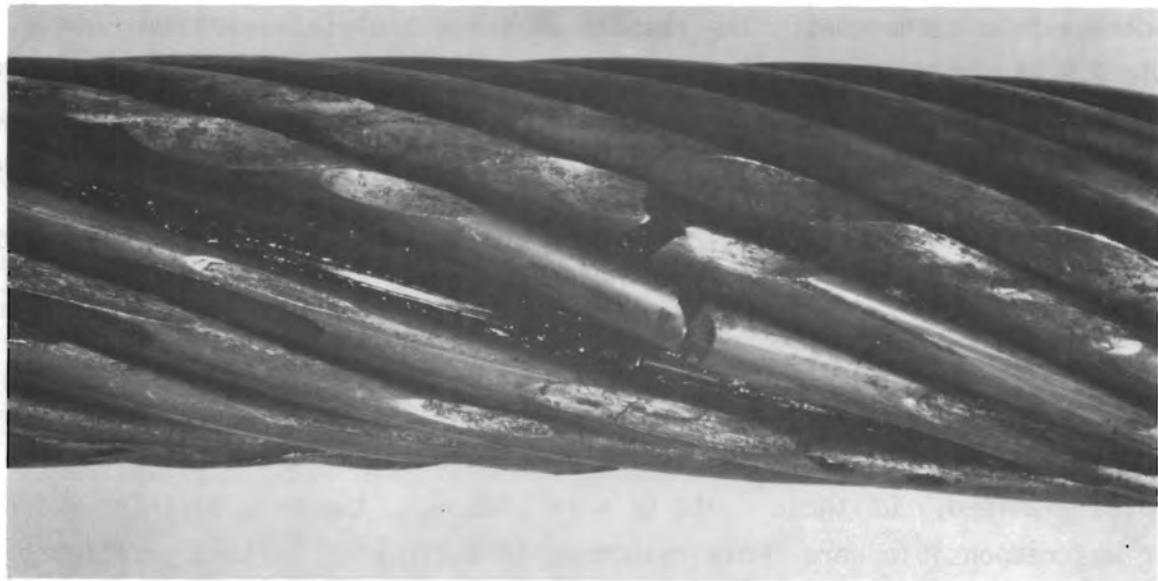
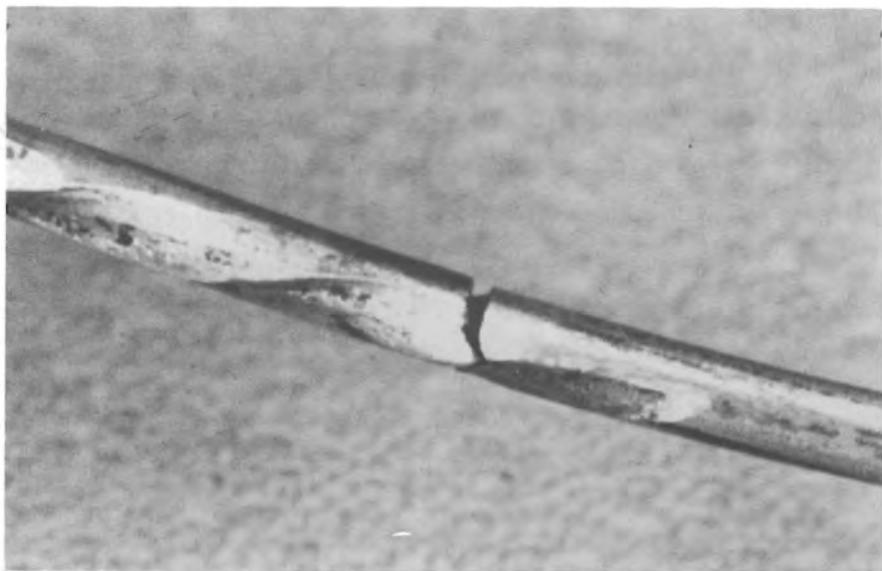
a. Valley Break Fractures in a Strand

b. Fractured Wire Removed from Strand

FIGURE 15. Typical Valley Break Wire Fracture

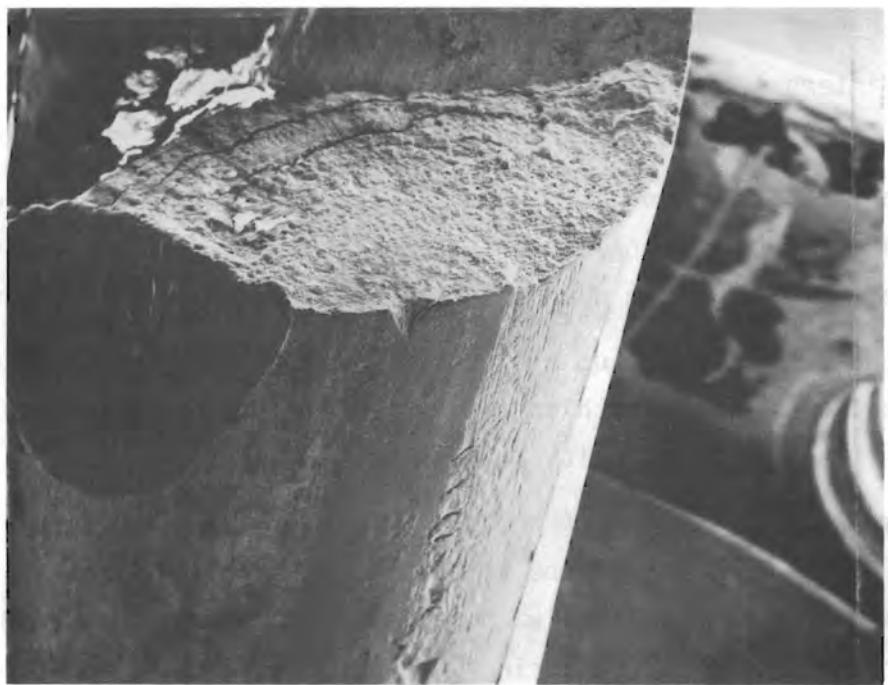
FIGURE 16. Fracture Surface of Wire Shown in Figure 15

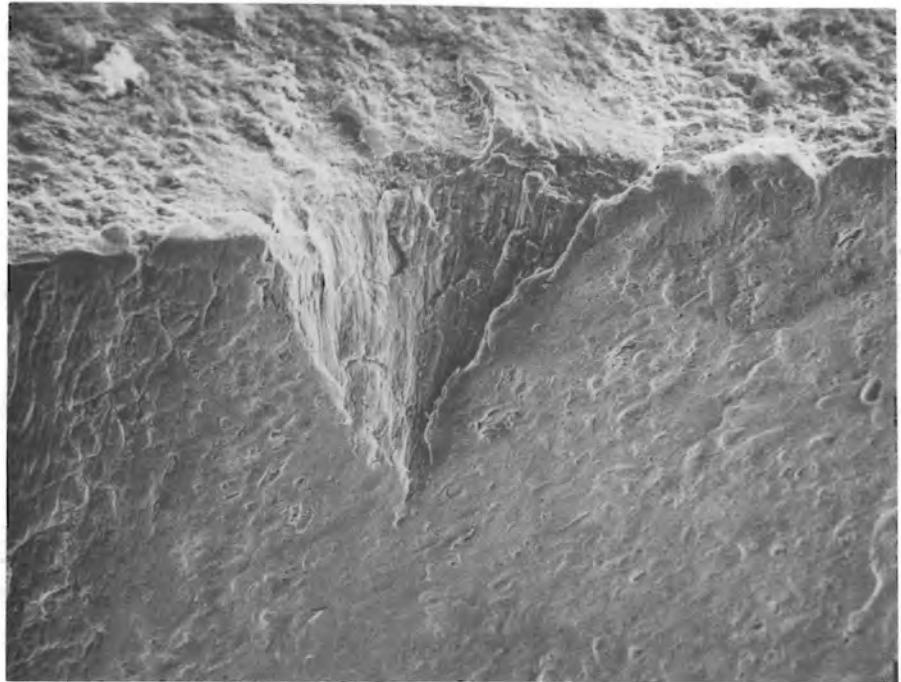
FIGURE 17. Detail of Origin at Defect in Wire Surface

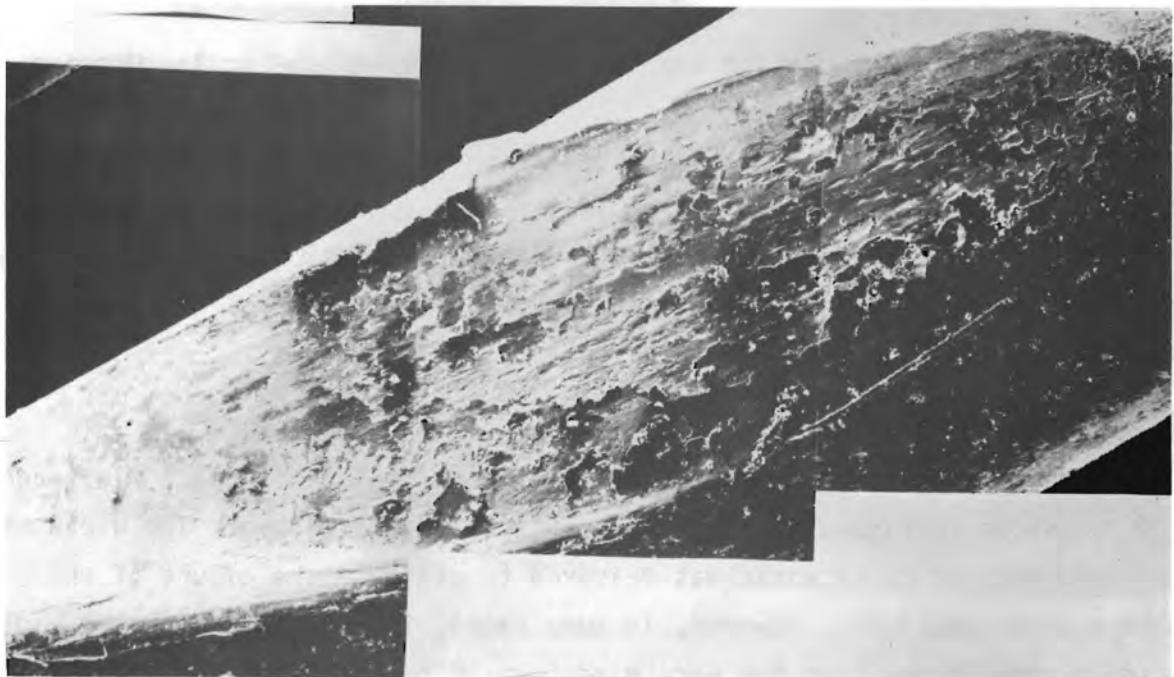
FIGURE 19. Detail Surface Micrograph of Typical Wire Notch from Strand-to-Strand Contact

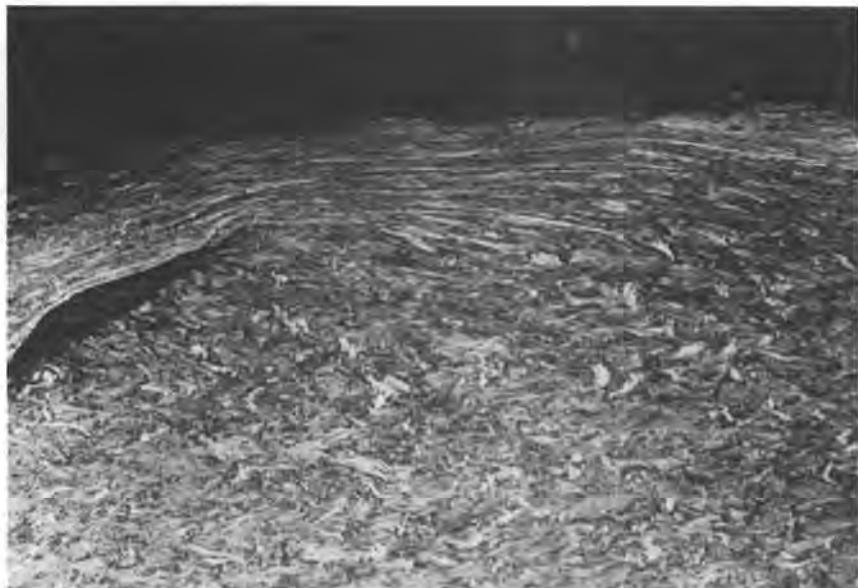
The size of notches produced by strand-to-strand contact is caused partly by wear. However, a significant part of the notch is the result of plastic deformation. Metallographic sections taken through notches show extensive plastic flow including formation of extruded lips at the boundaries of the notches. A typical section through a notch is shown in Figure 20.

FIGURE 20. Deformation and Extrusion in the Notch-Forming Process

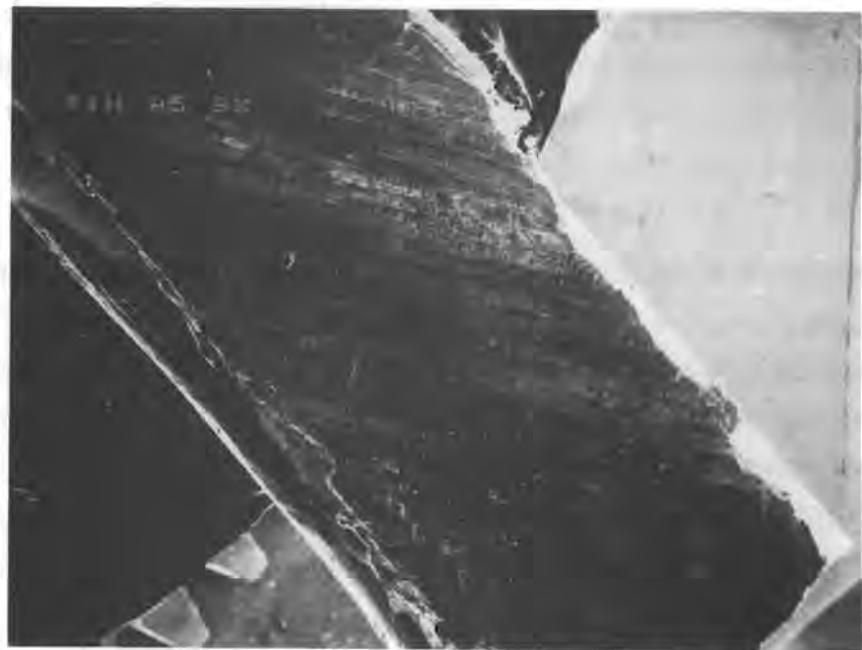
A typical outer wire wear scar is shown in Figure 21. Large abrasion gouging marks can be seen where sharp mineral surfaces have contacted and plowed across the wire surface as the rope was dragged through spoil. Evidence of surface flow and extrusion is seen along the edges of the wear scar. Details of gouging wear can be seen in Figure 22. The rounded debris particles on the surface are corrosion products.

FIGURE 21. Wire Section Flattening and Surface Extrusion in Outer Wire Wear

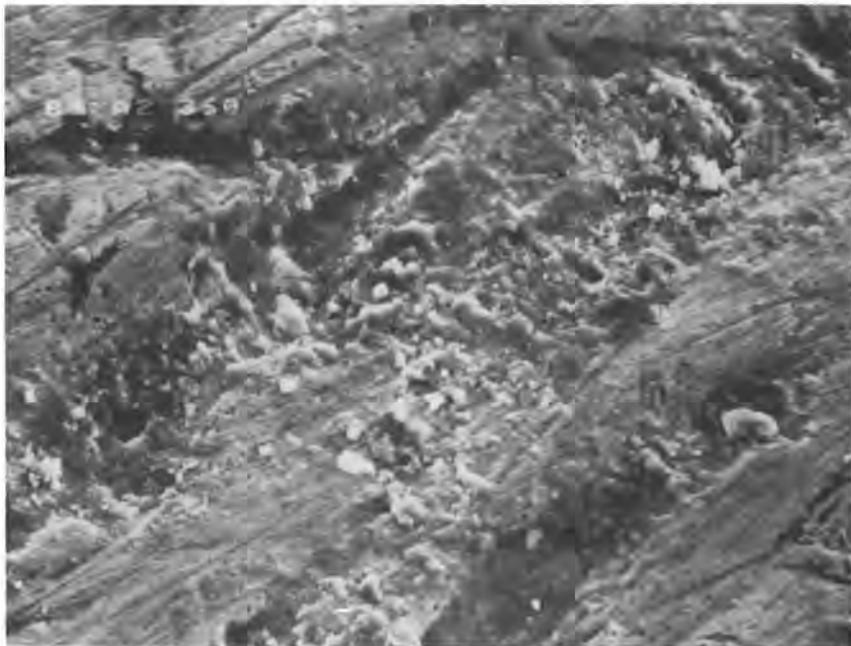
FIGURE 22. Gouging Abrasion Wear Pattern on Outer Wire

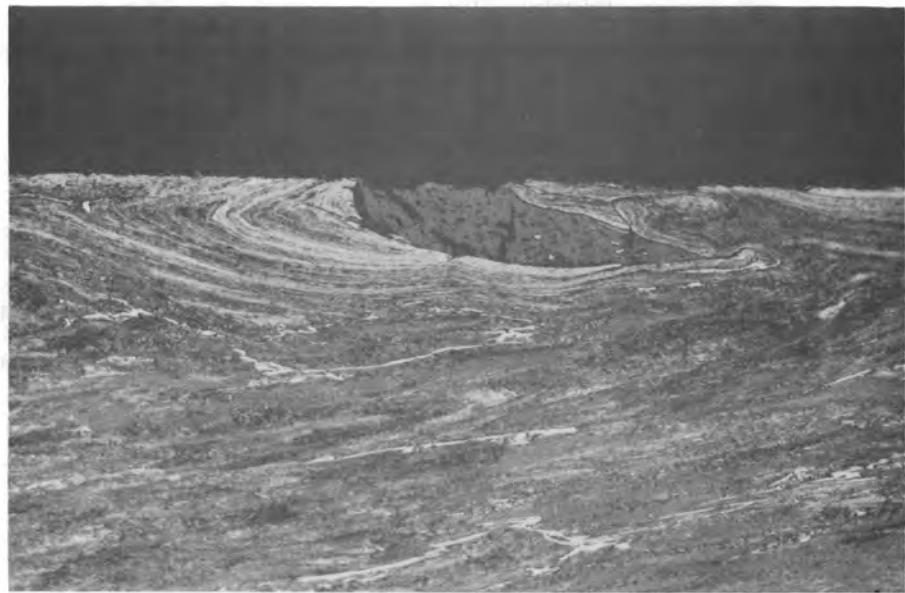
Areas of white etching at the surface of abraded outer wires were often found during metallographic analysis of wire samples. An example of this condition is shown in Figure 24. A two-phase structure can be seen. A layer at the surface shows no structure and, therefore, remains white after

FIGURE 23. Section of Outer Wire from Rope Exhibiting Abrasive Wear

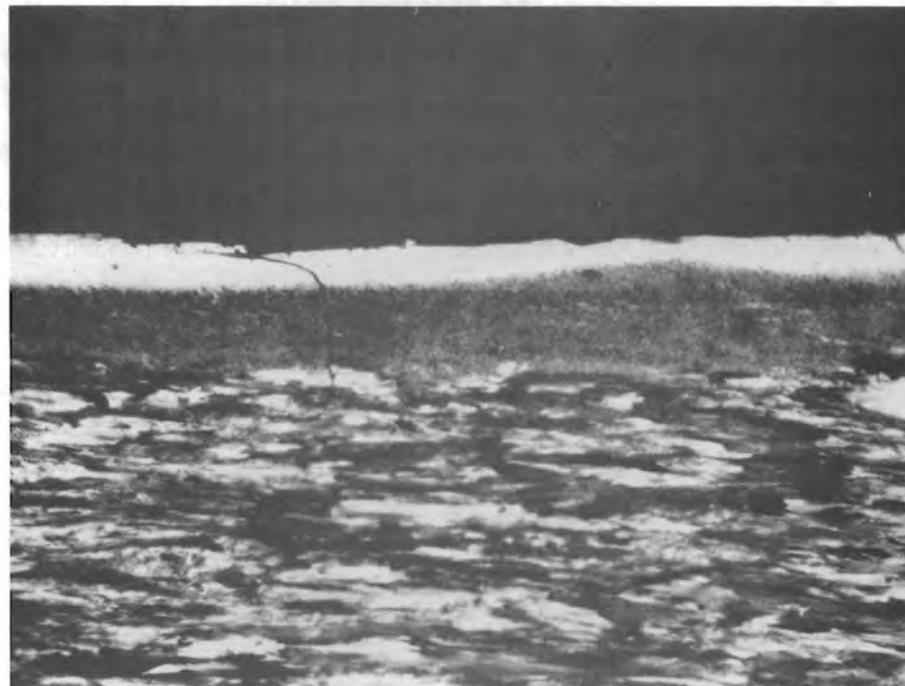
FIGURE 24. Metallographic Section Through Worn Outer Wire Showing White Layer (Rc 64), Intermediate Phase (Rc 48) and Crack

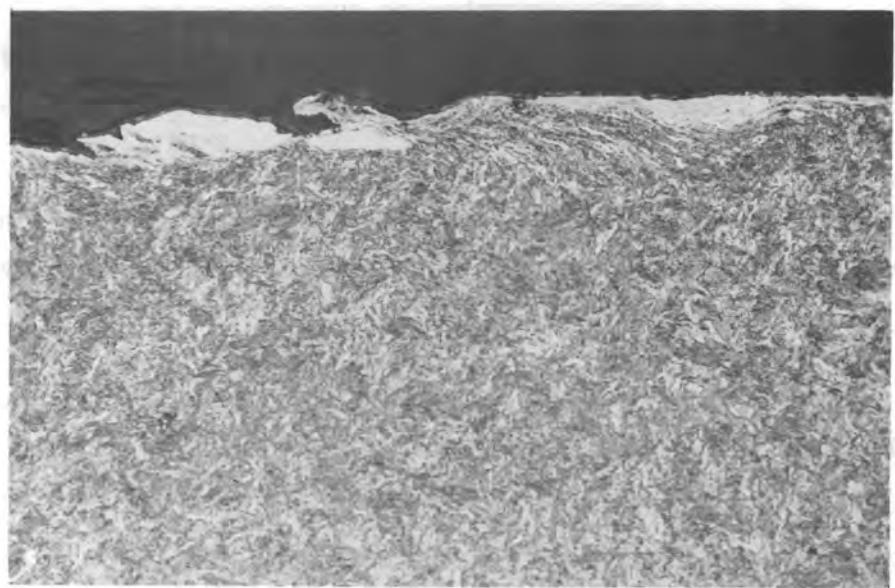
FIGURE 25. White Etching Layer on Worn Wire from Field Rope

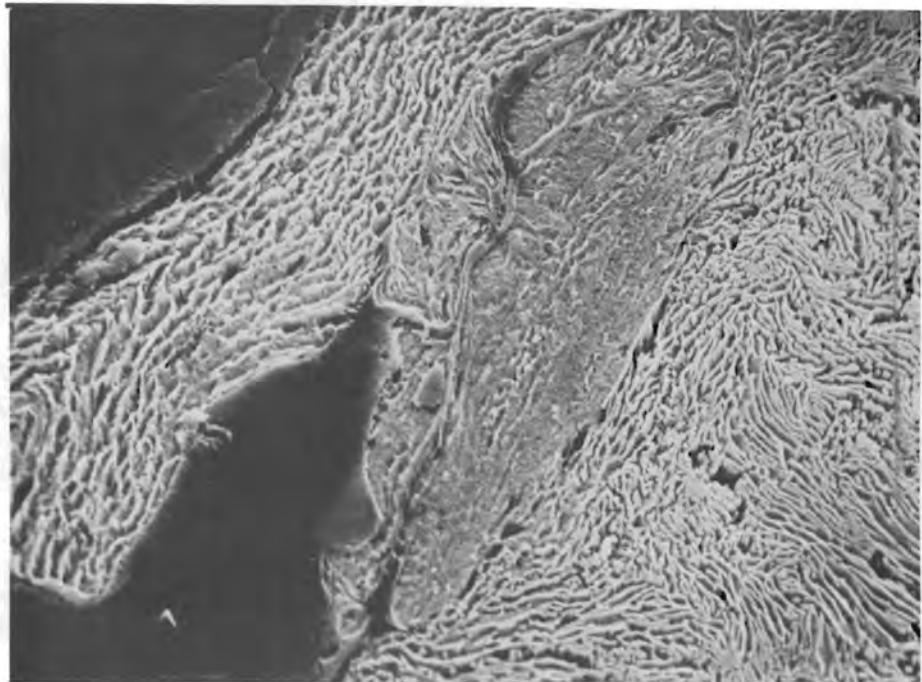
FIGURE 26. SEM Micrograph of Tongue Area, Figure 25

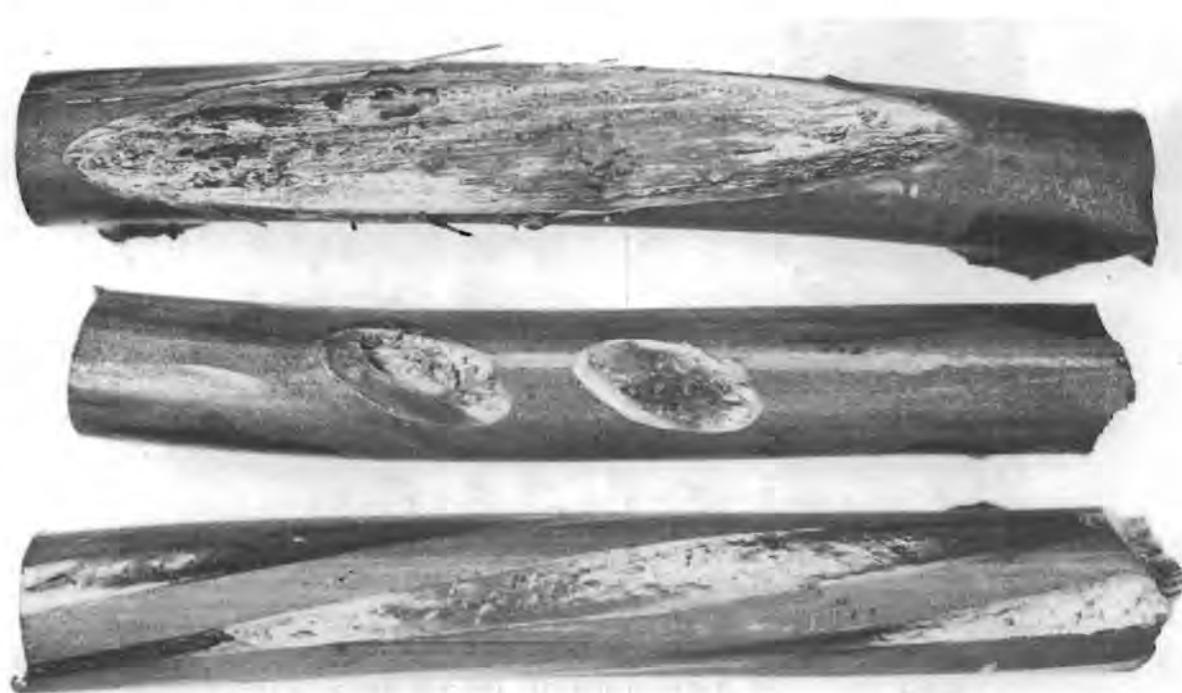
FIGURE 27. Notching and Wire-to-Wire Contact Fretting in IWRC Wires from 5-Inch Rope

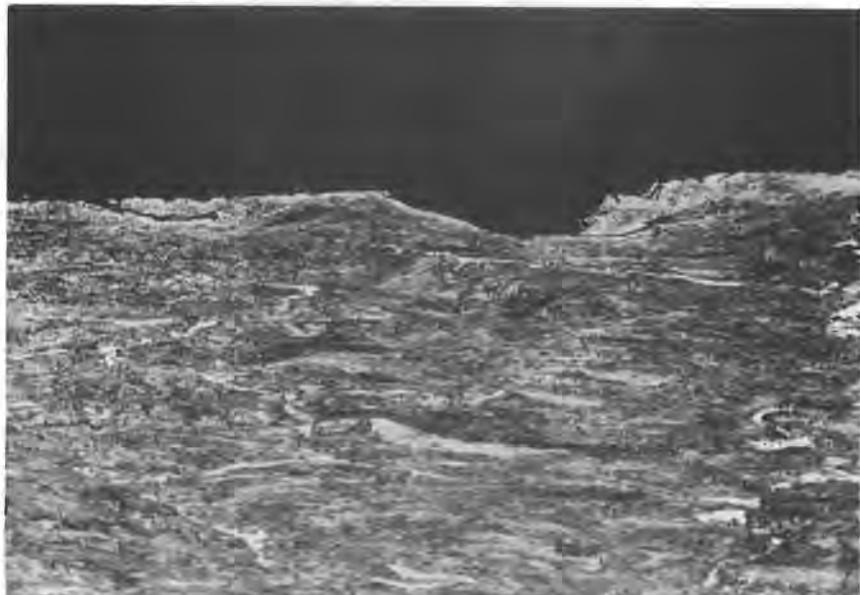
FIGURE 28. Delamination Wear in a Strand-to-Strand Notch

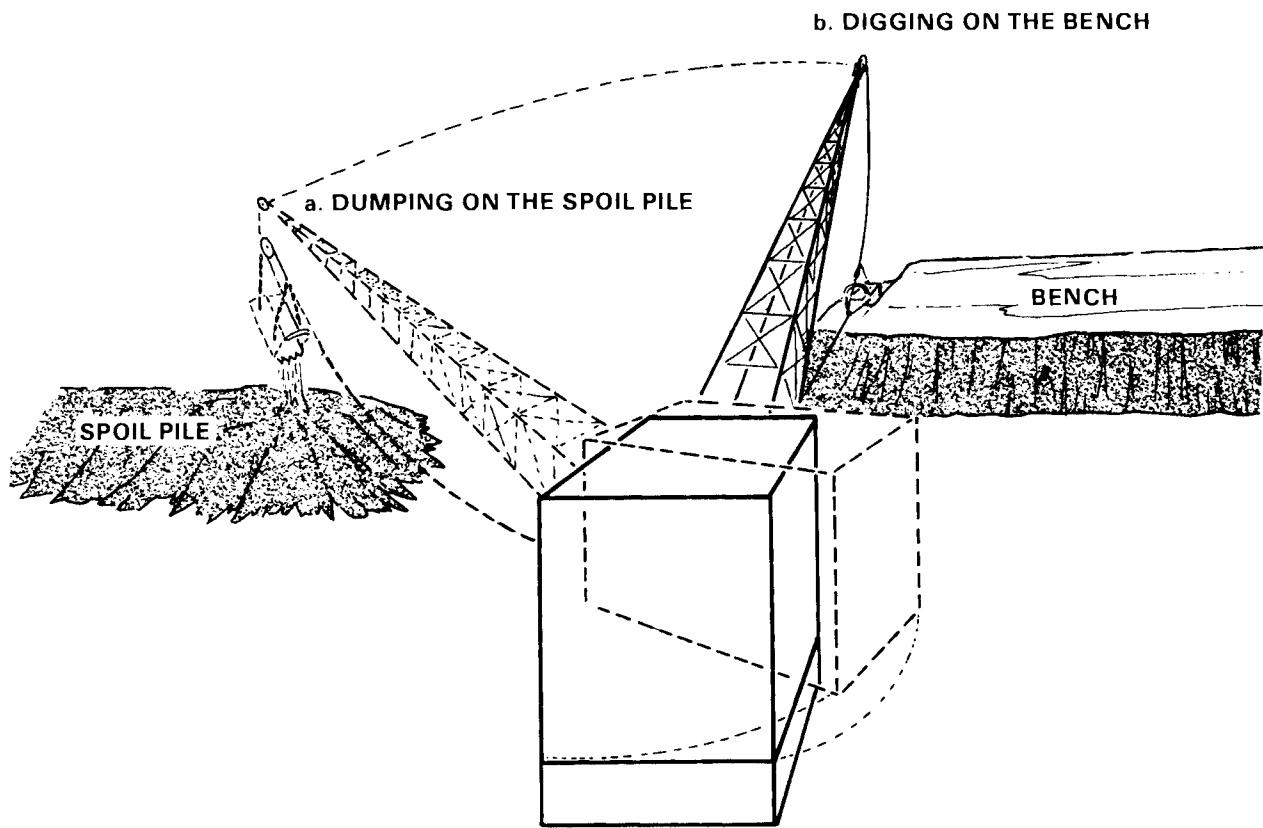
FIGURE 29. Digging and Dumping Features Employed During Load Sensor Operation

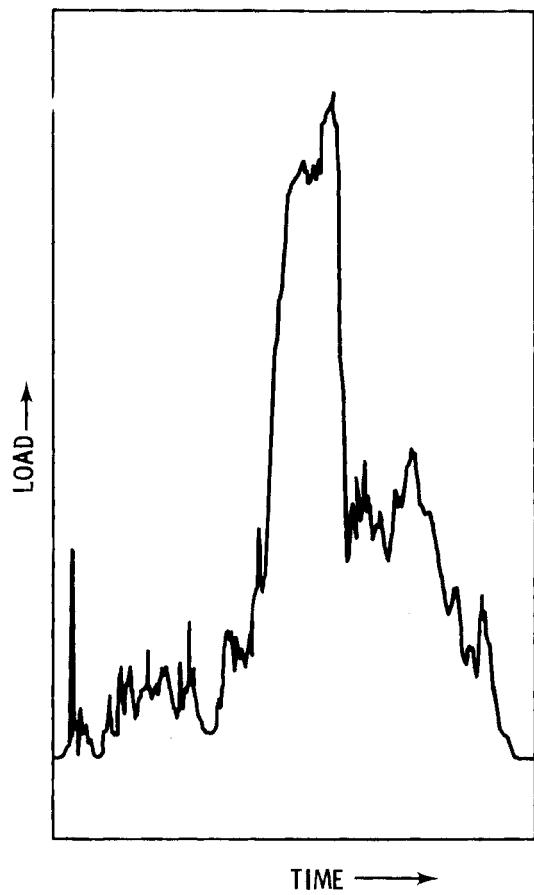
A typical load/time history is shown in Figure 30. During the four hours of data taken, 171 cycles were recorded for the left rope (as viewed from the cab) and 179 cycles were recorded for the right rope. The difference in the number of cycles was due to time spent initially calibrating the incoming signal. Data obtained for each rope are summarized in Table 16. Accuracy of the loads is better than $\pm 10\%$ of recorded values.

FIGURE 30. Sample Trace of Load/Time Signal from Drag Rope Load Sensors

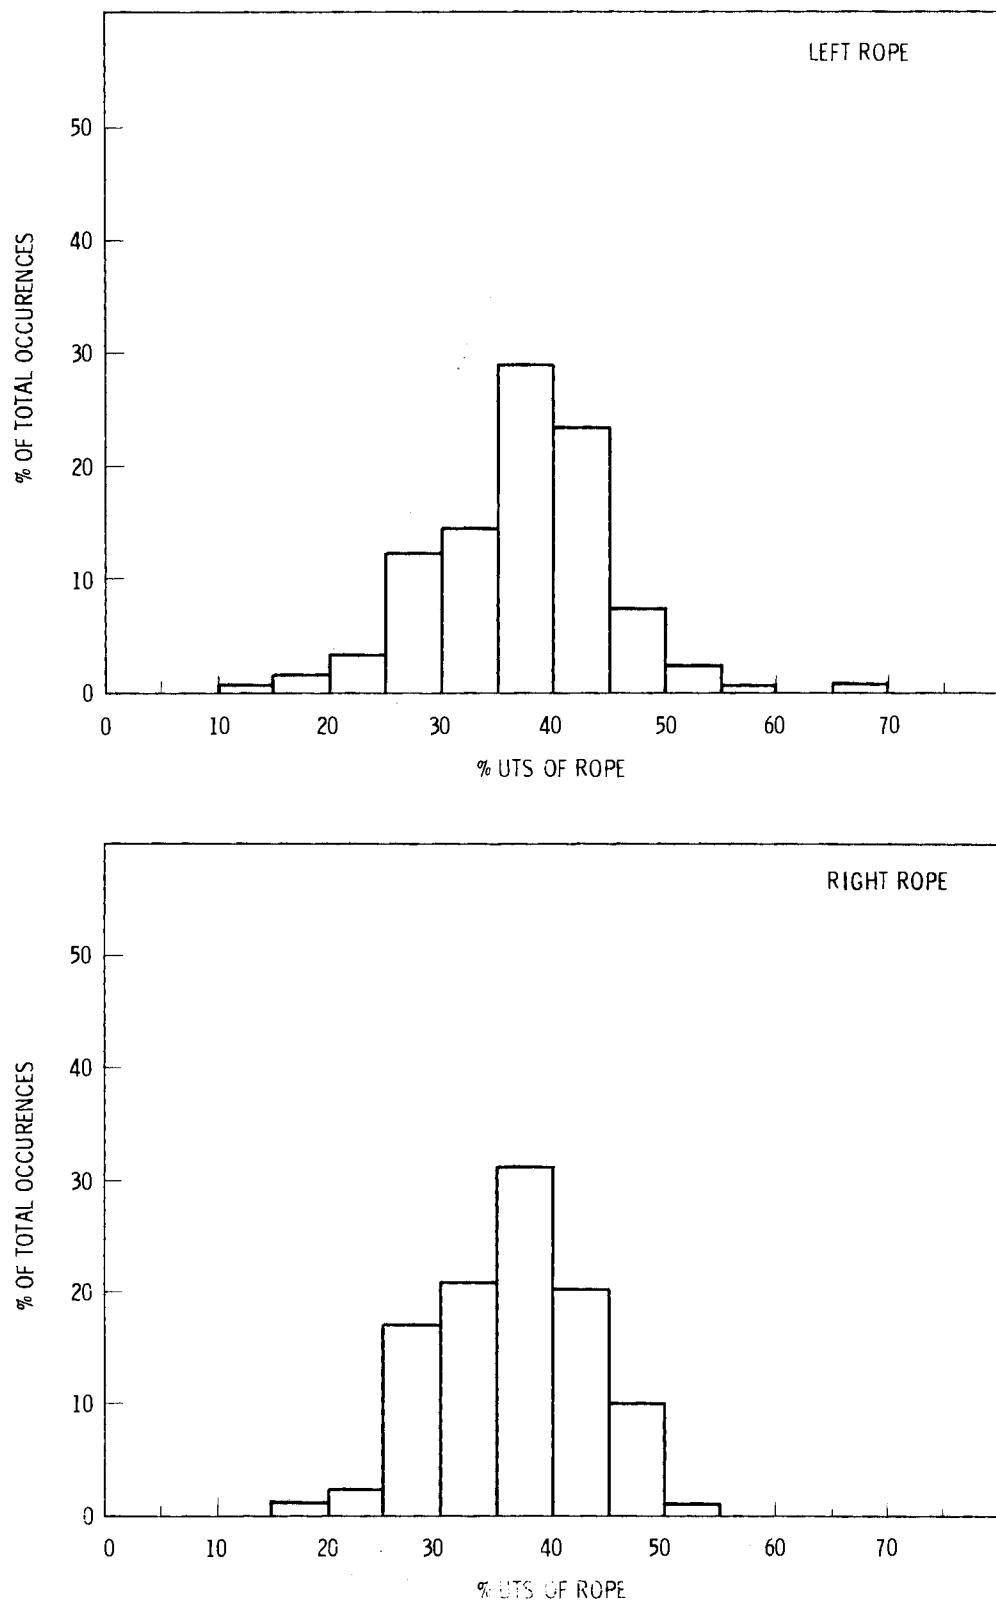
FIGURE 31. Occurrence Diagrams for the Subject Drag Ropes

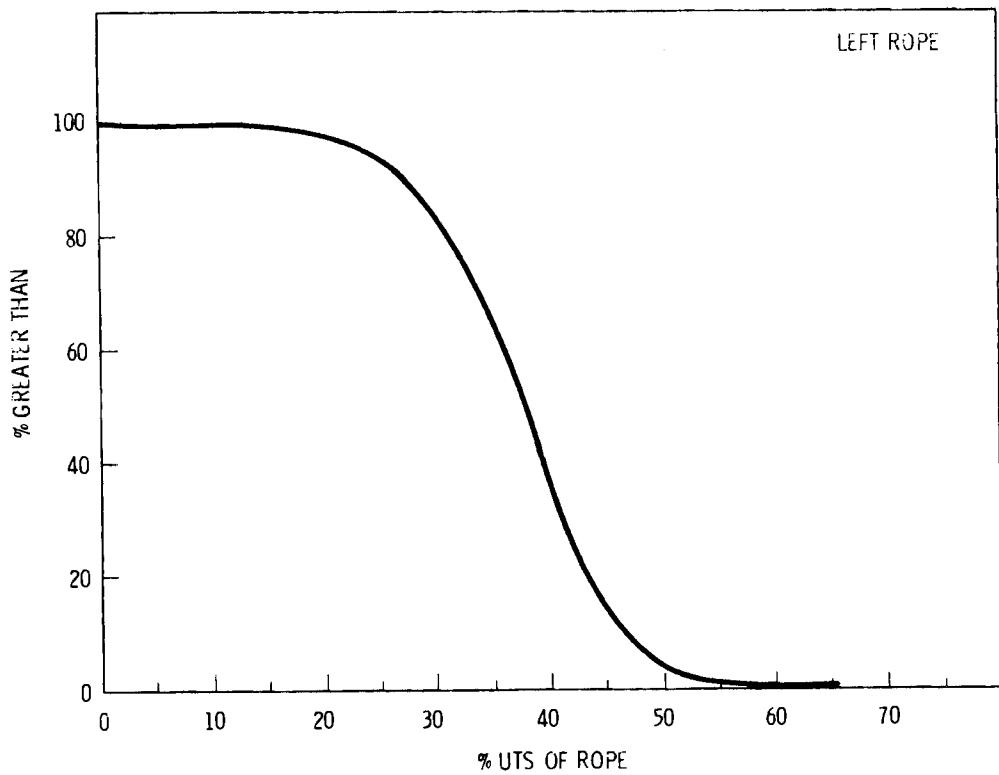
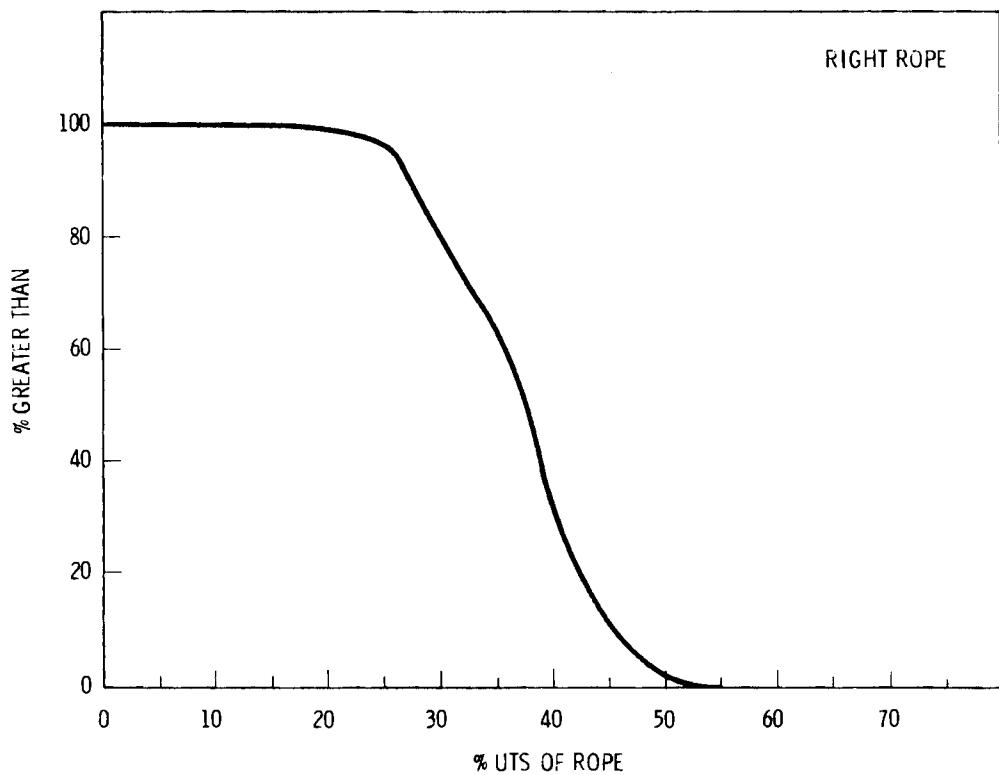
FIGURE 32. Exceedance Diagrams for the Subject Drag Ropes

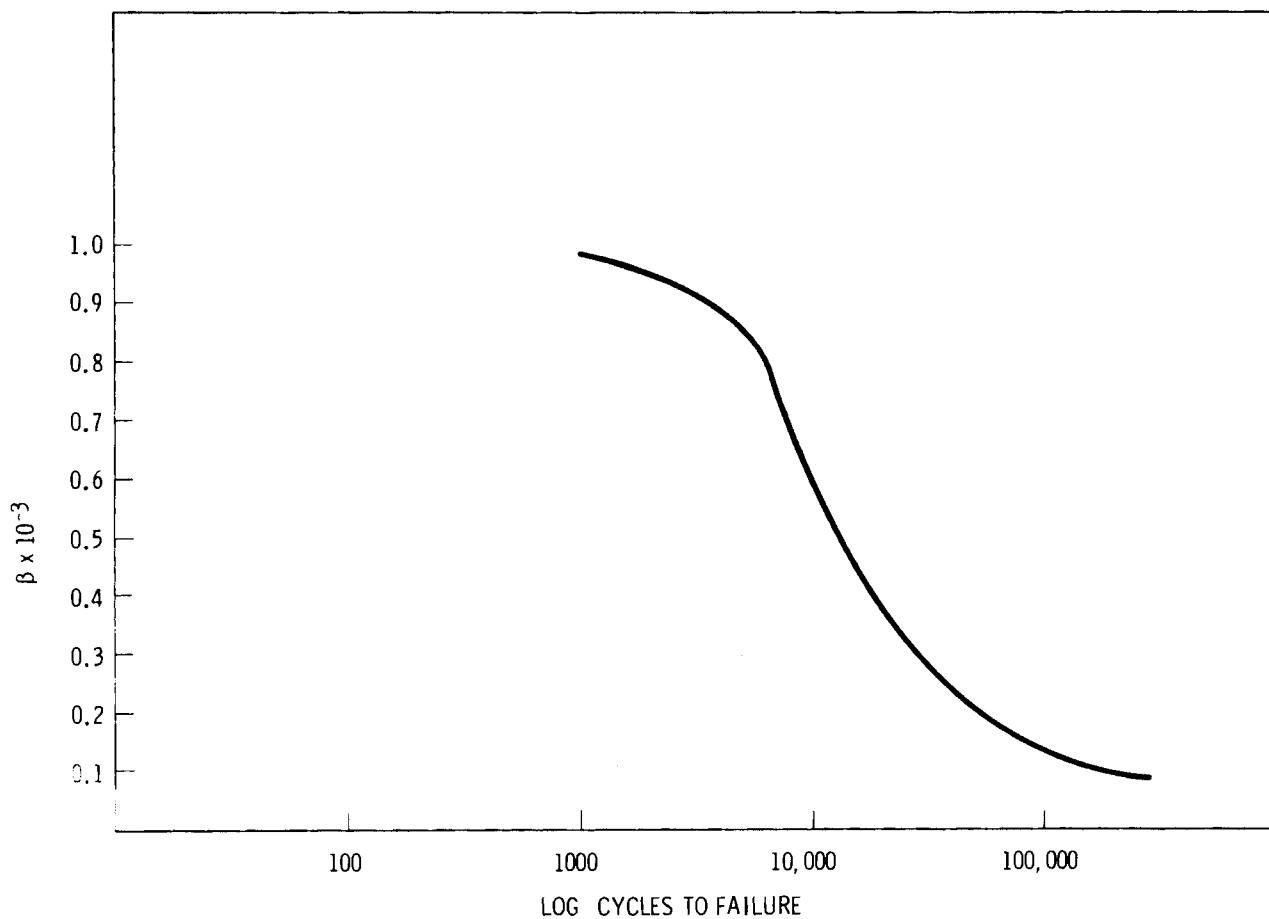
FIGURE 33. Fatigue Life Curve Used in Analyzing Cumulative Rope Damage
