FINAL REPORT

**Wire Rope Improvement
Program**

September 1981

**Pacific Northwest Laboratory
Operated for the U.S. Department of Energy
by Battelle Memorial Institute**

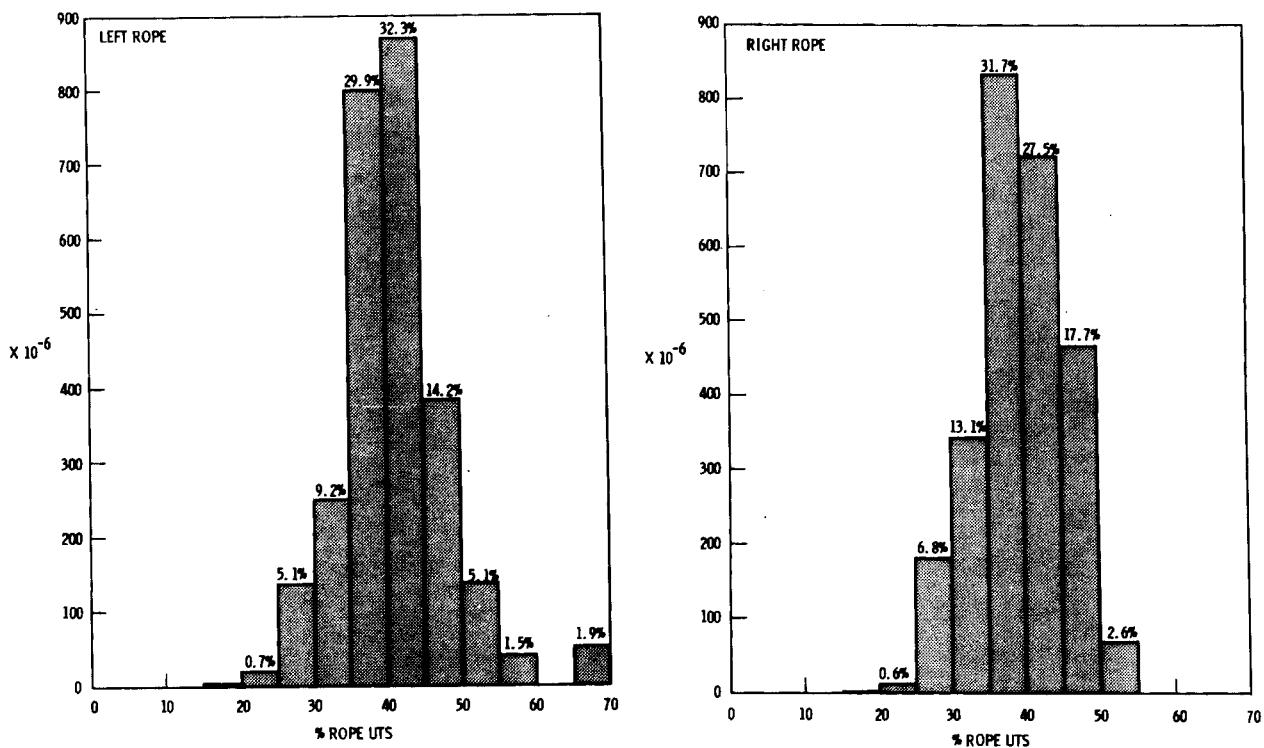
FIGURE 34. Plots of Relative Damage Factor Calculated From Fatigue Curve by Employing Miner's Rule

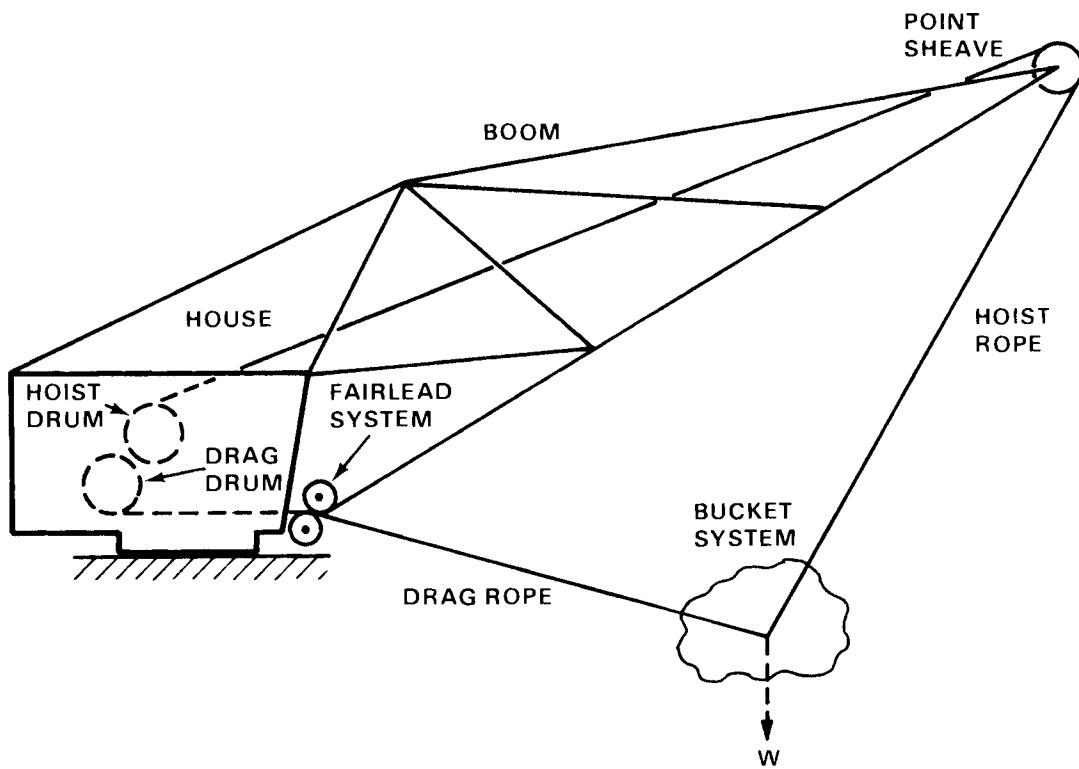
The dragline includes a primary structural frame containing the counterweight, motors, drums, and electrical equipment (Figure 35). Its long boom extends opposite the counterweight. The entire structure rotates on a large base and houses an operator's cab. The cab is positioned for viewing the bucket system, which is lifted and lowered by hoist ropes and pulled by drag ropes.

FIGURE 35. Schematic Arrangement of Walking Dragline

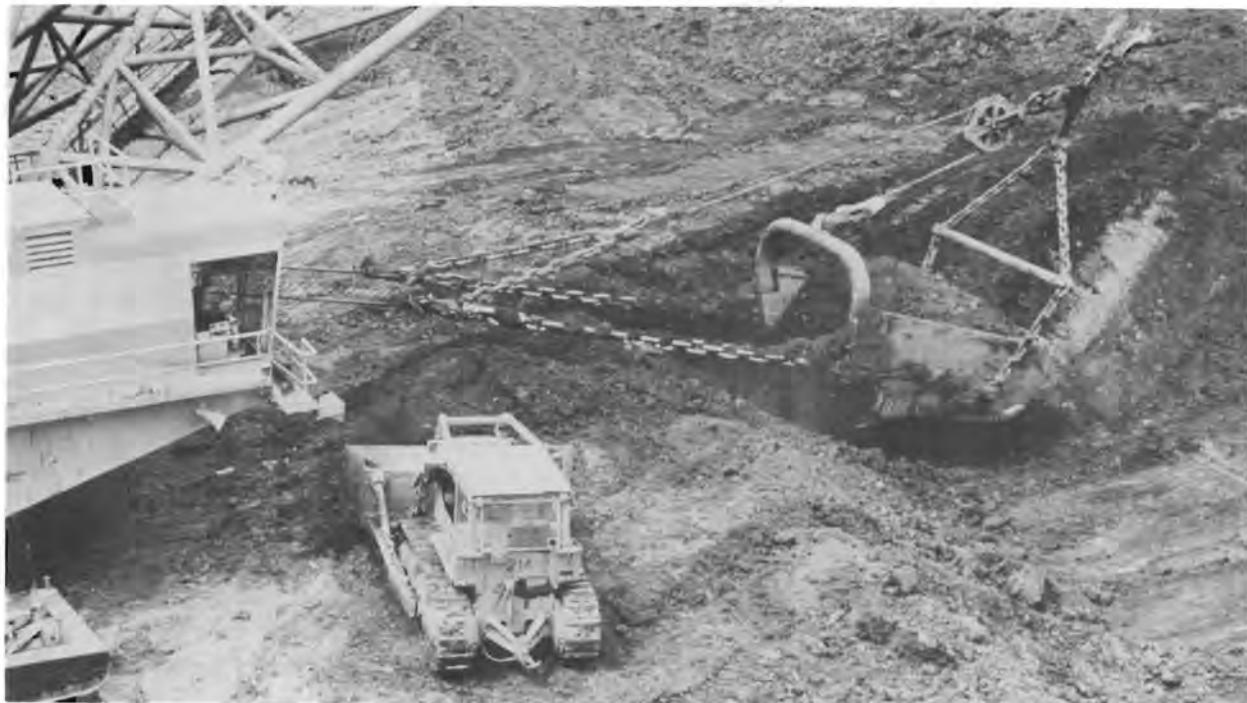
FIGURE 39. Bucket with Bale and Single Dump Rope System

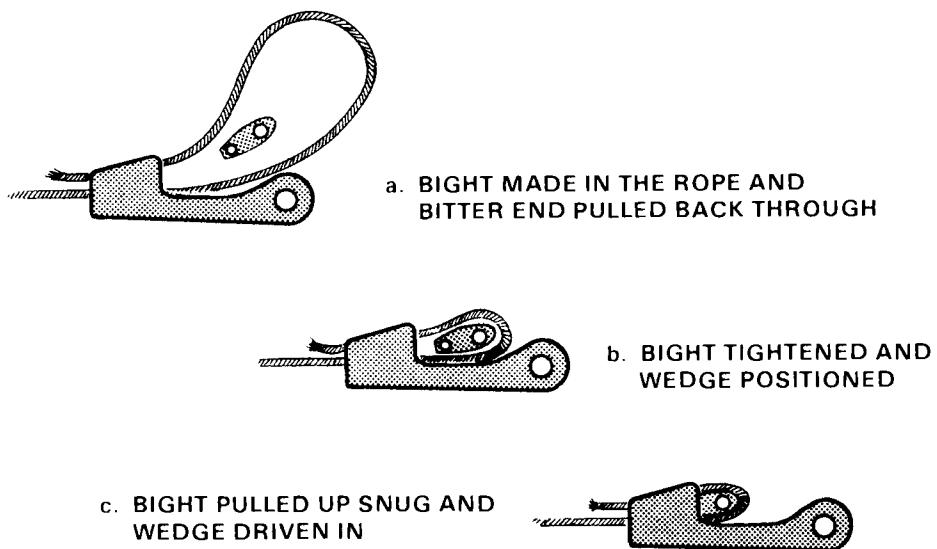
Socketing a rope requires power equipment. In the field a cat-tractor is generally used to pull the bitter end by tying onto it with smaller rope chokers. To pull the bight snug and drive in the wedge the socket must be

FIGURE 42. Schematic of Rope Socketing Sequence

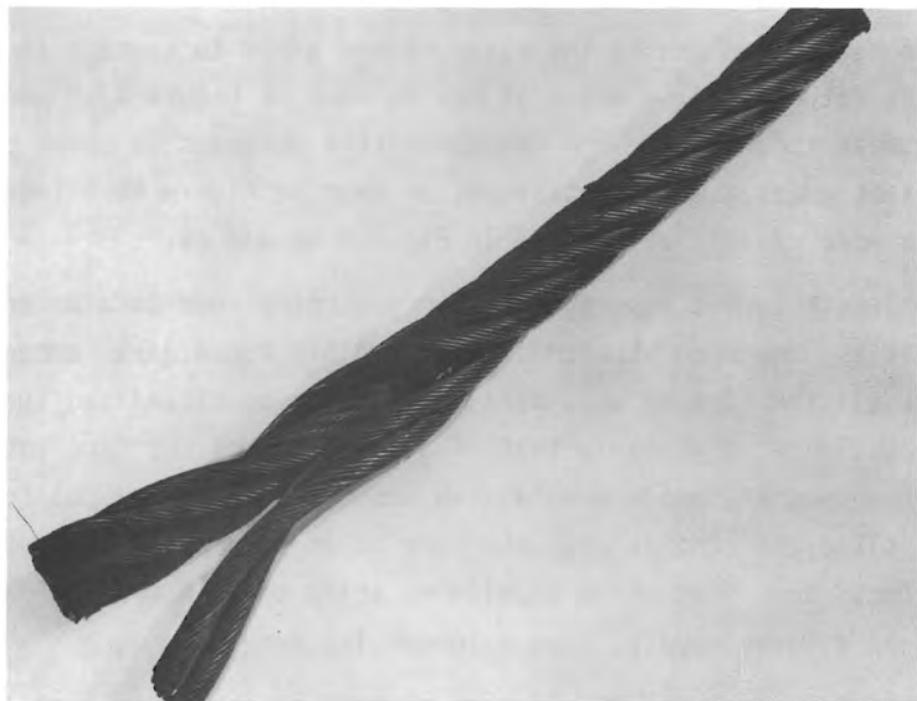
FIGURE 43. General View of IWRC Rope with Two Strands Twisted Out

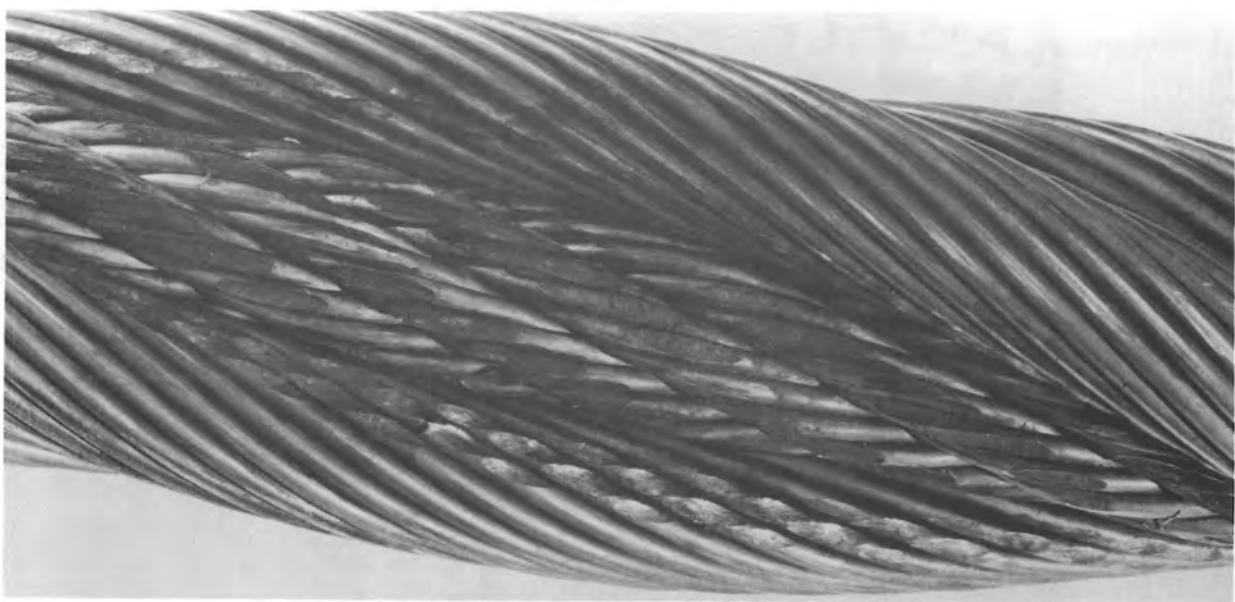
FIGURE 45. Closeup of IWRC and Strands in Figure 44

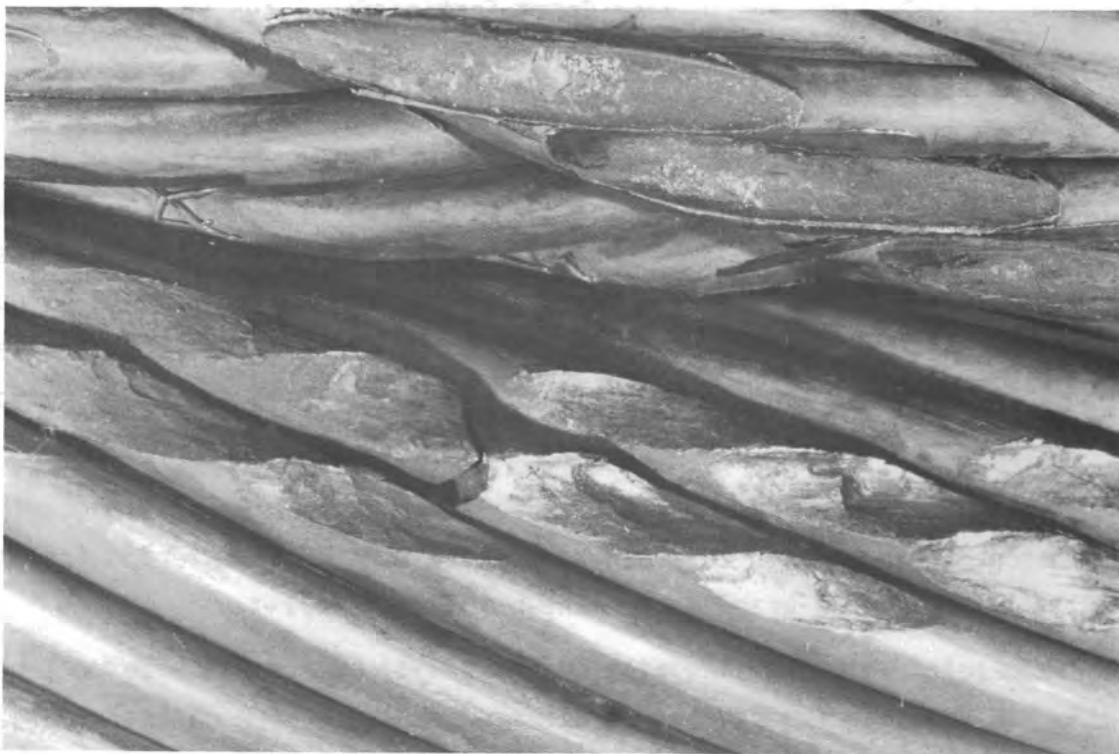
FIGURE 46. Detail of Wear Patterns and Wire Fracture Seen in Figure 45

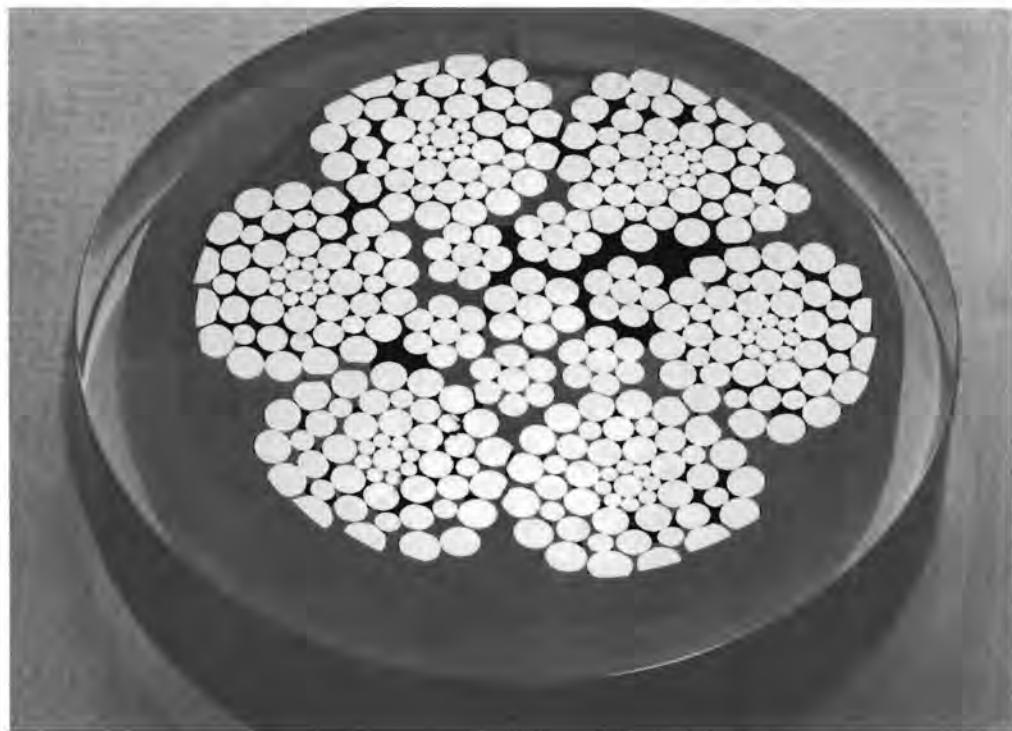
FIGURE 47. Sample Rope Cross Section from Used Drag Rope

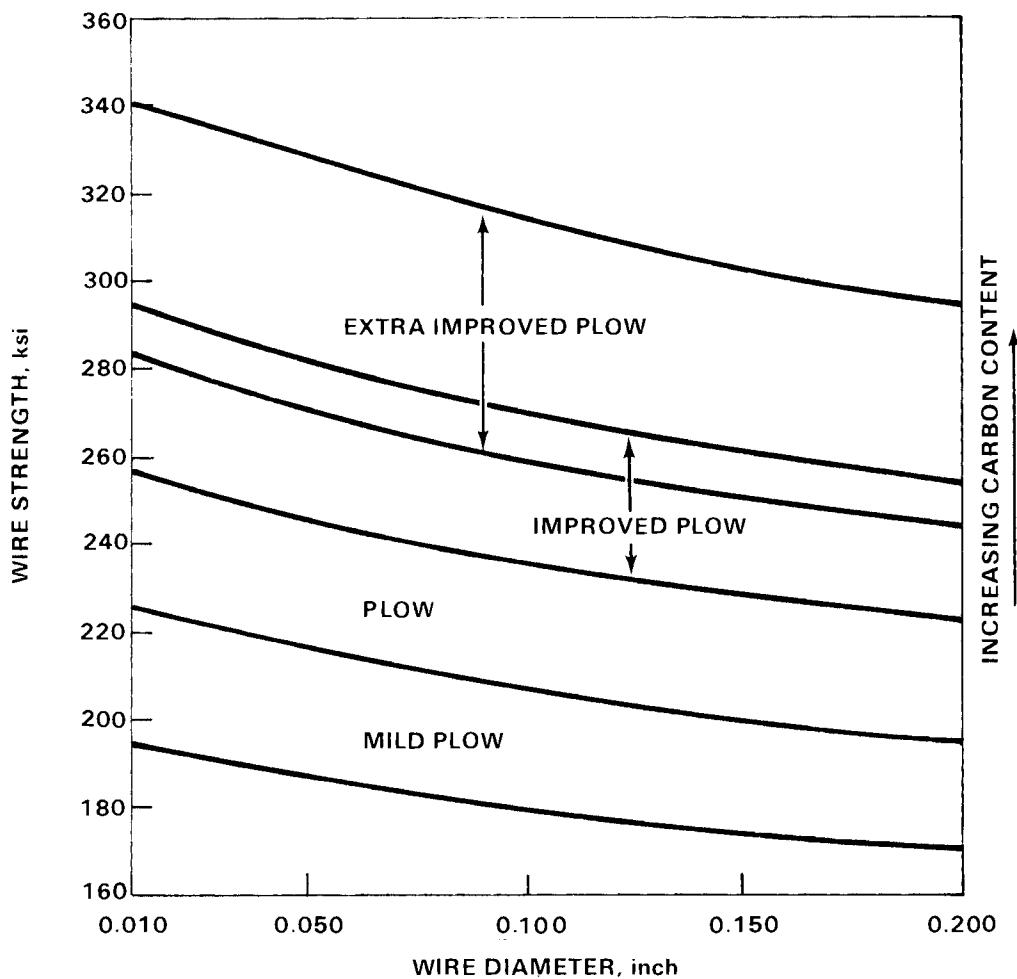
FIGURE 48. Carbon Steel Wire Strengths for Various Grades and Diameters

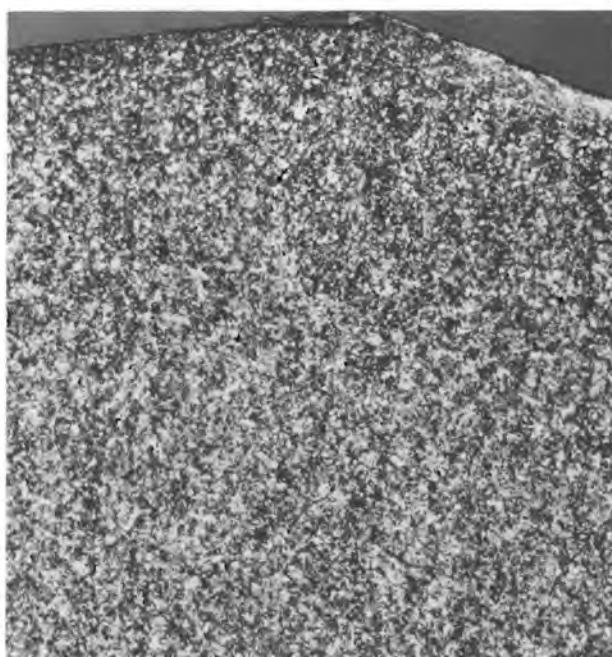
a. Transverse Section of a Small Wire (250X)

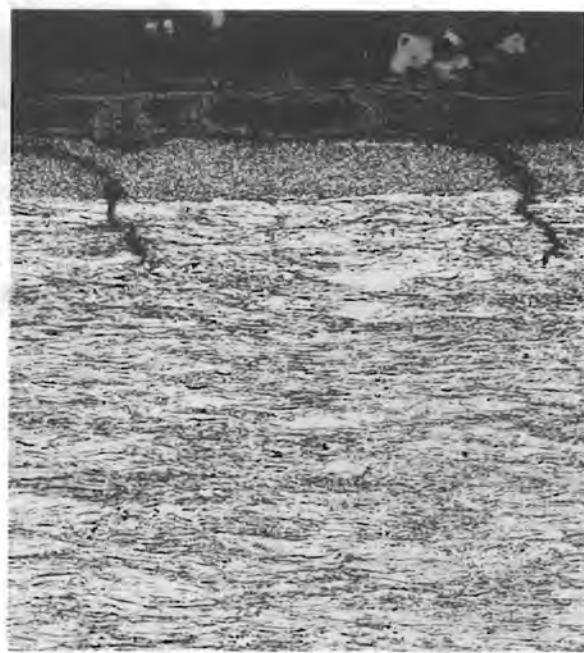
d. Longitudinal Wire Section Along Minor Contact Area (250X)

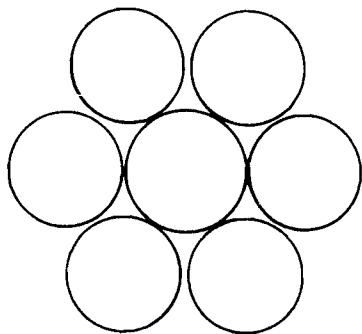
a. Intentional "Looseness" of As-Fabricated Rope

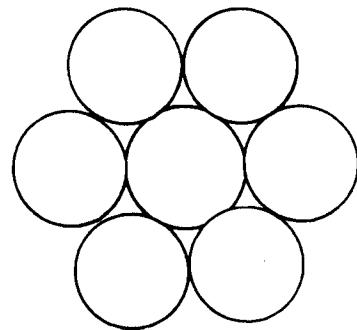
b. Snug Fit After Some Accommodating Wear/Deformation

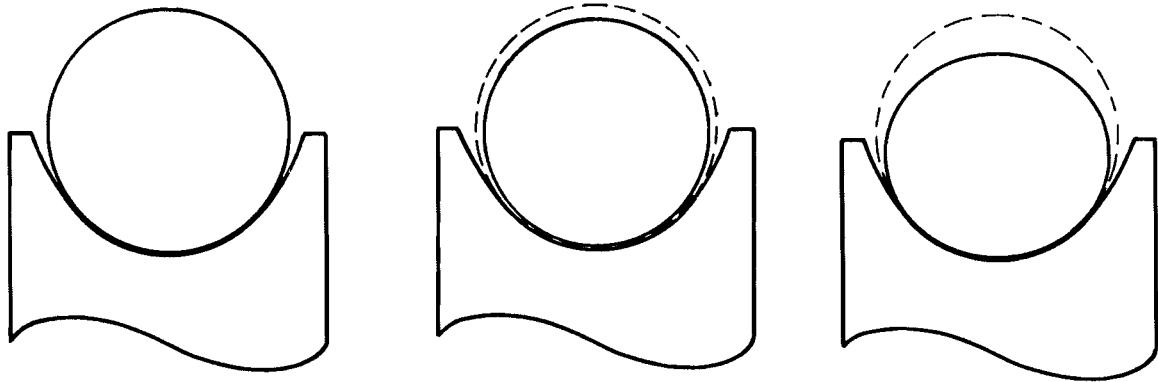
a. Snug Fit of Unloaded Rope b. Loose Fit of Axially Loaded Rope c. Flattened Fit of Loaded and Bent Rope

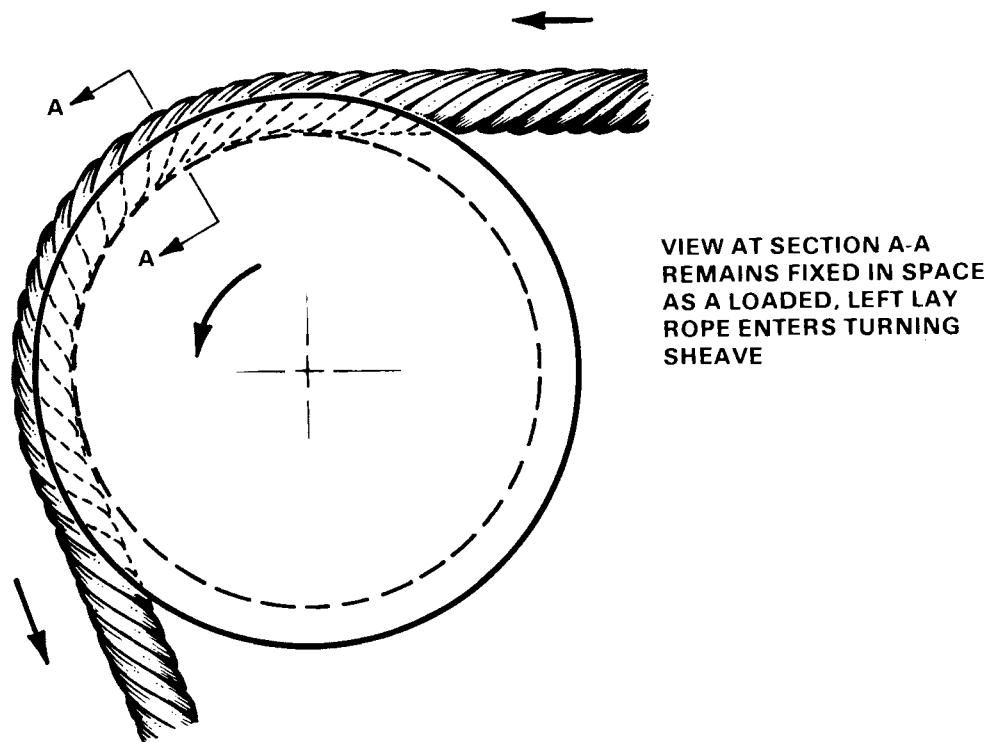
FIGURE 52. Schematic of Rope/Sheave Condition for Assessing Strand/Rope Motion via Seven-Circle Model of Rope in Slightly Oversize Sheave Groove

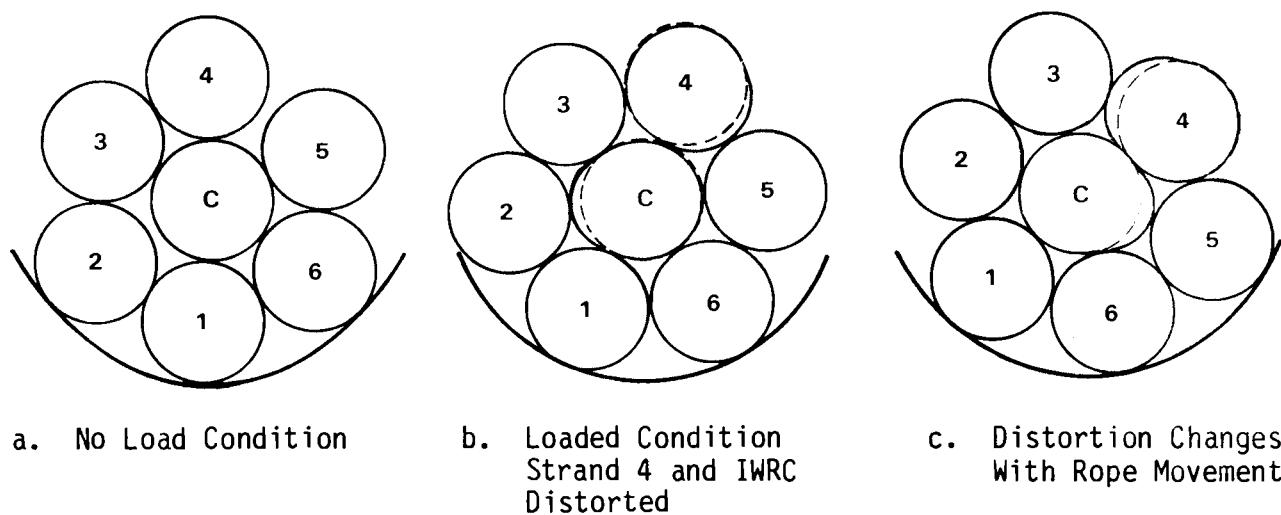
FIGURE 53. Seven-Circle Model of Loaded Rope Moving Onto Sheave Groove That is Somewhat Larger than Loaded Rope

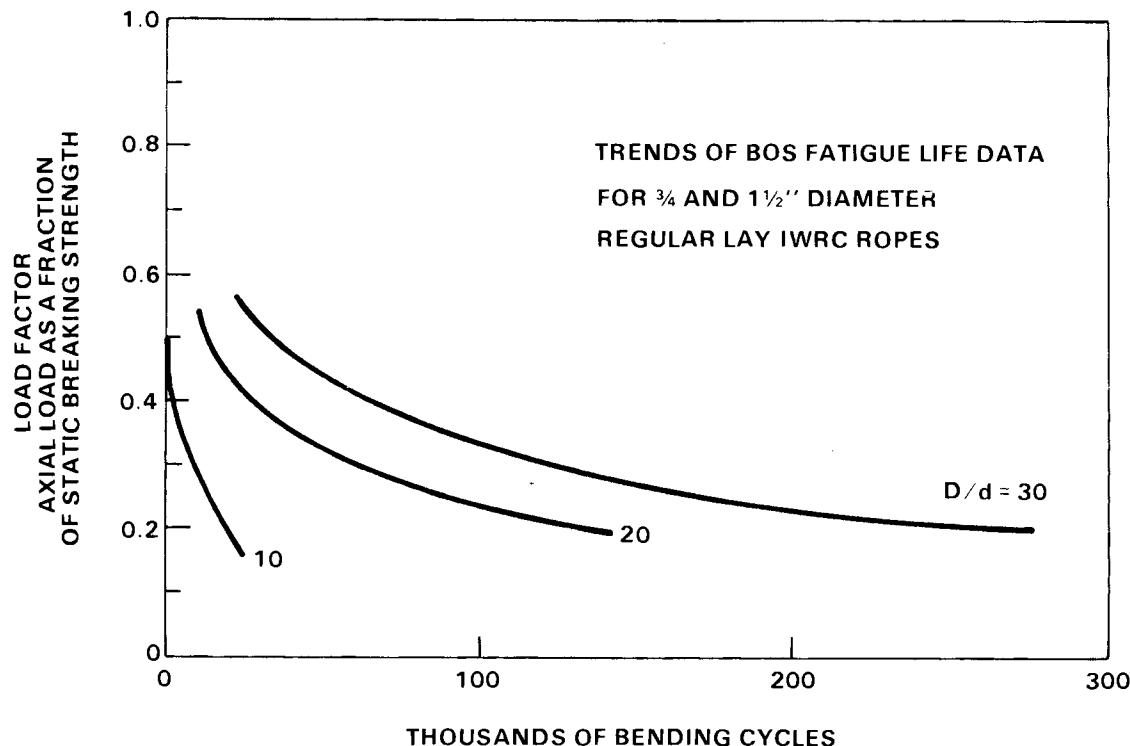
FIGURE 54. Linear-Life Plot of Small-Diameter Ropes in BOS Fatigue

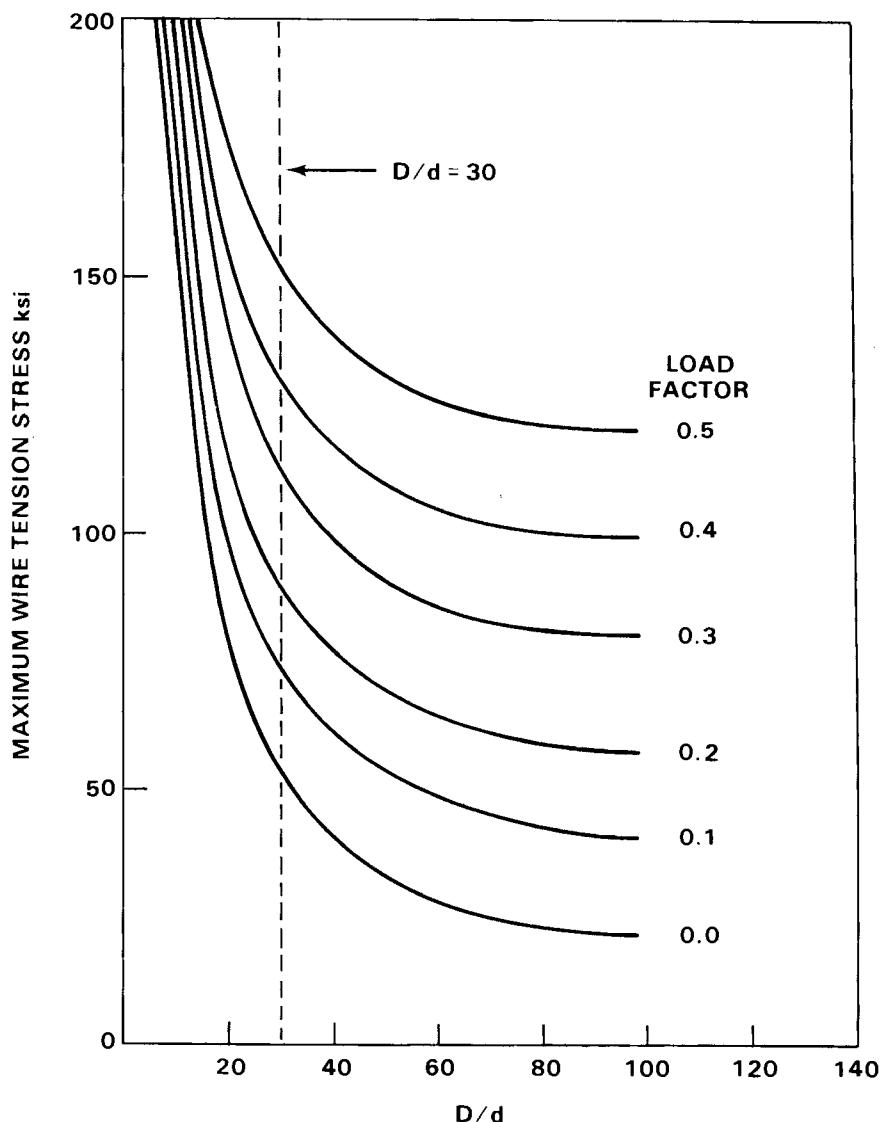
FIGURE 55. Combined Effects of Rope Bending and Axial Tensile Loads on Maximum Wire Stress in 3-in. Diameter B' Rope

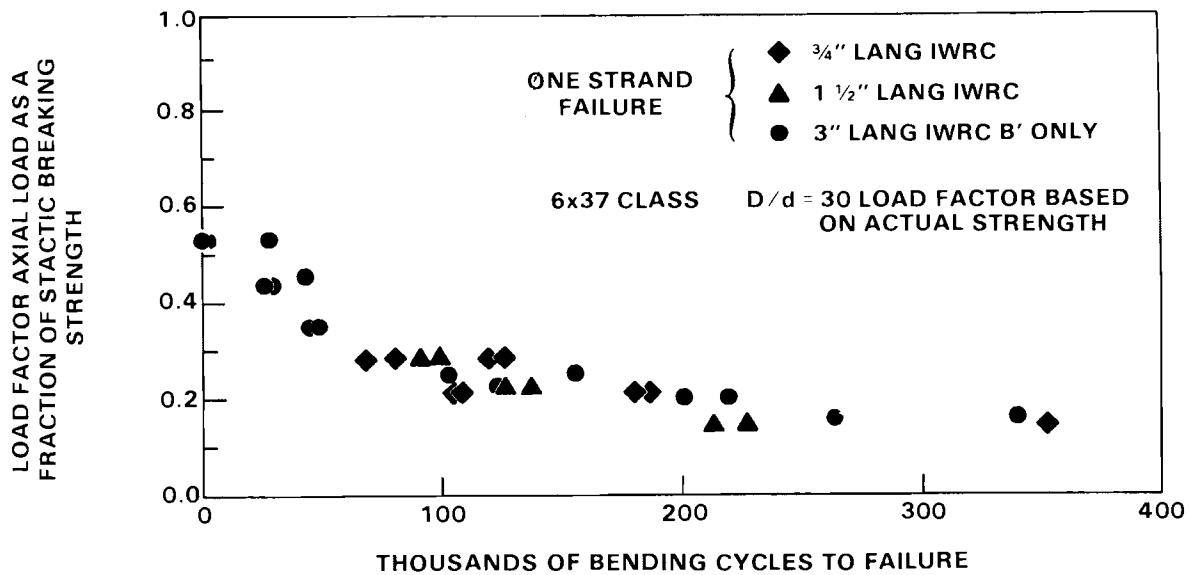
FIGURE 56. BOS Fatigue Life at One-Strand Failure for 6 x 37 Class Ropes at $D/d = 30$

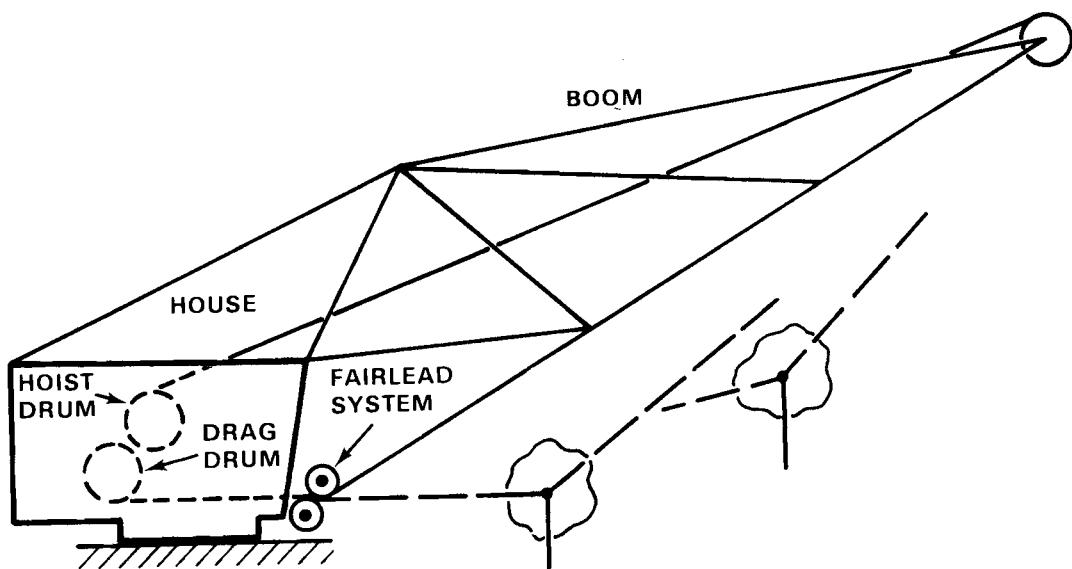
FIGURE 57. Situation in Which the Bucket Position Factor Causes Loads on the Hoist Ropes to be 1-1/2 Times the Bucket System Weight

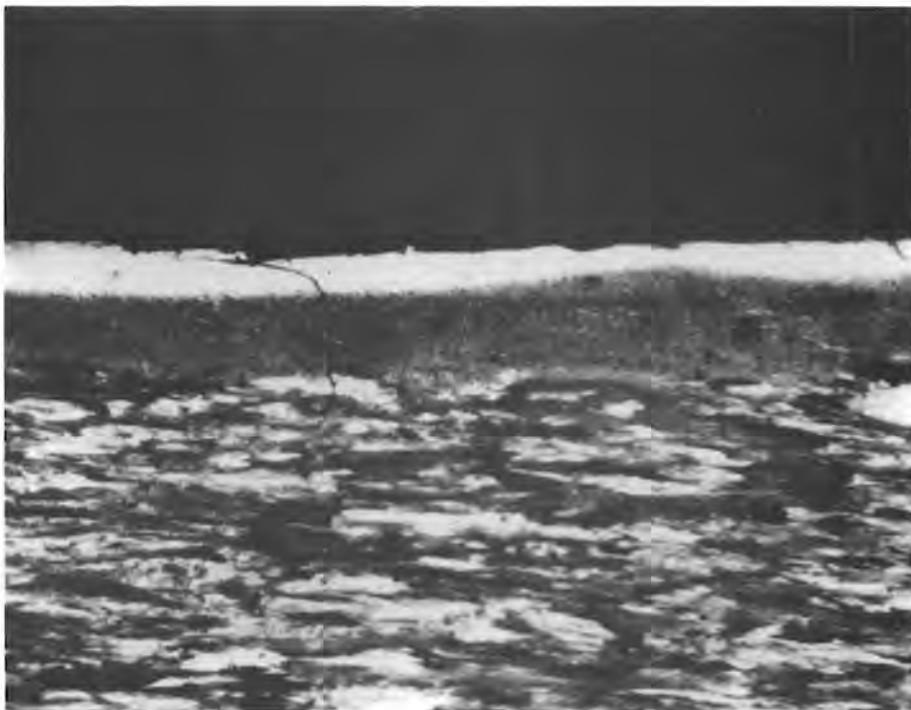
High Magnification View of White Etching Layer Showing Crack

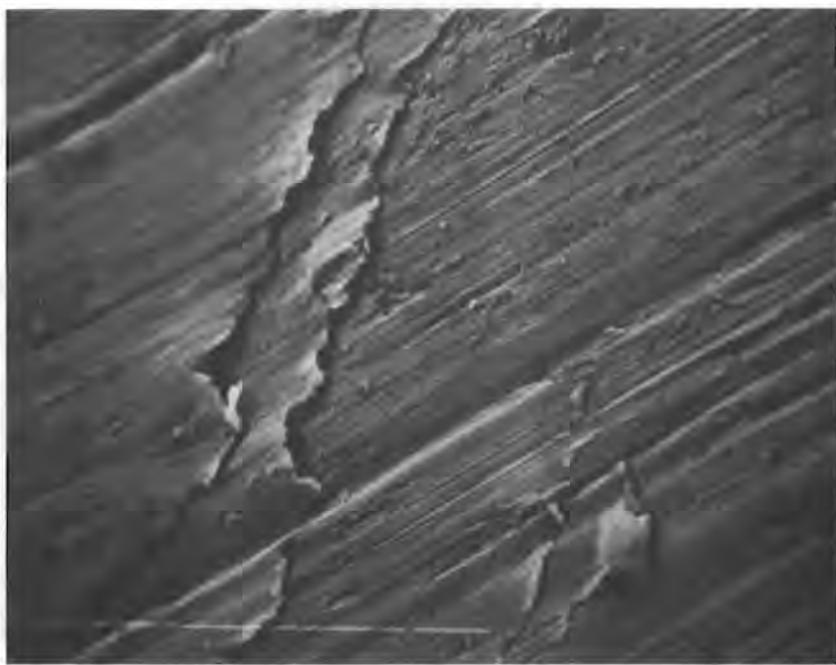
FIGURE 60. Detail of Abrasion Zone Showing Surface Flow and Delamination Type Wear

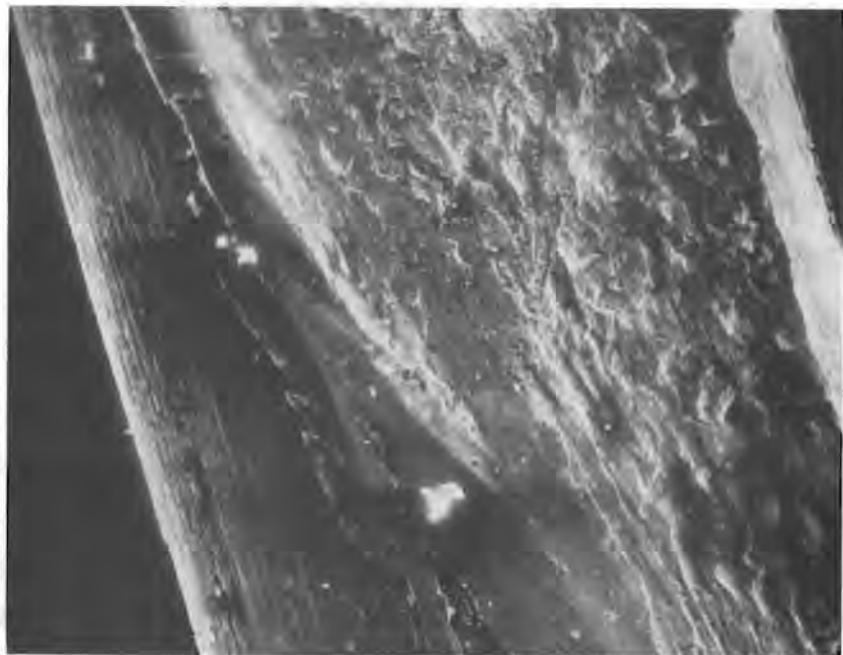
FIGURE 61. Detail of Wire Notching

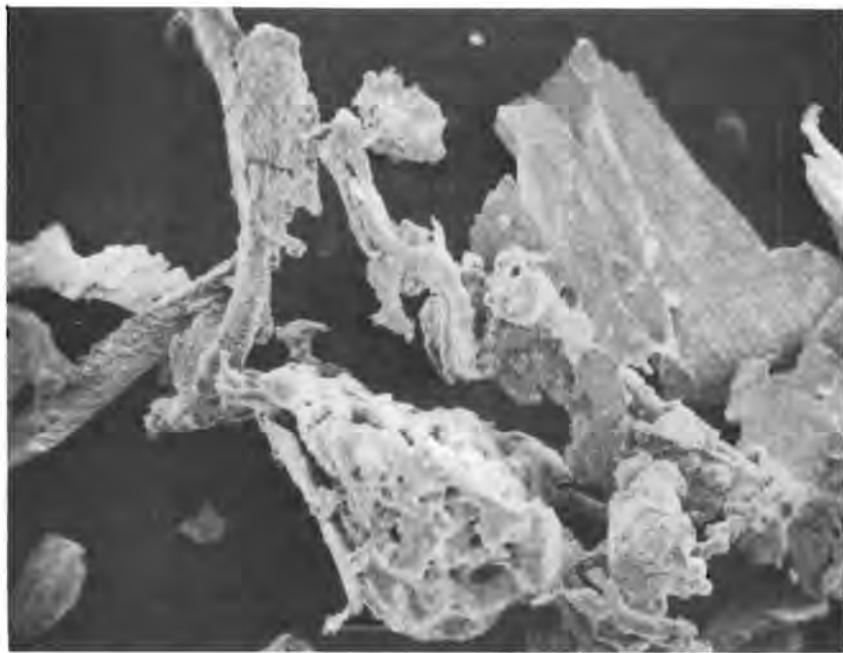
FIGURE 62. Steel Wear Debris Extracted from Wire Rope Sample

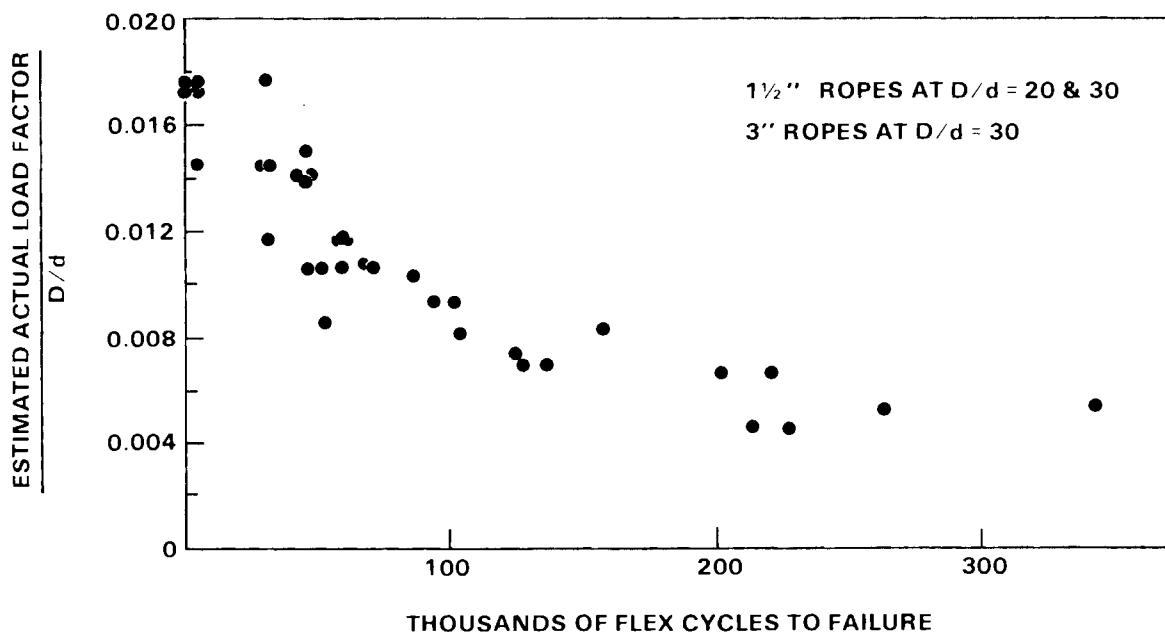
FIGURE 63. Bend-Over Sheave Fatigue Life Plots for 1-1/2- and 3-in. Ropes

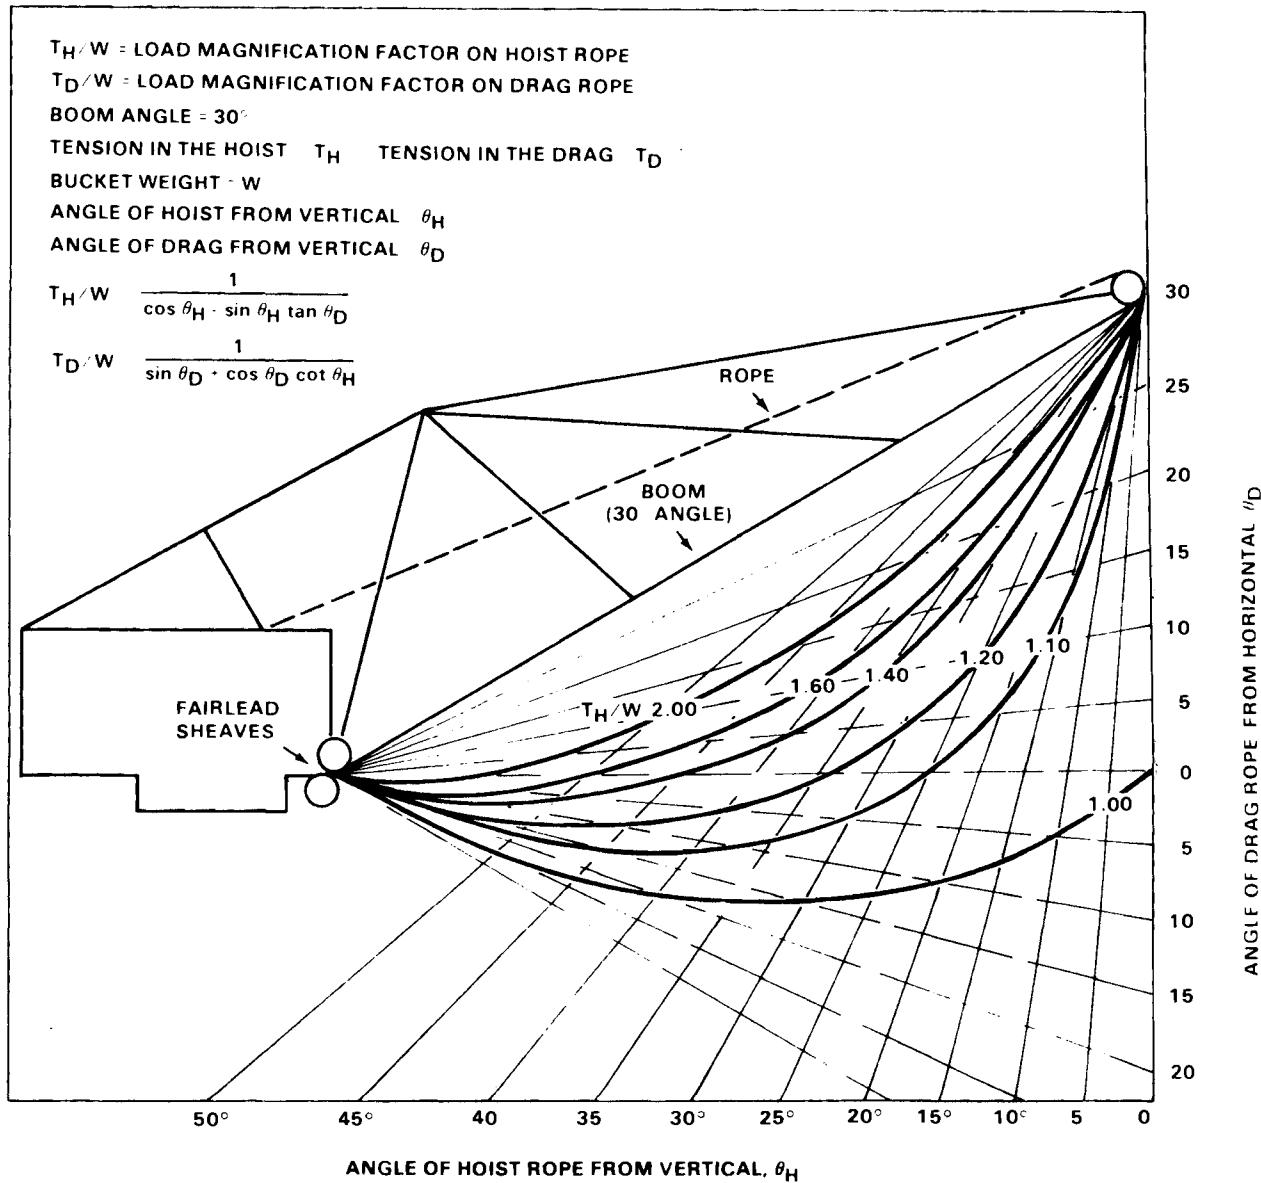
FIGURE A.2. Bucket Position Factor Effects on Hoist Rope(s)

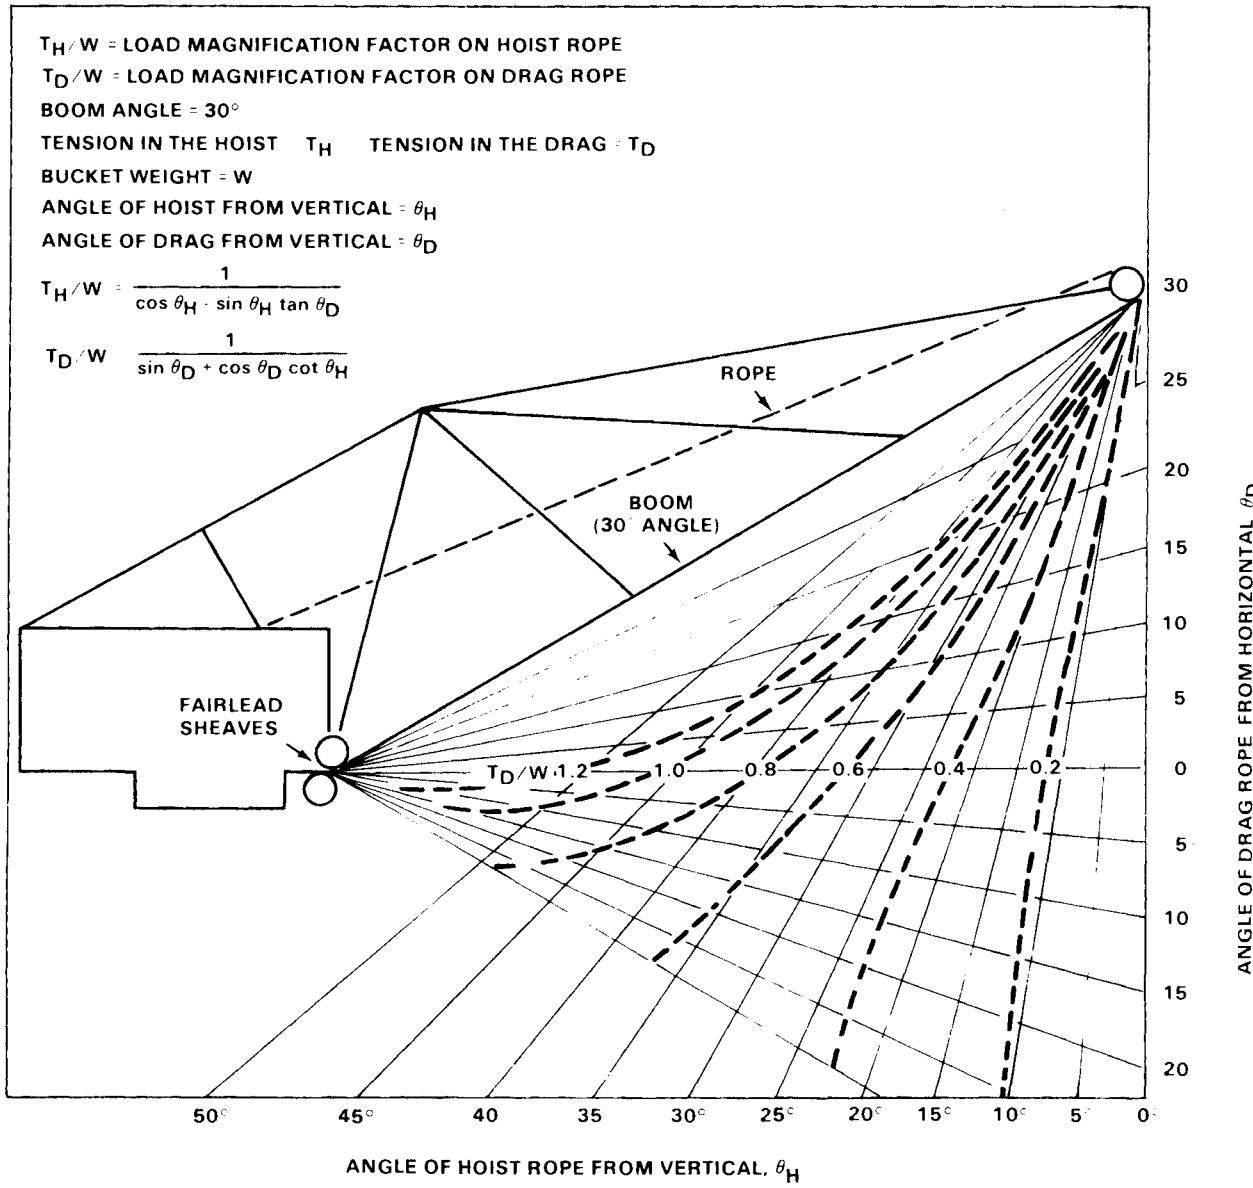
FIGURE A.3. Bucket Position Factor Effects on Drag Rope(s)

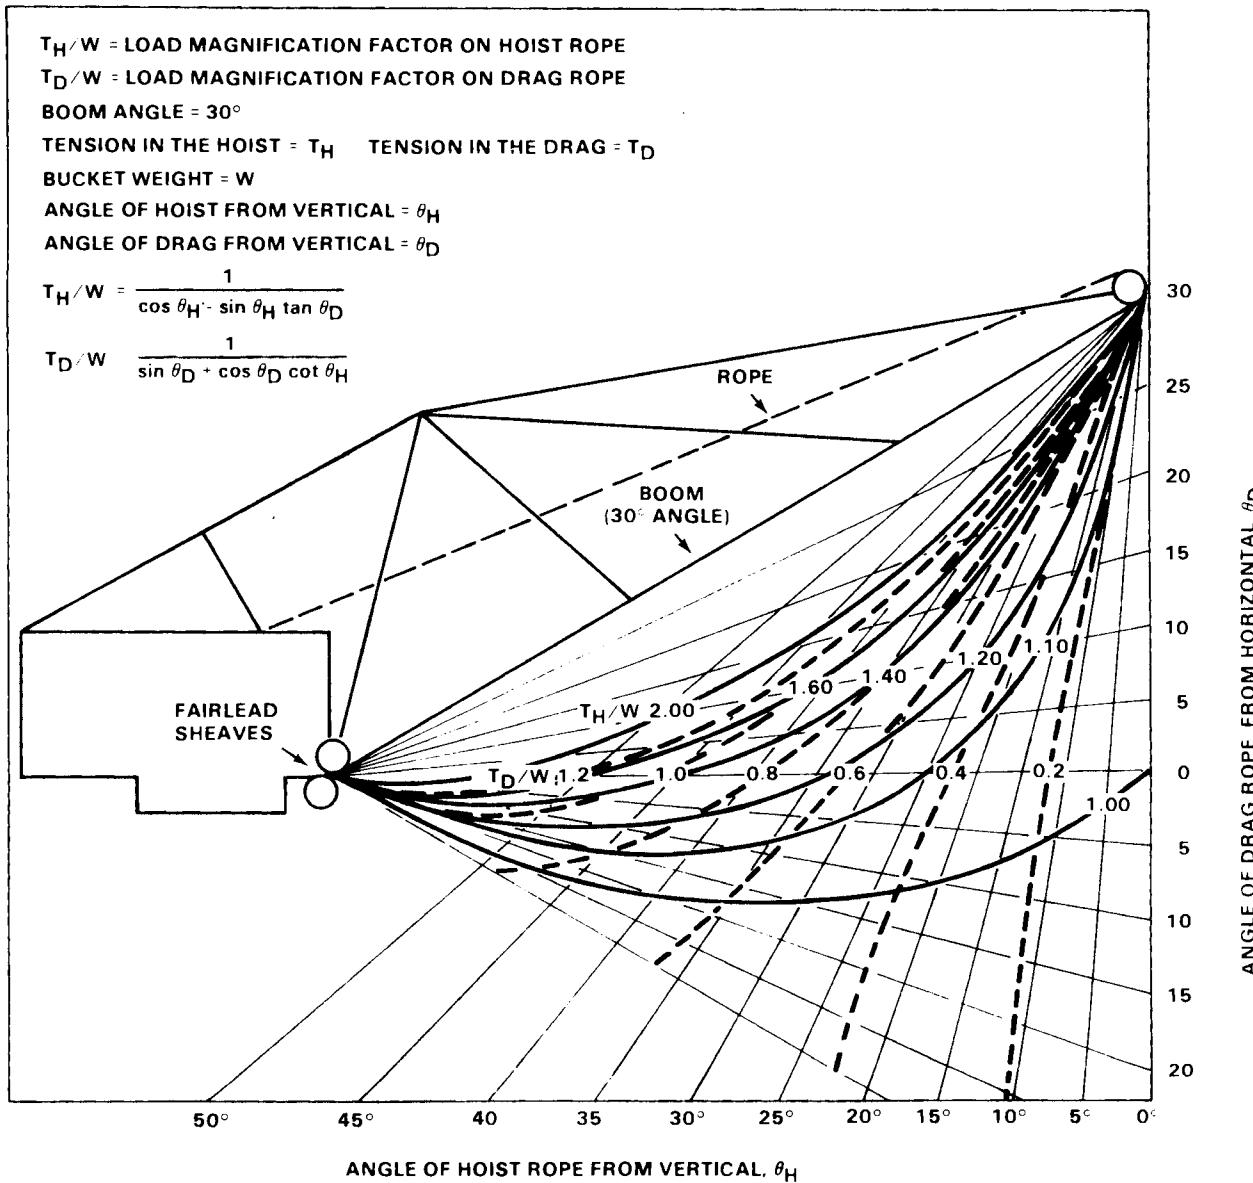
FIGURE A.4. Overlay Diagram of Hoist and Drag Rope Loads as a Function of Bucket Position
