EGG-WTD-9807

August 1991

### **In Situ Vitrification Application to Buried Waste: Final Report of Intermediate Field Tests at Idaho National Engineering Laboratory**

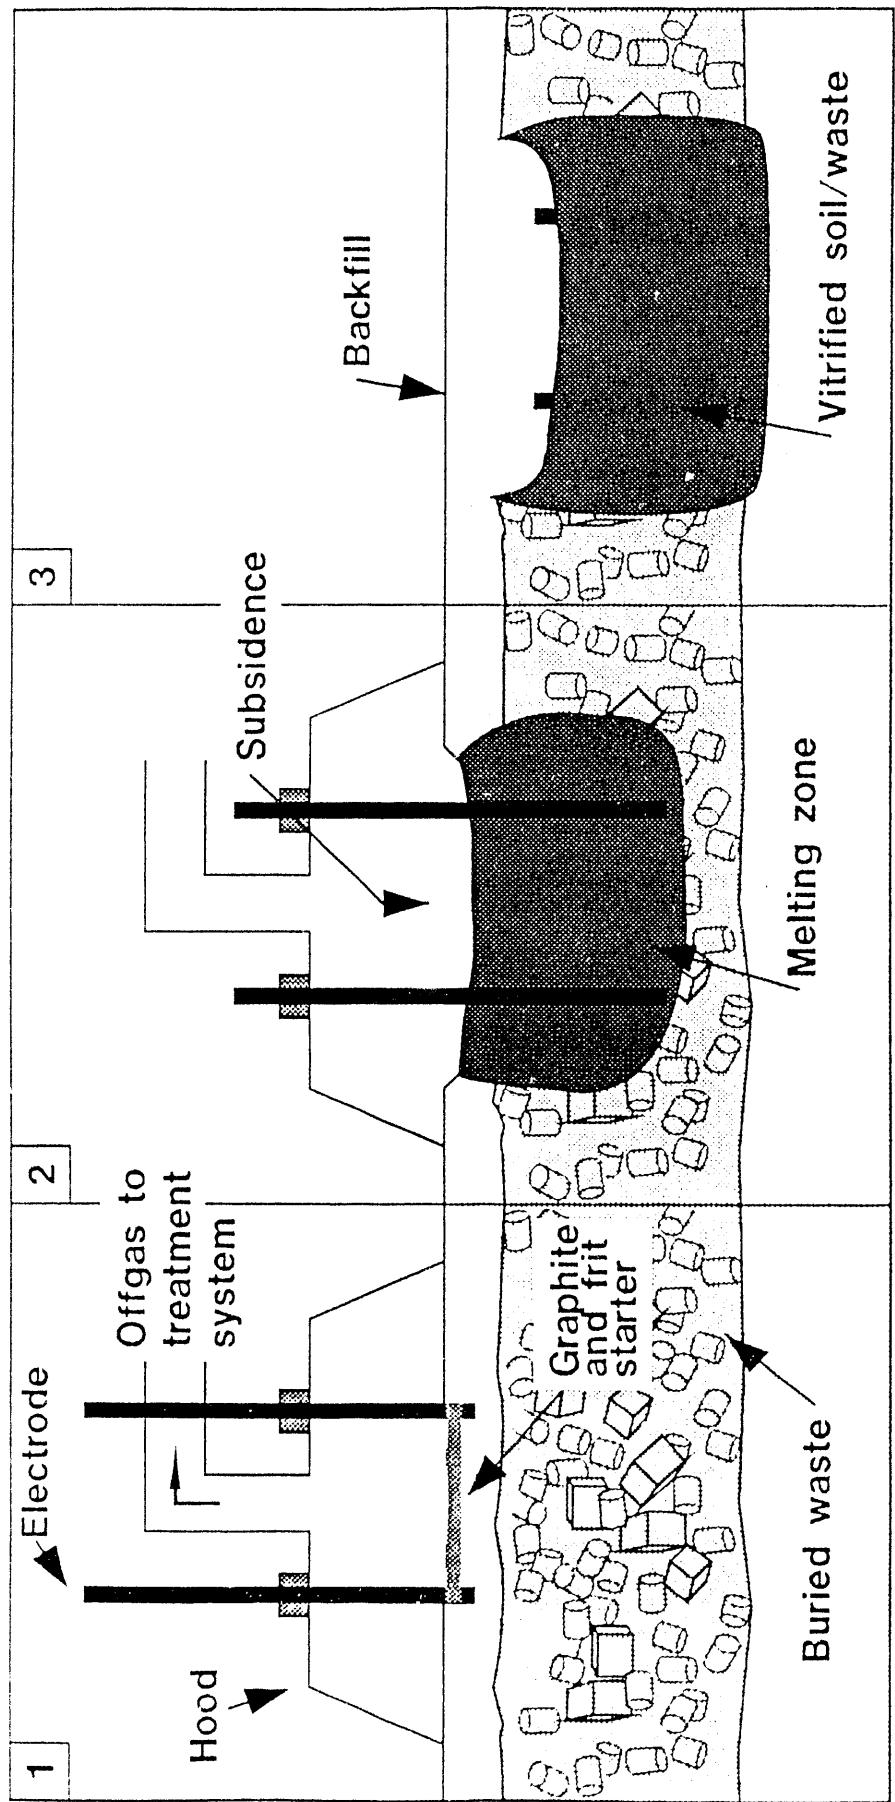
Figure 2. Electrode insertion during the ISV process.

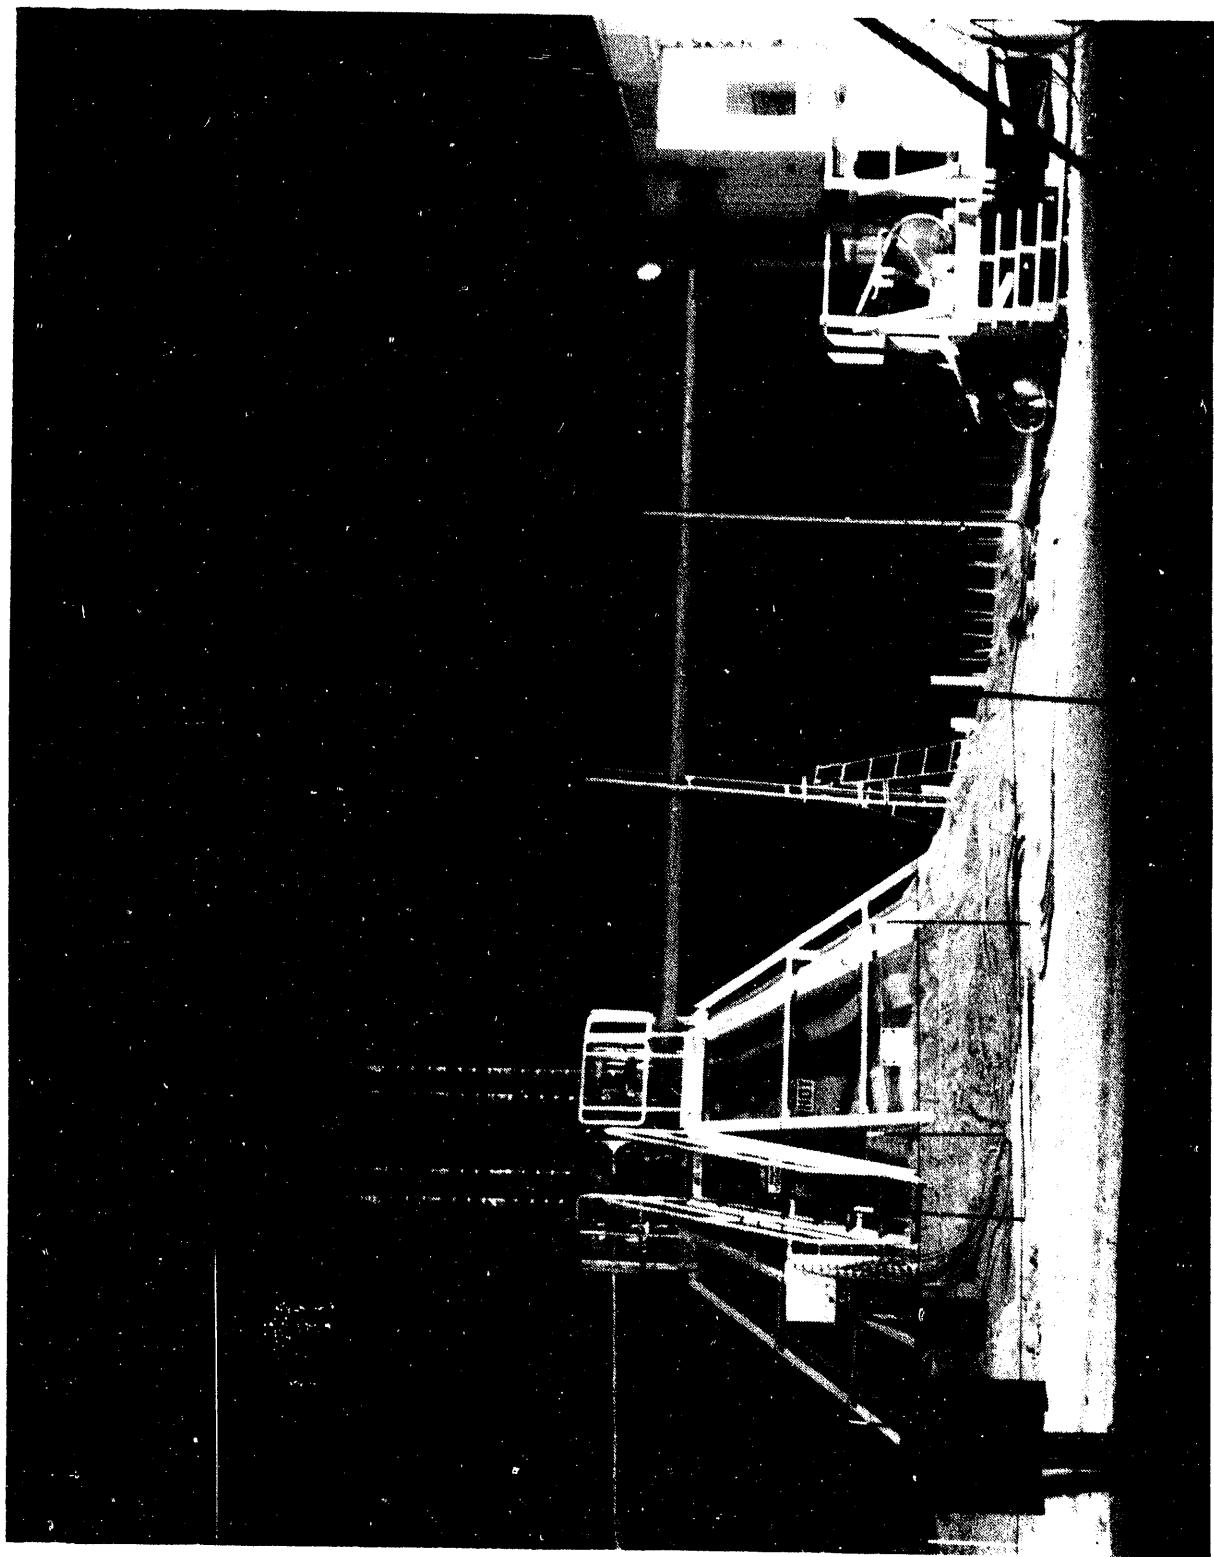
Figure 5. Intermediate-scale system setup at INEL Site.

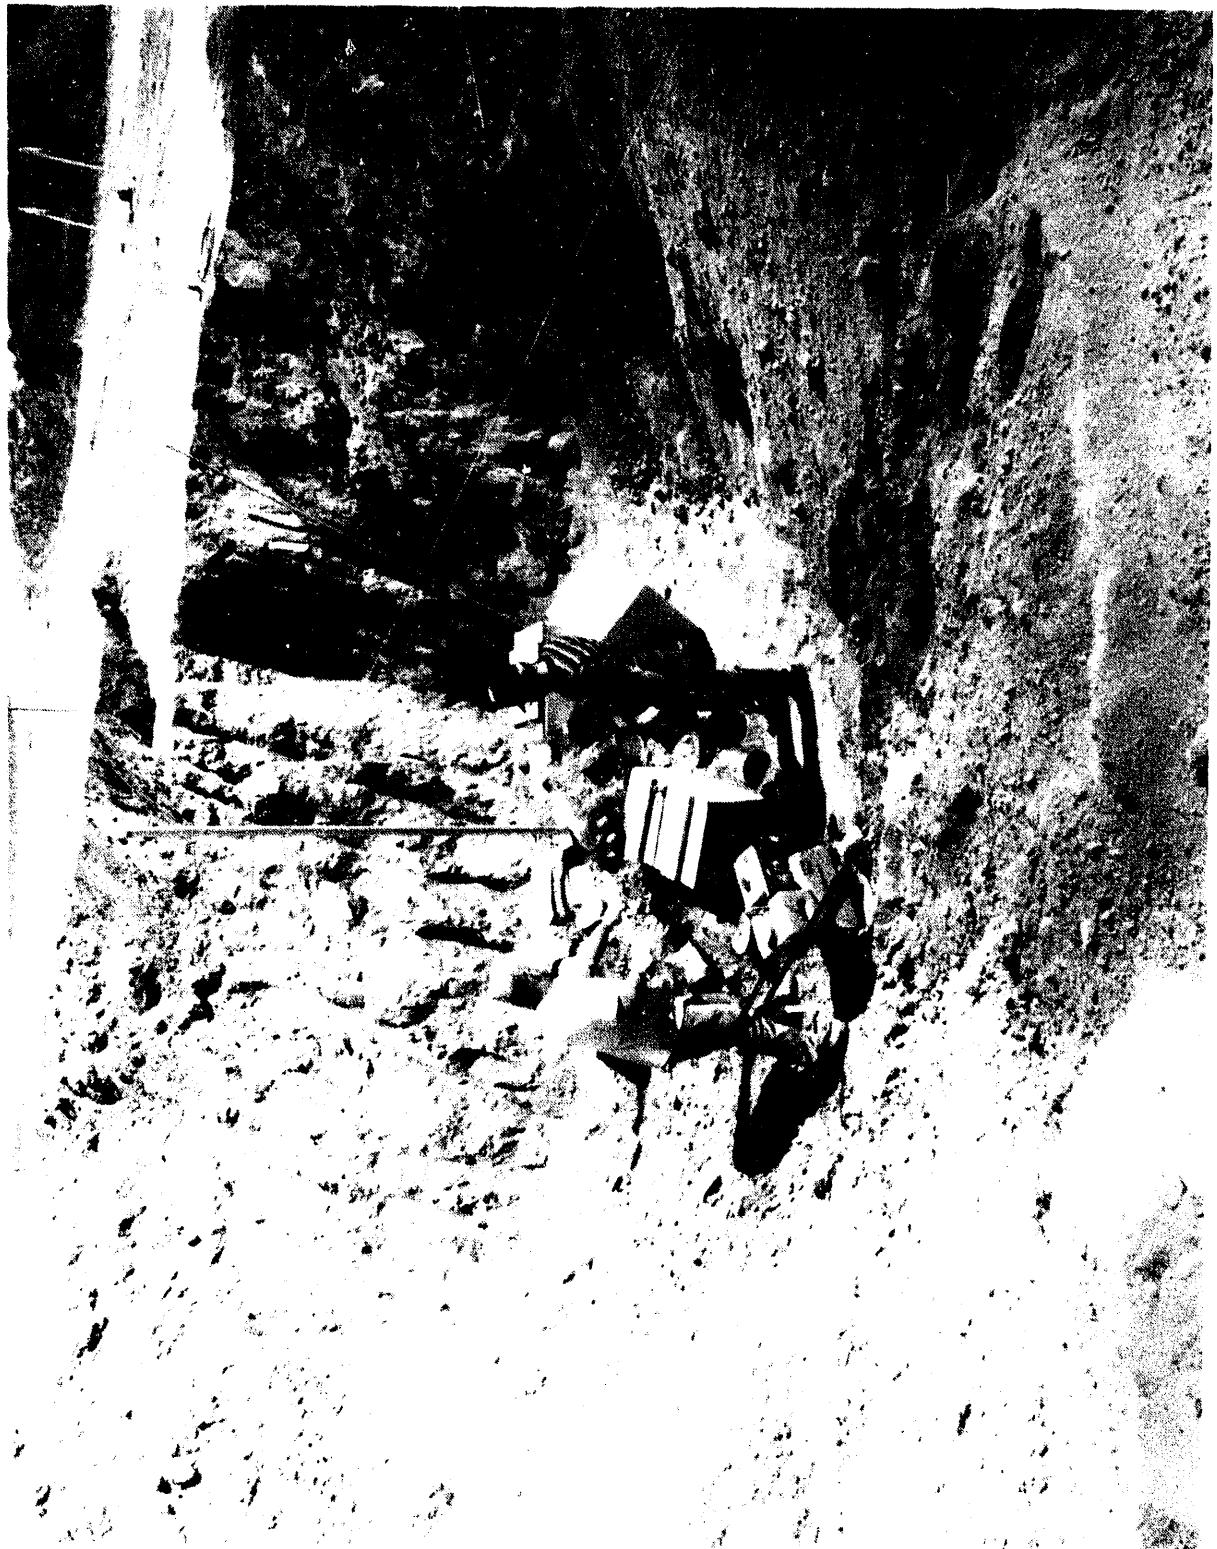
Figure 11. Cans and boxes placed in Test Pit 1, bottom layer (layer 4).

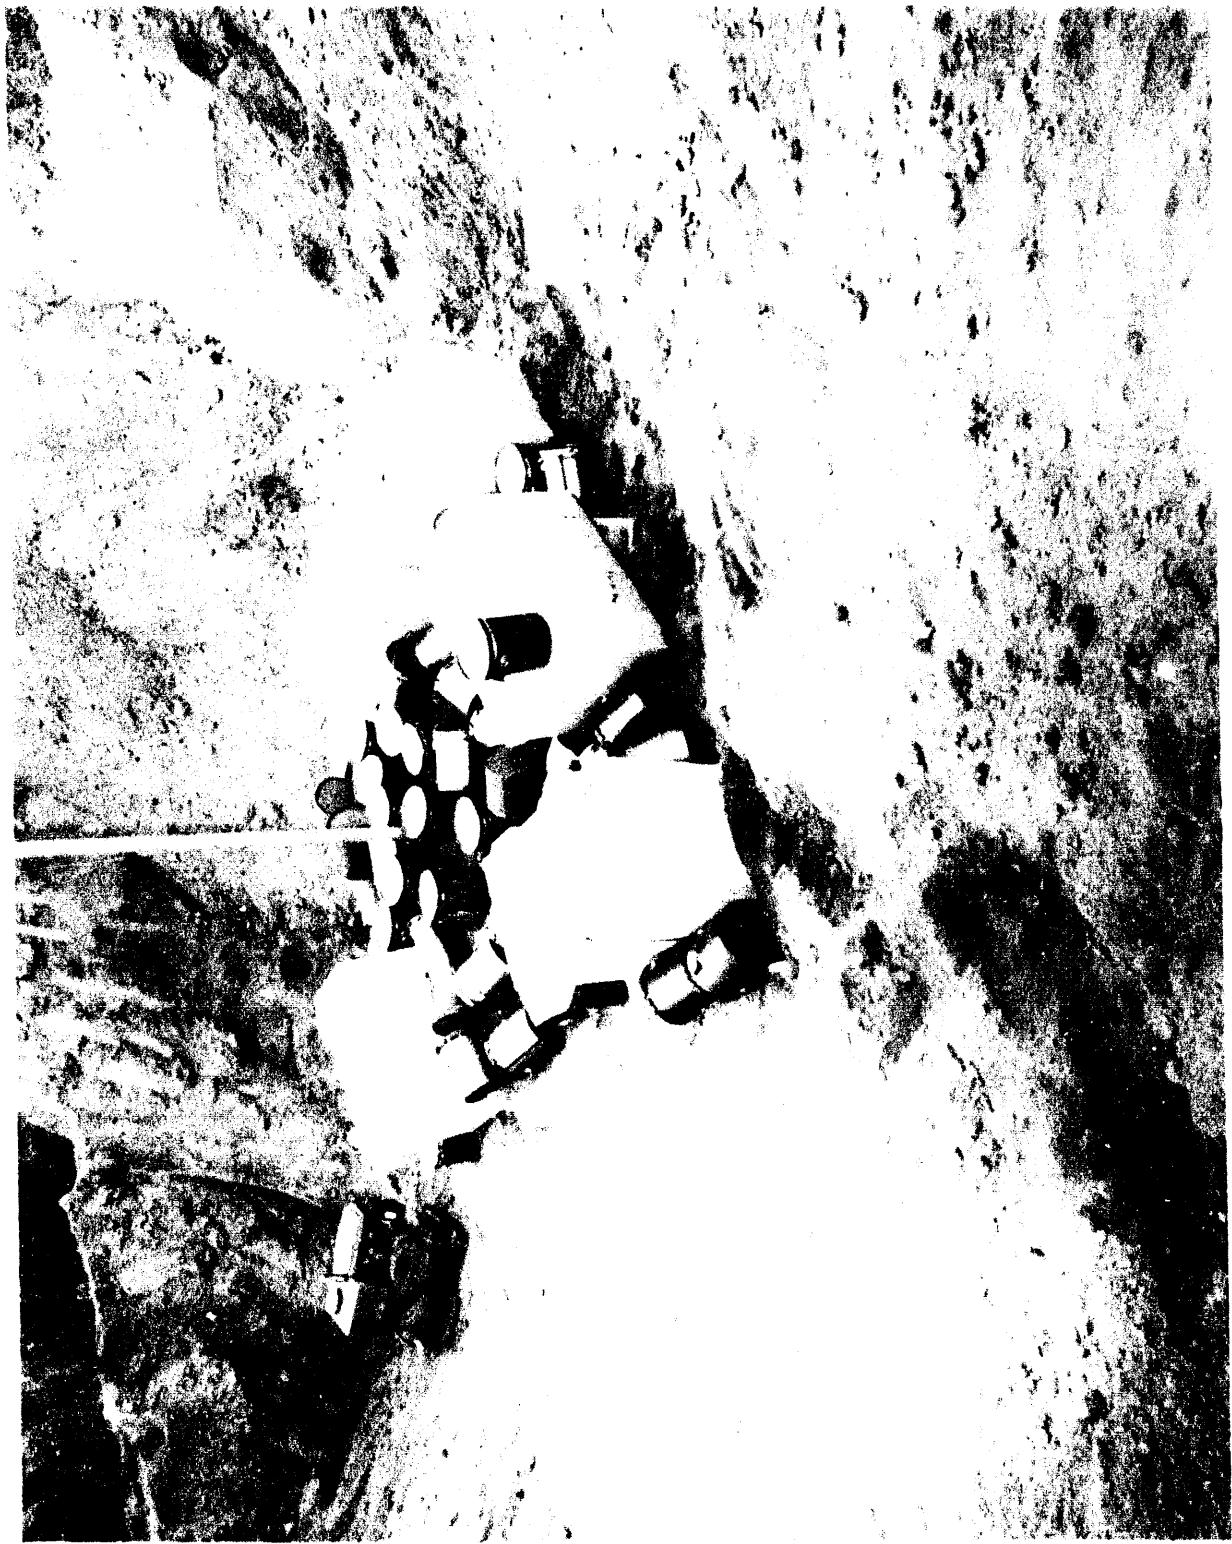
Figure 13. Cans, tracer cans containing ytterbium oxide, and boxes placed in Test Pit 1, layer 2.

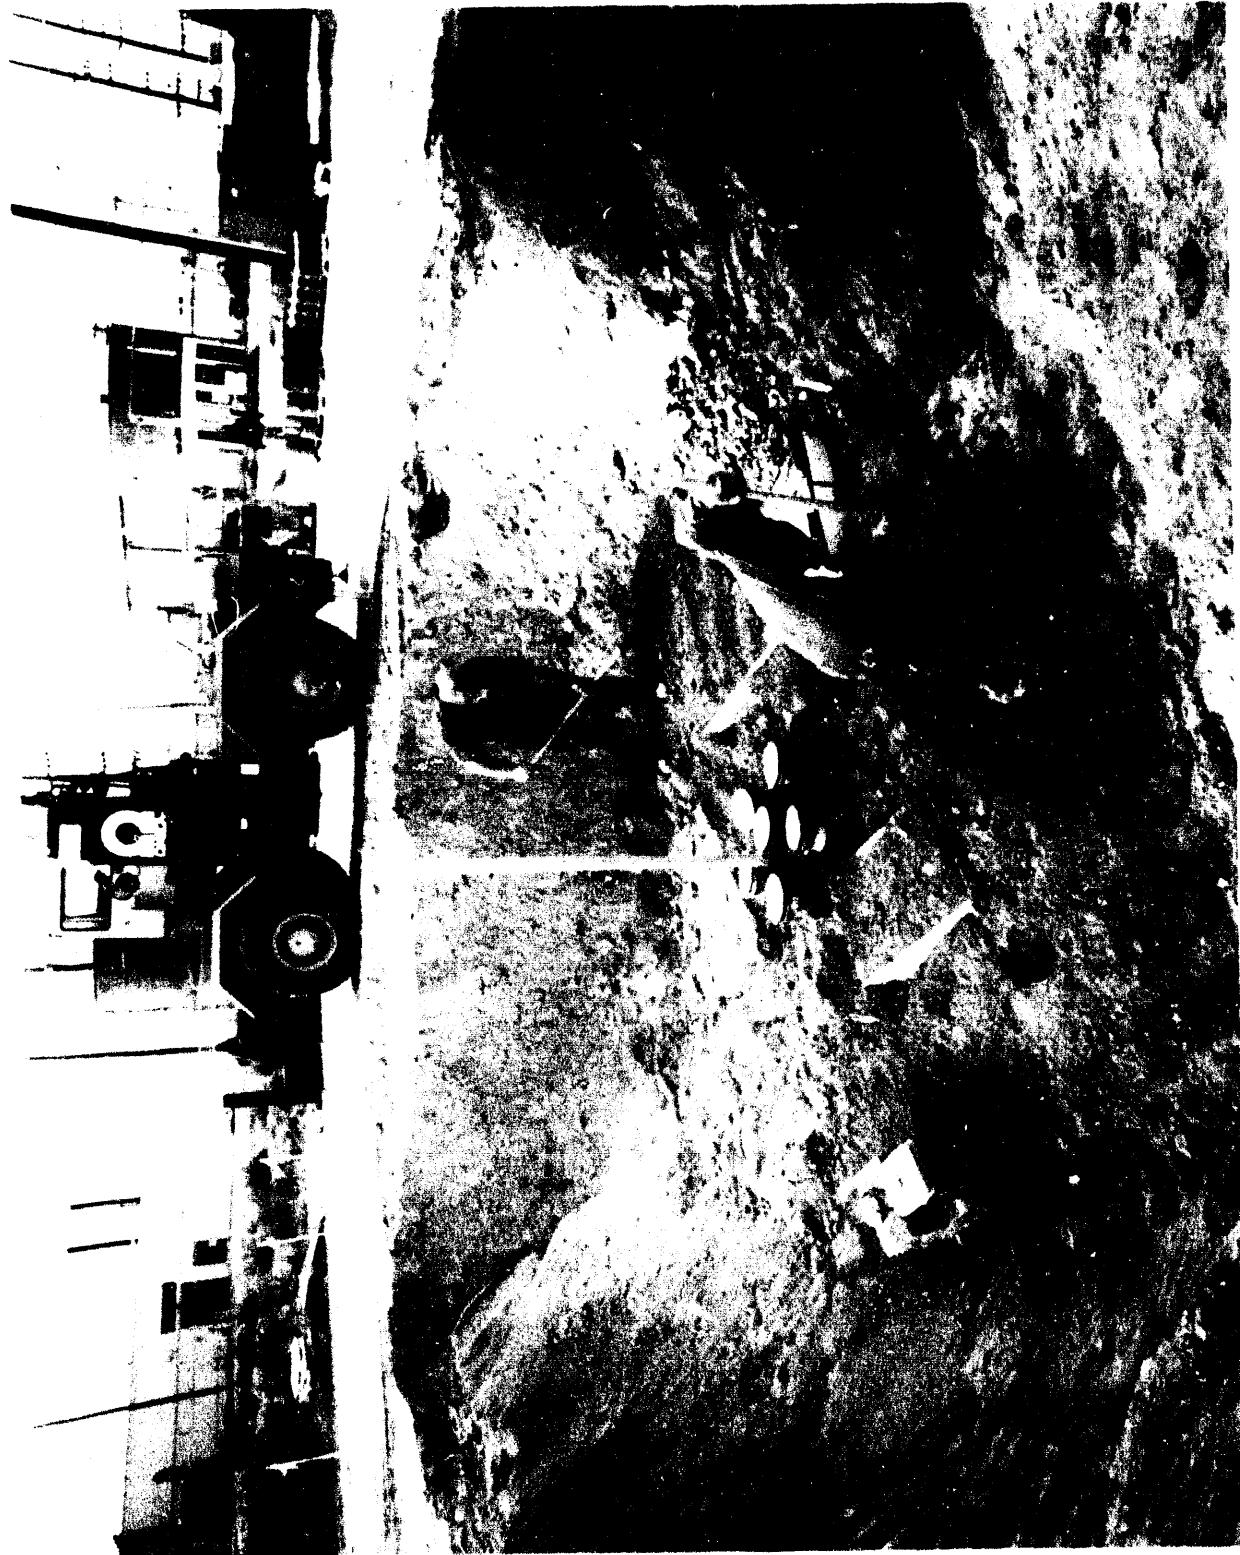
Figure 14. Backfill being placed over cans, tracer cans containing terbium oxides, and boxes in layer 2 of Test Pit 1.

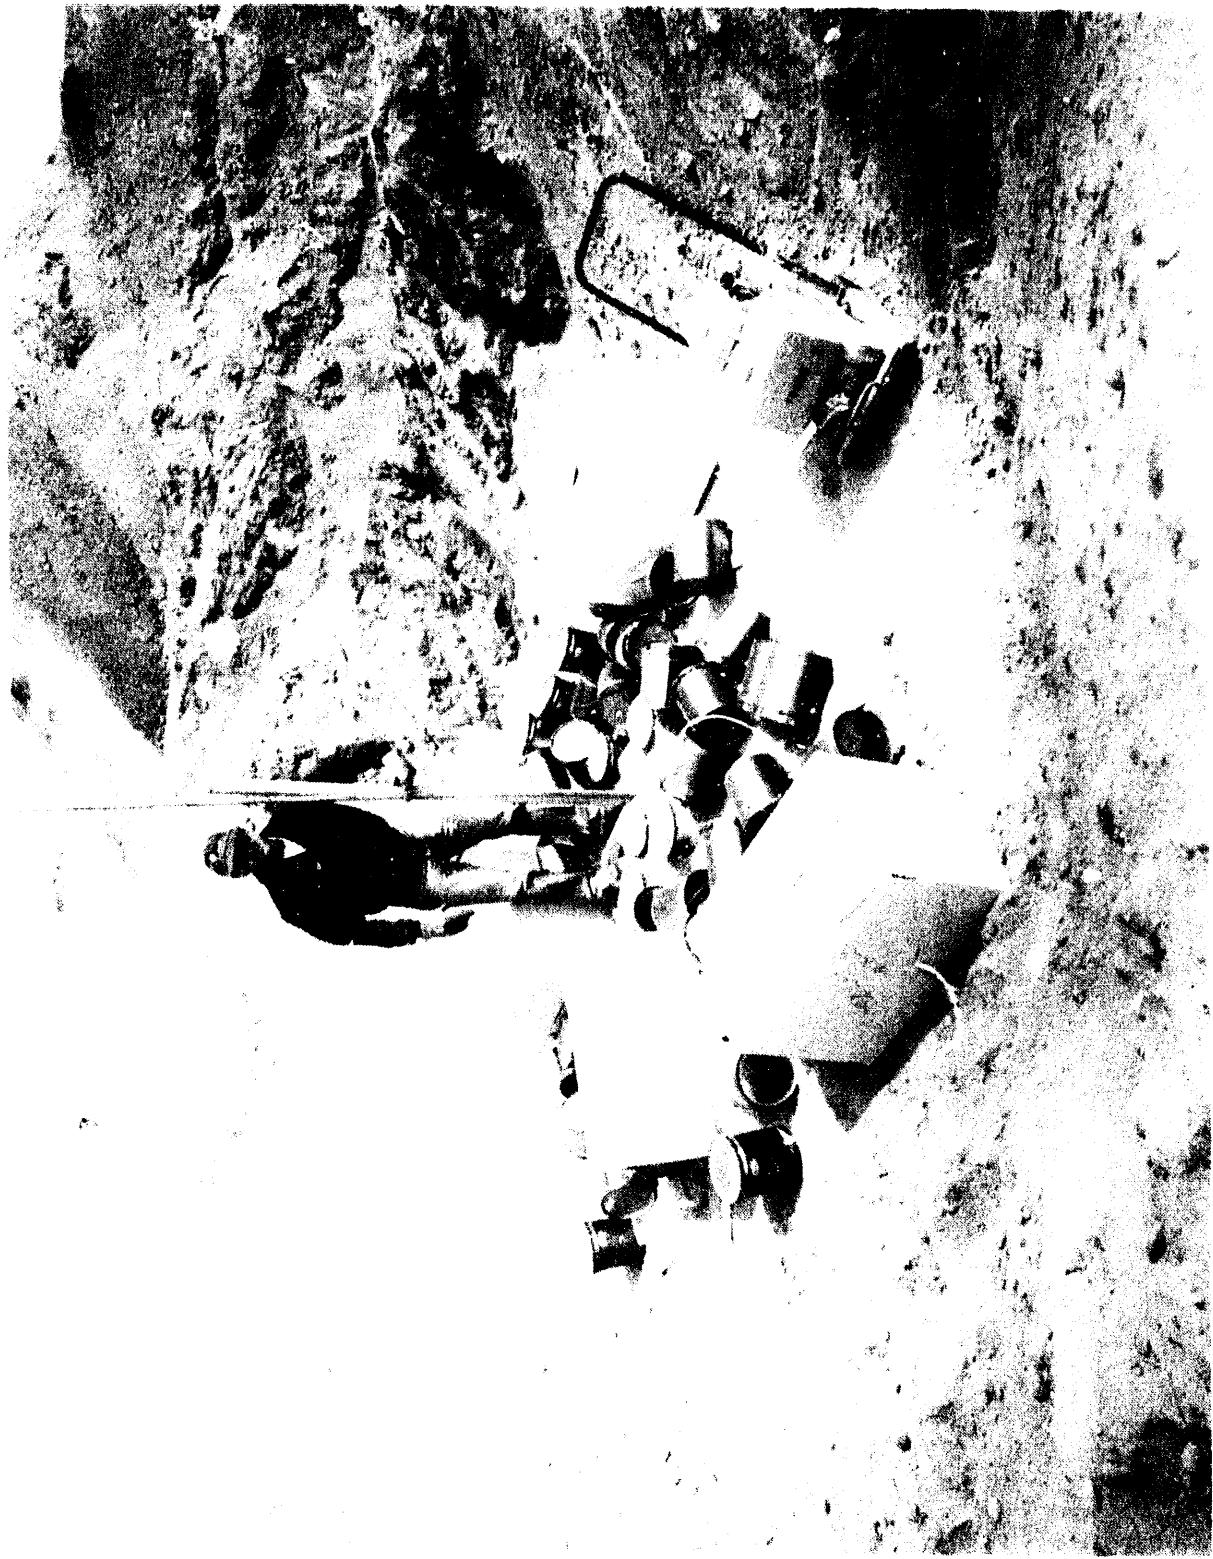
Figure 15. Cans and boxes placed in Test Pit 1, top layer.

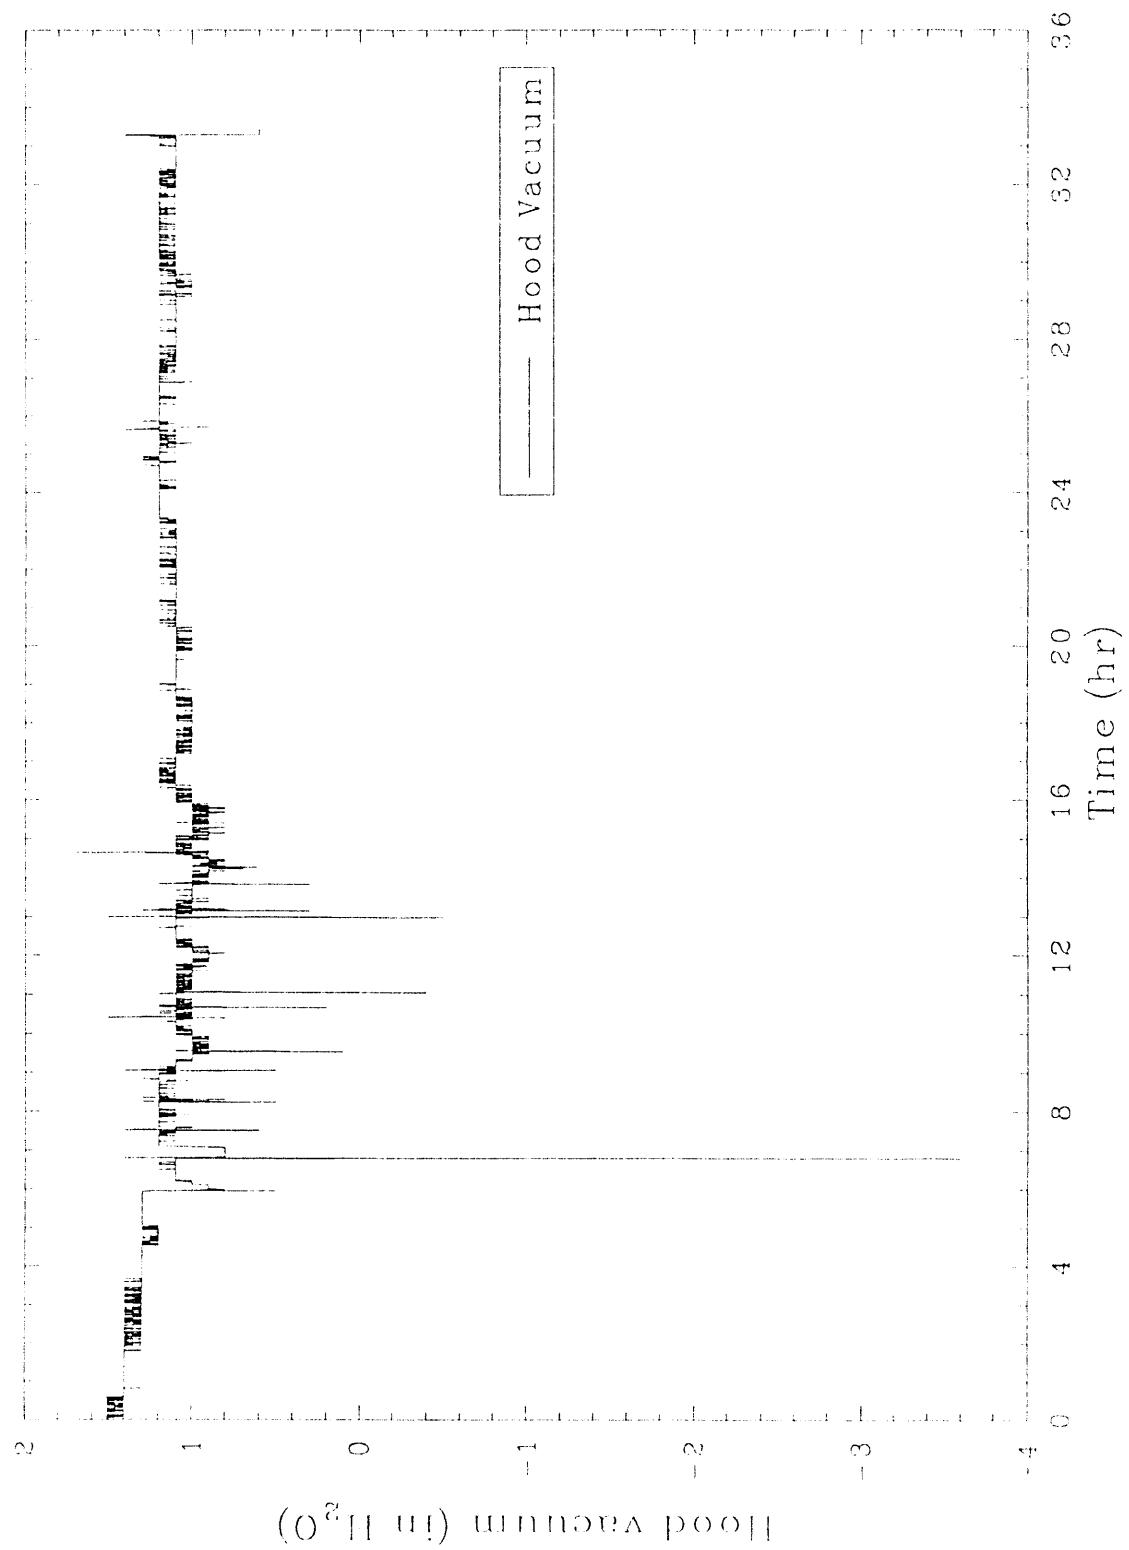
Figure 19. Hood vacuum plot showing pressure spikes for Test 1.

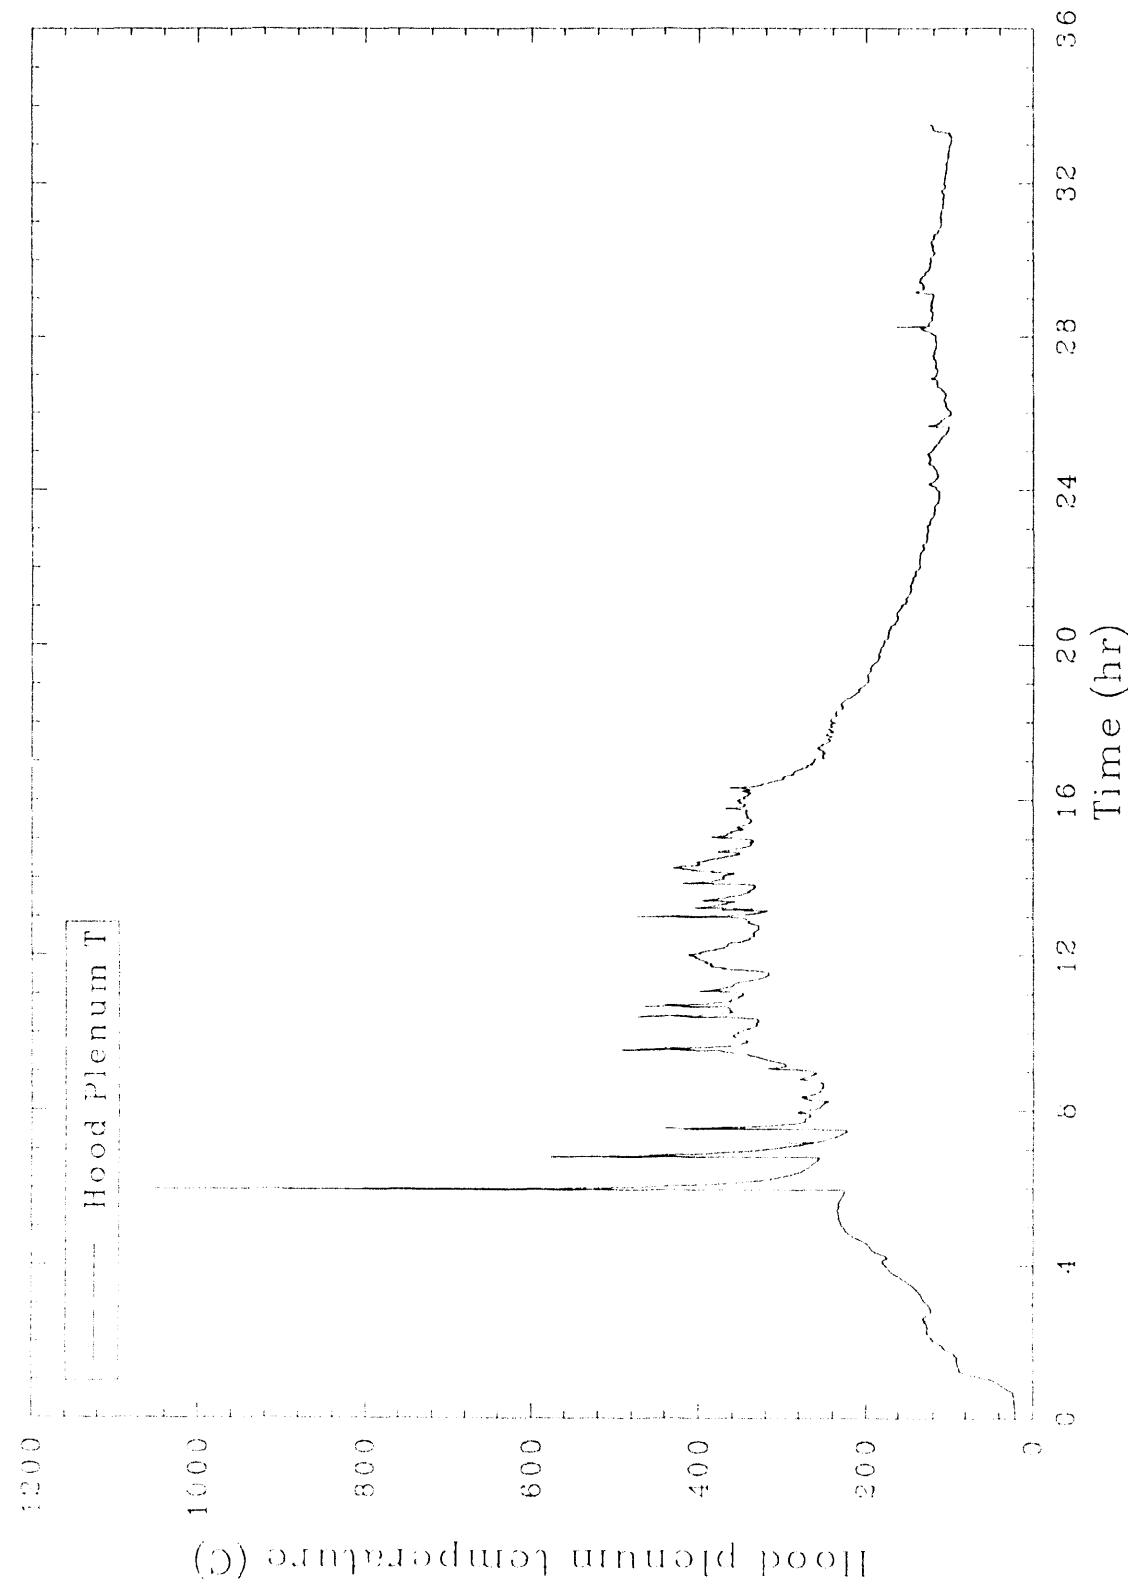
Figure 20. Hood plenum temperature plot showing temperature spikes for Test 1.

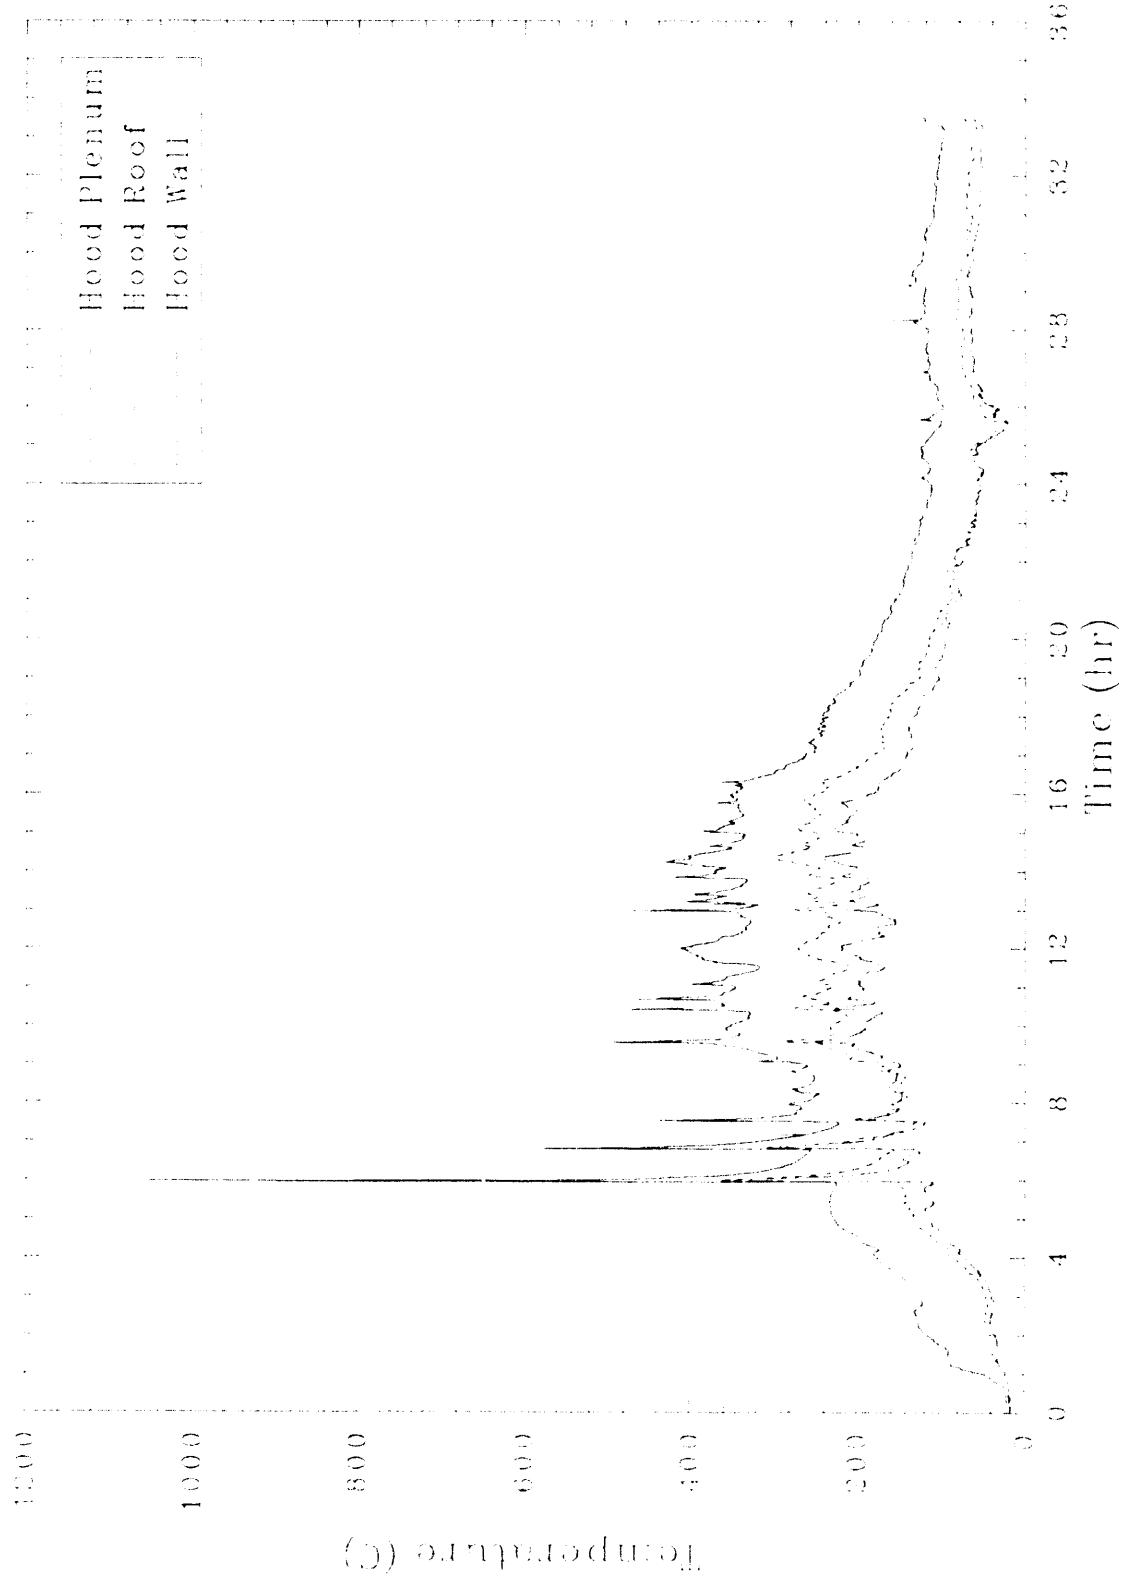
Figure 21. Hood Plenum, roof, and wall temperatures for Test 1.

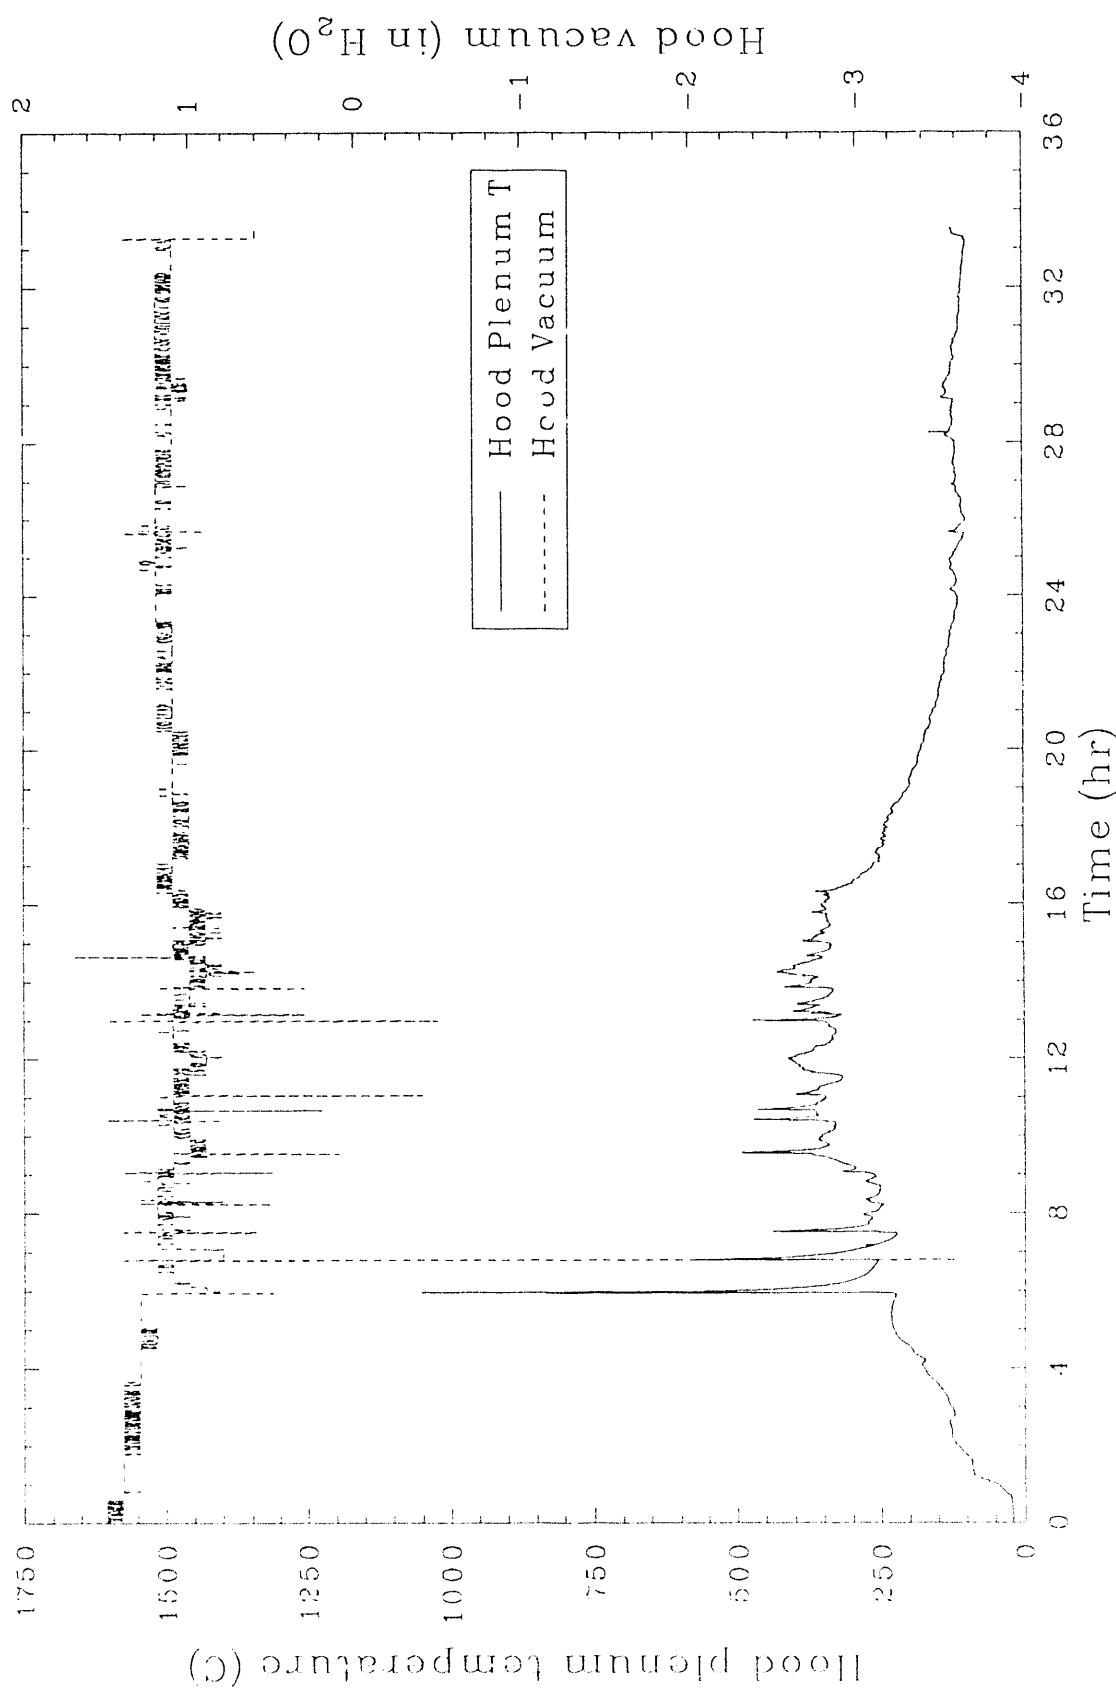
Figure 22. Hood vacuum and plenum temperature for Test 1.

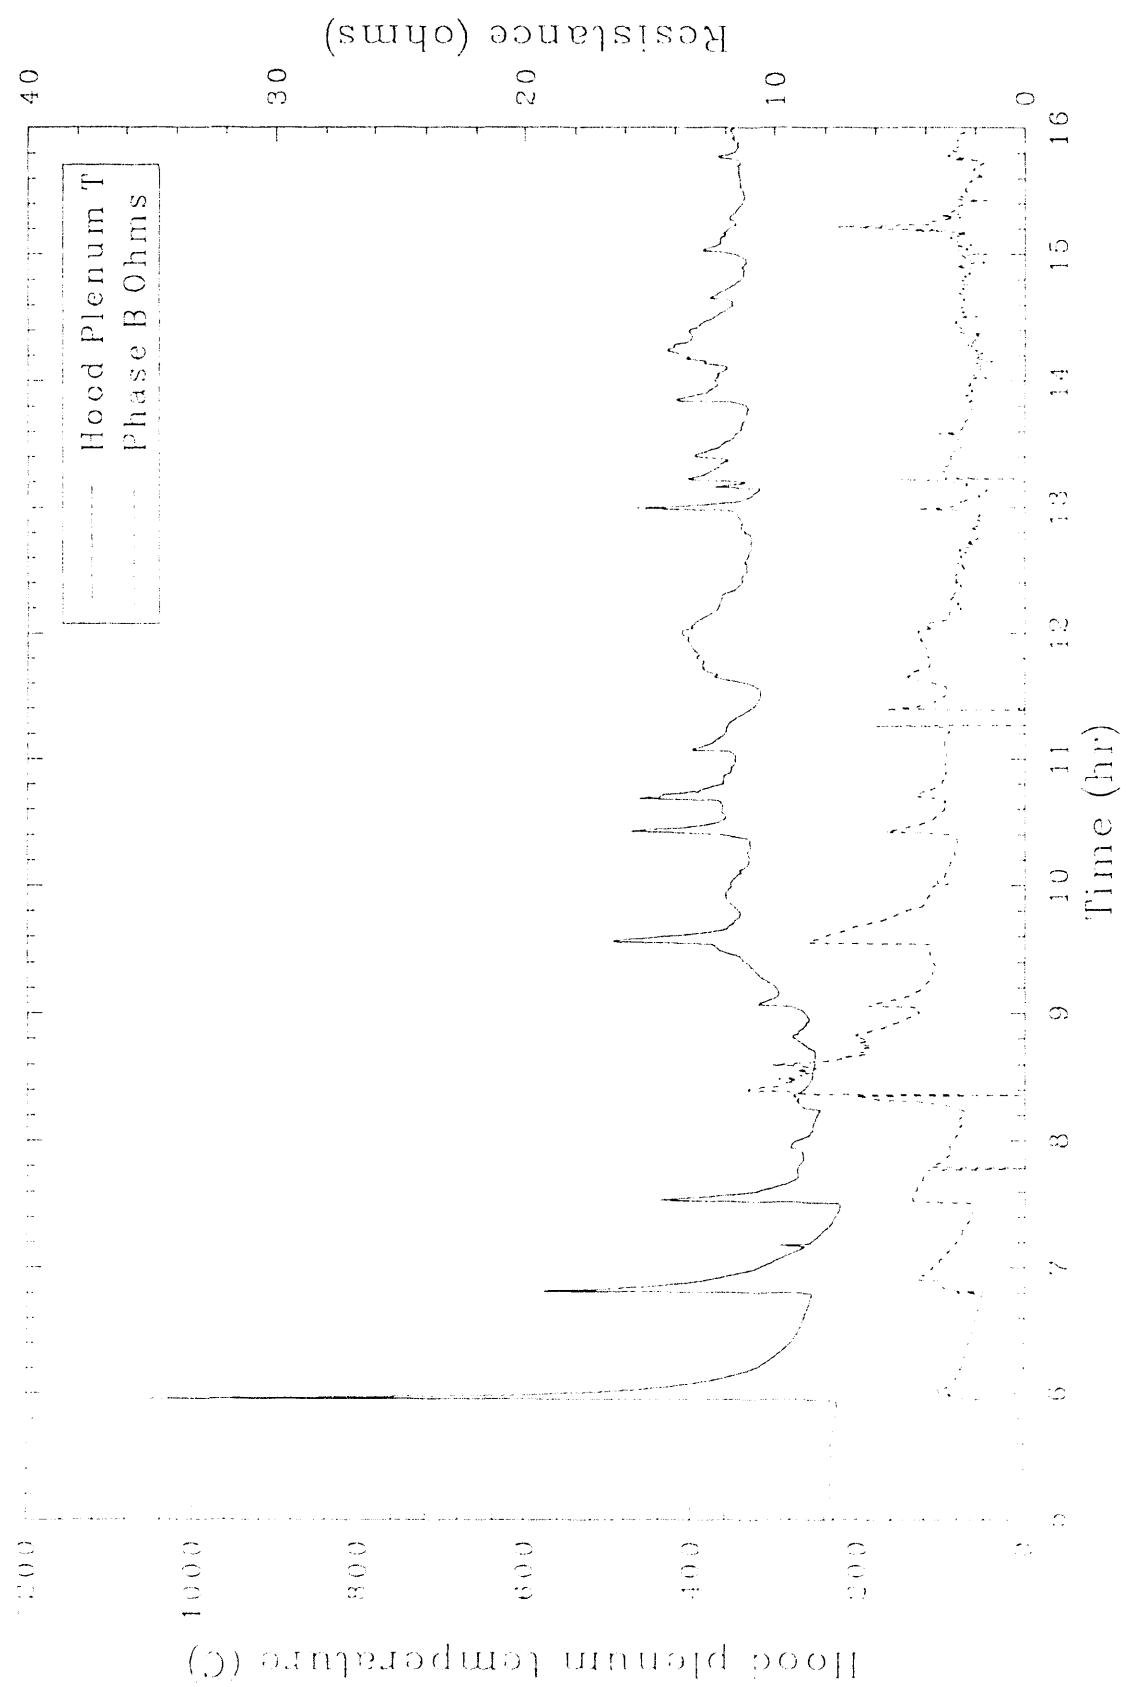
Figure 23. Hood plenum temperature and phase B resistance showing concurrent spiking in Test 1.

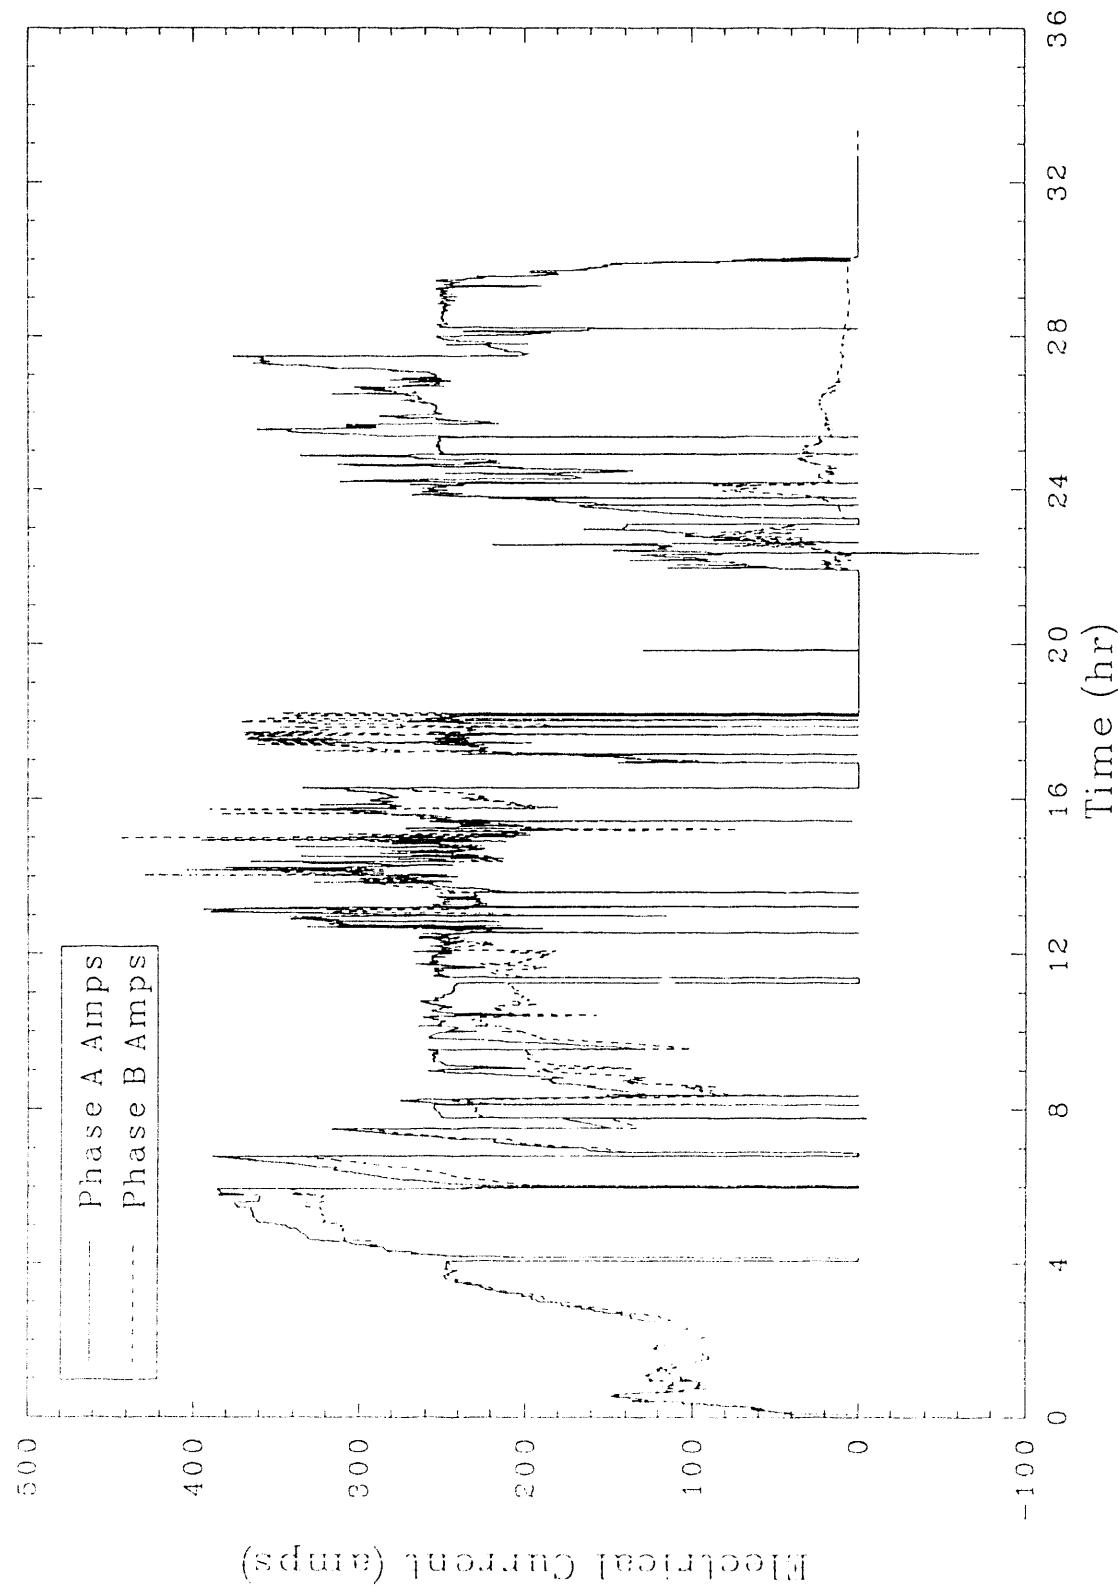
Figure 24. Phases A and B amperage for Test 1.

Test 1 resulted in a total power level that varied typically between 300 and 400 kW. Plots showing amperage and volts for each phase are provided in Figures 24 and 25.
