EGG-WTD-9807

August 1991

### **In Situ Vitrification Application to Buried Waste: Final Report of Intermediate Field Tests at Idaho National Engineering Laboratory**

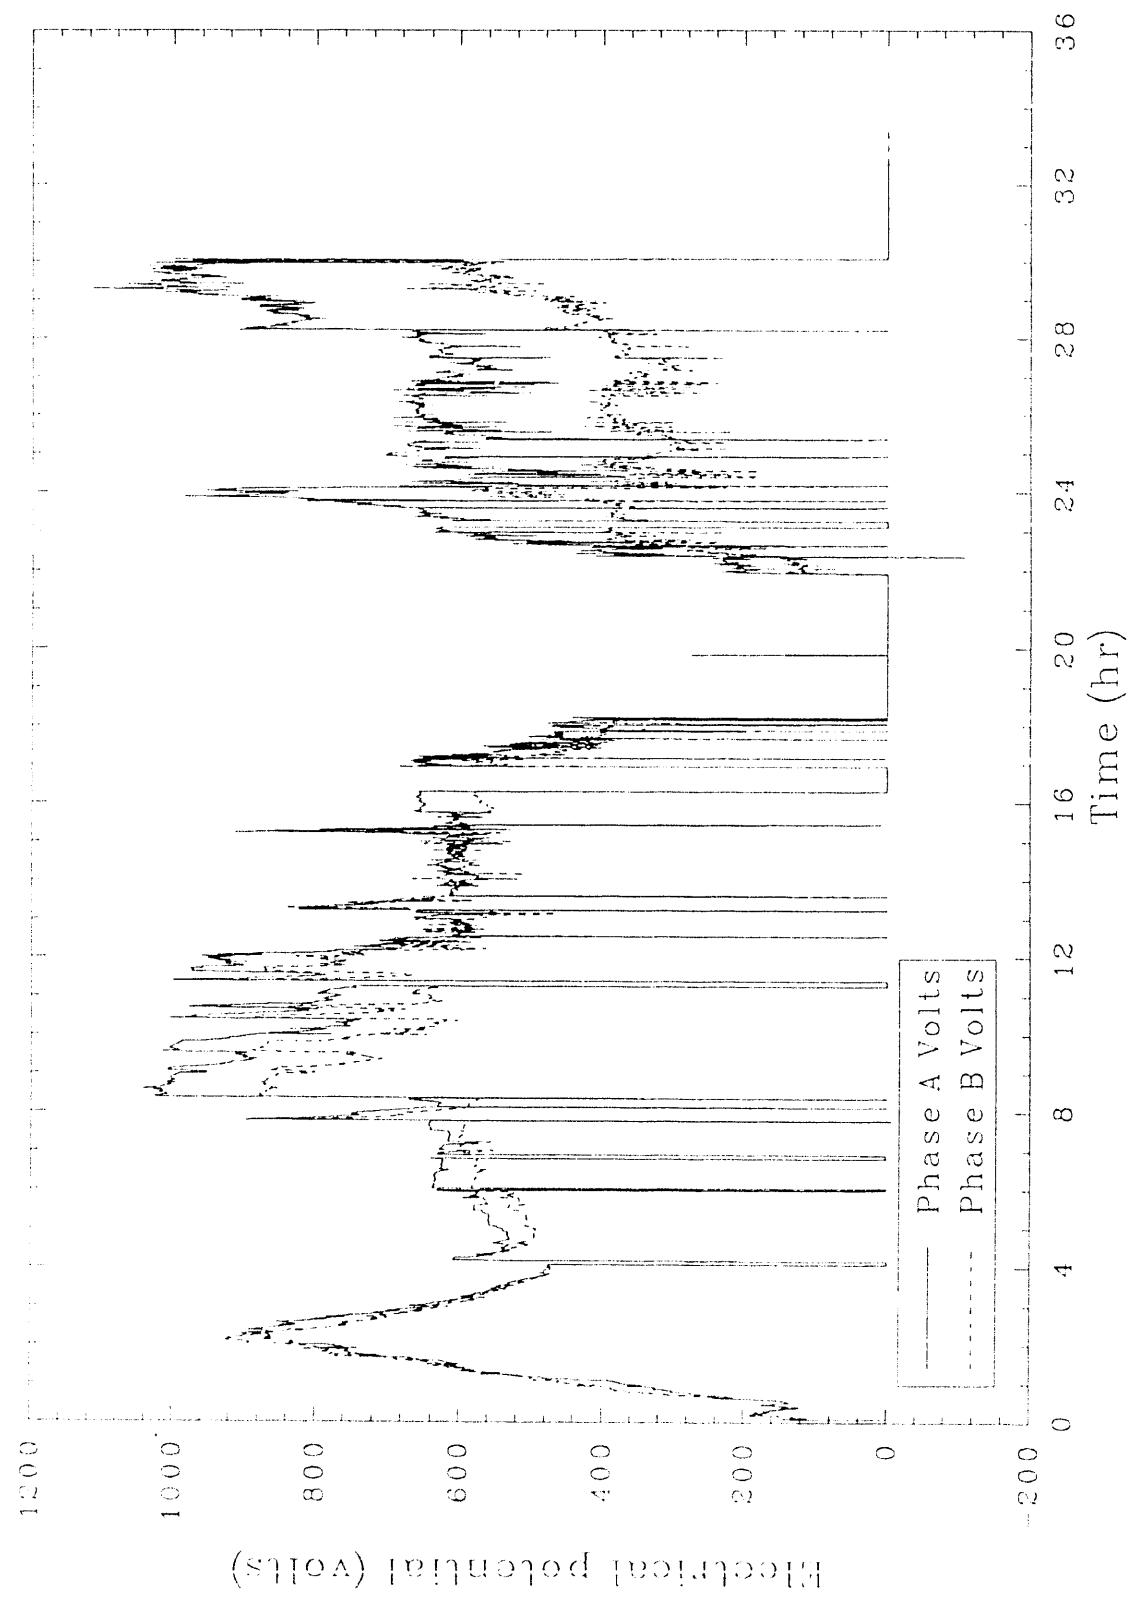
Figure 25. Phases A and B voltage for Test 1.

Test 1 resulted in a total power level that varied typically between 300 and 400 kW. Plots showing amperage and volts for each phase are provided in Figures 24 and 25.

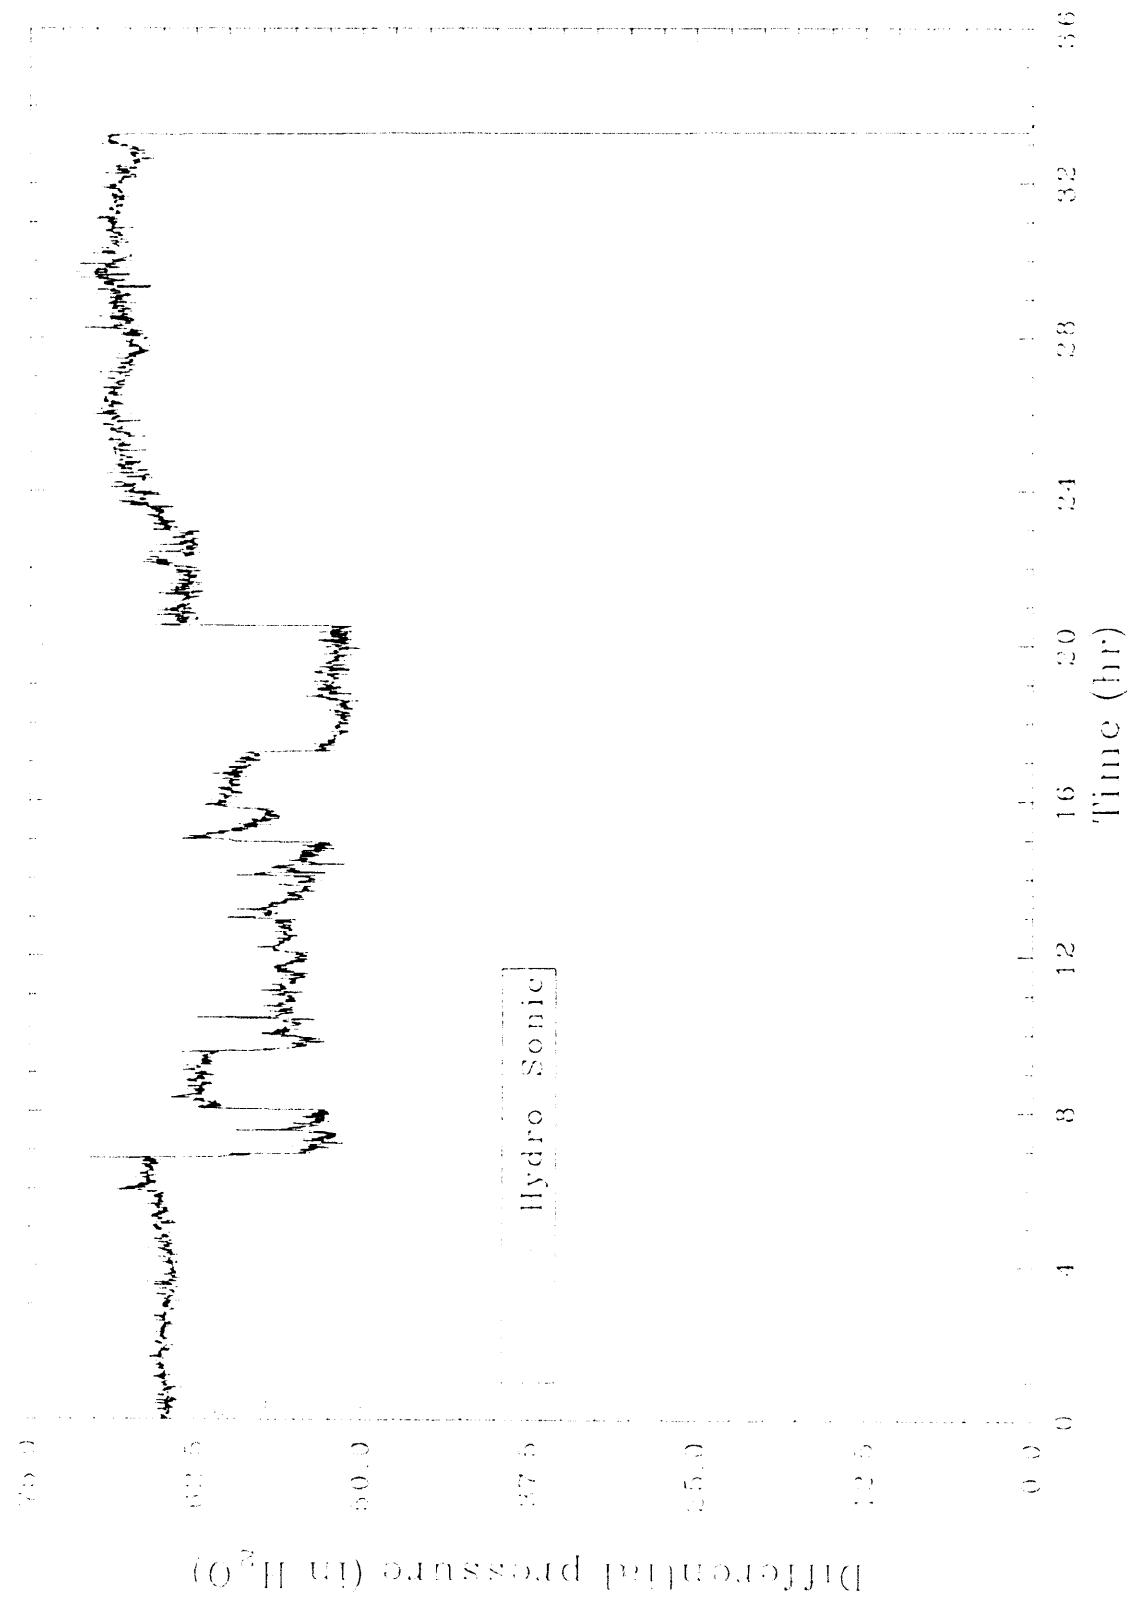
Figure 28. Hydro-Sonic scrubber differential pressure for Test 1.

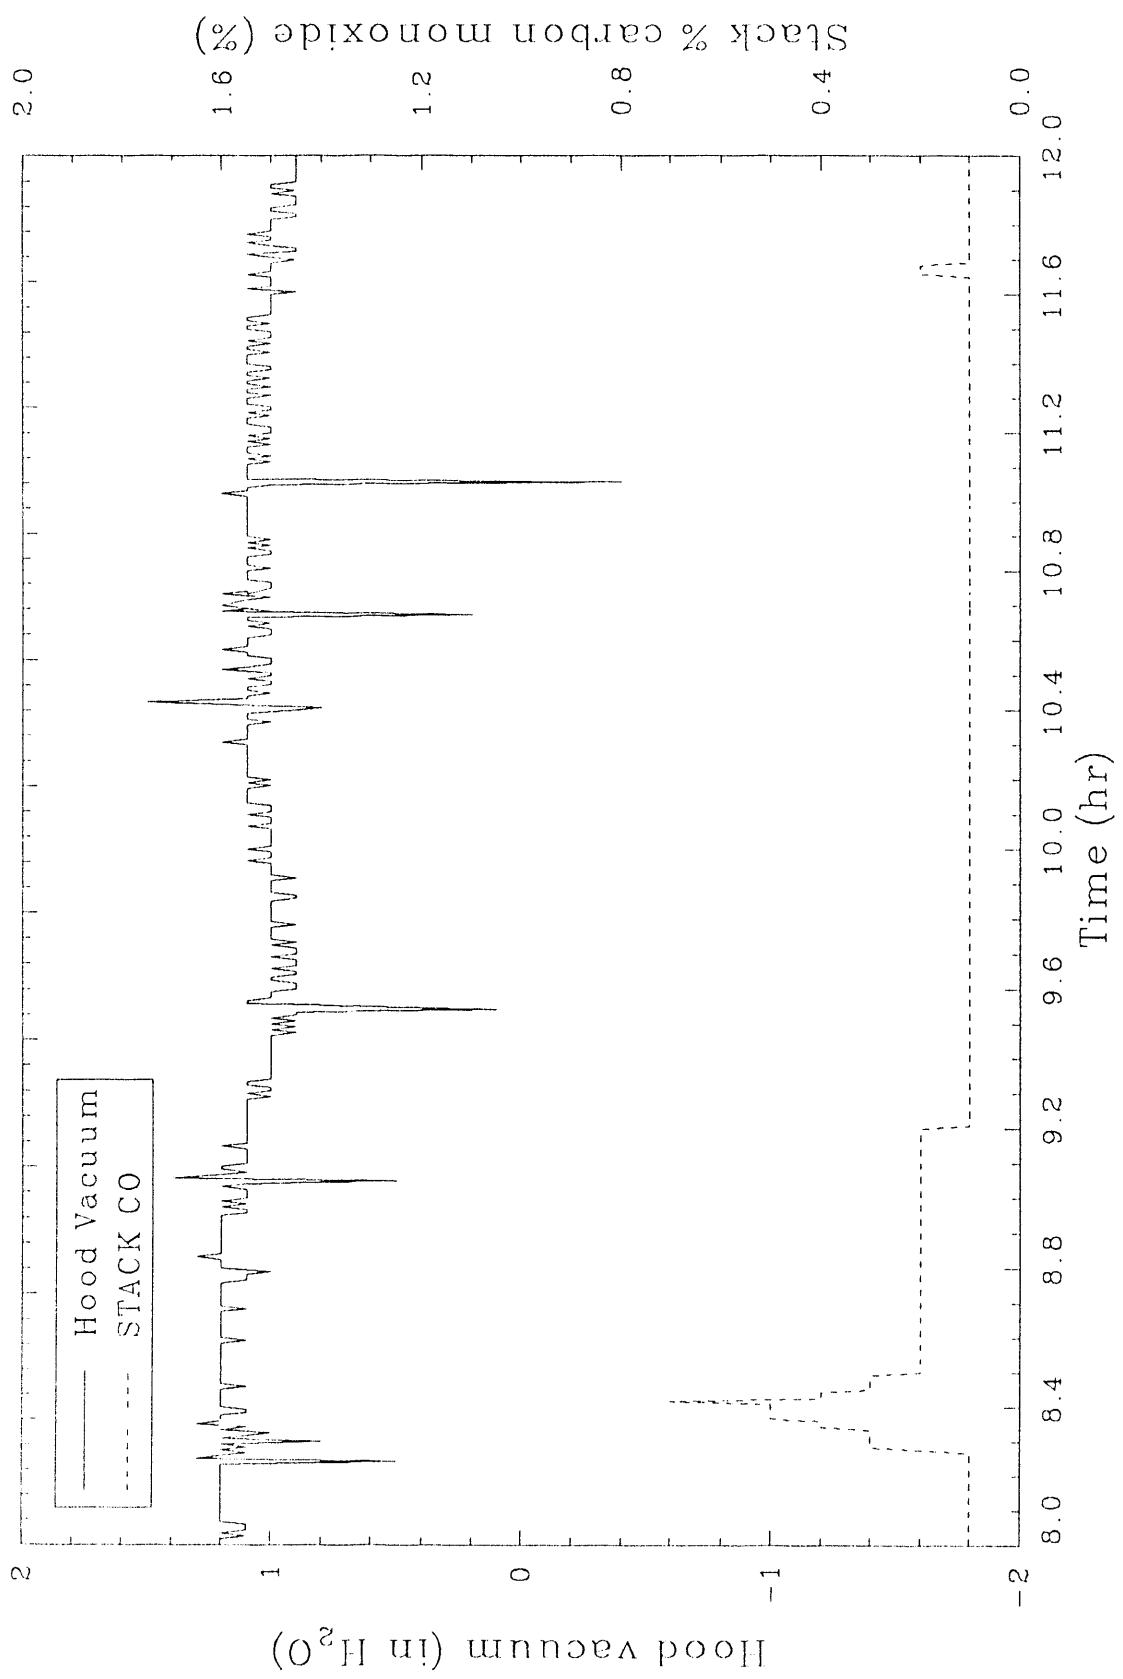
**Figure 33.** Hood vacuum and stack carbon monoxide concentration for Test 1, showing pressure events not concurrent with CO spikes.

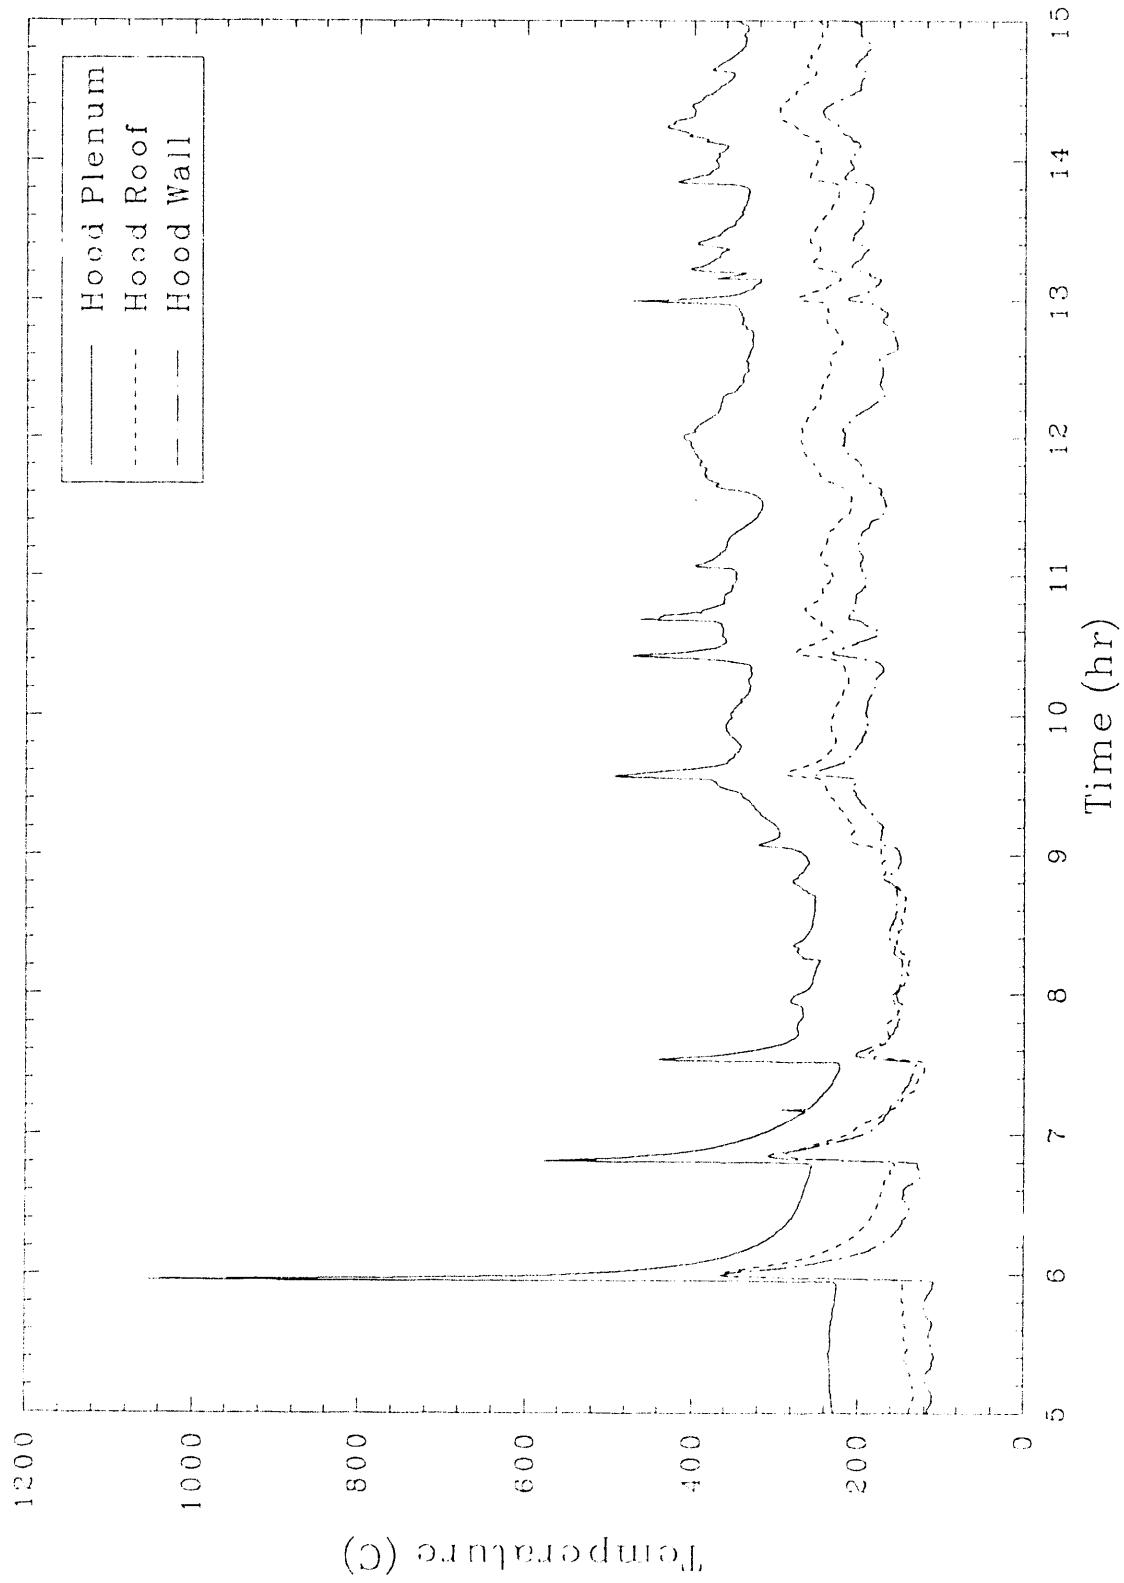
Figure 35. Hood, roof, and wall temperatures for several gas release events in Test 1.

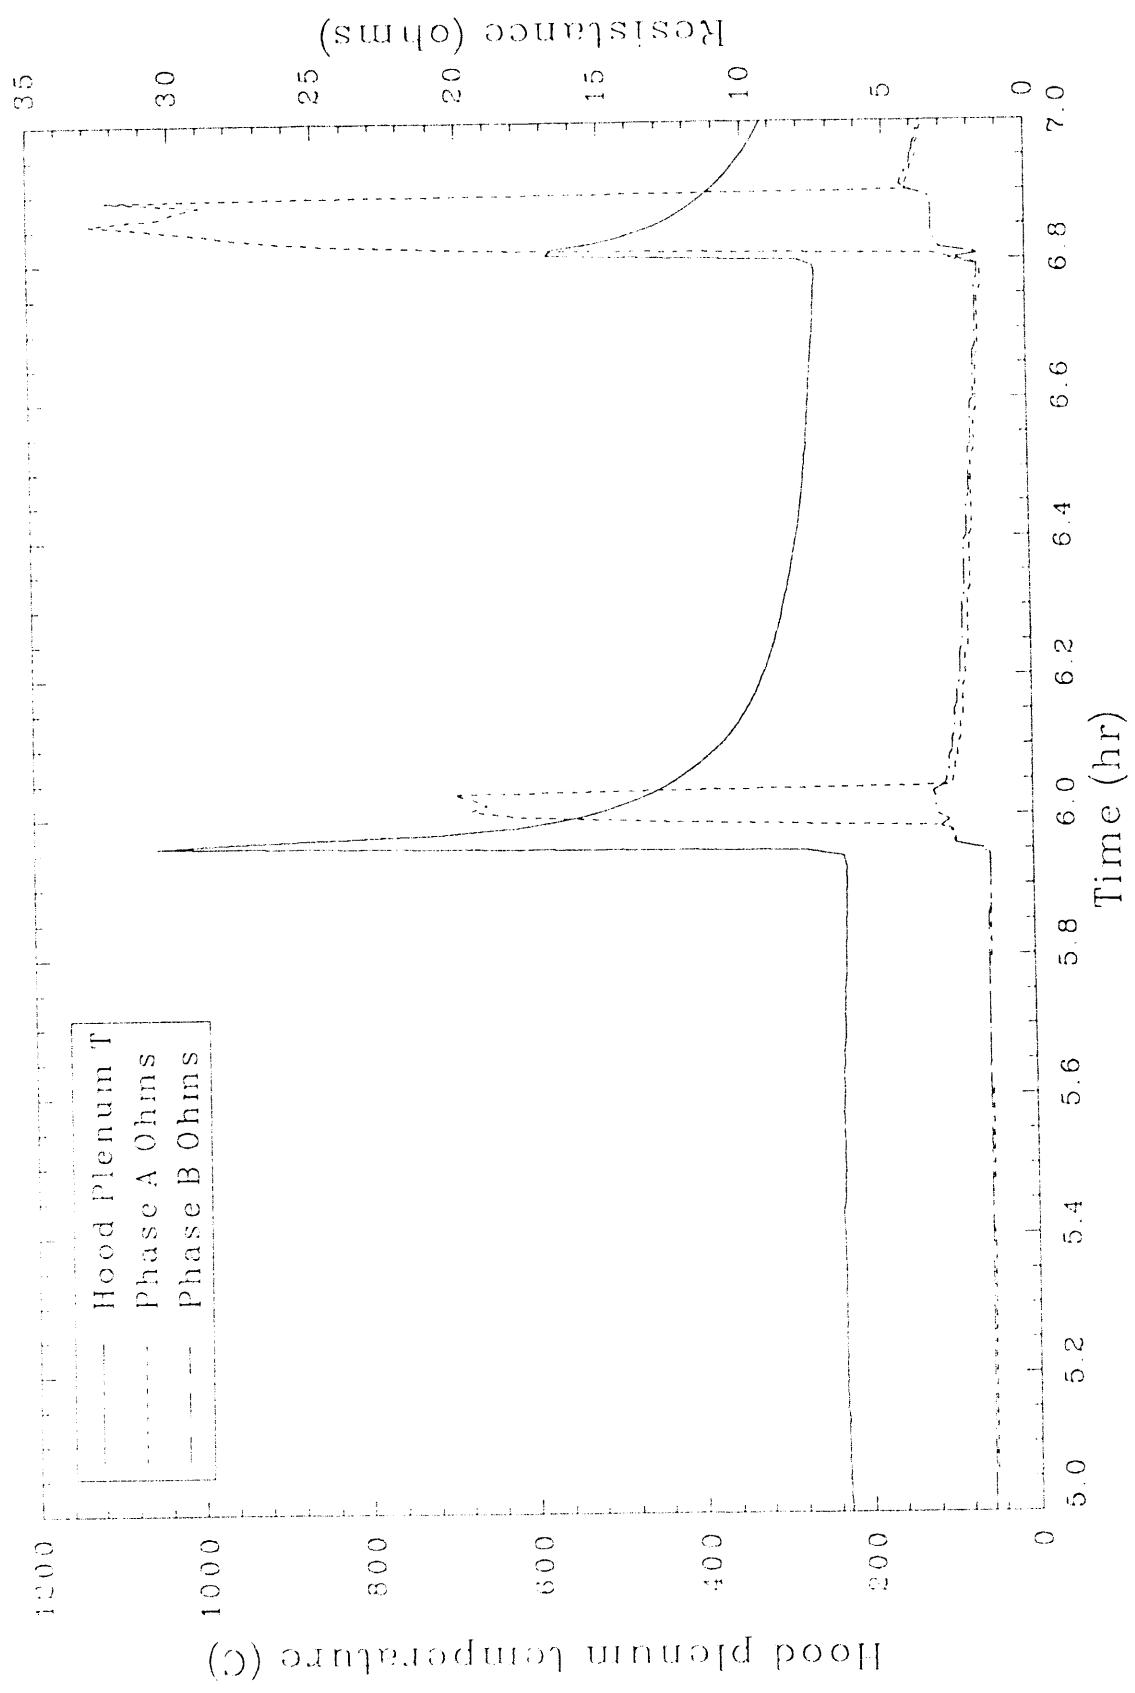
Figure 37. Phase A and B resistance during the initial gas release event in Test 1.

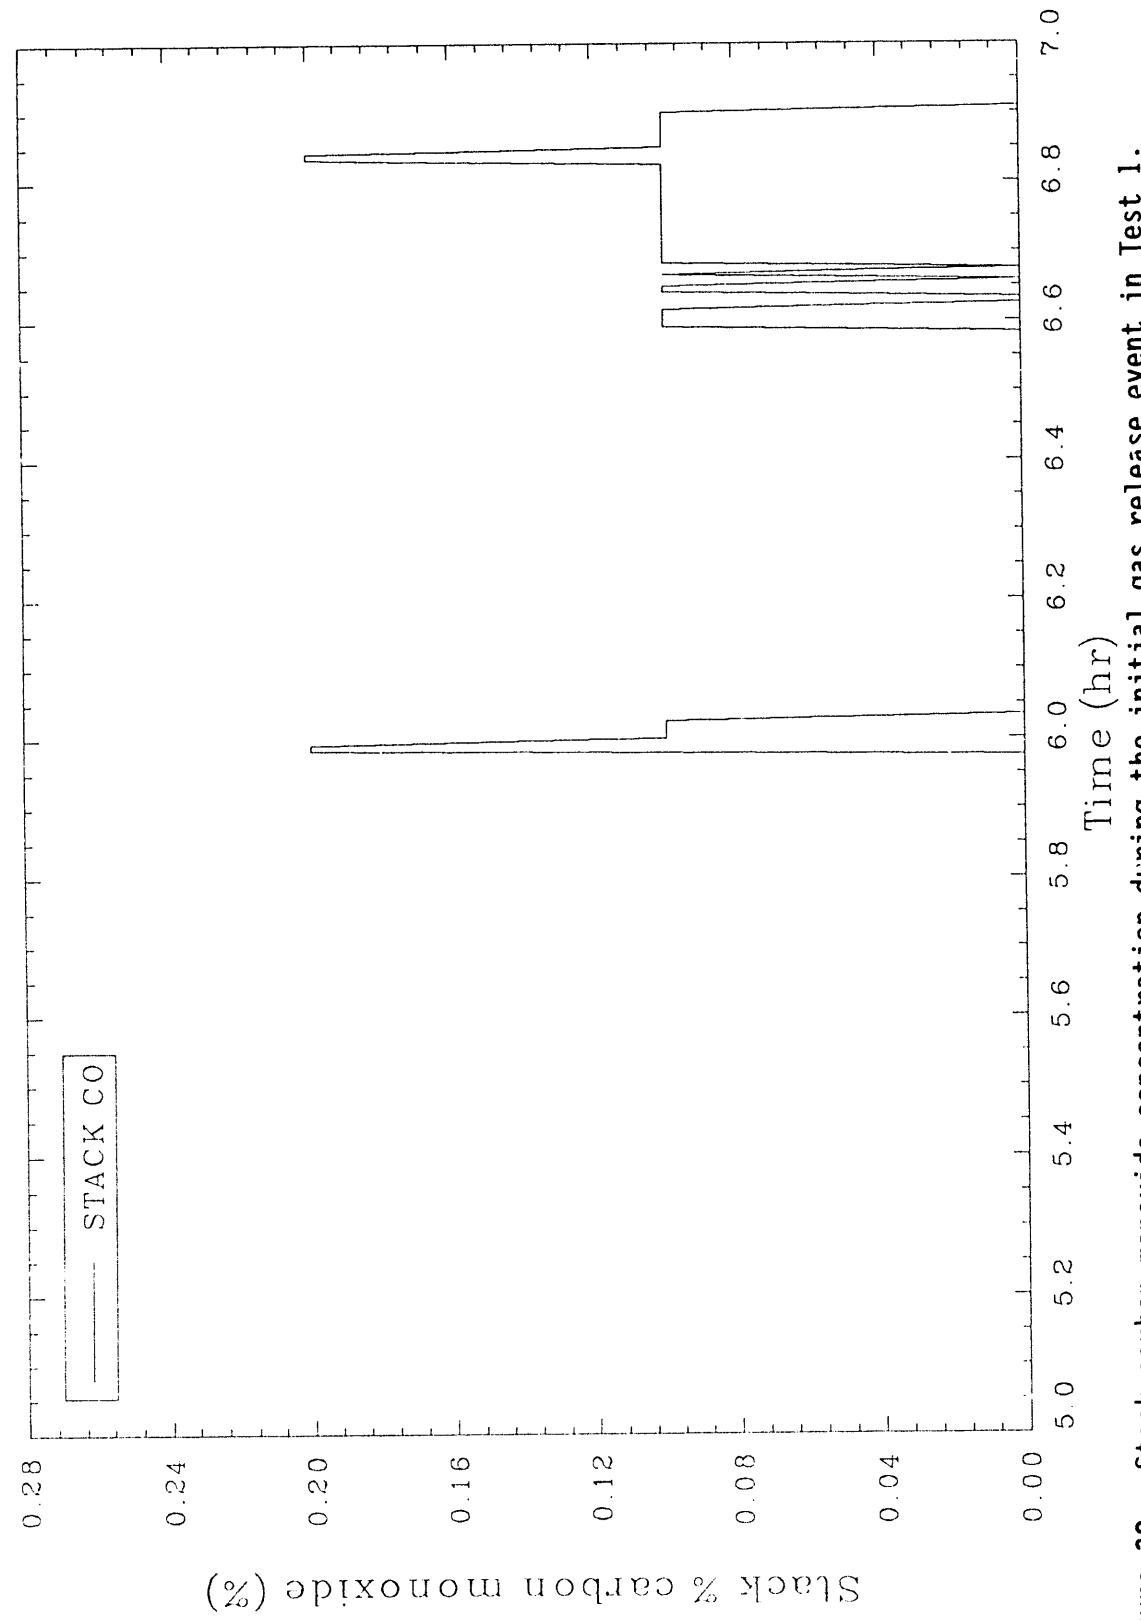
Figure 38. Stack carbon monoxide concentration during the initial gas release event in Test 1.

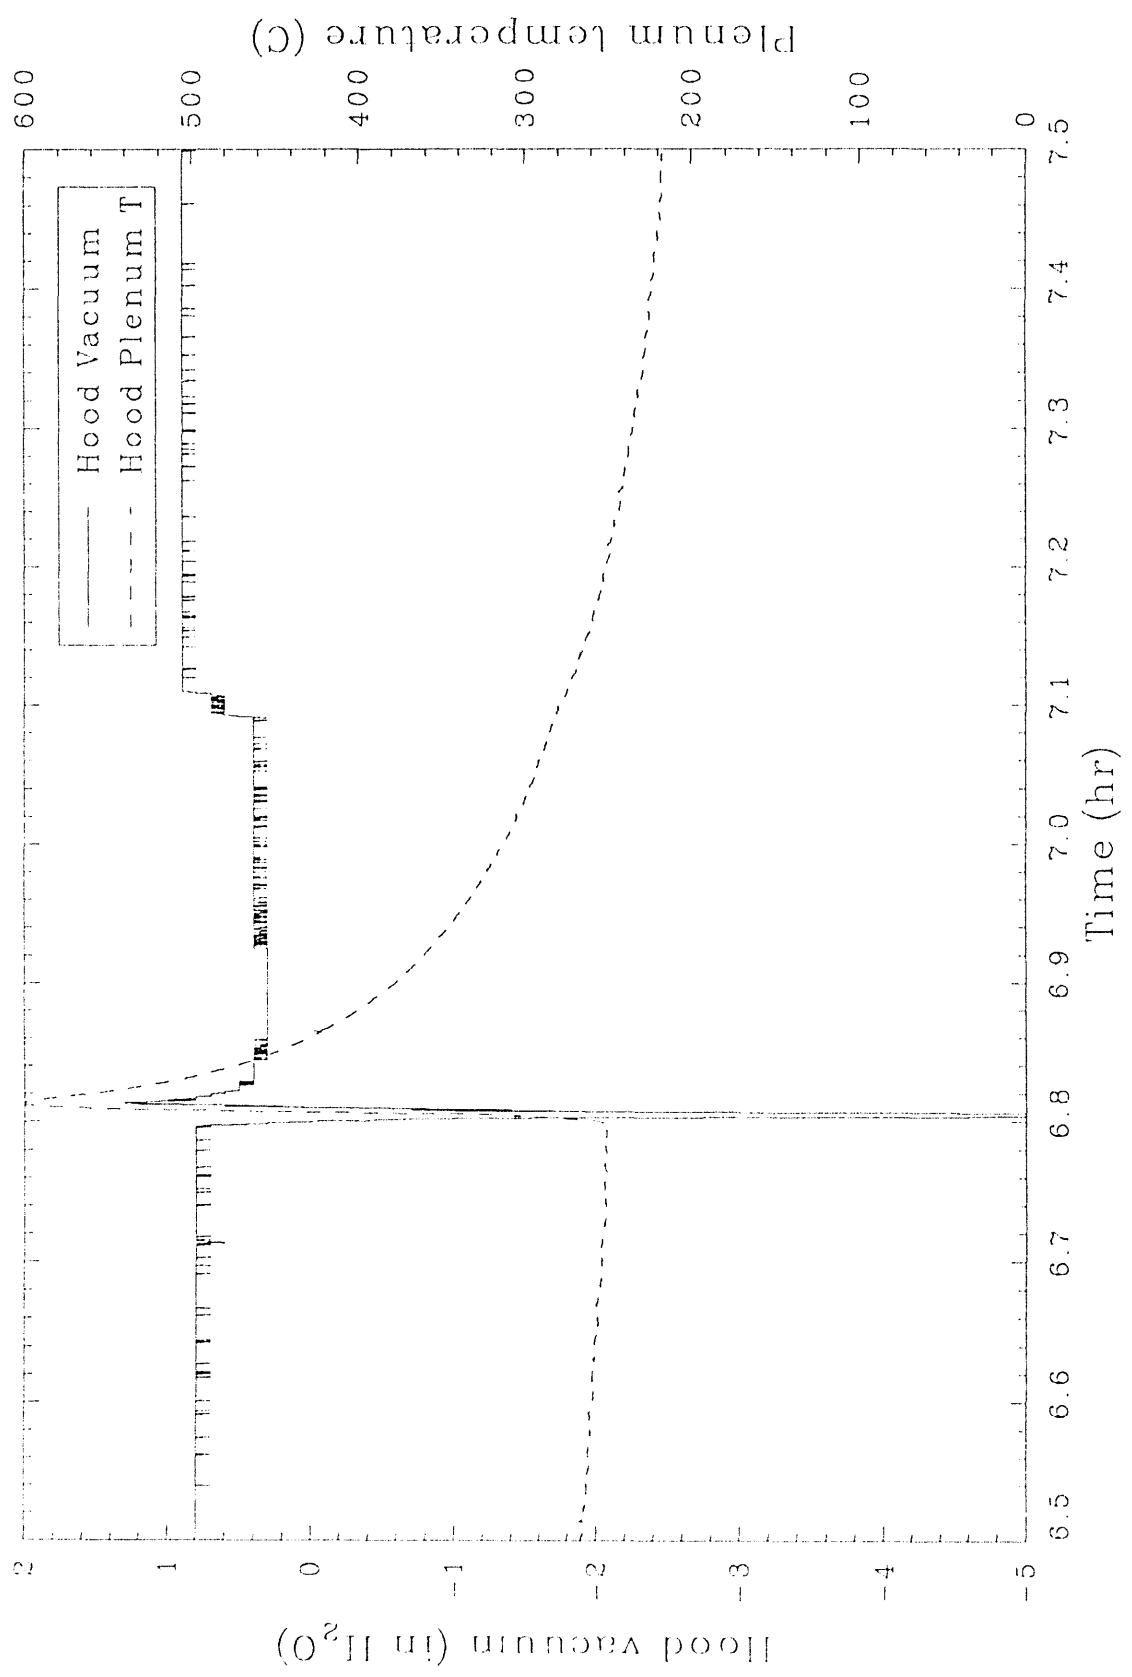
Figure 39. Hood vacuum and plenum temperature during the second event in Test 1.

**3.3.5.2 The Second Event.** A second event occurred at approximately 6.8 hours into the test. This event resulted in the a dramatic hood pressurization similar to the initial event. Hood pressure spiked from 0.9 in. of water vacuum to over 5.0 in. of water pressure, as shown in Figure 39. The pressurization was followed by a temperature spike from 260 to 600°C.

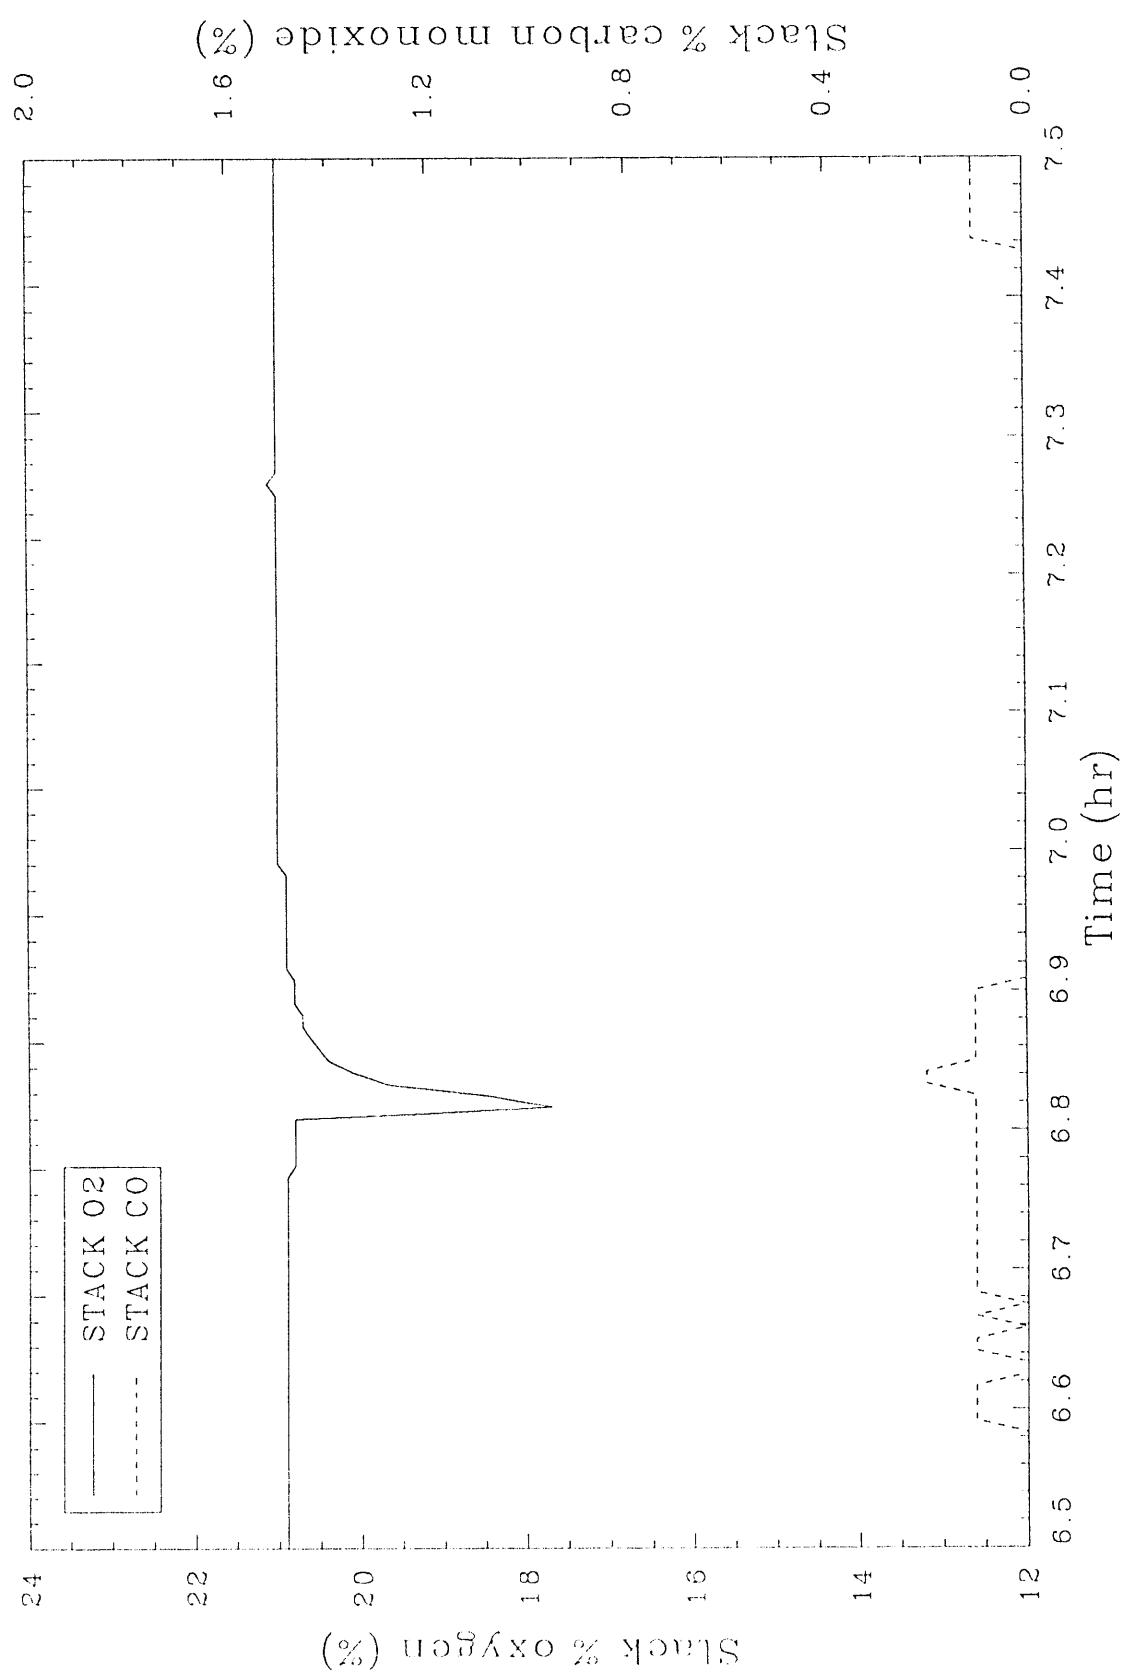
Figure 40. Stack oxygen and carbon monoxide concentrations during the second event in Test 1.

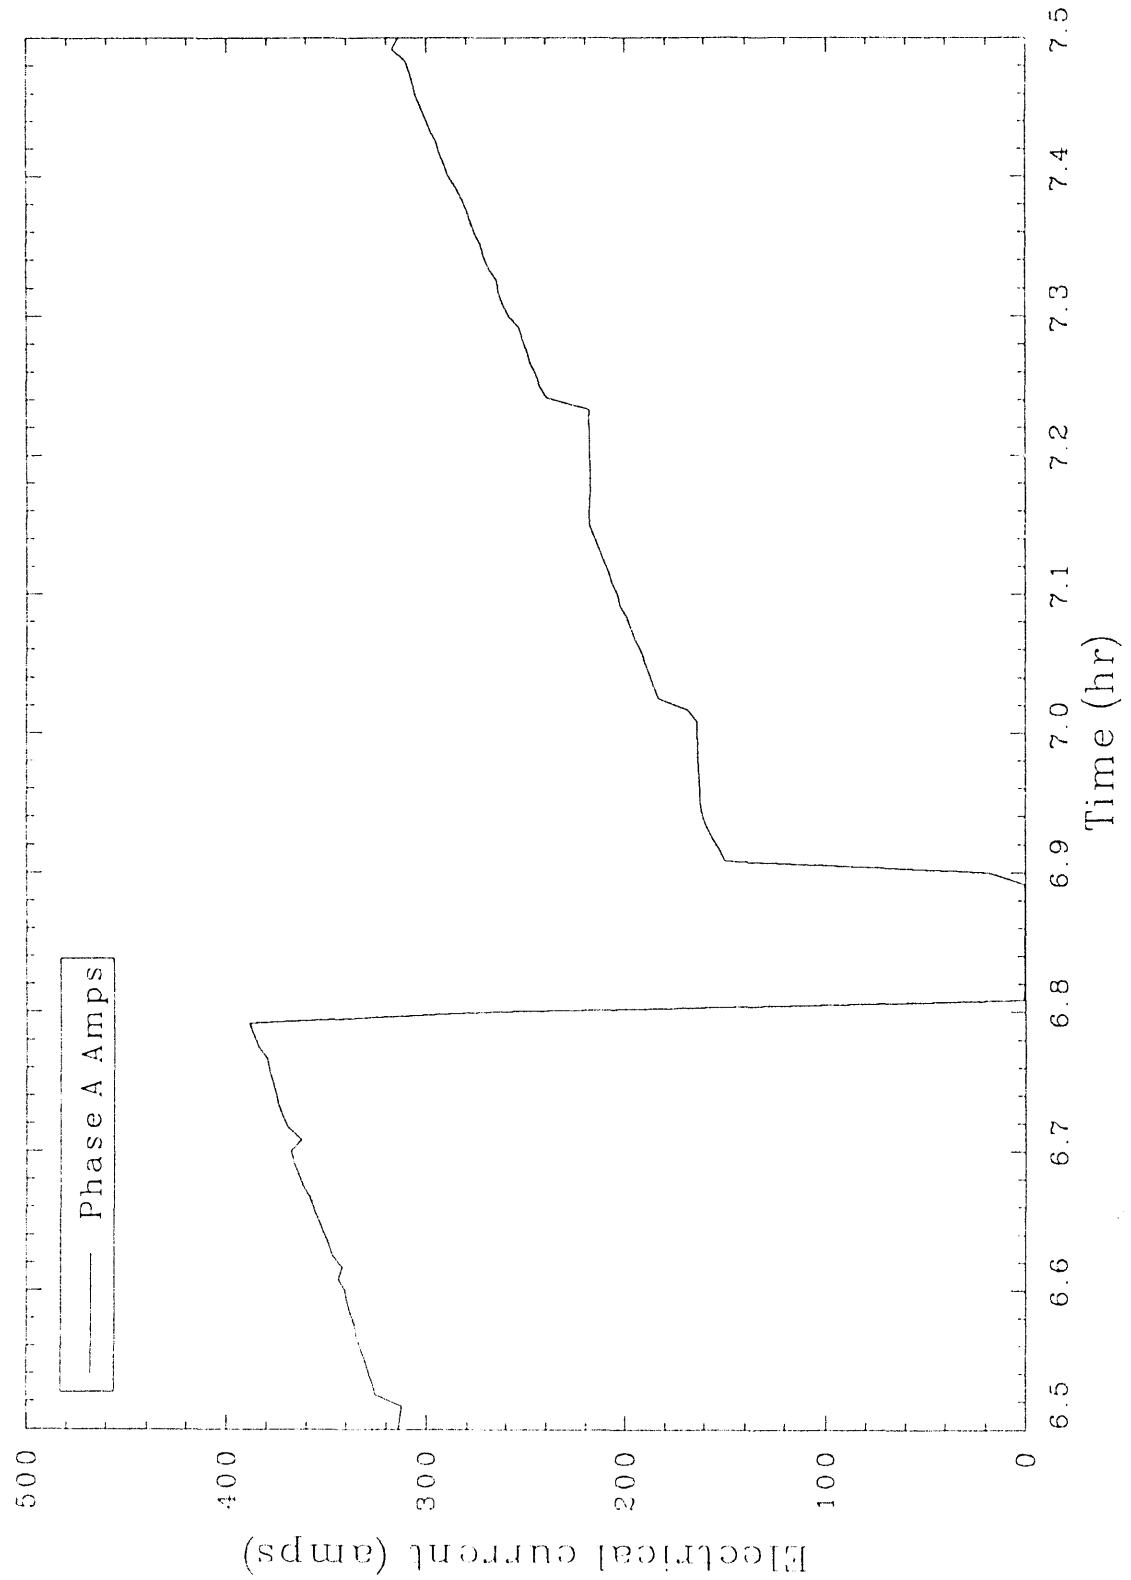
Figure 42. Phase A amperage during the second event in Test 1.

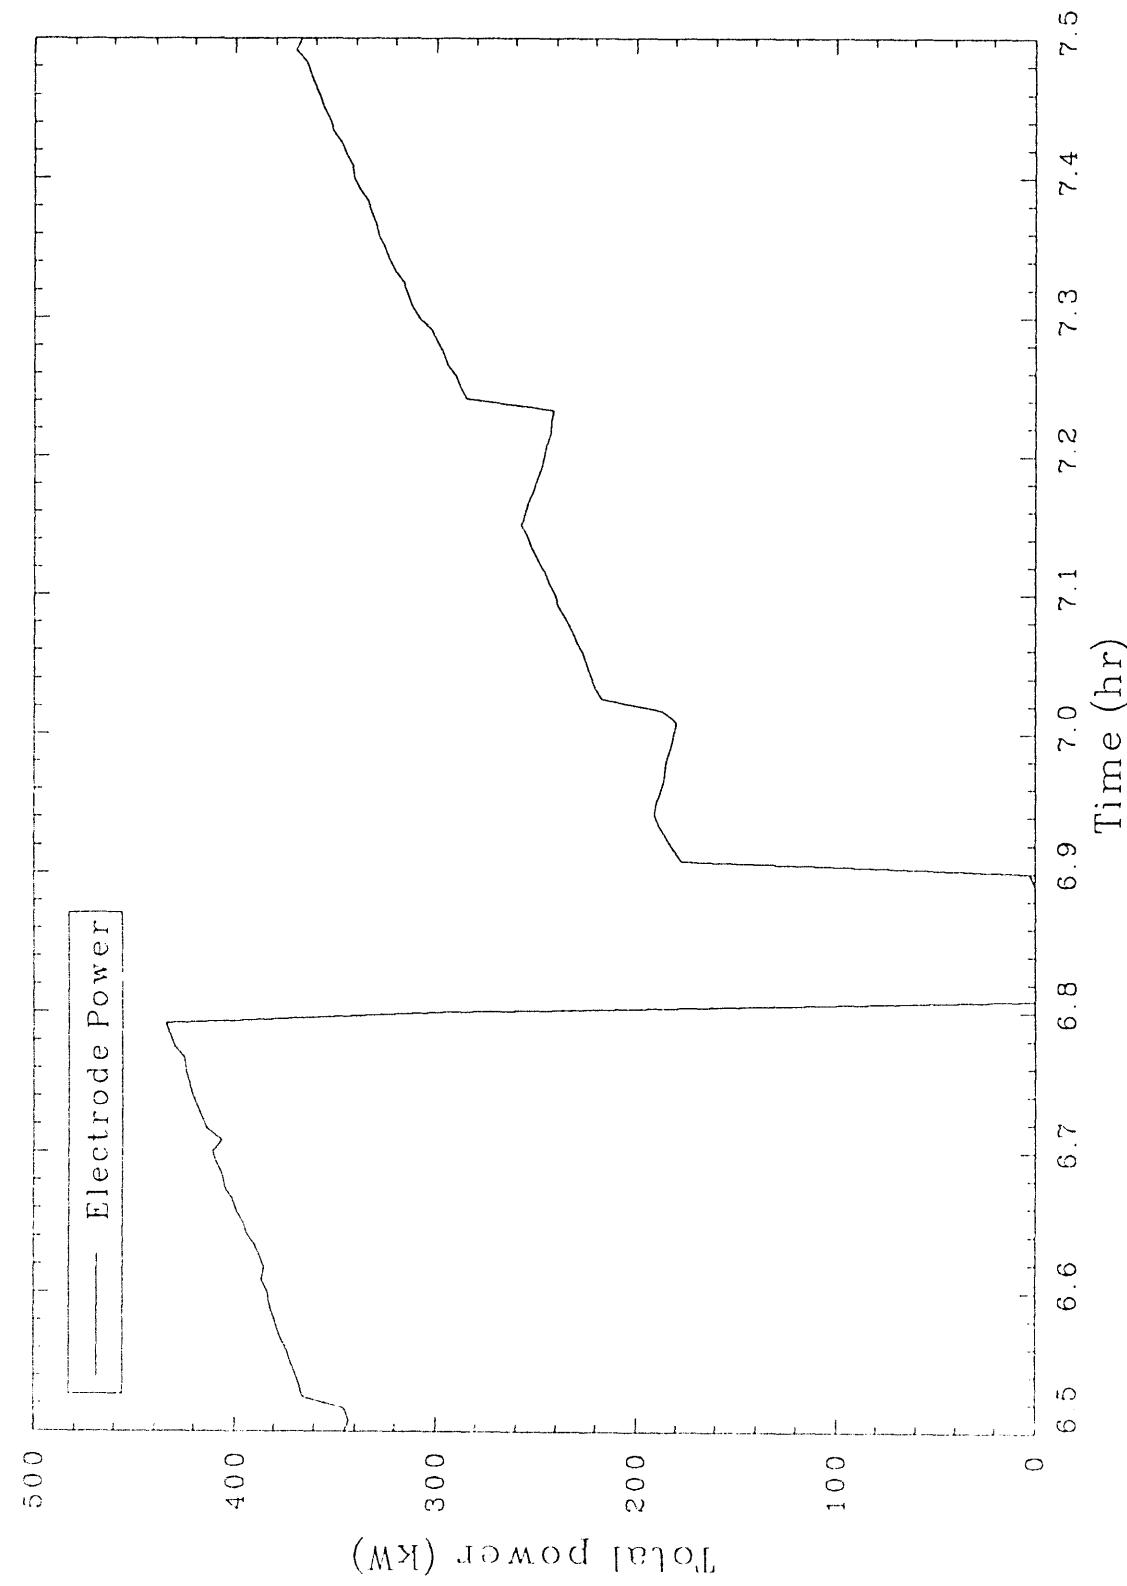
Figure 43. Total electrode power during the second event in Test 1.

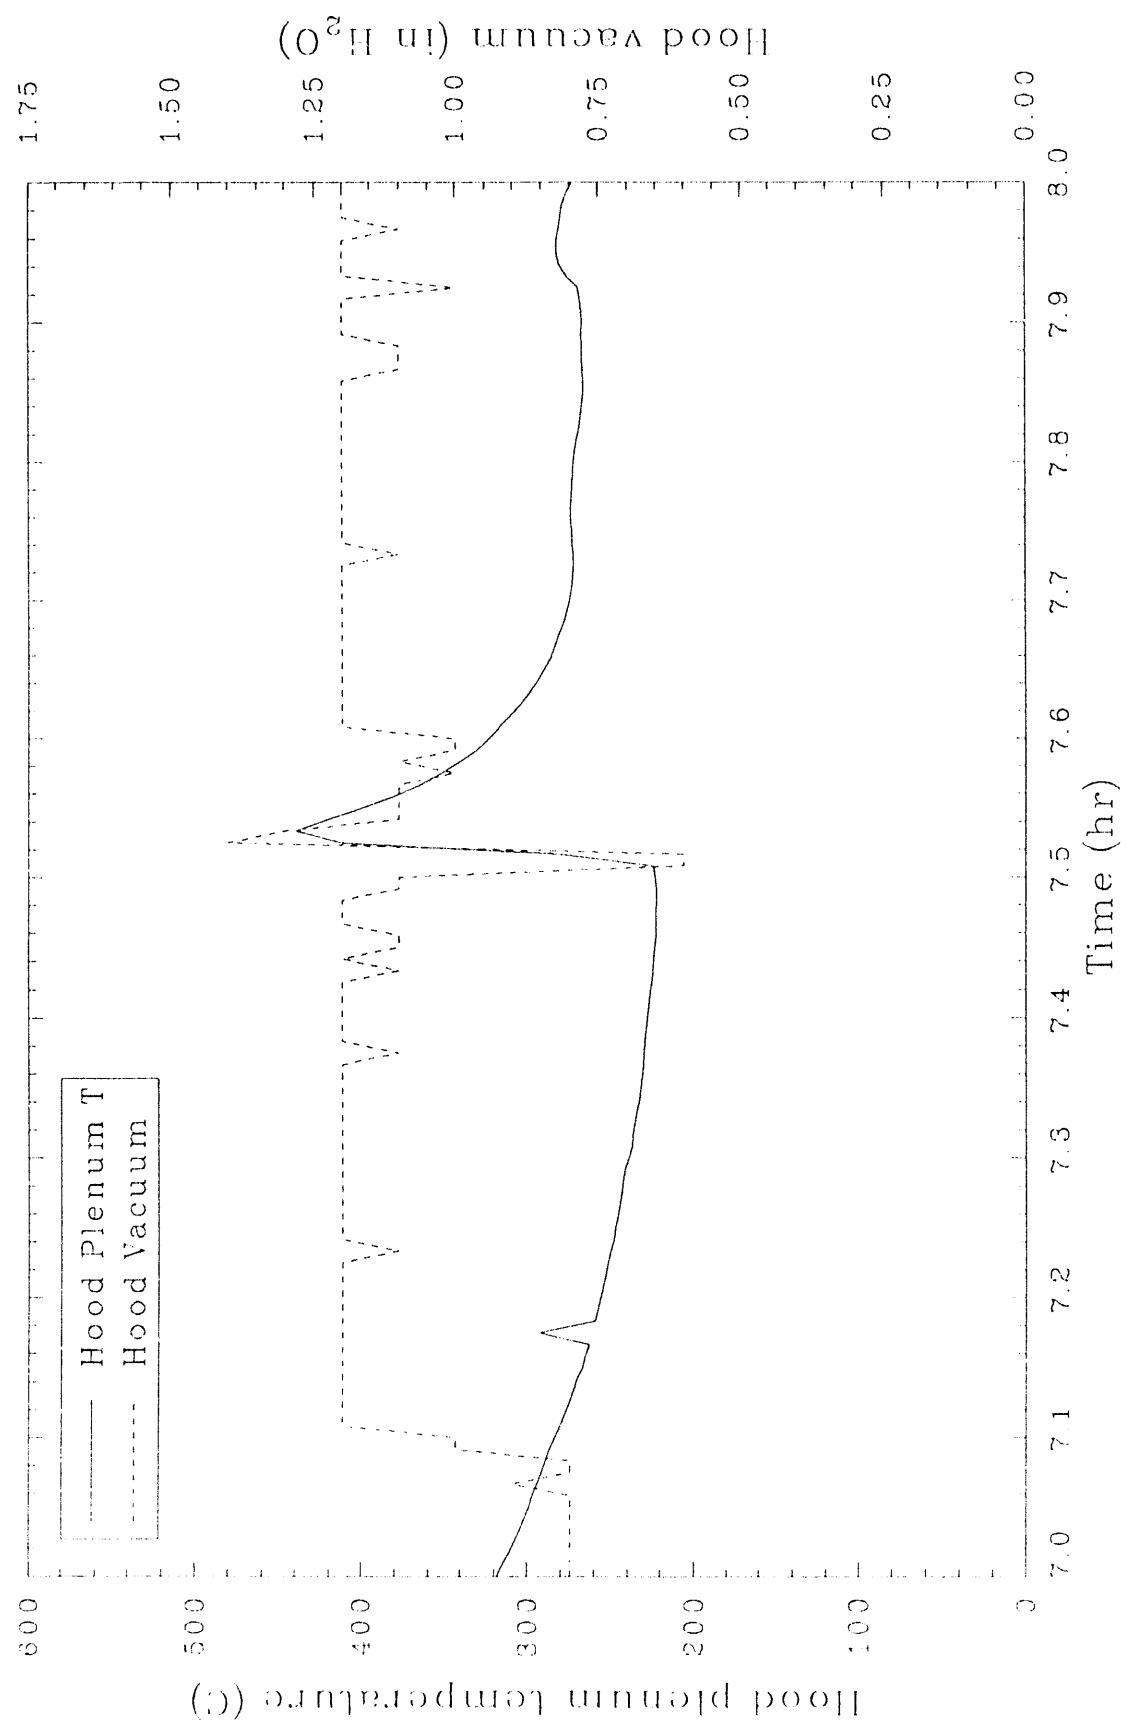
Figure 44. Hood vacuum and plenum temperature for the third event in Test 1.

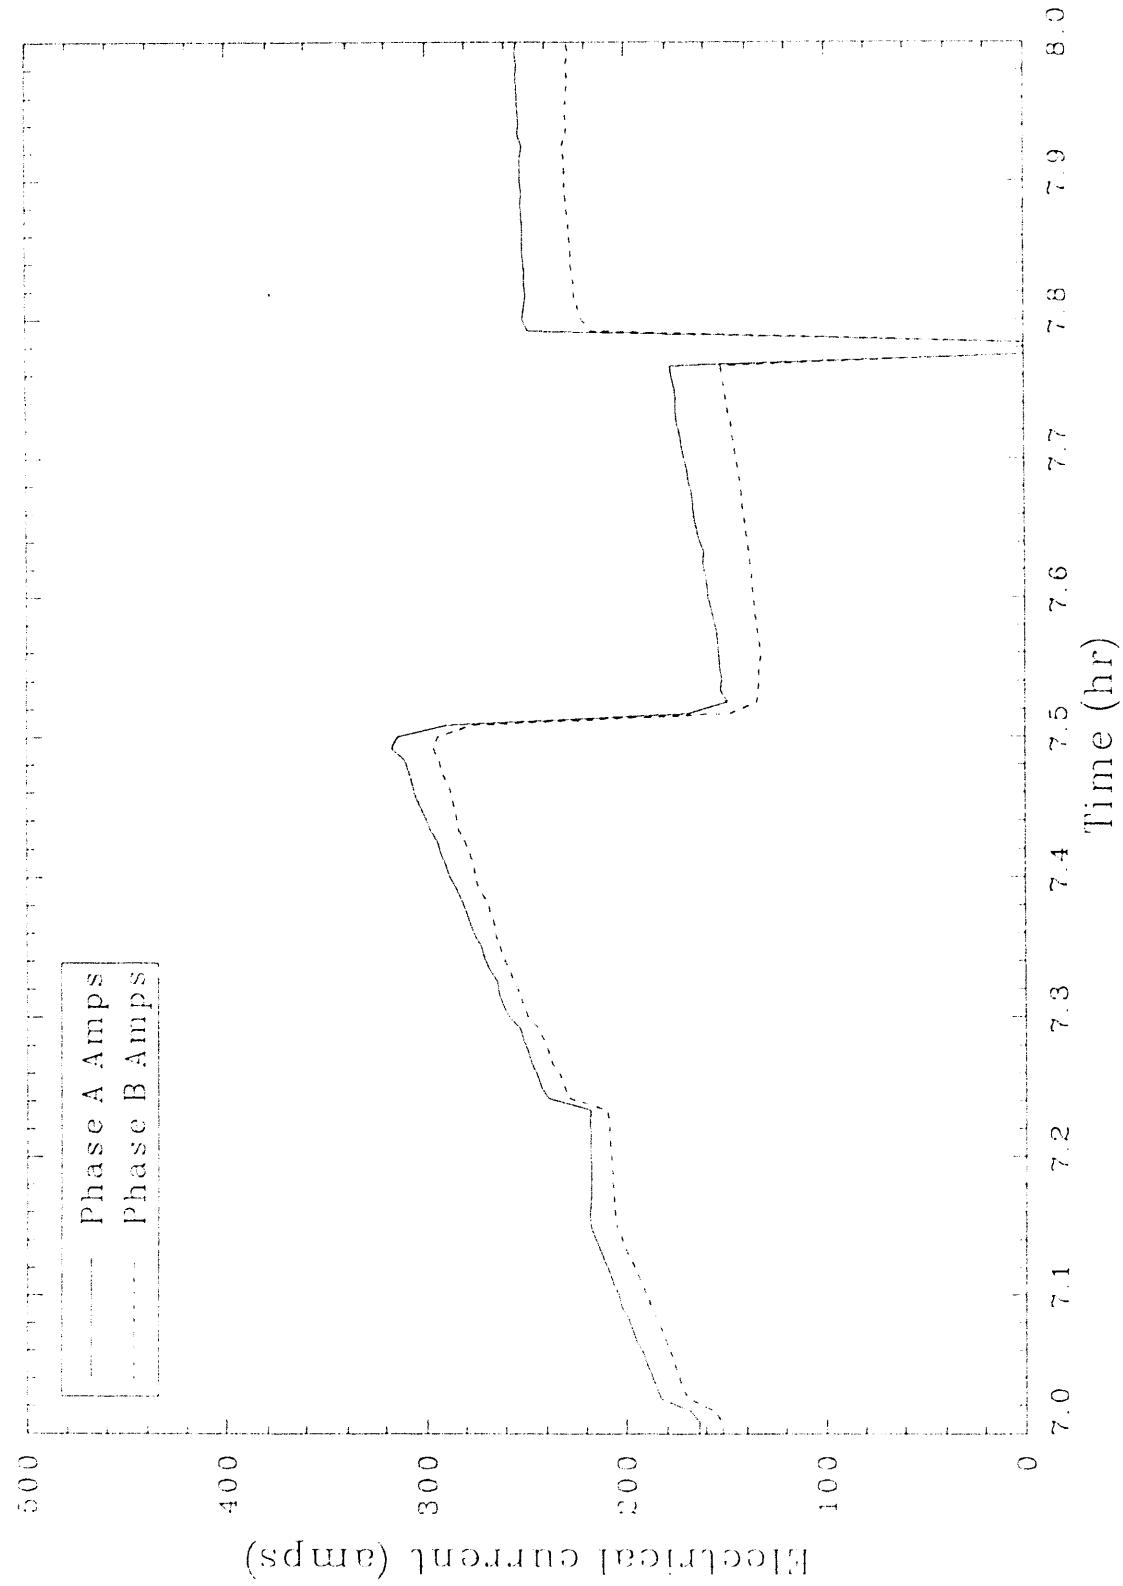
Figure 46. Phase A and B amperage for the third event in Test 1.

Electrical resistance data was balanced, unlike the previous two events. Phases A and B increased from 2 ohms to just over 4 ohms as a result of the event, shown in Figure 45. Power was not interrupted by operators during the event. Phase A amperage dropped from 320 to 160 A; and phase B amperage dropped from 300 to 140 A, as shown in Figure 46. Total power dropped from
