EGG-WTD-9807

August 1991

### **In Situ Vitrification Application to Buried Waste: Final Report of Intermediate Field Tests at Idaho National Engineering Laboratory**

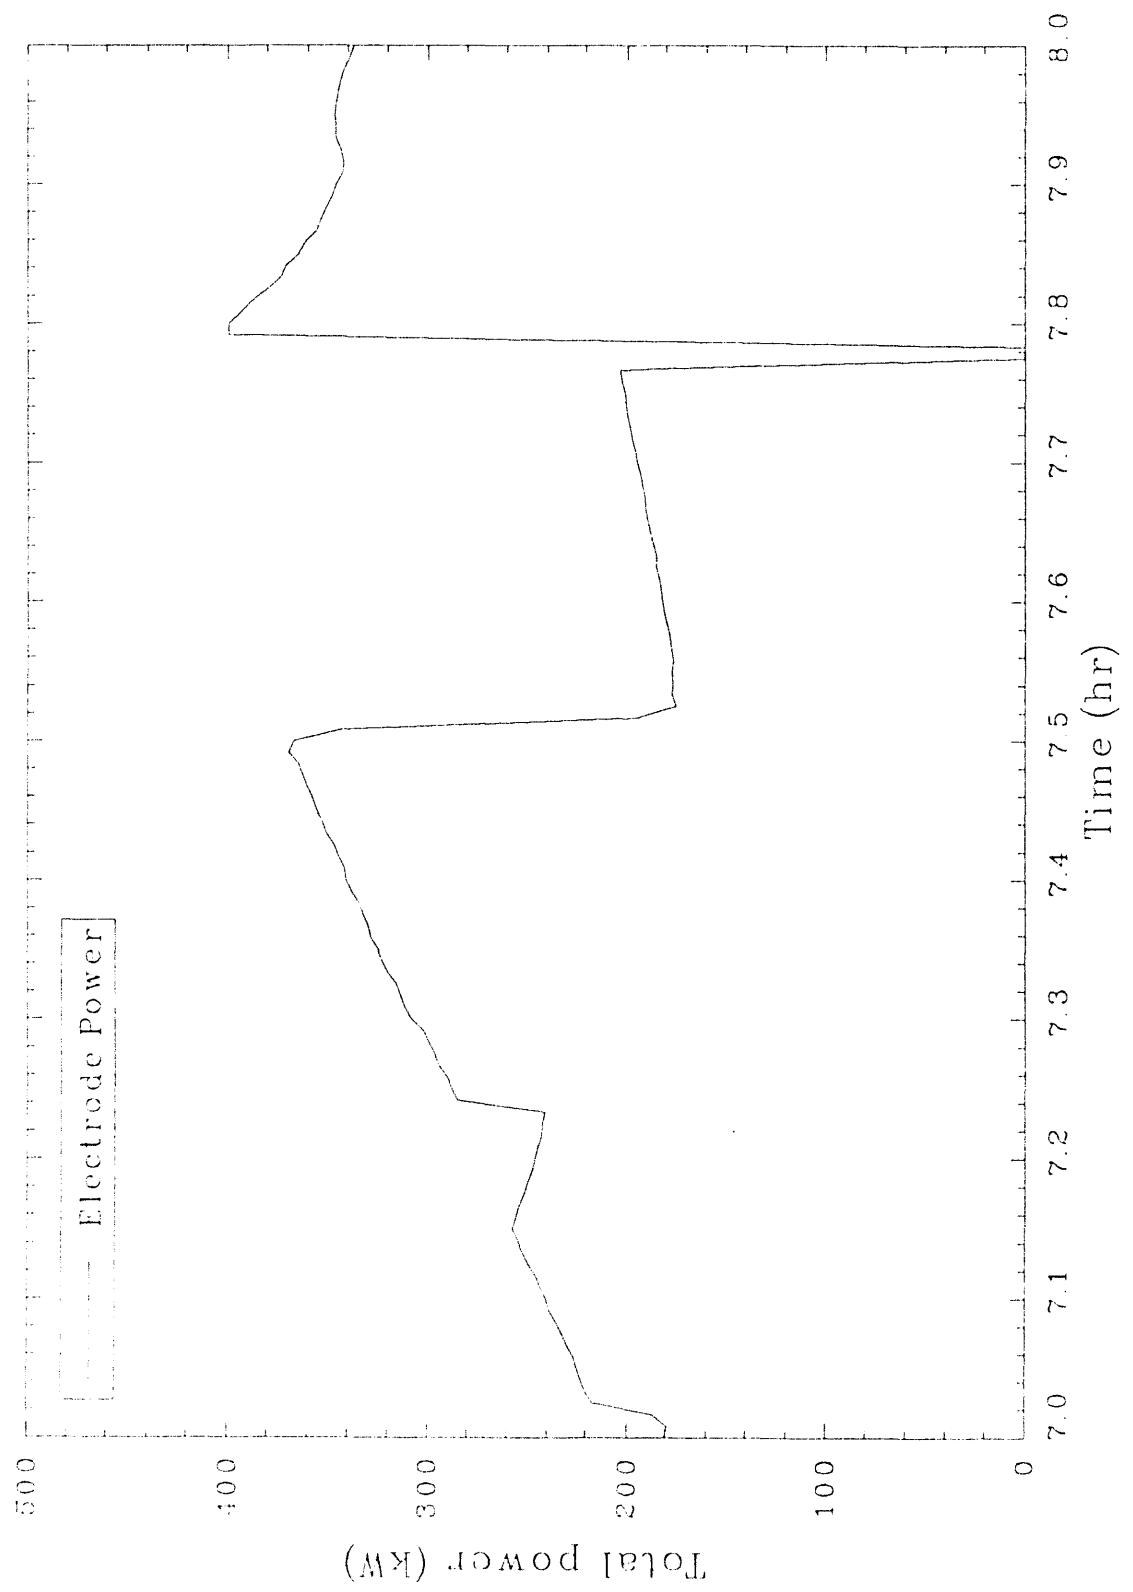
Figure 47. Total electrode power for the third event in Test 1.

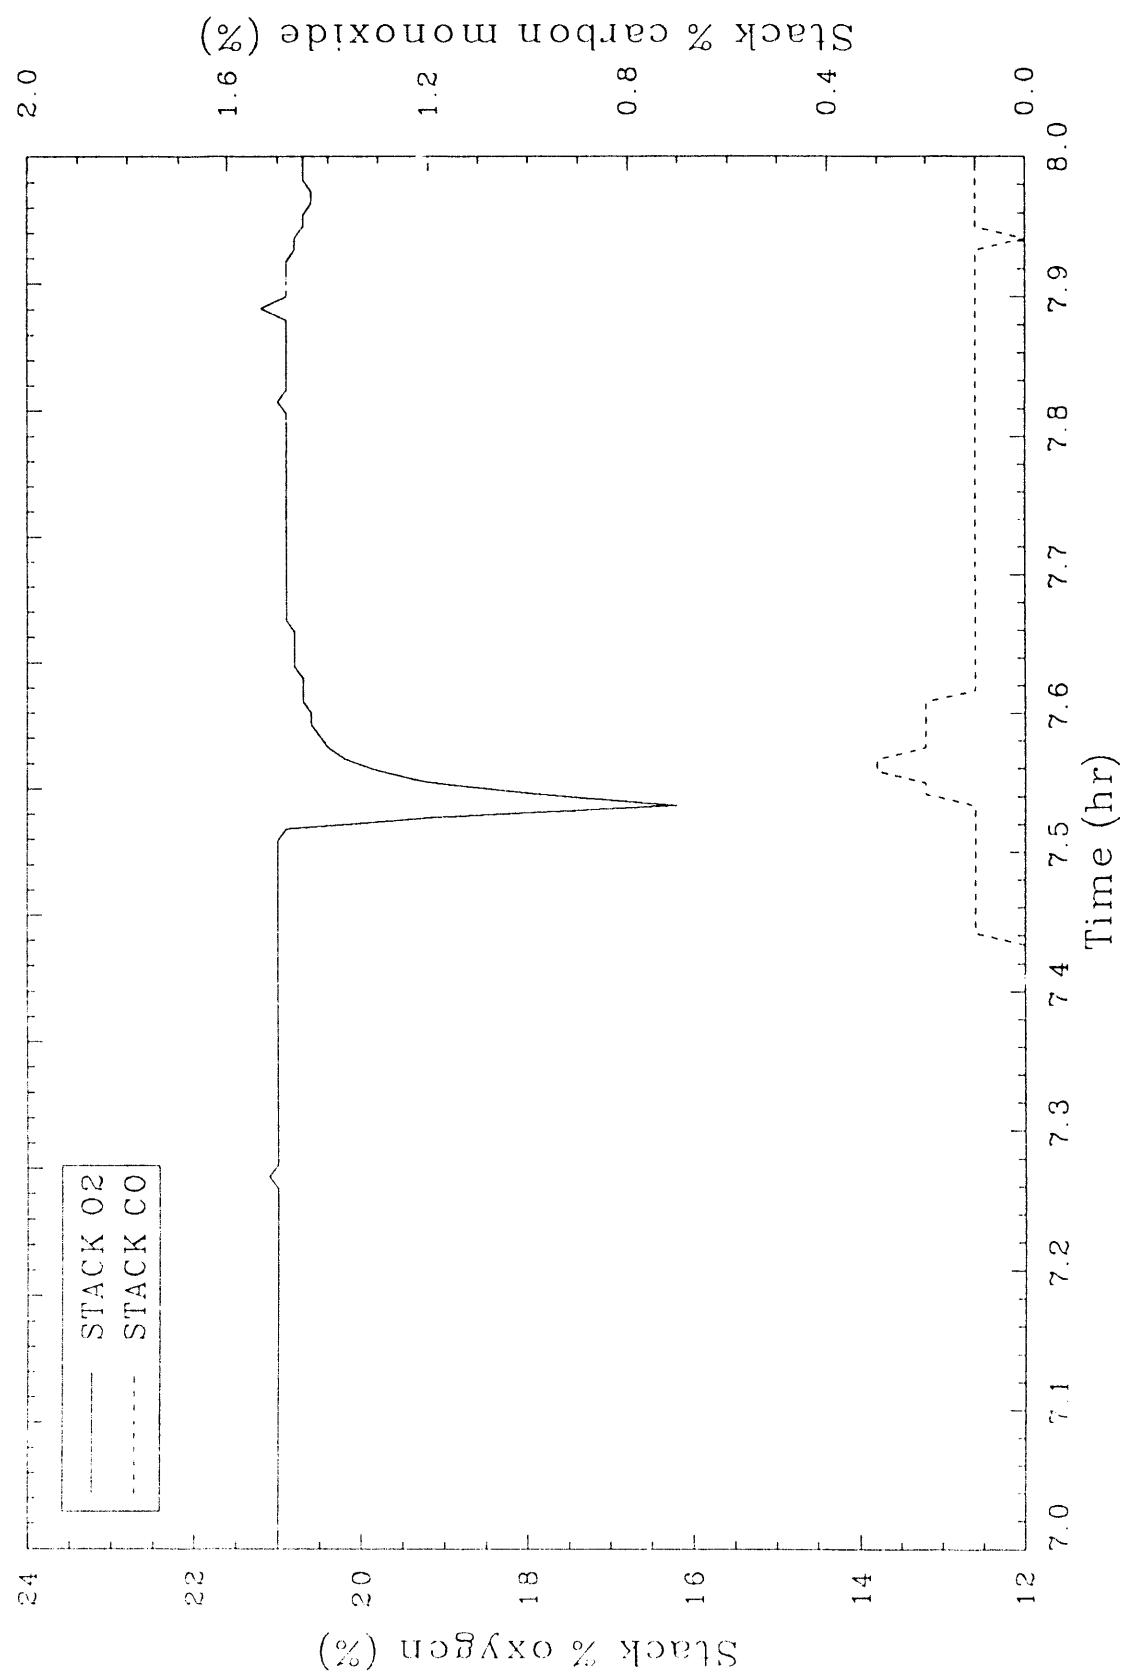
Figure 48. Stack oxygen and carbon monoxide concentrations for the third event in Test 1.

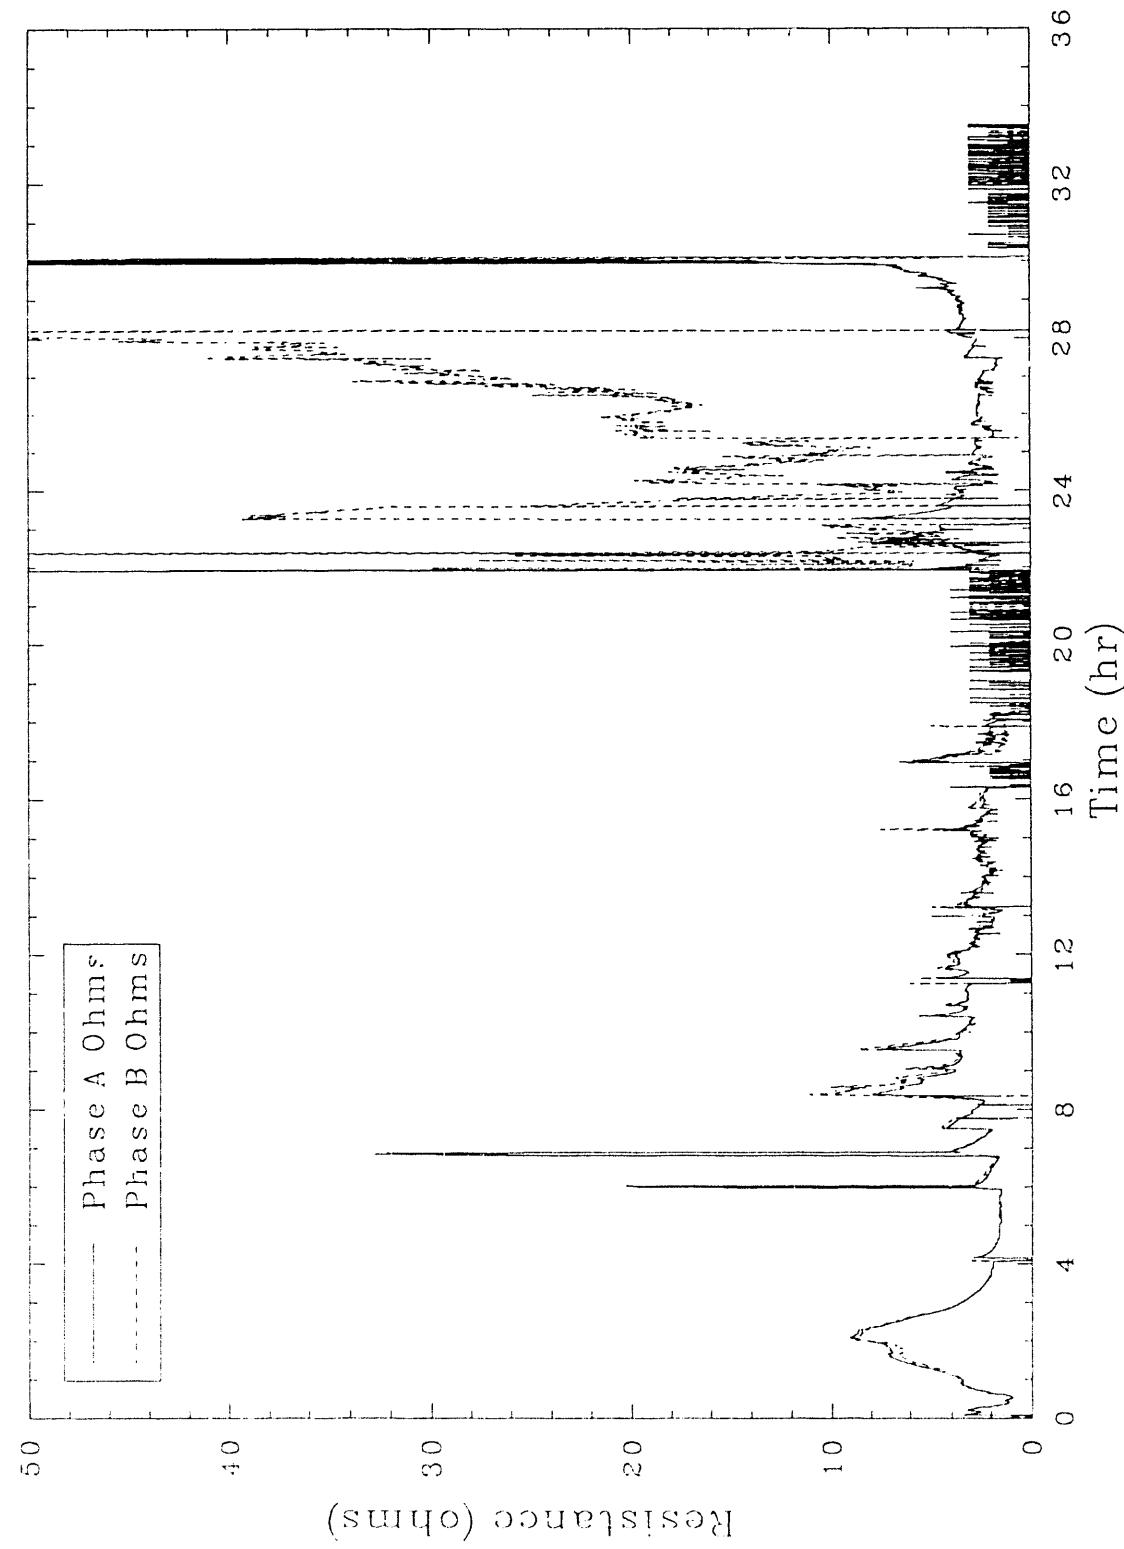
Figure 49. Phases A and B resistance for Test 1.

Attempts to replenish the heat to the melt via electrode power through phase A was futile and resulted in localized heating between the phase A electrodes. Phase A resistance gradually increased to 170 ohms, and the glass pool being heated by the phase A electrodes ultimately melted away from the four stuck electrodes. The test was terminated when phase A amperage began to wildly fluctuate while the phase A voltage correspondingly spiked to full-scale. This indicated the advancing melt had finally melted away from at least one of the phase A electrodes. At this point, because the electrodes were frozen in place and no longer in contact with molten glass, electrode power was terminated and preparations for process equipment shutdown were initiated.

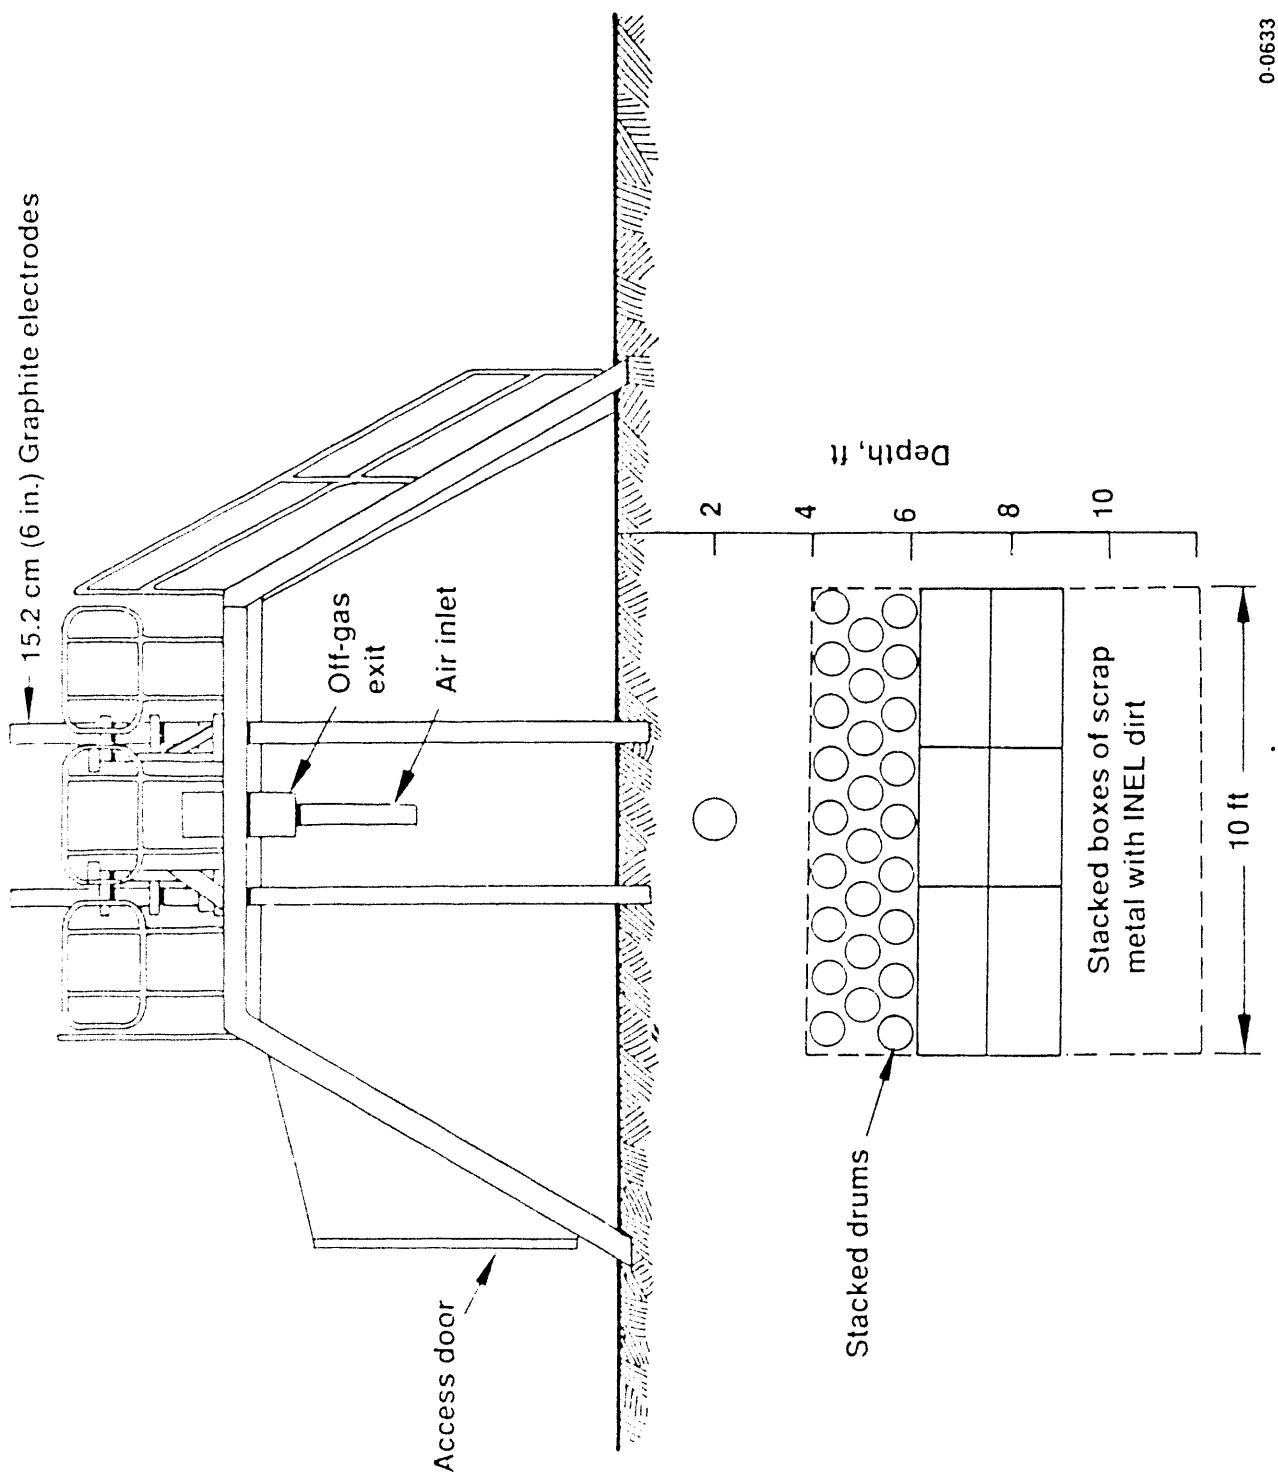
Test Pit 2 was constructed by laying the soil underburden, then placing the stacked boxes into the pit. The stacked cans were then placed and the overburden put on top. The stacked boxes containing scrap metal with added fill dirt were loaded onto pallets and lowered by crane into the pit. Each pallet supported 12 boxes. Figure 51 shows the placement of the stacked boxes into the pit. After the boxes had been placed approximately 2.5 to 5.1 cm (1 to 2 in.) of dirt was placed on top to cover the boxes prior to laying three layers of stacked cans. Figure 52 shows the completed bottom layer of cans. The cans containing the dysprosium oxide tracer were placed near the center of this layer.

Figure 50. Schematic of Test Pit 2.

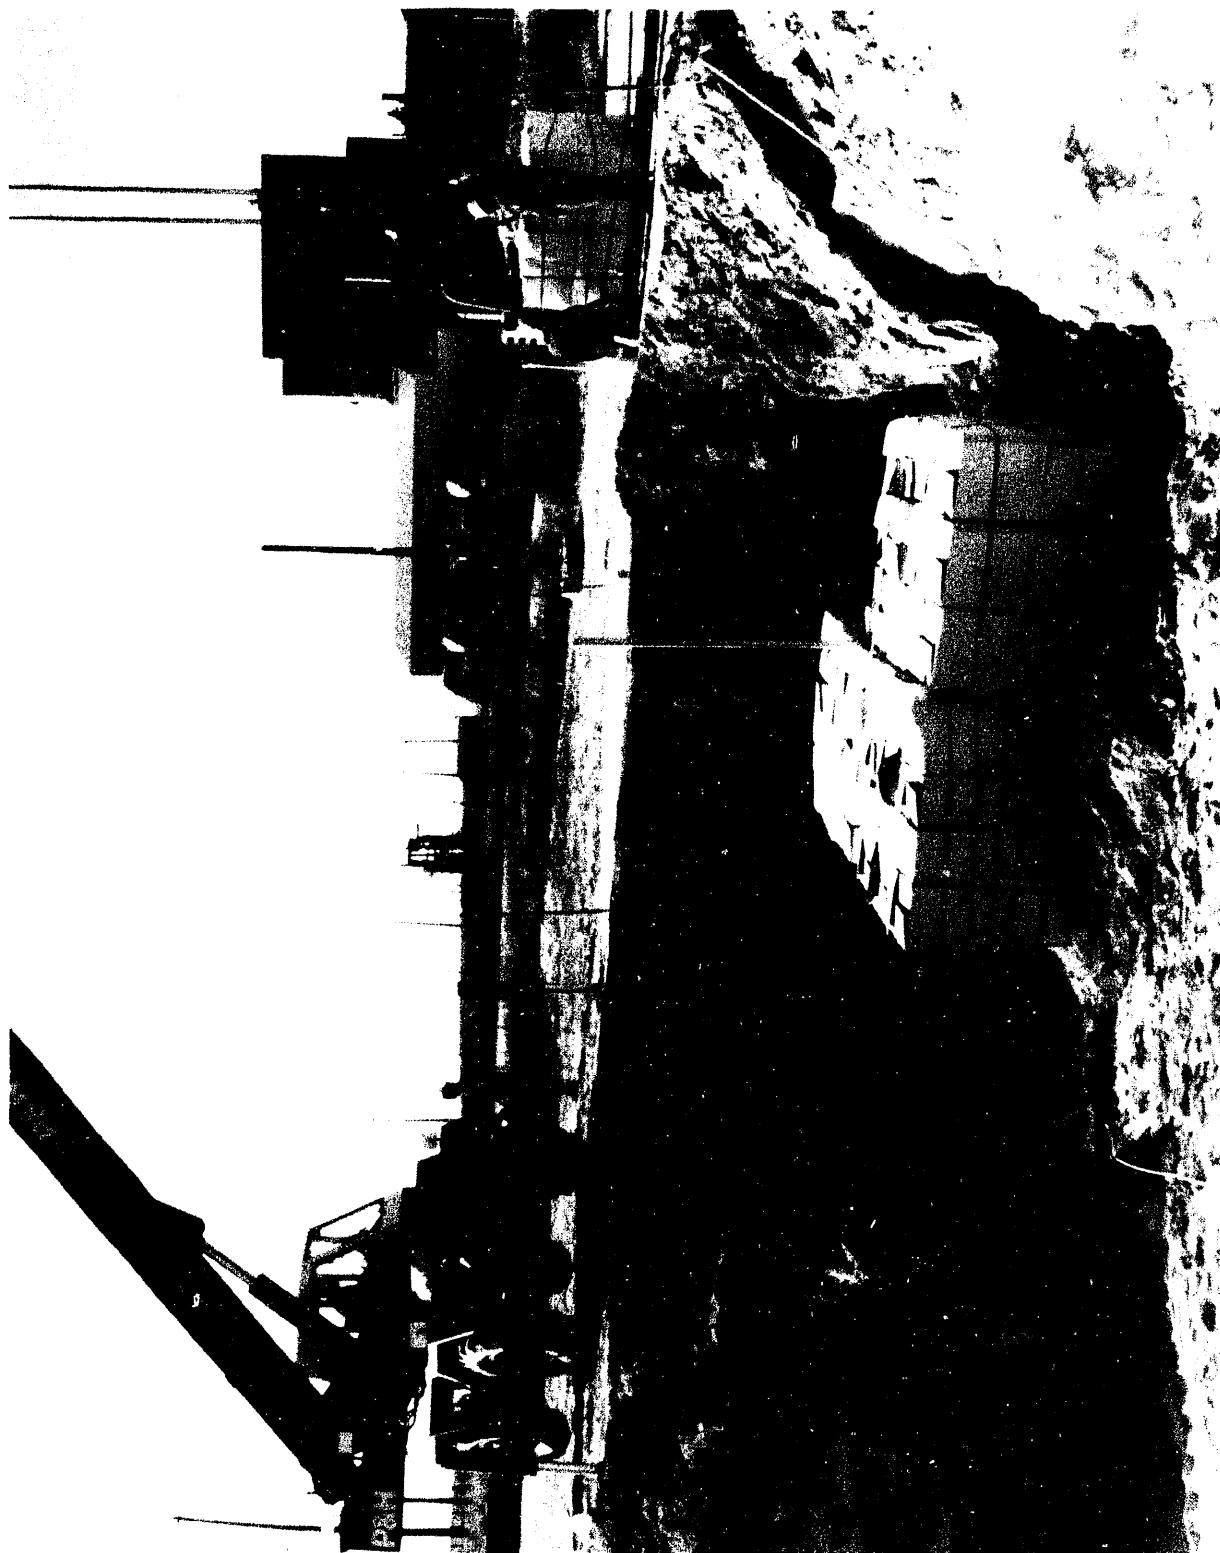
Figure 51. Placement of stacked boxes in Test Pit 2.

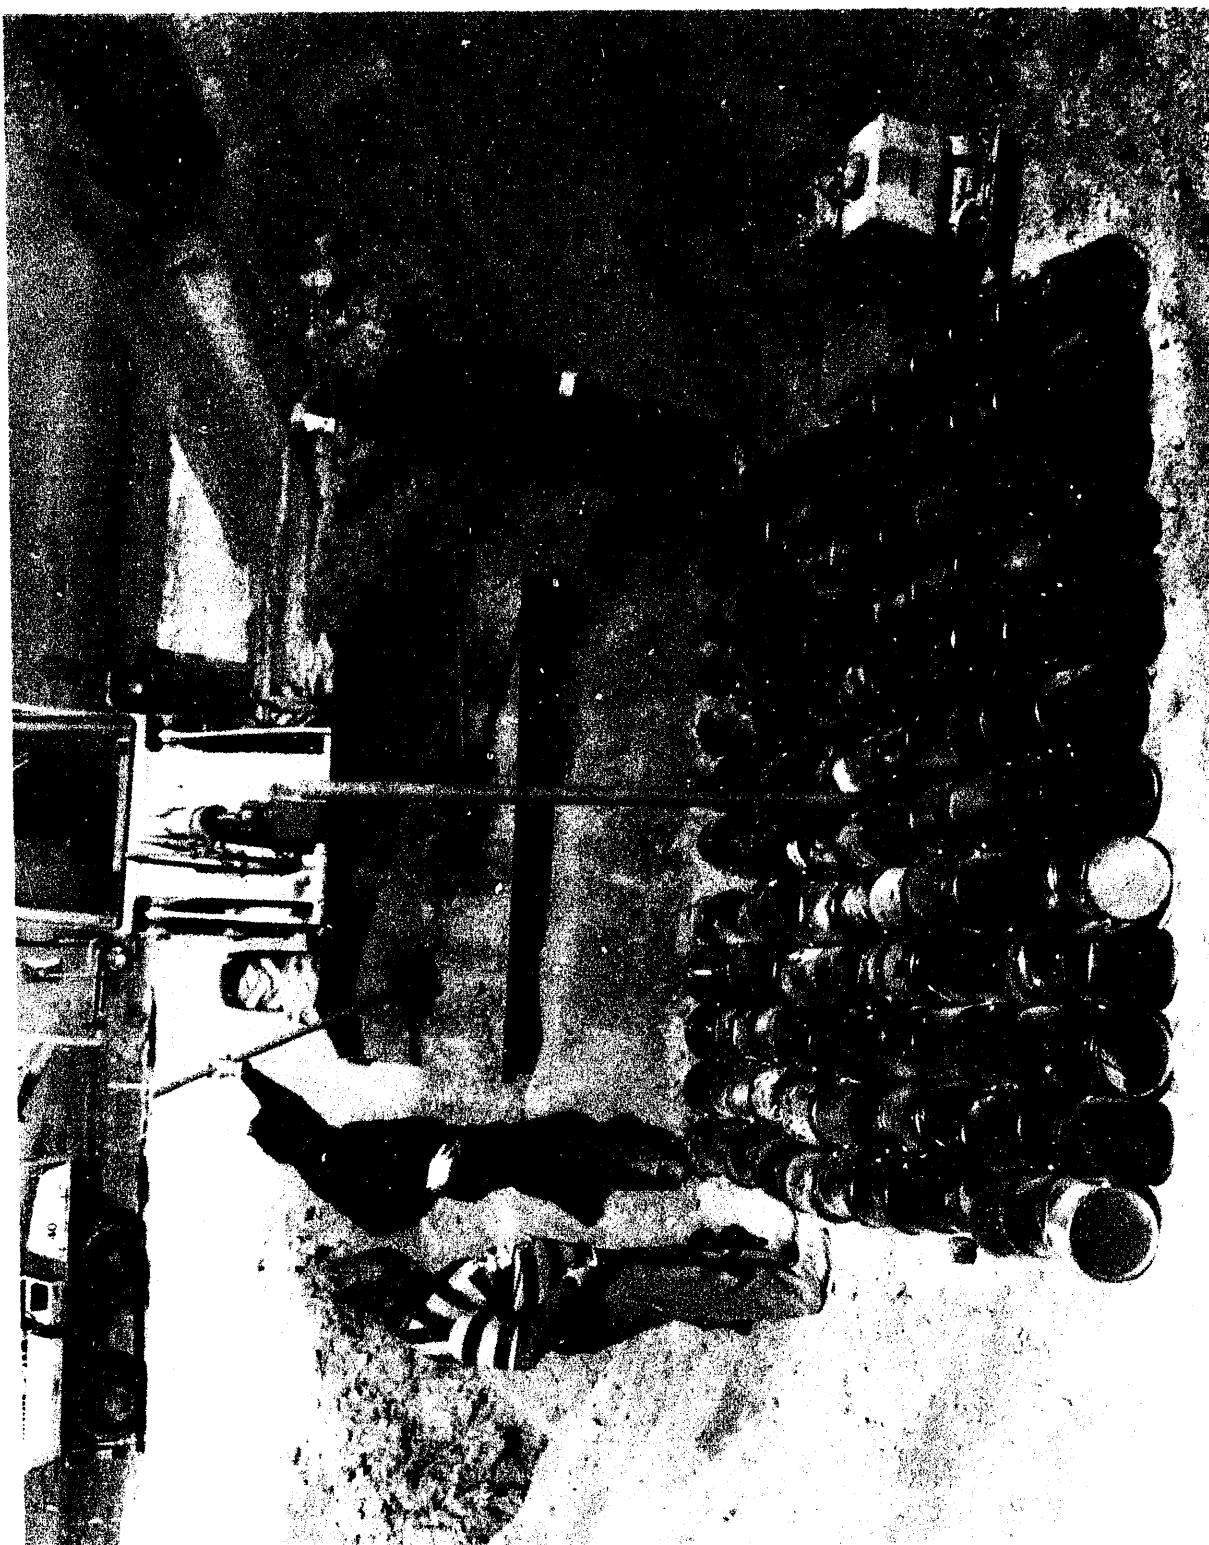
Figure 52. Bottom layer of cans in Test Pit 2.

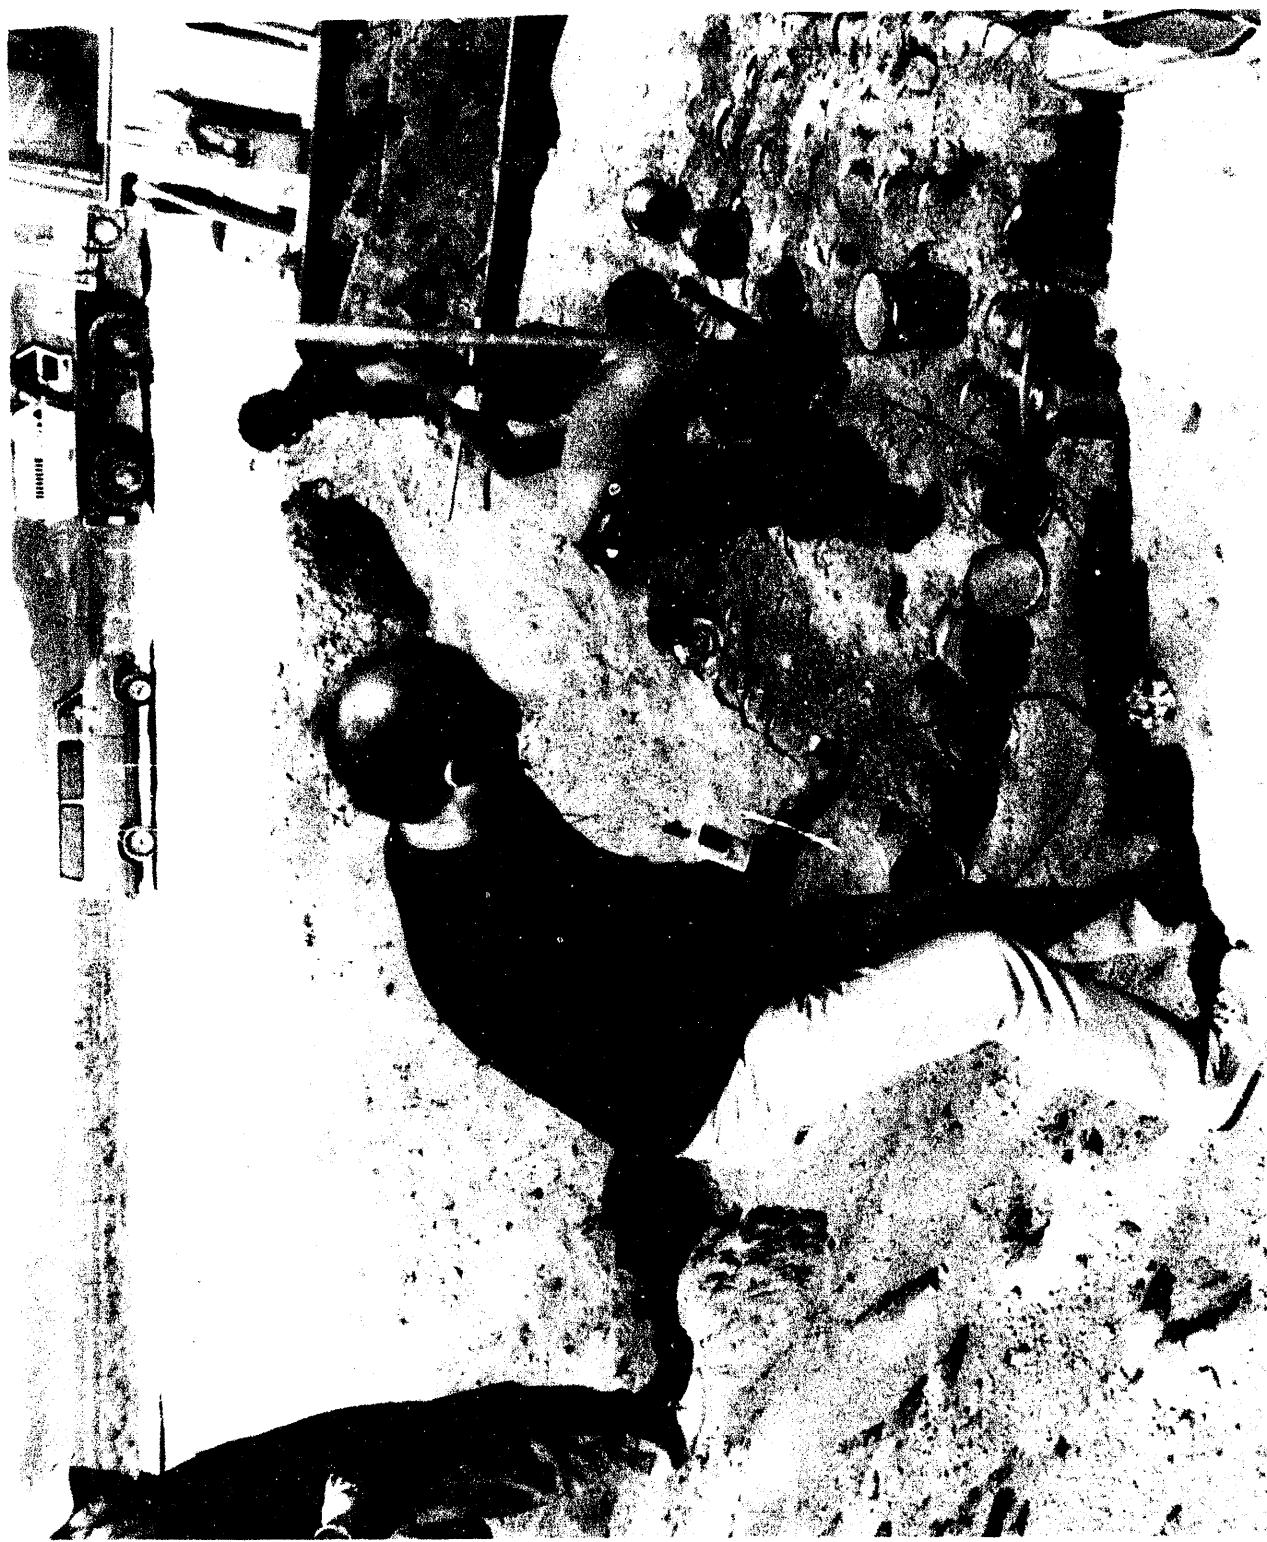
Figure 53. Placement of fill dirt between can layers in Test Pit 2.

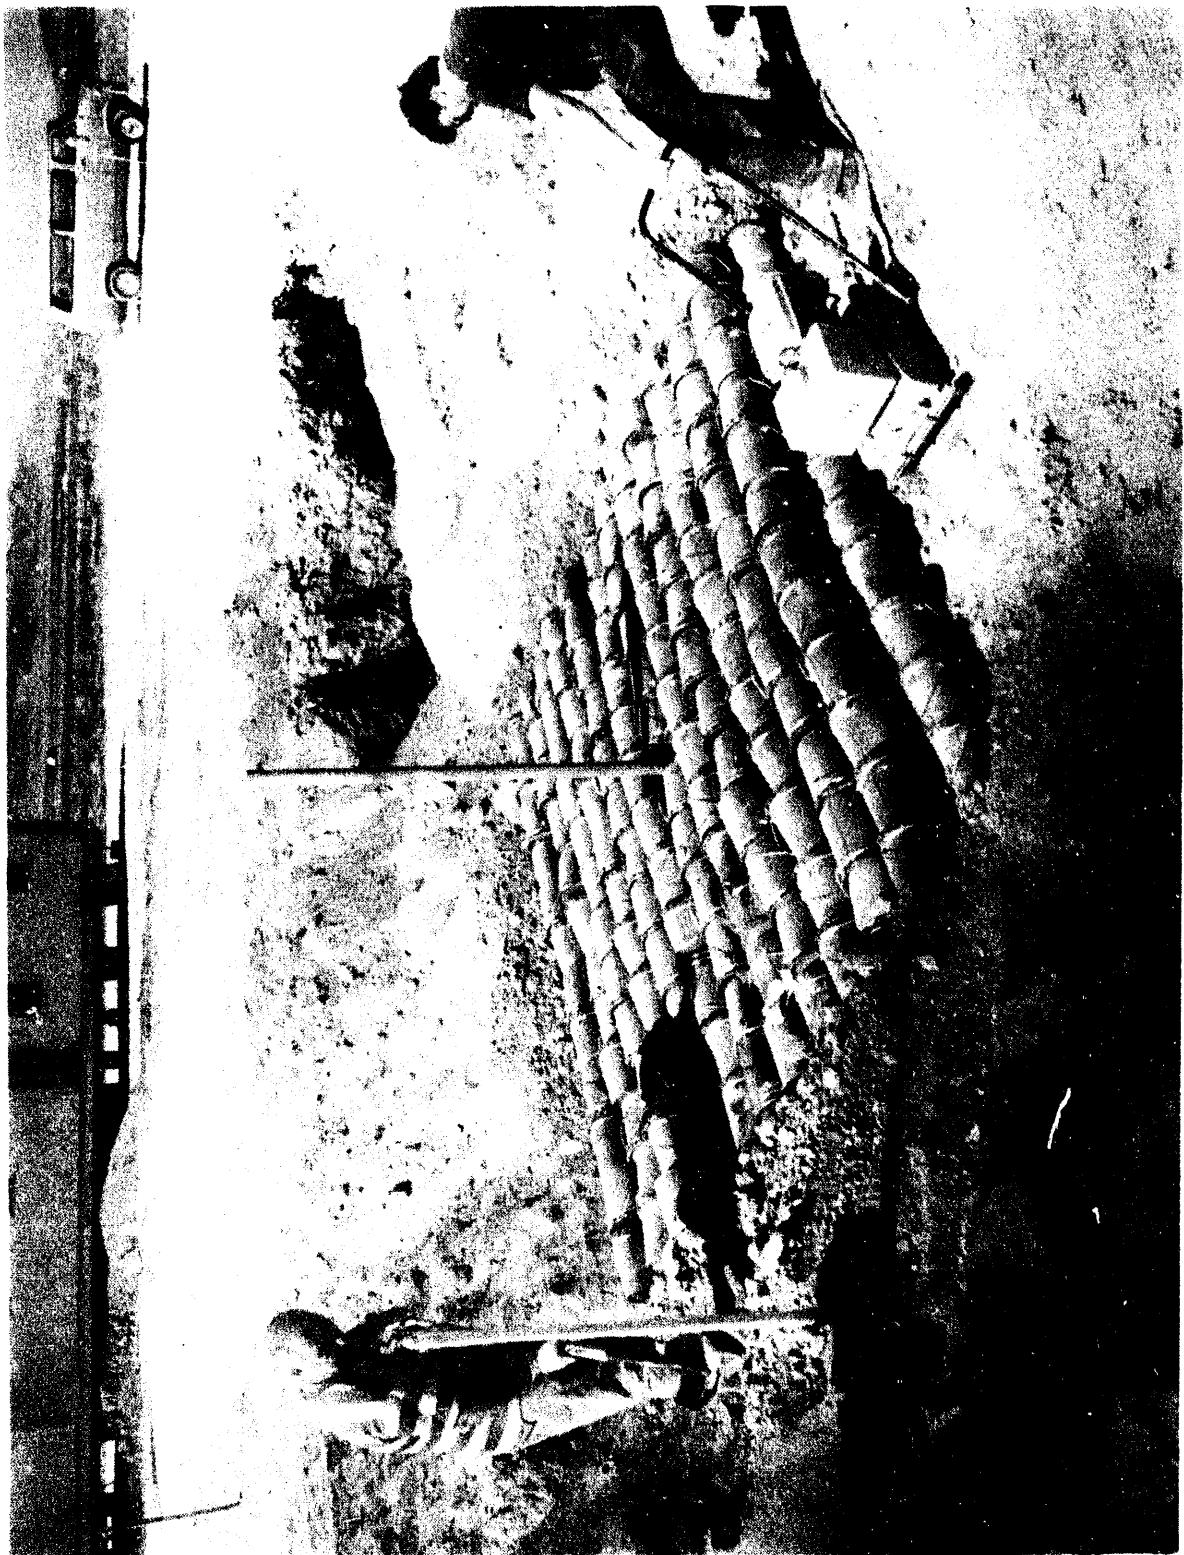
Figure 54. Placement of middle layer of cans in Test Pit 2.

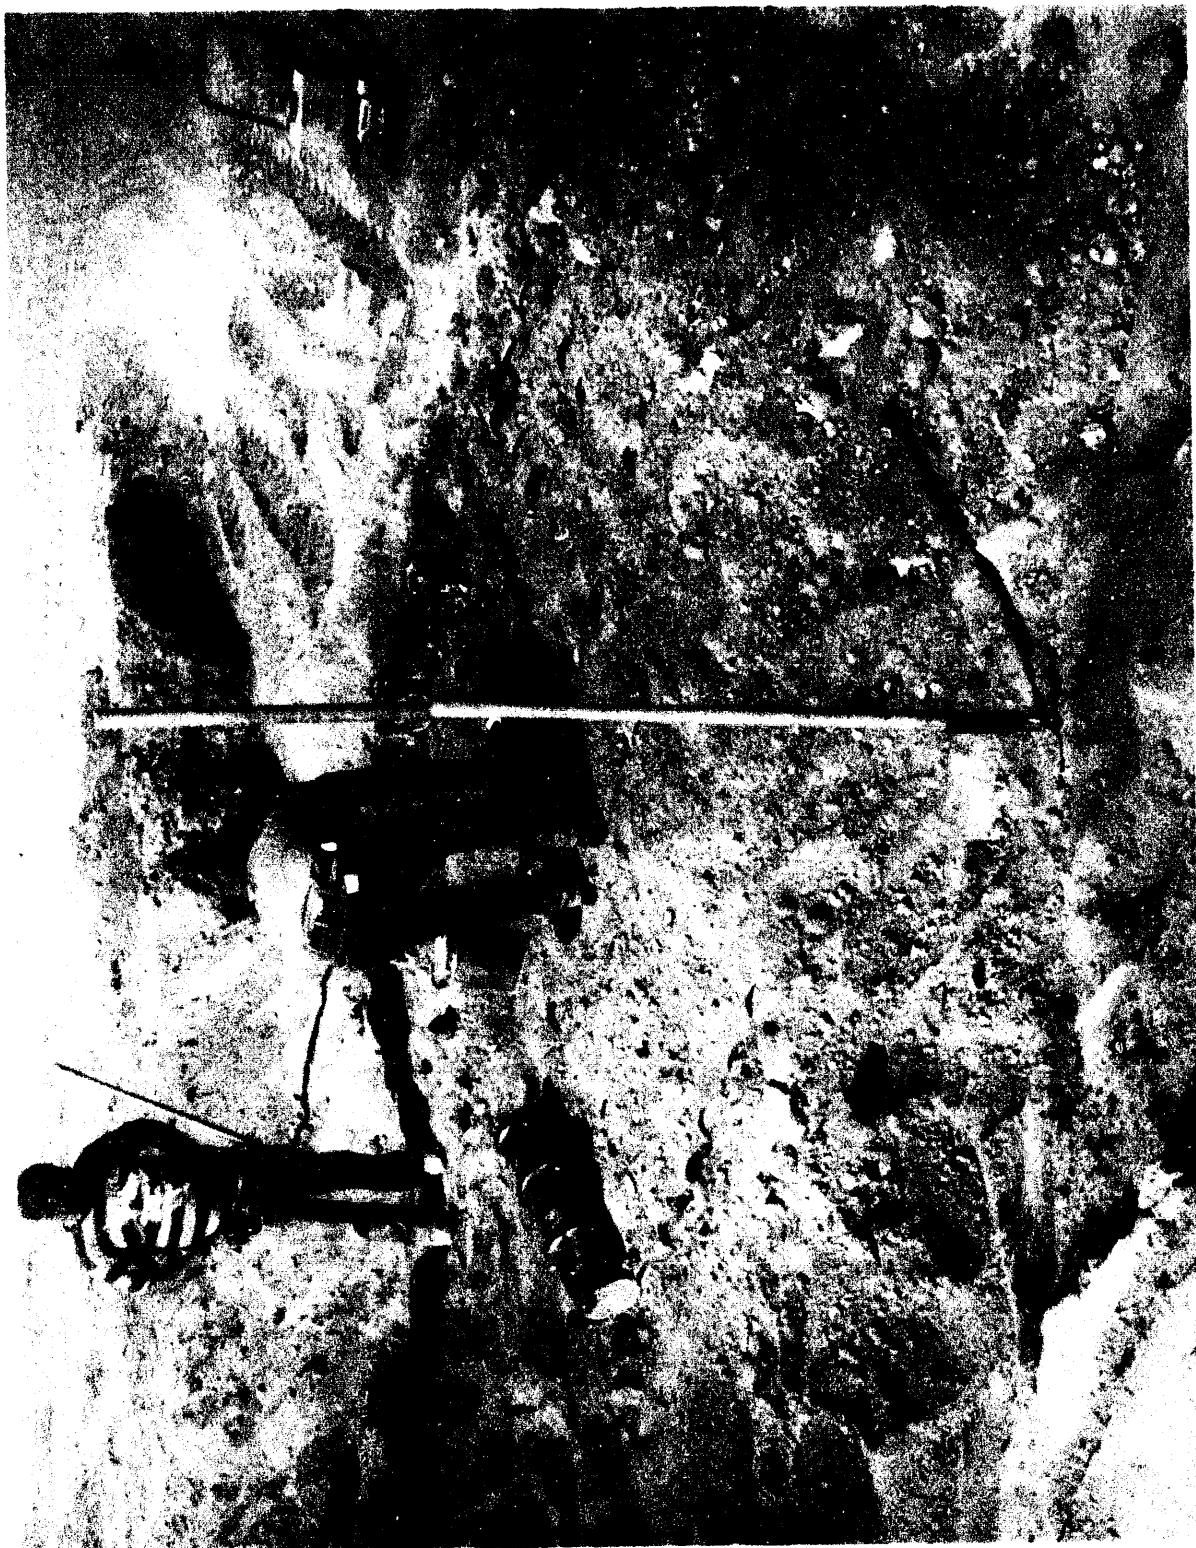
Figure 55. Dirt placed between middle and top layers of cans in Test Pit 2.

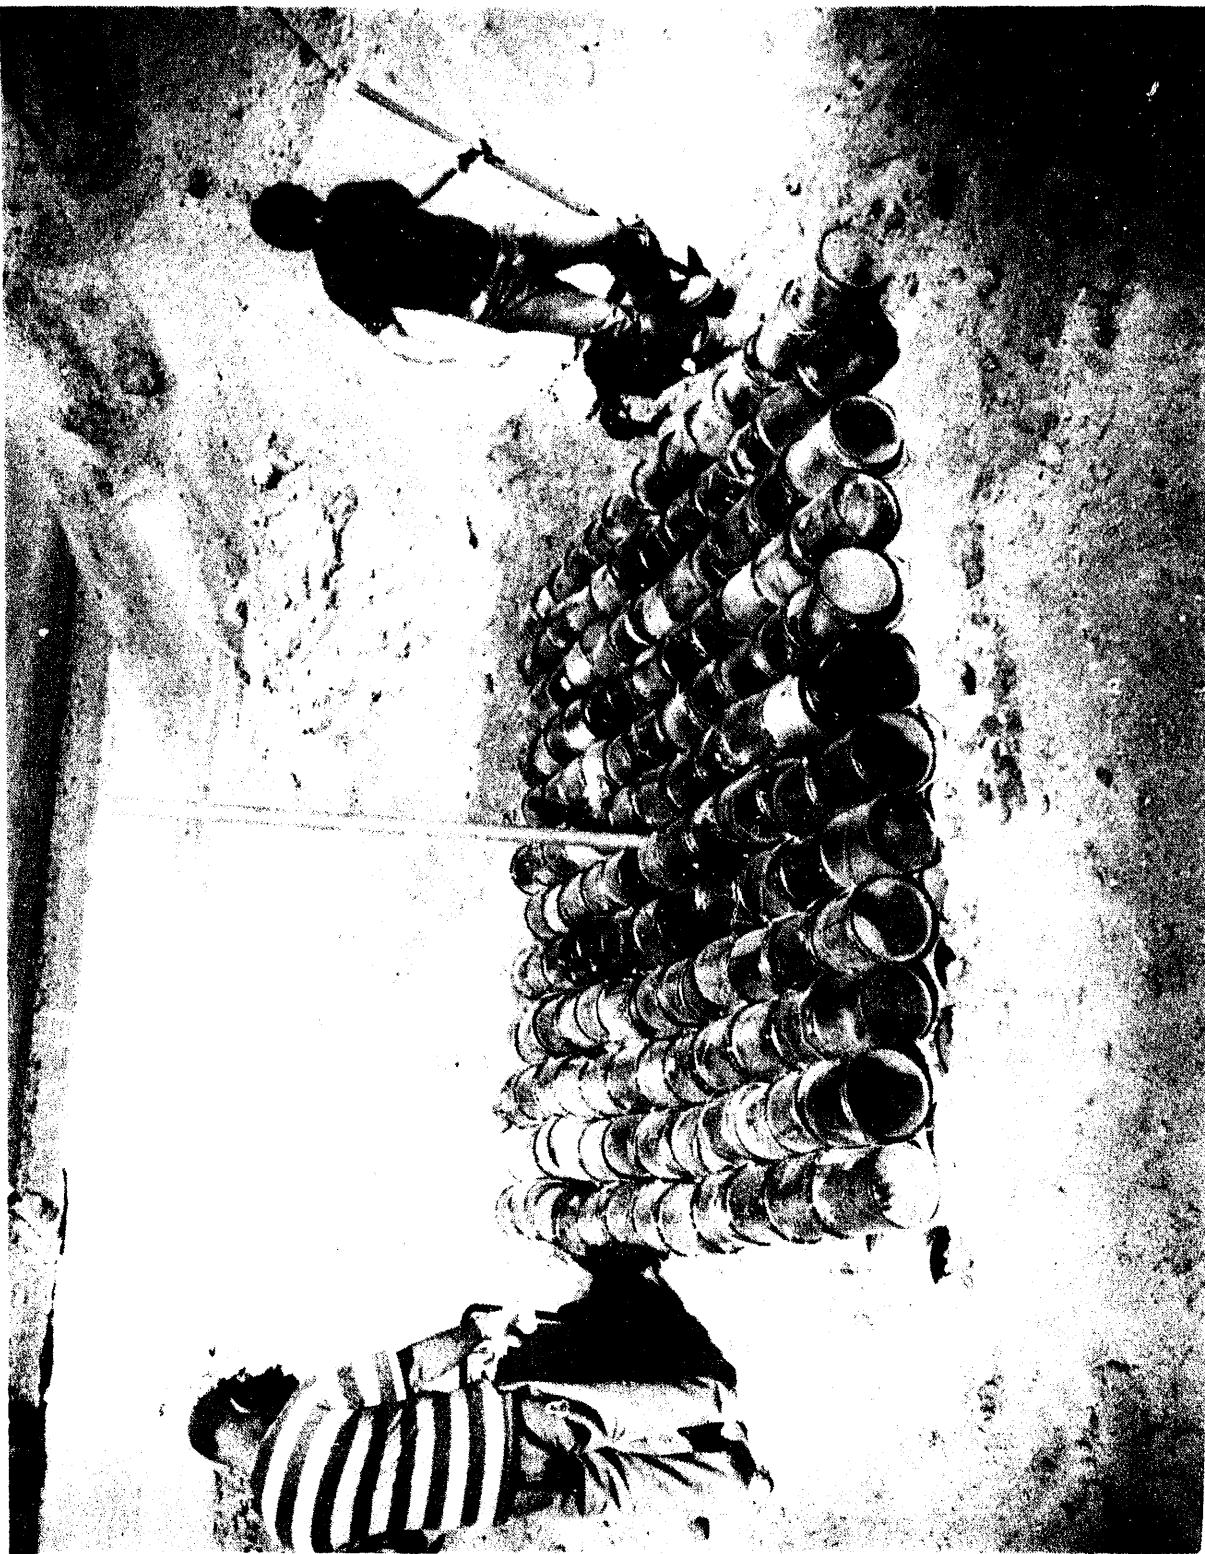
Figure 56. Placement of top layer of cans in Test Pit 2

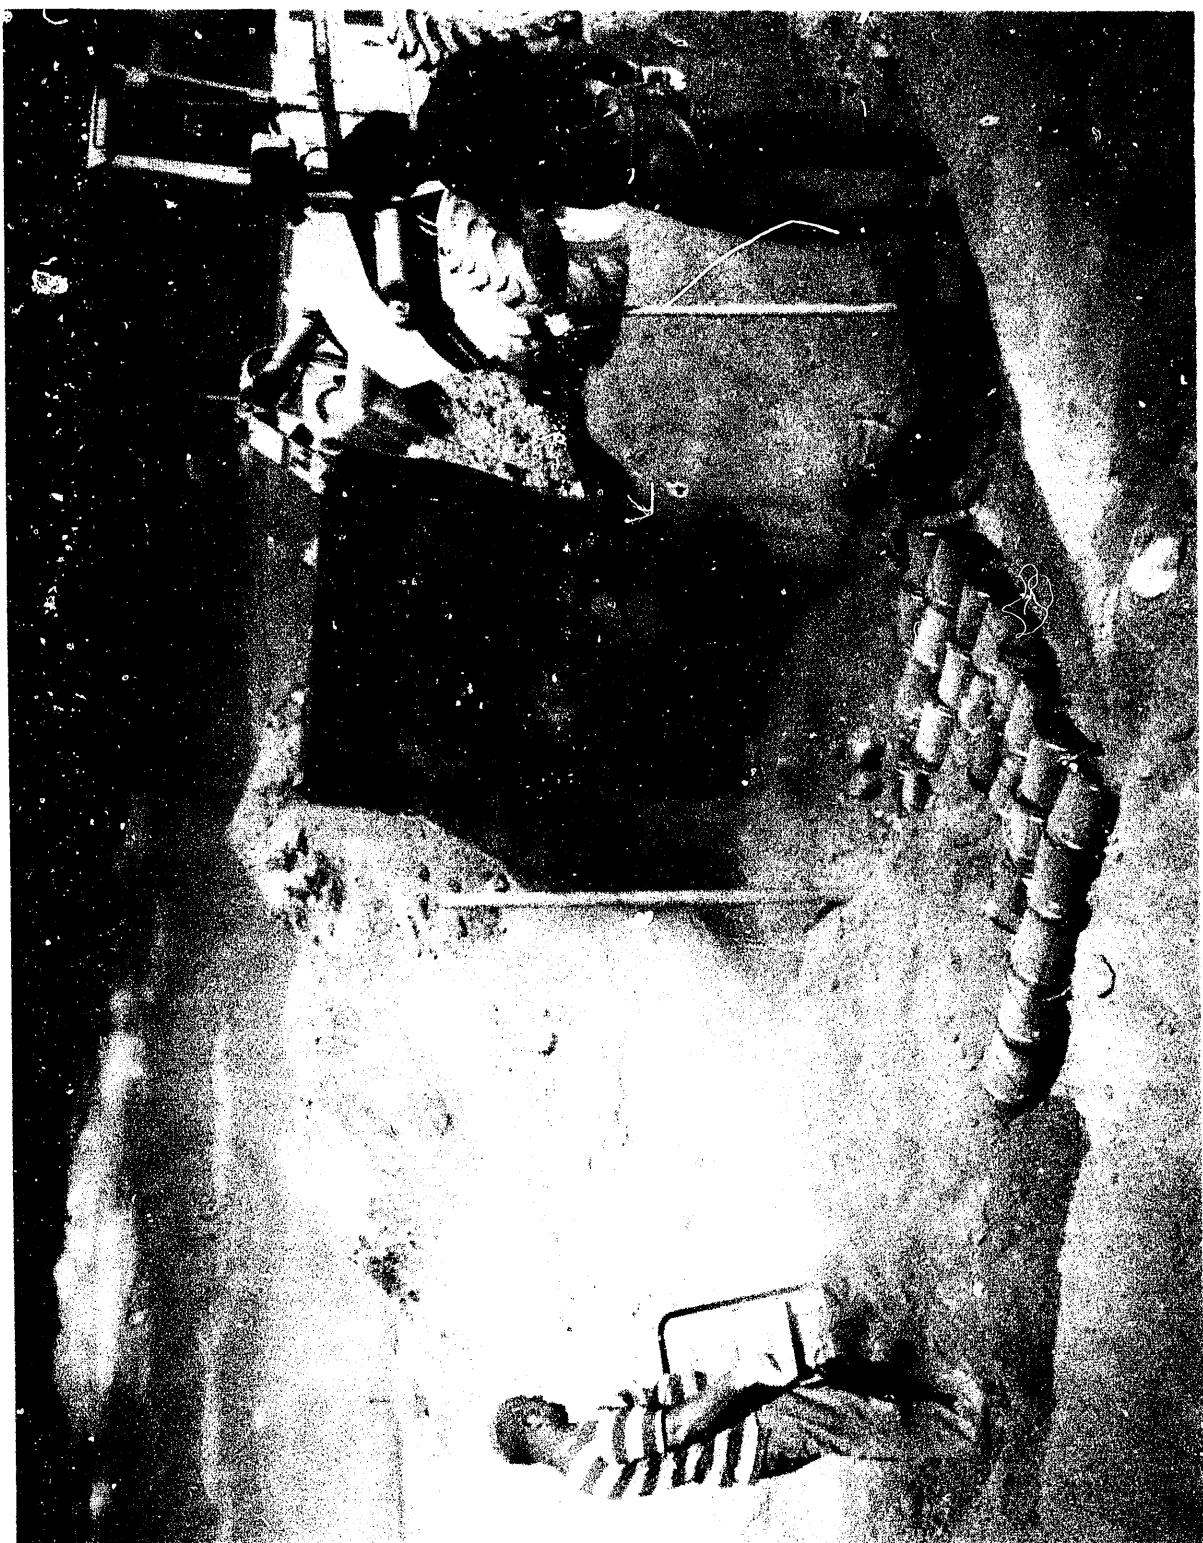
Figure 57. Final backfill for Test Pit 2.

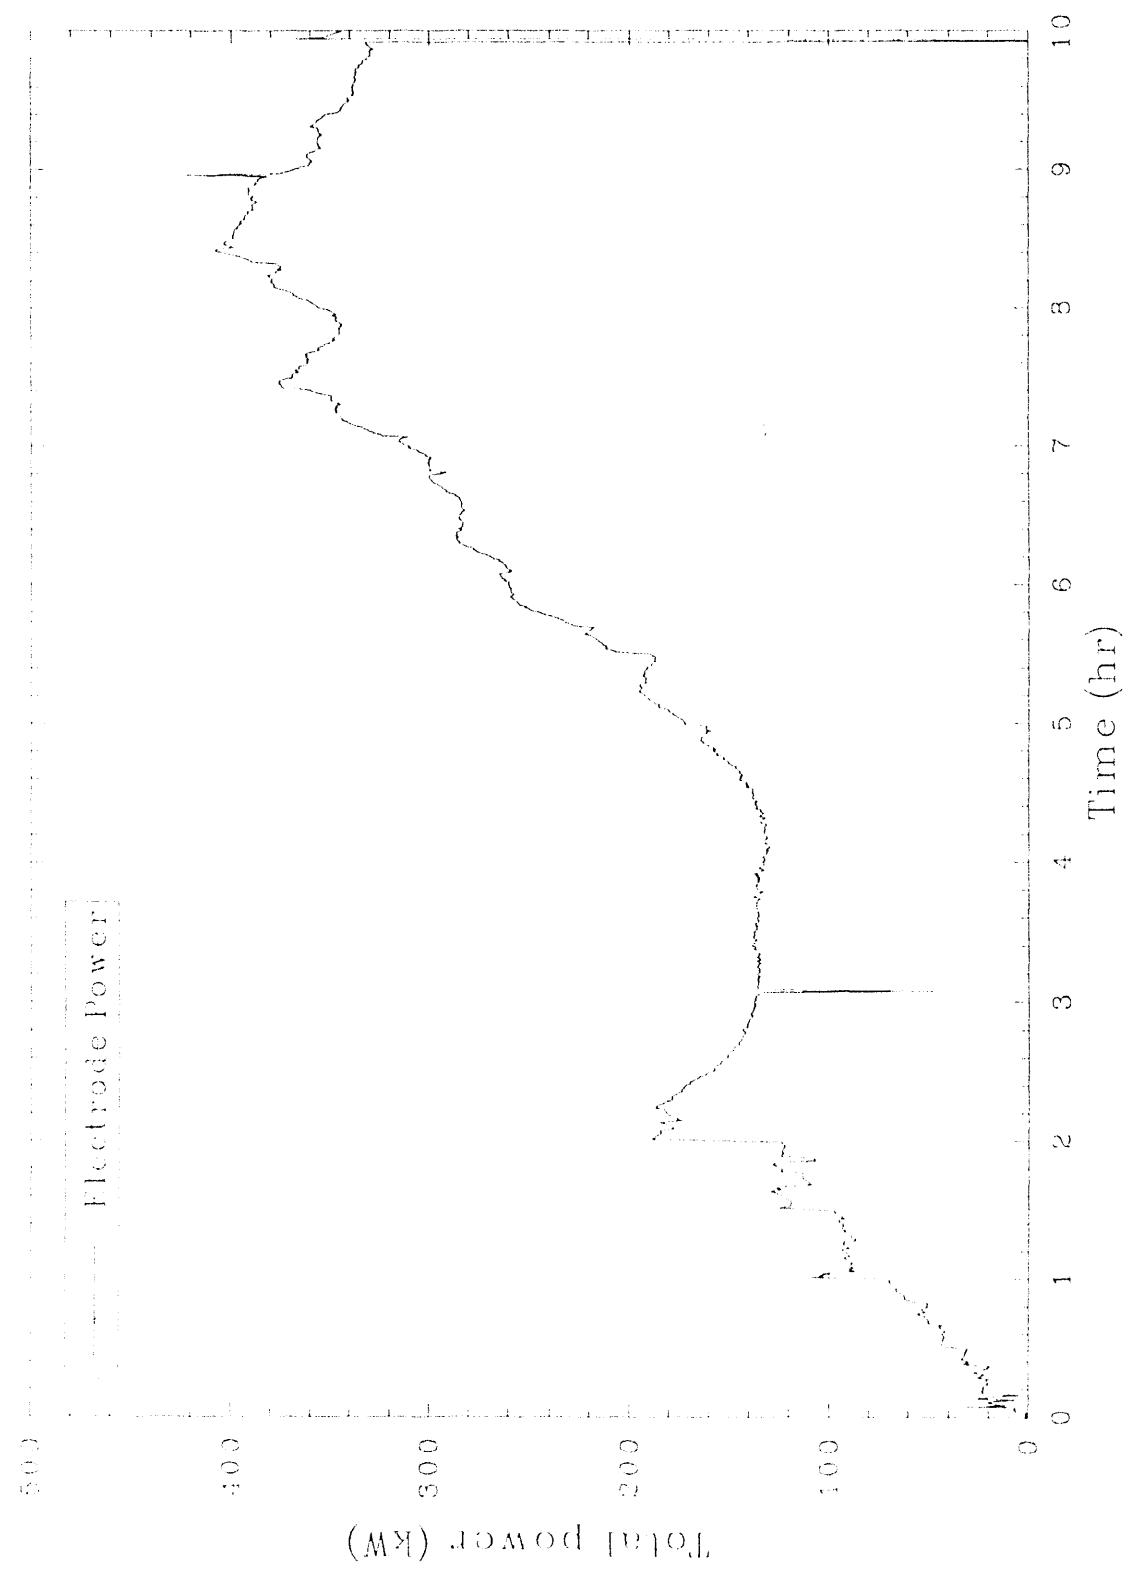
Figure 58. Total electrode power showing gradual increase during startup for Test 2.

Test 2 was initiated at 1540 hours on July 11, 1990. Power to the electrodes was initially brought up to 10 kW, in accordance with the planned graduated power buildup. Over the next 8 hours, power was gradually increased to approximately 400 kW, as shown in Figure 58. Resistance followed the expected curve, peaking at 14 and 13.8 ohms for phases A and B respectively, as shown in Figure 59. This resistance plot shows the gradual transition of
