EGG-WTD-9807

August 1991

### **In Situ Vitrification Application to Buried Waste: Final Report of Intermediate Field Tests at Idaho National Engineering Laboratory**

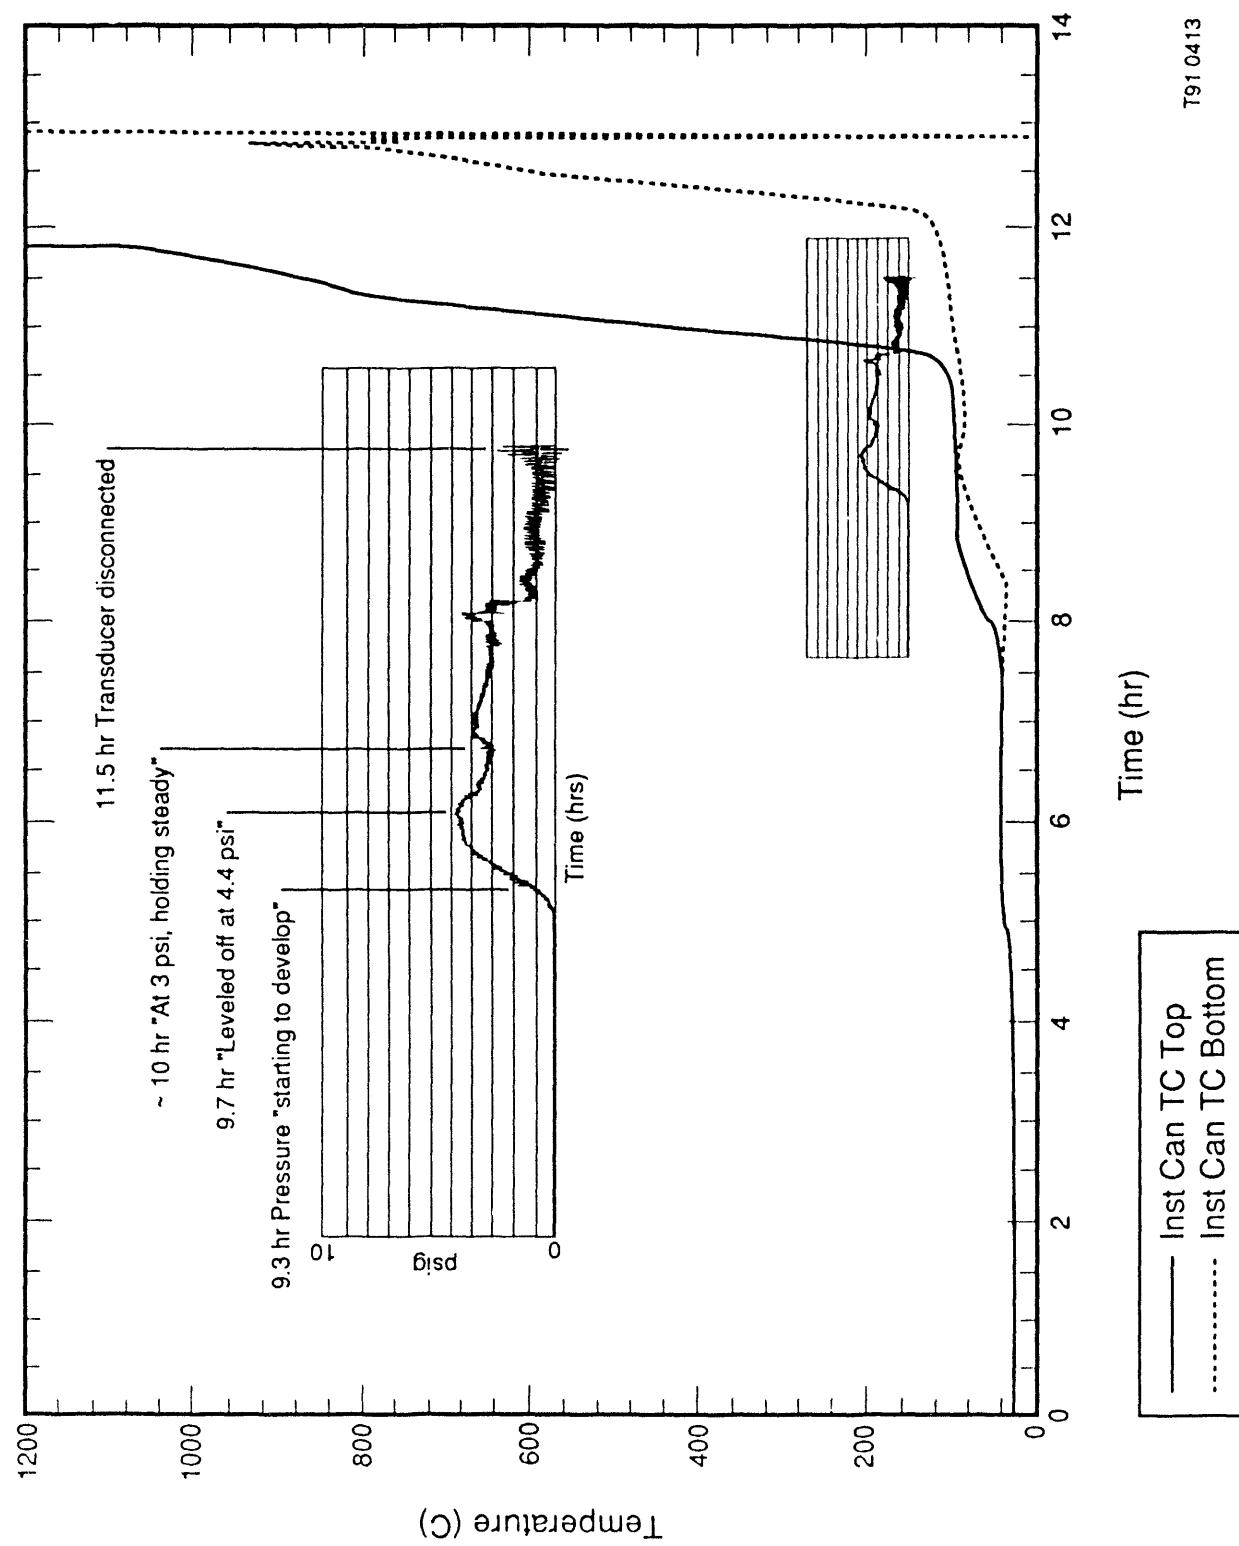
Figure 61. Instrumented can temperatures and can pressure for Test 2.

At approximately 8.5 hours, the melt started to thermally influence the can. At 8.9 hours, the can reached a maximum pressure of 4.5 psig with the upper thermocouple at 94°C and the lower thermocouple at 88°C (see Figure 61). At approximately 10.2 hours, an apparent gas release from the can caused the hood plenum temperature to spike to approximately 630°C (see Figure 62) and the hood to pressurize to 2.9 in. W.C. (see Figure 63). Immediately after the hood pressurization, an operator noted that the interior surfaces in the hood were covered with what appeared to be soil. A review of the pressure and temperature measurements of the can (see Figure 61) revealed that the can had not depressurized and was maintaining an internal pressure of 4 psig at 94°C for the upper thermocouple. Immediately after the event, the internal can temperature climbed steadily to just over 100°C. Since the can pressure was relatively steady, the temperature increase in the can is suspected to be due

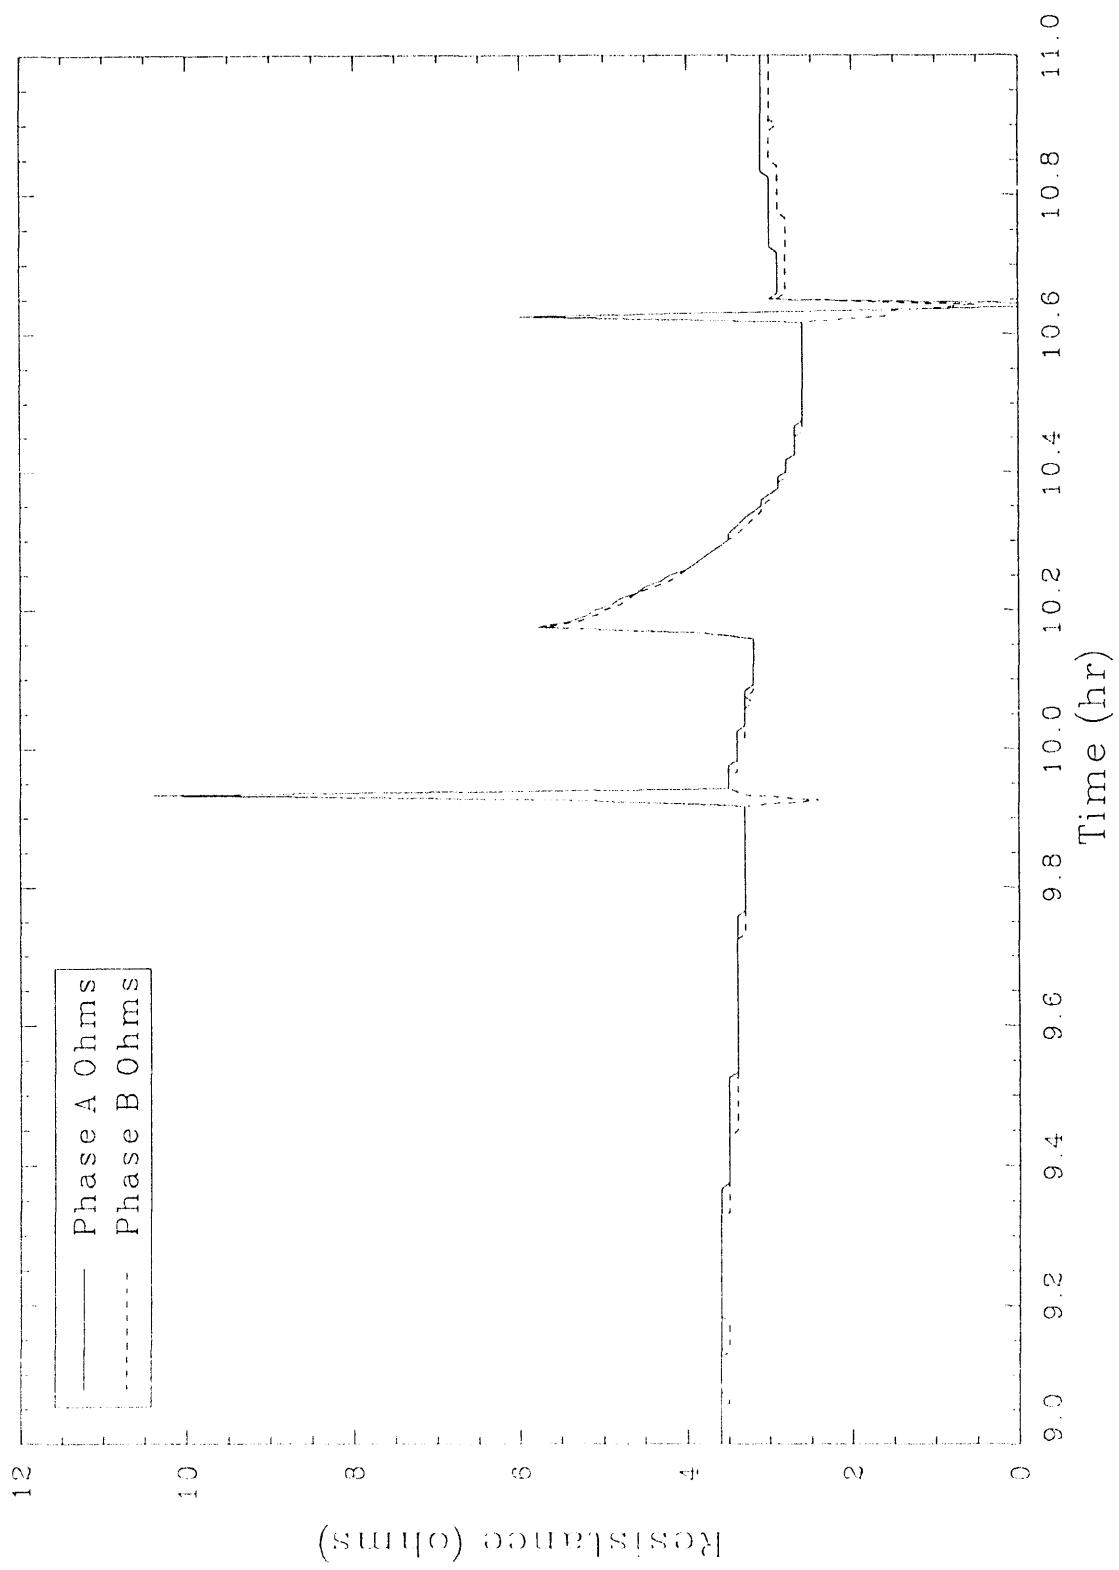
Figure 64. Phases A and B resistance during processing of the instrumented can in Test 2.

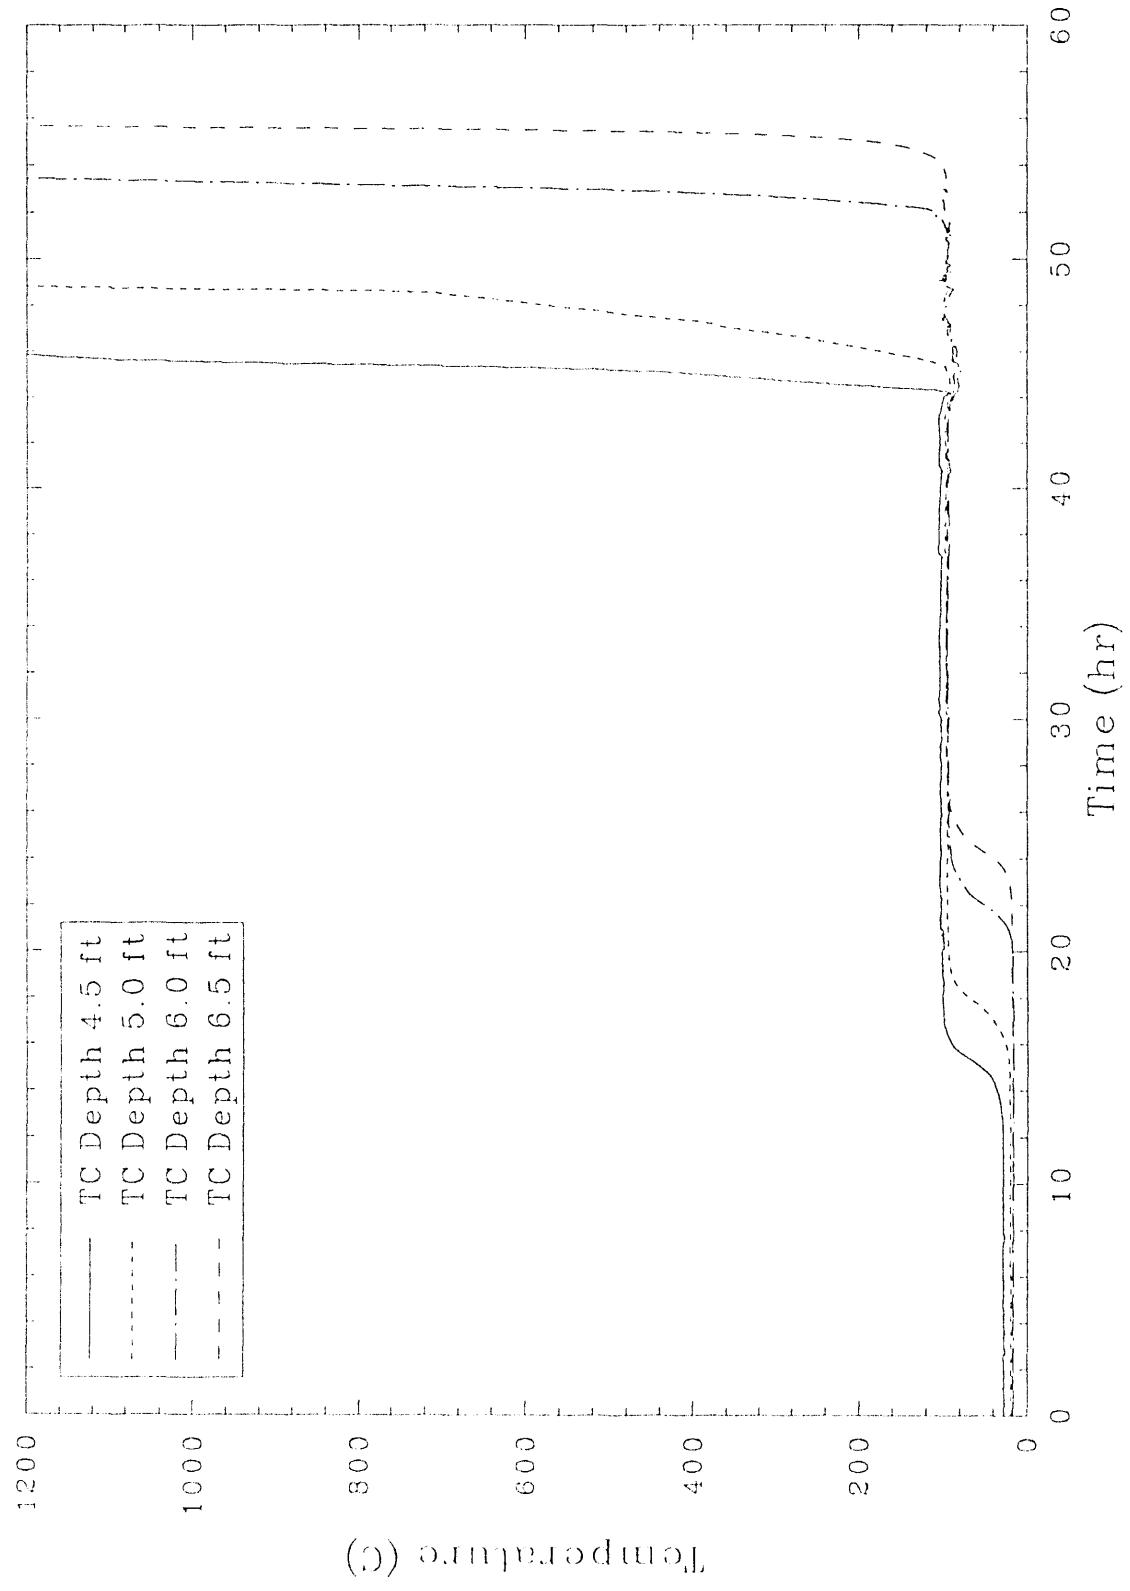
Figure 65. Thermocouple temperatures in the stacked can region for Test 2.

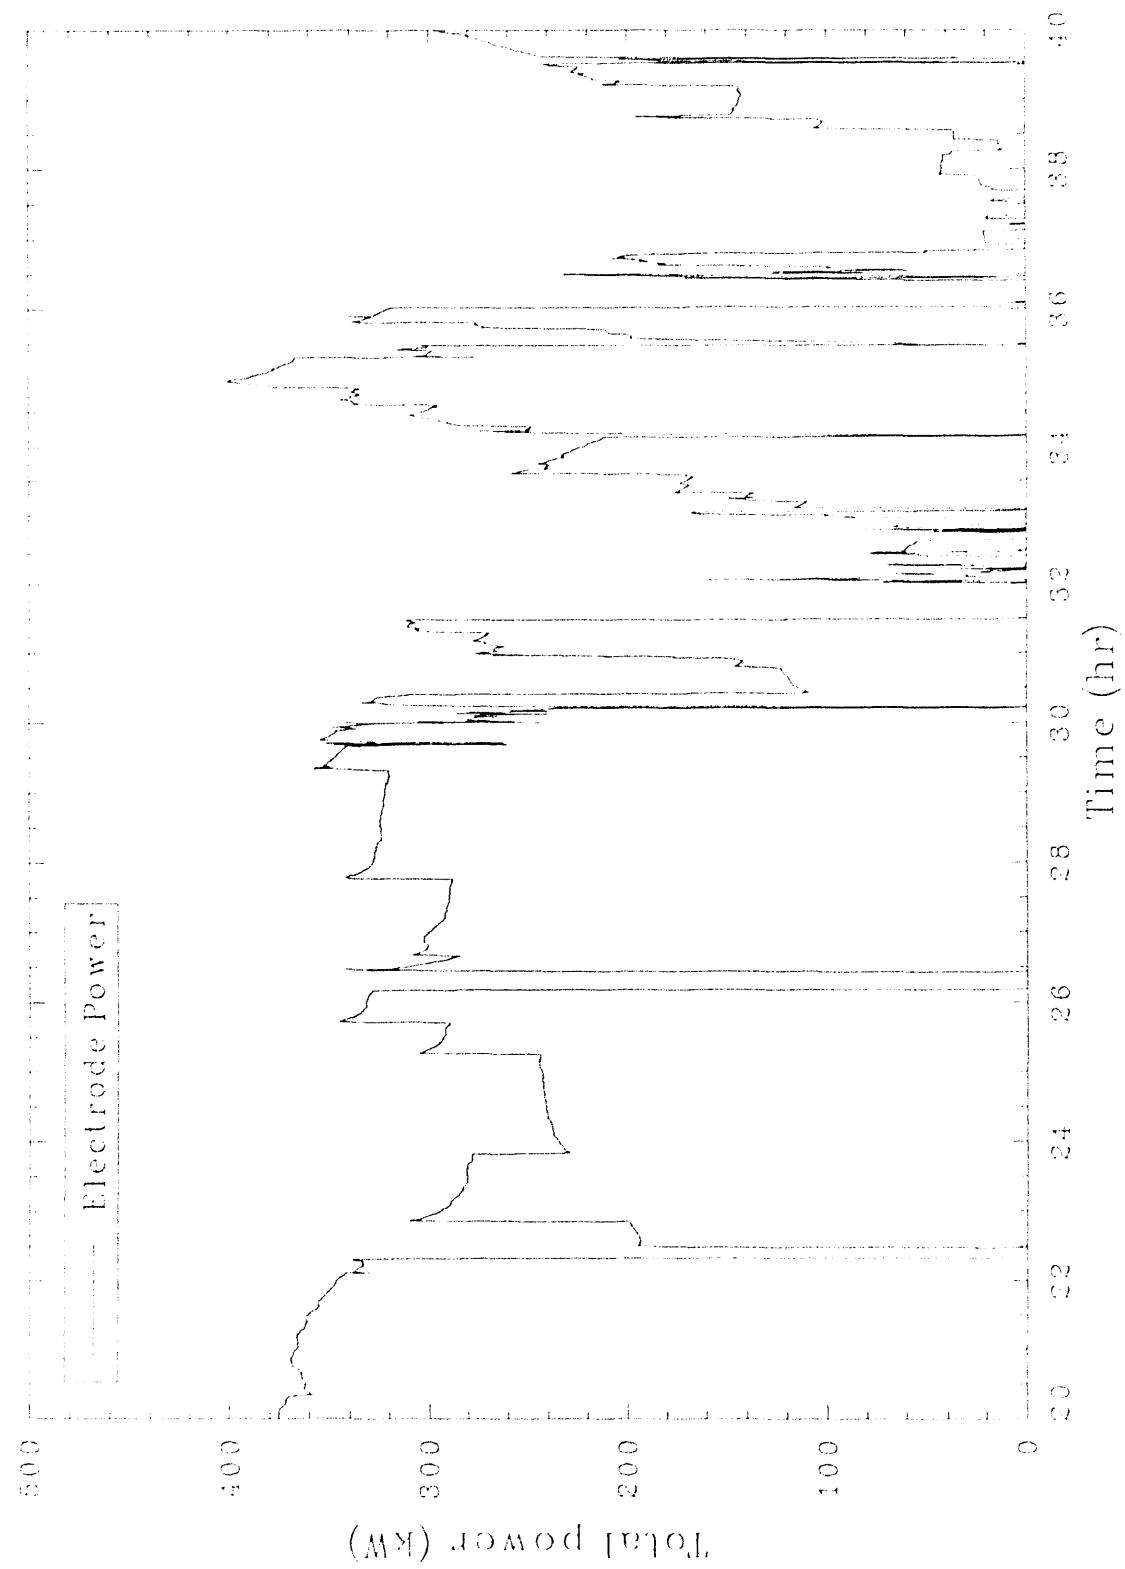
Figure 66. Total electrode power during processing of the stacked can region on Test 2.

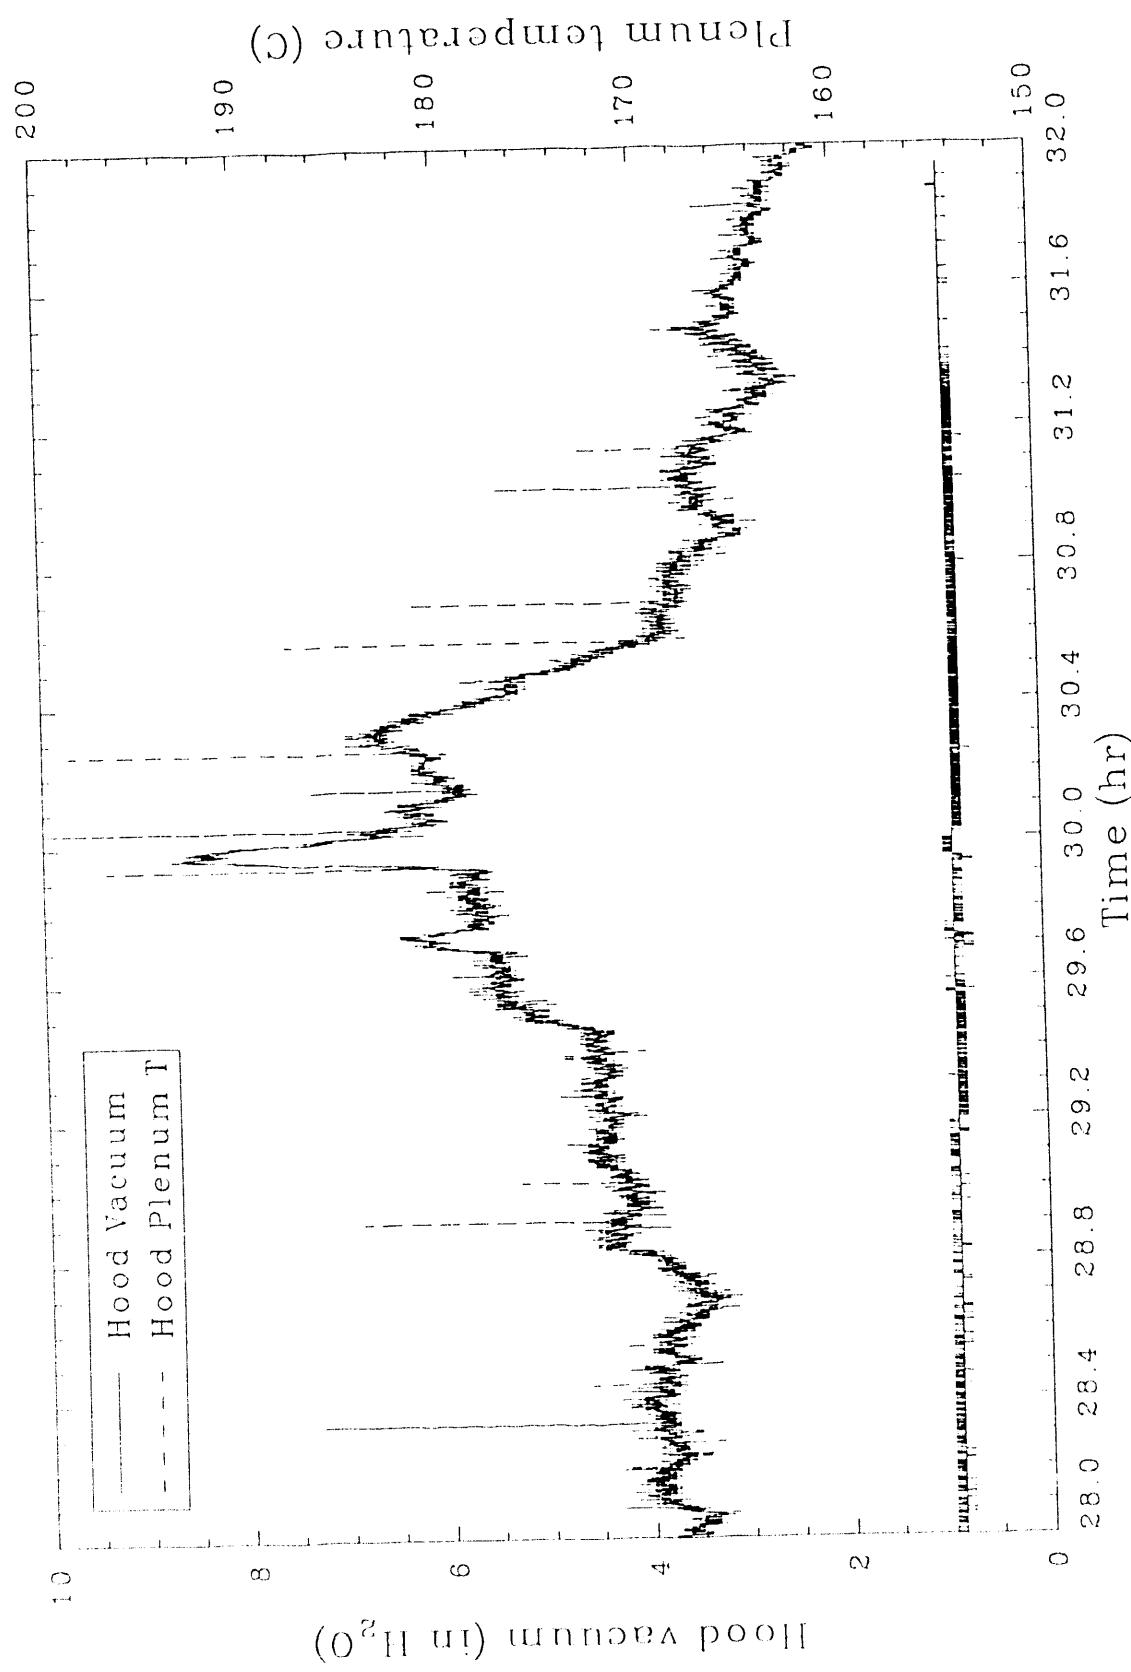
Figure 69. Hood plenum temperature and hood vacuum at approximately 30 hours, Test 2.

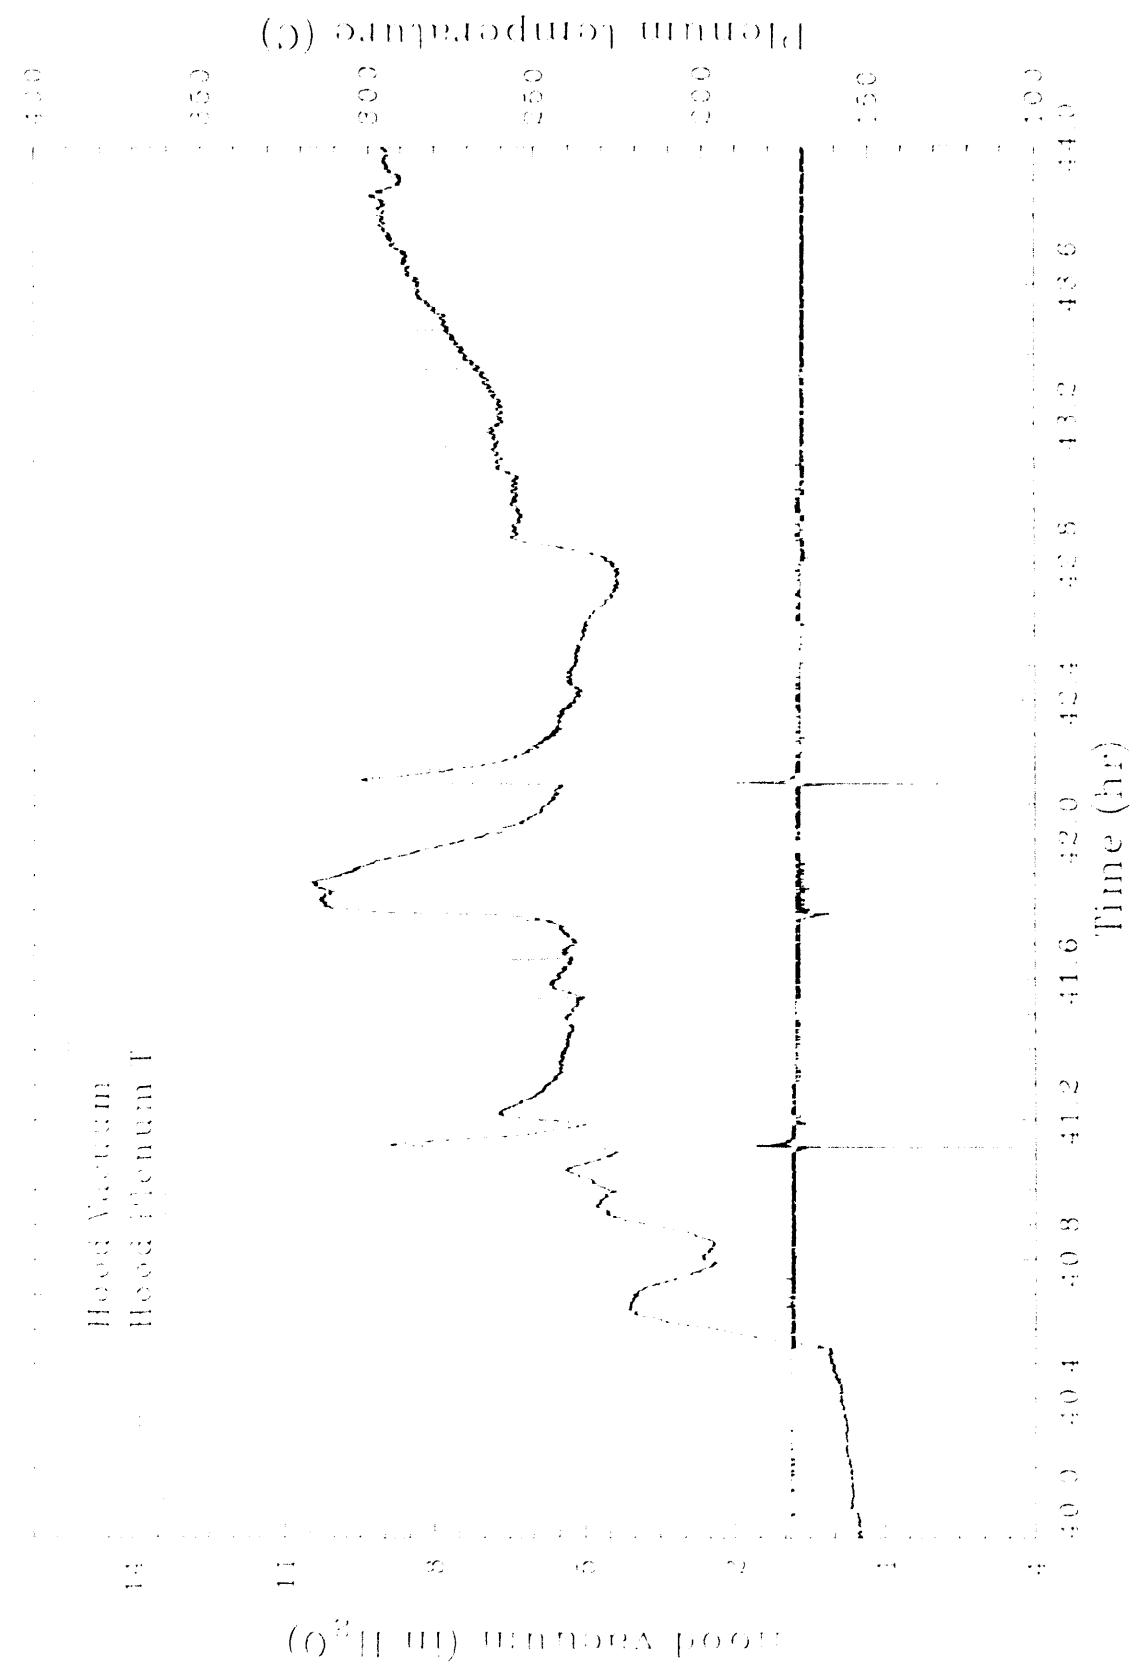
**Figure 70.** Hood plenum temperature and hood vacuum for several gas release events during processing of the stacked can region in Test 2.

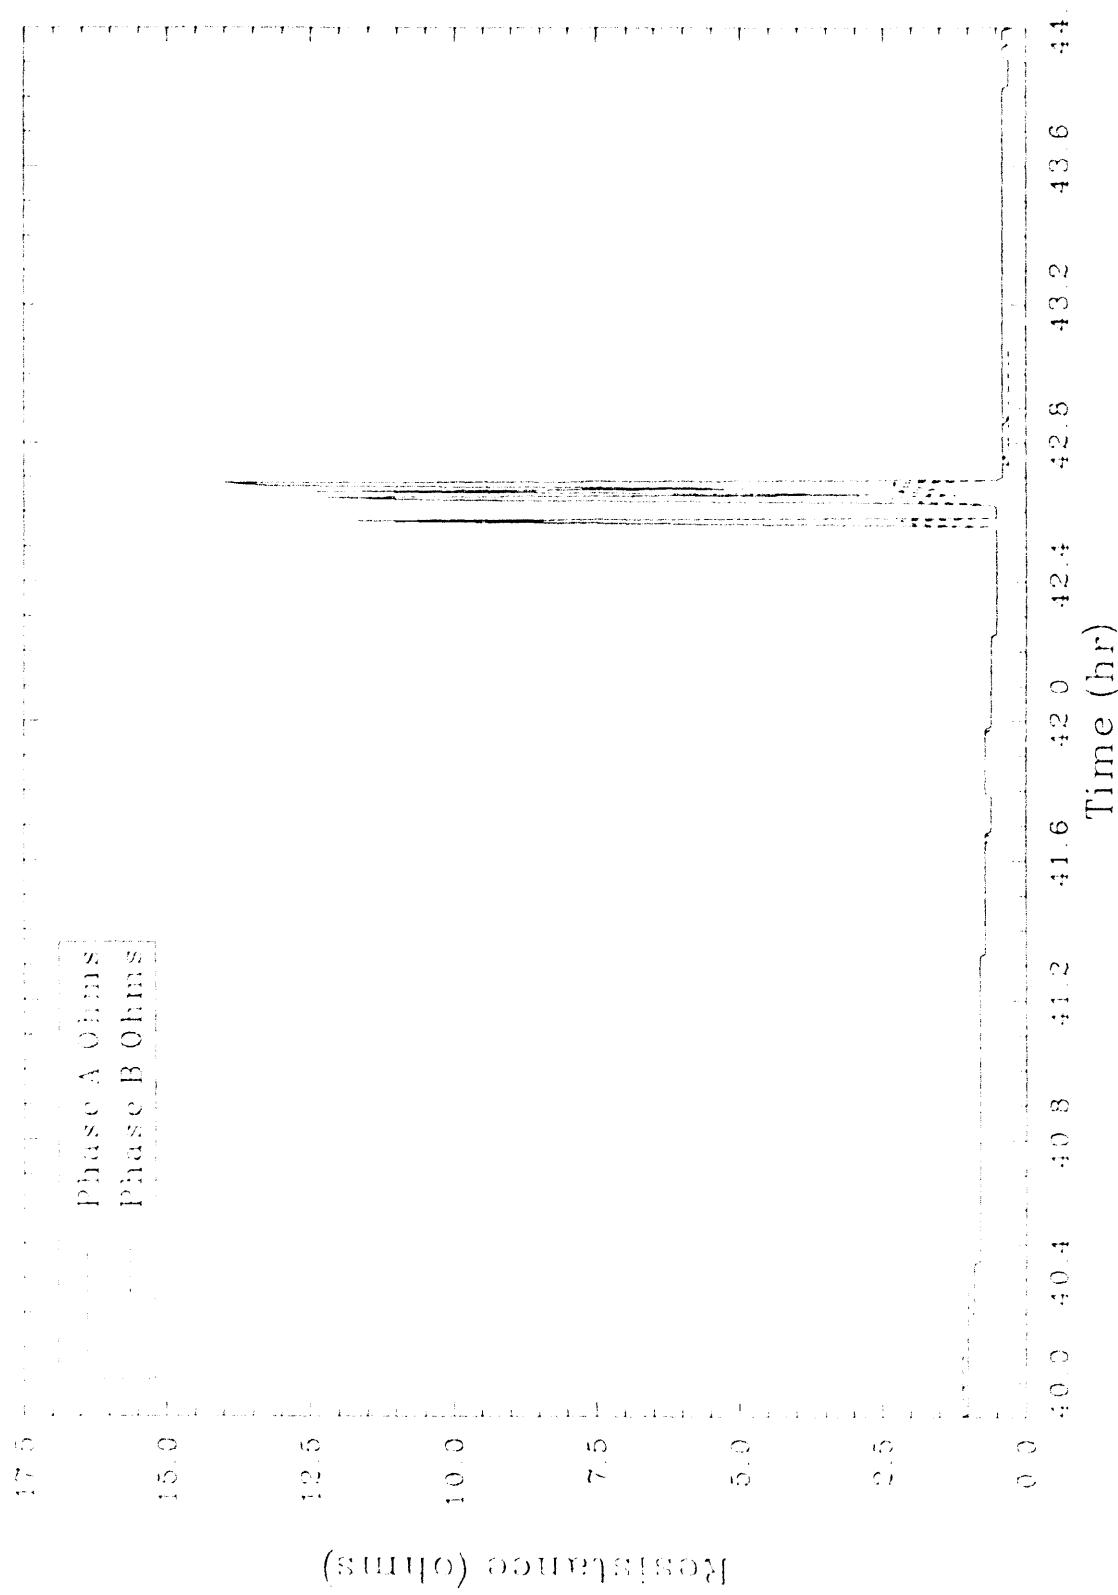
Figure 71. Phases A and B resistance for several gas release events during processing of the stacked can region in Test 2.

Phase A and B resistance did not fluctuate during this series of events, as shown in Figure 71. The spikes shown at 42.6 hours in this figure are not

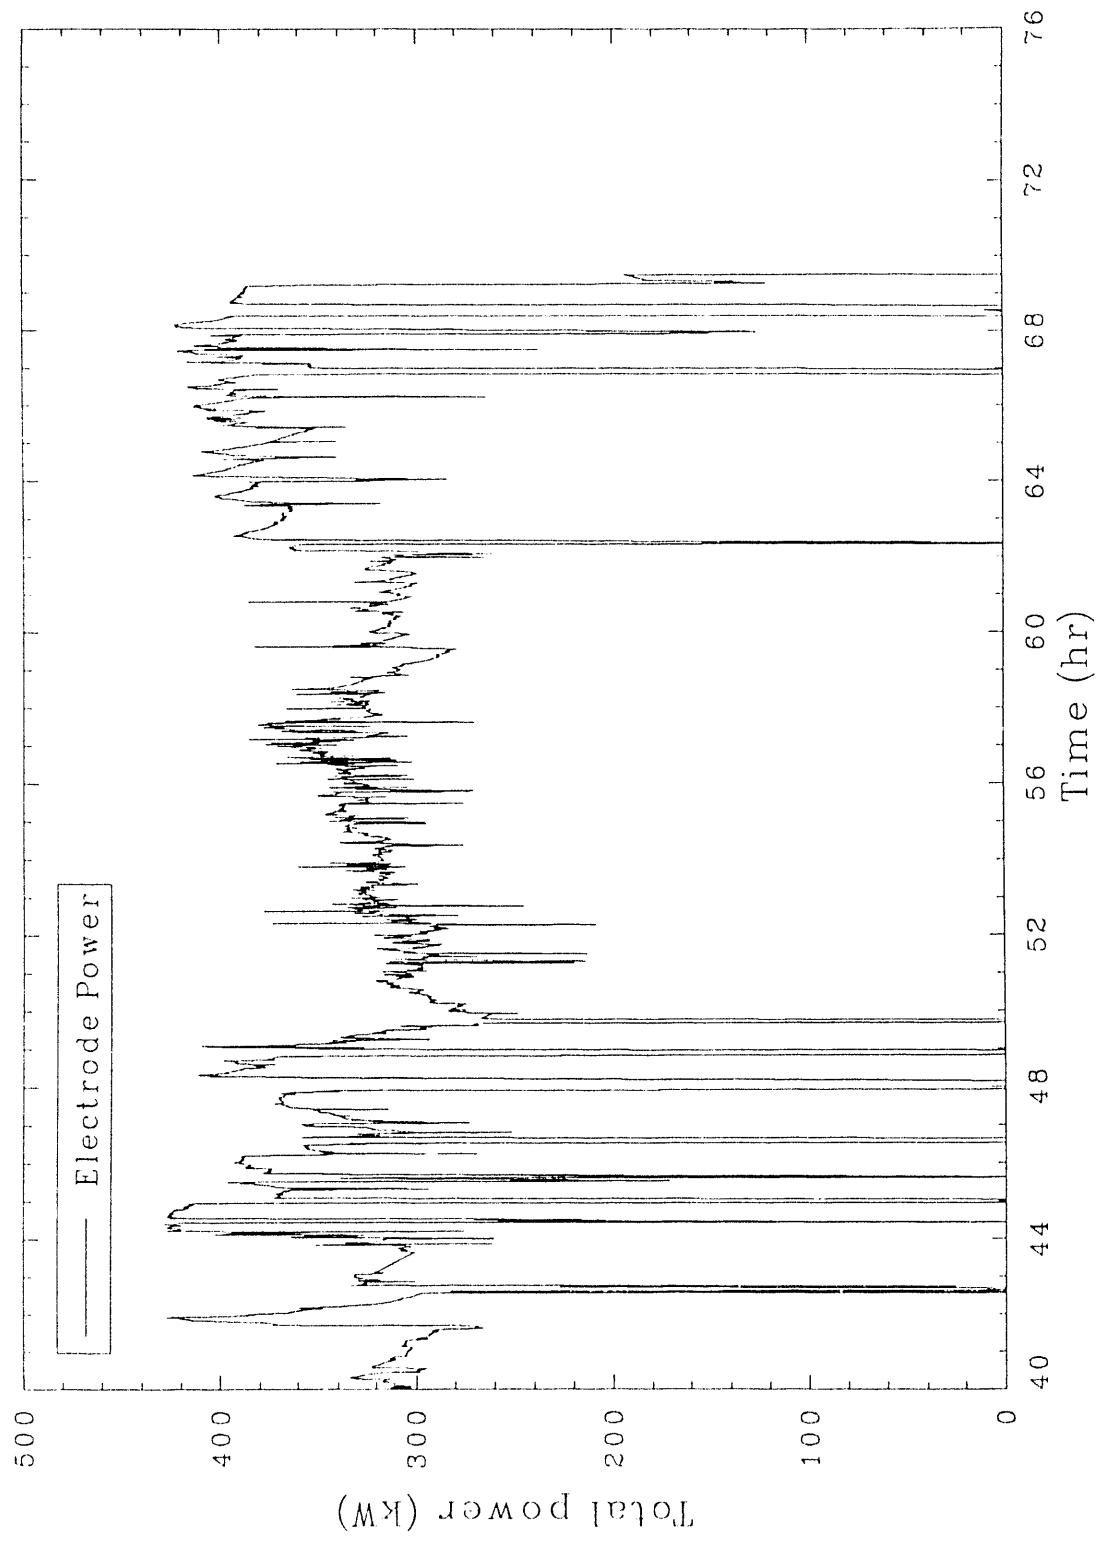
Figure 75. Total electrode power during processing of the stacked box region for Test 2.

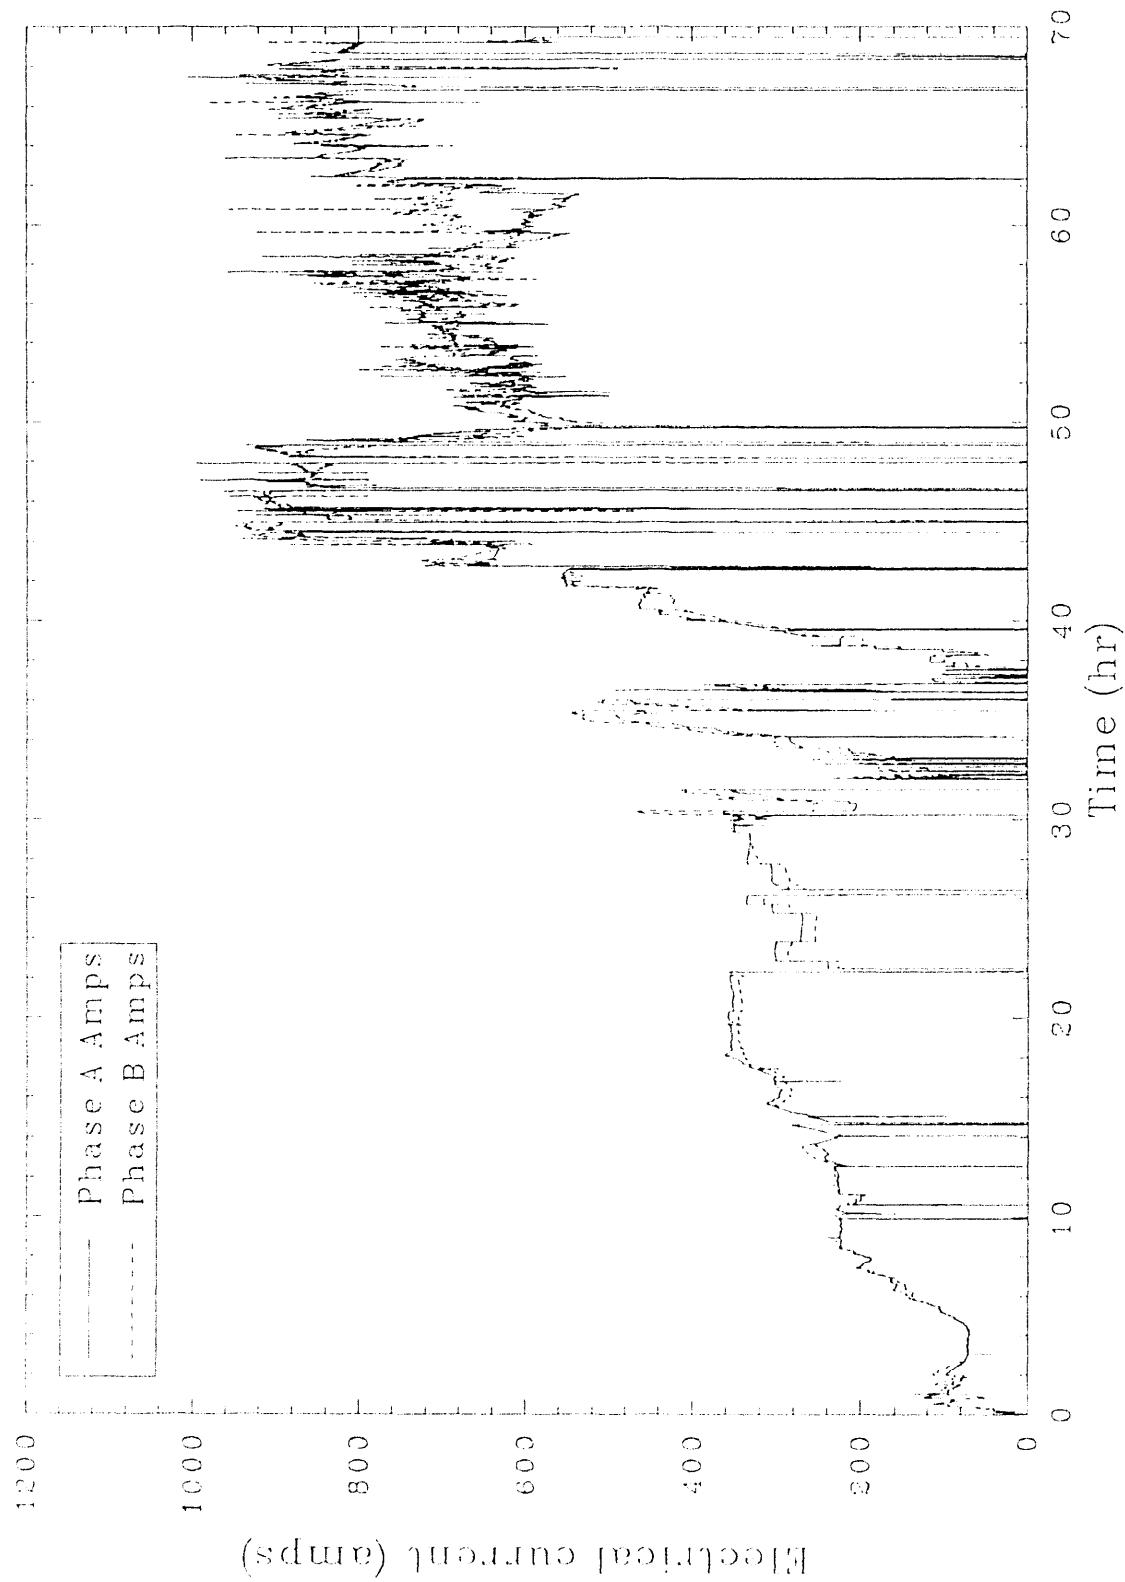
Figure 76. Phase A and B amperage for Test 2.

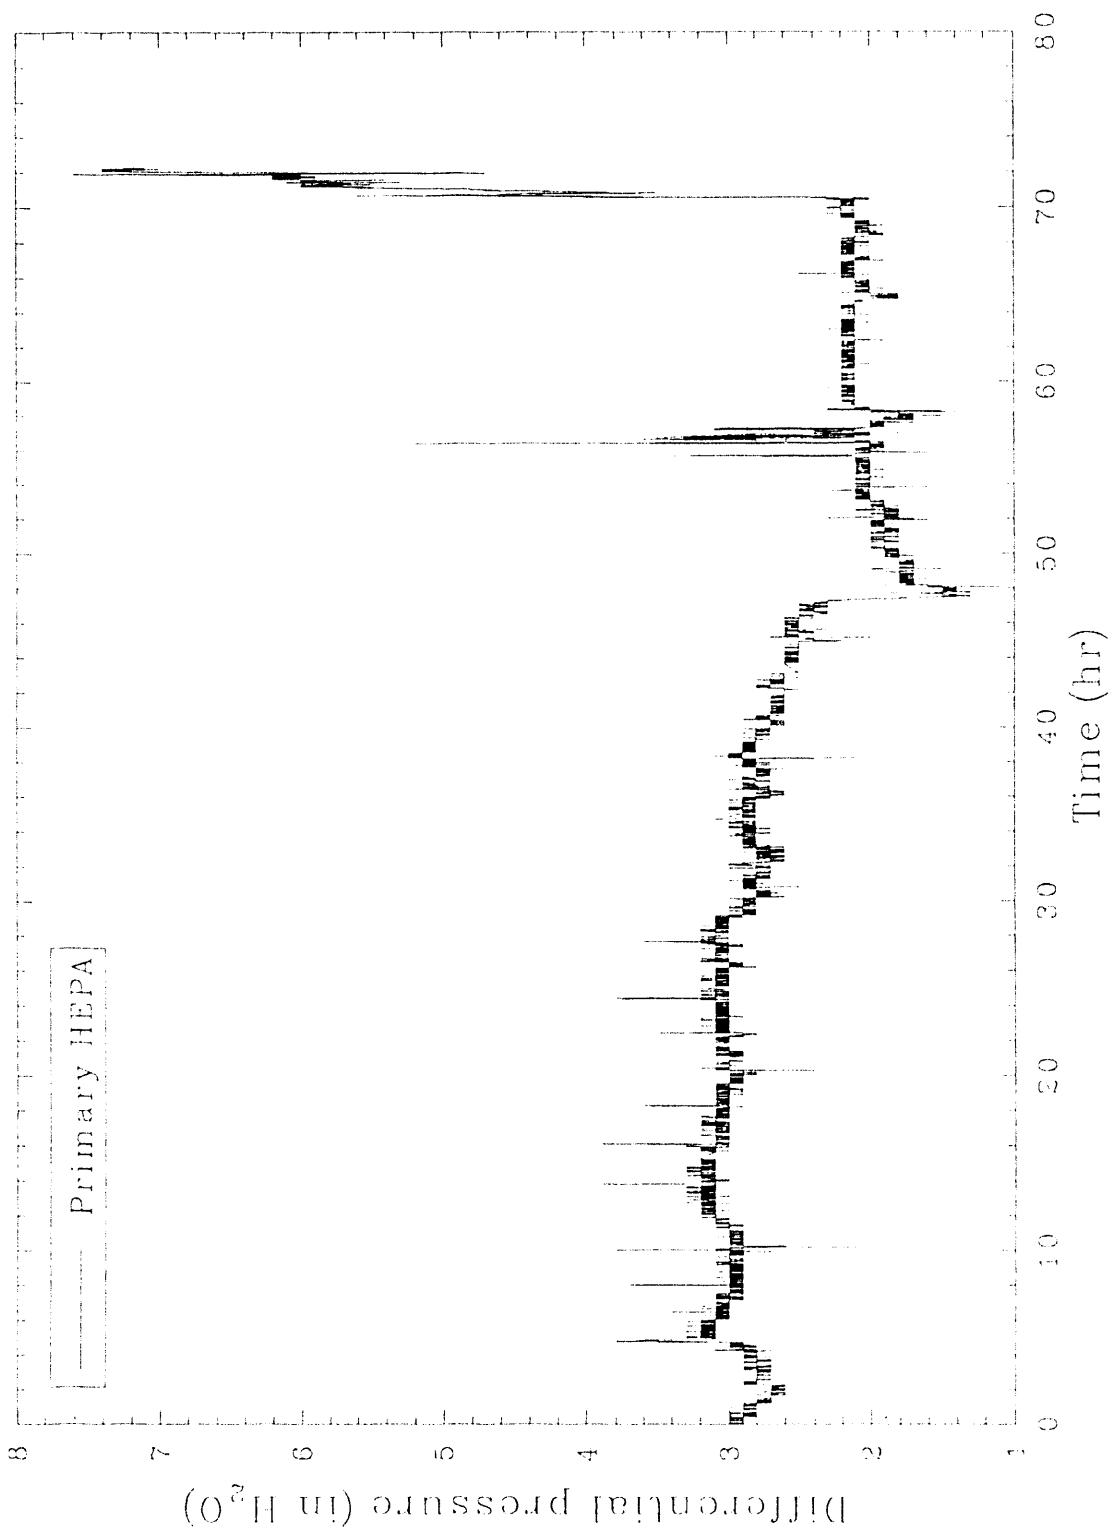
Figure 78. Primary HEPA filter differential pressure for Test 2.

The off-gas treatment system effectively removed particulate from the off-gas stream. Figure 78 illustrates that the efficient scrubbing action did not result in a gradual plugging of the filters due to particulate buildup. The sudden decrease in pressure at 48 hours reflected the increased rate of off-gassing from the melt and the corresponding decrease in hood vacuum. The

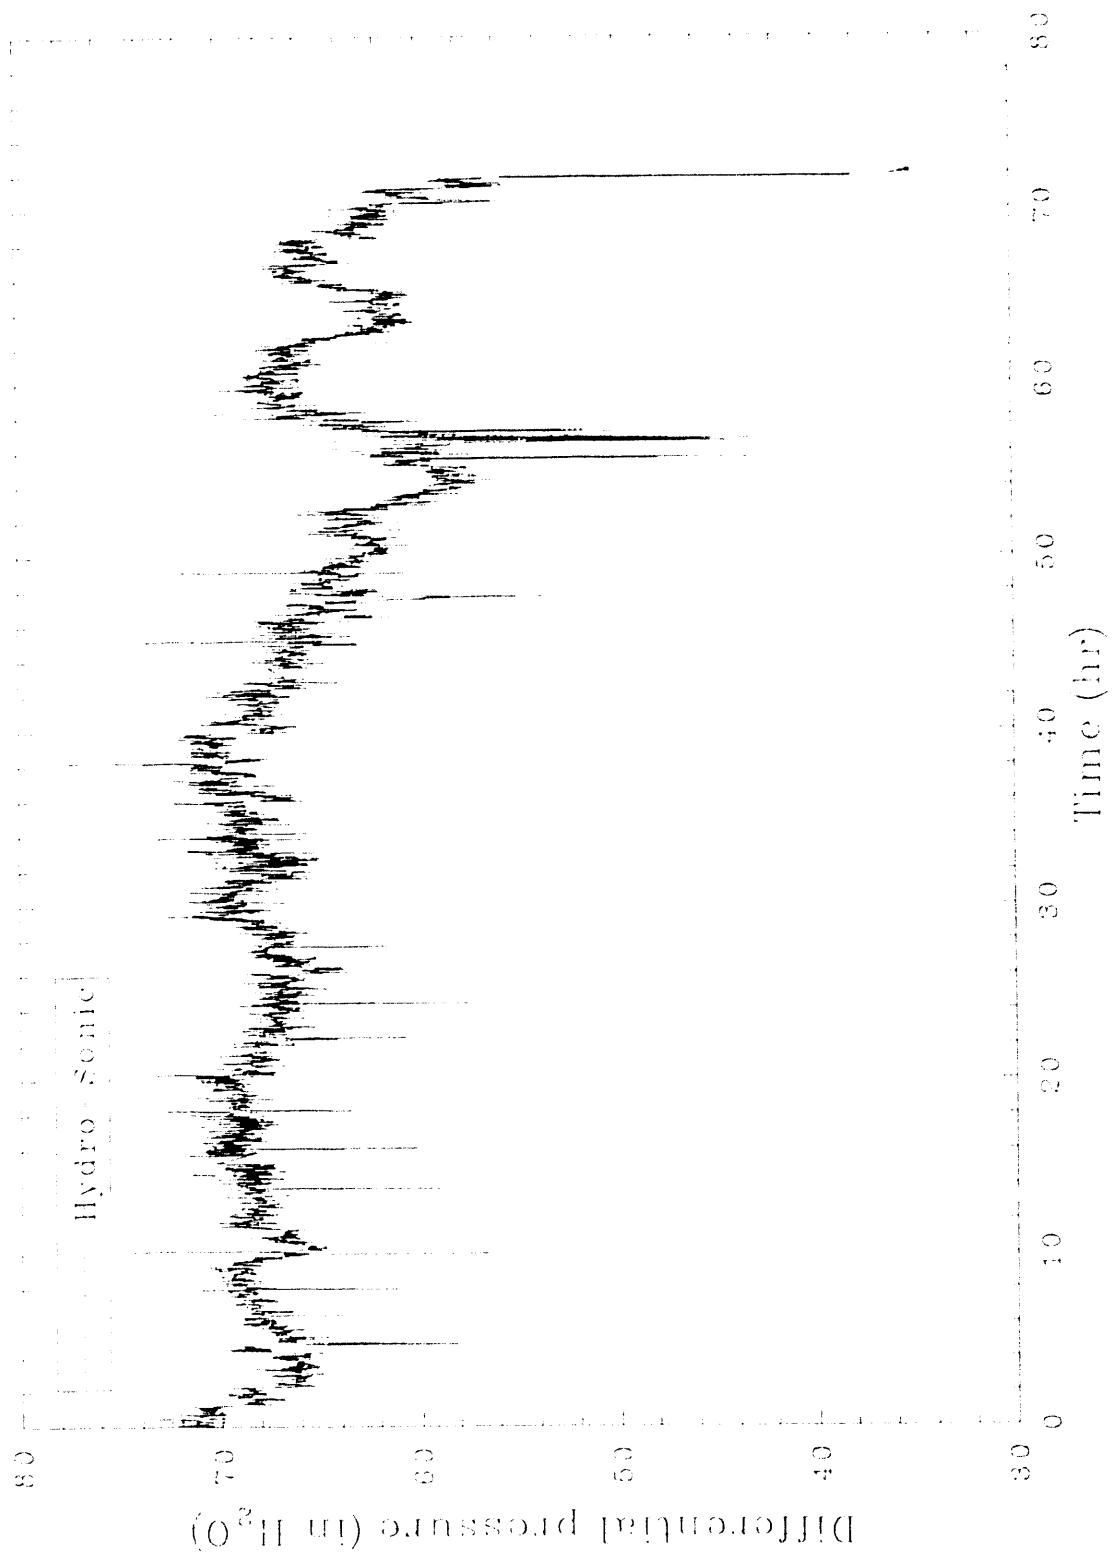
Figure 80. Hydro-Sonic differential pressure for Test 2.

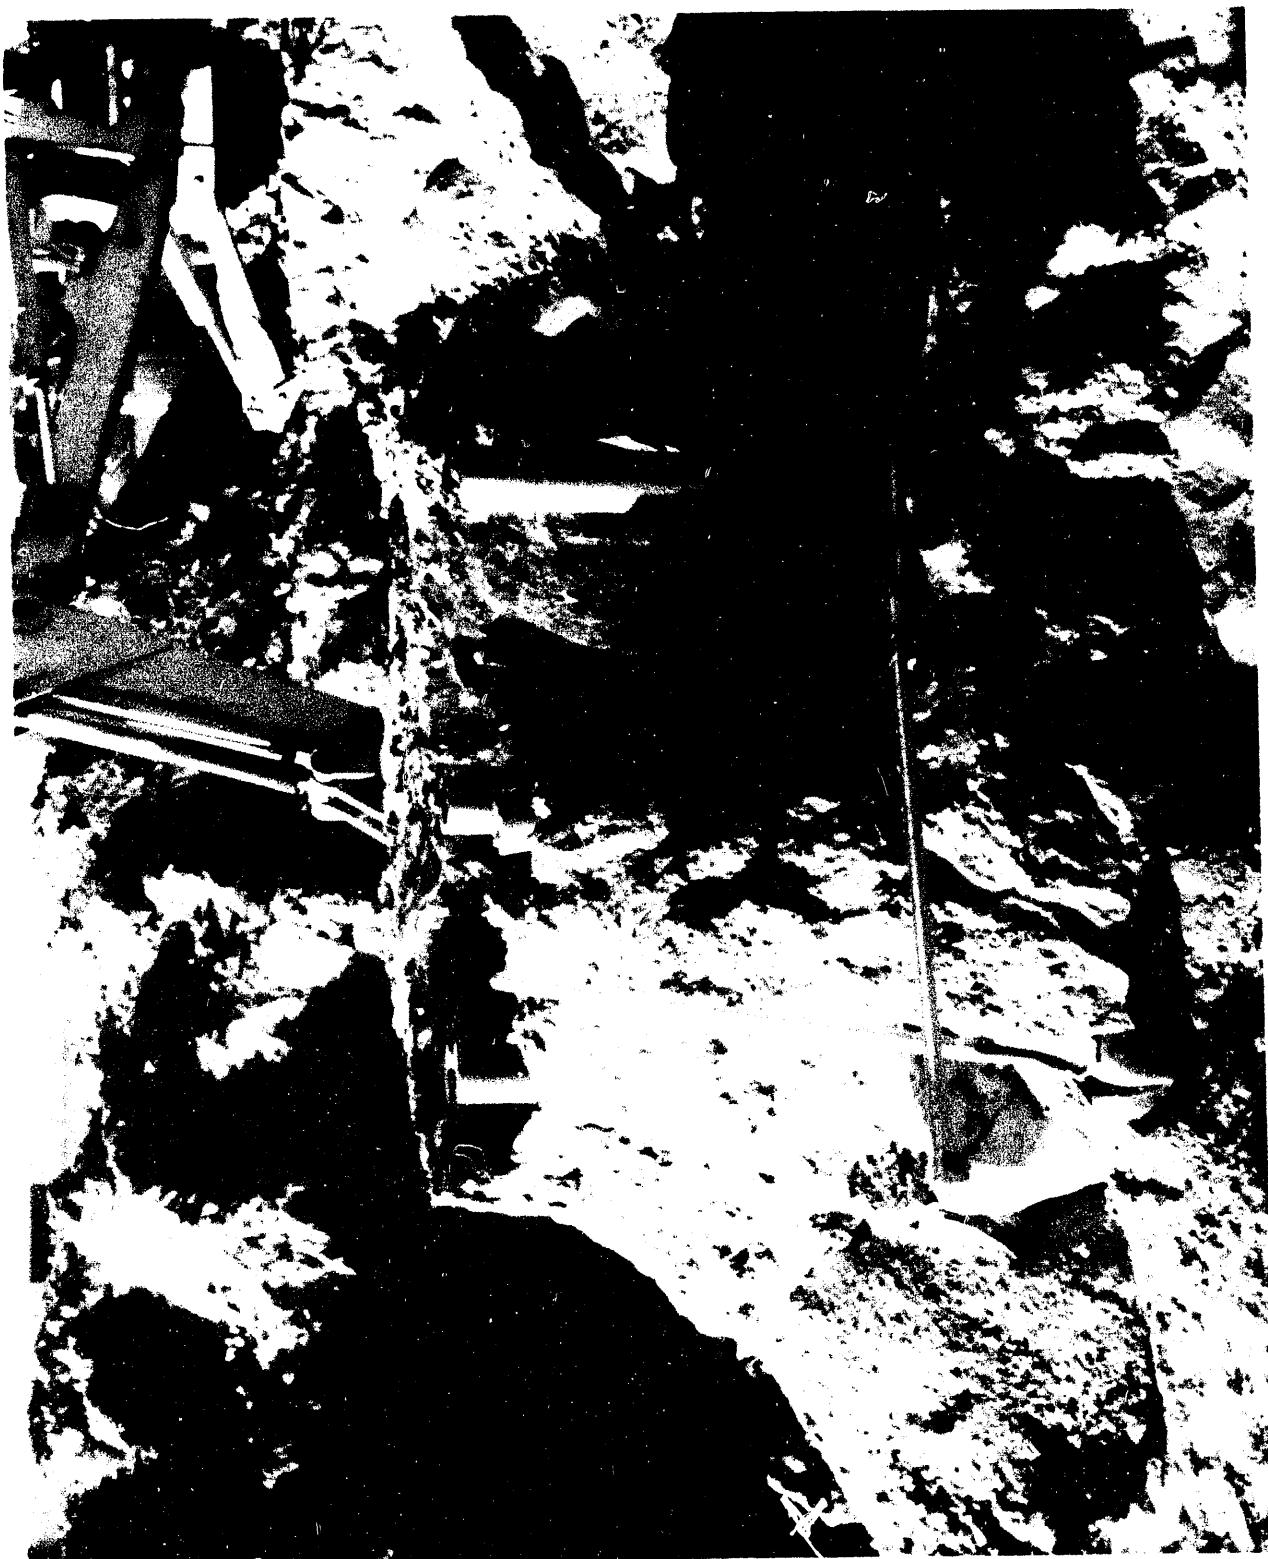
Figure 82. Test Pit 1 partially excavated.
