EGG-WTD-9807

August 1991

### **In Situ Vitrification Application to Buried Waste: Final Report of Intermediate Field Tests at Idaho National Engineering Laboratory**

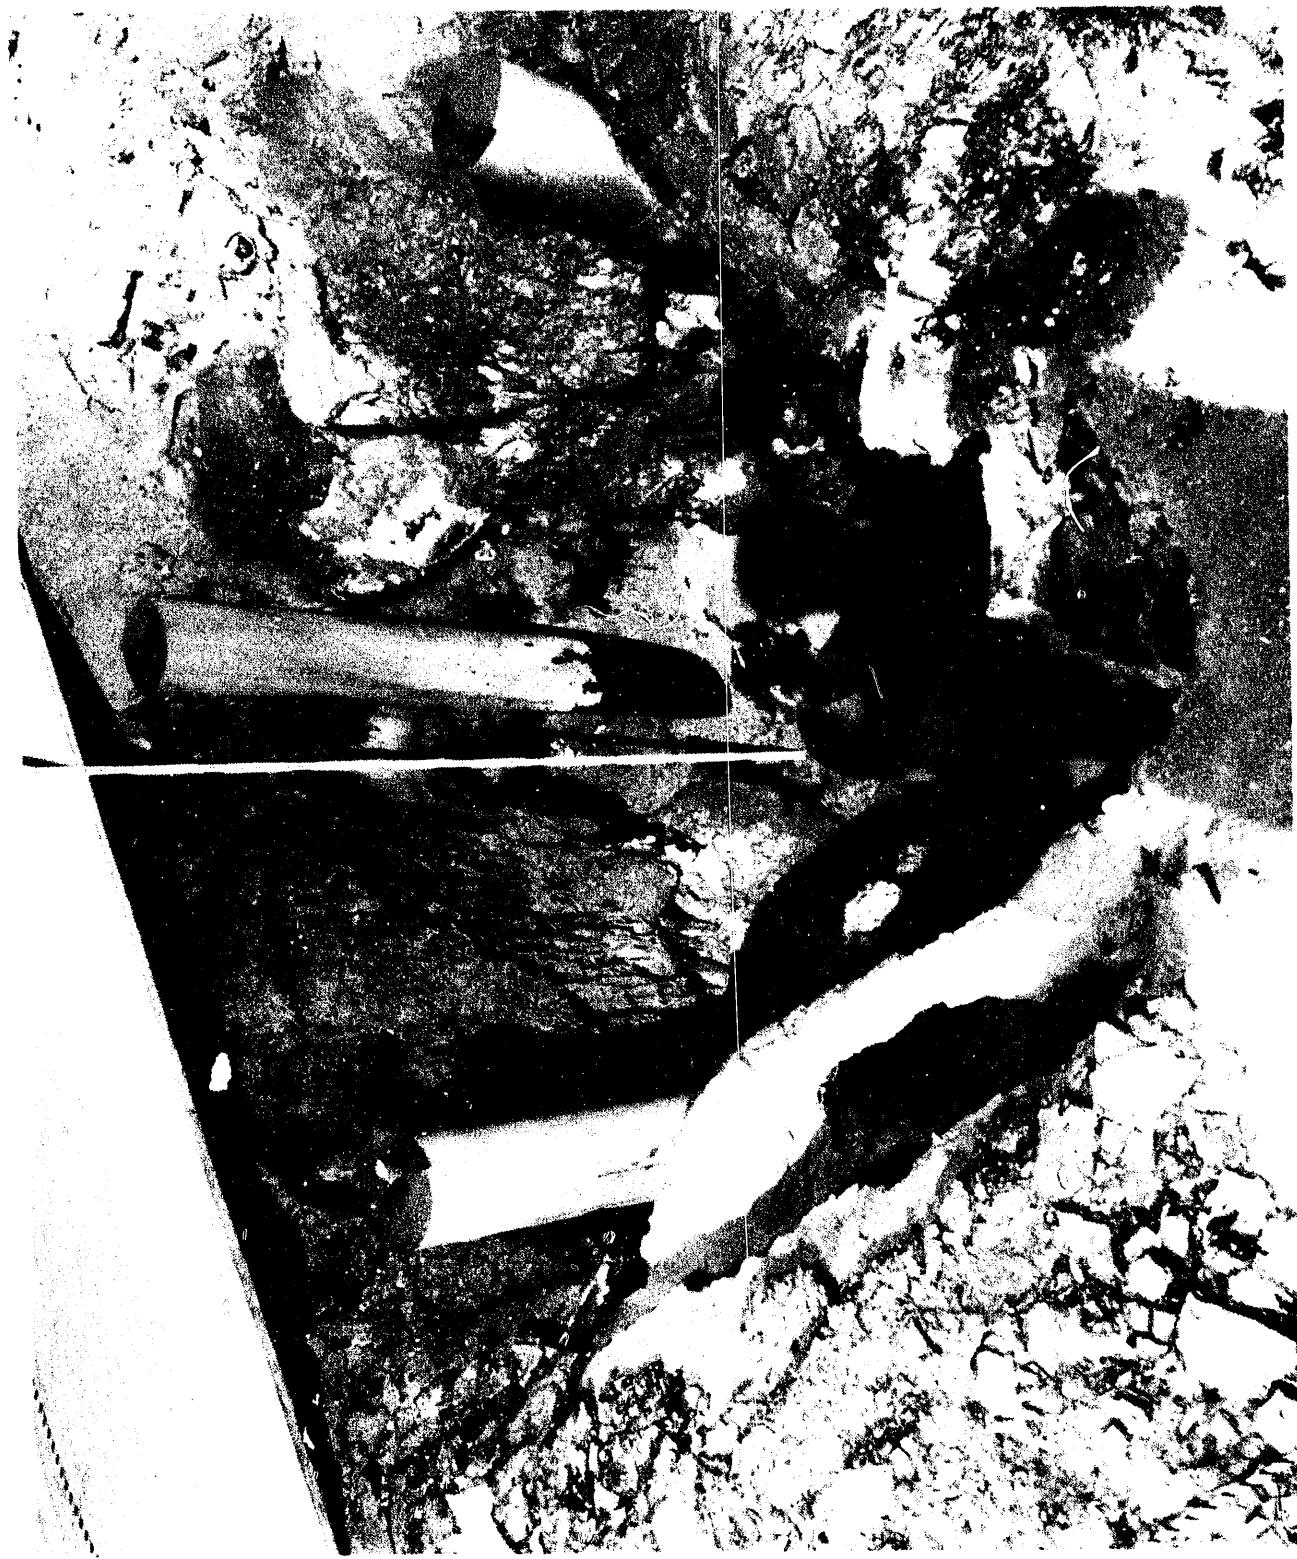
Figure 83. Test Pit 1 after ISV processing.

5.1.2.1 Processed Waste Test Pit 1. The general shape of Test Pit 1 after ISV processing was a square shaft with rounded corners, as shown in Figure 83. The depth from ground surface to the uppermost glassy material in the pit bottom, as measured directly from ground level, was about 1.5 m (5 ft). Depth from ground surface to the monolith (i.e., dense, well-defined glassy material in a contiguous mass), centered among the four electrodes, was approximately 1.9 m (6.1 ft) when measured during excavation. The monolith was approximately oval and about 1.5 x 1.8 m (5 x 6 ft) with the long axis under diagonal electrodes (SW to NE). The thickness of the monolith was about 0.55 to 0.61 m (1.8 to 2.0 ft) and was measured as the length of each of the cores taken from Test Pit 1. Figure 84 shows a schematic cross section of Test Pit 1 after ISV processing. Significant amounts of glassy material were found outside the cylindrical pit walls but within the simulated waste. This material was in the form of glassy fillings in cardboard boxes. The original shape of the boxes was preserved. A typical example of a "glassy box" is shown in Figure 85. In some cases, the boxes were completely filled with a mixture of glass and scrap metal. In other cases, the glassy boxes were empty and had a wall thickness as small as 0.64 cm (0.25 in.). Scrap metal was the only waste material found in the glassy boxes. An explanation for the "empty" glassy boxes suggests that the boxes originally contained nonmetal substances such as concrete and scrap glass. This material probably dissolved into the melt and/or was carried out of the box as the melt level in the pit dropped below the level of the box and as the molten material in the box drained back into the pit. Both glassy boxes and unaffected boxes were found at all levels in the pit. Glassy boxes were laterally distributed the full width, 3.05 m (10 ft), of the test pit. The total amount of processed waste recovered was 8267 kg (18,225 lb).

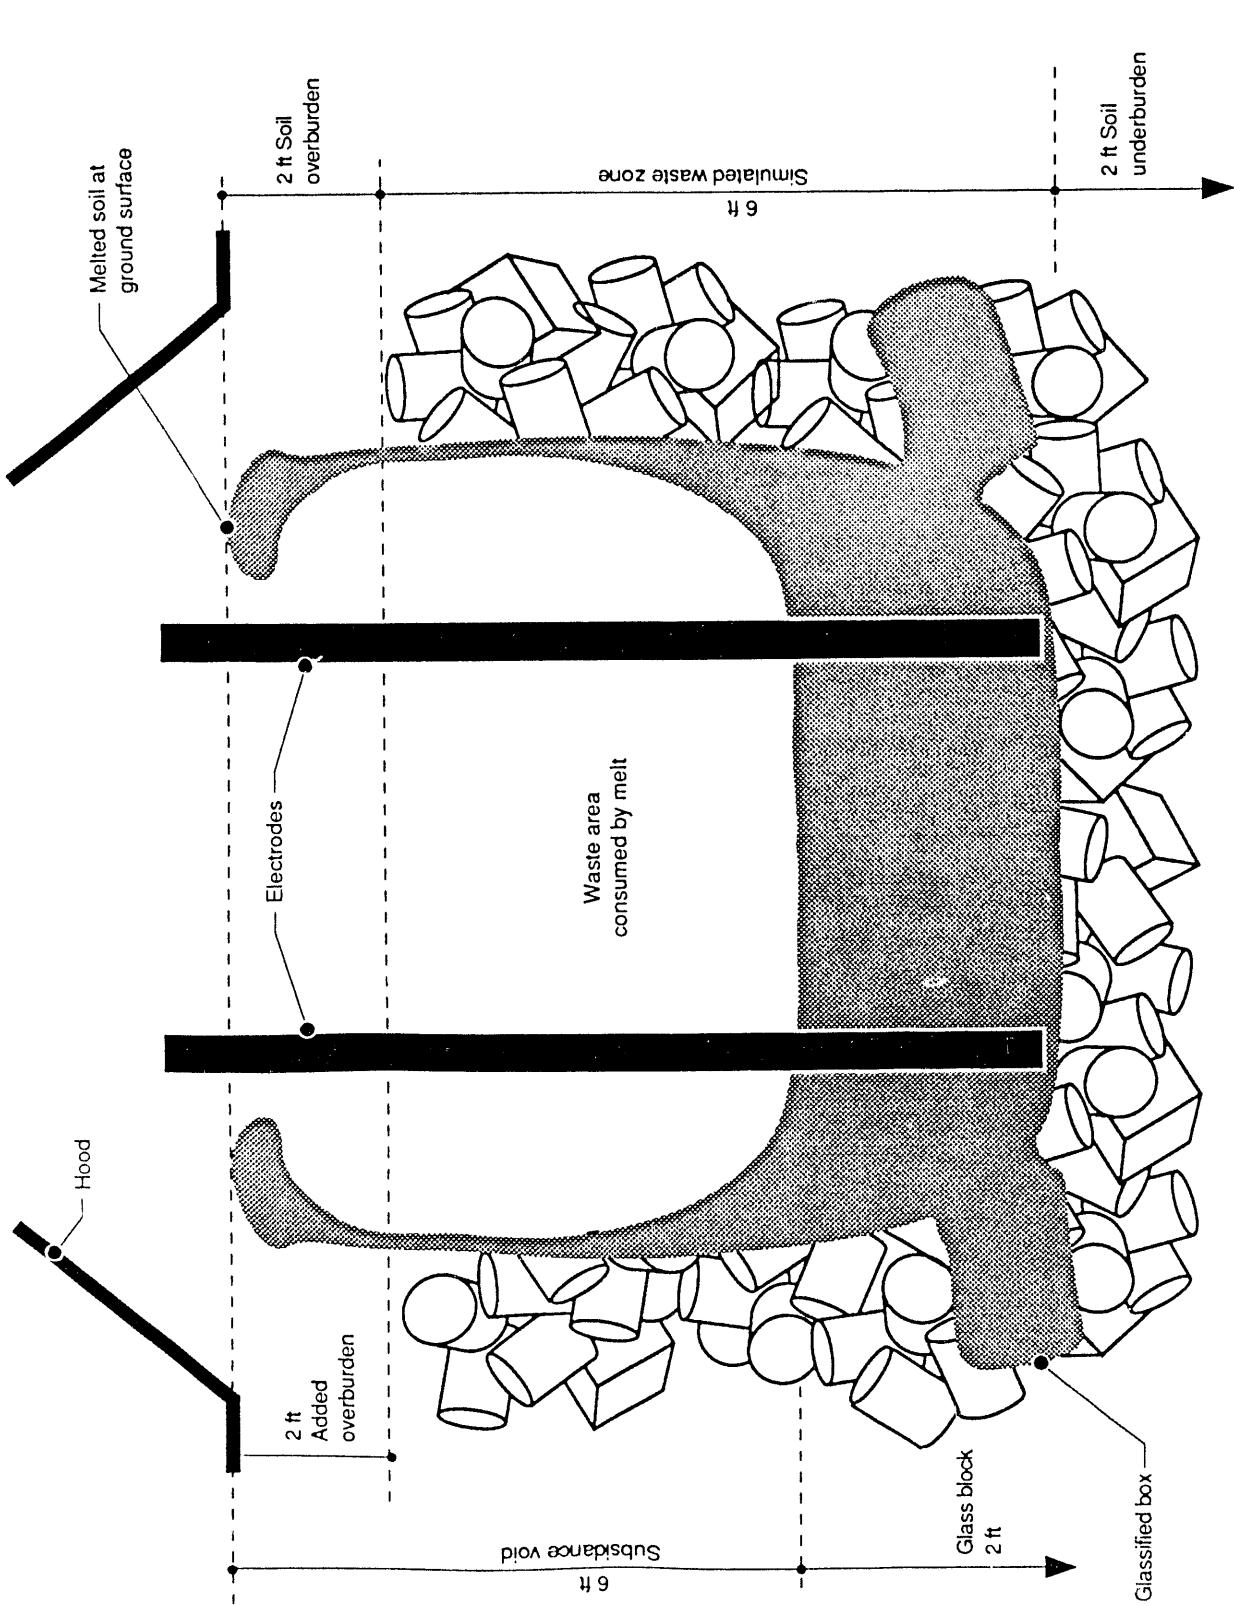
Figure 84. Schematic cross section of Test Pit 1 after ISV processing.

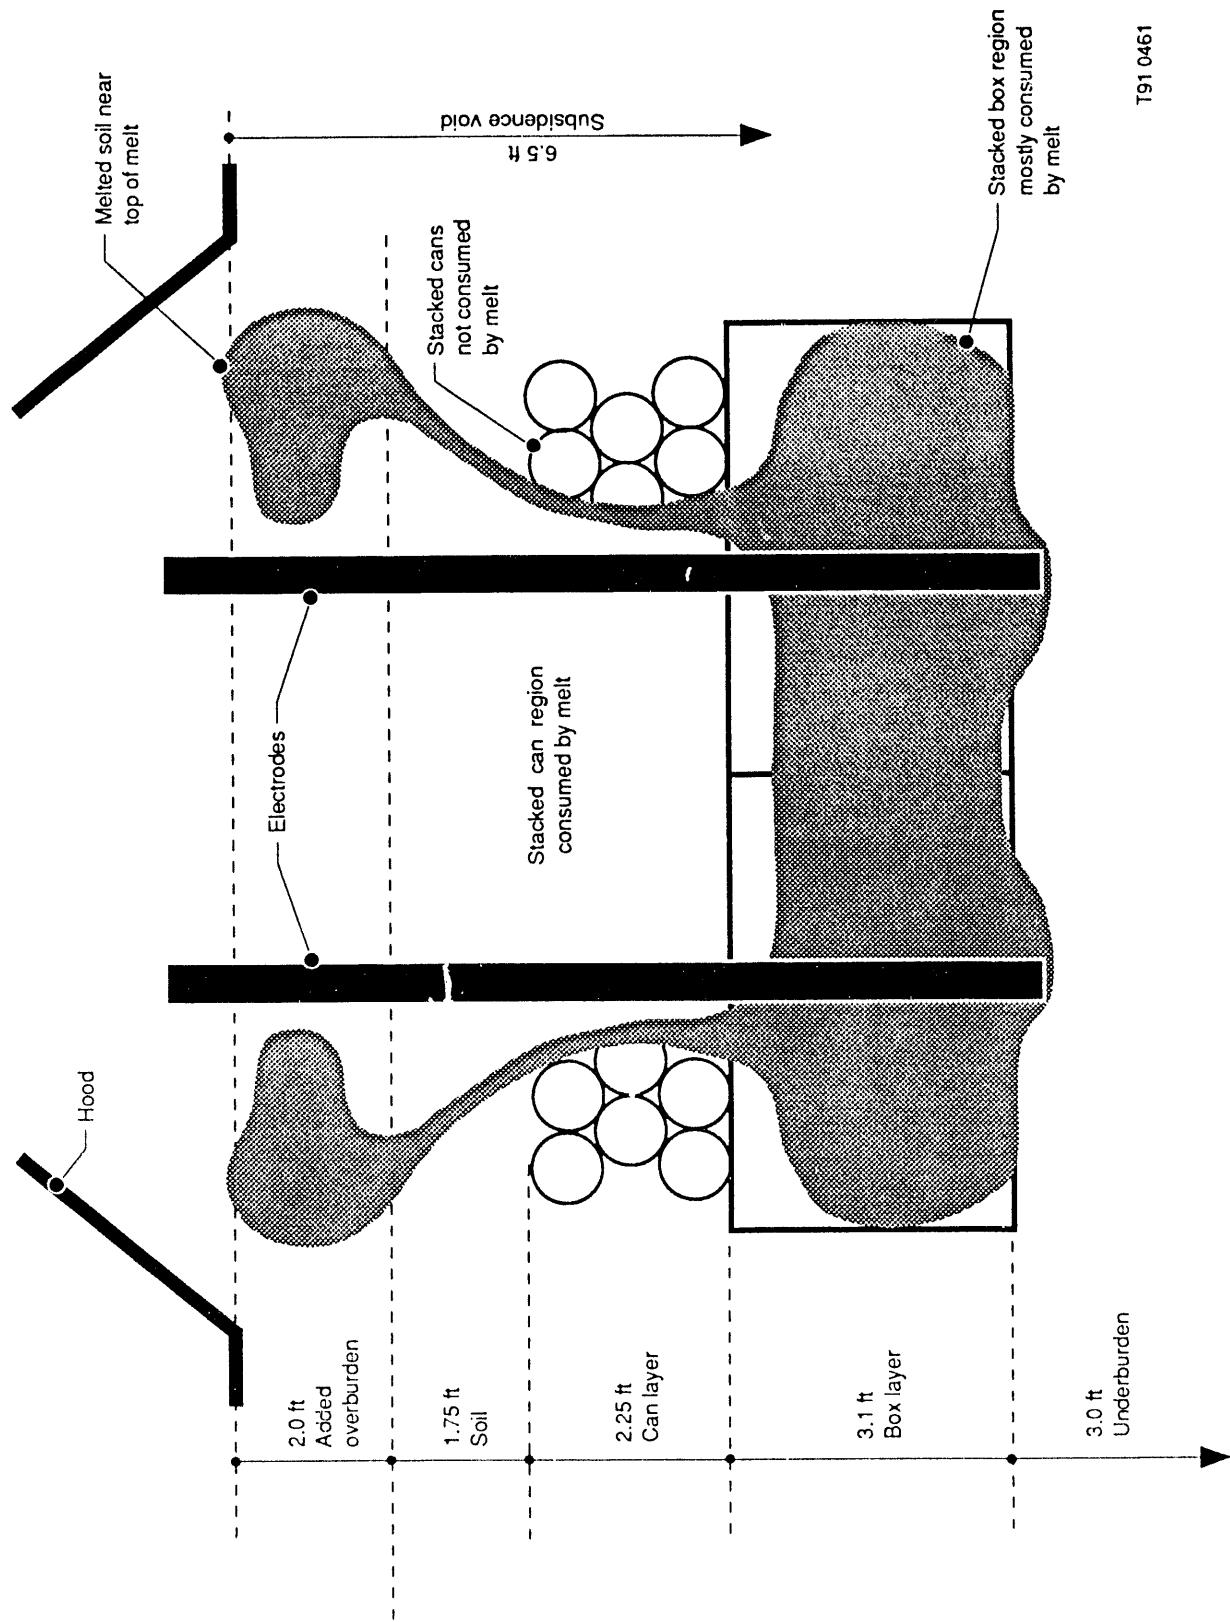
Figure 86. Schematic cross section of Test Pit 2 after ISV processing.

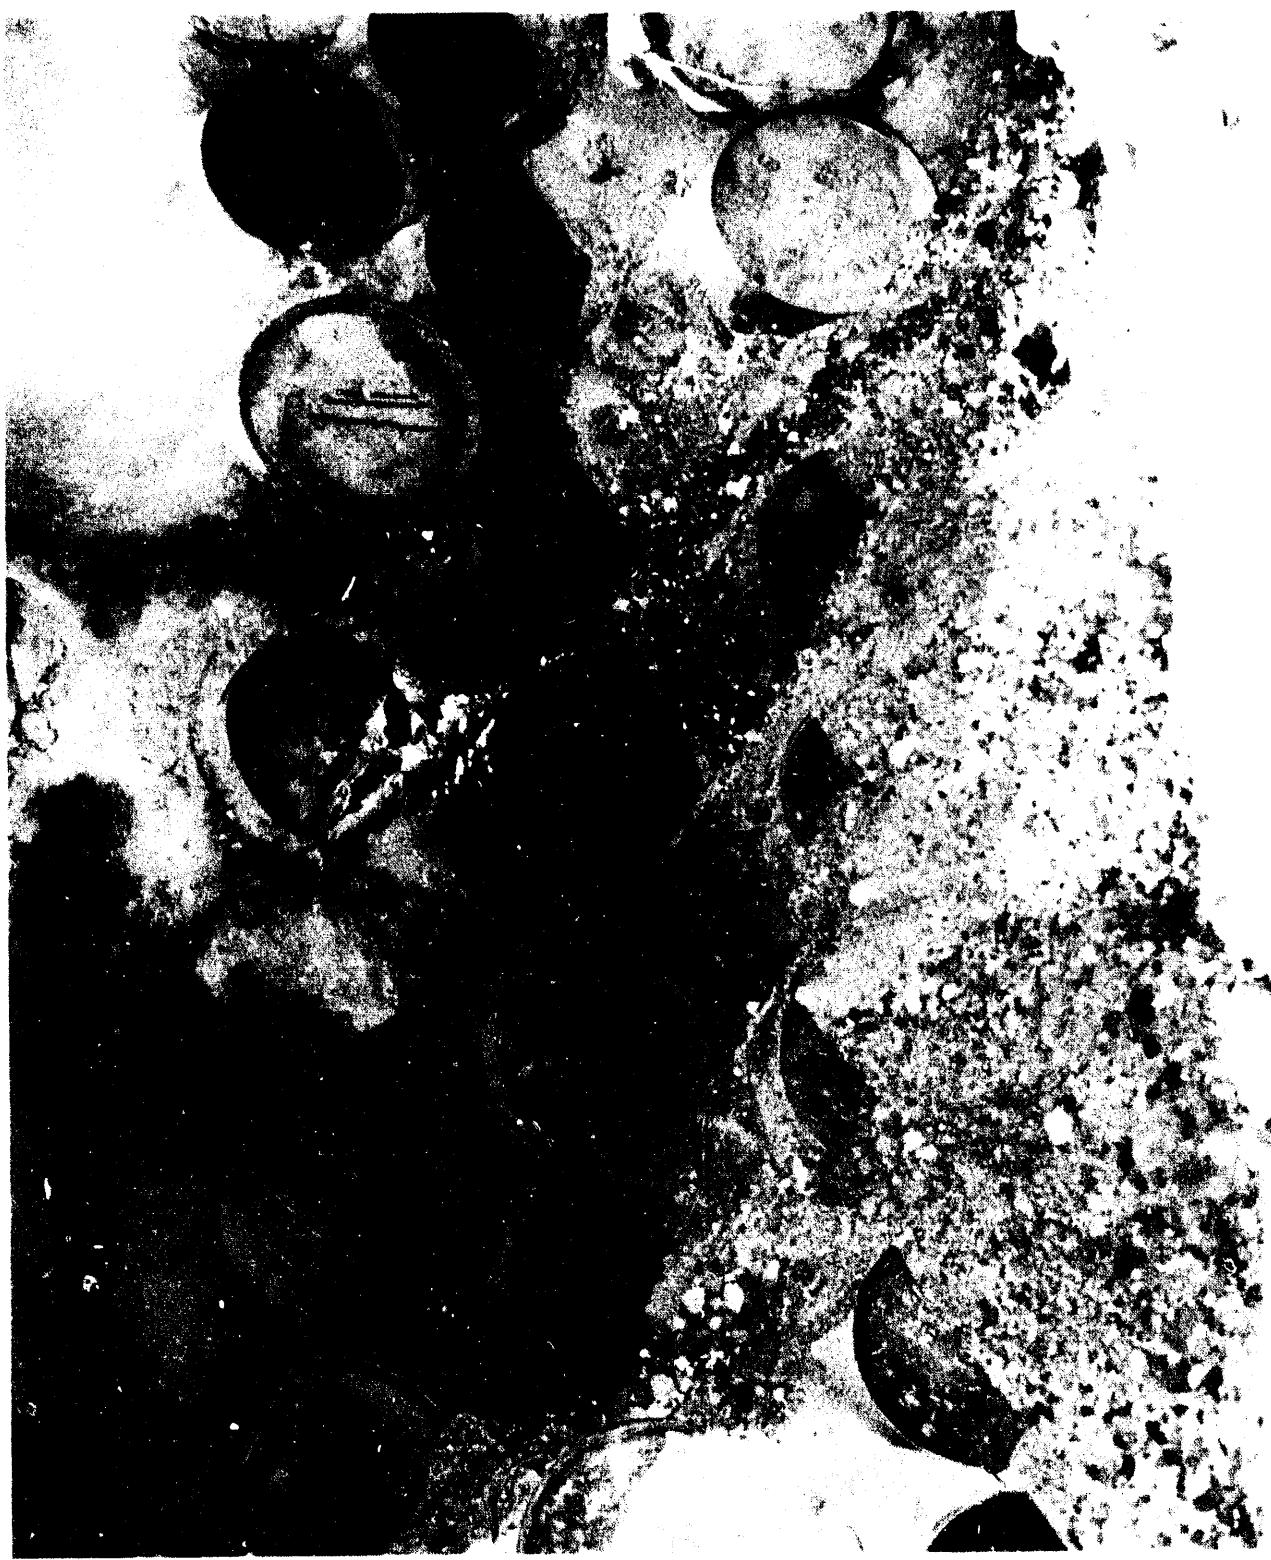
Figure 89. Edge effects on cans in Test Pit 2.

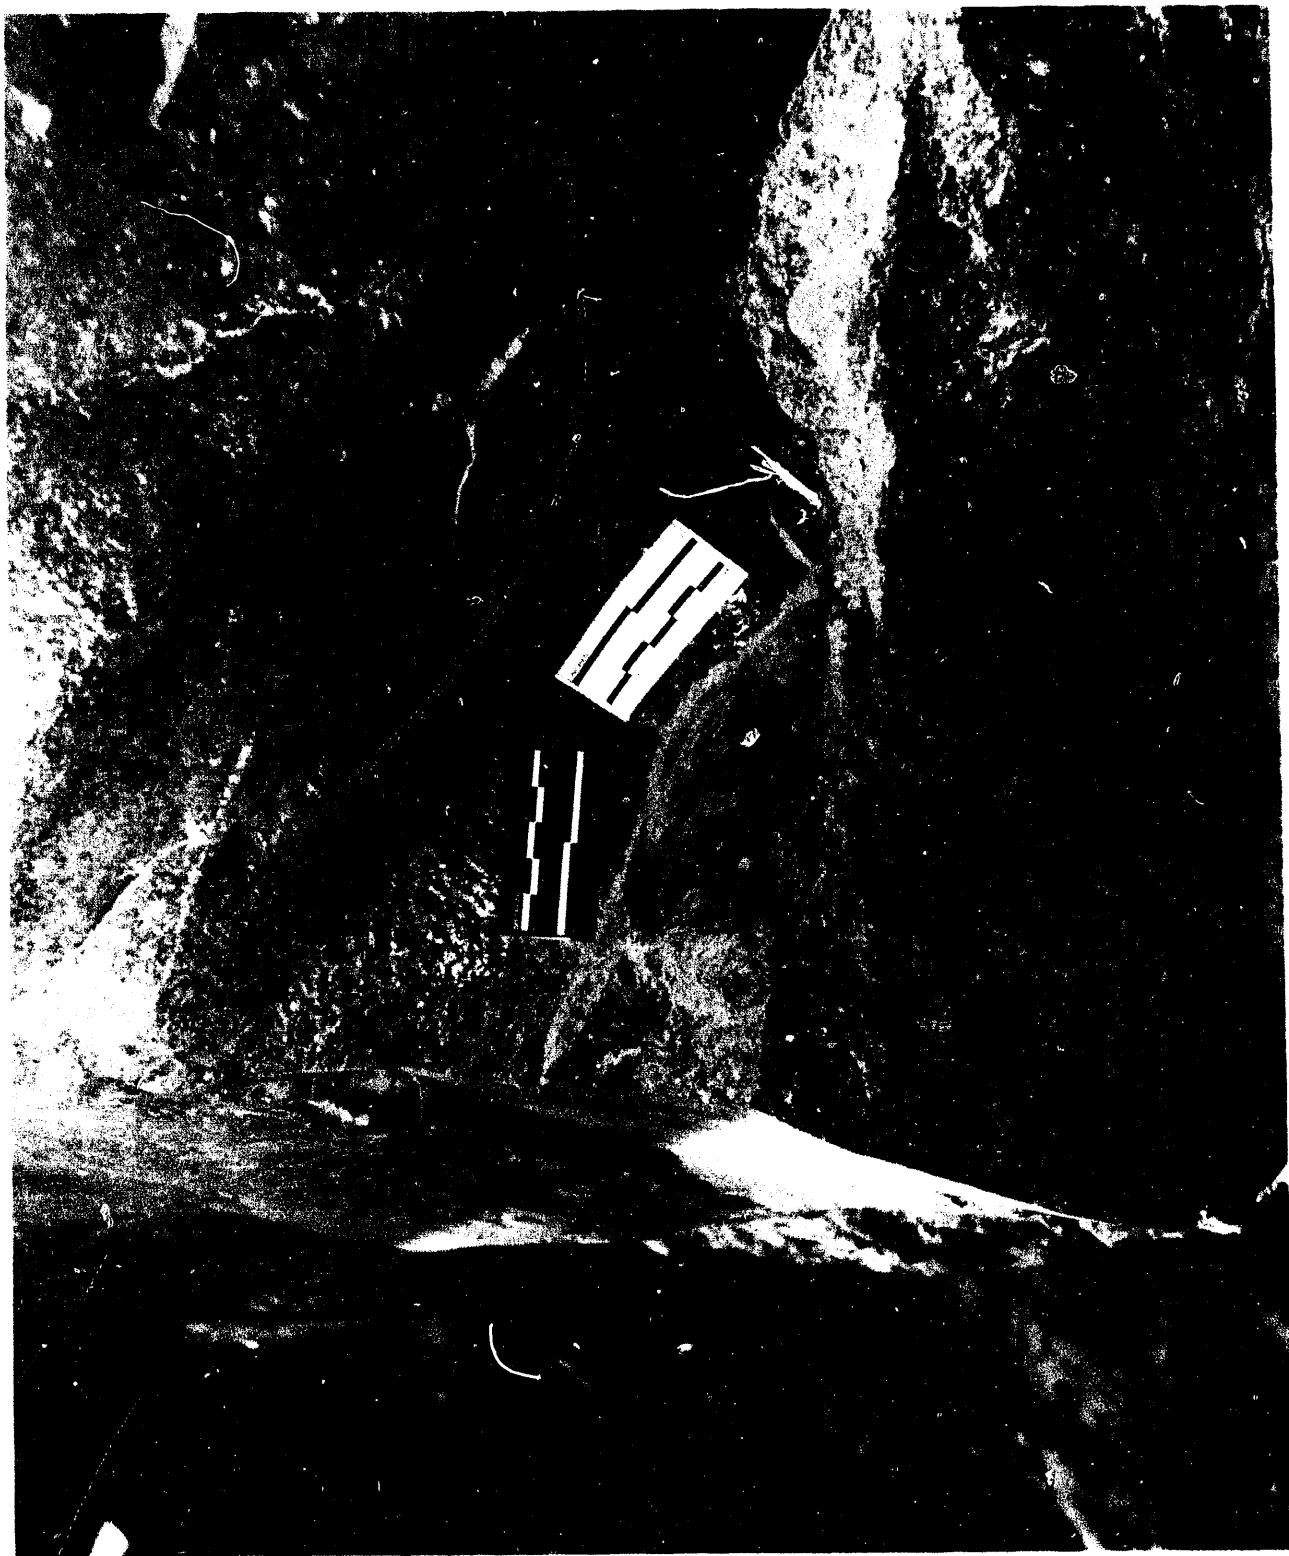
Figure 92. Test Pit 2 texture of vitrified monolith material.

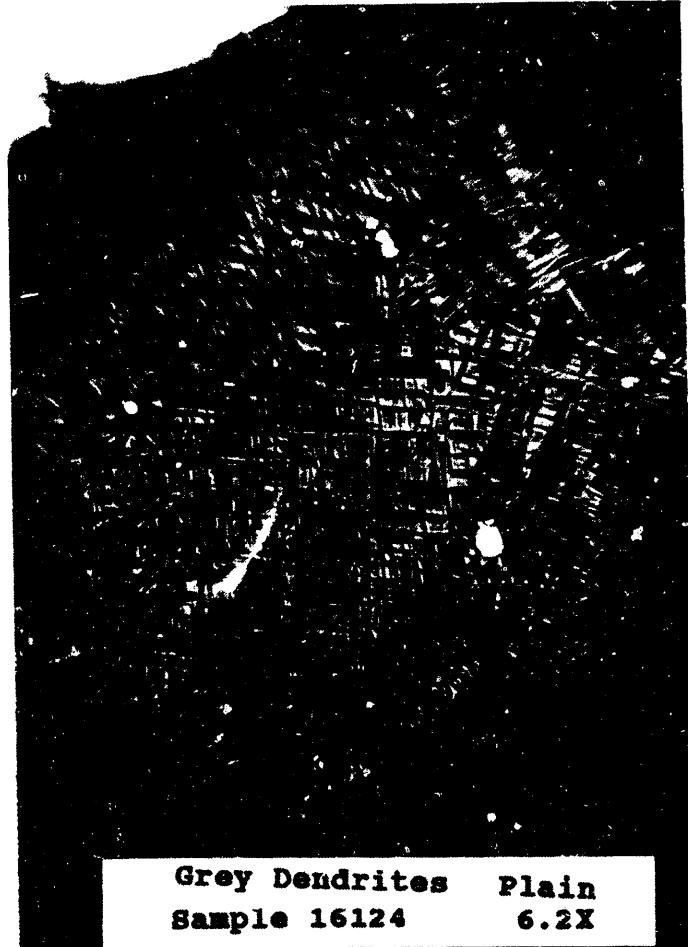
**Grey Dendrites Plain**  
**Sample 16124 6.2X**

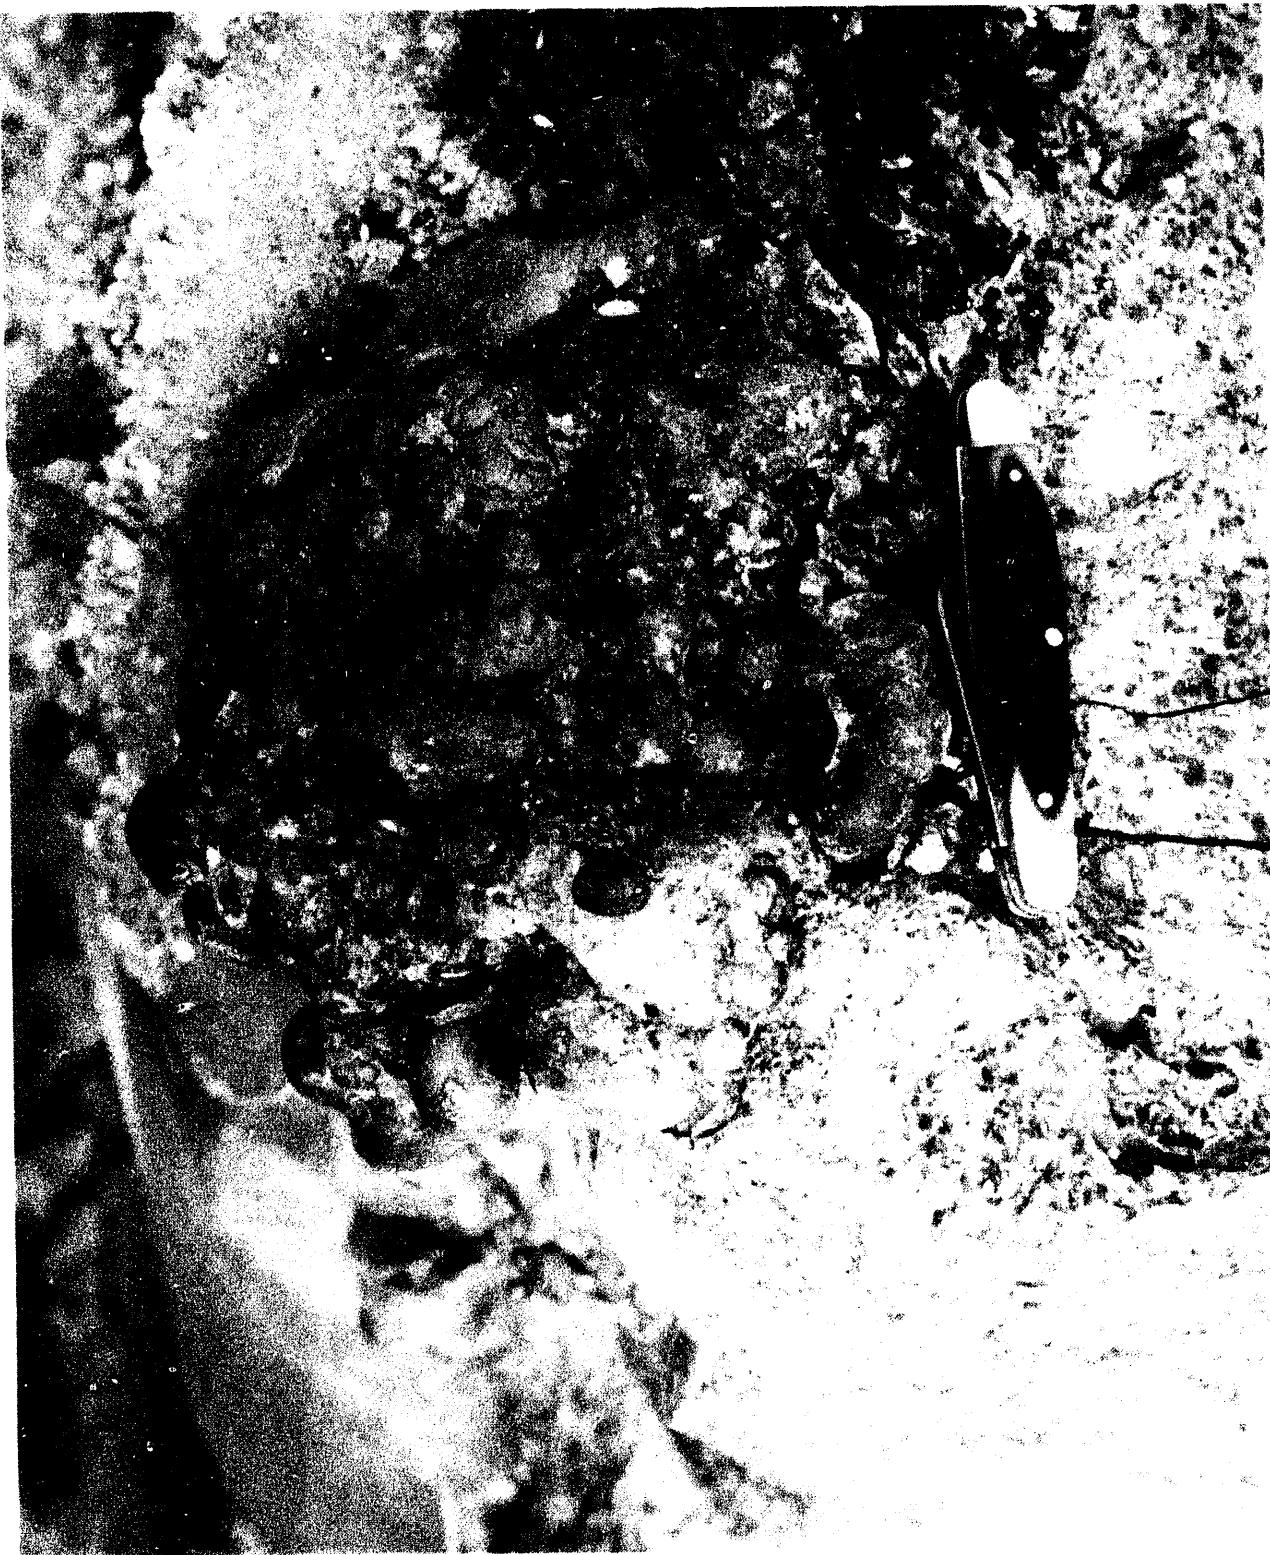
Figure 95. Metallic balls in Test Pit 2.

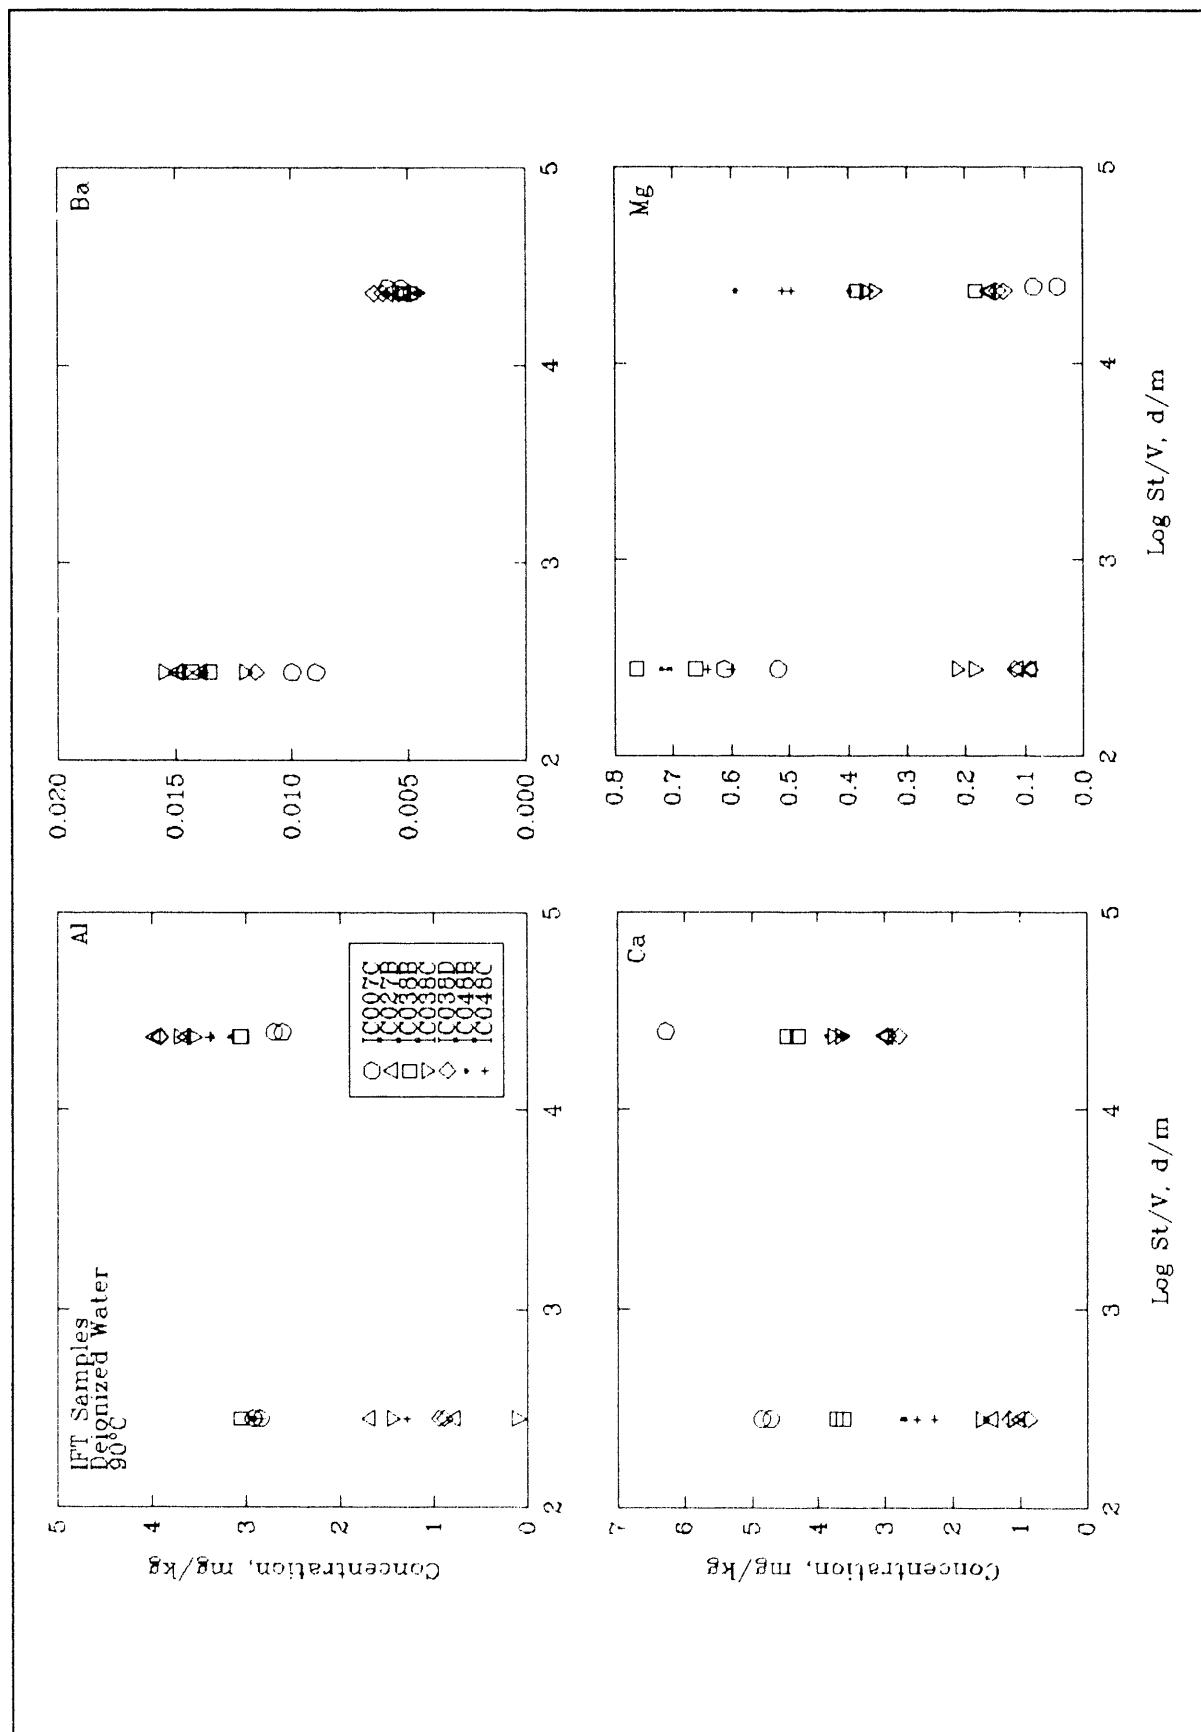
Figure 97. Release of selected elements from IFT samples in MCC-1 and modified PCT tests.

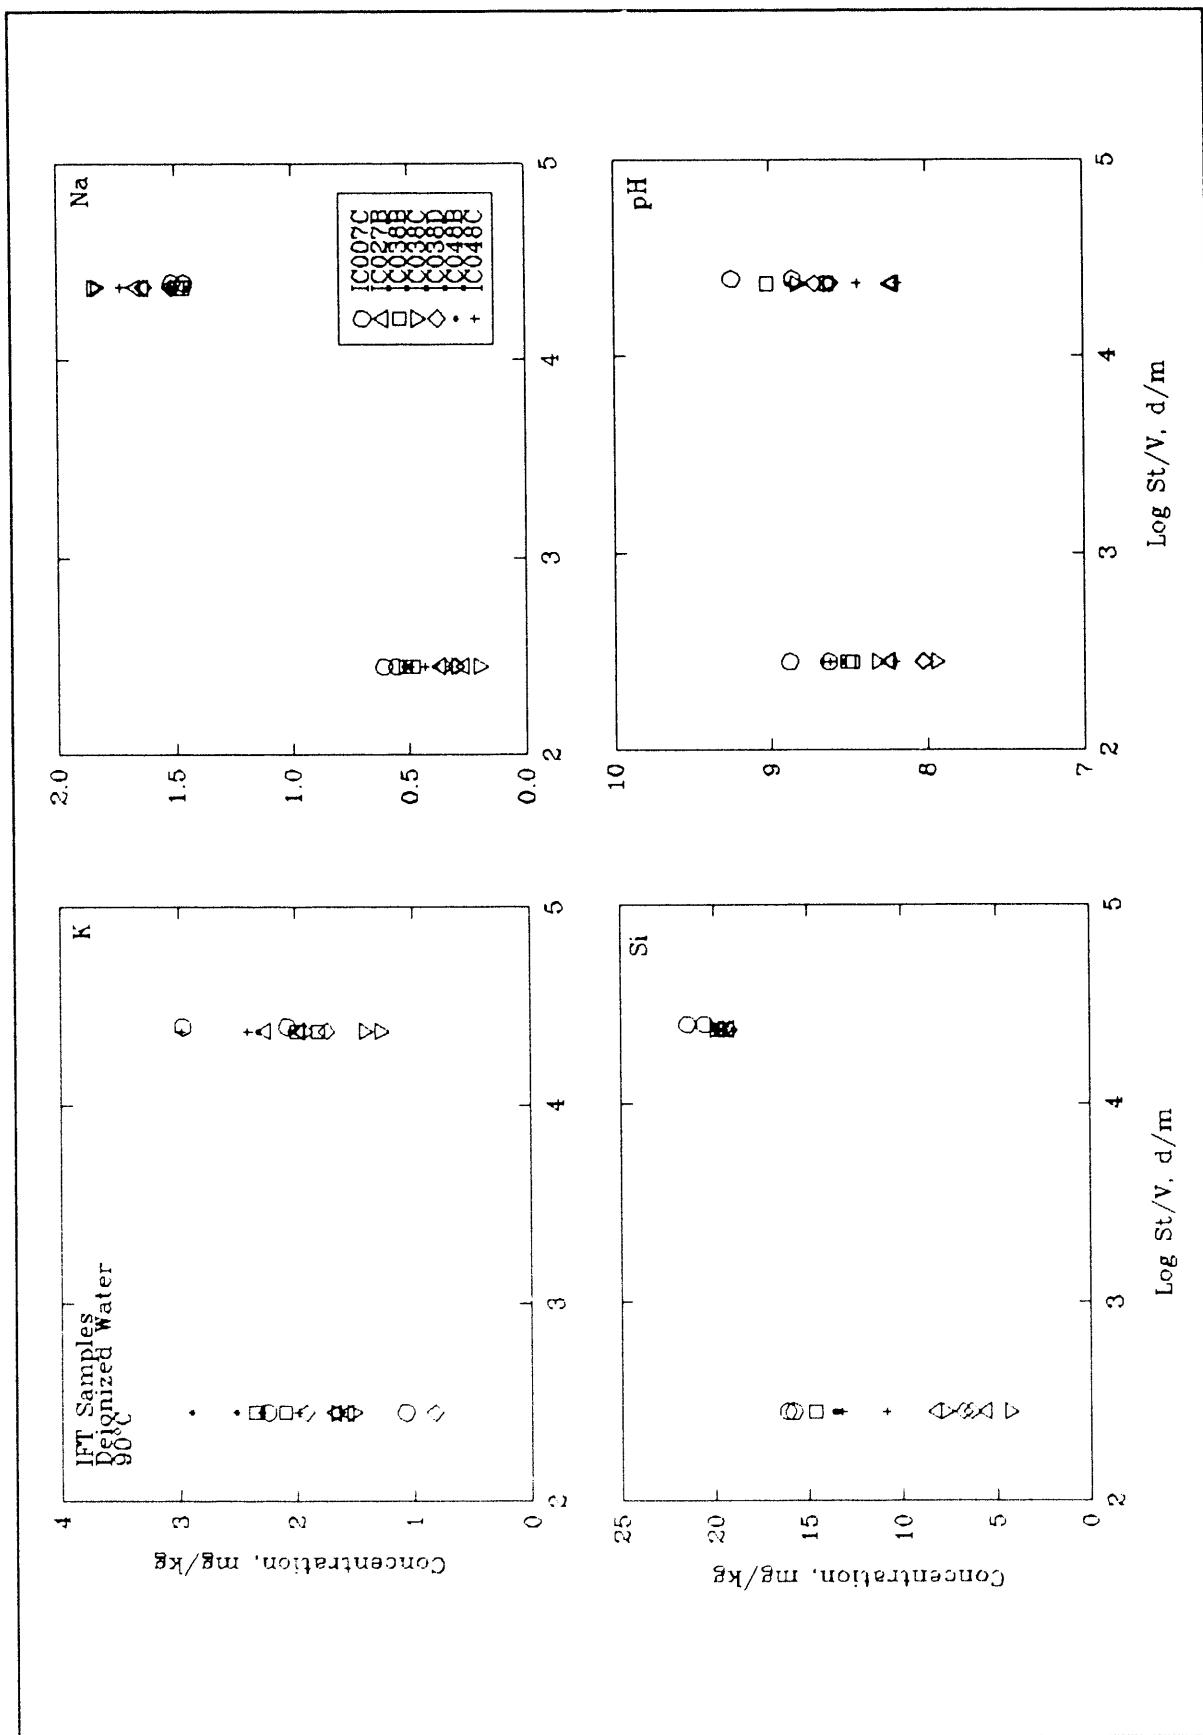
Figure 98. Release of selected elements and pH of IFT samples in MCC-1 and modified PCT tests.

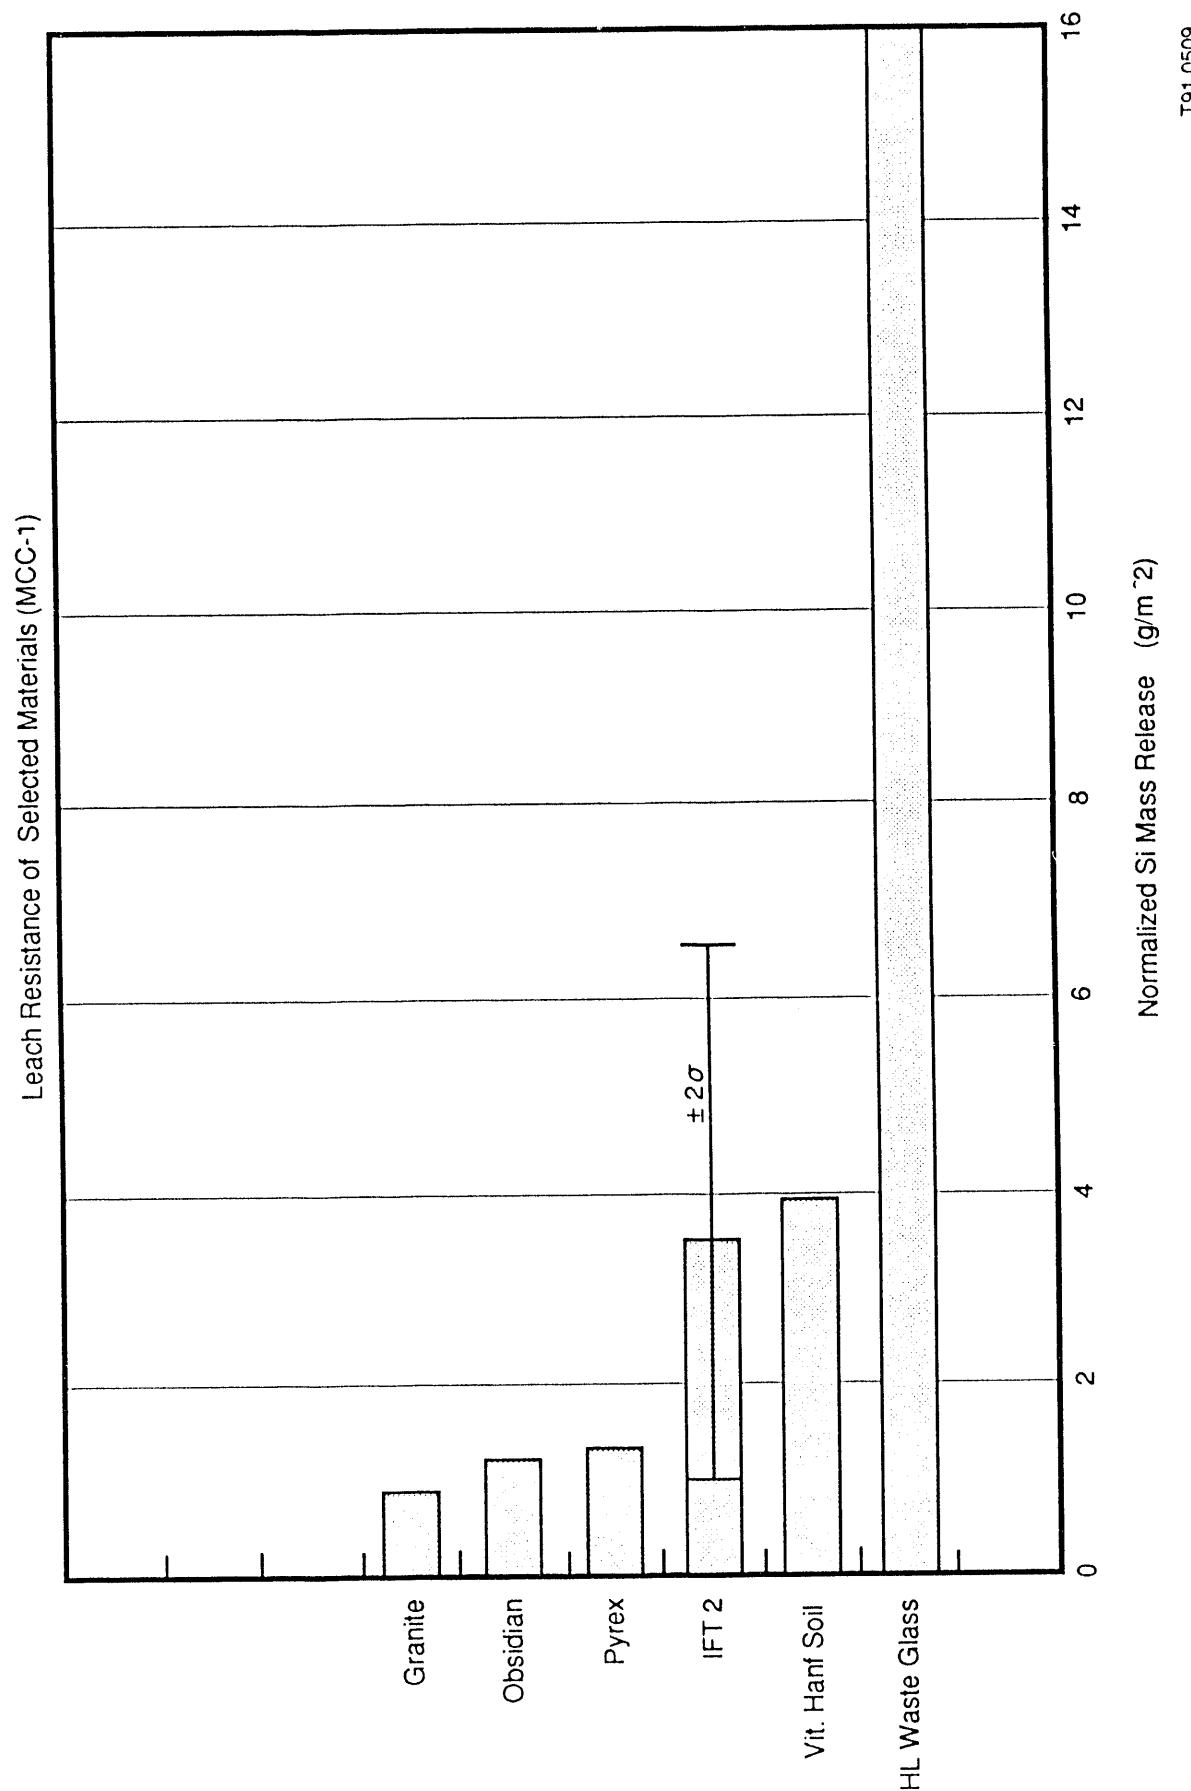
Figure 99. Comparison of durability of ISV samples based on MCC-1.<sup>17</sup>

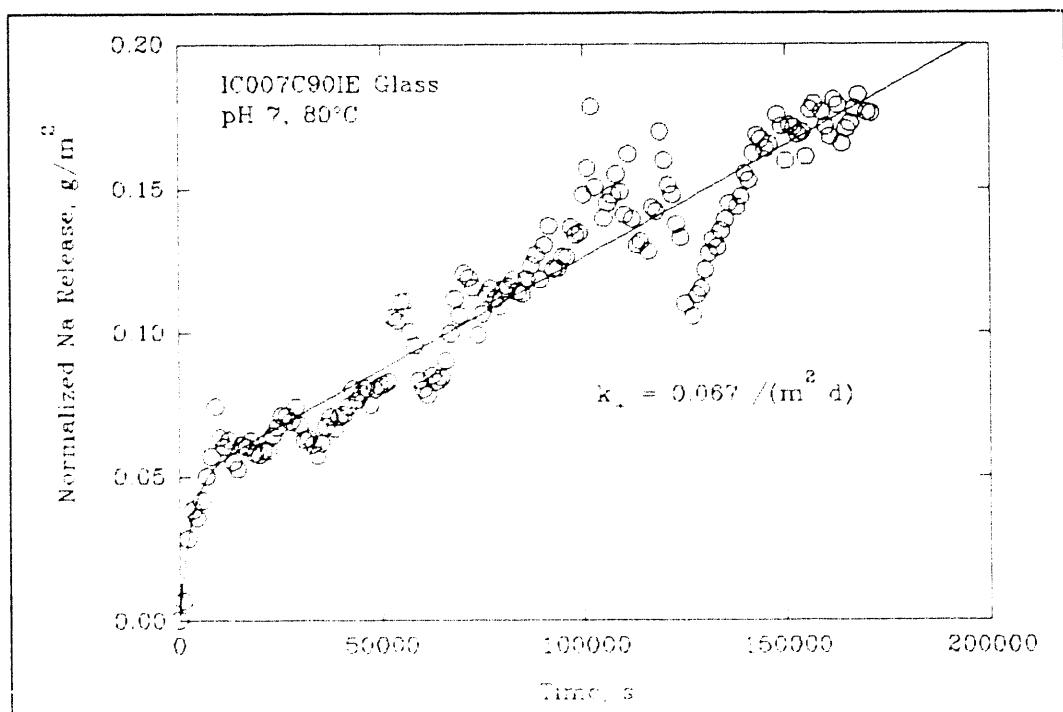
**Figure 101.** Dissolution behavior of IFT sample IC007C90IE at in situ pH 7 and 80°C.

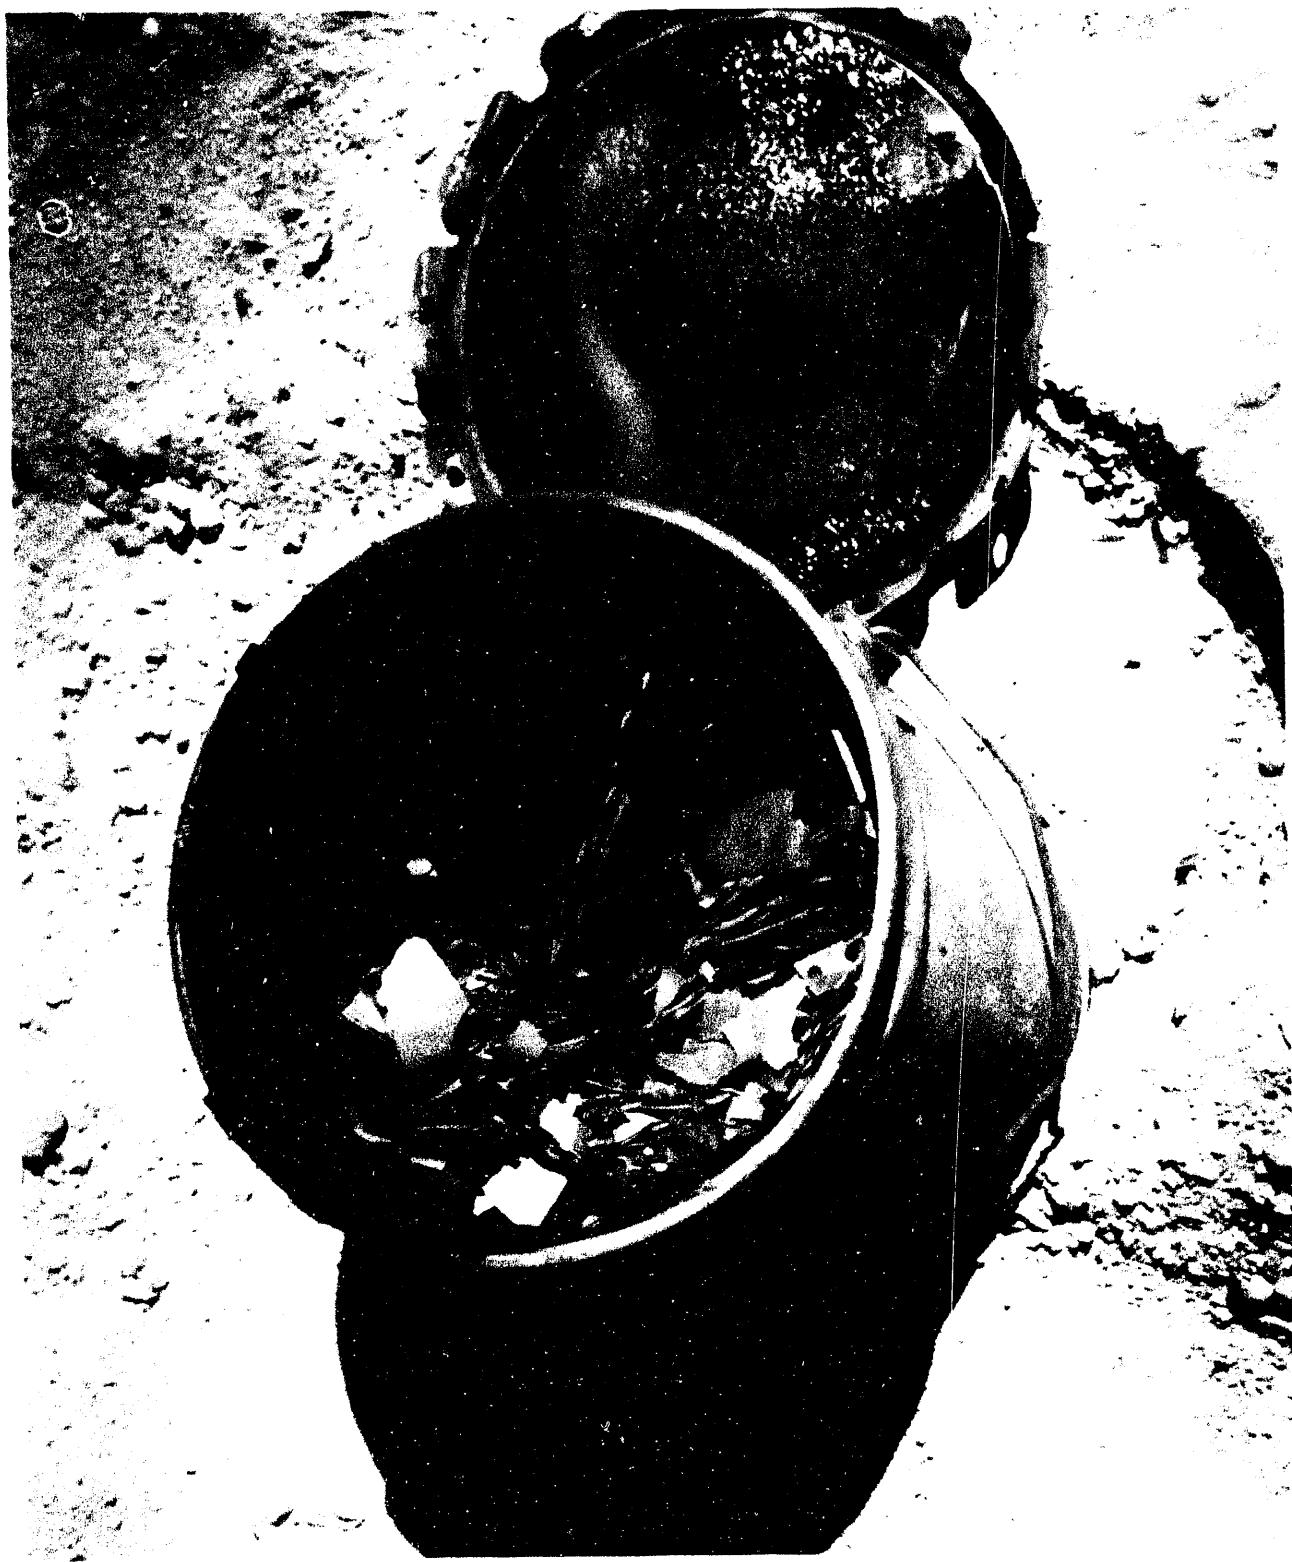
Figure 102. Carbonization of paper outside of vitrification zone for Test Pit 2.
