**IMPACT FAILURE OF MHW FUEL SPHERE MHFT 65:
REPORT ON INTERAGENCY TASK FORCE INVESTIGATION
AND SRL EVALUATION OF FAILURE
NOVEMBER 1979 - FEBRUARY 1980**

**E. I. du Pont de Nemours & Co.
Savannah River Laboratory
Aiken, SC 29808**

Publication Date: June 1981

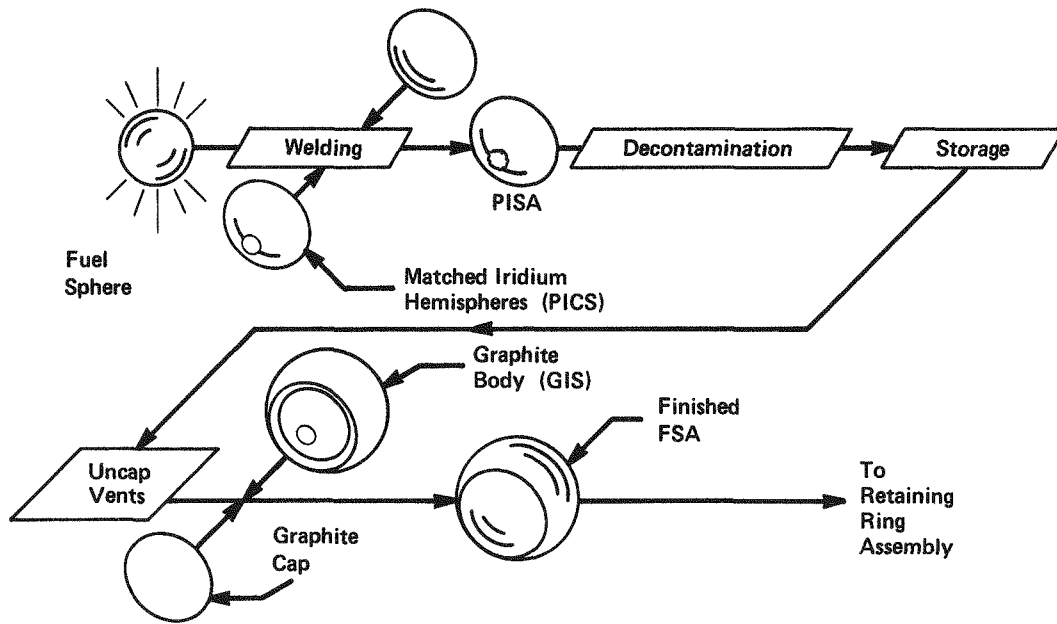
FIGURE 1. Assembly Sequence for Fuel Sphere Assembly

The assembly sequence for an MHW Fuel Sphere Assembly (FSA) is shown schematically in Figure 1. A $^{238}\text{PuO}_2$ sphere made in the Plutonium Fuel Form (PuFF) Facility at SRP is encapsulated in thin iridium hemispheres called Post Impact Containment Shells (PICS). The encapsulated fuel, called the Post Impact Sphere Assembly (PISA), is then placed in a Graphite Impact Shell (GIS). In the event of a mission failure and reentry of the Galileo space vehicle into Earth atmosphere, the GIS is designed to absorb the shock of earth impact sufficiently so that the fuel will not breach the iridium containment shell and contaminate the biosphere. The final assembly of a PISA within a GIS is called a Fuel Sphere Assembly (FSA). Twenty-four FSAs are assembled, as shown in Figure 2, into a radioisotopic thermoelectric generator (RTG).

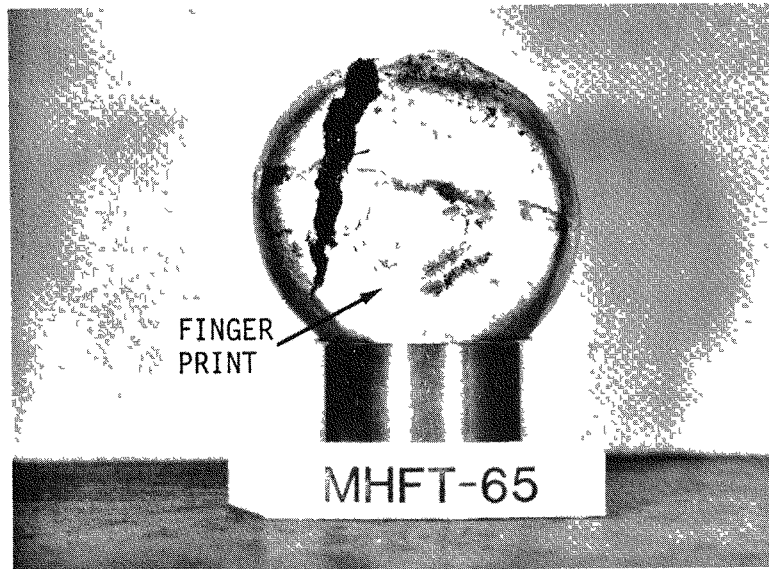
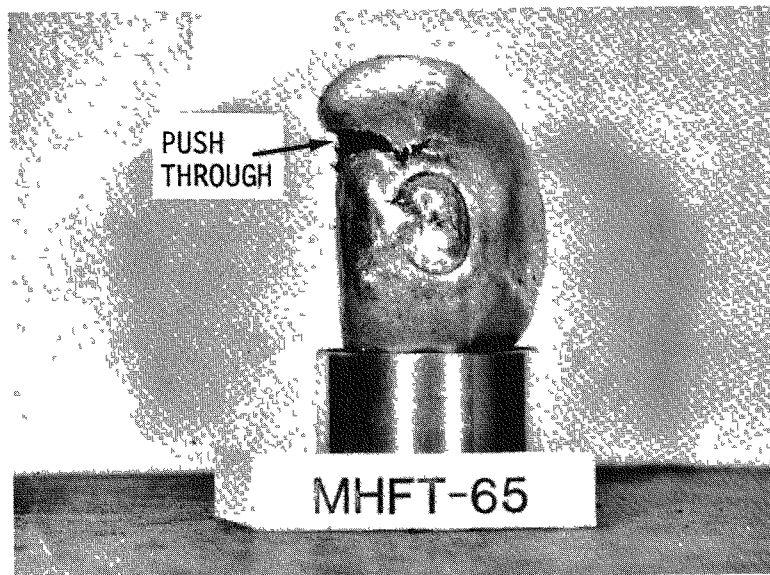
FIGURE 3. Face and Profile of MHFT 65 as a Result of Impact*

relative displacement of the adjacent parts is large enough to exceed the plastic limit of the iridium, and the iridium tears apart. Displacement is approximately normal to the iridium surface. A distinctive "lobe type" push-through deformation is identified as follows: The profile of this type of deformation resembles that of the impact face of a bag of sand dropped onto the edge of a table. Here the unsupported portion of the bag continues farther down the side of the table forming a pronounced "lobe" with the bag experiencing a very sharp bend angle at the edge of the table. The lobe type push-through deformation of MHFT 65 is shown in Figure 3.

The large push-through failure of MHFT 65 is shown in Figure 3. The details of this test, and impact tests of SRP fuel through MHFT 67, are summarized in Table 1. Various analyses were conducted on SRP- and LANL-produced impacted spheres. The most noteworthy results of these analyses were the presence of phosphorus and sulfur in the iridium, compared to previous MF FSAs, and the exceptionally high value of phosphorus in the iridium of MHFT 65 in particular.

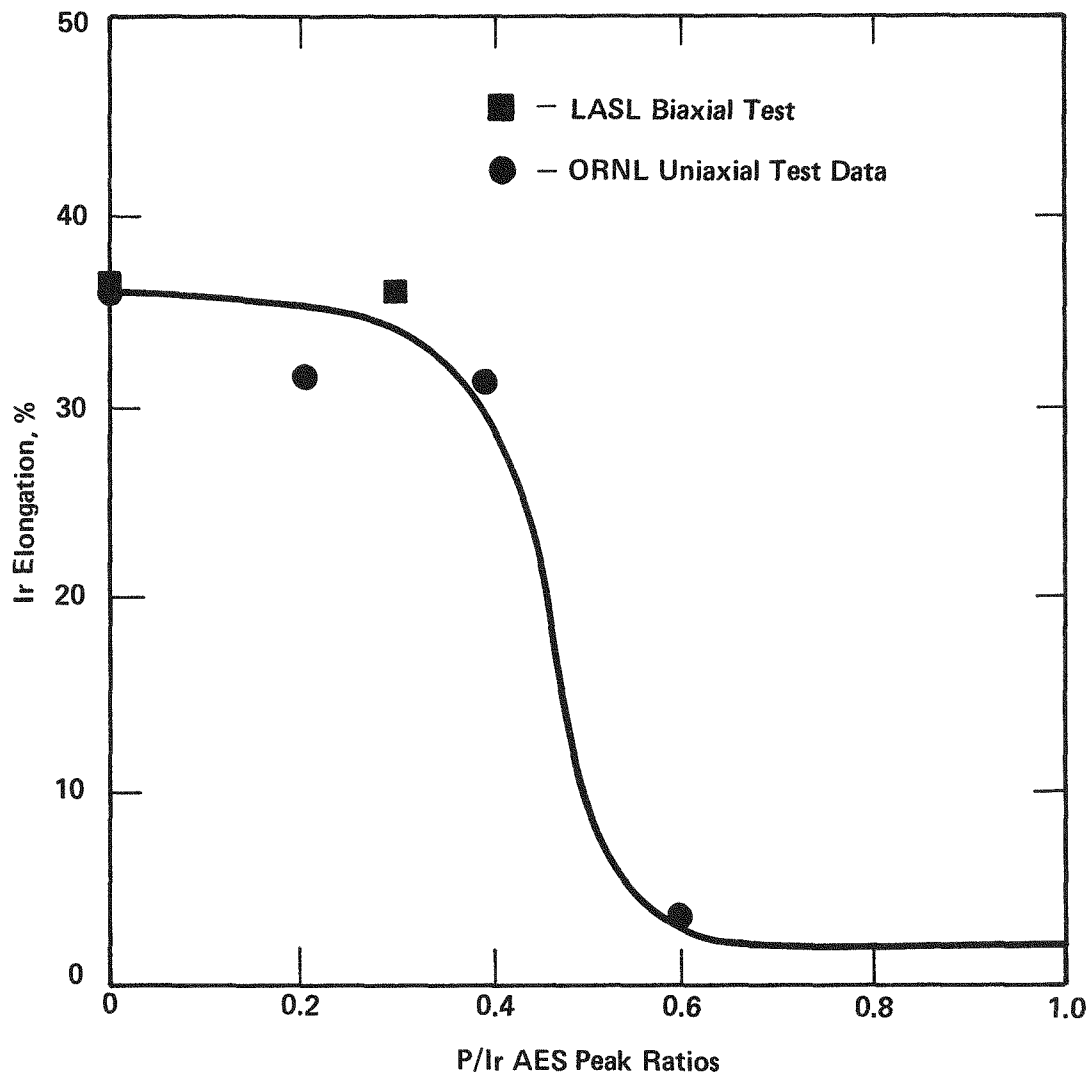
FIGURE 4. Iridium Ductility Vs. Phosphorus Concentration on Grain Boundaries*

Effects of phosphorus on iridium are not proven, but the available data favor a concentration effect, with a sharp threshold dividing that concentration causing embrittlement from that concentration not causing embrittlement (Figure 4). This concentration effect is based on Auger peak height ratios of phosphorus to iridium at grain boundaries. By coincidence, these peak height ratios are about numerically equivalent to the bulk concentration in ppm.* Therefore, the bulk threshold concentration for phosphorus embrittlement of iridium may be as low as 0.4 to 0.5 ppm. As shown in Figure 4, ORNL test data (for a limited number of tests) suggest that tensile test samples with phosphorus-to-iridium

* Bulk Concentration of P in ppm \approx peak height ratio.

peak height ratios >0.5 exhibit brittle failure, whereas samples with peak height ratios <0.45 to 0.50 show ductile failure. Table 9a shows that of all the SRP tests, only MHFT 65 had a phosphorus-to-iridium peak height greater than 0.50 . These data seem to justify the task force belief that the extra phosphorus sufficiently embrittled the iridium so that it was not resistant to strain as much as other spheres. For example, Figure 5 shows that MHFT 61 survived a 46 percent reduction in thickness compared to only 37 to 43 percent for MHFT 65.

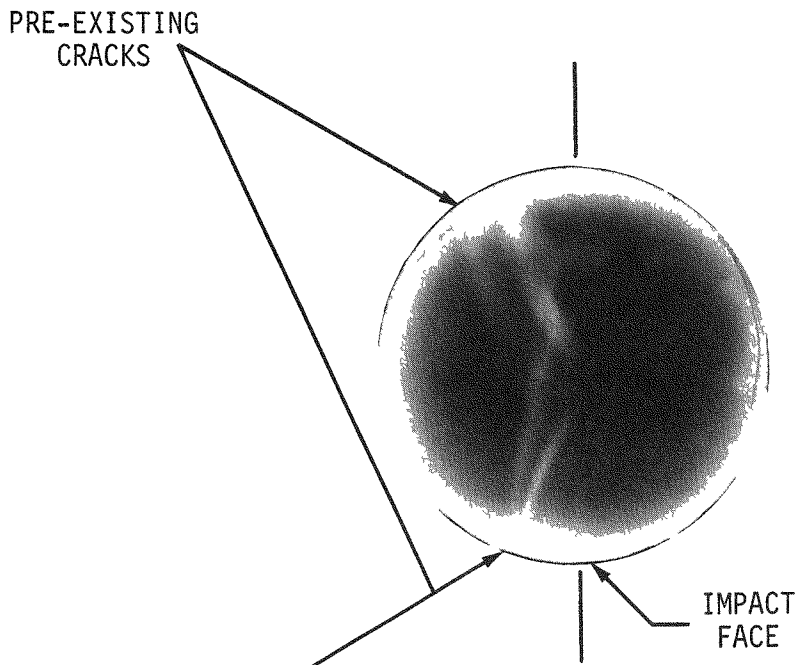
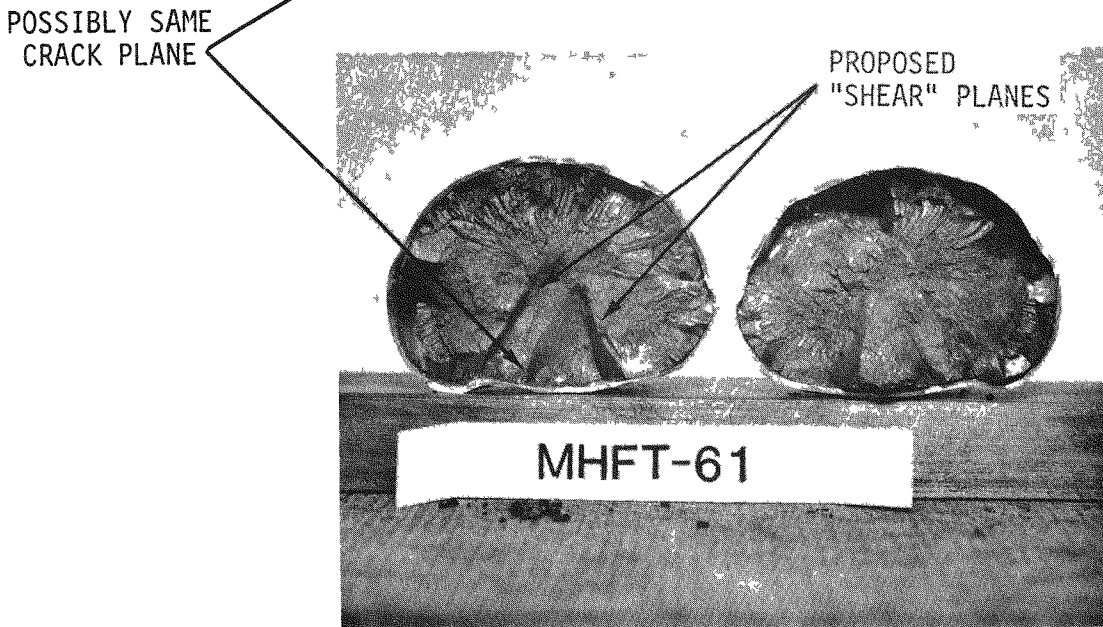
FIGURE 7. SRP Test Sphere MHFT 61*

- Shear planes (Figure 7) running from the center axis (perpendicular to the impact face) of impacted sphere MHFT 61 toward the push-through area of the impact face, form nearly an isosceles triangle. The triangle's base is along the impact face, and the triangle's apex is along the center axis about 2/3 to 3/4 of the distance from the impact face to the rear of the sphere. It is hypothesized that as material below these planes began to be slowed, large chunks above the planes slid along the planes and sheared the iridium PICS.

a. Radiograph of FSA Before Impact

b. Section After Impact

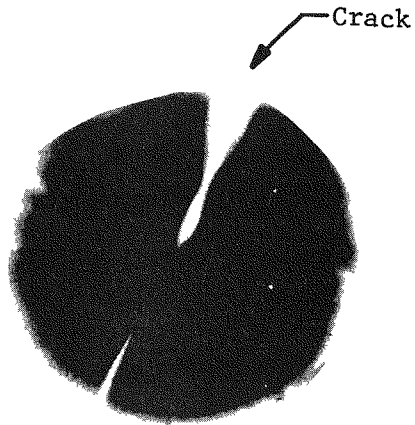
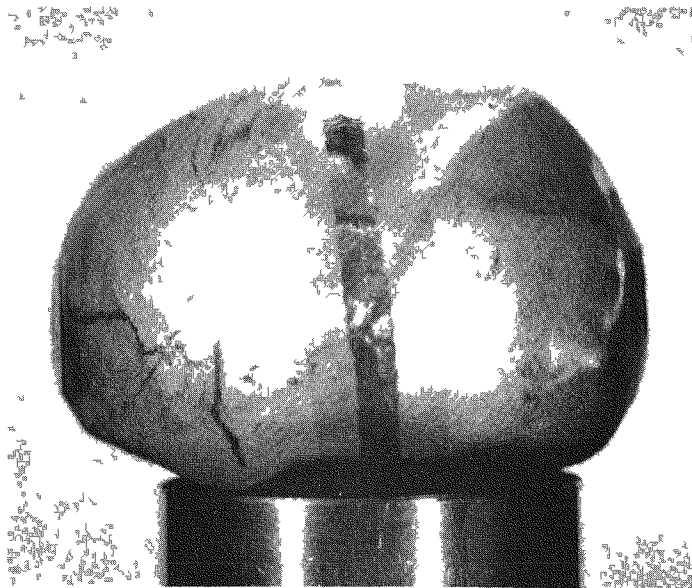
FIGURE 8. Impact of MHFT 70*

Pre-impact radiographs of Sphere MHFT 70 (SRP Sphere 39) showed that it was completely separated into two hemispheres along a flat pole-to-pole plane with the fracture plane oriented in the same direction, with respect to the impact face, as the deformation line shown in Figure 8. PuFF records show that this sphere had fractured prior to gauging and had to be assembled into the PICS for welding. This gave rise to the very large separation of two hemispheres seen in the radiograph. That the two halves appeared physically separated in the radiograph, and had been reassembled, suggests that they may have been kept apart by small particles and asperities which would have helped the two pieces slide over one another.

a. Radiograph of Sphere Before Impact

b. Deformation From Shear of Two Halves of Sphere.
No Push-Through Failure

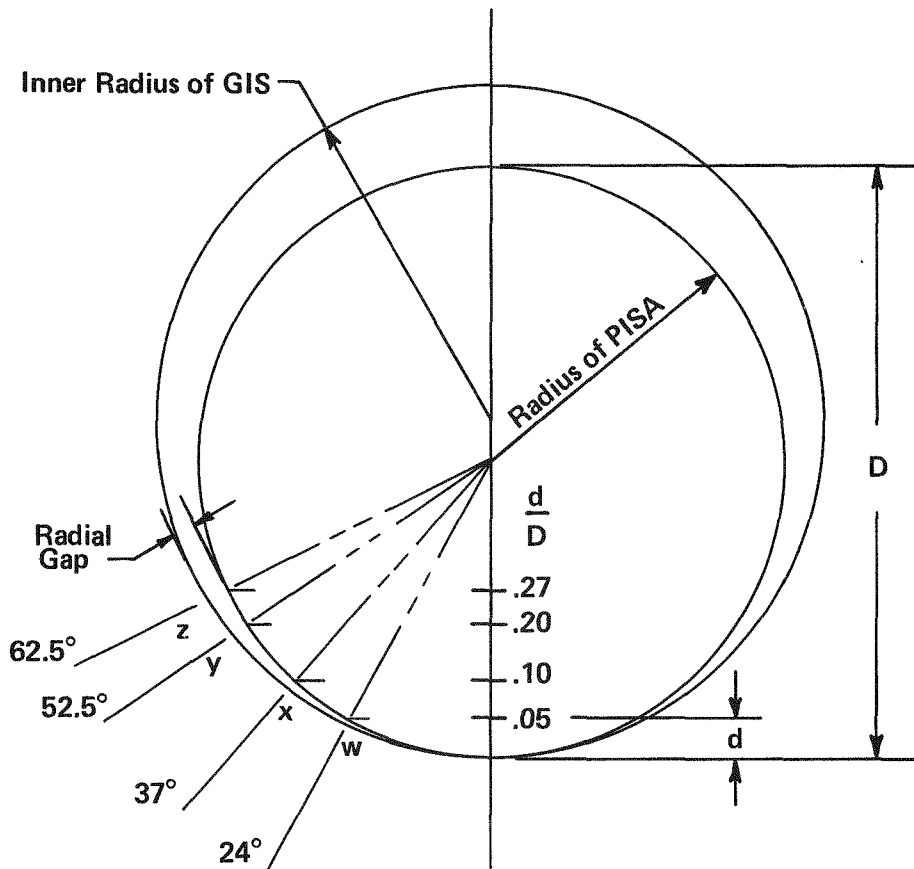
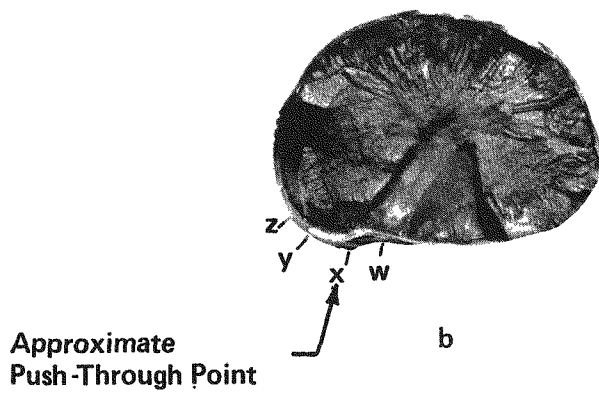
FIGURE 9. Impact Geometry of FSA

Figure 9a shows the geometry of the FSA at the moment of contact of the PISA with the GIS. (Deformation of the inner radius of the GIS due to its own impact is considered negligible at this early time.) Points along the PISA circumference corresponding to different d/D ratios used in the computer modeling are labeled w,x,y, and z. These same relative points are shown for comparison on the cross section of impacted MHFT 61 (Figure 9b). Point x corresponds very closely with the point of contact of the hypothesized push-through or shear plane of the pieces of fuel. In Figure 10, the calculated radial gaps² for each of the points are compared with the maximum radial shear experienced by the push-through in MHFT 61, estimated as shown in Figure 11. Though the radial displacement of the MHFT 61 push-through is difficult to determine accurately, it is clearly larger than the radial gap between the GIS and PISA. Hence, to accommodate the displacement observed, the GIS had to give way.

a) Geometry at Instant of Impact of PISA Into GIS
(neglecting small deformation of GIS already started)

b) Extrapolation of Points W, X, Y, Z to Impacted MHFT 61

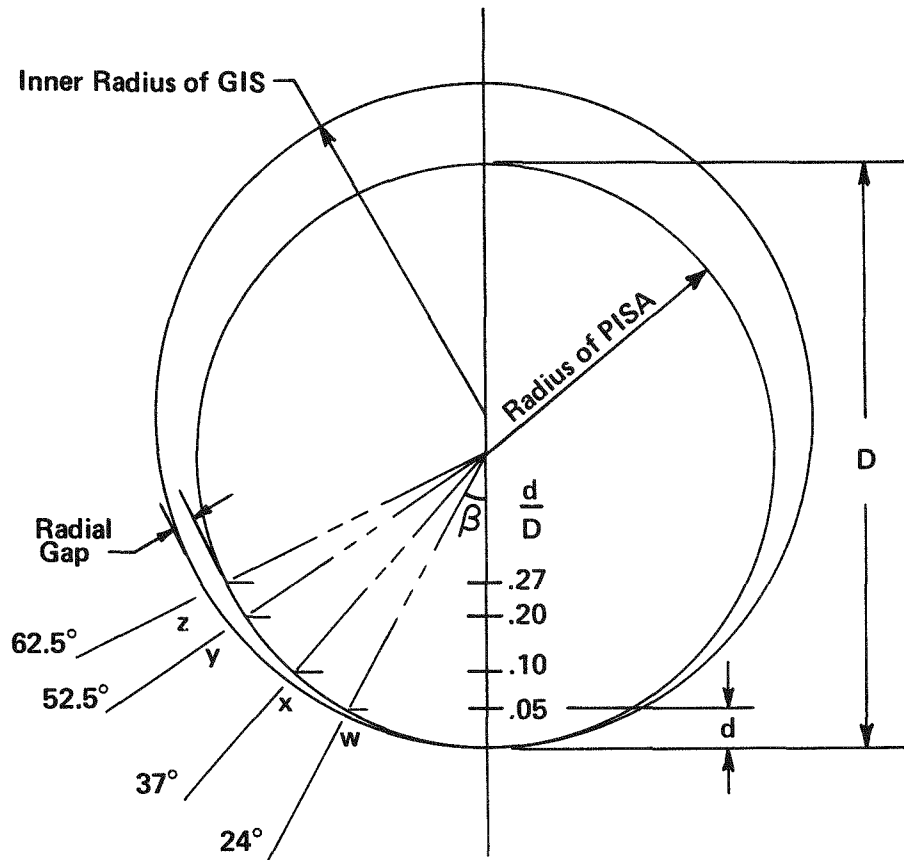
FIGURE 10. Initial Contact Geometry of FSA

$\frac{d}{D}$	Initial angle, β	Initial radial gap,* in.	Relative Impact Times** Ir-GIS, μsec	Fuel-Ir, μsec
0.05	24	0.004	17	45
0.10	37	0.009	28	53
0.20	52.5	0.016	52	72
0.27	62.5	0.023	72	83

Maximum radial displacement of push-through for MHT 61 is estimated from Fig. 11 to be ~0.090 in.

**Based on computer model "FSA 4": Strong GIS-Hard fuel-friction between GIS-Ir and Fuel-Ir. However, all other computer models (e.g. Strong GIS - Weak fuel - no friction) also showed the same relative impact sequence up to $d/D = 0.15$ (Ref. 1).

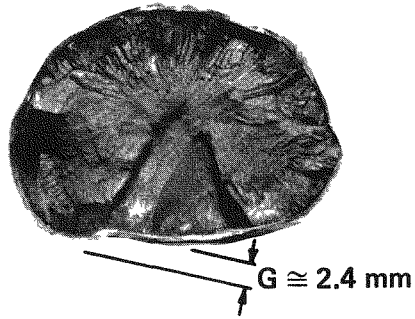
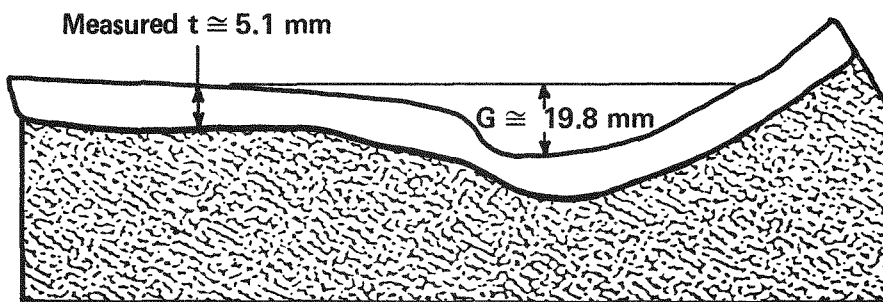
Scale Factor to Reduce G to Actual Size = 0.916
 $\therefore G_{\text{Actual}} \cong 2.2 \text{ mm} = 0.087 \text{ in}$

a. Calculation From Photograph

Actual Thickness t of Iridium = 0.024 in

\therefore Estimated Displacement, $G = \frac{19.8}{5.1} \times 0.024 = 0.093 \text{ in}$

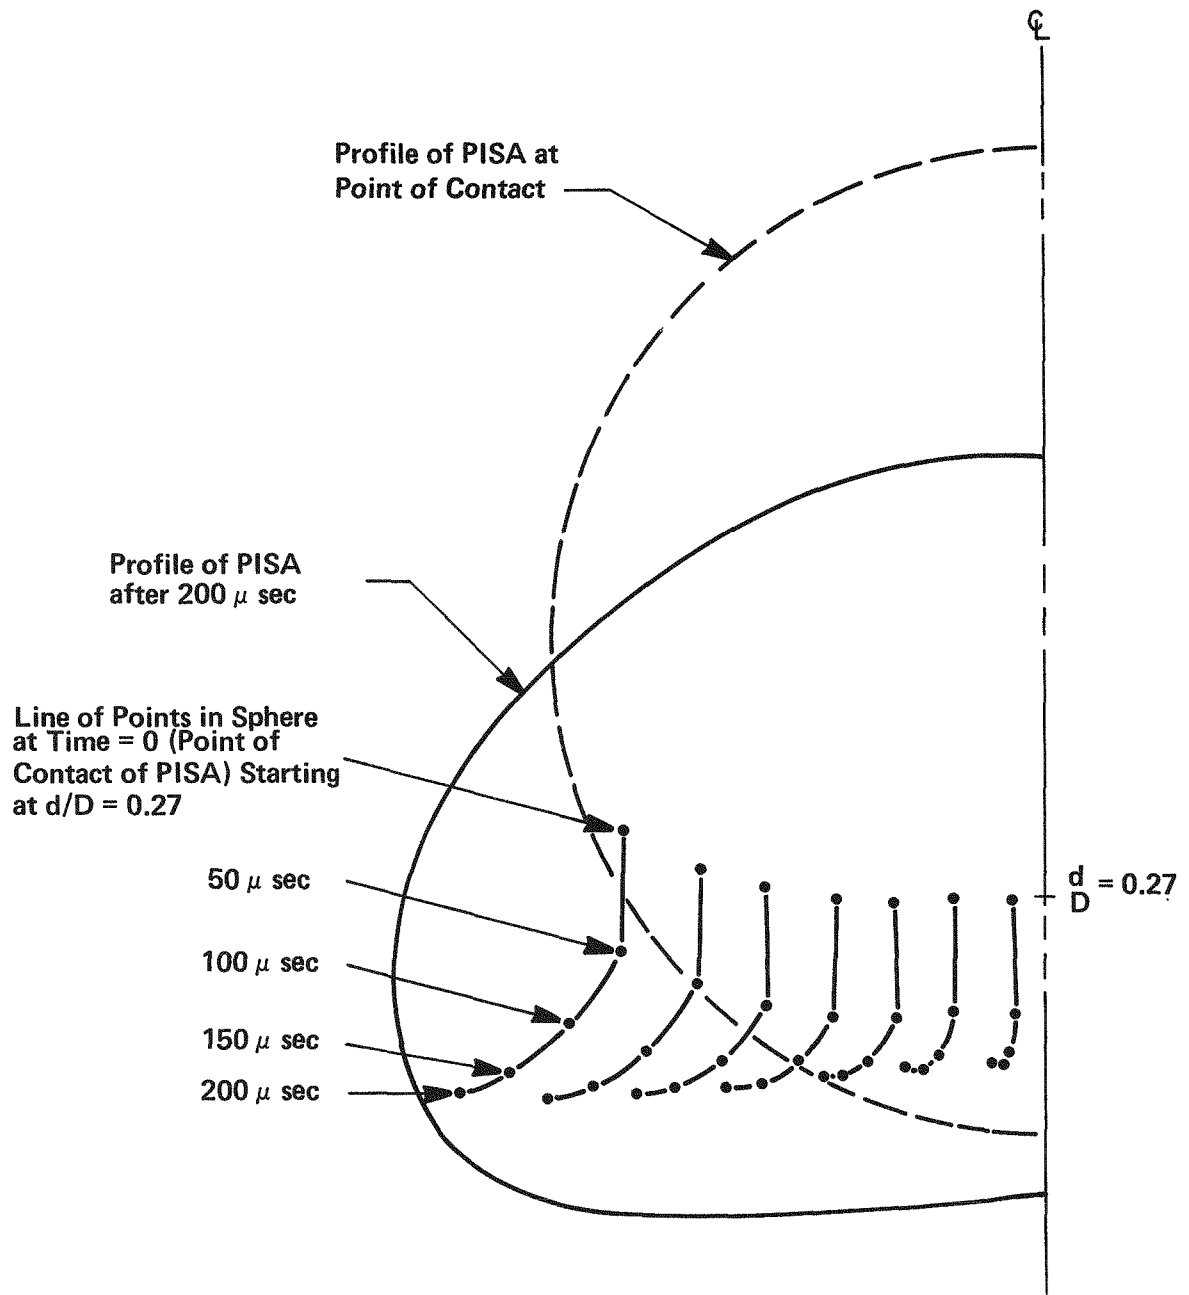
FIGURE 12. LOCI of Points in Fuel During Impact Showing Lateral Thrust Near End of Impact*

Summing all the evidence given in this section, it appears that the impact resistance of SRP fuel does not depend strongly on the nature of large pre-existing cracks. Both from the point of view of the available gap between the iridium and GIS and the relative GIS-iridium and fuel-iridium impact times, the data on the mechanics of impact of FSAs indicate that lobe type push-through deformation could not occur unless the GIS also failed. When the GIS fails, lobe type push-through can occur by sandbagging of the

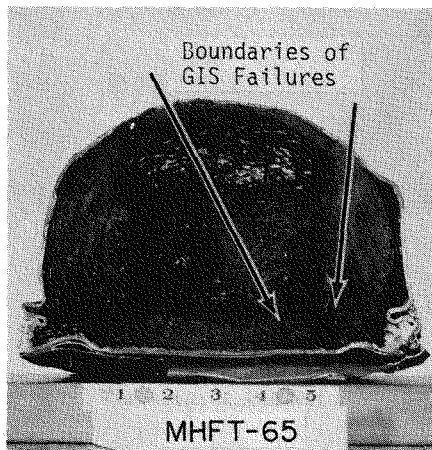
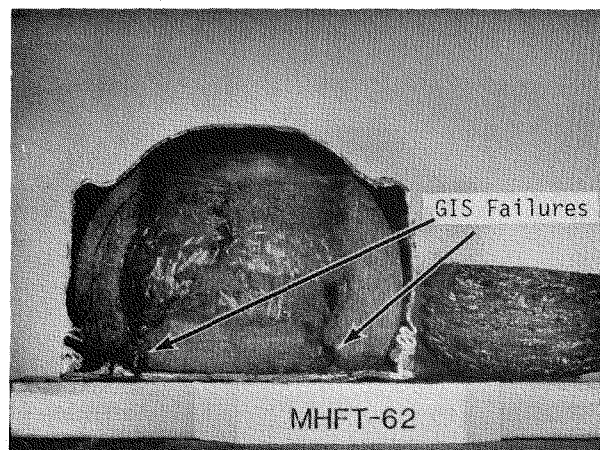
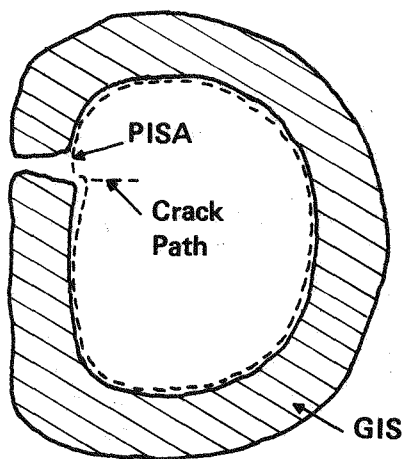
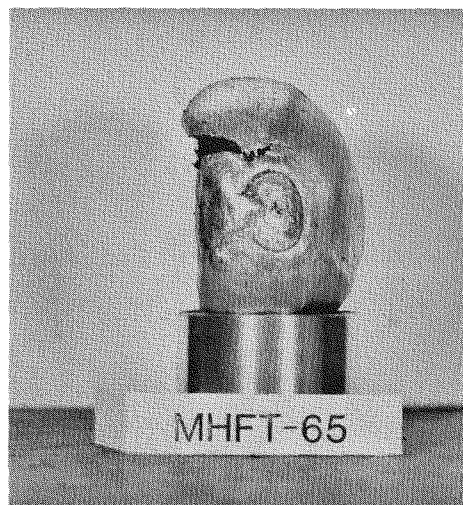
a. Sections of GIS's Used in MHFT 62 and 65*

b. Schematic Drawing of GIS Showing How Failure in GIS Corresponds to Lobe in MHFT 65 PISA

c. Actual Profile of MHFT 65

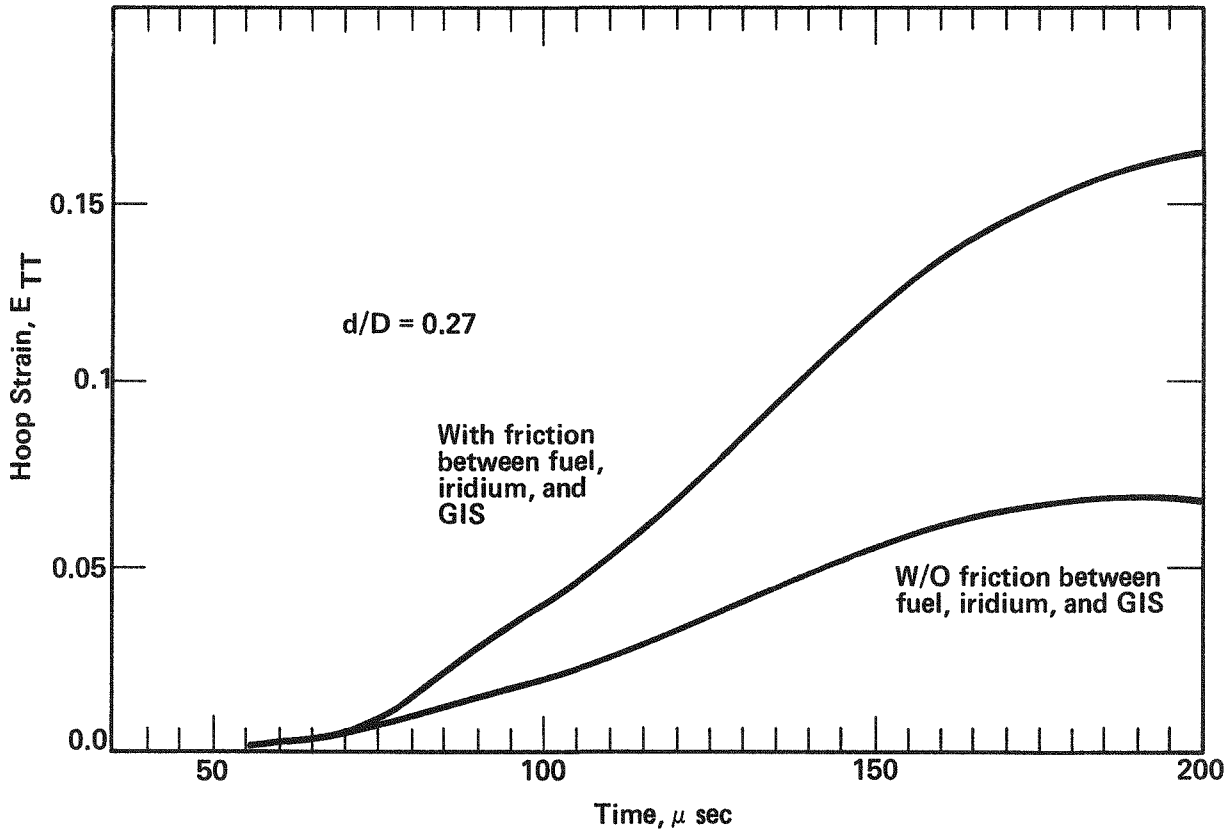
FIGURE 14. Comparison of Hoop Strain-Time Histories in the Iridium Zone

The computer simulation of FSA impacts¹ showed that as the interfacial friction between the GIS and iridium and the fuel and iridium increased, the amount of strain in the iridium increased. This is the result of locking of the iridium between the GIS and fuel so that the motion of the iridium relative to the GIS and the fuel is retarded. Because of this locking, the circumferential (from front around to back) deformation character of the iridium shell is altered, and the hoop strains are significantly increased (especially in the bend-over region where the flat impact face meets the curvature of the sides of the shell). Further, friction causes the circumferential strain to become tensile over most of the front flattened region of the iridium shell. When the coefficient of friction is zero, this strain is calculated by the computer model to be compressive, but becomes increasingly tensile as the coefficient of friction goes up. As the friction increases, the magnitude of the circumferential strain becomes of the same order as the maximum hoop strains and is largest in the area just before the bend-over region begins. There is also a very rapid change in strain rate in the iridium as the shell goes from compressive, very early in impact, to tensile as the impact face flattens out. Iridium is reported to be strain rate sensitive, with ductility decreasing with increasing strain rate. Differences in friction could arise from differences in the amount of dimpling
