Solar Industrial Process Heat (IPH) Project Technical Report October 1982-September 1983

E. L. Harley, W. B. Stine

This document contains a report of the work performed in the Solar Industrial Process Heat Project during FY 1983. The work involved eighteen industrial process heat experiments originally funded by the Department of Energy (DOE) under two separate programs. During FY 1983, eight of the experiments were in the operational phase directly supported by the DOE, seven had been completed previously and the solar equipment had been transferred to the plant owners for continued operation, and three had been discontinued.

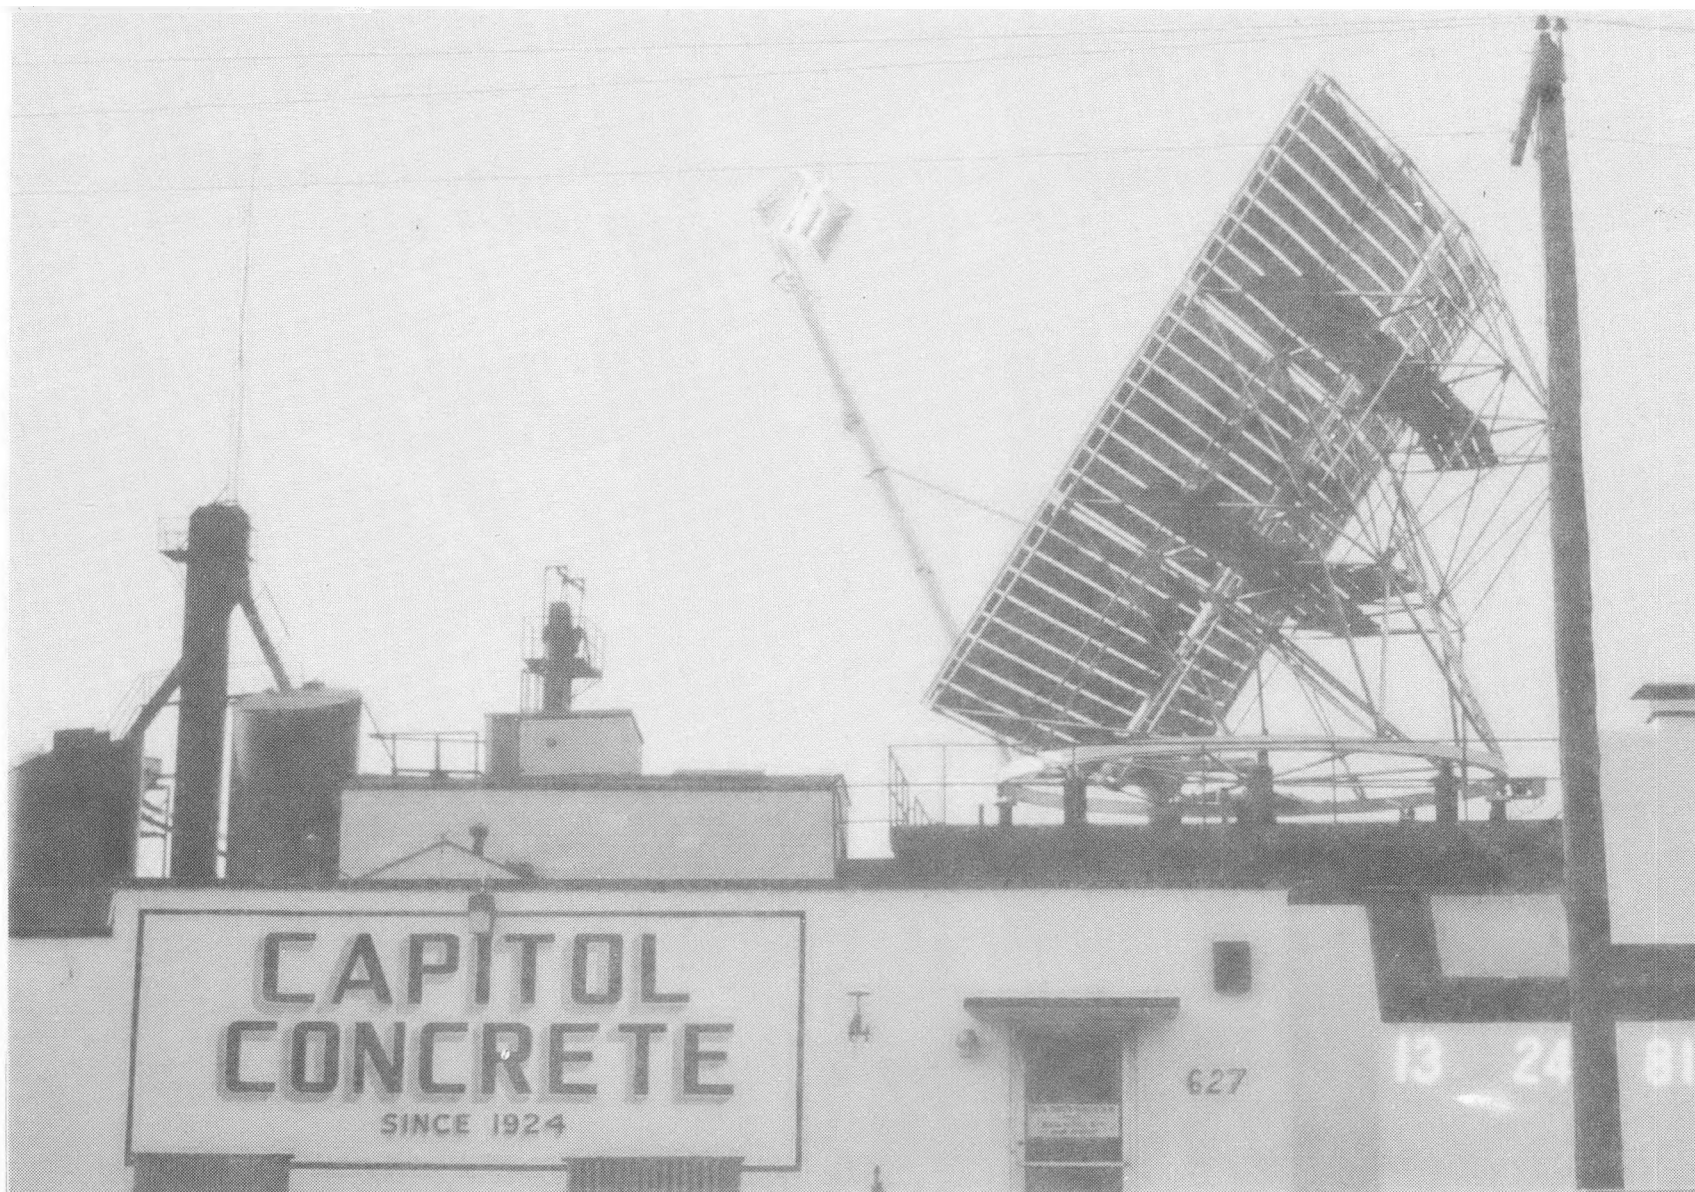
Figure 1-3. Solar Energy Collector at Capitol Concrete Products Inc., Topeka, Kansas

A well-insulated galvanized steel receiver is mounted on a boom at the focal point of the concentrator. Boiling takes

place within the receiver. A variety of receivers appropriate for specific applications has been tested including monotube and parallel-tube configurations. The entire collector system is located on top of a storage shed adjacent to the autoclave.

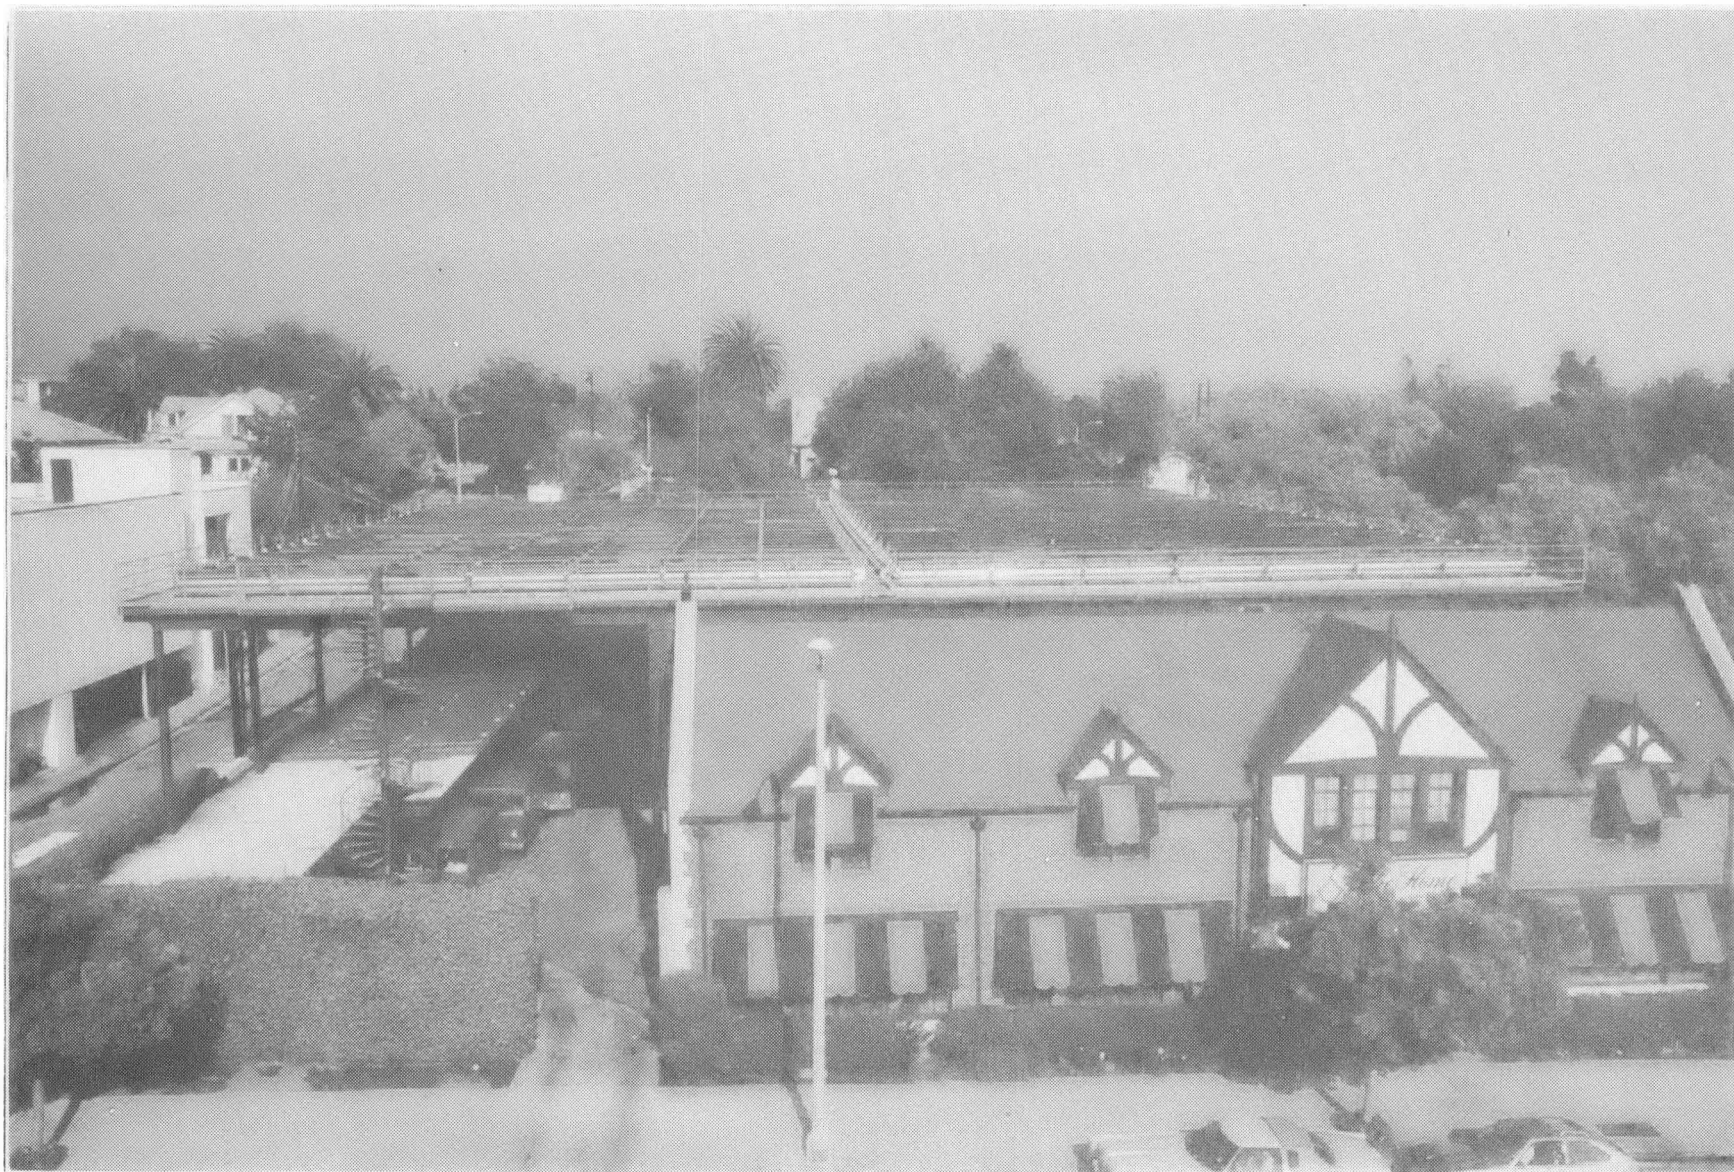
Figure 1-9. Solar Collector Array at Home Laundry, Pasadena, California

Home Laundry -- The solar IPH experiment at Home Laundry, Pasadena, CA, (Figure 1-9) a Cycle 2 project, began its operational phase in October 1982. At that time the system, which uses Del Manufacturing Co. parabolic-trough collectors, was operating well. However, problems with the data acquisition system prevented collecting and reporting good performance data until February 1983. The system operated throughout the year producing hot water and steam, the choice depending on demand from the laundry. During this period, the thermal efficiency for the system averaged 32%. The DOE contract expired in September 1983, the laundry moved to a different building, and operation of the IPH system was discontinued.

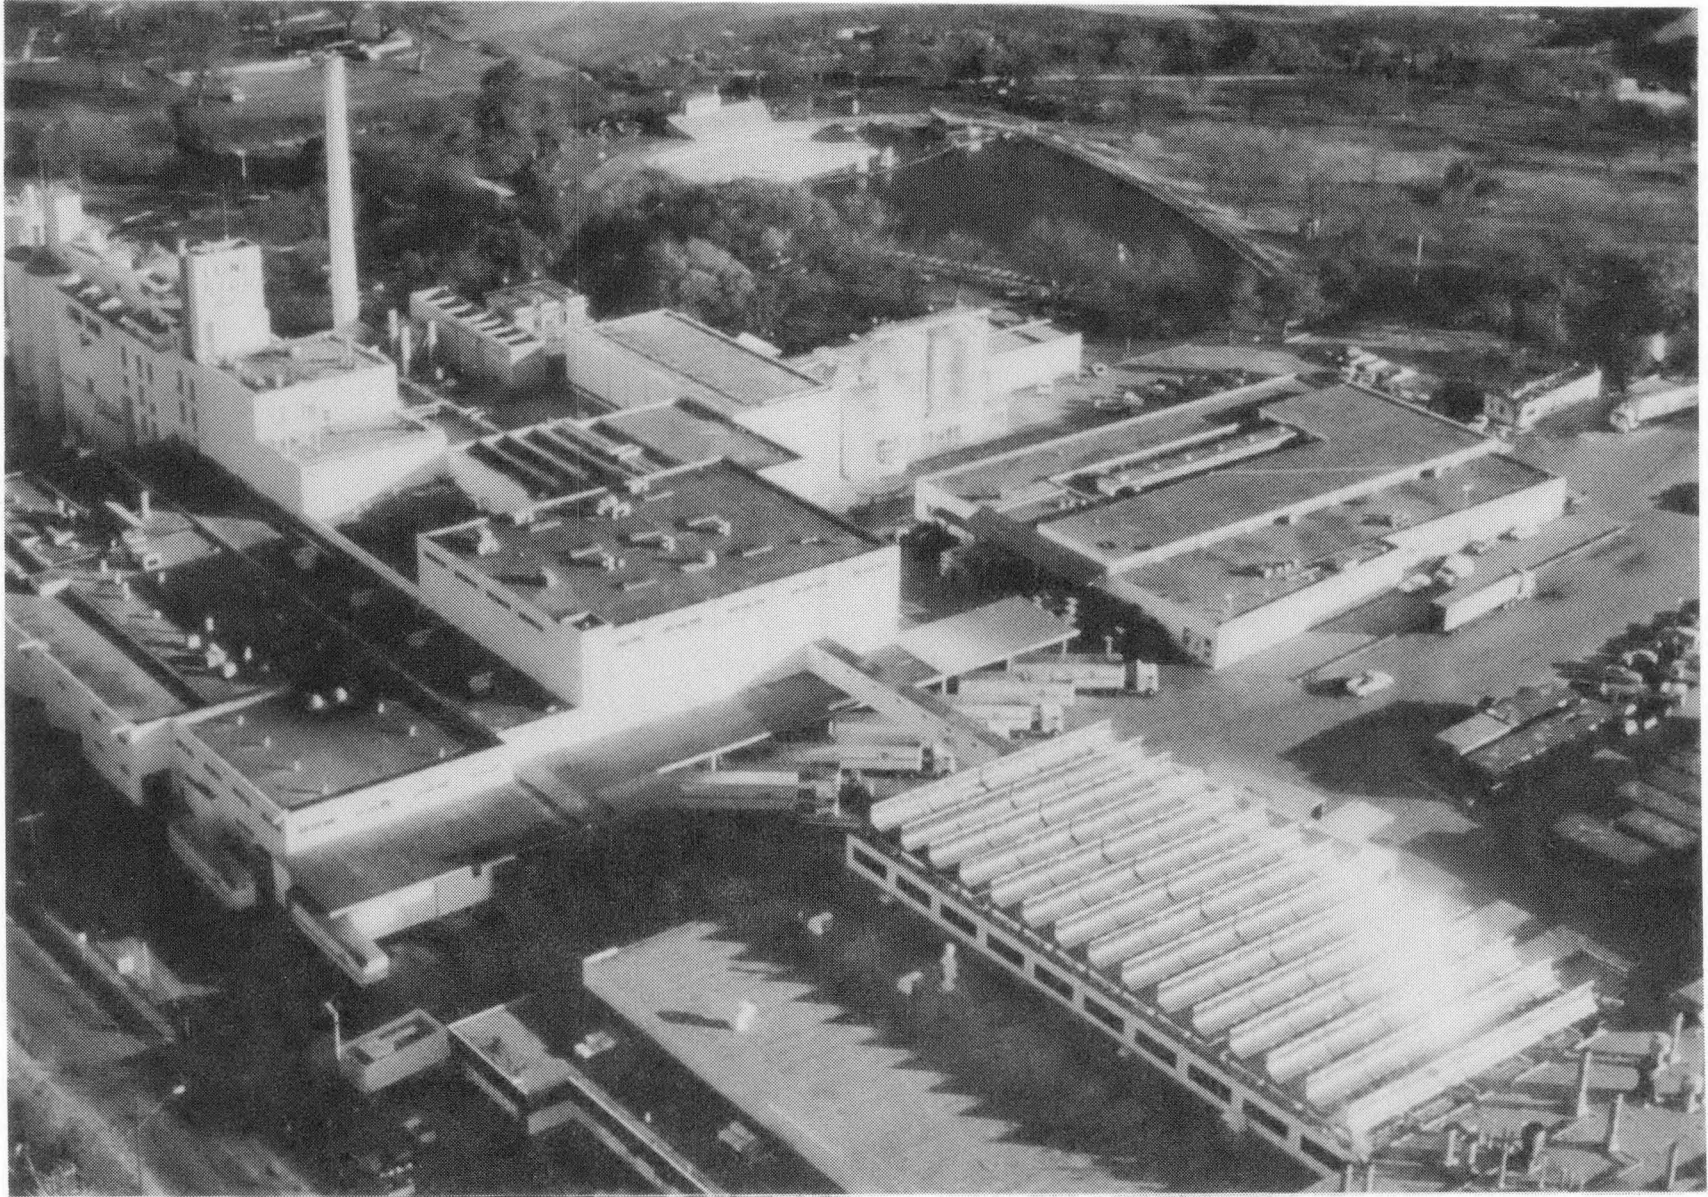
Figure 1-11. Solar Collector Array at Lone Star Brewery, San Antonio, Texas

Lone Star Brewery -- The solar IPH system at Lone Star Brewery, San Antonio, TX, (Figure 1-11) a Cycle 3 project, operated at reduced capacity from October 1982 through May 1983 with an average thermal efficiency of 17%. Two of fifteen rows of collectors were shut down because of oil leaks and subsequent damage from overheating. The system was shut down completely when additional oil leaks developed and when the DOE contract with Southwest Research Institute, the prime contractor, expired. A final Phase III (Operations) report was issued. Subsequently, the contract was reinstated, and an extensive upgrade was authorized. The upgrade includes converting from an oil-based heat-transfer fluid operating at high temperature to a lower temperature water system and generally improving the solar equipment.

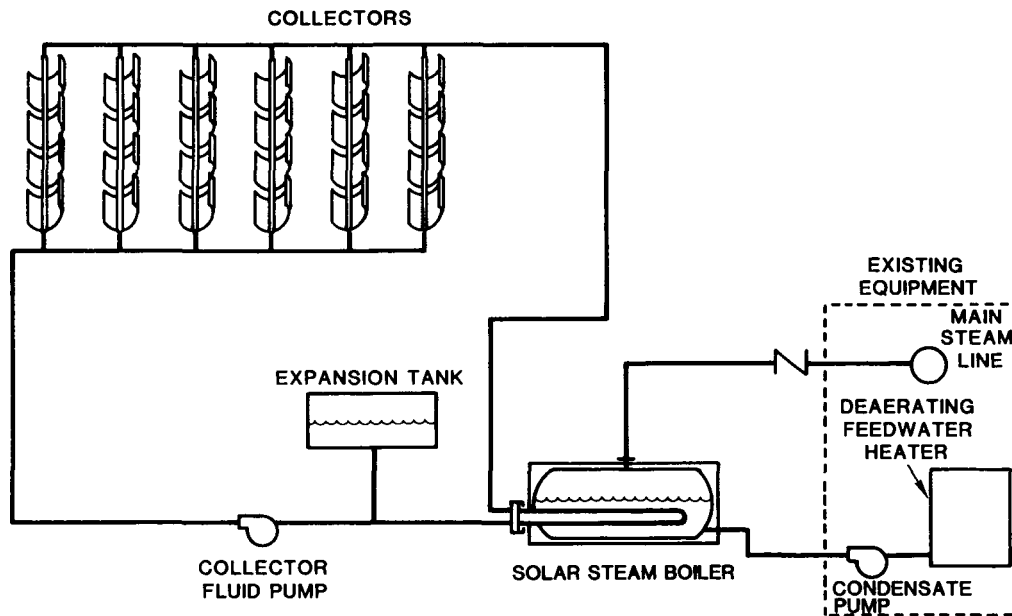
Figure 1-12. Schematic of Solar Energy System - Lone Star Brewery

Therminol 55 is the heat-transfer fluid in this closed-loop system. It flows through the collector loop at 3.76×10^{-3} m³/s (75 GPM) and attains a maximum temperature of 218°C (425°F) under maximum insolation conditions. The heat-transfer fluid was subsequently changed to water to eliminate concerns about leakage of heat-transfer oil leaking on the roof.

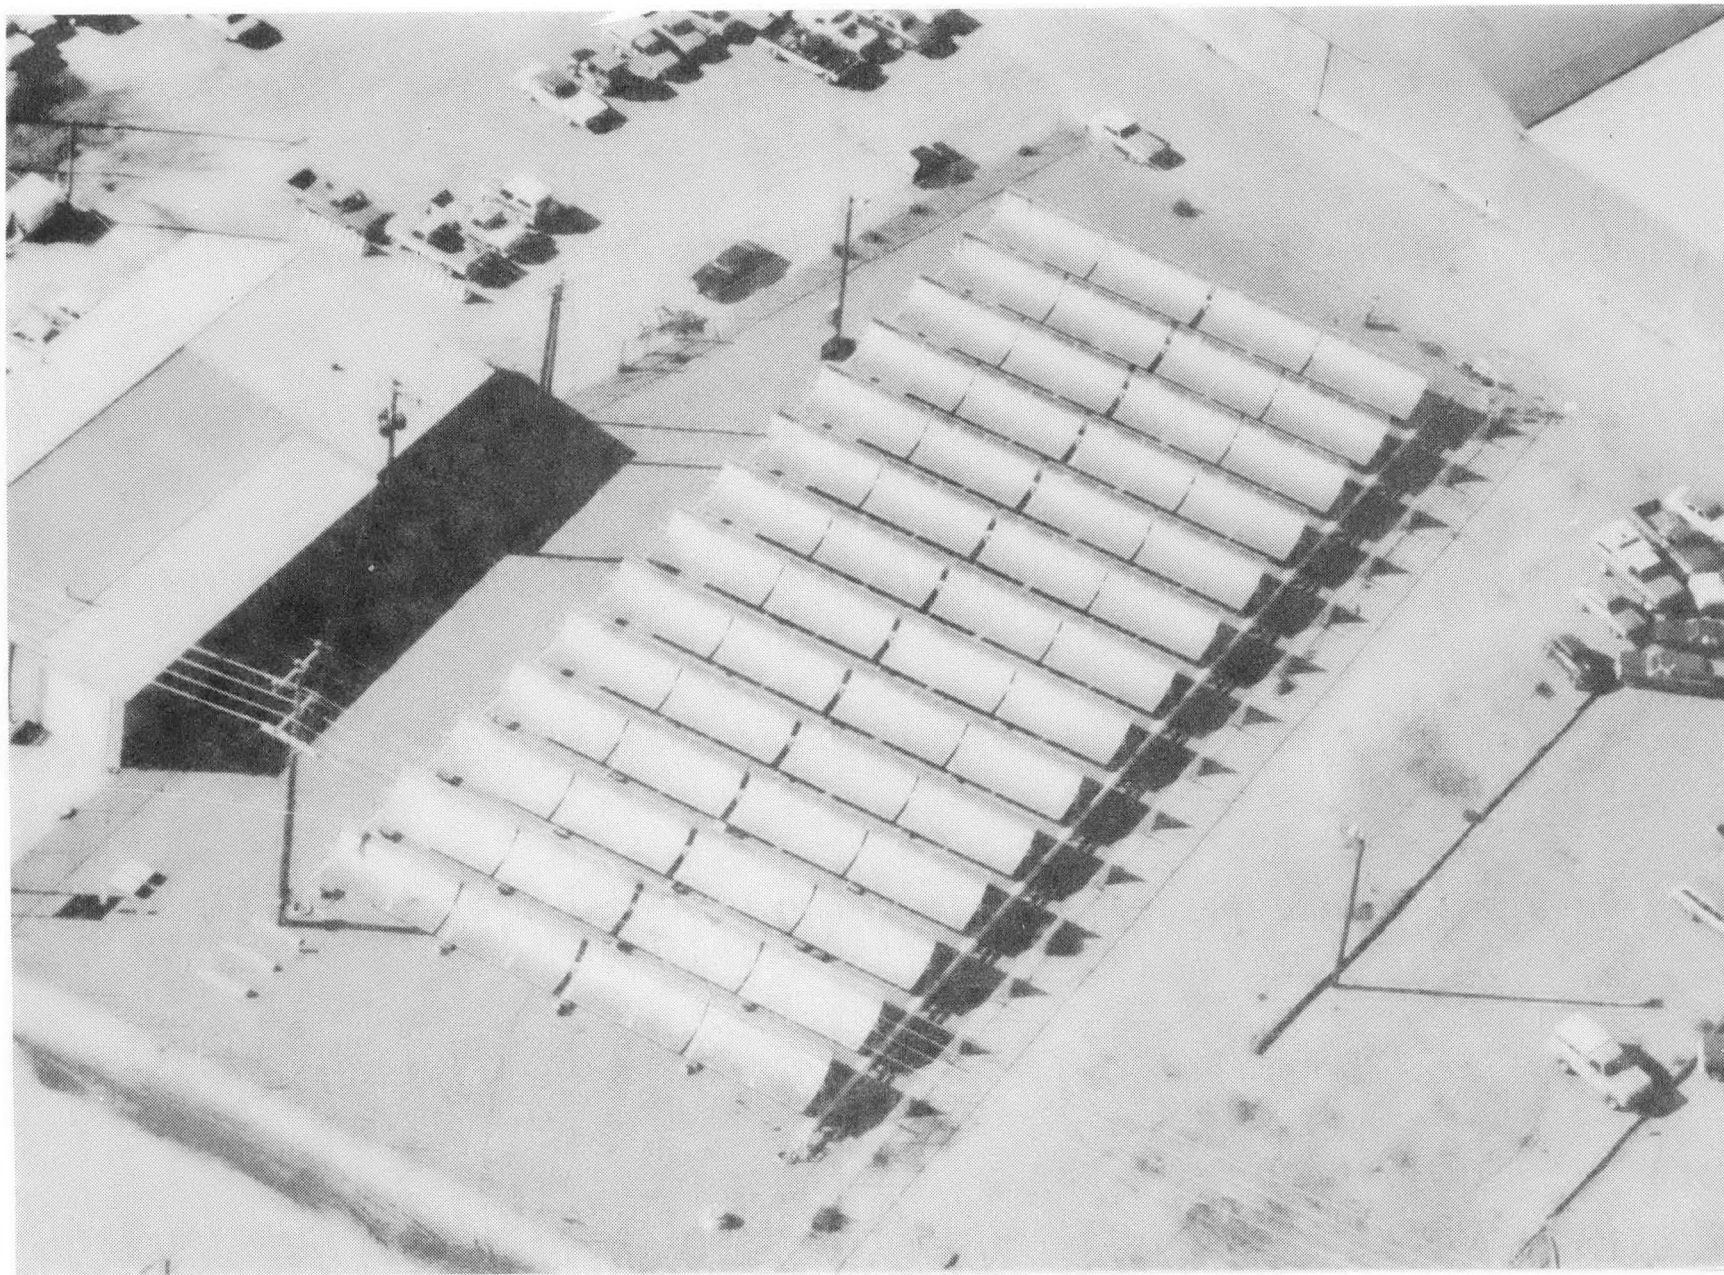
Figure 1-13. Solar Collector Array at Ore-Ida Foods, Ontario, Oregon

Ore-Ida Foods -- The solar IPH system at Ore-Ida Foods, Ontario, OR, (Figure 1-13) a Cycle 3 project, used parabolic-trough collectors to generate steam to provide heat for frying onions and potatoes. The acceptance test was performed in June 1981. Subsequently, it operated sporadically until the project was discontinued in March 1983. Problems with the main circulating pump and a flex-hose failure caused the system to be shut down for long periods. When the Phase III contract expired in March 1983, upgrade was considered but was declined because the value of the energy savings did not justify the cost of repairs.

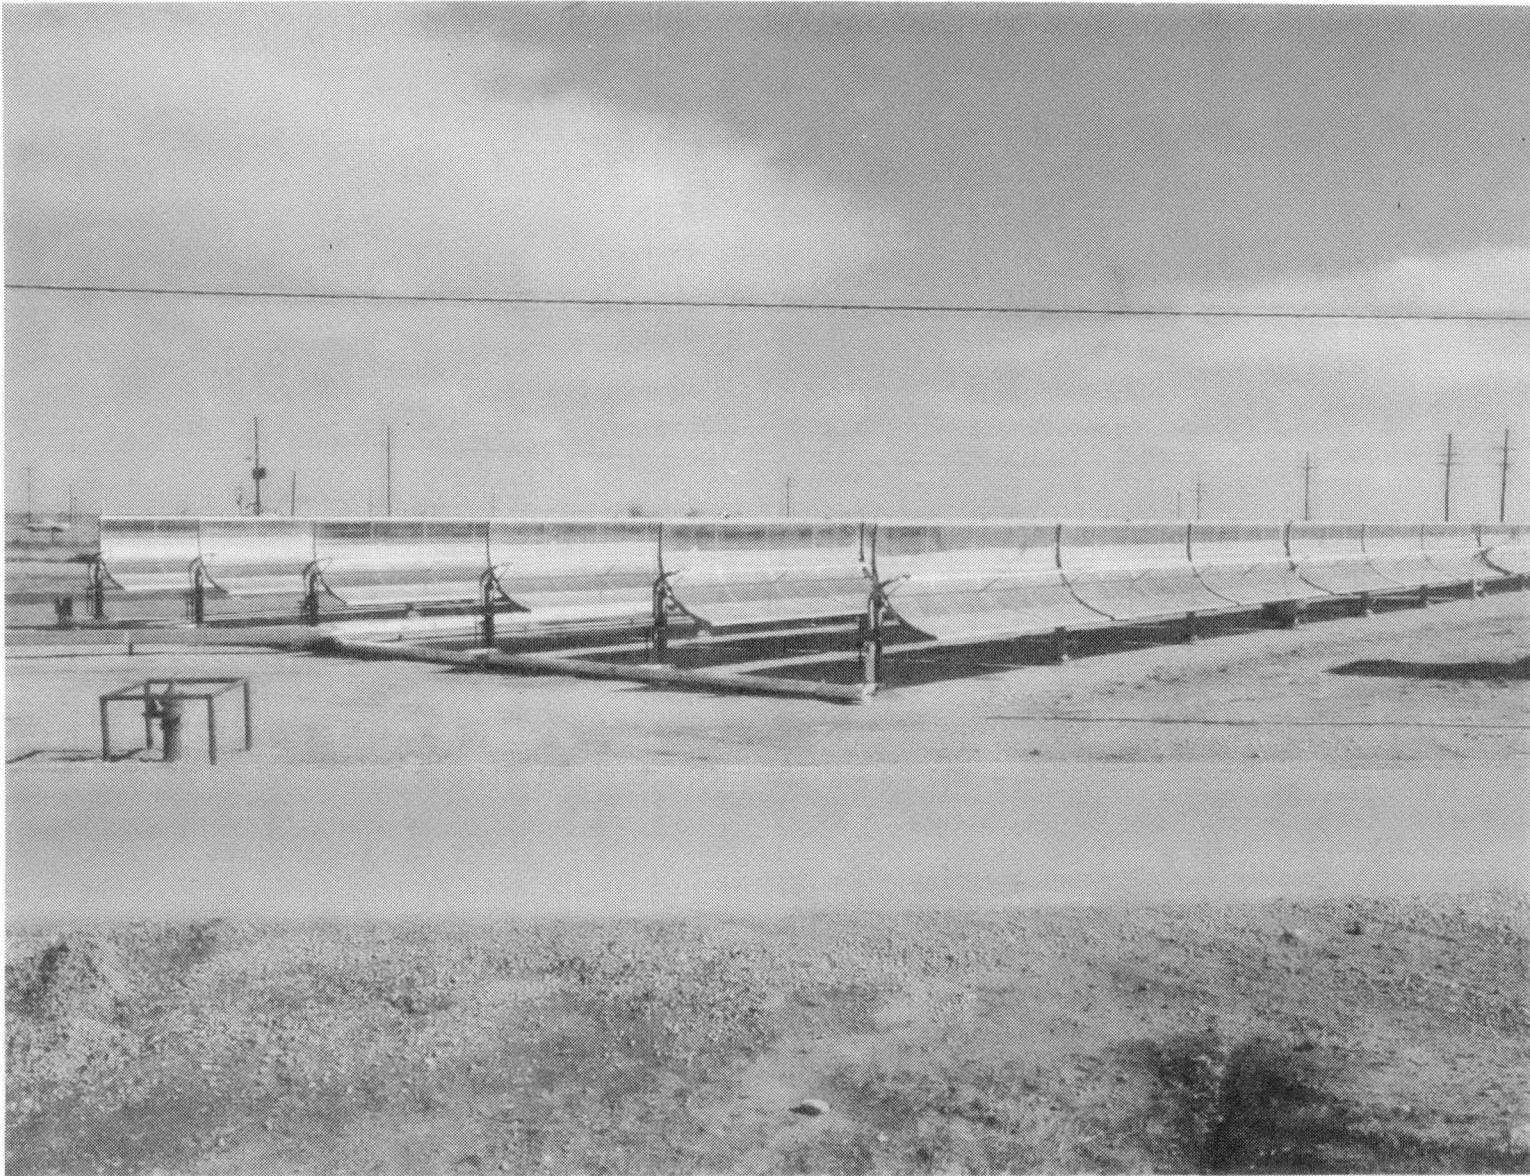
Figure 1-15. Solar Collector Array at Southern Union Refining Company,
Lovington, New Mexico

Southern Union Refining Co. -- The solar IPH system at Southern Union Refining Co., Lovington, NM, (Figure 1-15) a Cycle 3 project, was in the operational phase throughout the year. The system experienced many equipment problems, but energy production was reported from October 1982 to August 1983. During this period, the average system thermal efficiency was 19%. In September, the system was shut down for an extensive revision to the collector field piping. A system upgrade was authorized to correct solar equipment problems. The upgrade was in process at the end of the fiscal year.

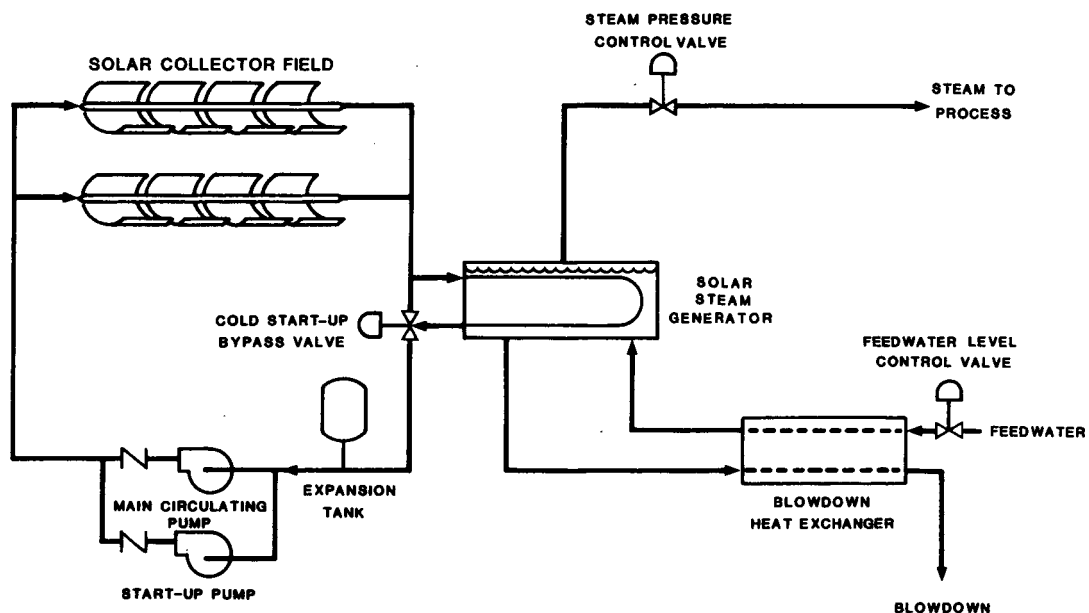
Figure 1-16. Schematic of Solar Energy System - Southern Union Refining Co.

At maximum operating conditions, the solar steam system produces 816 kg/h (1,800 lb/h) of 1,207-kPa (175-psig) saturated steam. The primary steam supply is generated by a natural gas-fired boiler. Thermal storage is not provided in the system.

A schematic of the system is shown in Figure 1-16. The design characteristics for this system are summarized in Table 1-7. The system and its operation are described in Reference 6.

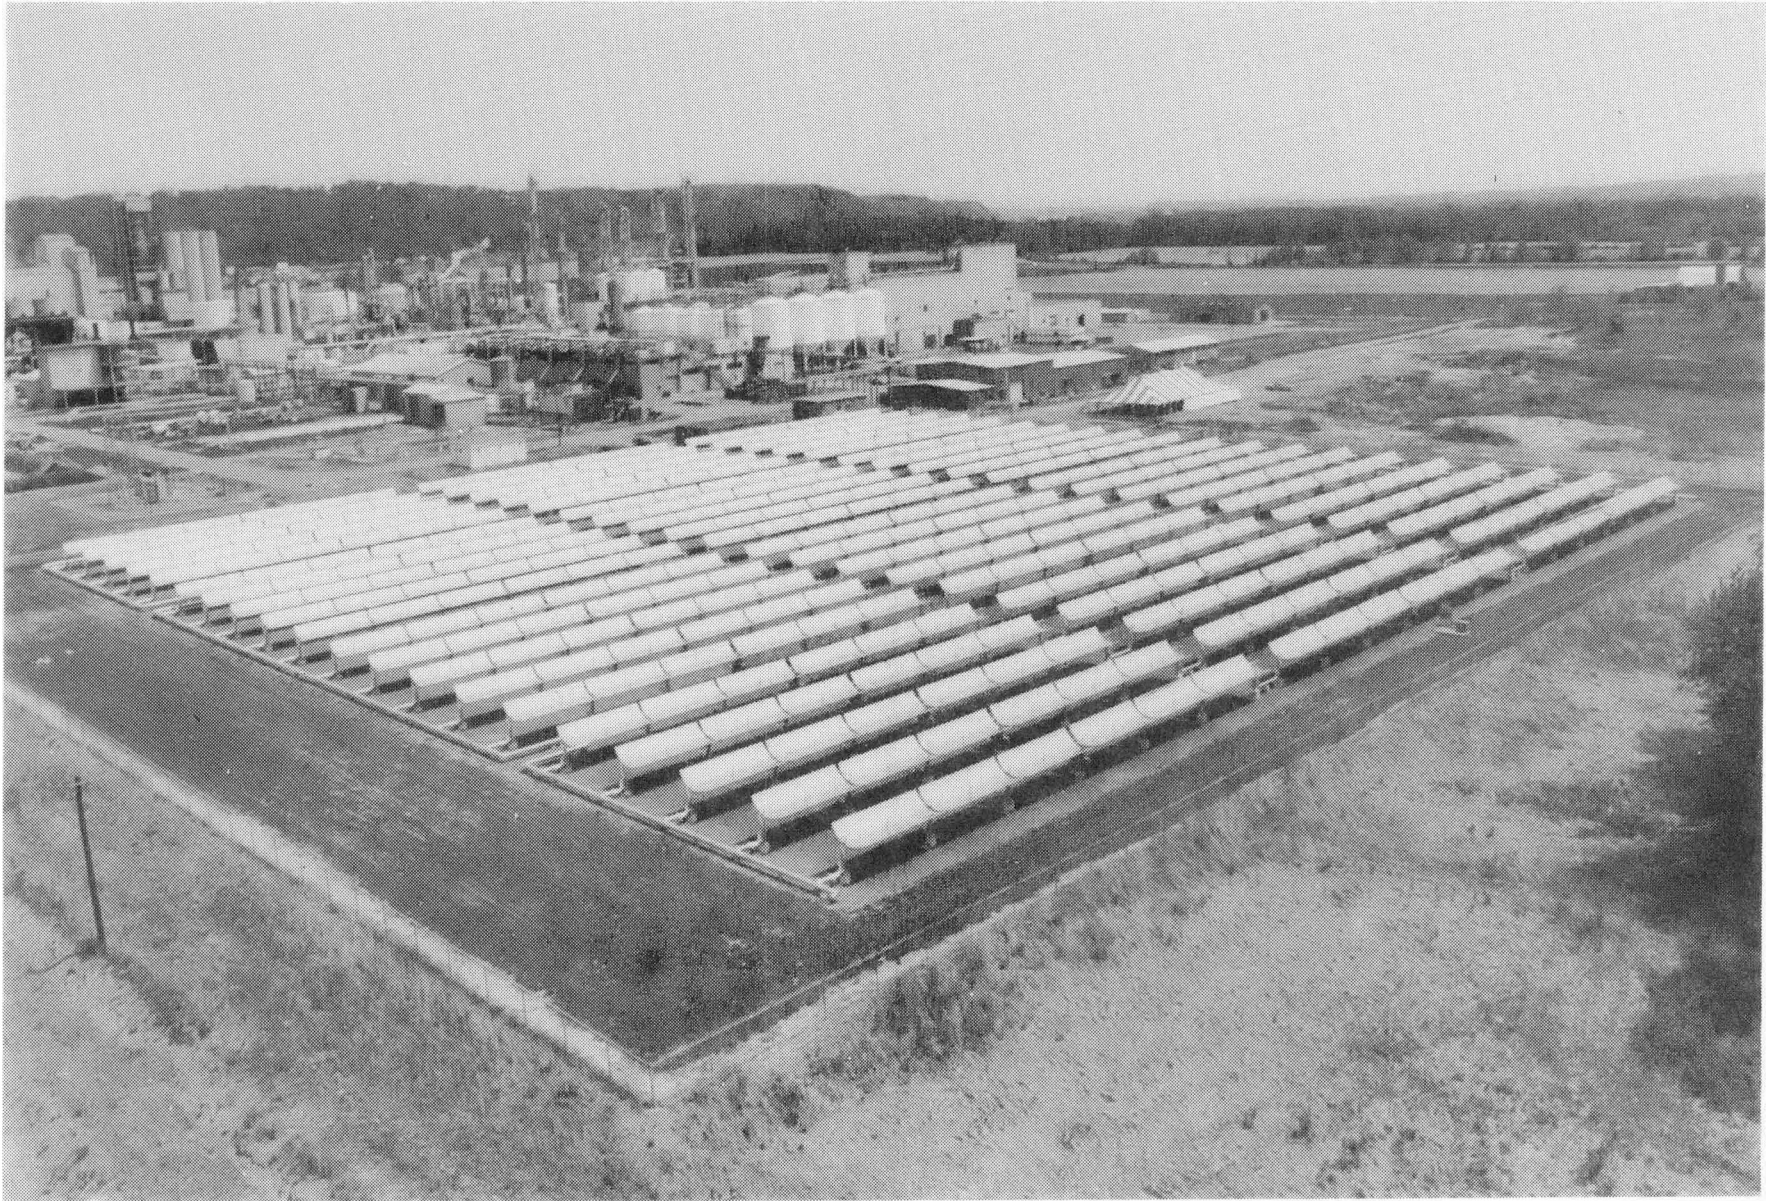
Figure 1-17. Solar Collector Array at USS Chemicals Company, Haverhill, Ohio

A heat-transfer fluid, Monsanto Therminol 60, is pumped through the solar collector array at a nominal flow rate of 14.5 kg/s (320 GPM). Solar collector outlet temperature after initial warmup is nominally 204°C (400°F), but actual outlet
